NASA Contractor Report CR-195395

# Two Rotor Stratified Charge Rotary Engine (SCRE) Engine System Technology Evaluation

**T. Hoffman, J. Mack and R. Mount**  
*Rotary Power International, Inc.*  
*Wood-Ridge, New Jersey*

October 1994

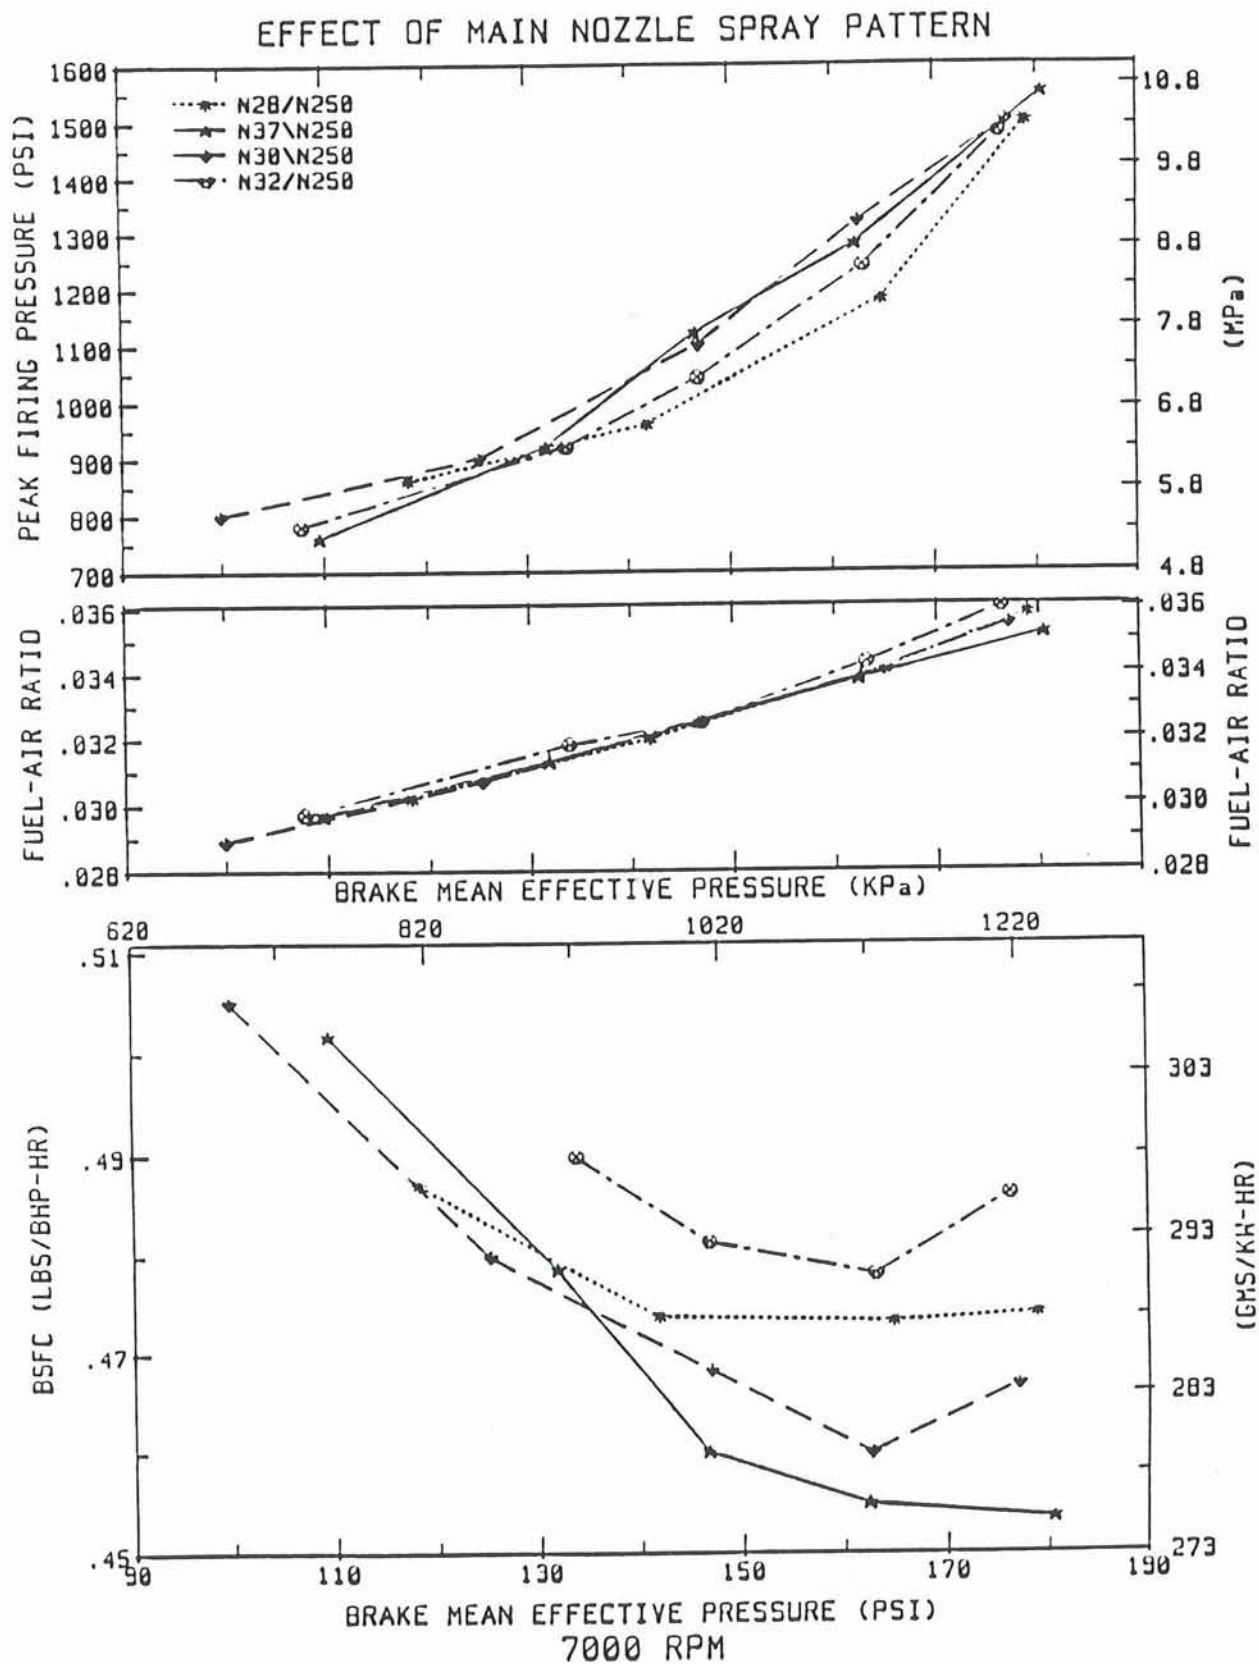
Figure 4.3.2-2 HSUI Main Nozzle Spray Pattern Performance - Single Rotor Engine

Four additional main nozzle configurations were evaluated. The observed performance at 7000 rpm is plotted as Figure 4.3.2-2. The "N30" is the same 7F pattern as originally tested, except the orifices are smaller (0.009" vs. 0.010"). The fuel consumption at the max

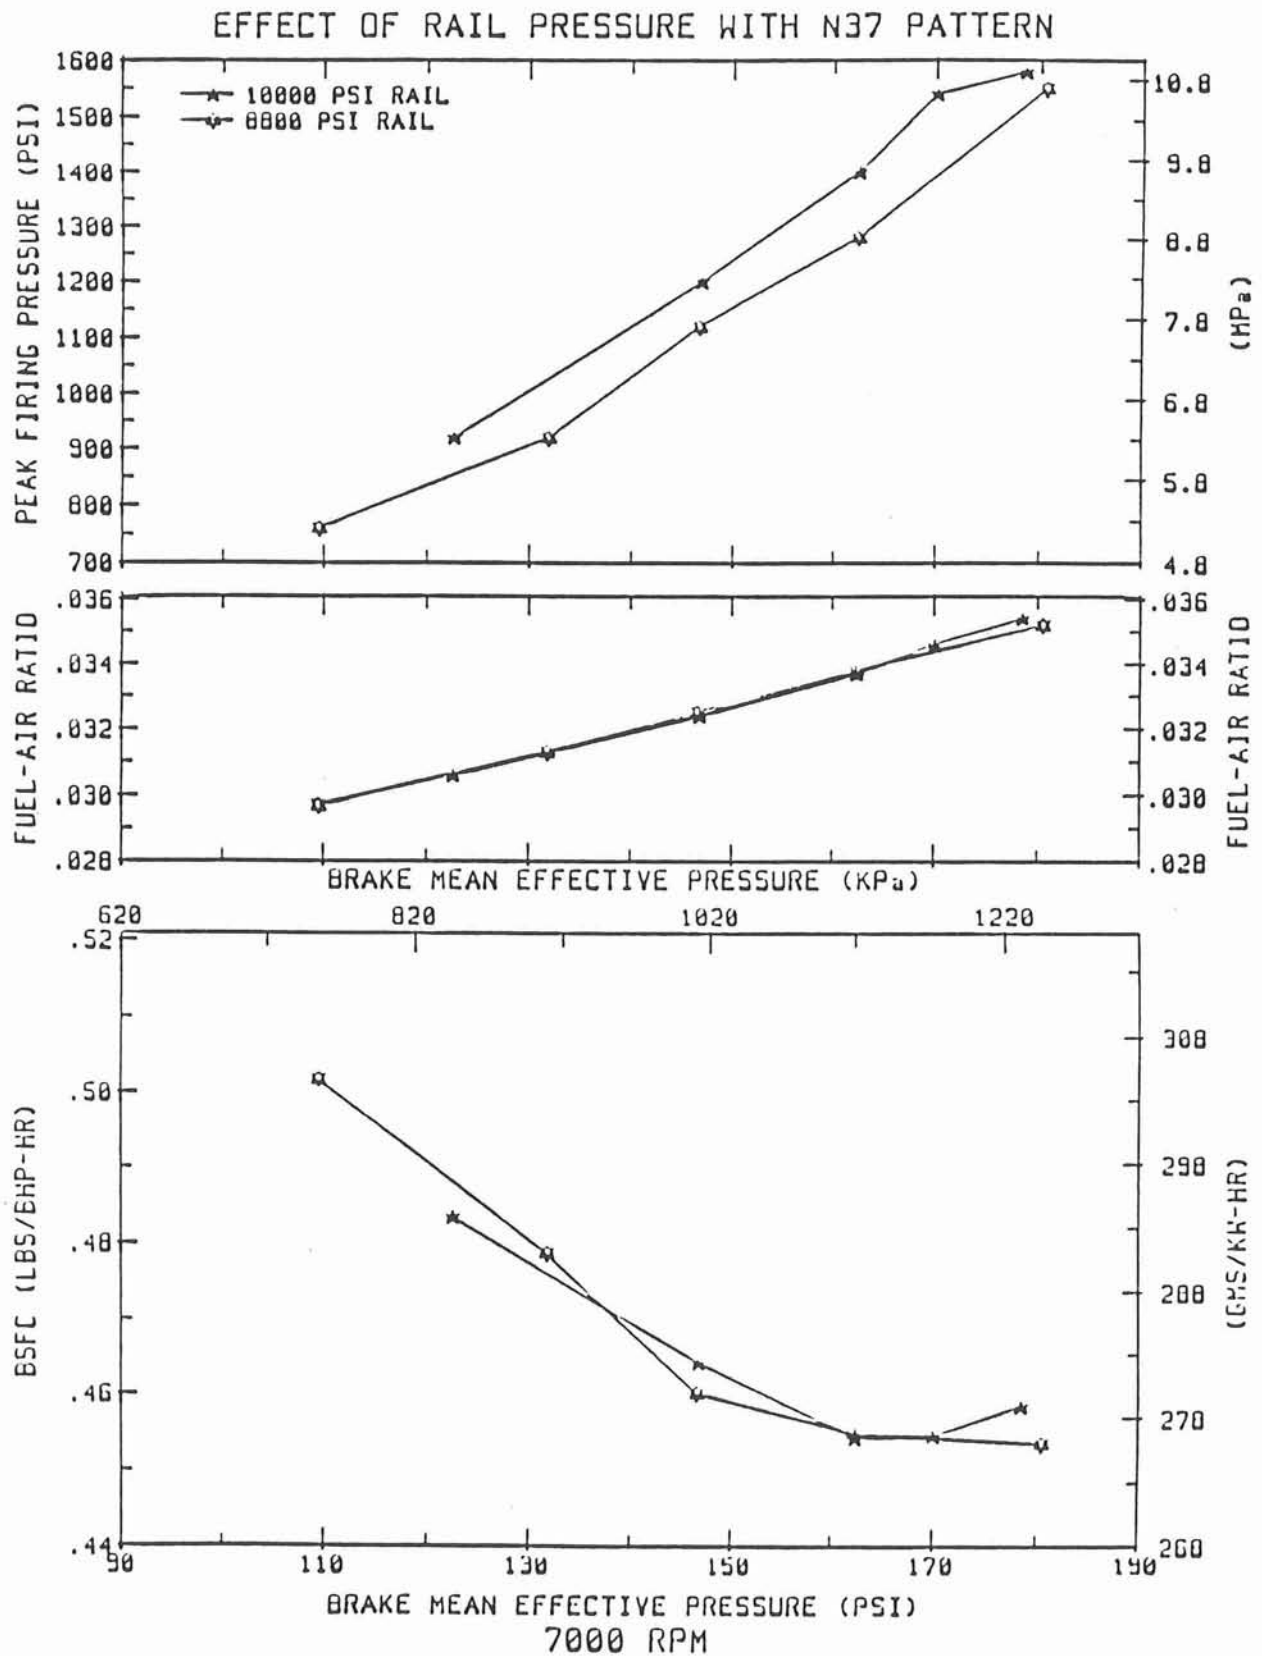
Figure 4.3.2-3 Performance Sensitivity to Rail Pressure with "N37" Main Nozzle Spray Pattern - Single Rotor Engine

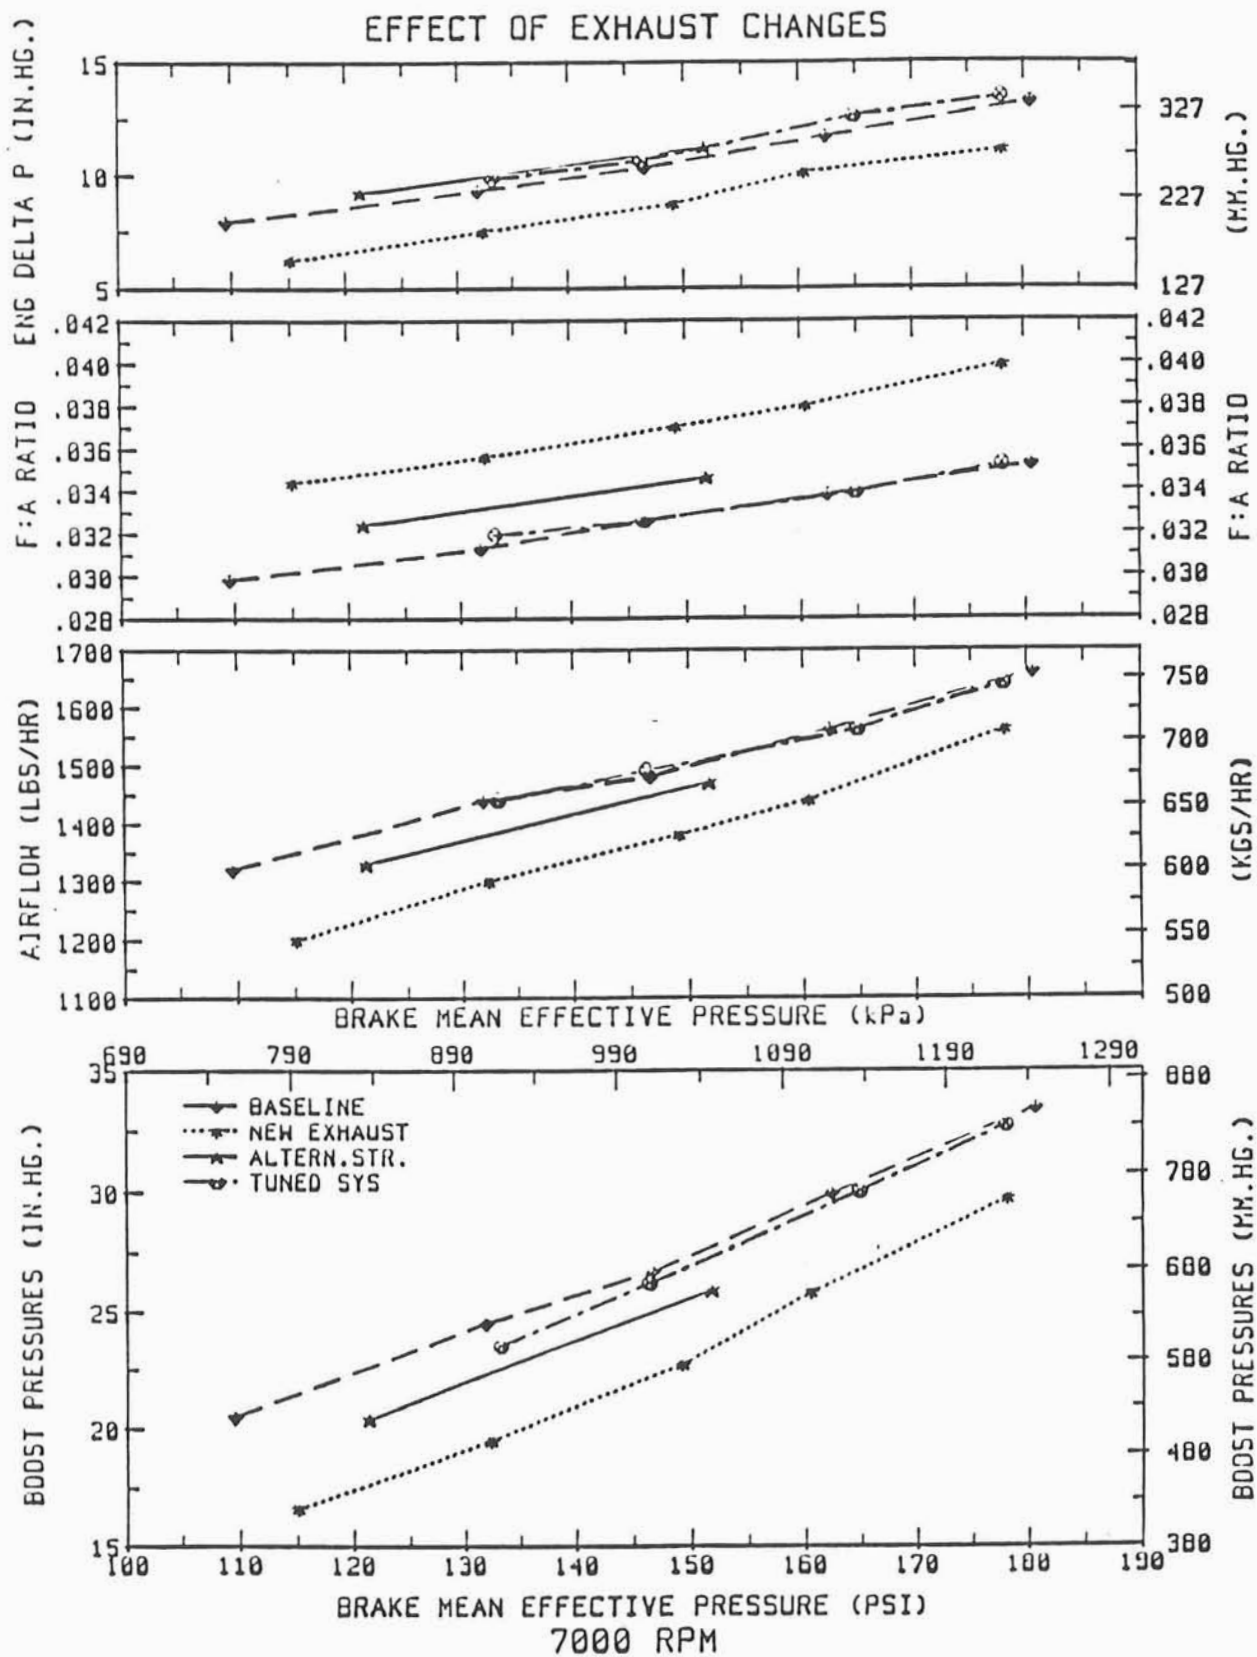
Figure 4.3.2-4 Performance Sensitivity to Exhaust System Configuration - Single Rotor Engine

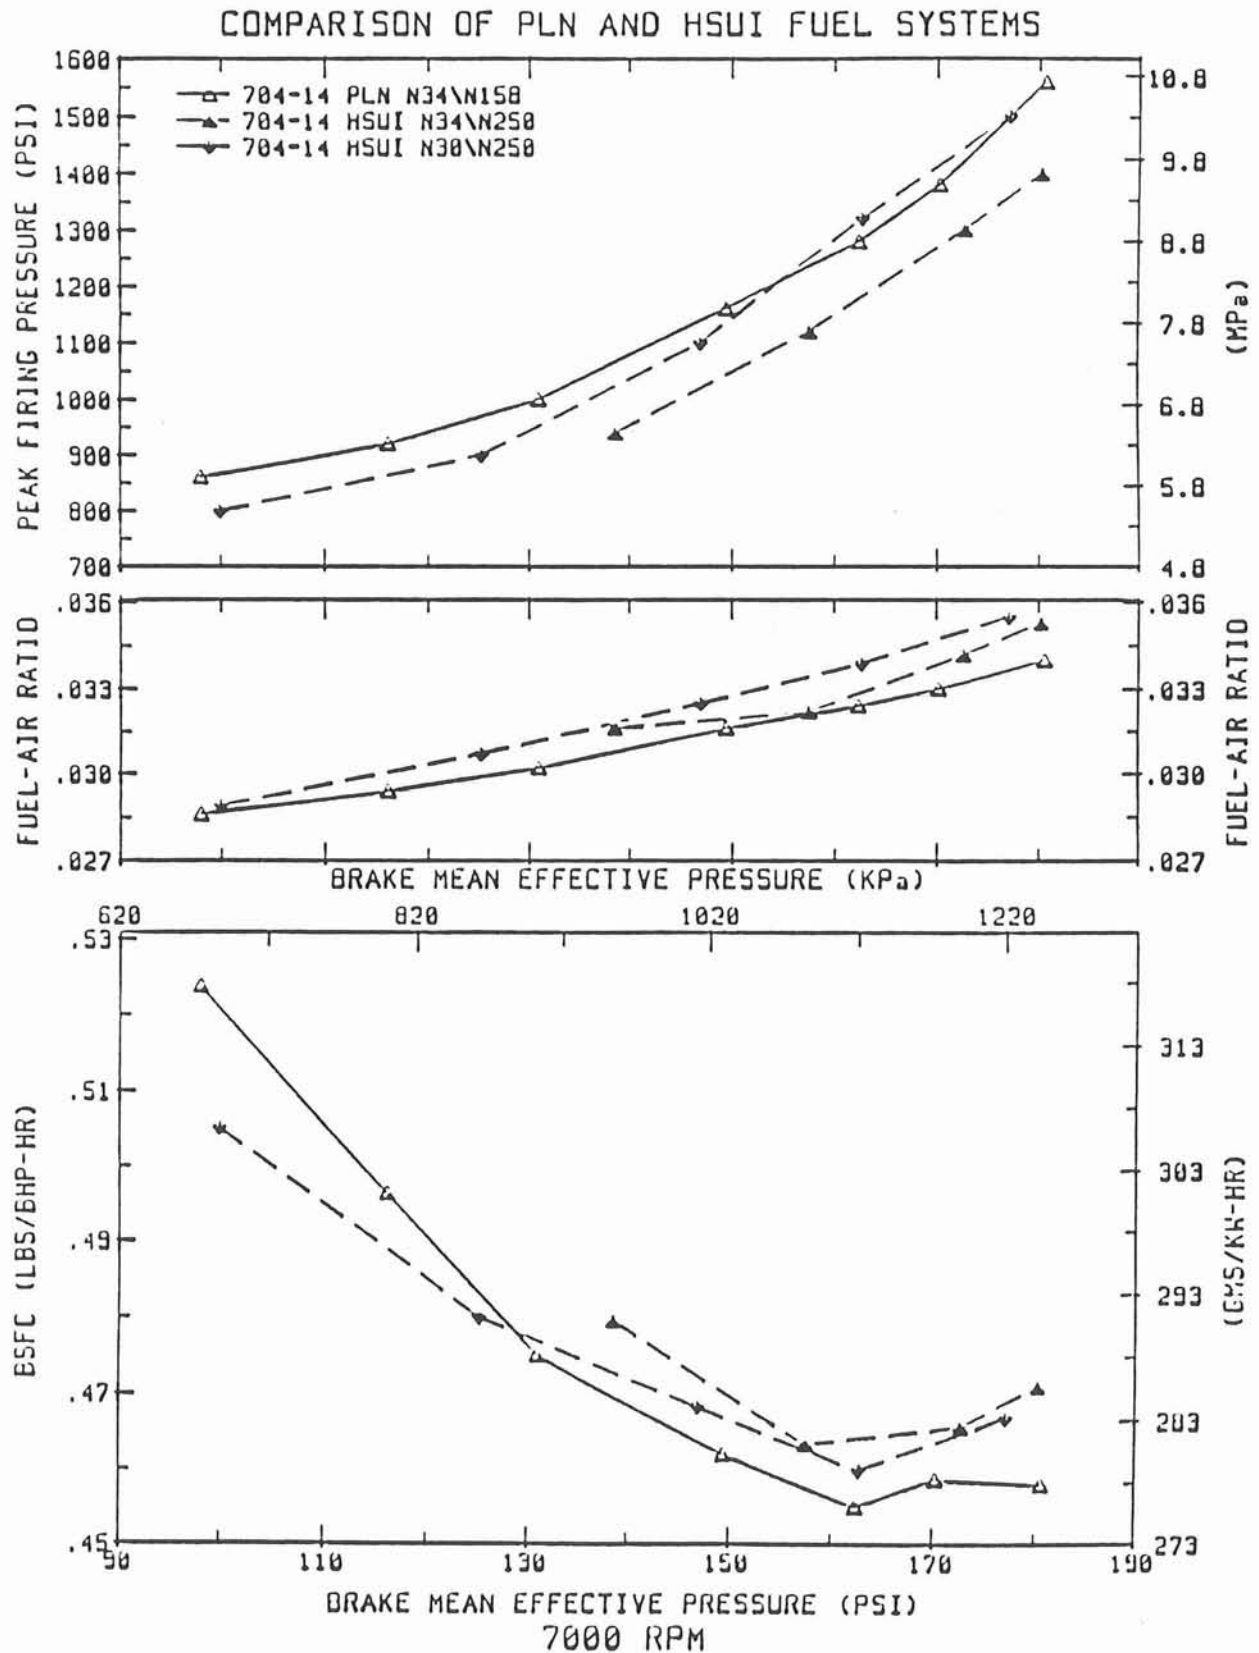
Figure 4.4.3-1 Performance Comparison of Pump-Line-Nozzle and HSUI Fuel Injection Systems - Single Rotor Engine

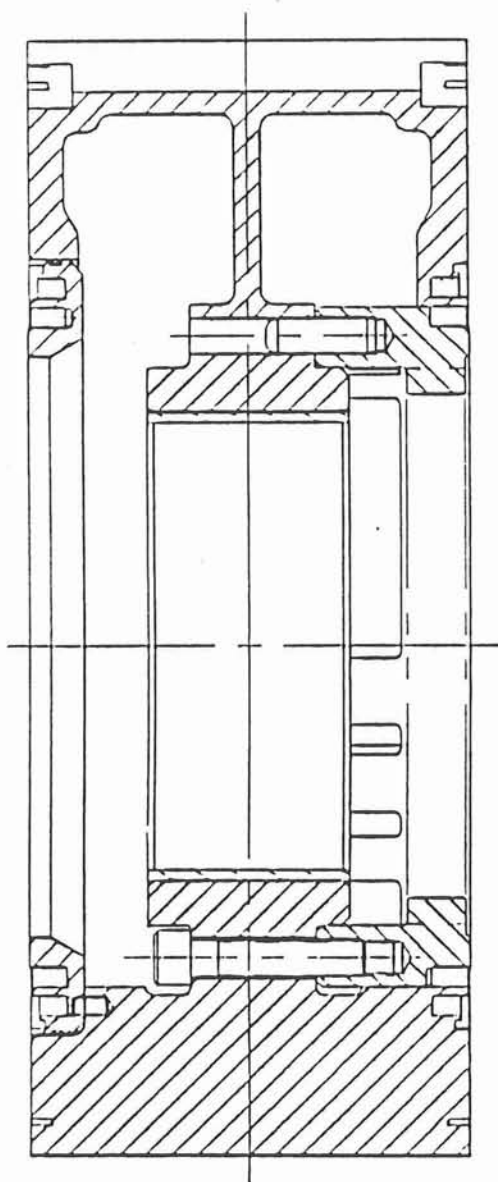
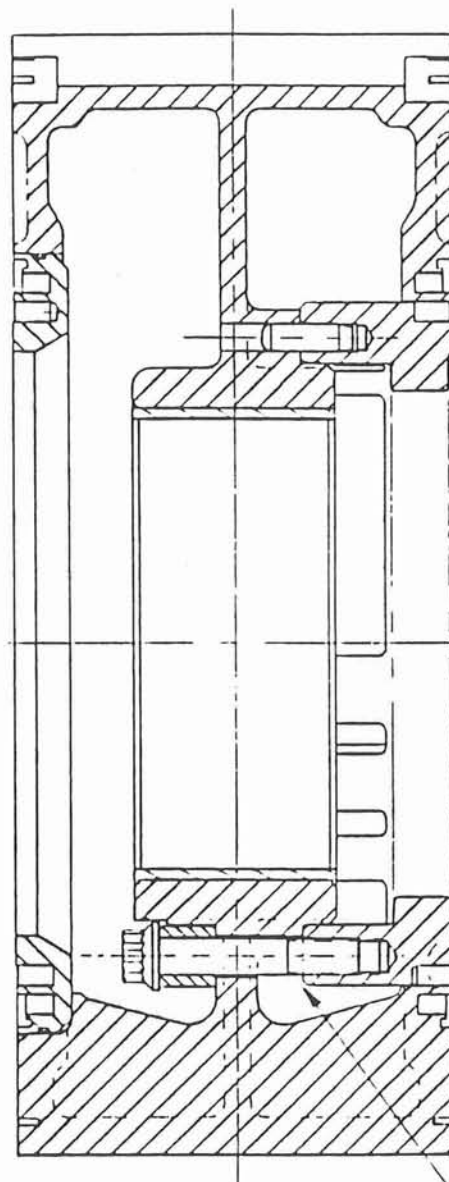
**"BLUEPRINT" DESIGN**

**SALVAGE REWORK**

**NOTE THE LACK OF SUPPORT AT  
THE OUTBOARD REGION OF THE  
GEAR ATTACHMENT LUGS**

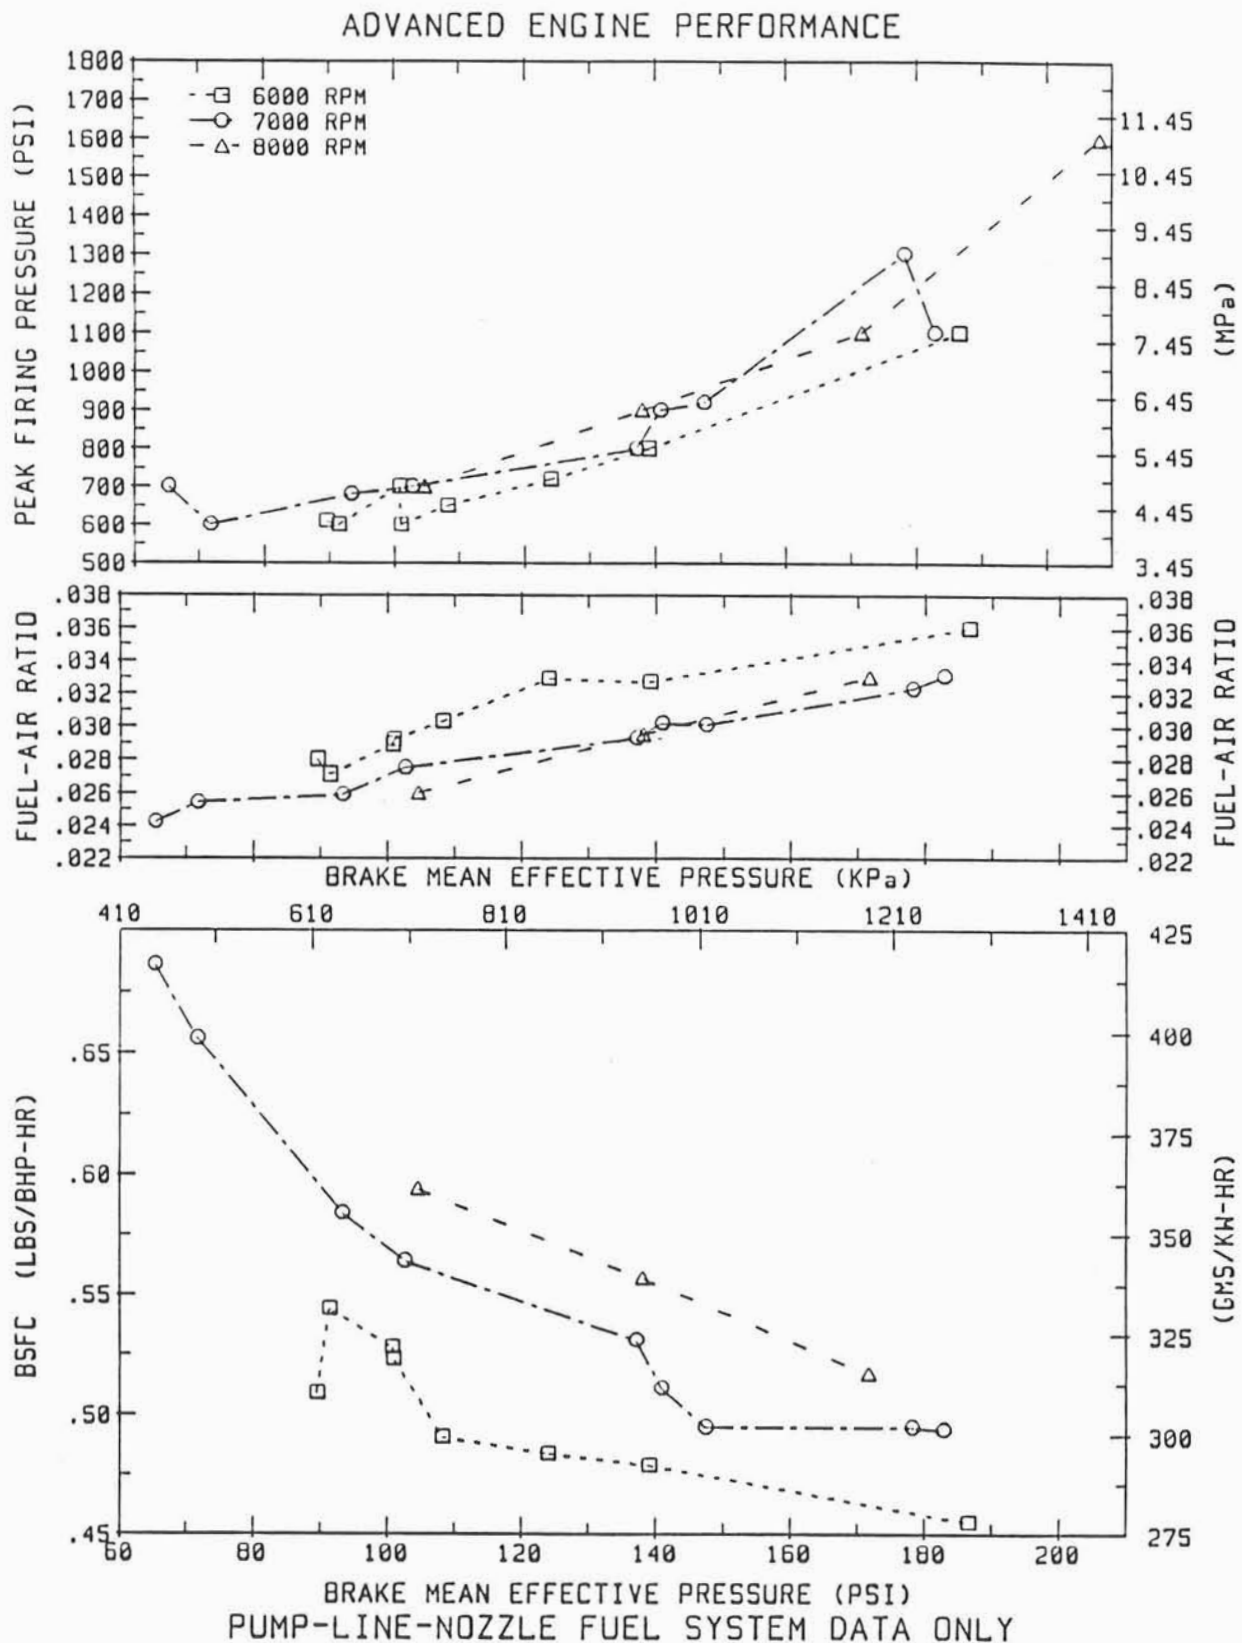
Figure 5.2.5-1 Advanced Engine Performance

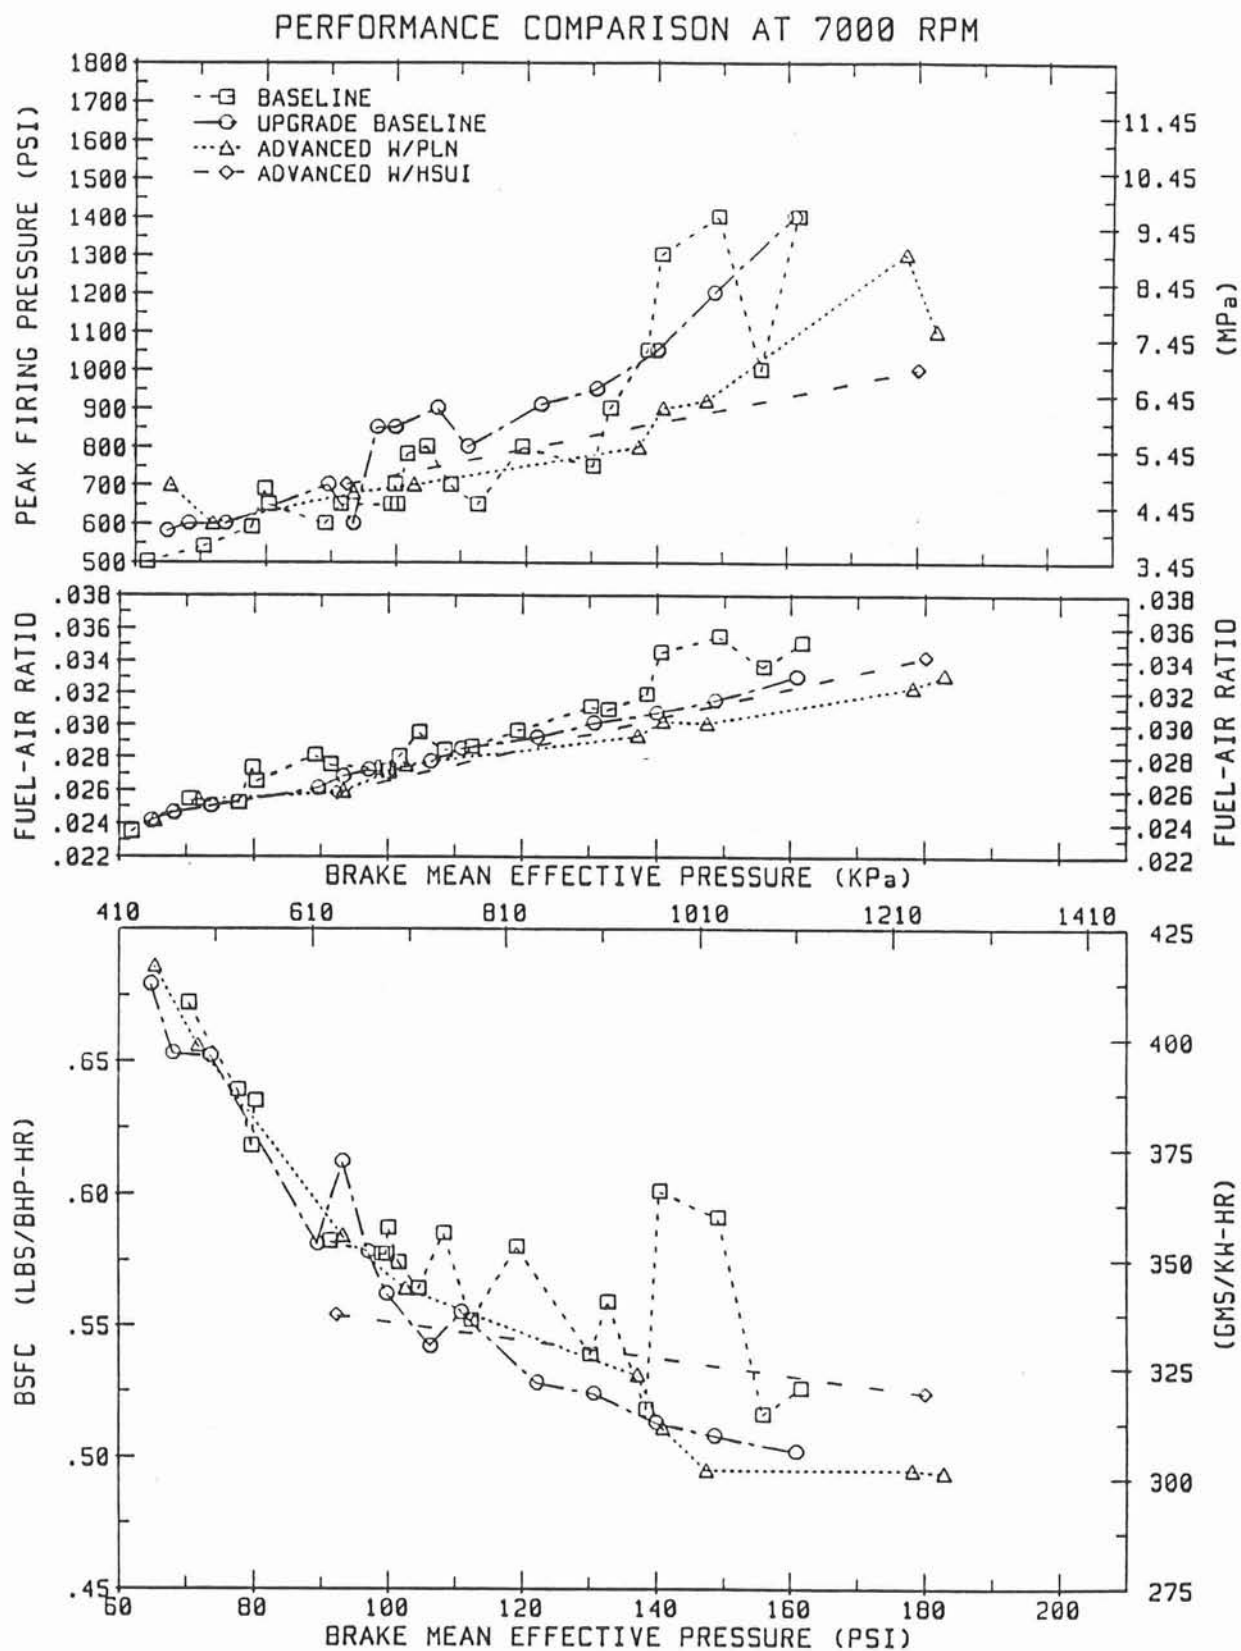
Figure 5.2.5-2 Two Rotor Engine Performance (7000 rpm)

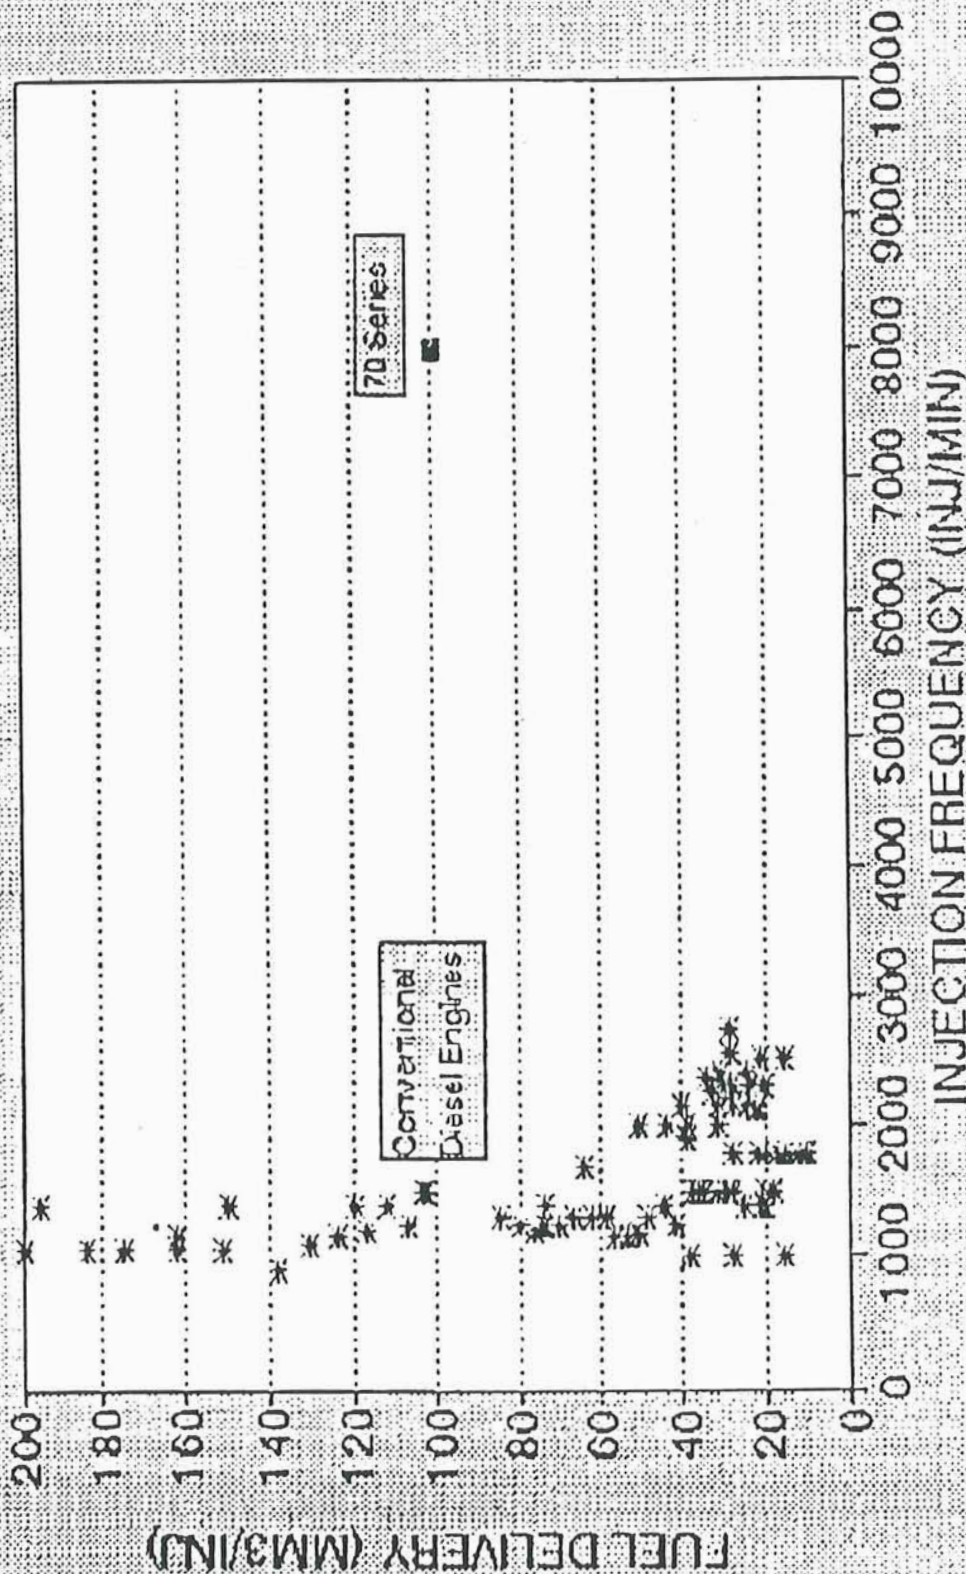
# COMPARISON OF FUEL SYSTEM REQUIREMENTS SCRE 70 VS CONVENTIONAL DIESELS

Figure 6.1.1-1 Fuel System Delivery Requirements Comparison

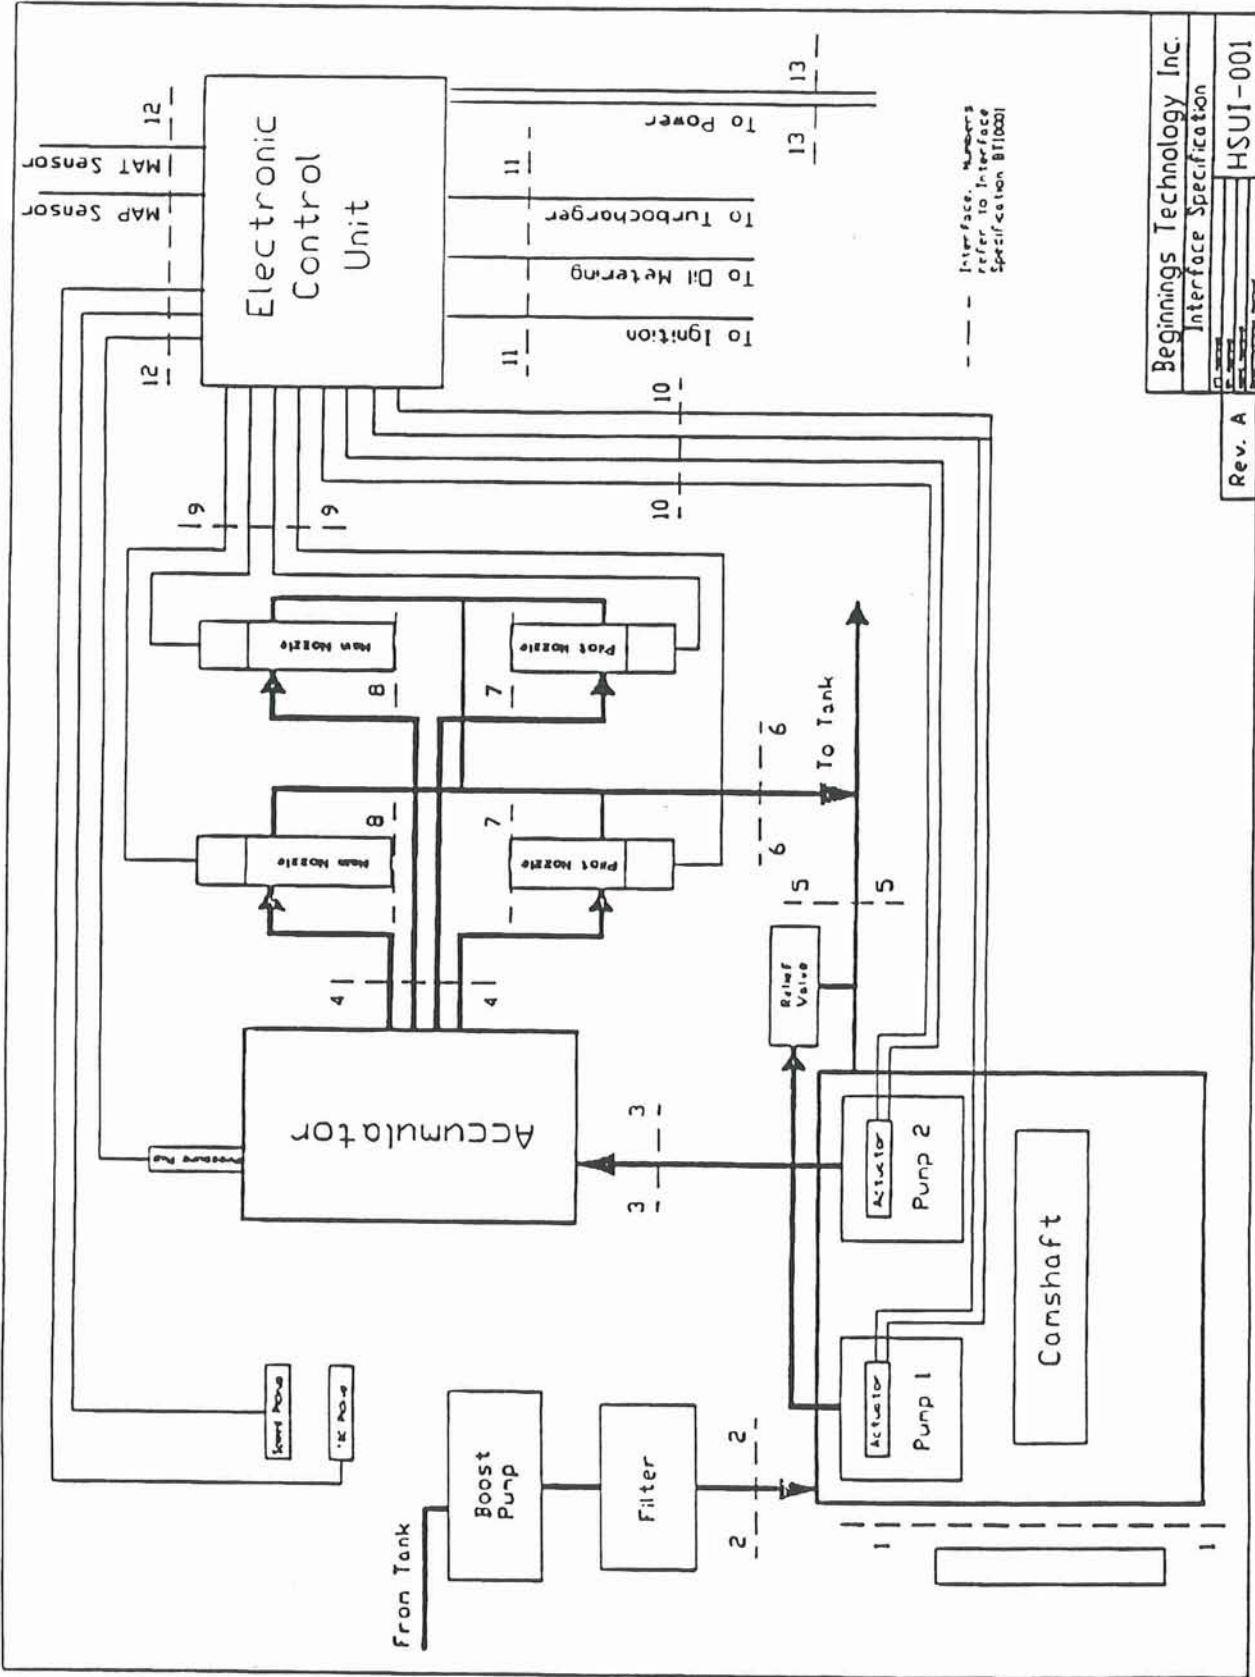
Figure 6.1.1-2 HSUI System Schematic

Figure 6.1.1-2 is a schematic of the HSUI system. Two high pressure variable displacement pumps provide fuel through check valves into the accumulator. Solenoid controlled injectors meter the high pressure fuel from the accumulator into the engine. Pressure, speed, and timing sensors provide inputs to the Electronic Control Unit (ECU) which provides control signals to drive the pump displacement actuators and the Injectors.

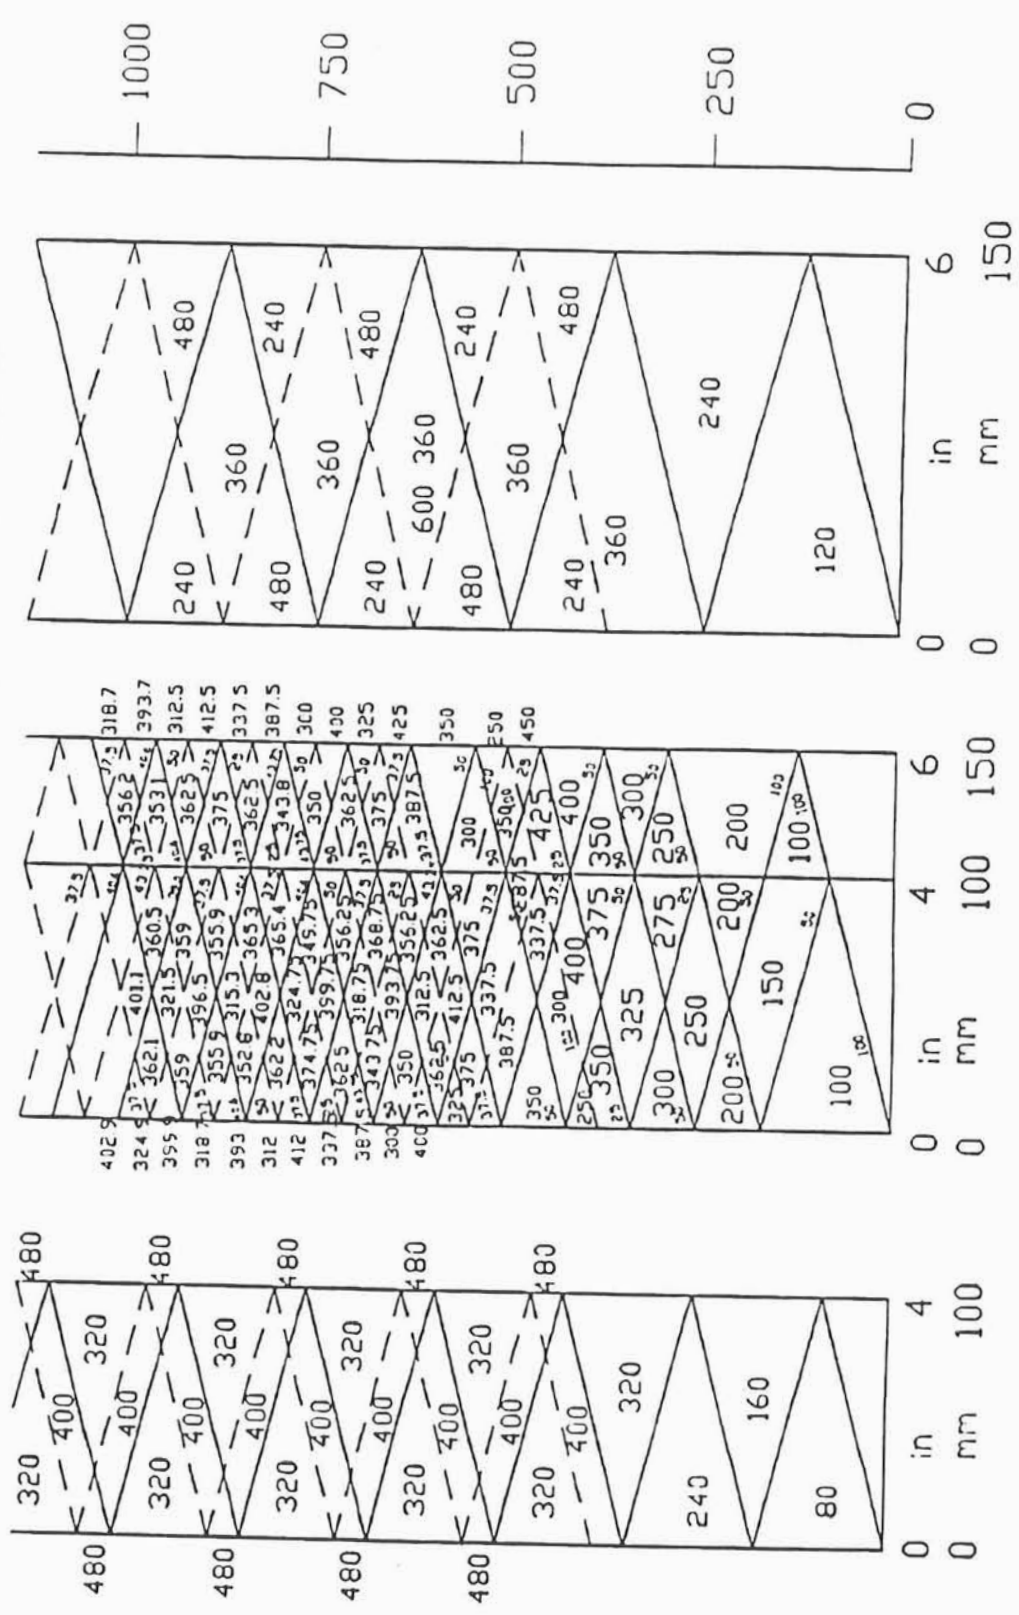
The numbers represent pressure in that sector

Figure 6.1.1-3 Comparison of Three Accumulator Designs

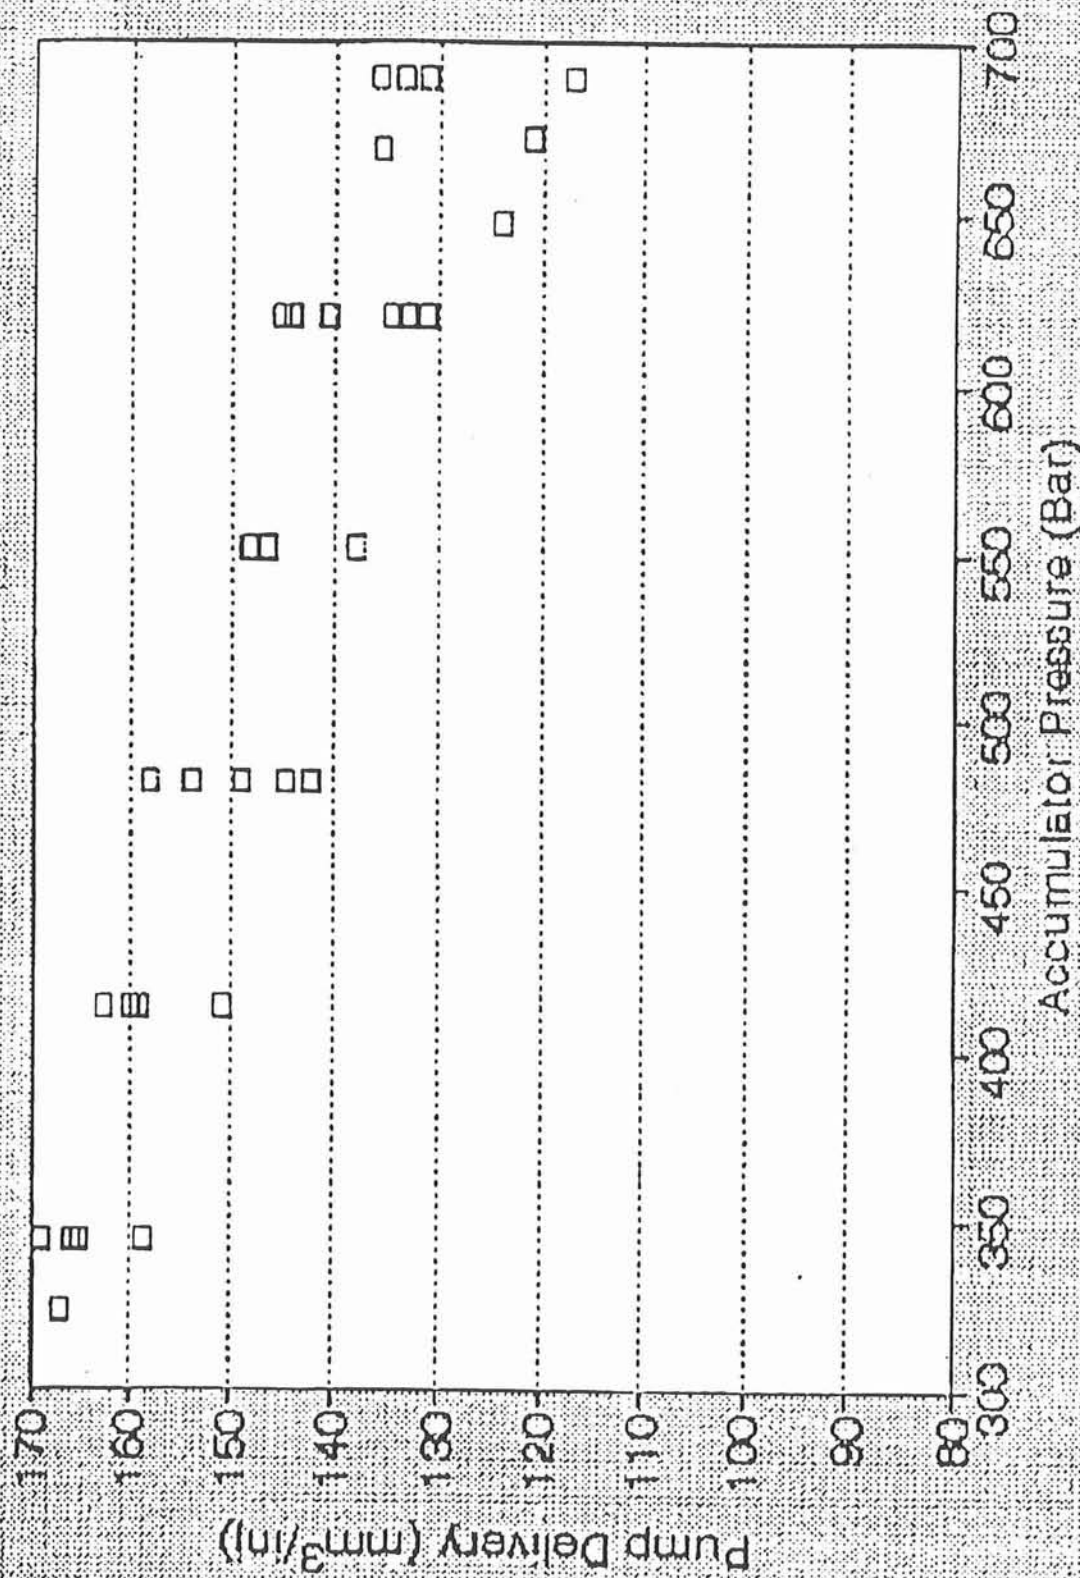
Figure 6.1.2-1 Single Head M100 Pump Delivery Into Accumulator

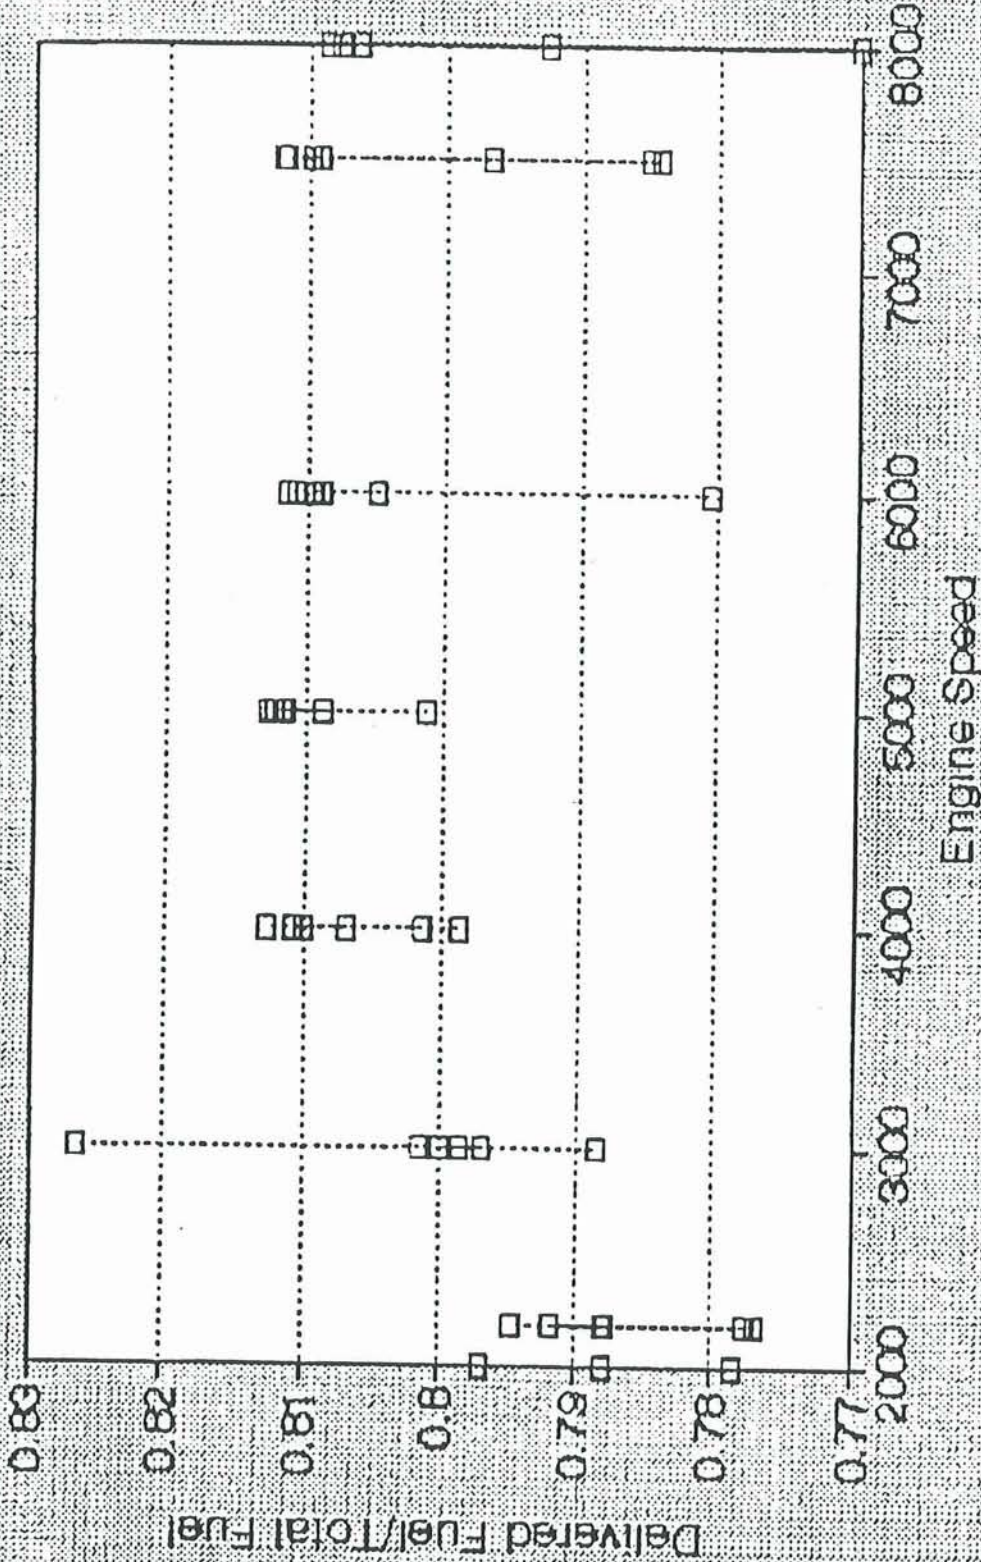
Figure 6.1.2-2 Flow Efficiency of Unit Injector - Configured with Main Nozzle
