NASA Contractor Report CR-195395

# Two Rotor Stratified Charge Rotary Engine (SCRE) Engine System Technology Evaluation

**T. Hoffman, J. Mack and R. Mount**  
*Rotary Power International, Inc.*  
*Wood-Ridge, New Jersey*

October 1994

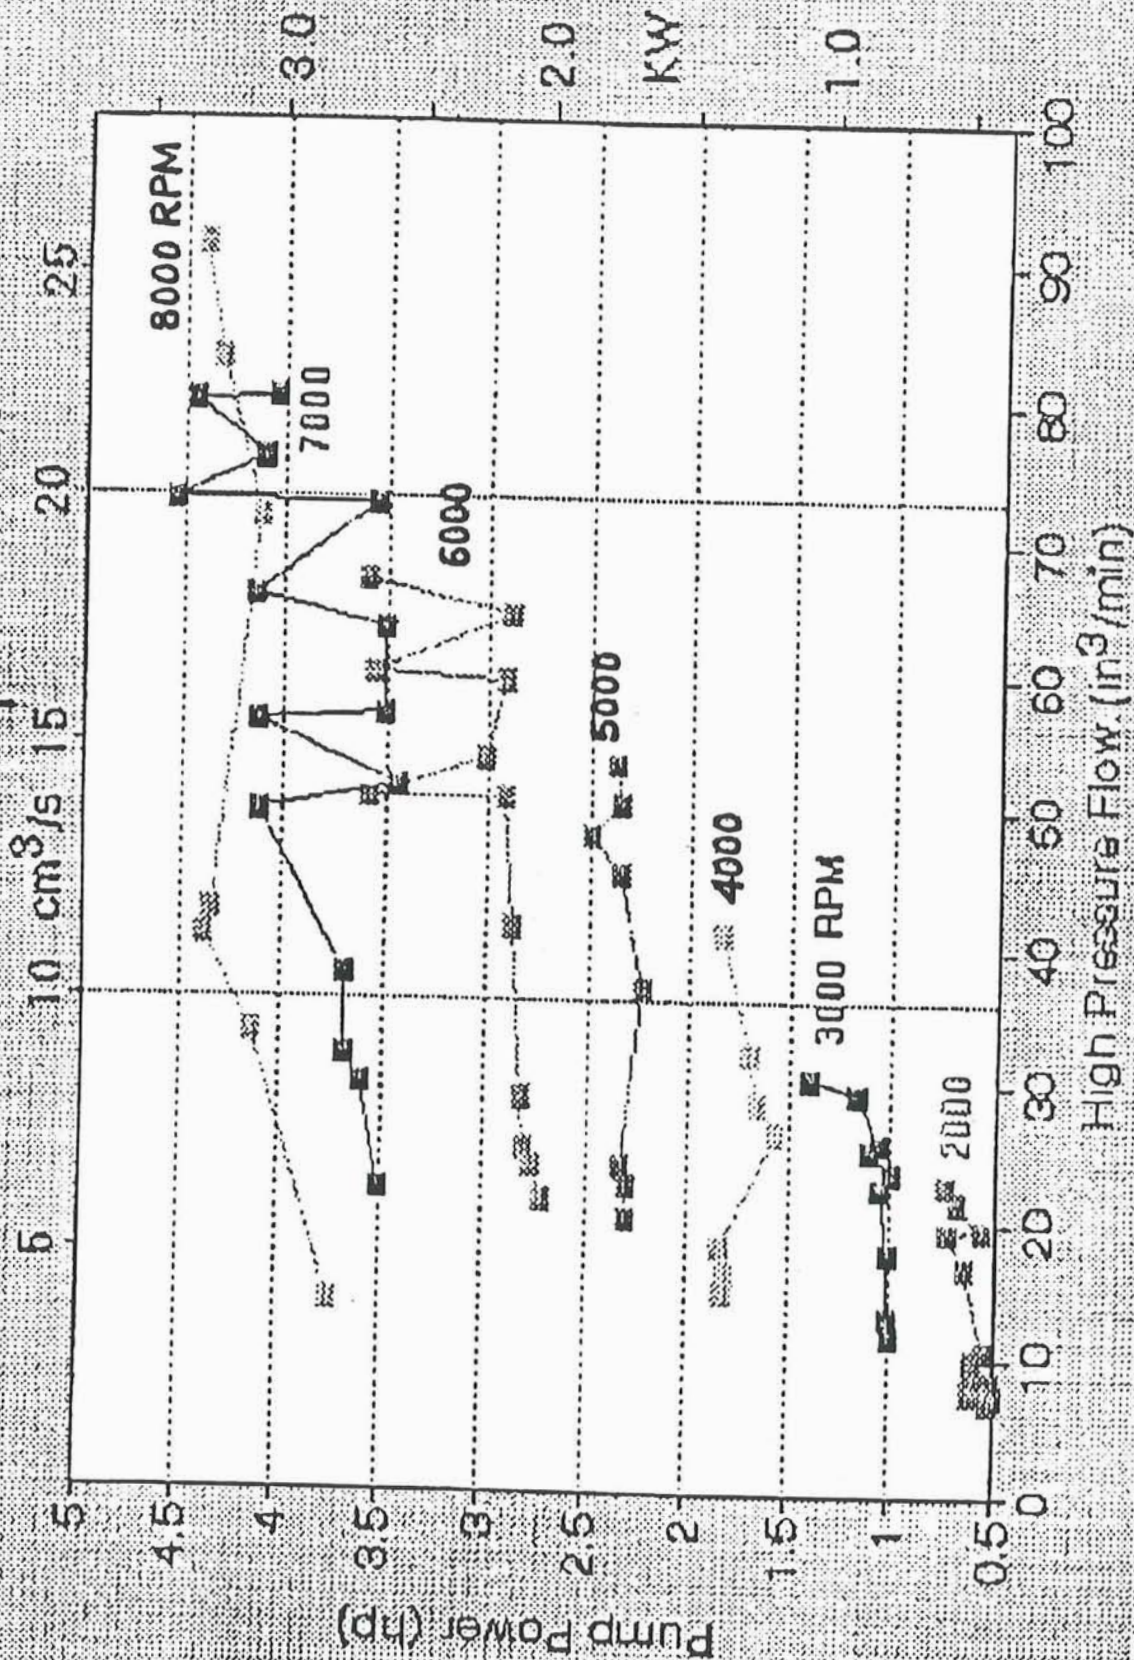
Figure 6.1.2-3 Estimated Pump-Drive Power - Tandem Head M100 Pump
