Technical Memorandum 107008

Technical Report ARL-TR-877

# Microstructural and Strength Stability of a Developmental CVD SiC Fiber

Prepared for the  
96th Annual Meeting and Exposition  
sponsored by the American Ceramic Society  
Indianapolis, Indiana, April 24-28, 1994

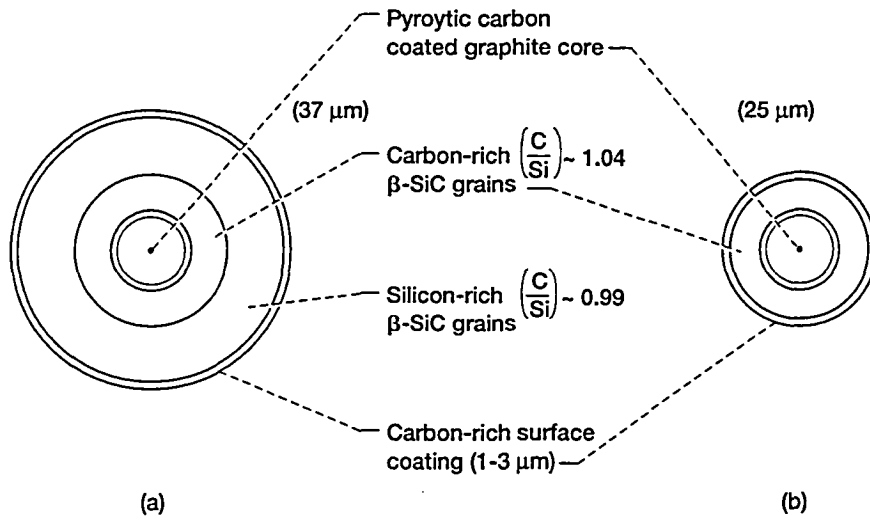
Figure 1.—Cross-section of CVD SiC fibers. (a) Textron SCS-6 fiber (~140 μm).  
 (b) Textron developmental SiC fiber (~50 μm).

The 50  $\mu\text{m}$  SiC fiber used in this study was manufactured by CVD of SiC onto a heated pyrolytic carbon-coated  $\sim 25$   $\mu\text{m}$  graphite core in a single stage reactor. Microstructurally, this fiber and the standard grade of CVD SiC fibers (SCS-6) manufactured by TSM are distinctly different. Schematics of the fiber cross-sections are shown in figure 1. The 50  $\mu\text{m}$  SiC fiber contains a single zone of carbon-rich SiC, whereas the SCS-6 fiber contains two zones of SiC having different composition. The C/Si ratio in the SiC sheath of the 50  $\mu\text{m}$  SiC fiber is similar to that of the inner zone of the SCS-6 fiber as determined by electron microprobe. Both fibers had  $\sim 1$  to 3  $\mu\text{m}$  thick carbon-rich coating on the outer surface of the SiC sheath. The coating is used to improve strength and abrasion resistance of the fiber (ref. 4).

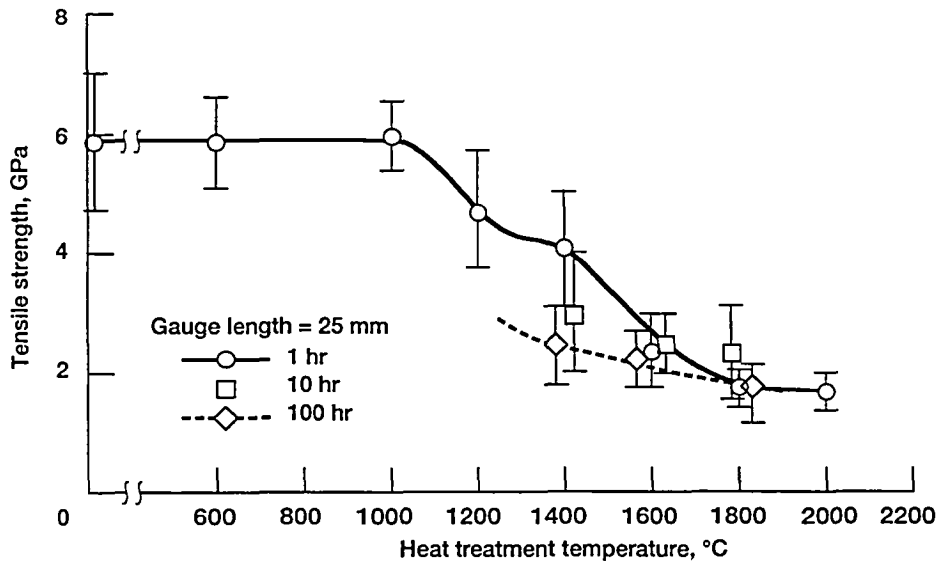
Figure 2.—Effects of temperature on the room-temperature tensile strength of 50 μm SiC fibers heat-treatment in 0.1 MPa argon.

Effects of thermal exposure on the room-temperature tensile strength of the 50  $\mu\text{m}$  SiC fibers after heat treatment in 0.1 MPa argon for 1, 10, and 100 hr from 600 to 2000  $^{\circ}\text{C}$  are shown in figure 2. For comparison, the strength of the as-fabricated fibers ( $\sim 6$  GPa) is also shown in the figure. Each data point represents an average of 10 to 15 individual tensile tests and the error bar represents one standard deviation. After one hour heat treatment in argon up to 1000  $^{\circ}\text{C}$ , the fibers displayed strength levels similar to that of the as-fabricated fibers. From 1100 to 1600  $^{\circ}\text{C}$ , the tensile strength decreased with increasing temperature. In the same temperature range, a slight decrease in strength was noticed with increasing exposure time, but the temperature of exposure had a greater influence on strength degradation than the time of exposure. Beyond 1600  $^{\circ}\text{C}$ , the strength approached  $\sim 2$  GPa, and the time of exposure had no significant influence on the strength.

It is evident from this study that the developmental 50  $\mu\text{m}$  SiC fibers show high as-received strength, ~6 GPa, and that even after 1 hr argon treatment between 1600 and 2000 °C, these fibers display high retained strength, ~2 GPa. This value is significantly higher than the strengths of SCS-6 or of Hi-Nicalon fibers after exposure to similar conditions. In argon environment, tensile strength degradation of the 50  $\mu\text{m}$  SiC fibers starts at ~1000 °C and occurs in two stages as displayed by the shape of the tensile strength versus heat-treatment temperature plot (fig. 2): the first stage ranging from 1000 to 1200 °C and the second stage ranging from 1300 to 1600 °C.

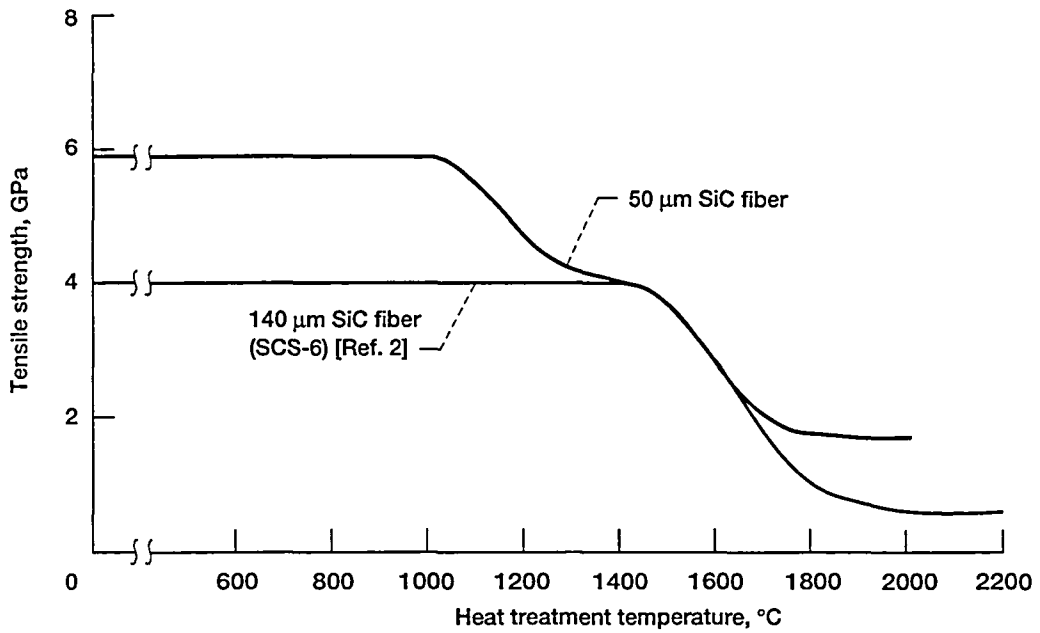
Figure 3.—Comparison of room-temperature tensile strengths of the 50 μm and 140 μm (SCS-6) SiC fibers after 1 hr heat-treatment in 0.1 MPa argon.

In figure 3, the average room-temperature tensile strength data for the 50  $\mu\text{m}$  SiC fibers after 1 and 100 hr exposure in argon between 600 and 2000  $^{\circ}\text{C}$  are compared with the data reported previously for the SCS-6 fibers in the same environment after 1 hr exposure in the same temperature range (ref. 2). Comparison of the best fit data in figure 3 indicates the following: First, the average as-fabricated tensile strength of the 50  $\mu\text{m}$  fibers is higher than

that of the SCS-6 fibers. Second, after 1 hr exposure the 50  $\mu\text{m}$  SiC fibers begin to show strength degradation at a lower temperature than the SCS-6 fibers. Third, the residual strengths of the 50  $\mu\text{m}$  SiC fibers after 1 hr exposure between 1400 and 1700°C are similar to those of the SCS-6 fibers. Fourth, the residual strengths of the 50  $\mu\text{m}$  SiC fibers exposed between 1600 and 2000 °C are generally higher than those of the SCS-6 fibers.

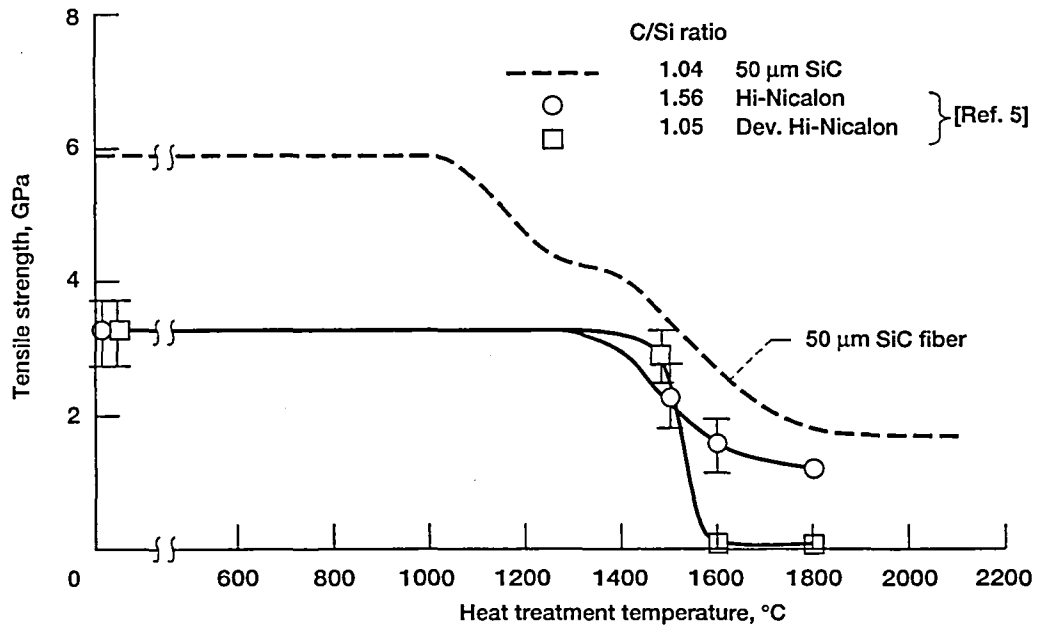
Figure 4.—Comparison of room-temperature tensile strengths of the 50 μm and 14 μm Hi-Nicalon SiC fibers after 1 hr heat-treatment in 0.1 MPa argon.

In figure 4, the room temperature tensile strength data of the 50  $\mu\text{m}$  SiC fiber after 1 hr exposure in argon between 600 and 1800 °C are compared with the data reported for the two types of SiC fibers derived from polymer precursor methods (Commercially available Hi-Nicalon and a developmental Hi-Nicalon) (ref. 5). For comparison purposes, the carbon to silicon (C/Si) ratios of the fibers are also given. The C/Si ratio of commercially available Hi-Nicalon is significantly higher than that of the 50  $\mu\text{m}$  SiC fibers. On the other hand, C/Si ratios of the developmental Hi-Nicalon and the 50  $\mu\text{m}$  SiC fibers are similar. According to figure 4, the 50  $\mu\text{m}$  SiC fiber shows strength degradation at a lower temperature (1000 °C) than both types of Hi-Nicalons. Beyond 1500 °C, the 50  $\mu\text{m}$  SiC fiber displays higher strength retention than both types of Hi-Nicalons. In fact, the developmental Hi-Nicalons have no strength at all after 1 hr exposure in argon beyond 1600 °C.

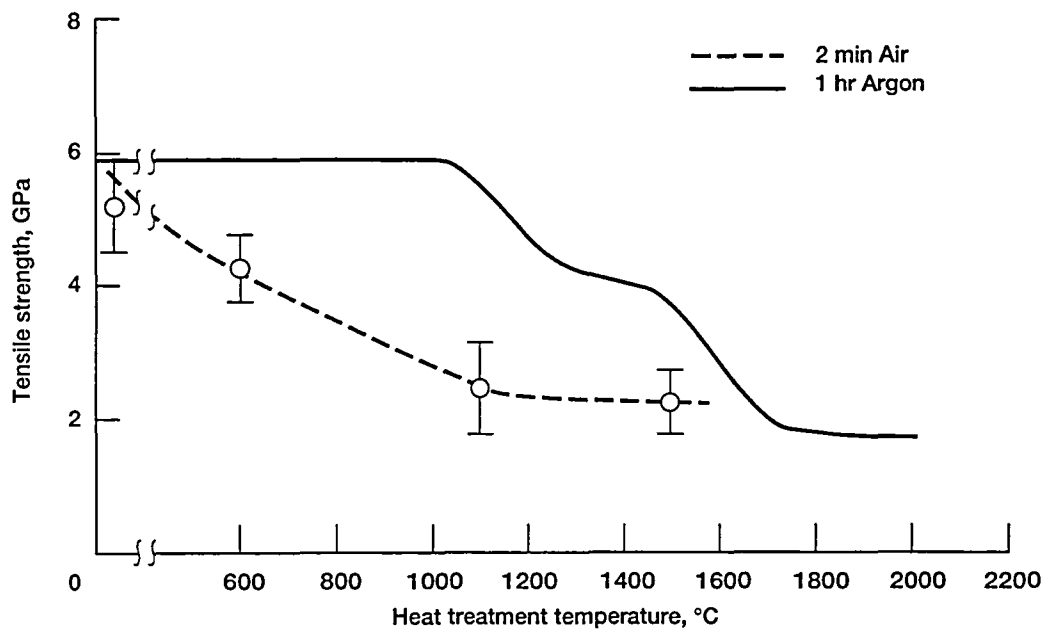
Figure 5.—Effects of temperature on the room-temperature tensile strength of the 50  $\mu\text{m}$  SiC fibers heat-treatment in air.

Influence of oxidation on the room-temperature tensile strength of the 50  $\mu\text{m}$  SiC fibers is shown in figure 5. For this study, fibers were heat treated in air for 2 min between 600 and 1500 °C and then tested at room temperature. Exposure temperatures above 1500 °C were not used to avoid strength degradation due to rapid and thick SiO<sub>2</sub> growth on the fiber surface. Figure 5 shows that with increasing exposure temperature, strength of the fiber decreased continuously and for 2 min in air near 1000 °C attained a level similar to that of the fibers heat-treated between 1500 and 1800 °C for 1 hr in argon.

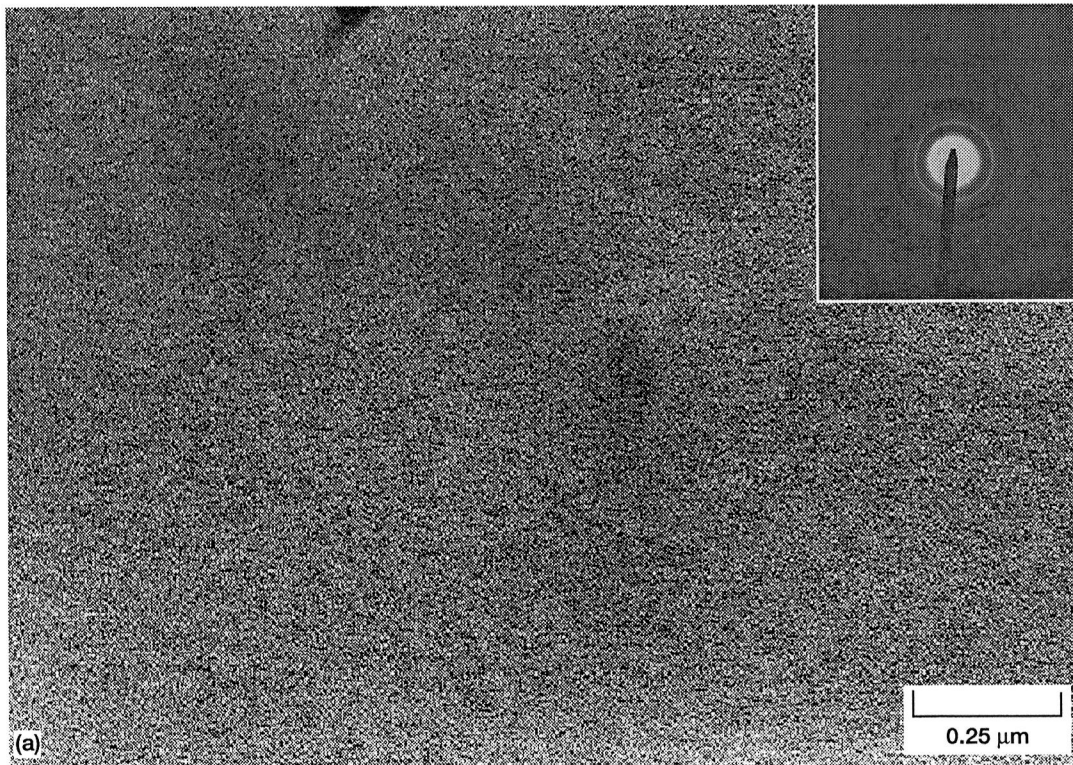
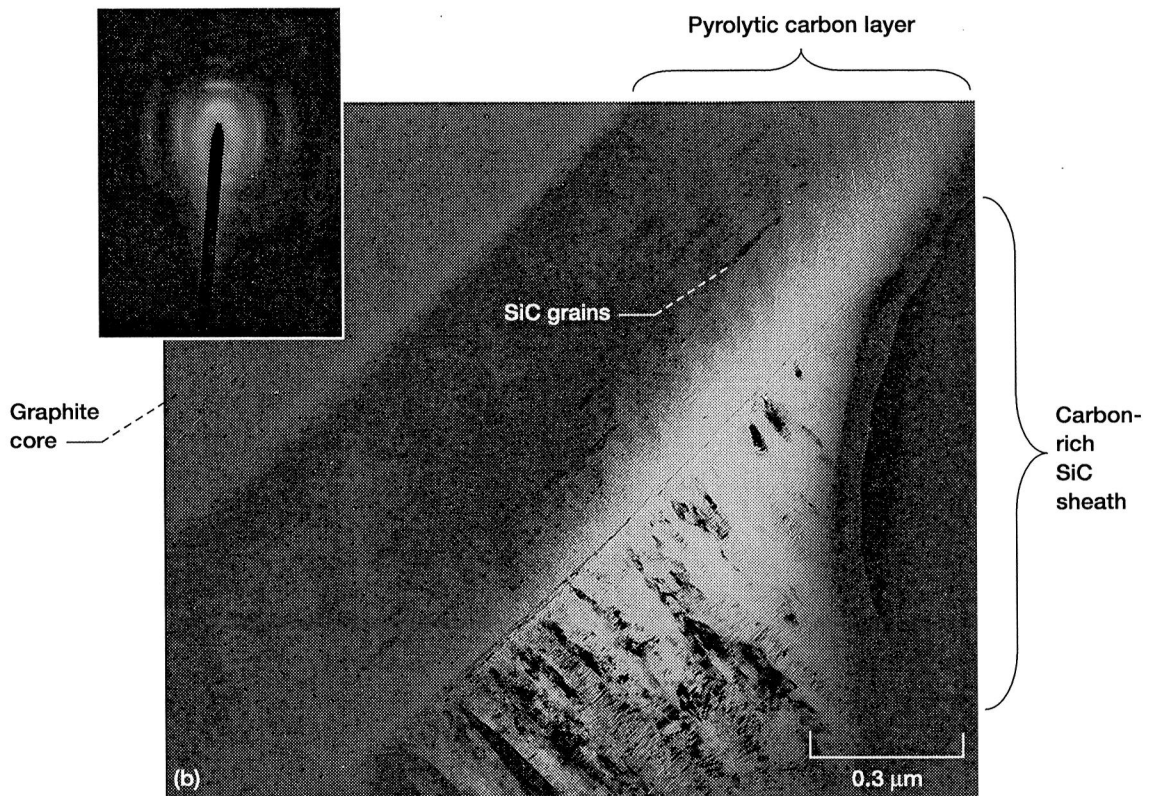
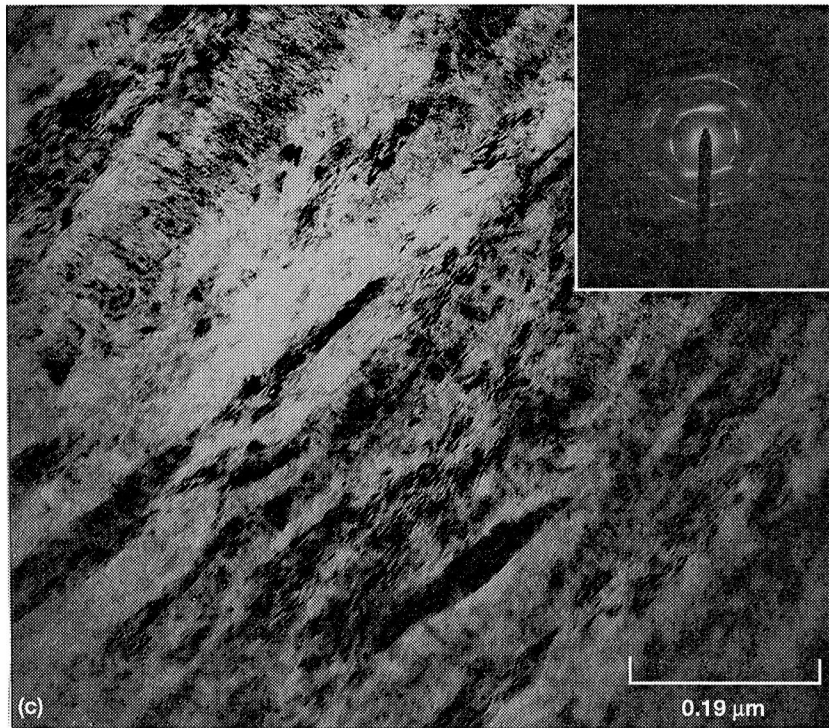
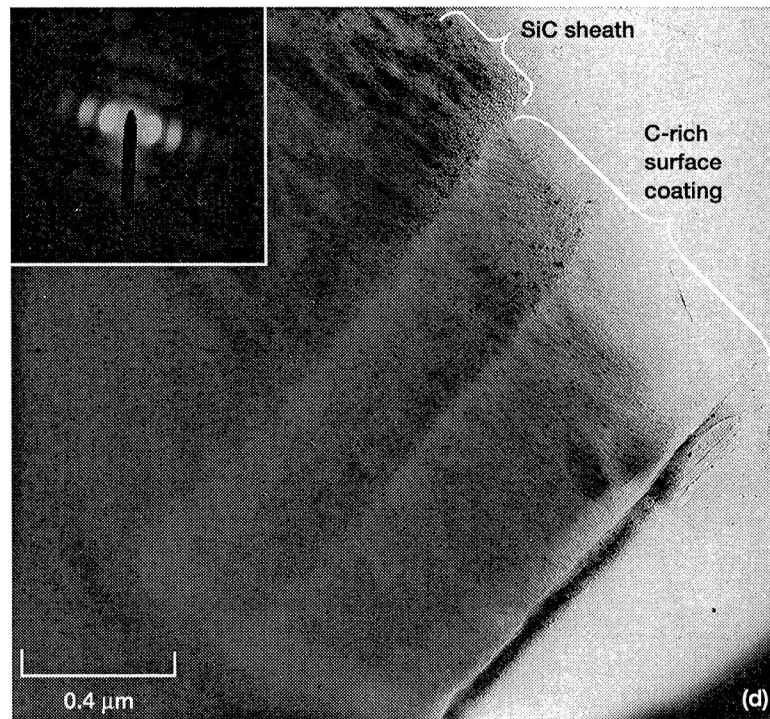
Figure 6.—TEM micrographs and corresponding SADP of different zones of an as-received 50  $\mu\text{m}$  SiC fiber. (a) Graphite core. (b) Pyrolytic carbon layer on the carbon core. (c) Carbon-rich SiC sheath. (d) Carbon-rich surface coating.

Figure 6.—Concluded. (c) Carbon-rich SiC sheath. (d) Carbon-rich surface coating.

To determine argon heat-treatment effects on the microstructure of fibers, TEM analysis was performed on the as-received and heat-treated fibers. In all cases, microstructure of the pyrolytic carbon coated graphite core, SiC sheath, and surface coating were analyzed. Results of this analysis for the as-received fibers are shown in figure 6. The core of the fiber contains randomly oriented turbostratic carbon (TC) blocks (fig. 6(a)). The pyrolytic carbon layer on top of the graphite core consists of TC blocks having a textured orientation. This layer is ~0.6  $\mu\text{m}$  thick (fig. 6(b)) and contains elongated SiC grains that are oriented normal to the radius of the fiber. The aspect ratio of these SiC grains is ~13. The carbon-rich SiC sheath is ~12  $\mu\text{m}$  thick and consists of elongated  $\beta$ -SiC grains running along the radius of the fiber (fig. 6(c)). These  $\beta$ -SiC grains are highly faulted and have an aspect ratio of ~8. The surface coating on top of the SiC sheath has two layers (fig. 6(d)). The first layer adjacent to the carbon-rich SiC sheath consists of textured TC blocks and small elongated SiC grains similar to that present in the pyrolytic carbon layer on the core. The aspect ratio of SiC grains is ~8. The outer most carbon layer consists of textured TC blocks and finely dispersed SiC particulates.

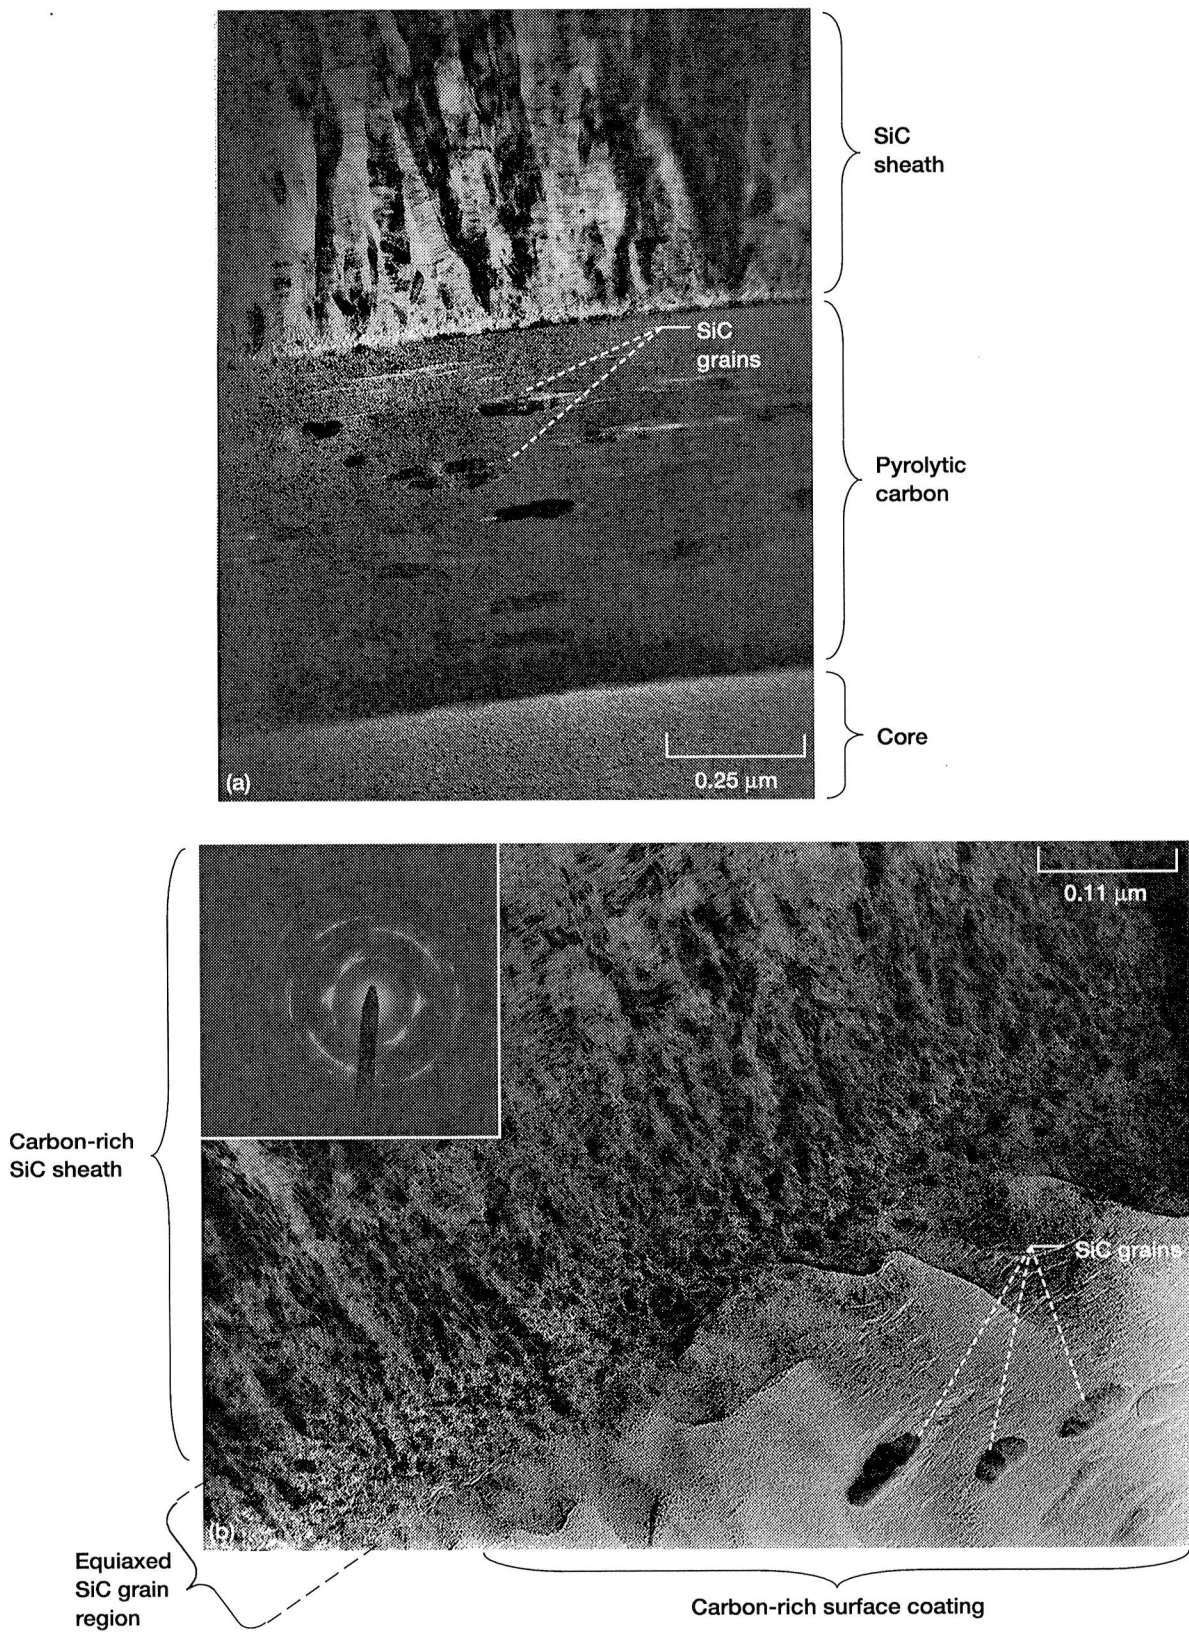
Figure 7.—TEM micrographs and corresponding SADP of a 50 μm SiC fiber heat-treated in argon at 1400 °C for 1 hr. (a) Pyrocarbon layer on the graphite core. (b) SiC sheath and carbon-rich surface coating interface.

One hour heat-treatment in argon at temperatures to 2000 °C had no significant effect on the microstructure of the graphite core and it remained turbostratic, but other zones of the fiber showed microstructural changes after 1 hr heat treatment beyond 1200 °C. With increasing temperature of exposure, spheroidization of SiC grains was observed in the pyrocarbon layer on top of the graphite core, and in the carbon-rich surface coating (figs. 7 and 8). At 1400 °C, a zone of equiaxed SiC grains formed at the interfaces of the SiC sheath and the pyrocarbon layer on the graphite core, and of the SiC sheath and the carbon-rich surface coating (figs. 7(a) and (b)). This zone, however, stopped growing after 1 hr exposure beyond 1600 °C. Typical thickness of the zone is ~100 nm. As the heat treatment temperature was increased, no change in the aspect ratio of the faulted grains in the SiC sheath was noticed, but secondary SiC grains started nucleating and growing along the original grain boundaries and at the intersection of two or more grains (fig. 8). The rate of growth of these secondary grains was slow.

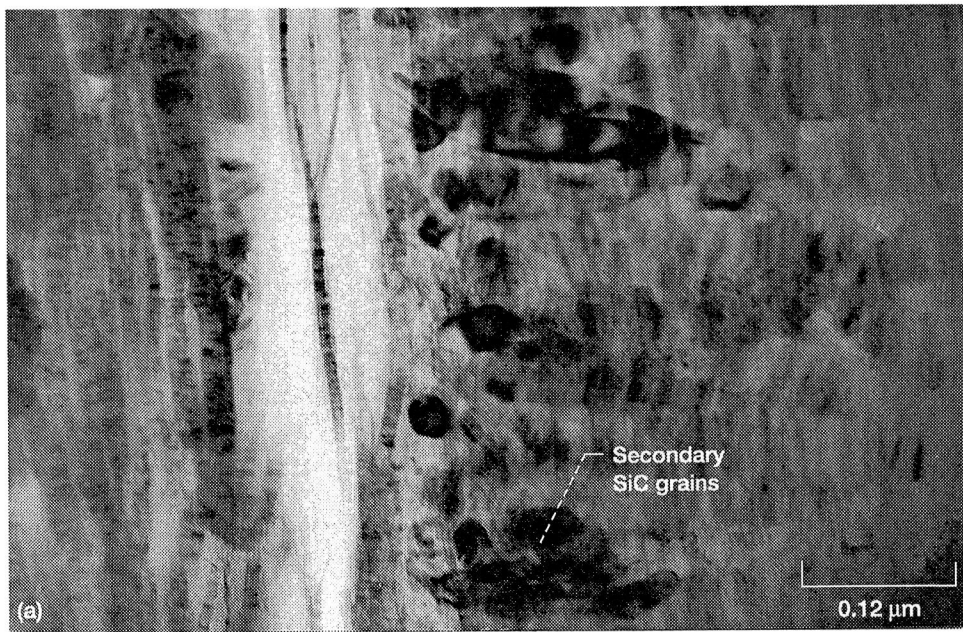
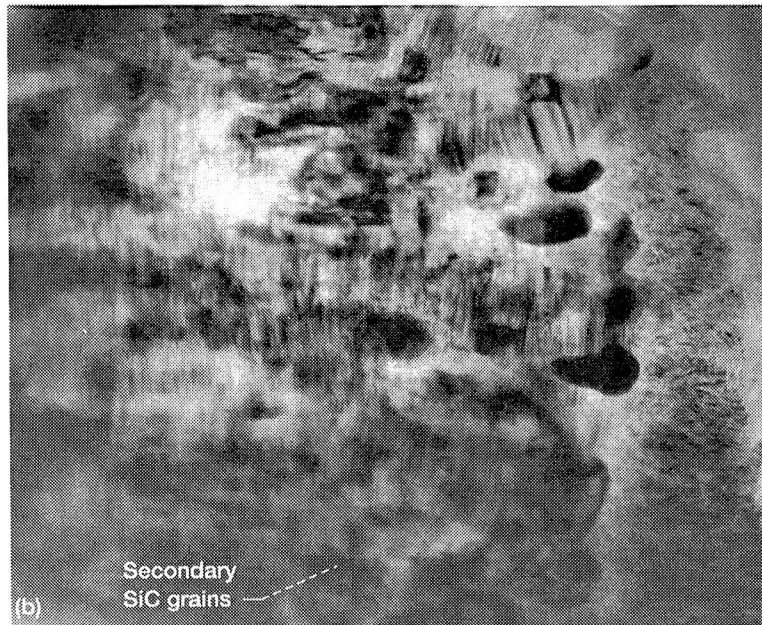
Pyrolytic carbon

SiC sheath

Equiaxed  
SiC grain  
region

Figure 8.—TEM micrographs of the interfaces of a 50  $\mu\text{m}$  SiC fiber heat-treated in argon at 1800  $^{\circ}\text{C}$  for 1 hr. (a) Interface between pyrocarbon layer and SiC sheath. (b) Interface between SiC sheath and carbon-rich surface coating.

The second stage of strength degradation takes place between 1300 and 1600 °C. In this temperature range, TEM study indicates that this degradation is the result of the flaws created by nucleation and growth of the equiaxed SiC grains in the SiC sheath at the pyrocarbon layer/C-rich SiC sheath, and the C-rich SiC sheath/C-rich surface coating interfaces, and along the grain boundaries of elongated SiC grains of the SiC sheath. The growth of the secondary SiC grains at the boundaries of the original grains is observed only in the 50 μm SiC fibers heat-treated beyond 1300 °C. Such growth was not observed in the heat-treated SiC fibers with Si-rich composition (SCS-6). The slow growth of these equiaxed SiC grains in the 50 μm SiC fibers with increasing time and temperature helps in limiting the size of the flaws. This allows the fiber to maintain the strength levels to ~2 GPa.
