TEST AND ANALYSIS RESULTS FOR COMPOSITE TRANSPORT FUSELAGE AND WING STRUCTURES

Jerry W. Deaton ✓
NASA Langley Research Center
Hampton, VA

Ram C. Madan and Victor L. Chen
Douglas Aircraft Company
Long Beach, CA

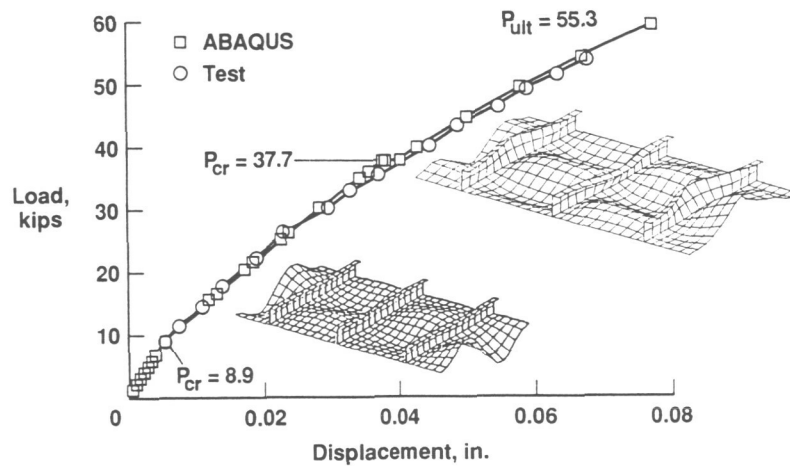
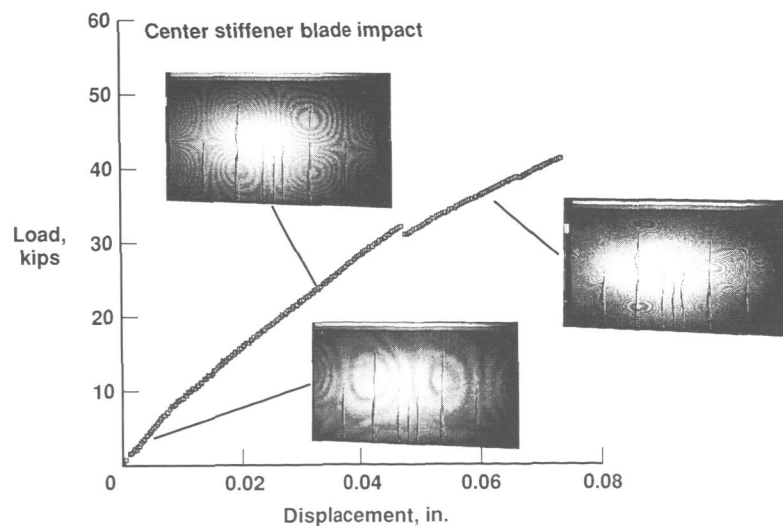
Figure 4 shows typical load-shortening data plots for the ATP and stitched/RTM fuselage J-stiffened panels under compression. Also shown in figure 4a are finite element simulation results obtained for the ATP panel using the ABAQUS code. Numerical predictions are shown to agree very well with test results. The ATP panel behaved linearly up to about 9 kips, then buckled into a one-half-wave mode (not shown) due to wide free edges. This mode smoothly grew into a two-half-wave mode slightly above the first P_{cr} , but the FEA showed lack of convergence and a nonlinear buckling (bifurcation) procedure was adopted. A three-half-wave mode was found numerically at 37-38 kips while tests showed this mode occurred around 35 kips with a loud popping sound. The FEA provided convergent results beyond 60 kips but predicted crippled stiffeners at about 55 kips, which is the measured failure load. Finite element simulation for the stitched/RTM fuselage panel has not been conducted because all necessary property data for the AS4 uniweave fabric/Shell 1895 material is not yet available. However, the load-shortening curve along with the Moiré fringe photographs, figure 4b, indicates that the stitched/RTM fuselage panel behaved similarly to the ATP panel under compression loading.

(a) ATP

(b) RTM

- Analysis correlated well with test results for ATP panel: predicted buckling and non-linear bifurcation load within 5 and 10 percent, respectively. Stitched/RTM laminate properties are being obtained for FEM analysis.

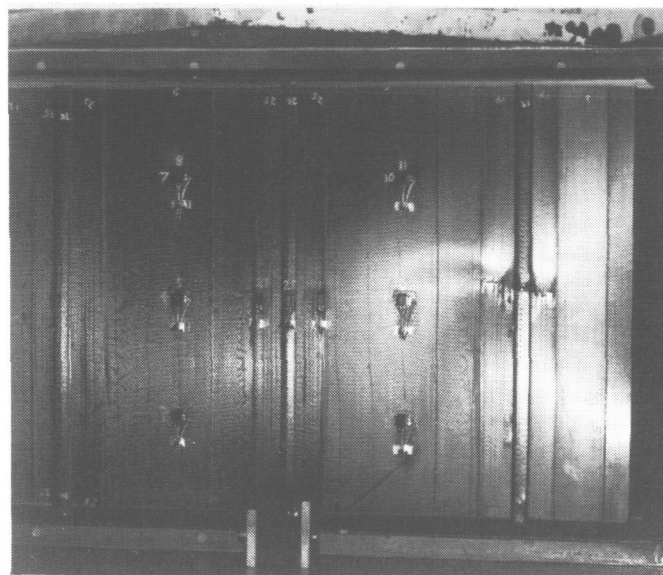
Figure 6

Additional photographs were obtained from the stiffener side of the failed panels. Figure 6a shows the same failed ATP fuselage panel shown in figure 5a, again, with a compression load of 1.5 kips applied. Crippling failure of all three stiffeners is evident along with some outer ply skin failure. Figure 6b shows the failed stitched/RTM fuselage panel shown in figure 5b with a 6.3 kip load applied. The stiffener on the right has failed in crippling, but the flanges remain attached to the skin. The failures shown in figures 5 and 6 are typical for all impacted J-stiffened compression panels.

(a) ATP

(b) RTM

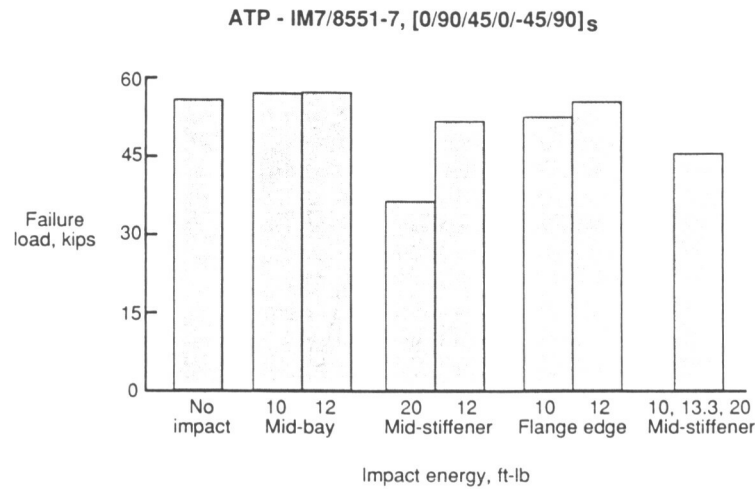
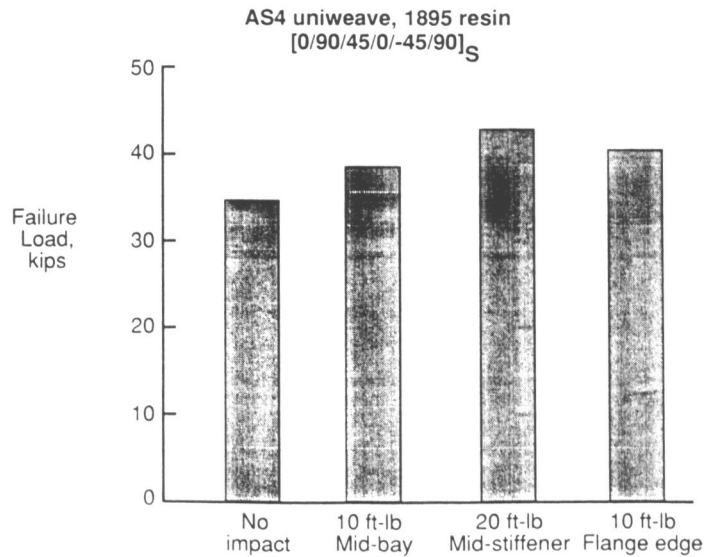
Figure 7
726

The failure load of each J-stiffened fuselage panel tested is shown plotted in figure 7 for each impact location and impact energy level evaluated. The ATP and stitched/RTM data are shown in figures 7a and 7b, respectively. The lowest failure load (denoted by asterisk) shown on each plot was obtained from tests which were conducted at a displacement rate 2.5 times faster than all other tests. At this loading rate, the panel may not have had sufficient time to redistribute loads between skin and stiffeners when the panel underwent buckling and mode shape changes, thus causing a premature failure. Design criteria (ref. 3) for the fuselage panels requires an ultimate compression loading of 1700 lb/in. or about 35 kips for the specimens being evaluated. All impacted specimens exceeded this requirement. The higher failure loads obtained for the impacted ATP fuselage panels compared to the stitched/RTM fuselage panels can be attributed to the higher strength fiber and toughened resin system used in their fabrication.

(a) ATP

(b) RTM

- Fuselage Structural Elements
 - Both fuselage concepts met compression design goals with impact damage present.
 - Critical impact sites were identified for both ATP and stitched/RTM fuselage concepts: mid-stiffener for ATP and mid-bay for stitched/RTM compression tests.

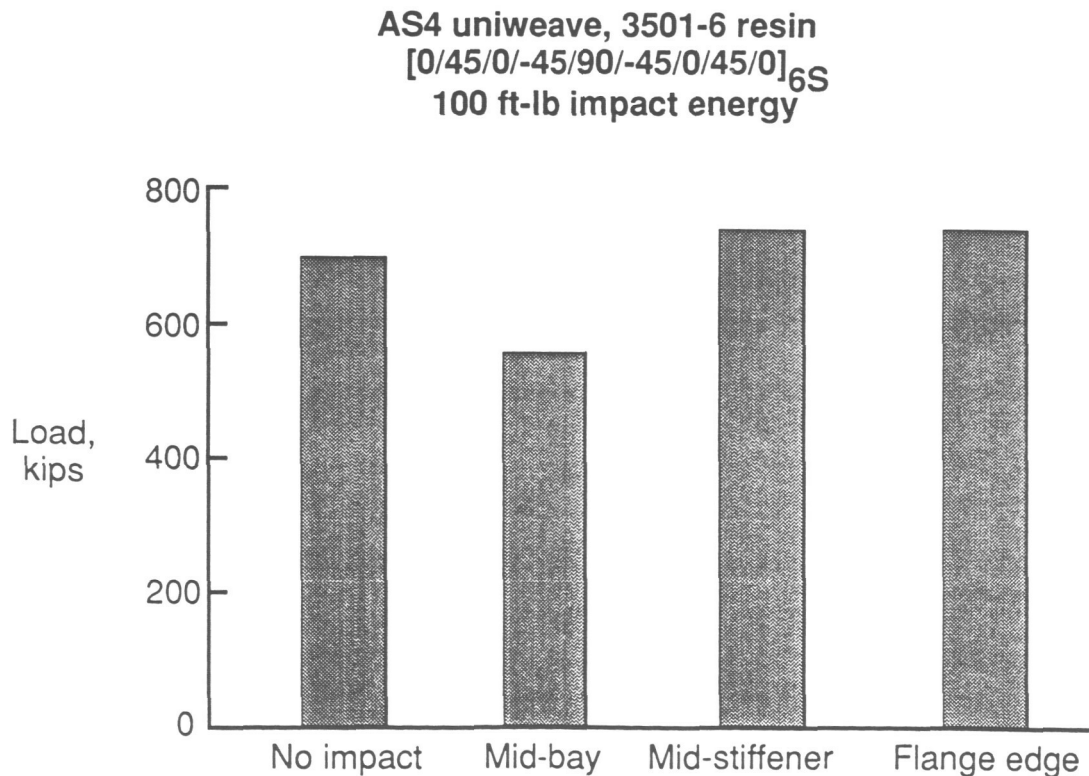
Figure 18

The failure load of each blade-stiffened wing panel tested is shown plotted in figure 18. Data are shown for panels impacted at mid-bay, mid-stiffener, and center stiffener flange-edge at an impact energy of 100 ft-lbs and are compared to the failure load of a panel without impact damage. Design criteria (reference 3) for the wing panels requires an ultimate compression loading of 23.6 kips/in. or about 496 kips for the 21-inch wide specimens being evaluated. All impacted specimens exceeded this requirement. The data indicate that the mid-bay impact is the most critical location for stitched panels subjected to compression loading where a reduction of about 20 percent in the failure load is indicated compared to the specimen which was not impacted. The panels impacted at the mid-stiffener and stiffener flange-edge at the 100 ft-lb energy level did not experience a reduction in load capability compared to the panel which was not impacted. The results shown in figure 18 are very encouraging when compared to the results obtained in reference 2 for mid-bay impacted panels fabricated from 1808I/IM6, a very damage tolerant material. The referenced panel was also 21-inches wide and had a 54 ply skin and 72 ply stiffeners of the same ply orientation as the stitched/RTM wing panel. The mid-bay impacted 1808I/IM6 panel of reference 2 failed at a load of 363 kips and the failure sequence consisted of skin/stiffener separation, skin buckling, and catastrophic failure.

- Wing Structural Elements
 - All three-stiffener and single-stiffener specimens met compression design goal after 100 ft-lb impact.
 - Mid-bay critical impact site for 100 ft-lb impact energy for three-stiffener compression panel test: 20 percent reduction in compression strength.

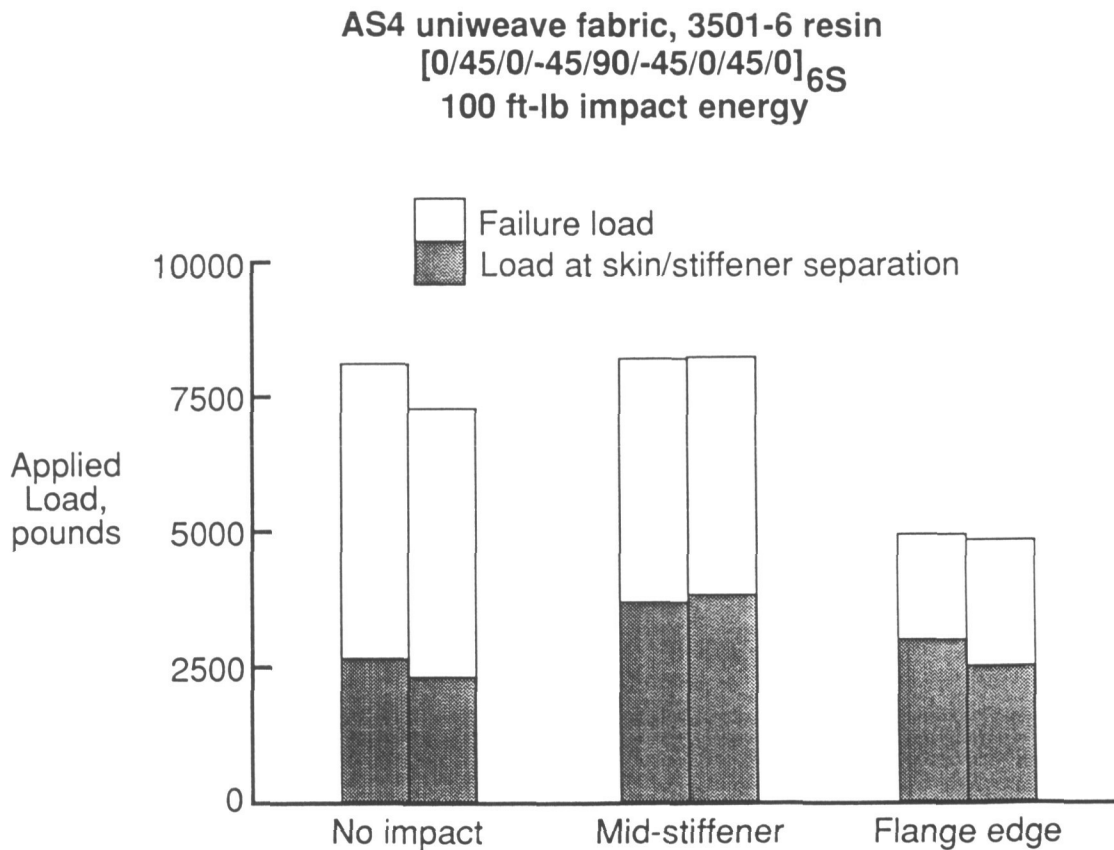
Figure 23

Results obtained from the wing stiffener pull-off tests are shown in figure 23. The shaded bars correspond to the pull-off load at which skin/stiffener separation initiated and the open bars represent the maximum failure load. Each bar represents an individual test. Recall that the ultimate pull-off load associated with the highest fuel pressure in the wing was 327 lb/in. which corresponds to approximately 1500 pounds of applied load for the 4.5-inch wide wing stiffener pull-off specimens. The data indicate that all specimens exceeded the ultimate load requirement without experiencing initial skin/stiffener separation. The failure load data indicate that the flange-edge is the critical impact location for this test where a reduction of approximately 37 percent in the pull-off load is noted. However, failure load exceeded the design ultimate requirement by a factor of three.

- Flange edge critical impact site location for 100 ft-lb impact energy from stiffener pull-off tests where a 37 percent reduction in pull-off load was obtained. Failure load still exceeded the design requirement by a factor of three.
