COMPRESSIVE RESIDUAL STRENGTH OF GRAPHITE/EPOXY LAMINATES AFTER IMPACT

Teresa A. Guy¹ and Paul A. Lagace
Technology Laboratory for Advanced Composites
Department of Aeronautics and Astronautics
Massachusetts Institute of Technology

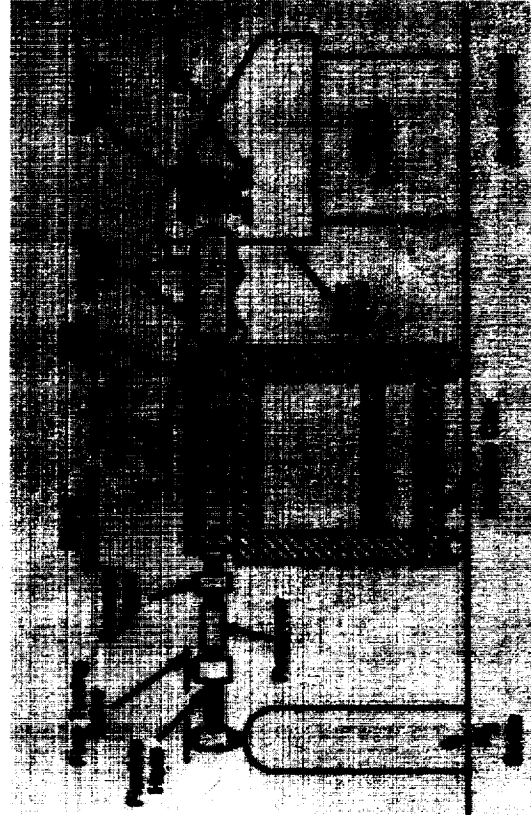
Figure 3. Illustration of Air Gun Impact Test Apparatus and Setup.

The second impact device, as shown in Figure 3, was an air gun initially developed and used at NASA Langley Research Center [26]. This was used for the low mass (8.4 g) impacts. This test apparatus consists of a variable pressure source, a low pressure reservoir, a solenoid trigger, a gun barrel, and 12.7 mm diameter spherical projectiles (steel balls were used in this work). The impactor velocity is measured with an LED system. The projectile passes an infrared LED that sends a signal to the optical trigger box that triggers the timing mechanism. When the projectile passes a second infrared LED, located 200 mm further along the gun barrel, another signal is sent to the optical trigger box to stop the timing mechanism. The time to transverse the two LED's is recorded in each test.

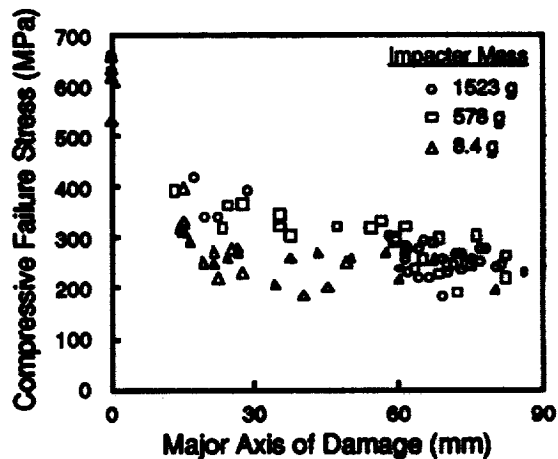
Figure 10. Compressive Residual Strength versus Major Axis of Damage Data.

Comparison of the compressive residual strength versus major axis of damage, presented in Figure 10, shows the curve for the 8.4 g impactor mass approaching the minimum compressive residual strength at a much smaller major axis of damage size (approximately 40 mm) than the curves for the 1523 and 578 g impactor masses (approximately 70 mm). There was a significant amount of scatter among the three impactor masses. Comparison of the compressive residual strength versus minor axis of damage, presented in Figure 11, resulted in less scatter than the major axis data comparison. Though the largest scatter band of data still represented a total difference of 33%, there was no obvious separation of data between the three impactor masses as there was in the case of the major axis. Comparison of the compressive residual strength versus core damage size, presented in Figure 12, also showed the curve for the 8.4 g impactor mass approaching the minimum compressive residual strength at a smaller core damage size (13 mm) than the curves for the 1523 and 578 g impactor masses (23 and 19 mm respectively). There was again, a significant amount of scatter among the three impactor masses. From these three comparisons, it would be inadvisable to predict compressive residual strength as a function of planar damage measurements such as the major axis, minor axis, or core damage size as there is insufficient detail in these damage measurements.

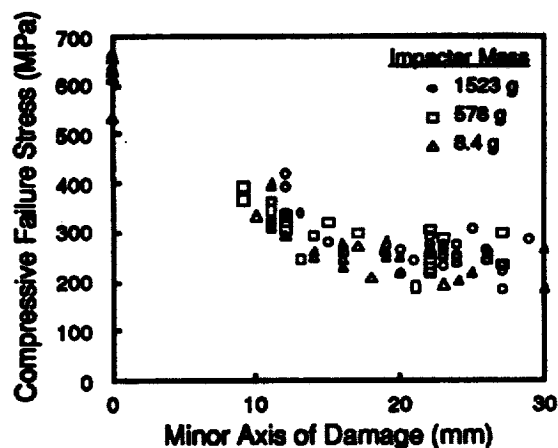
Figure 11. Compressive Residual Strength versus Minor Axis of Damage Data.

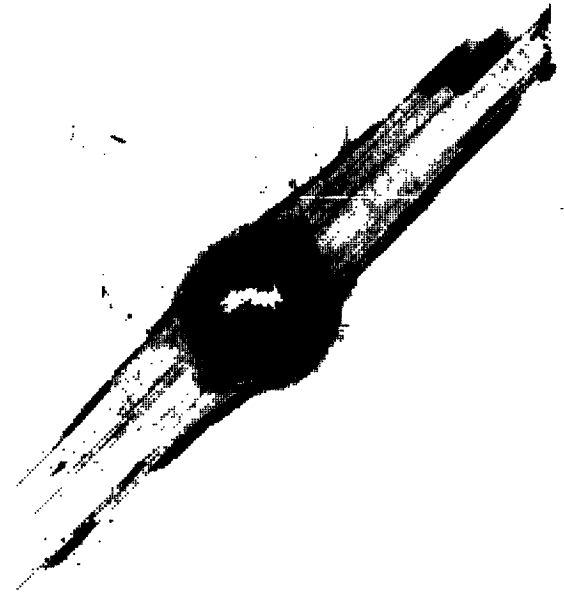
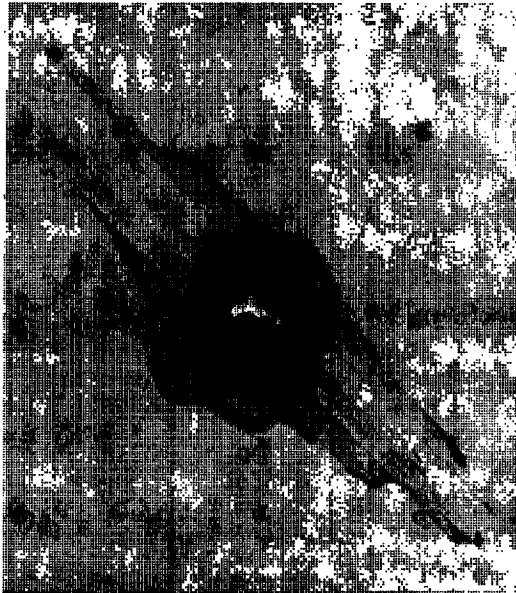
Mass = 8.4 g

Mass = 578 g

Mass = 1523 g

Figure 13. X-ray Photographs of Minimum Compressive Residual Strength Specimens for Three Impactor Masses (*top left*) 8.4 g, (*top right*) 578 g, and (*bottom*) 1523 g.

This can be further seen in Figure 13 where the X-ray characterization of the damage state at the minimum compressive residual strength condition is shown for the three impactor masses. These three cases appear to have slightly different damage states as the core damage size ranges from 17 to 23 mm, the minor axis of damage ranges from

21 to 27 mm, and the major axis of damage ranges from 69 to 80 mm. The integrated damage thus does not provide sufficient detail either in the X-ray photographs shown here, or in a typical ultrasonic scan. Three-dimensional information about the damage is therefore necessary.

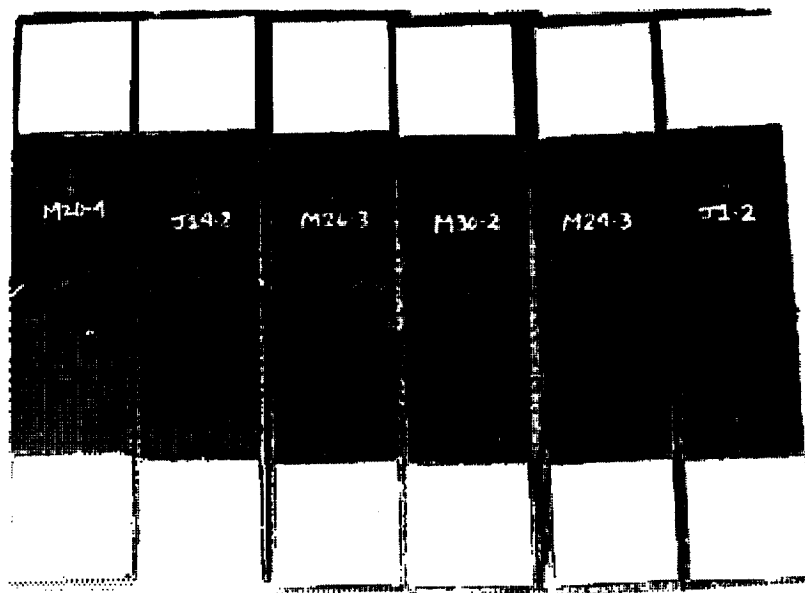
(Mass of 1523 g at 6.3 m/s)

(Mass of 8.4 g at 70 m/s)

(Mass of 578 g at 9.2 m/s)

Figure 17. Photograph of Impact-Damaged Specimens After Fracture
 Masses of (top left) 1523 g, (bottom) 578 g, and (top right) 8.4 g.

A postmortem examination of the specimens that failed at the minimum compressive residual strengths for the three impactor mass cases was conducted to determine if the failure modes were the same. These specimens, after failure, are shown in Figure 17. The postmortem examination of these minimum compressive residual strength specimens showed sublaminar buckling of ply 1 and fiber failure in the remaining plies. (Also evident was the extensive core damage and back side spalling of ply 1 due to impactor penetration.) Although it was not possible from the postmortem examination to determine which damage mode or combination of damage modes were controlling the compressive residual strength, it was clear that the failure modes in these three cases were similar if not the same. The postmortem examination of the open hole specimens on the other hand, showed the fracture in these cases to be consistently due to in-plane mechanisms as catastrophic failure occurred completely through each facesheet with no indication of delamination as shown in Figure 18.
