**The Long Duration Exposure Facility (LDEF)
Photographic Survey Special Publication**

Heavy Ions In Space (M-0001)

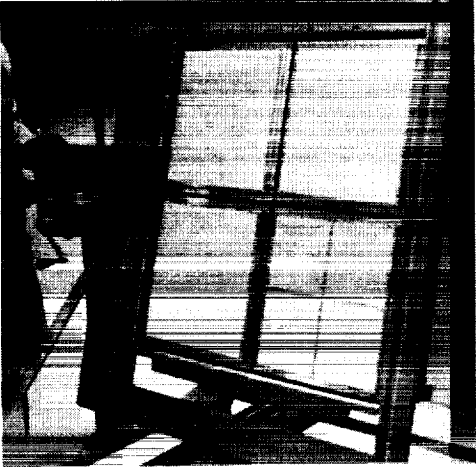
Figure 1

Preflight (Figure 1)

The four modules including the one subdivided into quadrants are shown mounted in a 4-inch deep space facing end tray. The exposed surface of each detector is Chemglaze II A-276 white paint on the aluminized Kapton top layer of a multilayer thermal blanket. The frame around each of the four modules is a "Z" shaped aluminum structure covered with a silvered teflon film secured with 3M-Y966 acrylic tape. The 3M-Y966 tape on a silvered teflon film is also used to attach the multilayer thermal blankets to the module frames.

Photo No.: KSC-384C-331/6
Photo credit: KSC 1/24/84
Digitized from dup. neg. L84-7187
Location: KSC SAEF II
Subject: Tray H12
Experiment: M-0001; Heavy Ions In Space
