EFFECTS OF LOW EARTH ORBIT ON THE OPTICAL PERFORMANCE OF  
MULTILAYER ENHANCED HIGH REFLECTANCE MIRRORS\*

## ABSTRACT

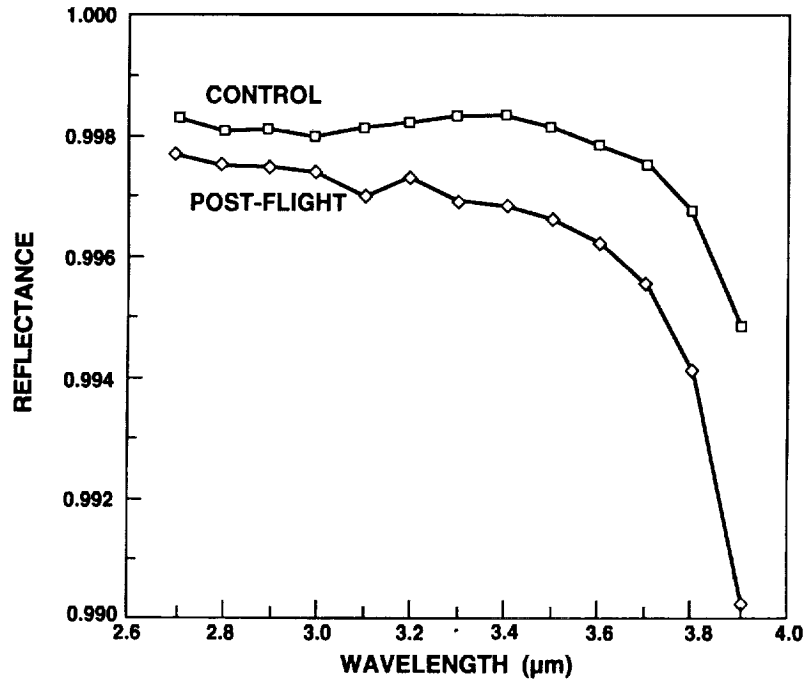
Figure 1. Post-flight reflectance of the leading-edge  $(\text{Si}/\text{Al}_2\text{O}_3)^3\text{Ag}/\text{Si}$  test sample compared to a laboratory control. The reflectance loss of the test sample relative to the control is less than 0.1% at the design wavelength (2.8  $\mu\text{m}$ ).

The spectral reflectance of the leading-edge (Si/Al<sub>2</sub>O<sub>3</sub>)<sup>3</sup>Ag/Si test sample after 90 days exposure to the effects of low-Earth orbit (LEO) is shown in Figure 1. As seen in the figure, the reflectance of the test sample is reduced less than 0.1% at the design wavelength (2.8 μm) relative to the laboratory control. The reflectance of the control was reduced by less than 0.1% after 10 years on the laboratory shelf. Profilometer measurements showed that increases in optical scatter resulted from surface debris and not

from changes in microstructure or topography. The scatter increase contributed to the small reflectance loss relative to the control.

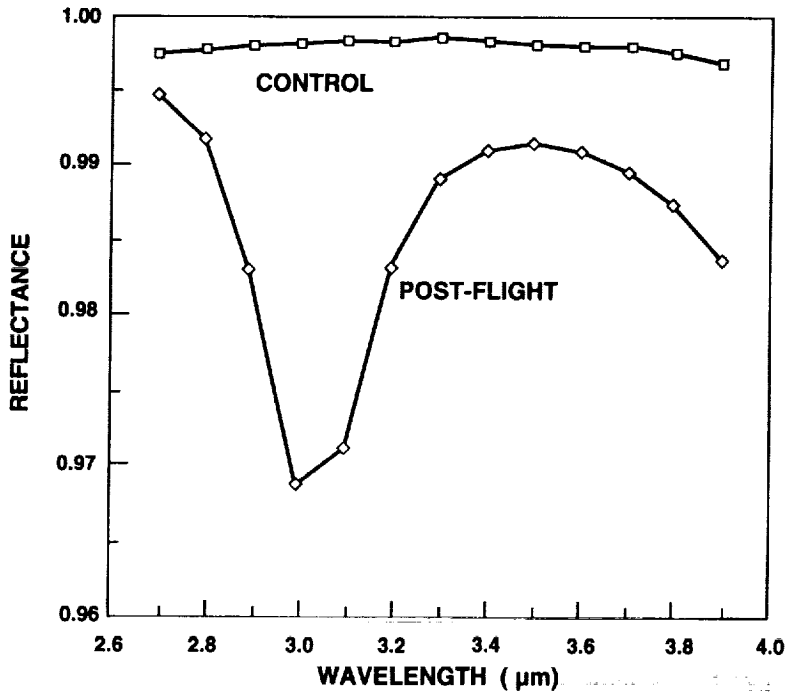
Figure 5. Post-flight reflectance of the leading-edge  $(\text{ZnS}/\text{Al}_2\text{O}_3)^4\text{Ag}/\text{Mo}$  test sample compared to a laboratory control.

The post-flight reflectance of the leading-edge (ZnS/Al<sub>2</sub>O<sub>3</sub>)<sup>4</sup>Ag test sample compared to a laboratory control is shown in Figure 5. The mirror was exposed for nine months beginning with the deployment of LDEF. The test sample has an absorption band centered at 3 μm which reduces the reflectance at the design wavelength of 2.8 μm. The control has no similar loss.

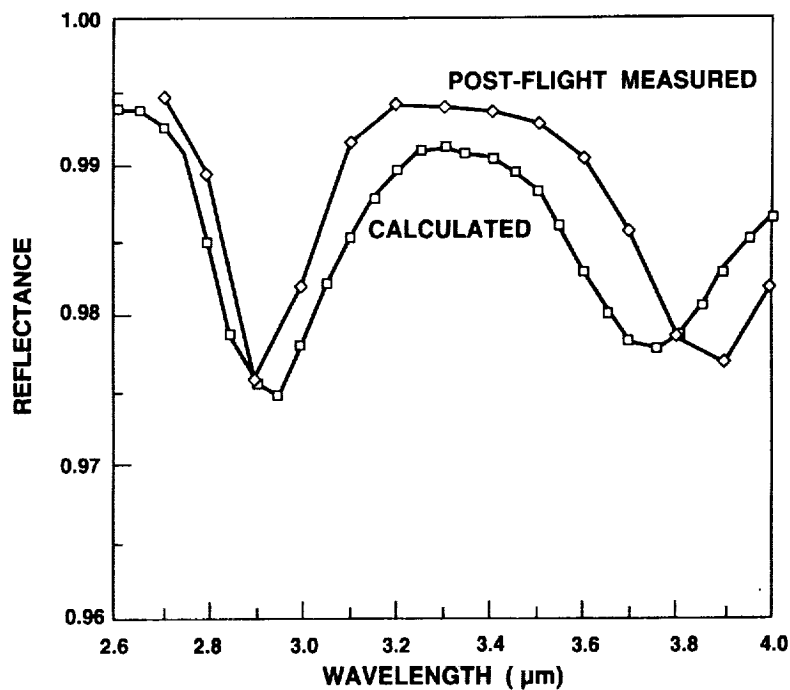
Figure 10. Measured post-flight reflectance of the leading-edge  $(\text{ZnS}/\text{ThF}_4)_5\text{Ag}/\text{Mo}$  test sample compared to a calculated reflectance curve. Thin layers of water contamination at film interfaces and layer thicknesses derived from the SIMS data shown in Figures 7-9 were used to match the calculated to the measured reflectance curve.

The calculated spectral reflectance values are compared with post-flight reflectance data in Figure 10. As seen in the figure, the SIMS data gives an excellent fit to the reflectance spectrum in the 2.9 to 4.0  $\mu\text{m}$  region. This result validates preflight simulations of combined solar-UV/charged-particle radiation at the Boeing Radiation Effects Laboratory<sup>2</sup> which showed that the irradiation of water-contaminated ZnS/ThF<sub>4</sub> multilayers increased the optical absorption about 1% at 2.9  $\mu\text{m}$ .
