SYSTEM RESULTS FROM FRECOPA

Christian DURIN CNES - CT/AQ/EQ/QM
18, Avenue E. BELIN, 31055 TOULOUSE Cedex (France)
Phone : (33) 61 28 14 39, Fax (33) : 61 27 47 32

FRECOPA SYSTEM RESULTS

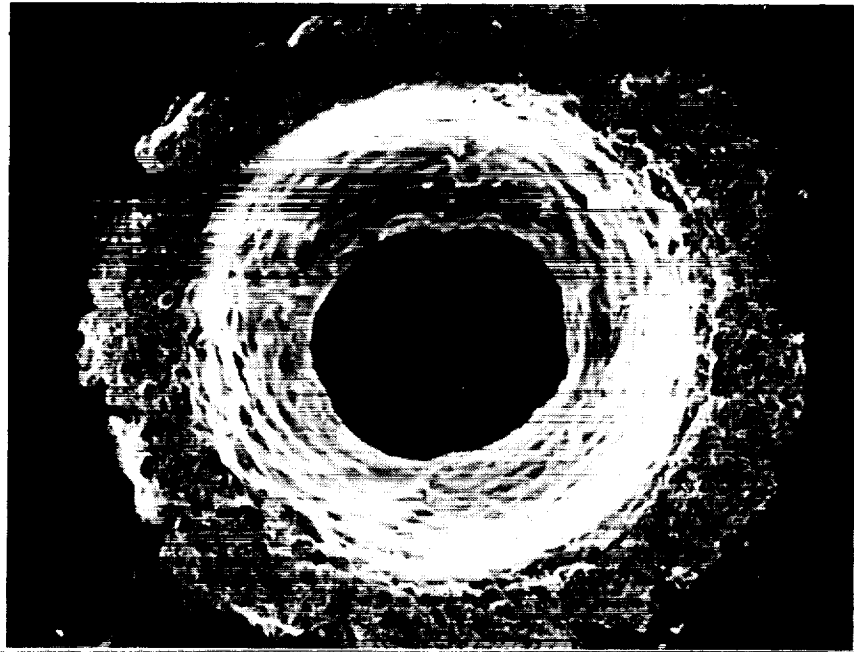
Two types of support were found to show signs of impact: thermal blanket screens in teflonized woven glass fabric and aluminum screens protecting the box seals. 90 impacts over 50 microns in size were counted in one m². The largest impact perforated the 0.8 mm thick aluminum screens, projecting a cloud of debris into the experiment (as seen in fig. 1). The position of the crater on the edge of the experiment explains why such an impact caused no internal damage. Another crater on the same screen was at the edge of the perforation.

Figure 1 - The biggest crater on FRECOPA tray (a)
cloud of debris on the structure (b)
