## ANALYSIS OF SELECTED SPECIMENS FROM THE STS-46 ENERGETIC OXYGEN INTERACTION WITH MATERIALS-III EXPERIMENT

Johnny L. Golden, Roger J. Bourassa, Harry W. Dursch and H. Gary Pippin

Boeing Defense & Space Group  
P.O. Box 3999 M/S 82-32  
Seattle, WA 98124-2499  
(206) 773-2846, FAX (206) 773-4946

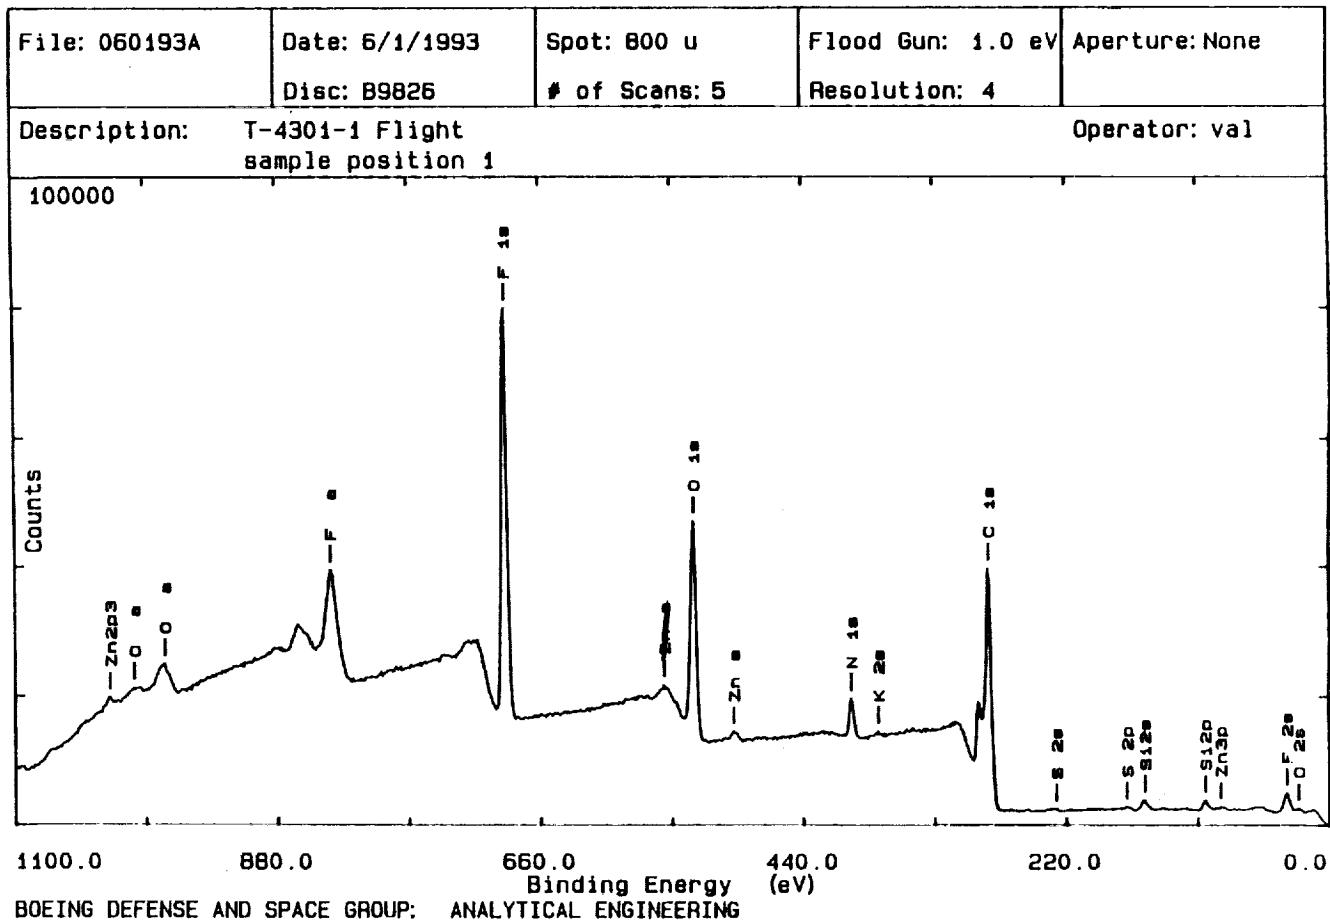
Figure 9. X-ray photoelectron spectroscopy of solid film lubricant Torlon 4301 flight specimen.

material also contains lead (Pb) and antimony (Sb). One final comparison involves the lubricant Torlon 4301, which gained significant weight with exposure on EOIM-III. Comparison of the control specimen in figure 8 with the flight specimen in figure 9 indicates a reduction in the carbon 1s signal for the flight specimen, but with no corresponding signal increases (such as for oxygen) to explain the weight increase observed for this material.

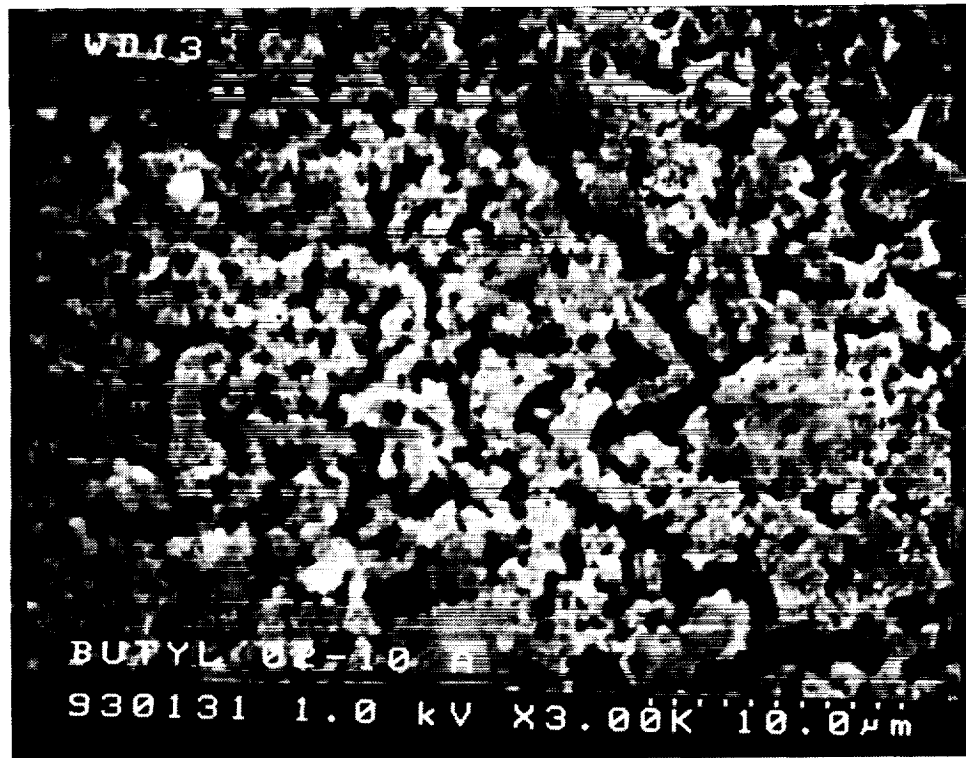
Figure 12. Scanning electron microscope images of o-rings postflight at 3000X magnification. The images are of specimens flown under compression. The top image is of a butyl rubber specimen, the bottom image is of a silicone (S383).

Scanning electron microscopy (SEM) images of the o-ring surfaces were made postflight. Figures 11 and 12 show comparison of the surfaces of butyl and silicone rubber o-rings that were held under compression during environmental exposure at 1000X and 3000X, respectively. General AO erosion is visible on the butyl rubber surfaces while no apparent erosion occurred on the silicone rubber. The silicone rubber was similarly unaffected in the tensile loading configuration. The butyl rubber, however, showed erosion patterns affected by the amount of tension applied. Figure 13 shows two butyl o-rings at 500X, the first loaded in tension by stretching it to 60% above its original diameter, the second to 100% above its original diameter. The 100% tension specimen has developed a cracking erosion pattern perpendicular to the direction of stress. Figure 14 shows a comparable erosion pattern at 80% tension. Also shown in figure 14 is the pattern of uneroded surface resulting from the AO shielding provided by the stainless steel mesh covers.

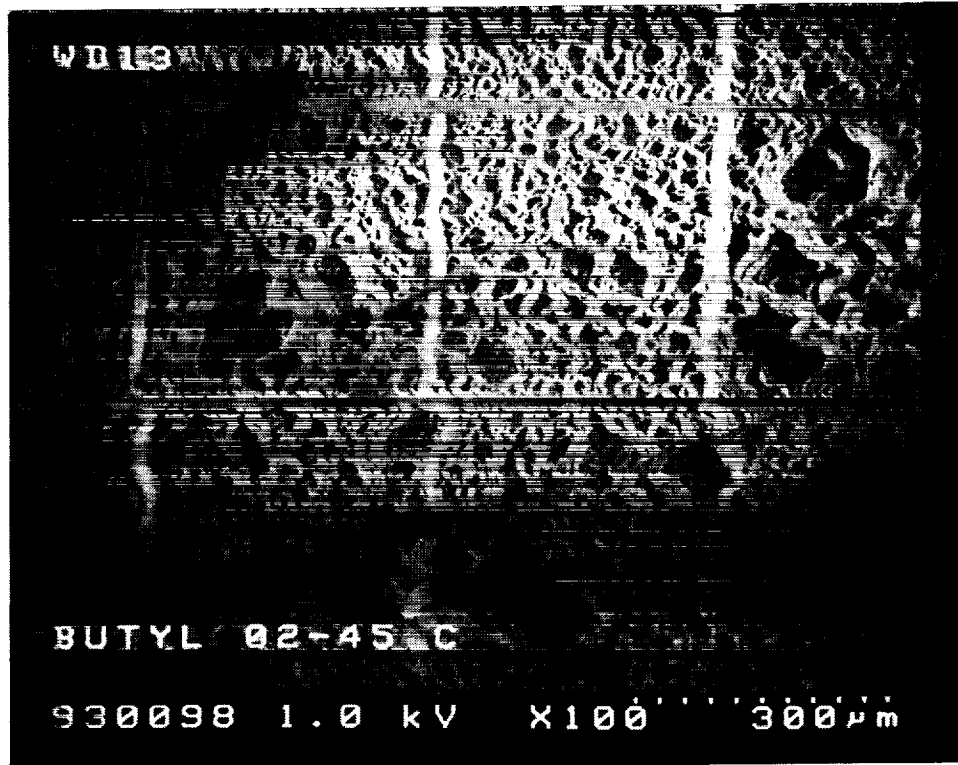
Figure 14. Scanning electron microscope images of a butyl rubber o-ring postflight at 100X and 500X magnification. This o-ring was flown under 80% tension.

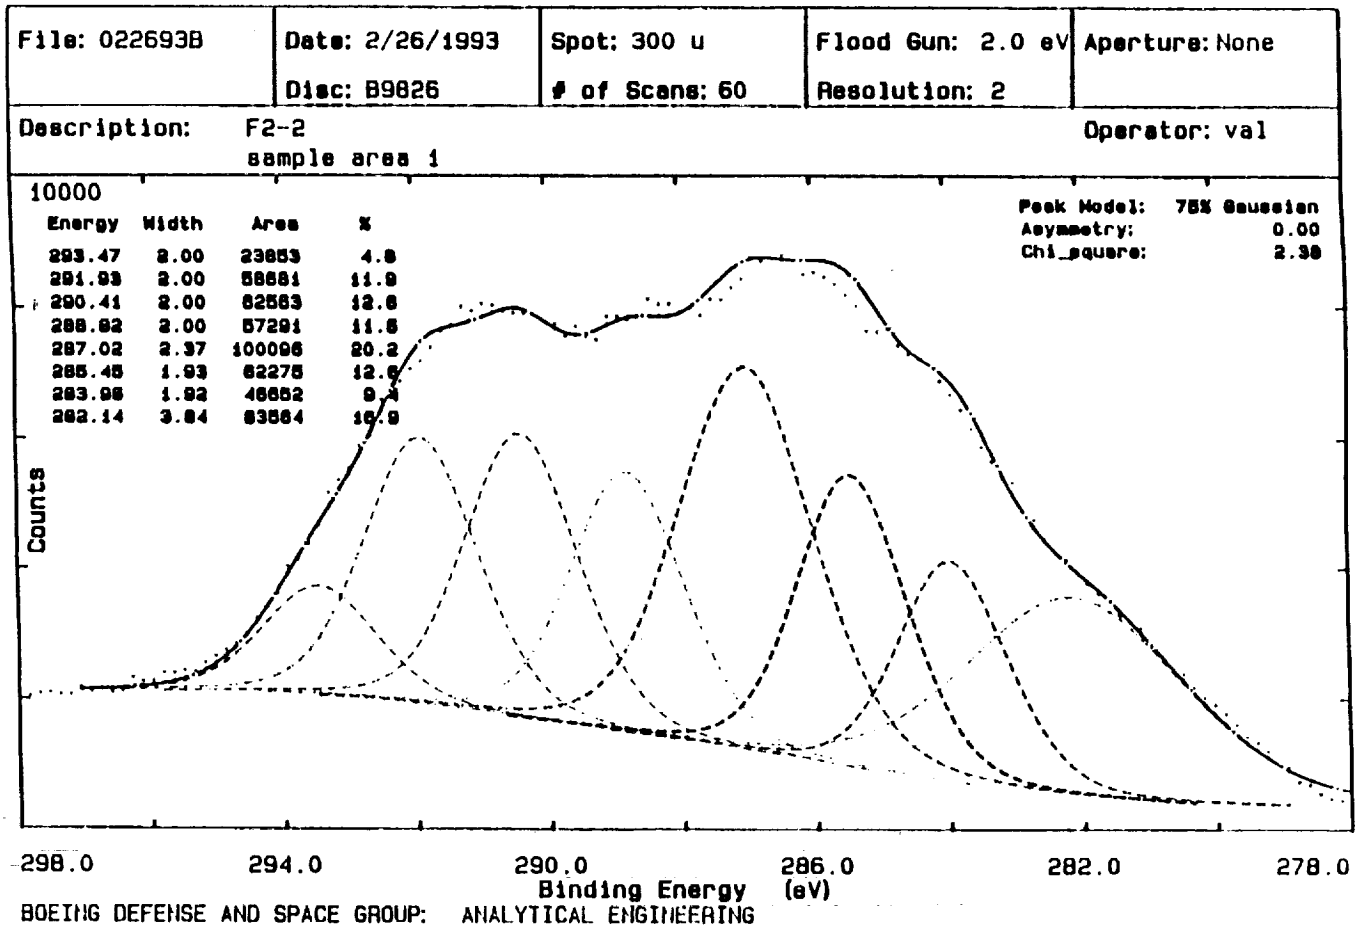
Figure 18. ESCA measurement of Ag/FEP specimen from LDEF tray F2, analyzing the carbon 1s binding energy region.

The CF<sub>3</sub>/CF<sub>2</sub> carbon 1s peak intensity ratio is lower for each LDEF specimen reflown on EOIM III in comparison with each corresponding LDEF specimen (taken from the same blanket) not reflown. This indicates the oxygen is removing some of the surface FEP material previously altered by solar exposure. Figures 18 and 19 show the comparison between surface conditions on blanket F2 after the LDEF flight and after the subsequent EOIM III flight.
