NASA Contractor Report 195042

Effects of Through-the-Thickness Stitching on Impact and Interlaminar Fracture Properties of Textile Graphite/Epoxy Laminates

Suresh K. Sharma and Bhavani V. Sankar
University of Florida, Gainesville, Florida

February 1995

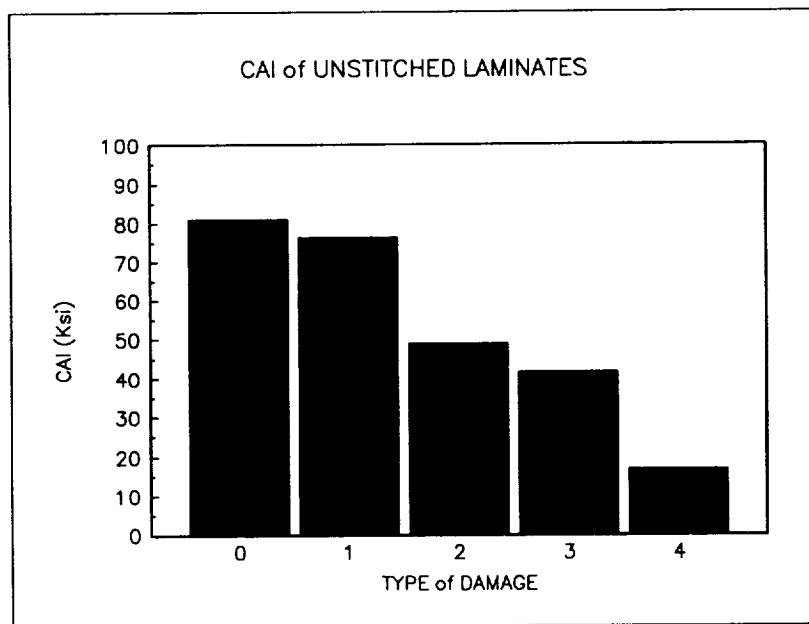
Figure 2-5: Drop of compression strength in unstitched laminates with different types of damages.

The average values of CAI strength normalized for 2.4" gage length are given in Table 2-1. The variation in CAI strength data did not exceed 5% in 90 specimens out of the total 126 tests and it did not exceed 10% in the remaining specimens which indicates good consistency in test results. CAI strengths of different damage types for the unstitched laminates are plotted in Fig. 2-5. The CAI strength drops significantly with

increasing delaminations for the unstitched laminates. The effect of stitching with different yarns of 4x1/4" stitch density is shown in Fig. 2-6. The effect of increased stitch density 8x1/8" can be observed from Fig. 2-7. It is clear from the CAI strength data and the above mentioned graphs that all three stitch yarns seem to improve the CAI strength to about same extent when their stitch densities are equal. This may be due to the fact that any through-the-thickness stitch yarn with sufficient breaking strength and stiffness is able to restrain buckling of the sublaminates by holding them together. More evidence of this is discussed in the next section on the sublaminates buckling failure mode.

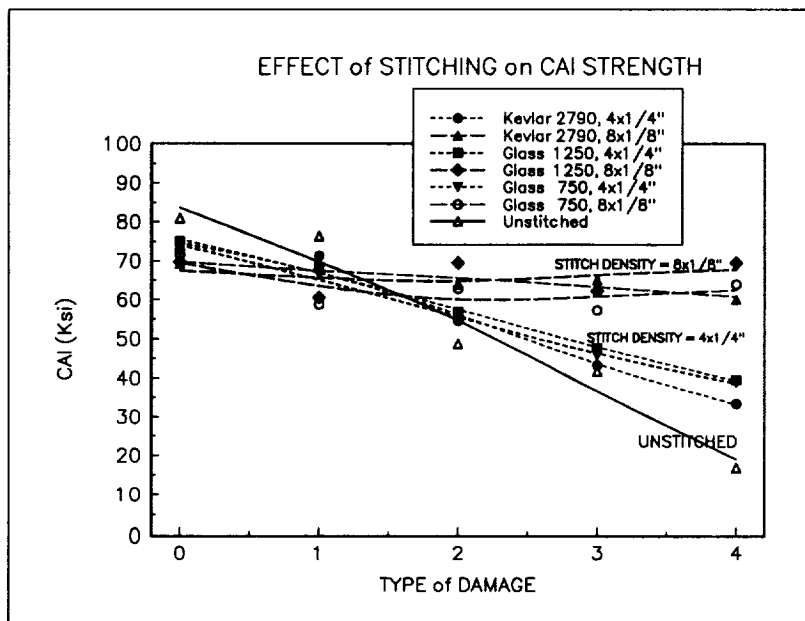
Figure 2-9: A trend of the effect of stitch density on CAI strength

Apart from the initial apparent loss of the compressive strength, the CAI strength of delaminated stitched laminates showed excellent improvement over the delaminated unstitched laminates. The improvement in the case of the worst delaminated specimens (Damage type #4) with high stitch density ($8 \times 1/8''$) was as much as 400% over the unstitched laminates. To study a comparative trend of the improvement in CAI strength data due to stitch density, the data were curve fitted using a locally weighted linear regression (Axum software) and the curves are plotted in Fig 2-9. Here, it was assumed that the different delaminated states (i.e., Damage types #Zero to 4) simulate impact damage of an increasing order.

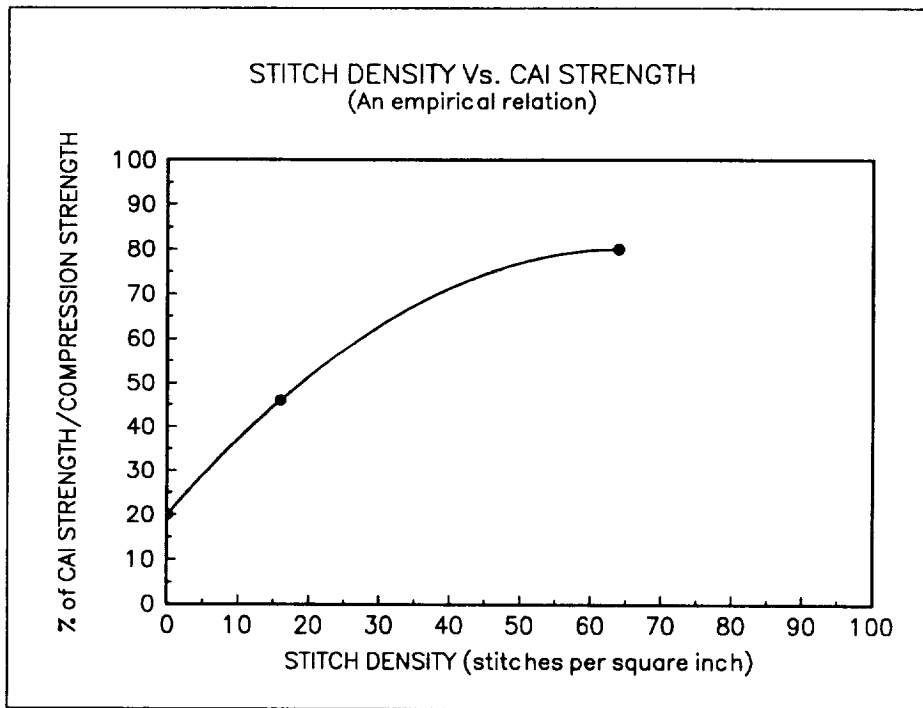
Figure 2-13: An empirical relation between stitch density and CAI strength

empirical relation. Further improvement of strength for a stitch density of more than 45 stitches/in² is insignificant as the curve tends to reach its peak. However, a higher than 45 stitches/in² stitch density may be selected if higher impact damage states than the one investigated in this study are considered.

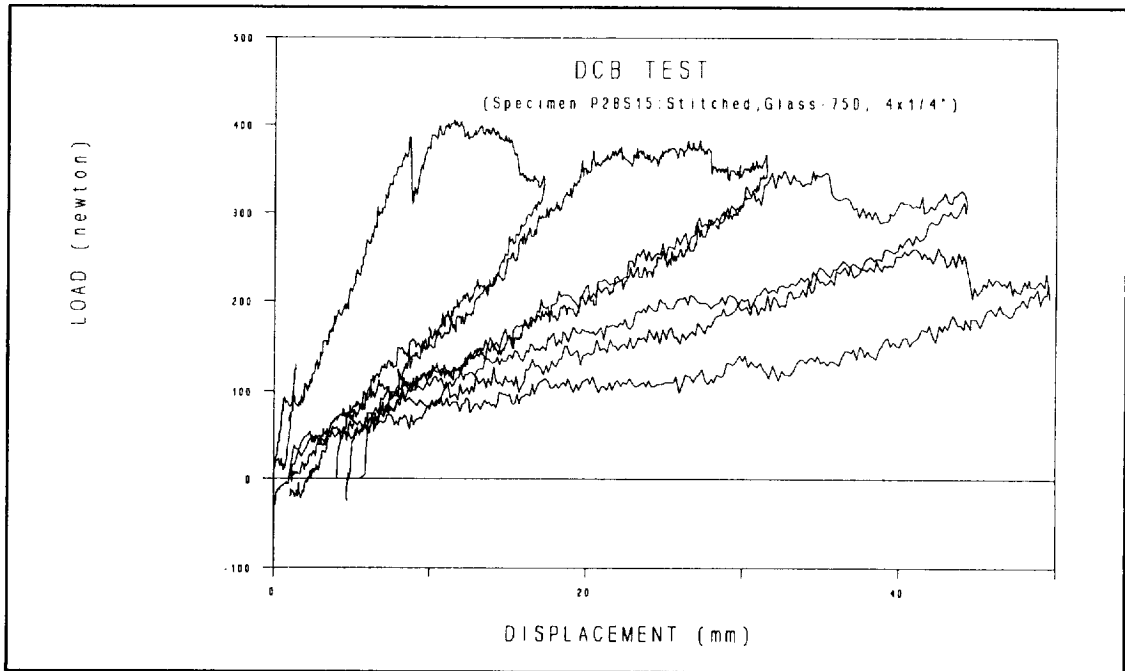
Figure 3-4: A set of typical P- δ curves for a stitched laminate DCB test

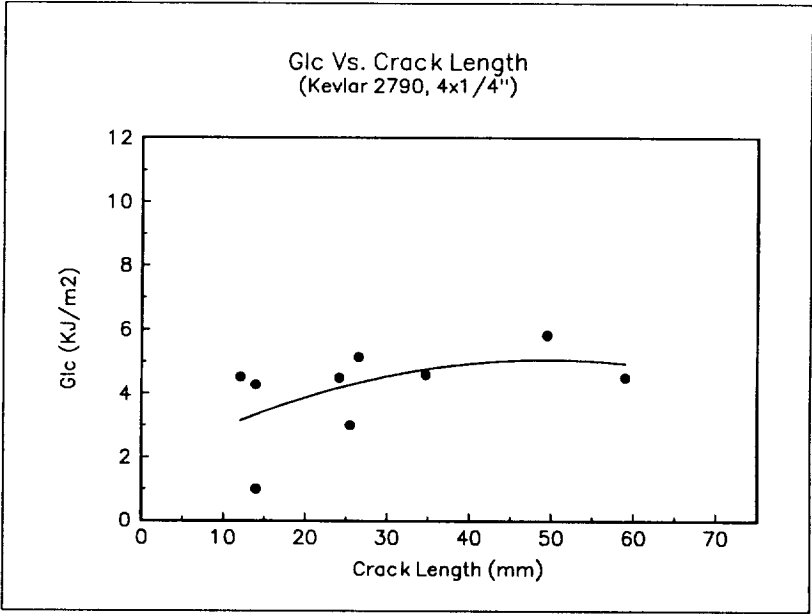
Figure 3-6: G_{Ic} vs. Crack length for Kevlar-2790, 4x1/4" stitched laminate

propagation seems to occur at lower energy requirements. This could be due to manufacturing flaws such as the first stitch line not being perfectly straight. Subsequently, the critical energy release rate appears to stabilize as the crack starts propagating in a self similar manner. The first low value of G_{Ic} introduces a variation of up to 25% in the data for the stitched laminates. Overall, the variation in the G_{Ic} does not seem to be significant as the crack grows. The fracture toughness reaches a fairly steady value soon after the onset of crack propagation. This also brings out the importance of ensuring that the first stitch line is straight.

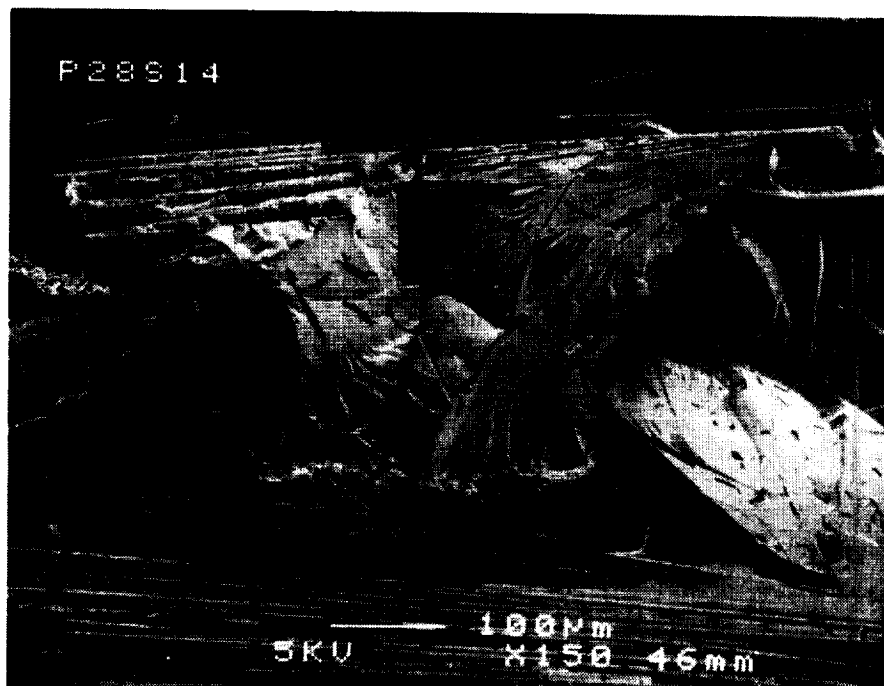
Figure 3-15: Matrix in the adjoining area of the Glass -750 stitch appears "ploughed"

In order to gain insight into debonding, stitch failure and the role of stitch-matrix interaction during the crack opening phase, Scanning Electron Microscopy was conducted on the top surface of a failed stitch and the adjoining matrix area. A stitch that was not compressed during the unloading phase of the test was selected for this study. Some of these photographs are shown in the Figs. 3-14 through 3-17. These studies indicate that the stitch yarn movement is resisted by the matrix surrounding it. Though the stitch yarn in a DCB test is assumed to fail in tension, it does deform the adjoining matrix as the yarn tends to bend when the crack openings grow. The resistance offered by the matrix adds to the toughness brought about by the yarn tensile strength. The texture of the plastically deformed matrix appears to be like that of "ploughing" of earth. The matrix appears "ploughed" by the stitch as seen in the Fig. 3-15.

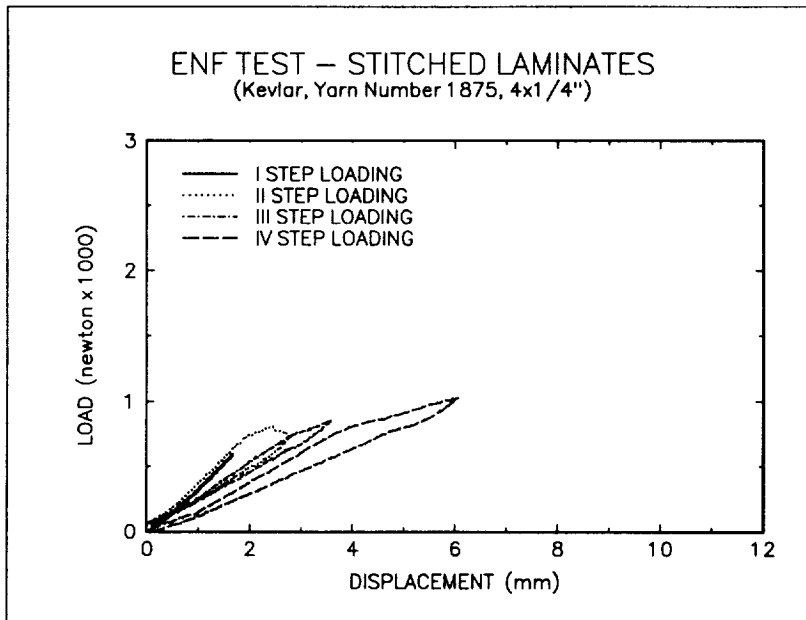
Figure 4-3: A typical set of P- δ curves for intermediate steps of crack propagation

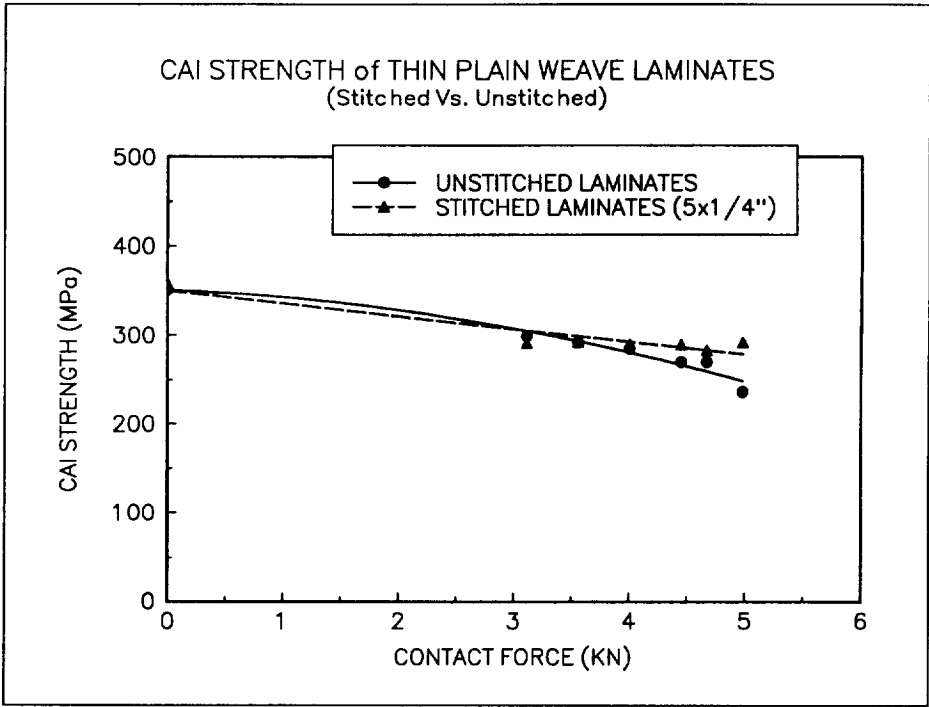
Figure 5-13: Stitching improves the CAI strength of thin plain weave laminates by about 25% for the maximum contact force applied.
