SURFACE CHARACTERIZATION OF LDEF CARBON FIBER/POLYMER MATRIX COMPOSITES

Holly L. Grammer and James P. Wightman
Virginia Polytechnic Institute and State University
Department of Chemistry
Blacksburg, VA 24061
Phone: 703/231-5854, Fax: 703/231-3971

Philip R. Young and Wayne S. Slemp
NASA Langley Research Center
Mail Stop 226
Hampton, VA 23665-5225
Phone: 804/864-4265, Fax: 804/864-8312

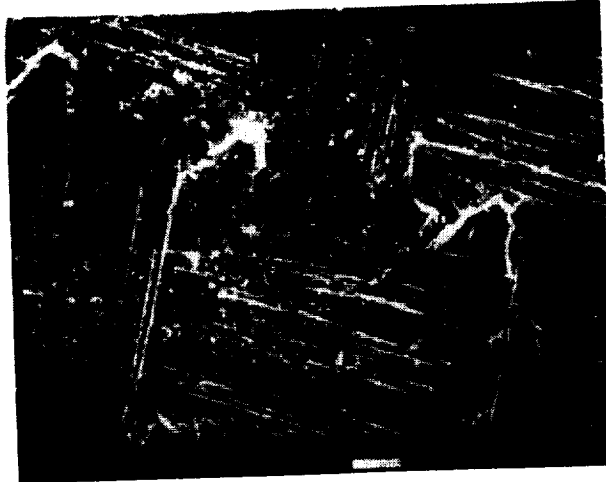
The SEM photomicrograph of the control sample (see Fig. 1A) shows an apparent resin rich surface. The weave pattern seen on this control sample is not the weave pattern of the carbon fibers within the composite but rather the impression left from the scrim cloth used in the consolidation of the composite.

The SEM photomicrographs of the control, 10- and 69-month flight samples are shown in Figure 1. Three very different surface topographies are observed in Figure 1 and support the results obtained from the XPS curve fit analysis.

FIGURE 1: SEM PHOTOMICROGRAPHS OF 934/T300 EPOXY COMPOSITE SAMPLES

(A) CONTROL (B) 10 MONTH (C) 69 MONTH.
