NASA Contractor Report 4604

Evaluation of Seals and Lubricants Used on the Long Duration Exposure Facility

EVALUATION OF SEALS AND LUBRICANTS USED ON LDEF

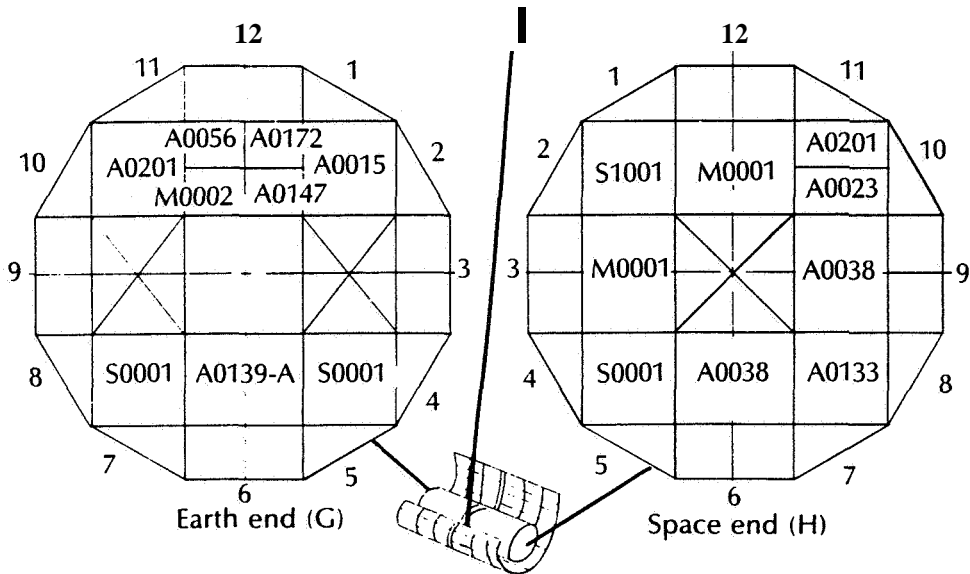
Figure 2-1. Location of experiments on LDEF.

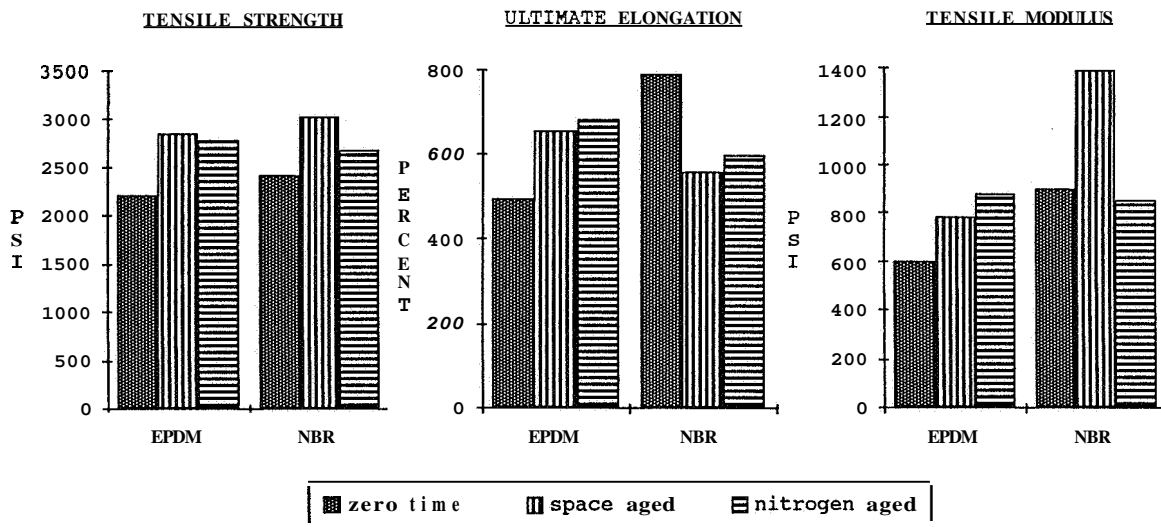
Table 4-4 and figure 4-5 shows the results from mechanical testing of the control, nitrogen aged, and LDEF specimens. During testing the samples were strained at two inches per minute at 77°F. Both elastomers exhibited increases in maximum strength for the nitrogen and LDEF specimens. The LDEF NBR specimens exhibited a 55% increase in tensile modulus while similar specimens aged in nitrogen showed a slight decrease. Both EPDM LDEF and nitrogen aged specimens showed increases in tensile modulus (ref. 7).

Figure 4-5. Performance of NBR and EPDM control, LDEF, and nitrogen aged specimens.

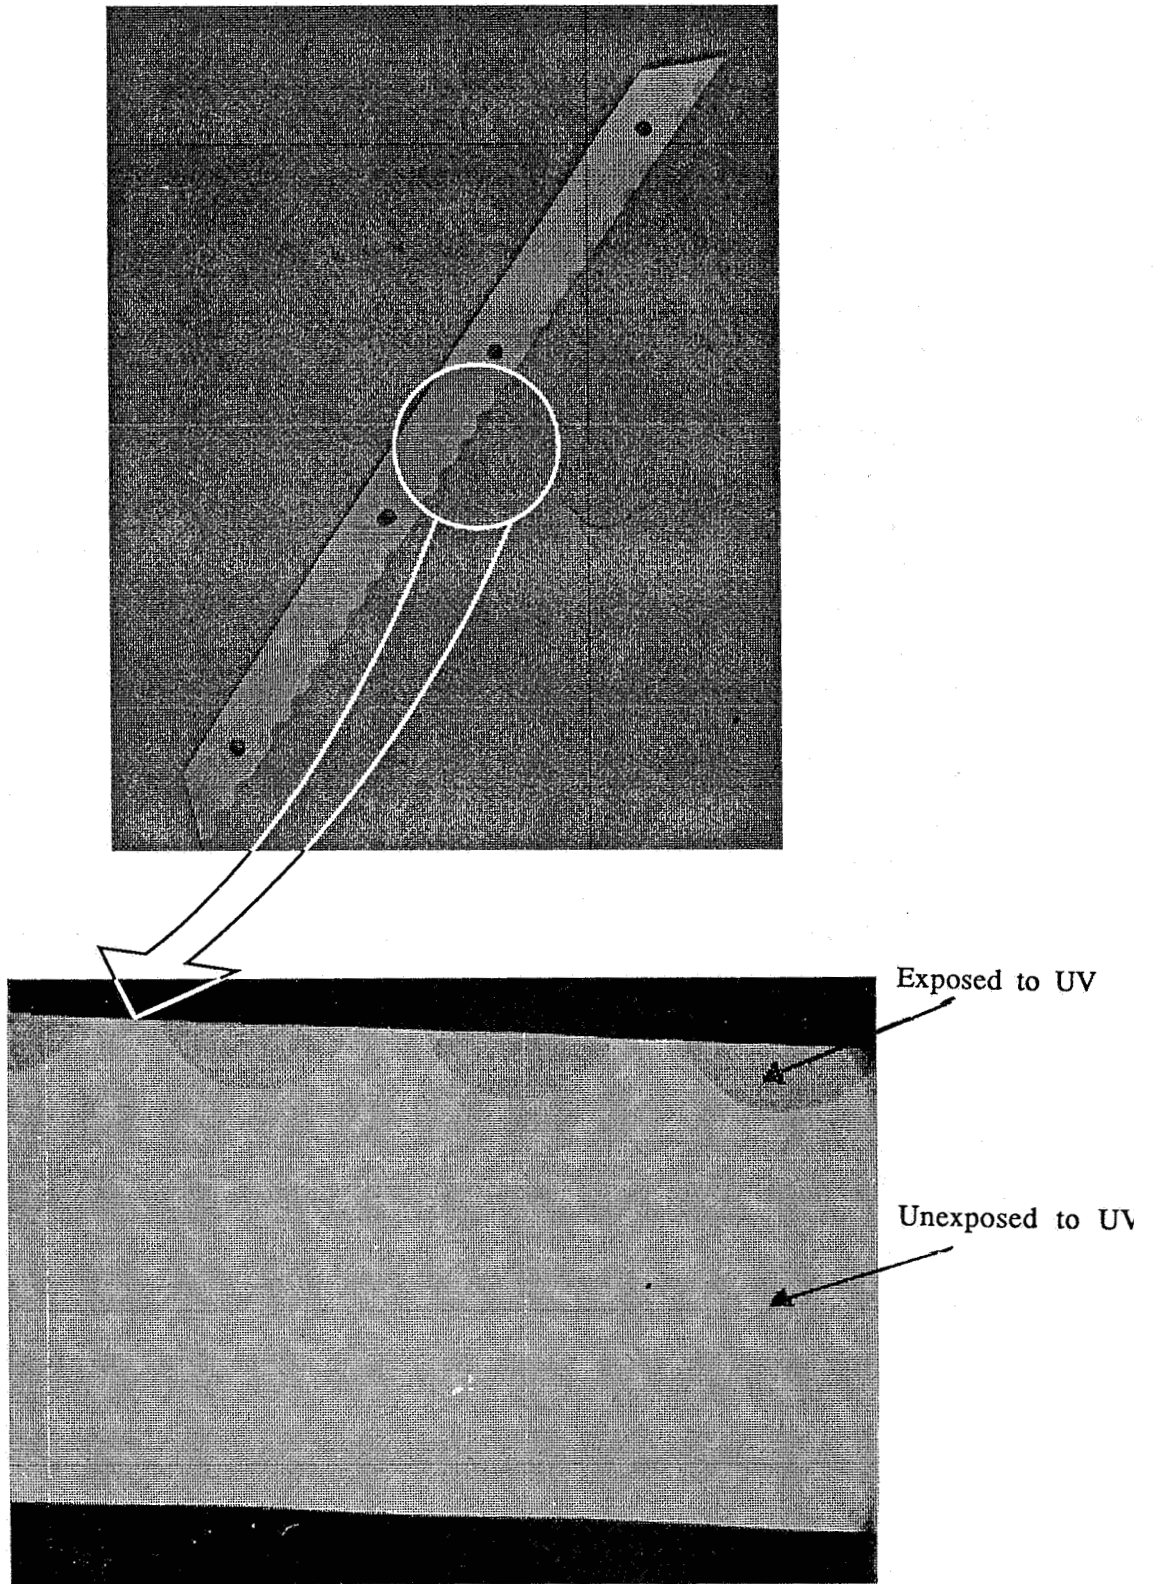
Silicone rubber was used as a cushioning gasket between the sunscreen and the tray in experiment S0050, Investigation of the Effects on Active Optical System Components. Portions of the gasket were exposed through holes in the sunscreen. Since the experiment was on the trailing side of LDEF (row 5), the gasket saw UV, but not atomic oxygen. The exposed areas of the gasket were slightly darkened but did not show any other signs of degradation (see figure 4-6). The hardness of the gasket was the same in exposed and unexposed areas, and all material was very pliable. Tensile strength and elongation were determined. Five specimens were tested and the average ultimate stress was 725 psi and the average elongation at failure was 100% (Appendix D-1 contains the test data sheet). Although control specimens were not available, the properties of the cushioning gasket were found to be within the range of other silicone elastomers.

Figure 4-6. Silicon Rubber Cushioning Gasket Used on Experiment SO050.

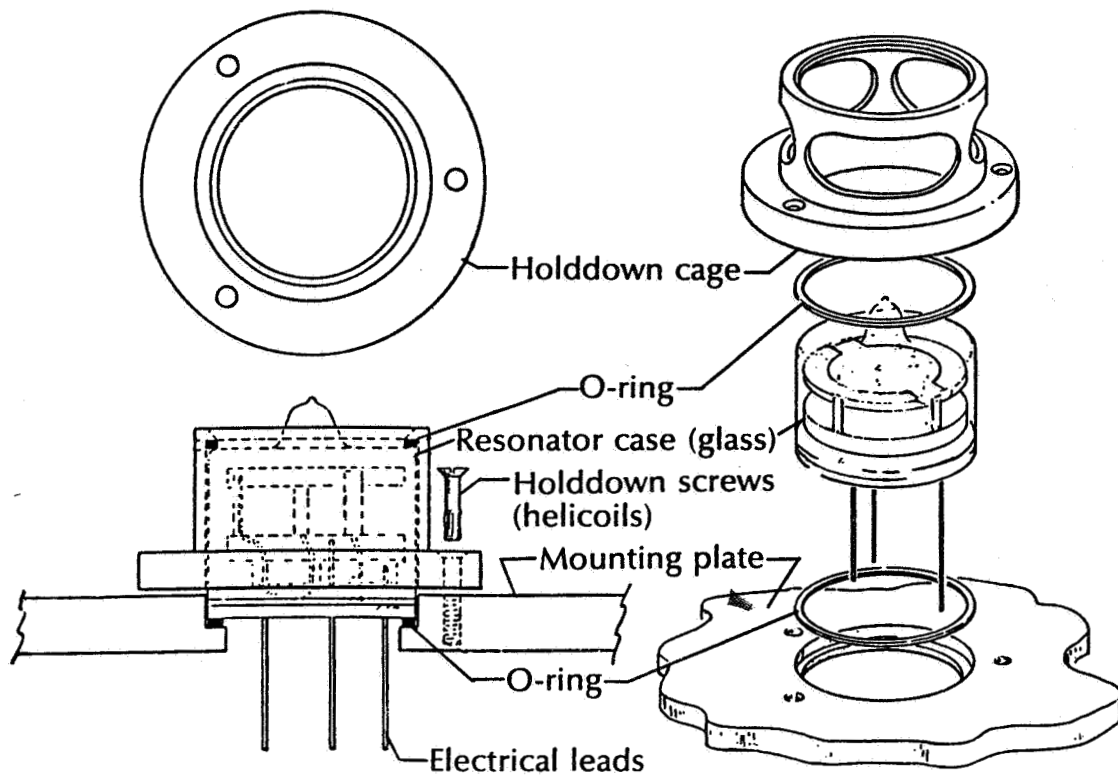
Figure 4.7. Location of Viton O-rings used on the Quartz Crystal Oscillators Flown on Experiment A0189

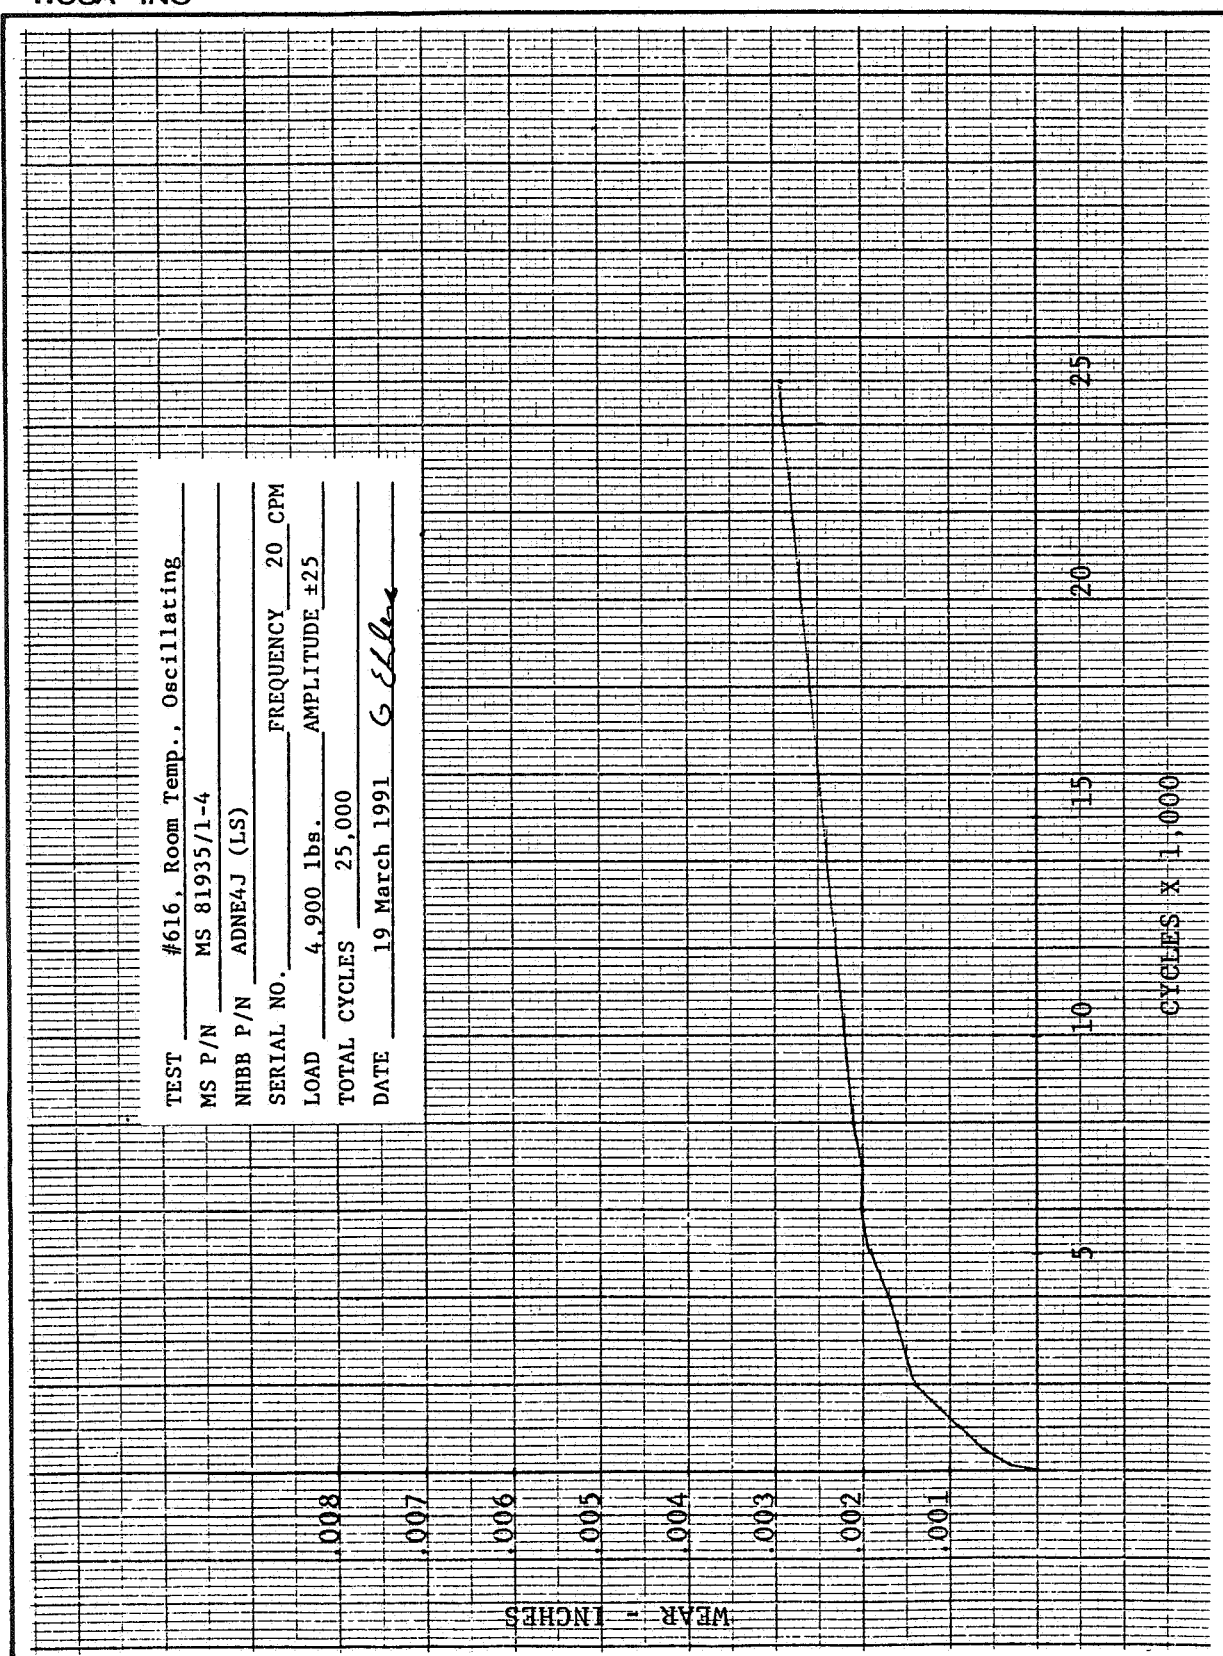
TEST #616, Room Temp., Oscillating
 MS P/N MS 81935/1-4
 NHBB P/N ADNE4J (LS)
 SERIAL NO. _____ FREQUENCY 20 CPM
 LOAD 4,900 lbs. AMPLITUDE ±25
 TOTAL CYCLES 25,000
 DATE 19 March 1991 *G. E. Lane*

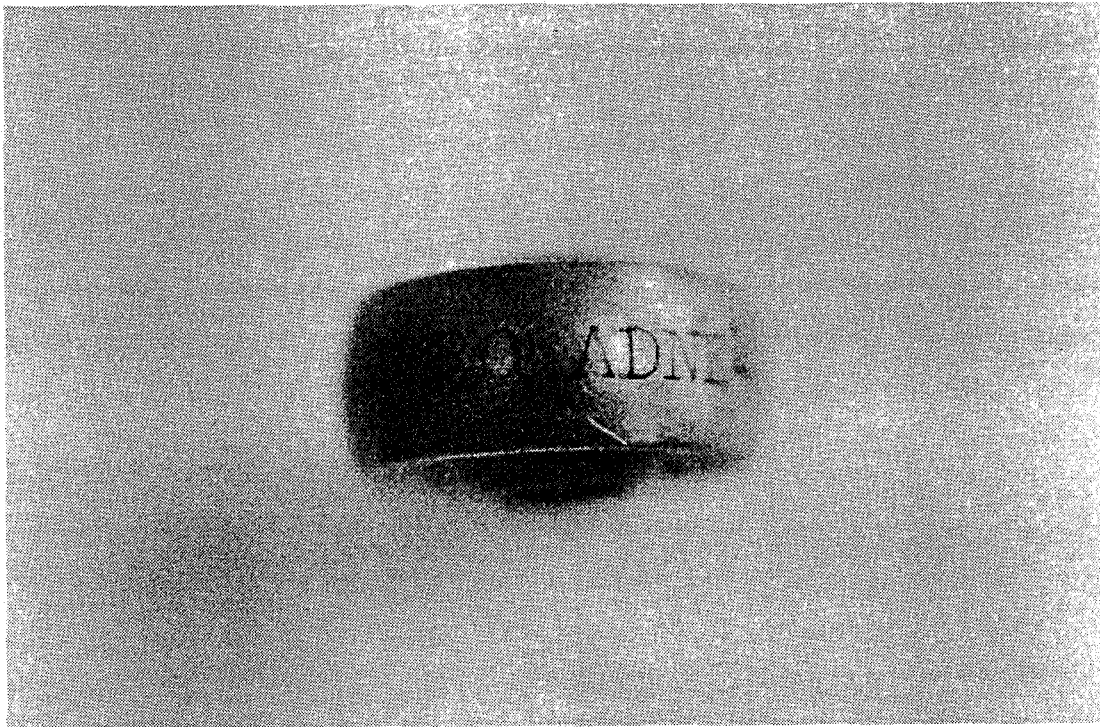
Photograph No. 2

Head end of short shank (SS) bearing showing part number, electrochemically etched. Note only partial loss of chromate coating.

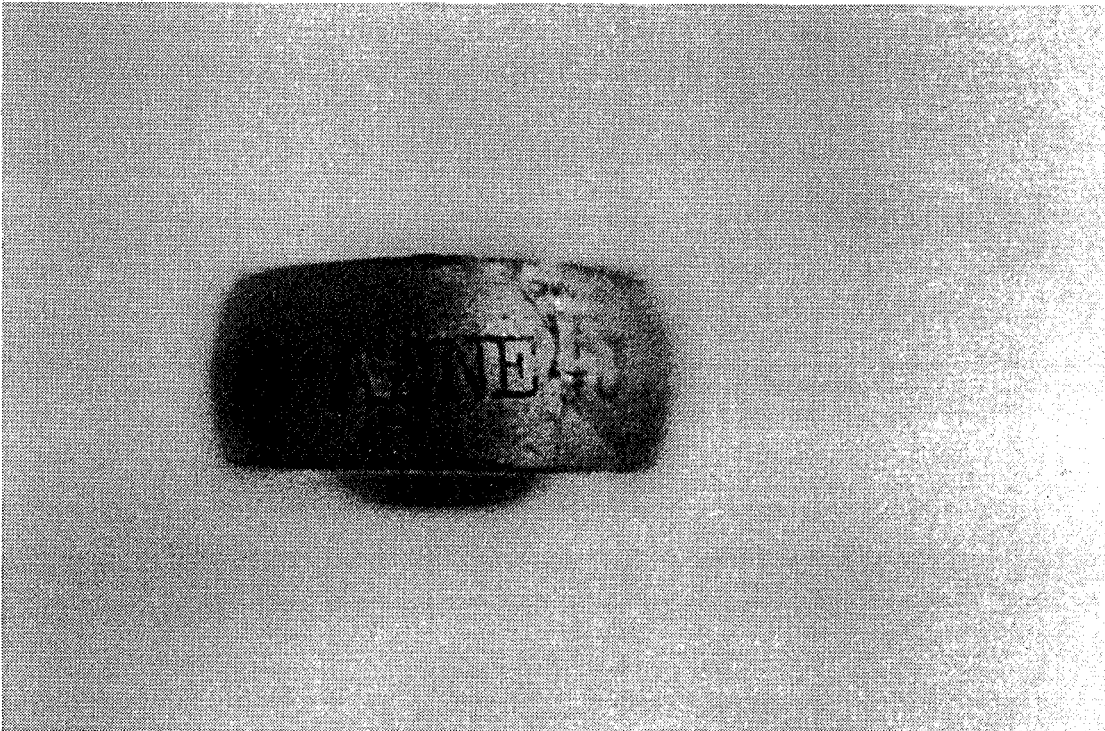
Photograph No. 3

Head end of long shank (LS) bearing showing part number, electrochemically etched. Less chromate coating loss than on SS bearing in this area.
