NASA Contractor Report 191195
R94AEB175

Fiber Optic (Flight Quality) Sensors For Advanced Aircraft Propulsion

Final Report

Gary L. Poppel
GE Aircraft Engines
Cincinnati, Ohio 45215

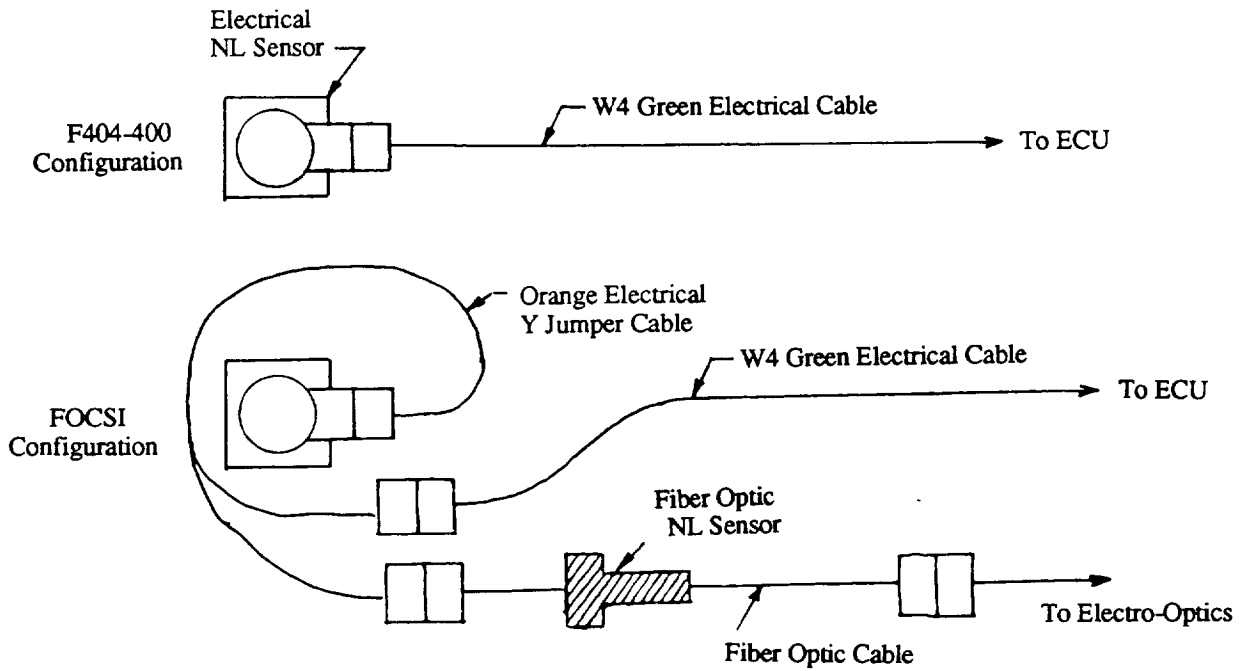
Figure 6 - Fiber Optic NL Speed Sensor Interface With F404-400 NL Speed Sensor

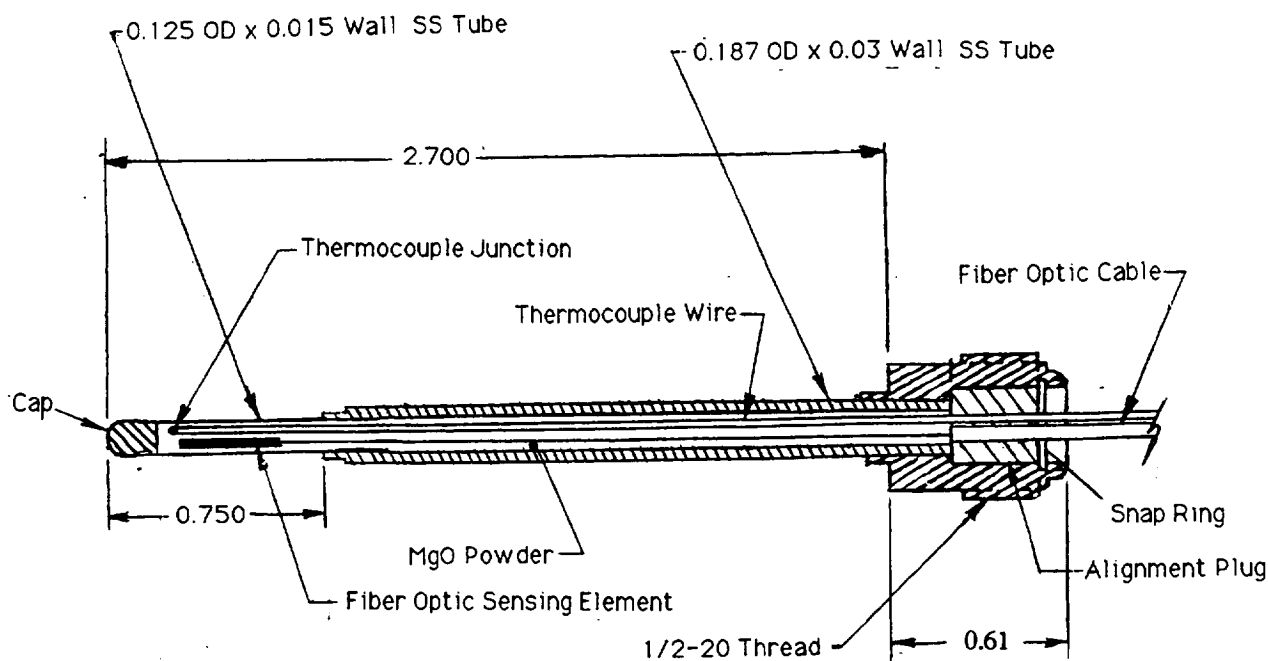
Figure 9 - T2.5 Temperature Probe Package

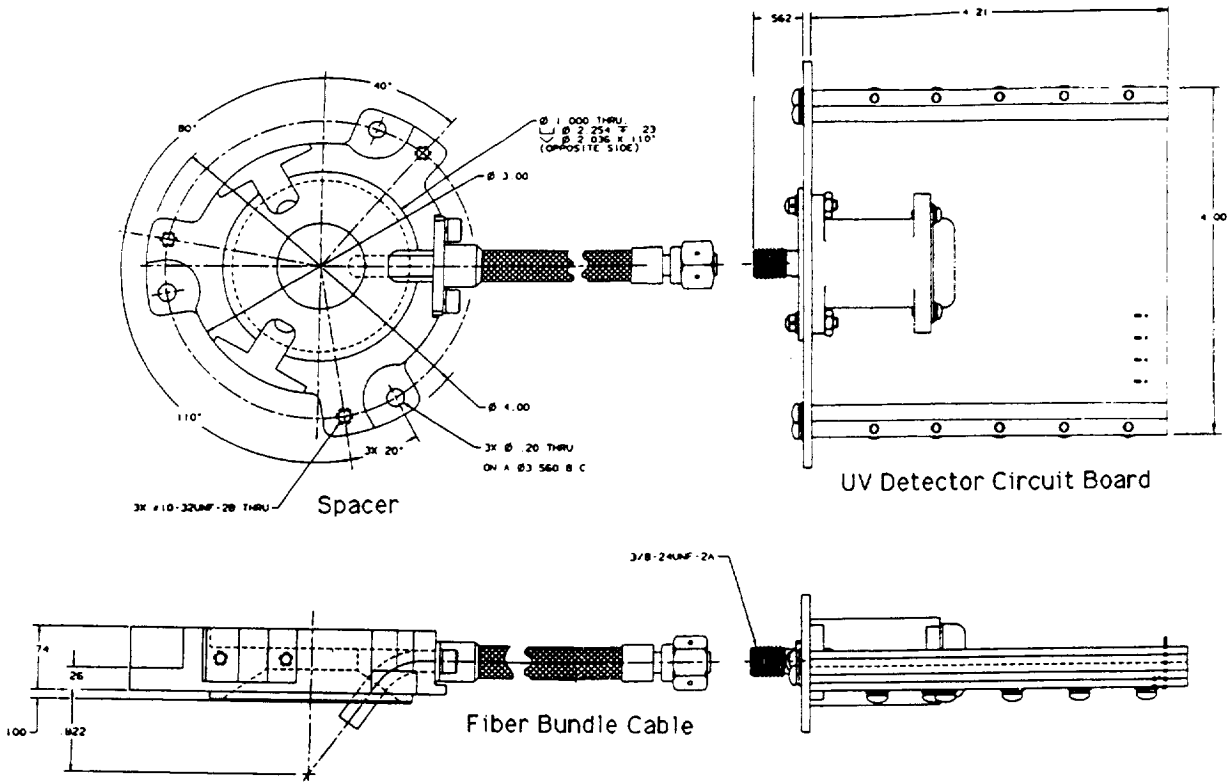
Figure 16 - A8 Flame Detector Components

The detector assembly components include the following: (1) A stainless steel spacer, installs under the F404-400 electrical flame detector. The original height of 0.74 inches was reduced to 0.50 inches for flight testing. It has three possible places where the fiber optic cable can be installed to view the flame. (2) A 59 inch long, 0.375 inch OD, fiber optic bundle cable, containing approximately 100, 200/220, step index, aluminum-coated fibers. (3) A UV detector circuit board. These are shown in Figure 16. This configuration allows the F404 detector to continue to function simultaneously. In a product design, only a small casing pad would be required for the end of the cable.

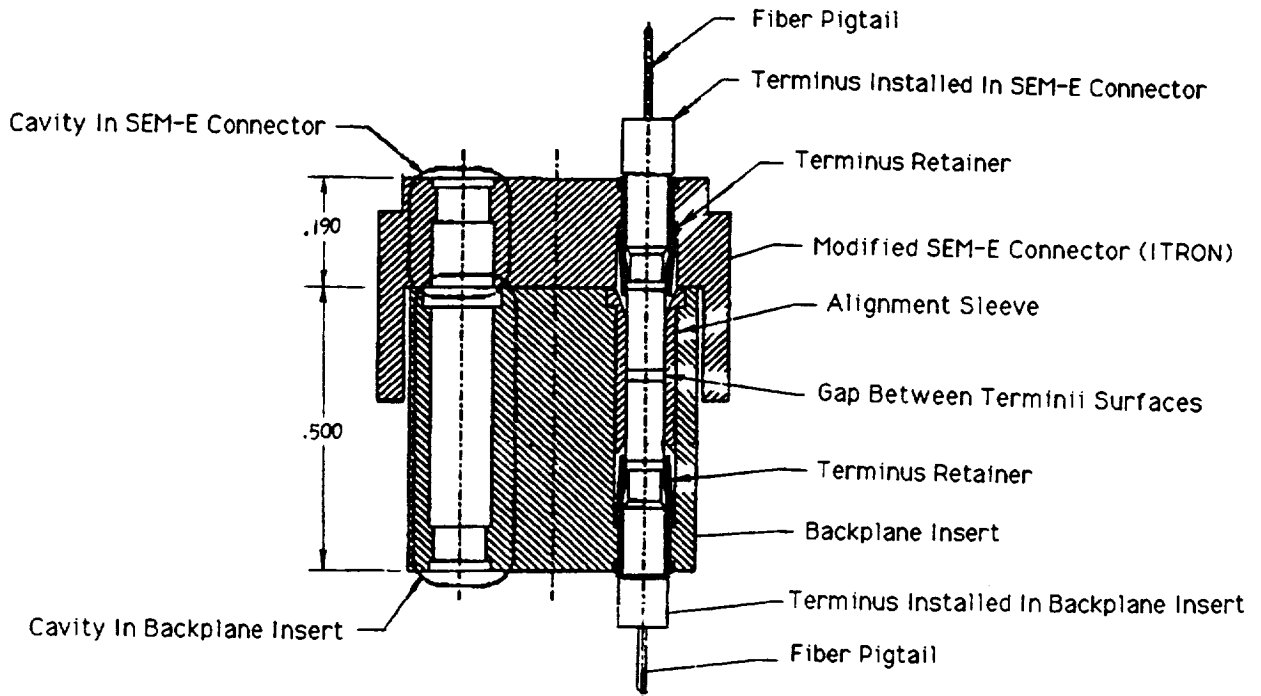
Figure 17 - G&H Fiber Optic Terminus Configuration For EOA Backplane

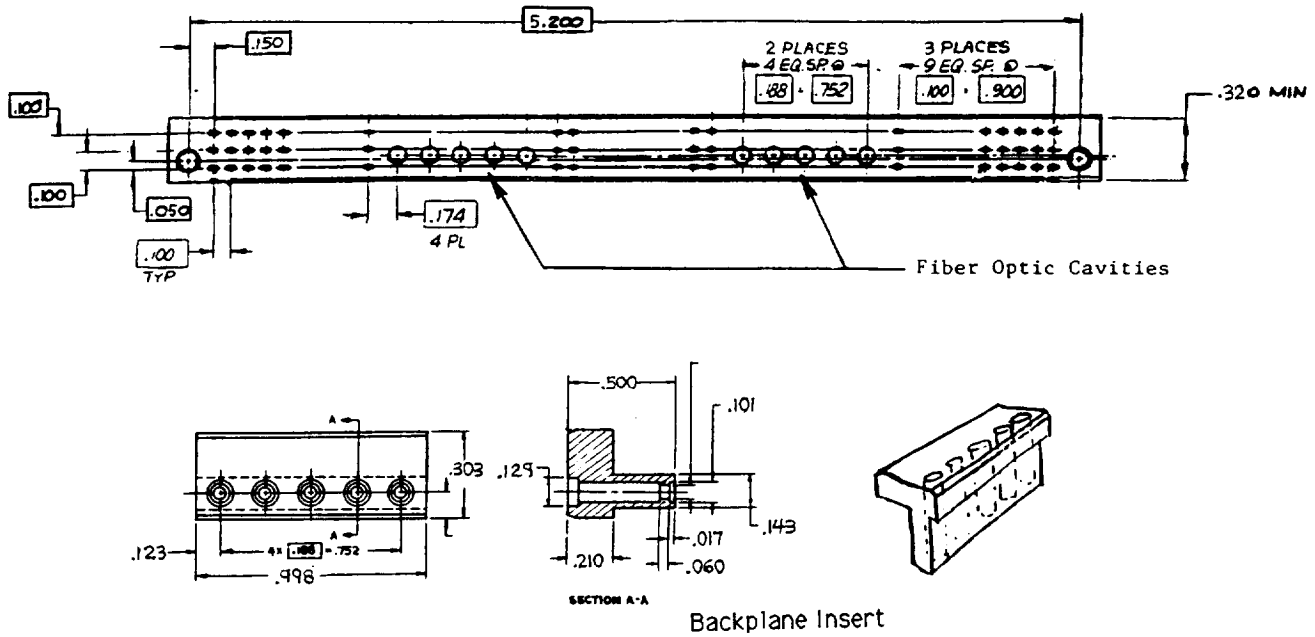
Figure 18 - Modified SEM-E Connector and Backplane Insert For Backplane Fiber Optic Terminus

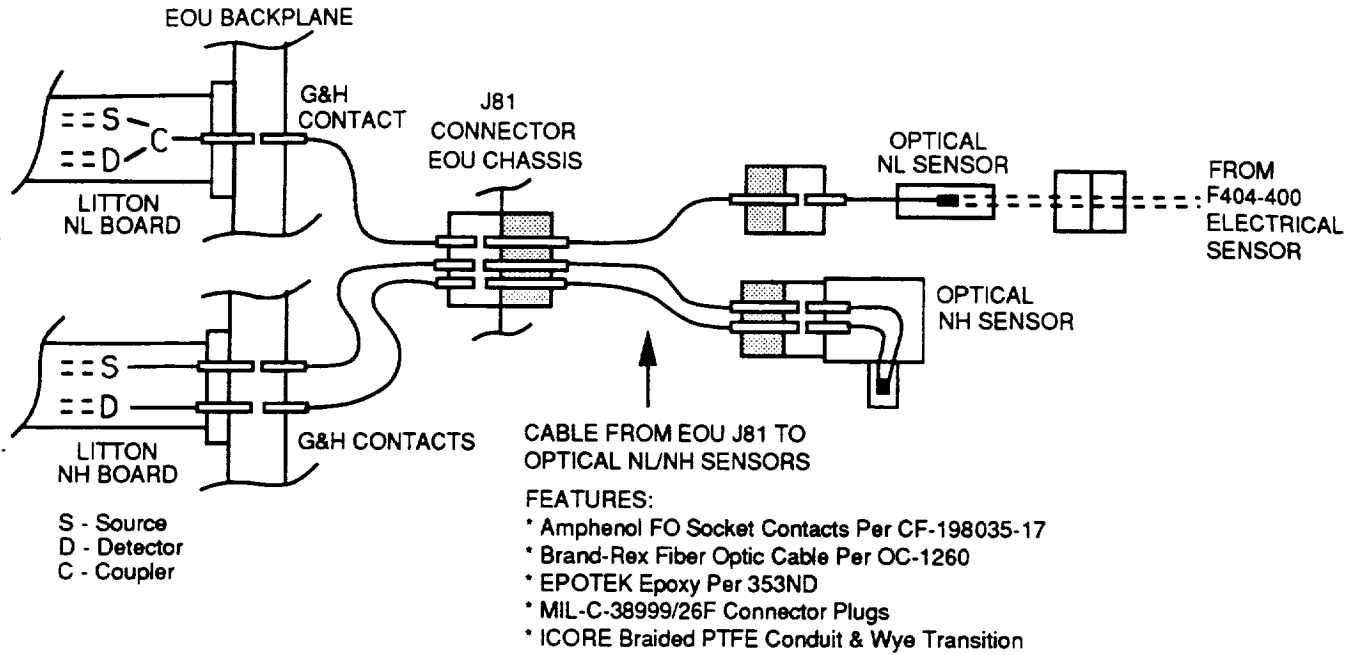
Figure 23 - Optical Fiber Configuration For NL/NH Sensors

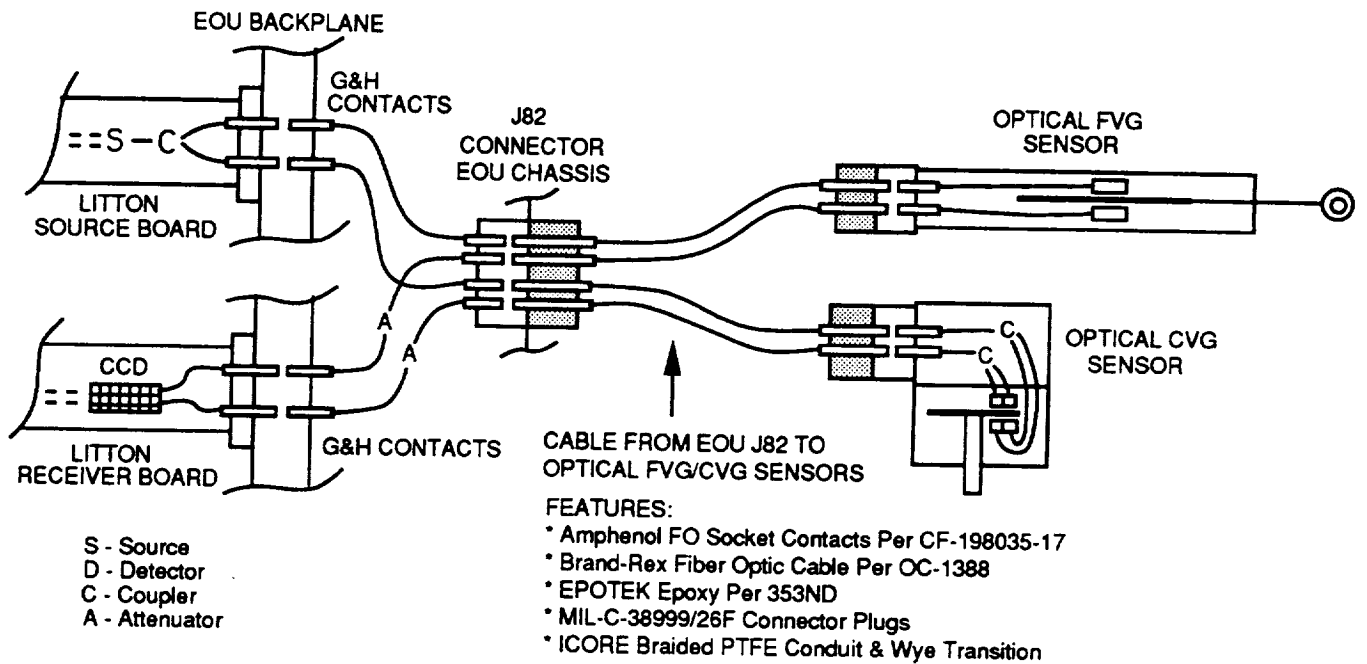
Figure 24 - Optical Fiber Configuration For FVG/CVG Sensors

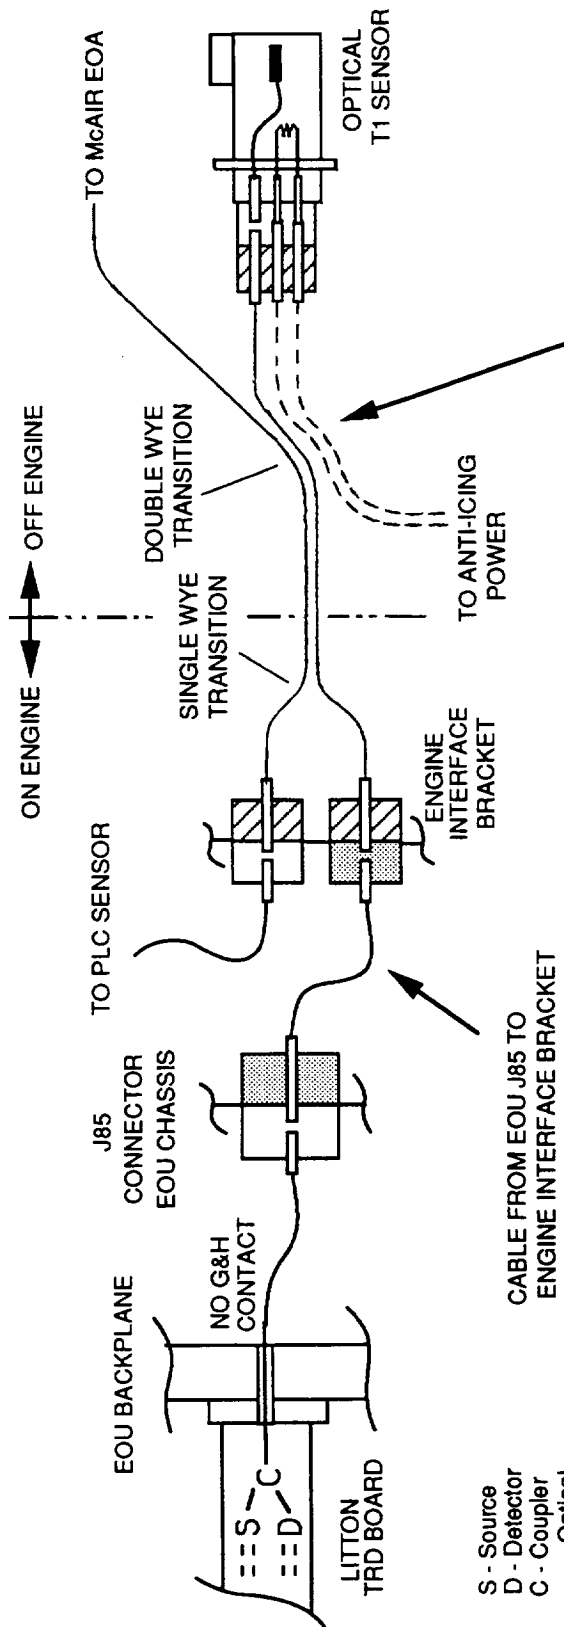
S - Source
 D - Detector
 C - Coupler
 ——— Optical
 - - - Electrical

Figure 25 - Optical Fiber Configuration For T1 Sensor
