N94-31028**IMPACT OF LDEF PHOTOVOLTAIC EXPERIMENT FINDINGS UPON SPACECRAFT
SOLAR ARRAY DESIGN AND DEVELOPMENT REQUIREMENTS****Leighton E. Young**NASA Marshall Space Flight Center
Marshall Space Flight Center, AL 35812
Phone: 205/544-0707, Fax: 205/544-5847**SUMMARY**

Photovoltaic cells (solar cells) and other solar array materials were flown in a variety of locations on the Long Duration Exposure Facility (LDEF). With respect to the predicted leading edge, solar array experiments were located at 0° (row 9), 30° (row 8), and 180° (row 3). Postflight estimates of location of the experiments with respect to the velocity vector add 8.1° to these values. Experiments were also located on the Earth end of the LDEF longitudinal axis. Types and magnitudes of detrimental effects differ between the locations with some commonality. Postflight evaluation of the solar array experiments reveal that some components/materials are very resistant to the environment to which they were exposed while others need protection, modification, or replacement. Interaction of materials with atomic oxygen (AO), as an area of major importance, was dramatically demonstrated by LDEF results. Information gained fro

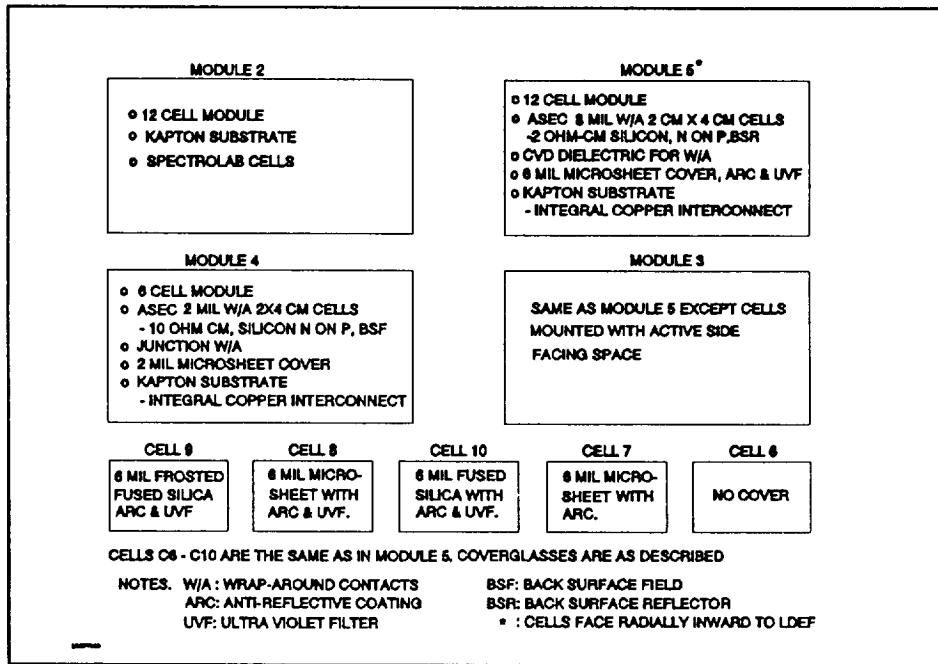
Figure 3. Description of MSFC SAMPLE solar cell test assemblies.

At first observation, the most striking changes to materials resulted from interactions with AO. Erosion of polymeric (Kapton) substrates on the SAMPLE experiments resulted in loss of two out of the four MSFC multicell test articles (modules) to space (see Fig. 2). Module 2 (Fig. 3) was missing upon shuttle rendezvous with LDEF. Module 3 drifted away upon grapple with the shuttle arm. Module 5 (Fig. 5) had lost structural attachment at three out of four points and was recovered from the floor of the shuttle cargo bay when LDEF was removed at Kennedy Space Center. The MSFC single-cell test articles (Cell 6 through Cell 9) in Figure 3 also showed considerable erosion to their Kapton substrates. Some parts of these substrates showed less erosion than others, apparently as a result of shading from the AO flux offered by adjacent test articles.

Conventional (glass) coverslides as described in Figure 3 and Table II were flown as part of the solar cell assemblies on the MSFC SAMPLE experiments. The APEX contained MSFC provided cells with conventional and polymer covers as described in Table II. Comparing the postflight electrical performance of the MSFC SAMPLE cells Cell 6 through 10 (C6 through C10 in Figure 9), it can be observed that conventional covers provided considerable protection against the space environment. The extra degradation experienced by Cell 6 (no coverslide) can be attributed largely to the proton/electron radiation environment. Postflight visual (no magnification) comparison of Cell 6 antireflective coating with the antireflective coating of Cell PC1L with its coverslide removed did not reveal any differences.

Figure 3 describes the layout and characteristics of the MSFC SAMPLE test articles. Module 5, the only SAMPLE 12 cell module not lost to space, was first illumination tested as a module showing approximately 32-percent degradation in its maximum power capability from the preflight value. It was then dissected into individual cells (PC1L, PC2L, ..., PC4R in Fig. 9), and performance curves of the individual cells were taken under a flash solar simulator. Degradation in the maximum power point power (PMP) of the individual cells ranged from 4.6 to 80 percent (Fig. 9). Although not visually discernible, it was originally thought that the high electrical performance degradation in Module 5 must have resulted from its fall to the shuttle cargo bay since test articles that stayed in place exhibited much lower degradation. Current/voltage (I/V) curves indicated a dramatic increase in series resistance of the poorly performing cells. Figure 10 shows I/V curves for the three highly degraded and the least degraded cells from Module 5. There were also slight indications of decreased cell shunt resistance in some Module 5 cells. Low power optical inspections did not reveal any clues as to the cause of the increased series resistance. However, the Kapton module substrate had been eroded to the extent that holes/cracks were made that would allow AO flux to impinge upon the silver back-surface metalization and wraparound contacts. It was postulated that interaction of the AO with the wraparounds could cause erosion which would result in increased series resistance. Coverslides were removed on four of the most degraded cells, and scanning electron microscope images were made on the wraparounds to confirm this postulate. These images showed a high percentage loss of material in the wraparound metalization (Fig. 6). Electrical resistance measurements were taken across the wraparound and found to be high. Cell PC2C (PMP degraded 80 percent) resistance measured 2.78 ohms. A resistance test on the wraparound of the same type cell that had not flown showed 0.007 ohms. Bridging of the wraparounds with a small wire soldered on the front and rear surfaces restored good performance on the cells that were evaluated in this manner (see Fig. 11). Another observation of data from these tests is that degradation is proportional to the series resistance increase, further indicating that it is the major contributor to the degradation in the highly degraded cells. Modern cells with all contacts on the rear surface of the cells would not have this problem because the wraparound would be replaced by a wrap-through or be protected with a coating. A comparison of electrical performance of cells with impact craters (PC1L and PC2R) with that of cells without craters (Cell 7 to Cell 10) in Fig. 9, indicates that the crater damage could cause 2- to 4-percent degradation in PMP. However, since these cells have not been evaluated in terms of other performance degradation mechanisms, these values can only be taken qualitatively, i.e., craters up to 100 micron in diameter cause relatively small performance degradation. Electrical performance degradation caused by small craters on the cell coverslide was not discernible in measurement.
