INTEGRITY TESTING OF BRUSH SEAL IN A T-700 ENGINE

Robert C. Hendricks, Thomas A. Griffin, George A. Bobula, and Robert C. Bill
National Aeronautics and Space Administration
Lewis Research Center
Cleveland, Ohio, 44135

SUMMARY

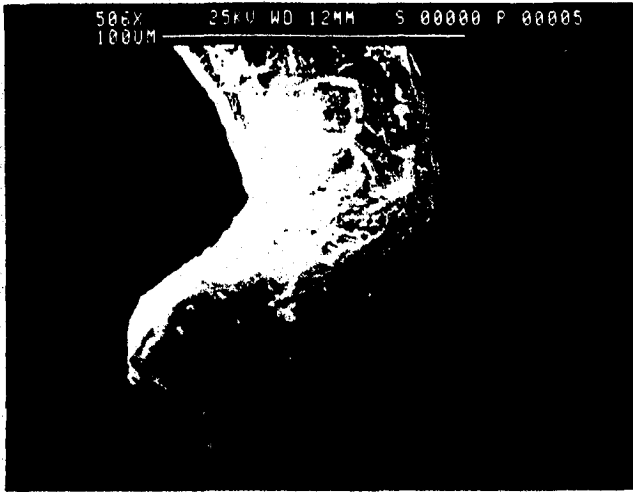
(a) Typical bristle tips.

(b) Surface features.

Figure 9.—Typical brush seal debris found in engine exhaust duct.

Upon initial engine startup, an orange burst was noted and was assumed to be expelled brush bristles (i.e., those that were inadequately attached, were pulled out by rotor irregularities, or were embedded within the blade row gaps during the blind installation and "snapped" or "yanked" or "bent" aside during engine break-in). Residual bristles from the exhaust were photographed (fig. 9). Although they appeared to be highly oxidized and stressed, they were curly and still wirey. The number of residual bristles decreased with operation until none were noted. It is assumed that at this time the bristles and the rotor were in nearly line-to-line contact (i.e., rubbed in). Precooling the bristles during the initial rub-in may mitigate bristle loss and the orange burst.

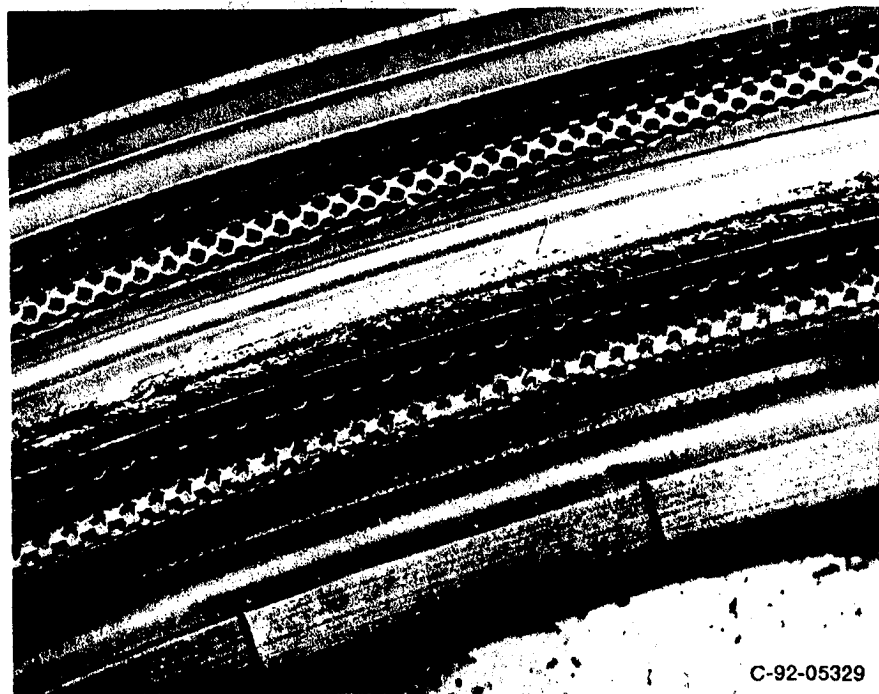
Figure 10 illustrates bristle spreading after testing, with a central core of bristles rubbed (probably clip cut and worn to shape). Although the environment was hostile, the brush did not disintegrate, but bristle pullout could be noted in a few places. Some upstream bristles (two or three rows) show spreading and perhaps one row downstream (toward the exhaust). The remainder of the bristles show wear (or cutting plus wear). Detailed estimates of the bristle stubble heights are given in figure 11(a) as taken from the set of photographs in figure 11(b) corresponding to positions (joint, J+1, J+1.5, J+2, J+2.5, J+3, J+3.5, J+4, and J+4.5) shown in figure 11(a). The last two photographs in figure 11(b) correspond to the minimum stubble height, where the rotor actually rubbed the fence (position J+3); the view is looking toward the bristle stubbles to show the rubbed fence. Figure 11(c) shows wear track and fence rub, and figure 11(d) shows the joint wear track.

Figure 10.—Post-test view of brush seal showing bristle spreading and core of rubbed bristles.

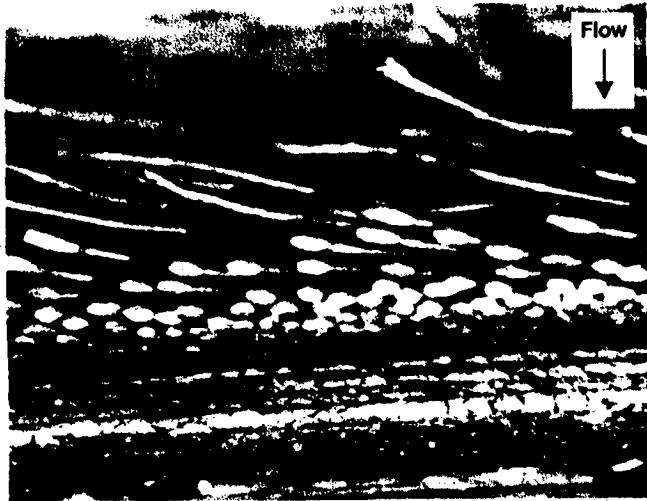
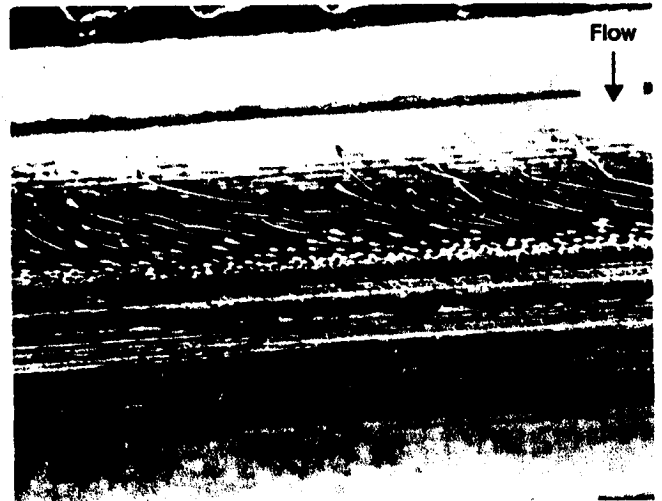
(c) Wear track and fence rub.

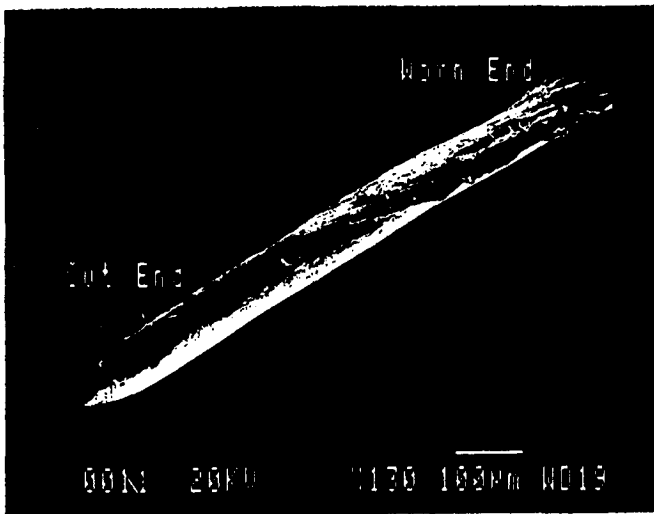
Metallographic results (fig. 13) illustrate some material migration along the bristle and material transfer both from and to the surface. Material smears seem to be in line with a softer material rubbing a harder material even to the point of melting. Thus, one would conclude that the interface became very hot, but the interface followed the classic Block slider problem, where the penetration depth (radial) is very small. Thus, the thermal effect at the interface appeared to be topical, wearing the brush bristles until line contact with the rotor and smear transfer of both materials occurred. Such evidence is presented in figure 14, for an individual bristle that was clipped from the brush. The clipped end was removed from the interface, and the worn end is representative of interface materials. There are material smears, oxidized spots, and apparent pits. It is not clear how the irregularities of the interface affected these results, but it is clear that materials were transferred.

(a) Bristle 1 spread away from wear track.

(b) Analysis of bristle 1.

Figure 13.—Post-test metallographic results for single bristle.
