NASA Technical Memorandum

NASA TM - 108431

MICROSTRUCTURAL STABILITY OF WROUGHT, LASER AND ELECTRON BEAM GLAZED NARLOY-Z ALLOY AT ELEVATED TEMPERATURES

November 1993

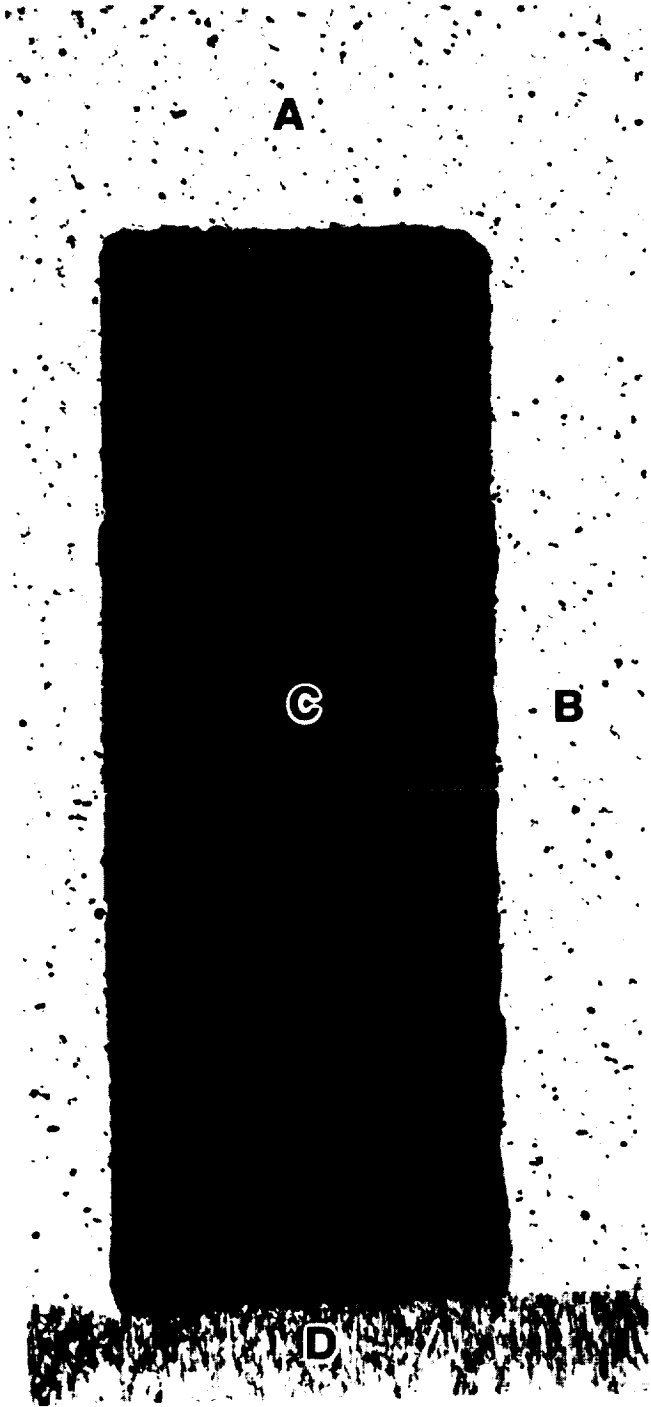
- A – Hot wall
- B – Channel land
- C – Cooling channels
- D – Cold wall (ED Cu)
- E – Electrodeposited Ni

Figure 2. Uniform microstructure in wrought NARloy-Z hot wall.

The present liner undergoes a heat treat cycle that includes solutionization in a vacuum furnace for 4 h at 935 °C (1,715 °F), water quenching to room temperature, and age hardening for 4 h at 480 °C (900 °F). This cycle produces a coarse-grained microstructure, with a Cu matrix that contains localized nonuniform distribution of Cu-Ag-Zr intermetallic phases and Zr oxides (fig. 2, regions A and B). The ductility of the liner is decreased by Ag- and Zr-rich phases at grain boundaries, which change fracture morphology from transgranular to intergranular.¹ These phases do not dissolve into the matrix by solutionizing heat treatment.²

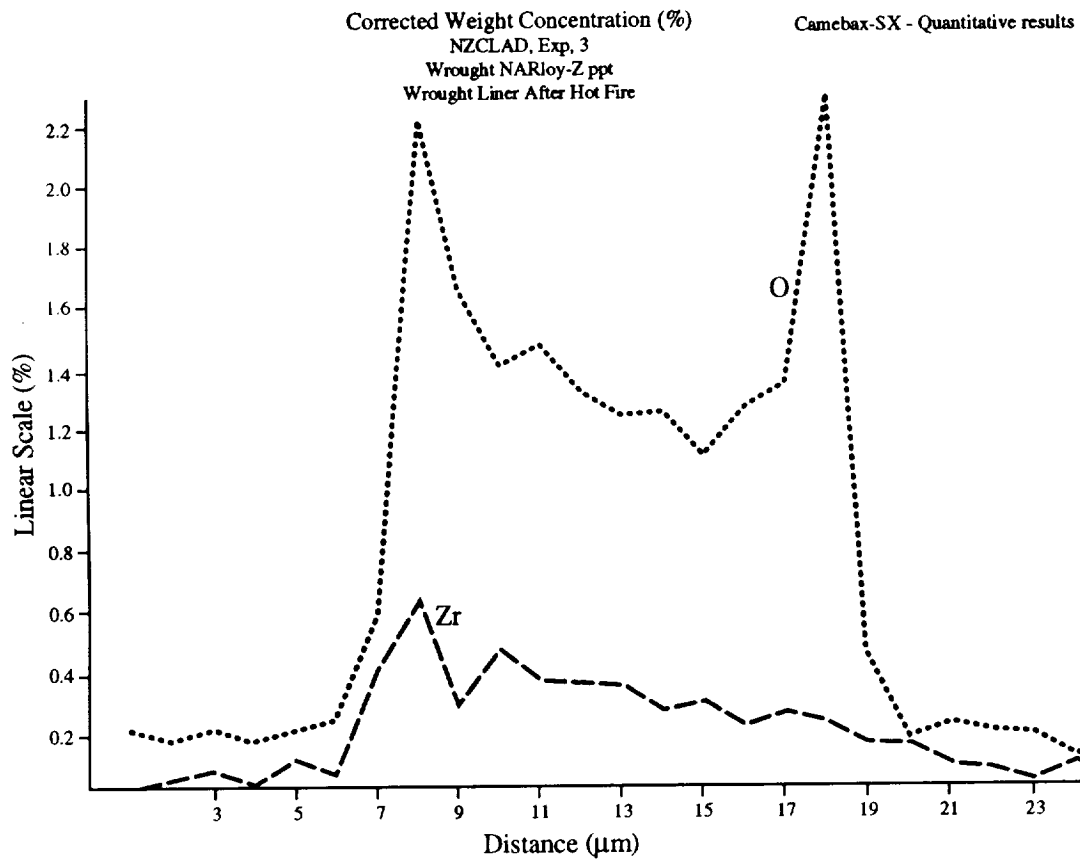
Figure 8b. EPMA across the second phase in wrought NARloy-Z, showing Zr present as Zr_2O_3 into Cu matrix.

Wrought NARloy-Z. In general, the wrought NARloy-Z starting material had a coarse-grained microstructure (fig. 8a) with an uneven distribution of secondary precipitates. Microprobe analyses showed that Zr was present, probably as Zr oxide Zr_2O_3 (fig. 8b). Ag- and Zr-rich intermetallic phases were present in the Cu matrix (figs. 8c and 8d). In addition, oxides of Ag and Cu were present in the matrix. The secondary phases varied in size from 1 to 10 μm . The average grain size was approximately 150 μm . Figure 9 shows precipitation and coarsening in the Cu matrix and at the grain boundaries after exposure to 593 °C (1,100 °F) for up to 94 h. Figure 10 shows the microstructural changes in NARloy-Z after exposure to 649 °C (1,200 °F) up to 48 h. Precipitate-free zones (PFZ's) were observed near the grain boundaries and large intermetallic phases as shown by arrows in figure 10. The size of precipitates and PFZ width increased at 649 °C (1,200 °F) as exposure time increased from 24 to 48 h. After 24 h exposure at 649 °C (1,200 °F), the volume fraction and size of precipitates in the Cu matrix (fig. 10b) were noticeably larger than those in the starting material. The same was true for NARloy-Z exposed to 594 °C (1,100 °F) for ~94 h (fig. 9).

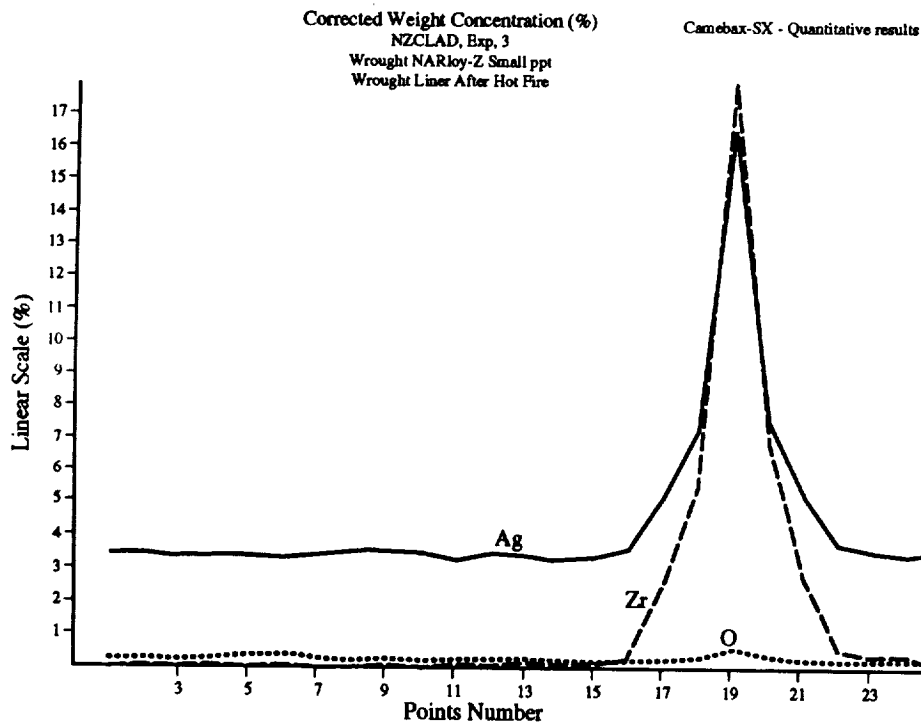
Figure 8d. EPMA across the second phase in wrought NARloy-Z, showing Zr-rich intermetallic phases present into Cu matrix.

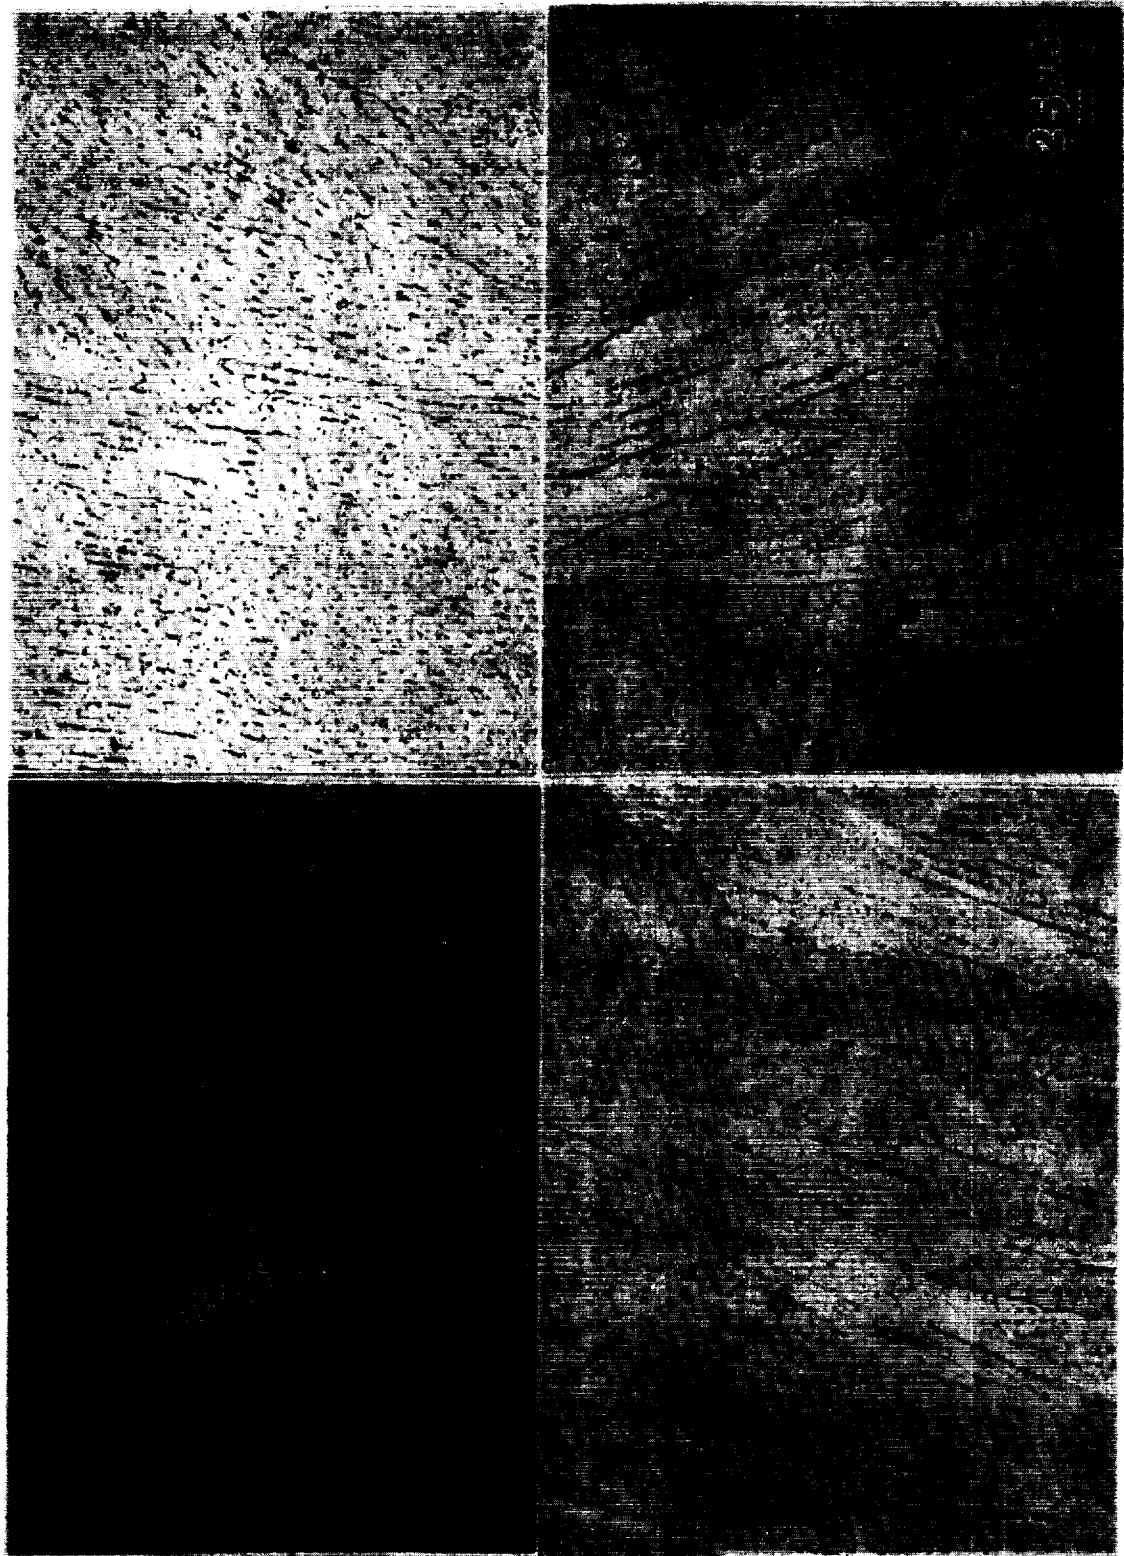
Figure 17. Laser-glazed NARloy-Z showing uniform distribution of second phases in Cu matrix after exposure at 593 °C (1,100 °F) for (a) 24, (b) 48, (c) 72, and (d) 84 h.

Laser and Electron-Beam Glazed NARloy-Z. Metallographic examination of laser-glazed NARloy-Z revealed uniform distribution of second phases in the Cu matrix (fig. 16). No grain boundary segregation was observed. In the rapidly solidified region, the average grain size was 100 μm , which is about half the wrought NARloy-Z grain size (150 to 300 μm). No significant change in the microstructure was observed on exposure at 593 °C (1,100 °F) for up to 84 h (fig. 17). A small amount of

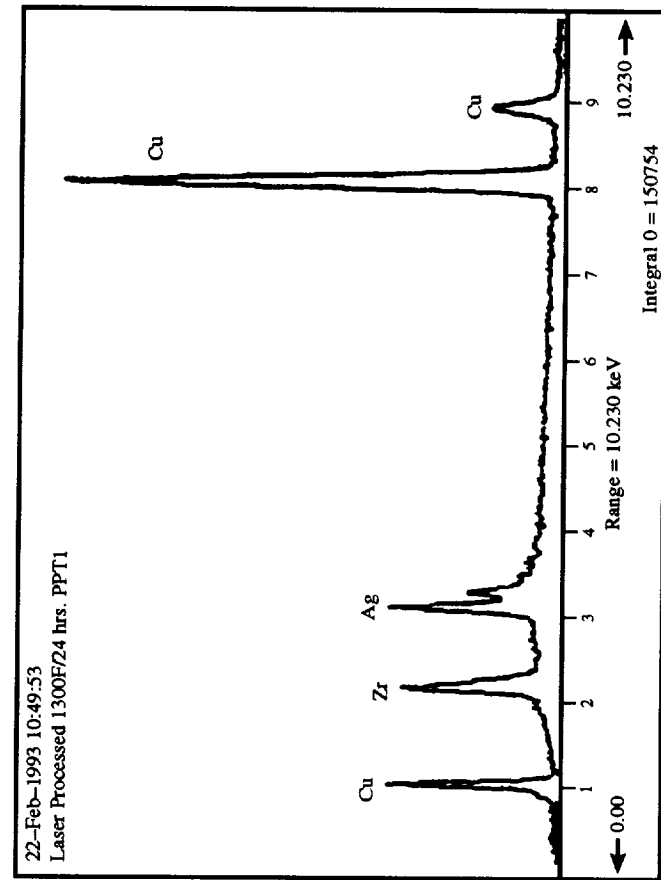
Figure 21. EDS spectrum of precipitate and matrix from figure 20.
