**NASA
Technical
Paper
3391**

**Effect of Temperature
and O-Ring Gland
Finish on Sealing
Ability of Viton V747-75**

Cynthia L. Lach
*Langley Research Center
Hampton, Virginia*

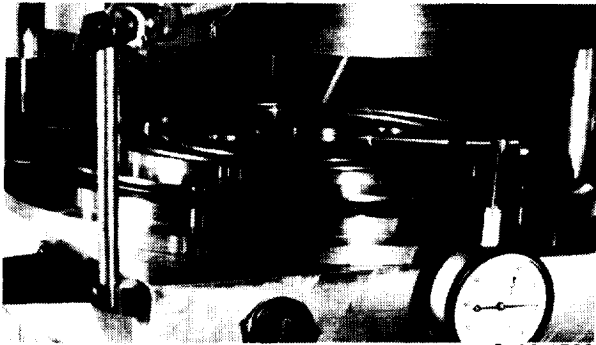
(a) Schematic of face seal fixture. All dimensions are given in inches.

(b) Photograph of lower half of face seal fixture.

Figure 3. Face seal test fixture used for seal tests.

Tests were conducted in a series of laboratory-scale face seal fixtures which contained two glands that were fabricated with the cross-sectional dimensions of the redesigned field joint gland. (See fig. 3(a).) The prescribed O-ring gland surface finishes with allowed tolerances (in parentheses) for the face seal fixtures were 32 Ra (± 10 Ra), 63 Ra (± 15 Ra), 125 Ra (± 40 Ra), and 250 Ra (± 50 Ra). The allowed surface finish tolerances were designed to represent actual full-scale machining effects. The primary and secondary Viton test O-rings had nominal inner diameters of 8.022 in. and 6.272 in., respectively. The nominal cross-sectional diameter of both test O-rings was 0.290 in., which was the same cross-sectional diameter selected for the full-scale redesigned SRB O-rings. A new set of O-rings was used for each test. Figure 3(b) shows one of the fixtures mounted in a servo-hydraulic test machine. The face seal fixture squeezed the O-rings in a direction normal to the plane containing the O-ring.
