EFFECT OF TOW ALIGNMENT ON THE MECHANICAL PERFORMANCE OF 3D WOVEN TEXTILE COMPOSITES

Timothy L. Norman

Department of Mechanical and Aerospace Engineering,
West Virginia University, Morgantown, WV 26506

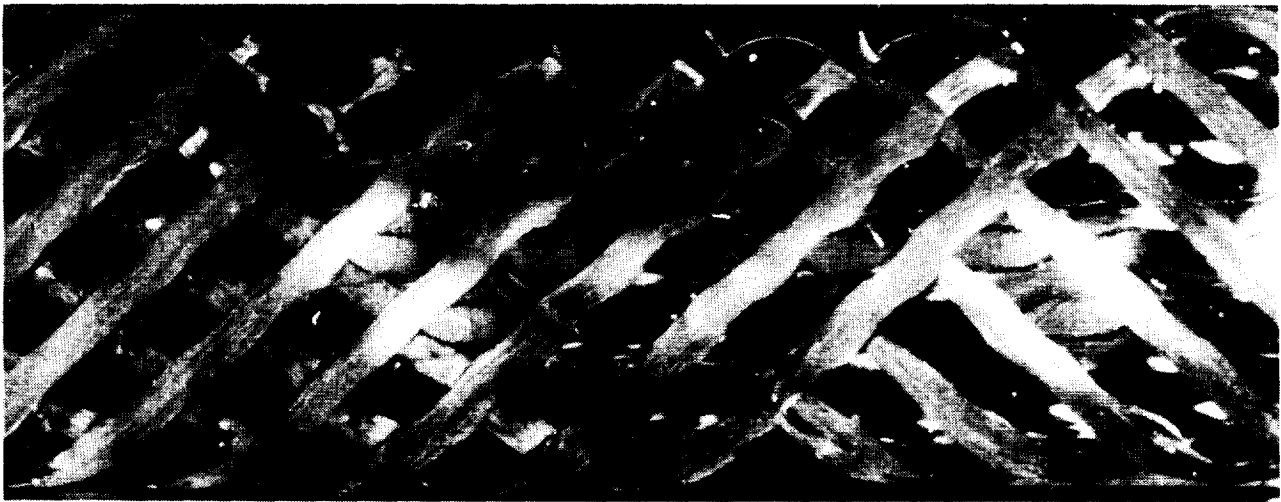
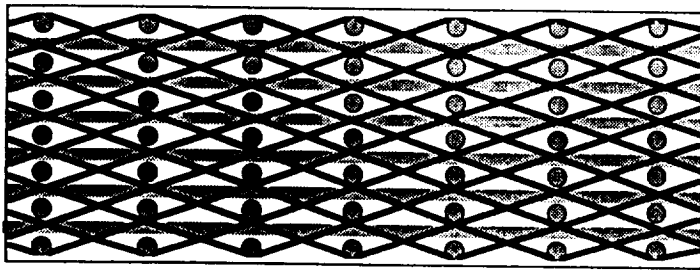
Figure 1. Cross-sectional view of the uniform construction shown as a) photomicrograph of 90° view, and b) computer drawing of 90° and 0° views.

Four different material architectures are used in this study and are identified as: uniform, uniform with tape, nonuniform, nonuniform with tape. Cross-sectional views of the uniform and nonuniform preforms are shown in figures 1 and 2, respectively.

Since this architecture is 3-D with many interlocking weaves of tows, the structure is difficult to visualize. As a result, determining damage mechanisms and damage progression of the composite requires careful evaluation of many planes of view. By nature, the 3-D weave configuration of the preform causes there to be a continuously varying cross-section. This contradicts the typical convention of laminated composites where there is a constant material cross-section, making material sectioning a matter of personal preference. The complexity of this 3-D textile structure necessitates a well planned method of evaluation. The material evaluation technique/protocol created was based on the idealized planes of view shown in figures 1b and 2b.

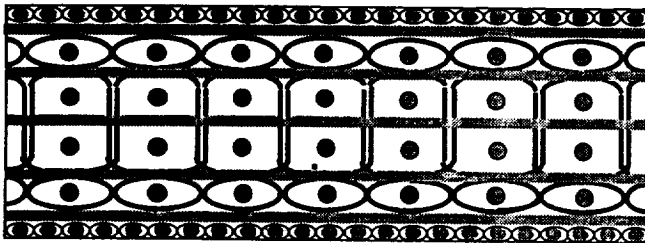
Figure 2. Cross-sectional view of the nonuniform construction shown as a) photomicrograph of 90° view, and b) computer drawing of 90° and 0° views.

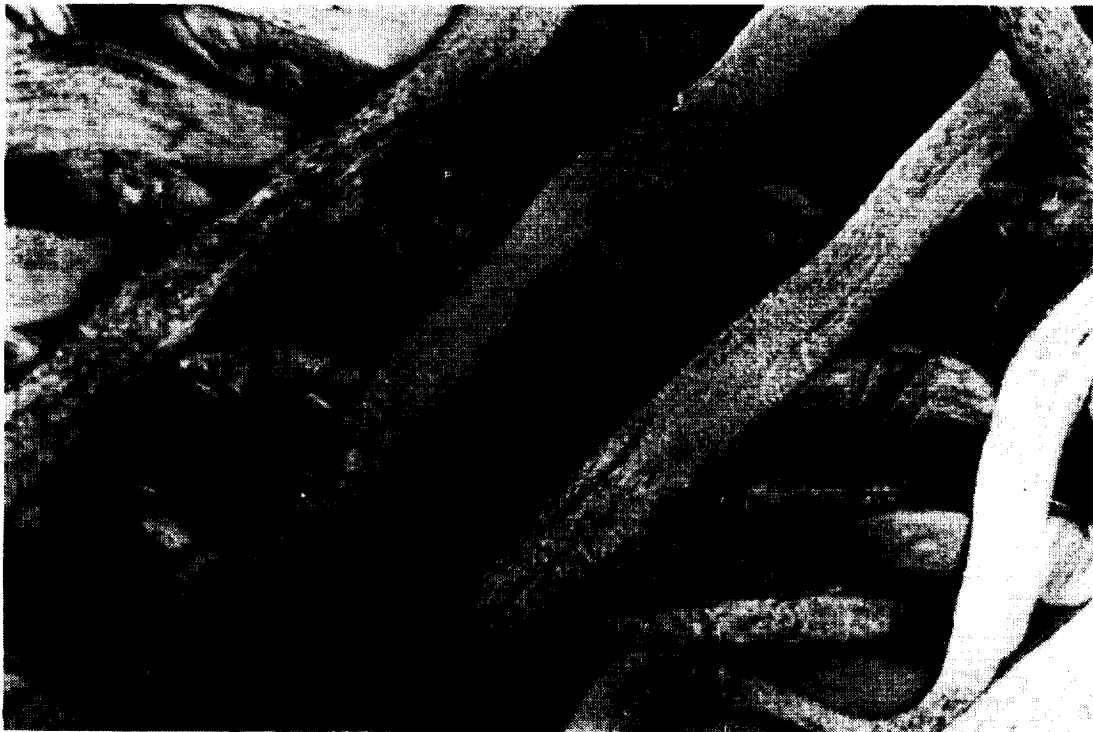
Figure 3. Photomicrograph of 90° cross-sectional view of a uniform construction showing cracking in tows found in pretest specimens.

Specimens of uniform construction with tape were used to investigate pre-test characteristics. Tows appeared to be well bonded to matrix but were present with microcracks (figure 3). These microcracks were also found lying in resin pockets. Microcracks are not clearly observed in the photo because of the epoxy used when making the mold of the specimen. This emphasizes the importance of using a radioluscent filler in the epoxy for materials with voids and cracks in resin filled areas. Cracking was not restricted to a single fiber direction or plane of view. A small resin rich layer between coincident fiber bundles within the same tow can also be recognized in the figure.

The exact cause of these pre-existing cracks or their effect on material strength and damage resistance is unknown, but stress fractures in fibers during the weaving process and shrinkage during cure are viable explanations for their origination. This problem was corrected in subsequent material preforms.

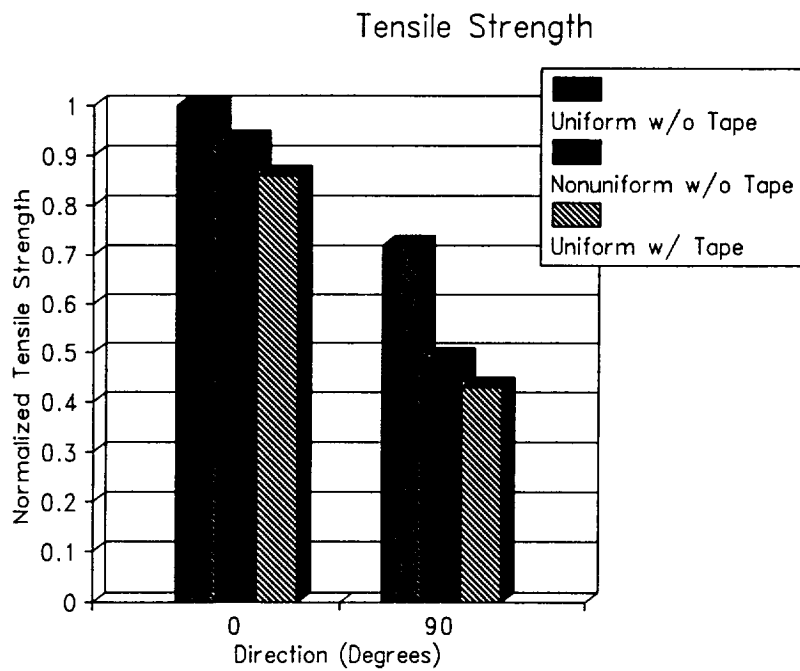
Figure 4. Tensile strength of uniform and nonuniform specimens.

Figures 4 and 5 show tensile strength and stiffness, respectively, for 0° and 90° uniform, uniform with tape and nonuniform specimens. The data shown in the figures has been normalized to the 0° tensile properties. Both 0° and 90° specimens of figure 4 show reductions in strength for the nonuniform preform. Uniform specimens with tape resulted in further reductions in strength. Testing of nonuniform preform with tape was discontinued due to the applied gripping force necessary to prevent slippage of the specimen. This high grip force caused out-of-plane compression failure, which may have resulted in strength reductions. Stiffness reductions for nonuniform specimens are also observed in 90° specimens. Nonuniform specimens, however, exhibited a small increase in stiffness of approximately 5%. Stress-strain curves for 0 and 90 degree uniform specimens are shown in figures 6 and 7, respectively. Uniform and nonuniform specimens exhibited similar behavior: a region of linear elastic behavior followed by a region of nonlinear behavior. Average 0° uniform strain at failure was higher than nonuniform; however, average 90° uniform strain at failure was higher than nonuniform strain at failure.

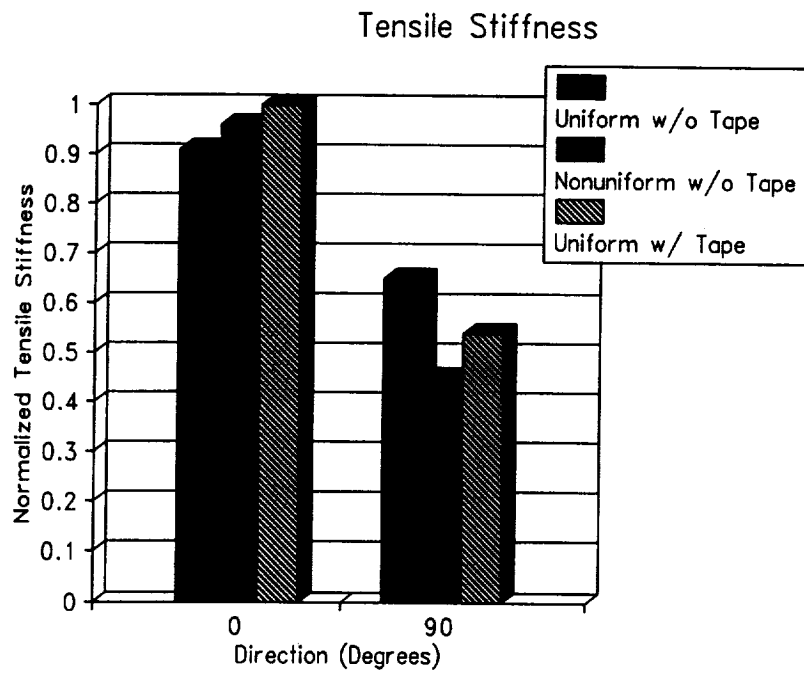
Figure 5. Tensile stiffness of uniform and nonuniform specimens.

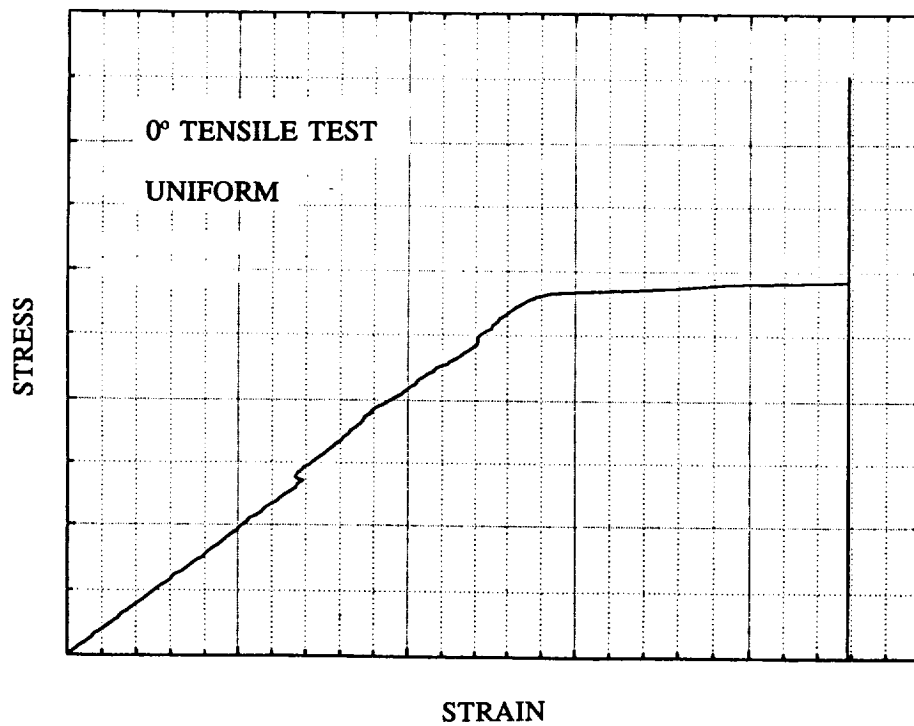
Figure 6. Stress-strain curve of 0° uniform specimen under tensile loading.

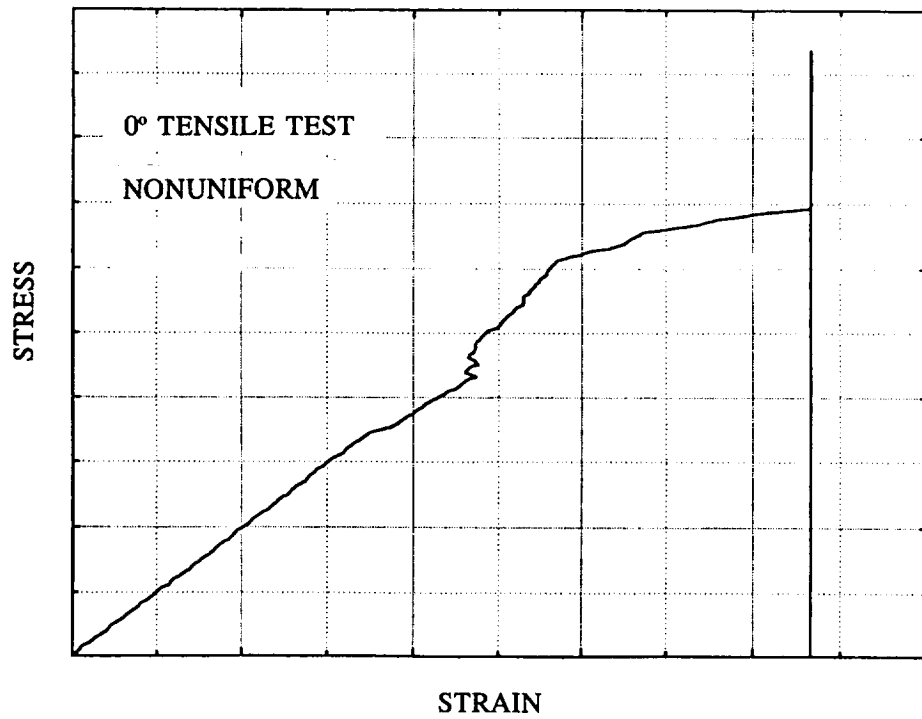
Figure 7. Stress-strain curve of 0° nonuniform specimen under tensile loading.

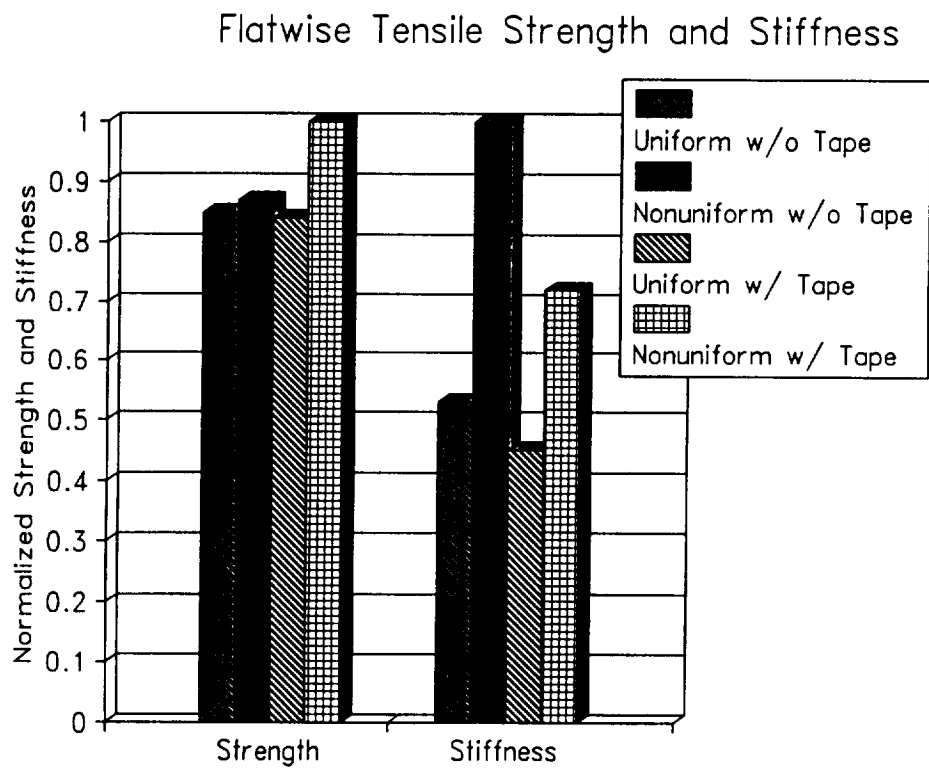
Figure 8. Strength and stiffness of uniform and nonuniform flatwise tension specimens.

Figure 8 shows a comparison of strength and stiffness for flatwise tension uniform and nonuniform specimens with and without tape. Results of this figure show that through thickness strength and stiffness is higher for nonuniform specimens than for uniform specimens: out-of-plane strength was only slightly higher but stiffness was significantly higher. Strength and stiffness decrease when tape is added to uniform specimens. Tape decreased stiffness of uniform specimens but increased strength of nonuniform specimens.

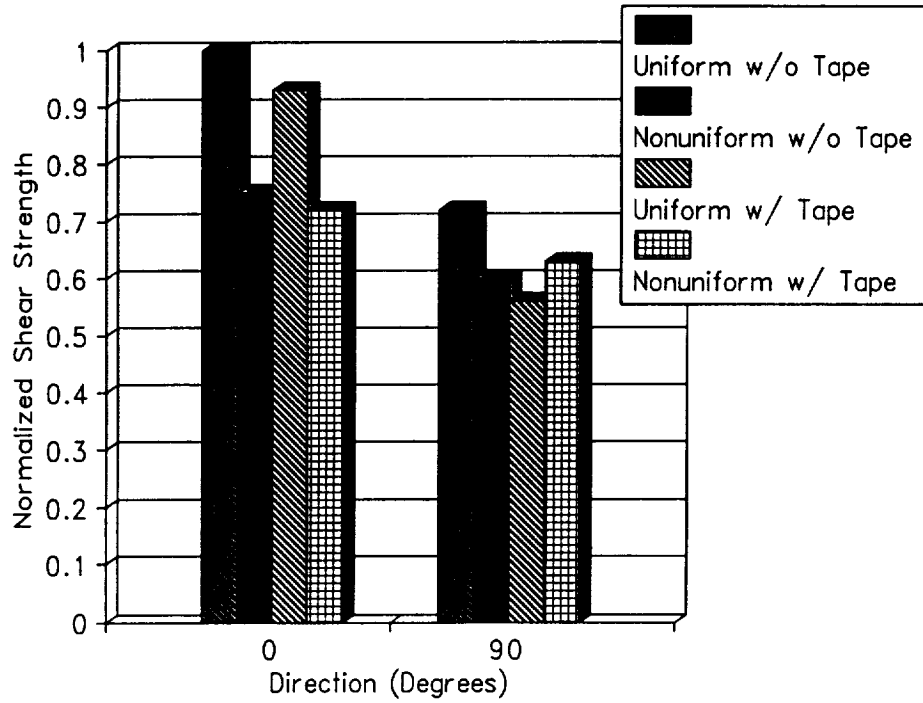
Figure 9. Interlaminar shear strength for uniform and nonuniform specimens.

Results from interlaminar shear strength tests are shown in figure 9. These results show that interlaminar shear strength and stiffness of 0° and 90° uniform specimens was higher than that of nonuniform specimens. No significant differences were found between nonuniform specimens with or without tape. Notable decreases were observed for uniform specimens with tape. 0° flexure test results (fig. 10) show that stiffness and strength was significantly higher for uniform than for nonuniform specimens.

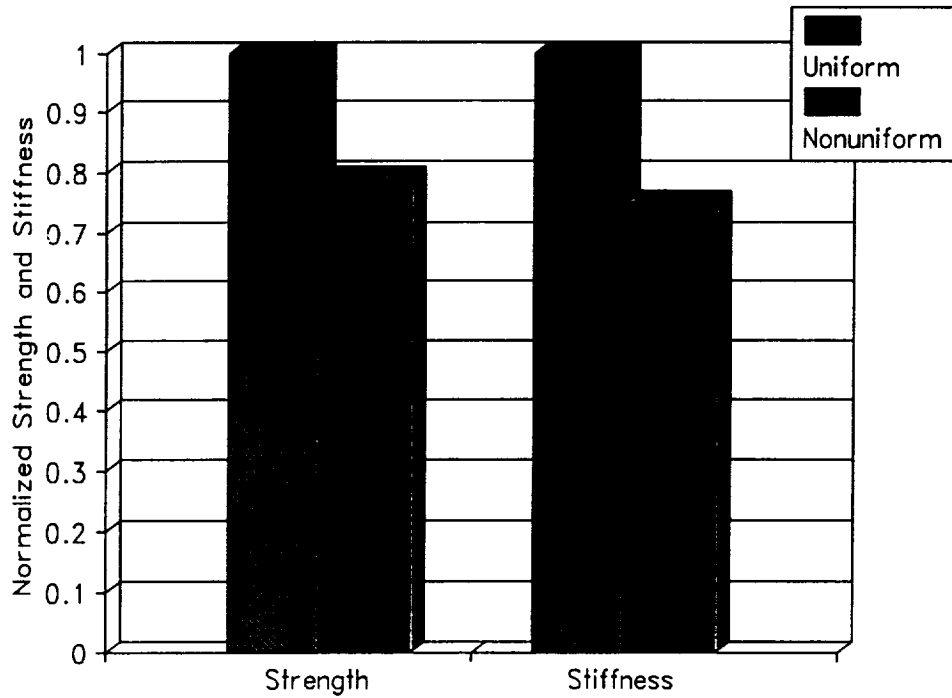
Figure 10. Flexural strength and stiffness for uniform and nonuniform specimens.

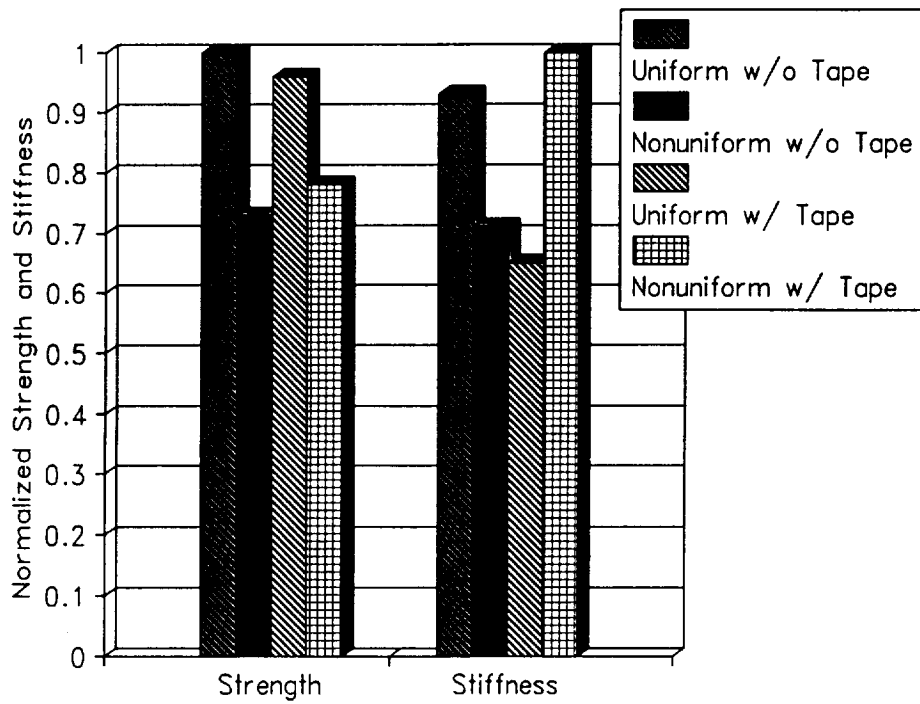
Figure 11. Knight block strength and stiffness for uniform and nonuniform specimens.

Knight block compression strength and stiffness of uniform specimens was higher than nonuniform specimens (fig. 11). Strength and stiffness of uniform specimens with tape increased but decreased for nonuniform specimens with tape.

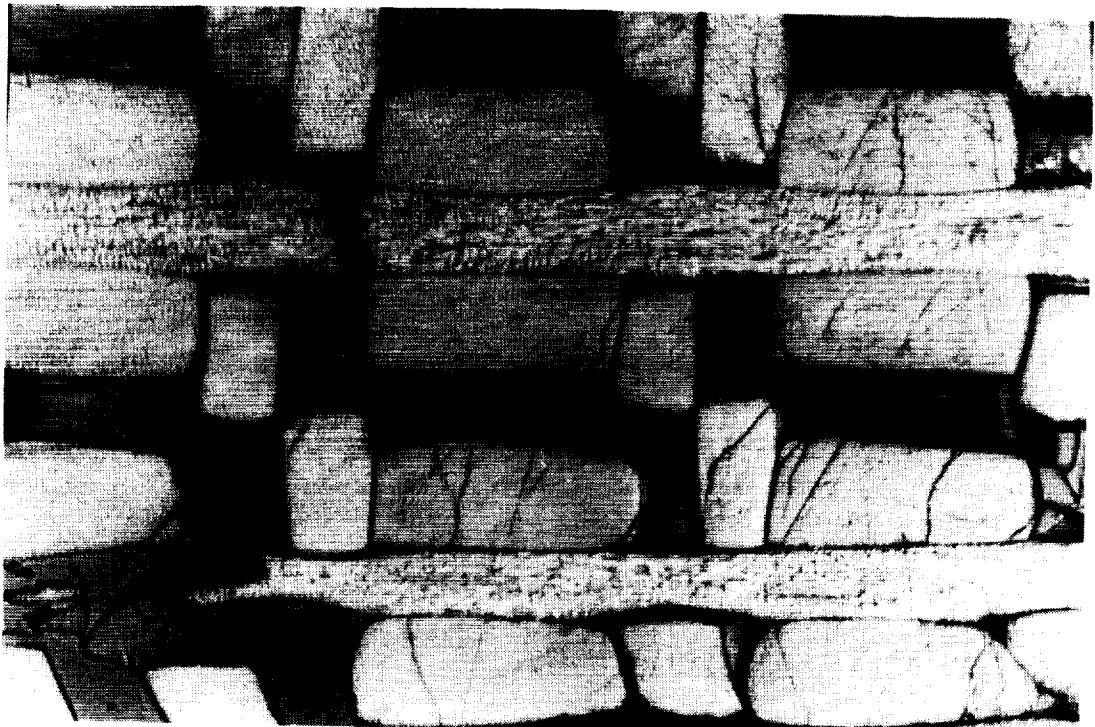
Figure 14. 0° cross-sectional view of a 90° tensile specimen. The photograph shows significant matrix cracking, fiber-matrix debonding and intra-tow cracking.

A pronounced "arrowhead" failure pattern became characteristic of the through thickness damage in the 0° tensile specimens (fig. 12). Tow separation occurred between adjacent 90° tows along the shear plane that runs along the 0 direction created by the interlocking geometry of the ±45° architecture. The direction of the fracture reverses at the midplane of the composite where the ±45° tows cross. The 90° specimens failed nearly perpendicular to the loading direction (fig. 13). All specimens exhibited matrix cracking, tow rupture and tow pullout at the fracture site. Intra-tow fracture occurred in tows perpendicular to the loading direction. Widespread matrix cracking is present at the fracture site and at locations remote from the fracture site. Figure 14 shows a photomicrograph of a 90° specimen after loading that exhibits matrix cracking, fiber breakage and intra-tow failure. Figure 15 shows a crack propagating through 0° and 90° fibers and fiber debonding.
