Interim Progress Report

USE OF PHOTOSTRESS TO ANALYZE BEHAVIOR OF AN AFT SKIRT TEST SPECIMEN

**SEMI - ANNUAL REPORT**

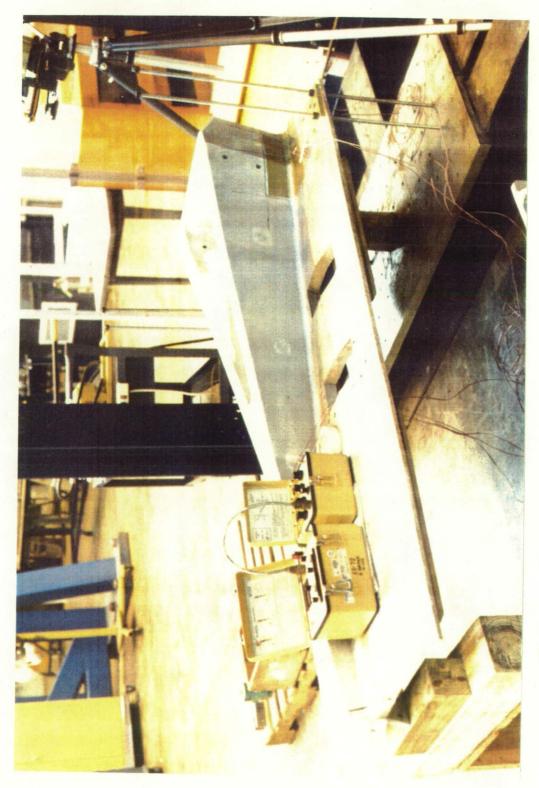
View of Hold-Down Post with Photoelastic Coating Photo 1.

Photo 1 shows the hold-down post with the photoelastic coating near the right end at the critical area and Photo 2 is a close-up of the coated critical area.

- 1. Photoelastic coatings were poured, contoured, and attached by NASA personnel to the aft skirt hold-down post as seen in Photos 1 and 2. The average thickness of the coating was 0.0731 inches with a standard deviation of 0.0043 inches. Within plus or minus two standard deviations, this variation produced an overall accuracy in measuring shearing strains of
