NASA Contractor Report 189687

**HIGH TEMPERATURE ELECTROMAGNETIC
CHARACTERIZATION OF THERMAL PROTECTION
SYSTEM TILE MATERIALS**

MCDONNELL DOUGLAS AEROSPACE
Saint Louis, Missouri

Contract NAS1-18763
September 1993

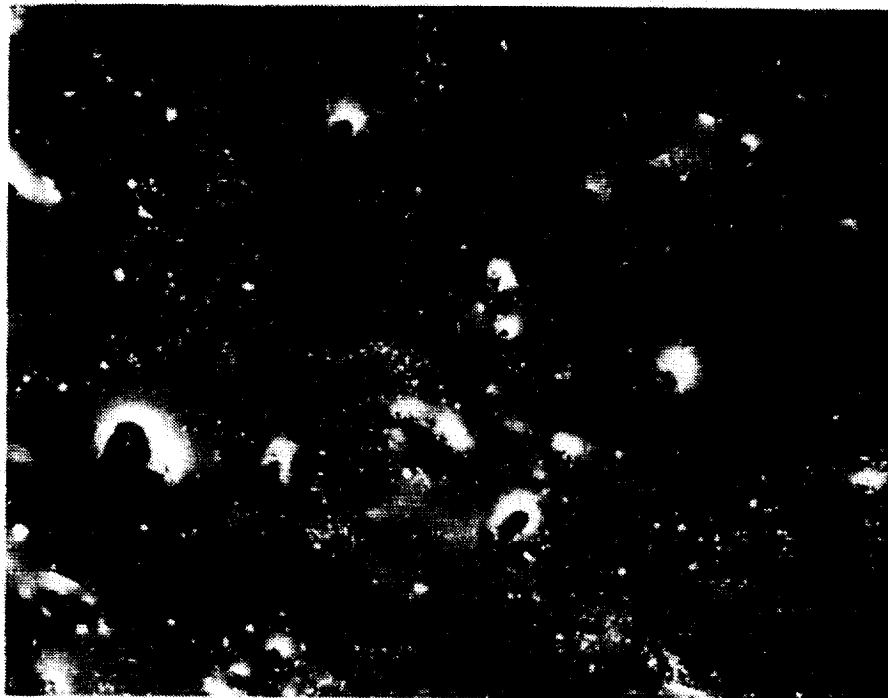
FIGURE 26 - 200X MICROPHOTOGRAPH OF LASER DAMAGED
RCG COATING

FIGURE 27 - 200X SEM MICROPHOTOGRAPH OF UNDAMAGED
RCG COATING

After laser testing, the LI-2200 specimen was cross sectioned through a damaged region, polished and examined with a scanning electron microscope (SEM). Images of the RCG coating and RCG-substrate interface for damaged and undamaged areas of the specimen are presented in Figures 26-29. Note that the RCG surface appears to have undergone local melting but that the material immediately under the RCG shows no signs of deformation.

4.3.2 Surface Glazing. This phenomena was also noted during the initial laser test performed in October. Figures 26 and 27 show microphotographs of a glazed and unglazed area on the test specimen. This phenomena appears to be a result of molten RCG material flowing into and filling the small pores that naturally exist in the surface layer.

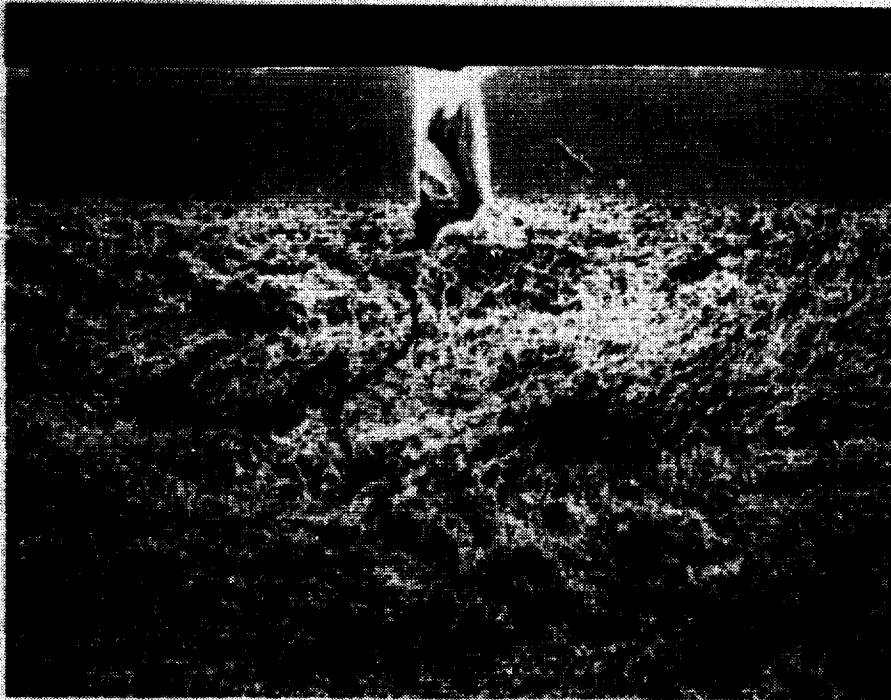
FILE 159849-003-1036

FIGURE 45 - 50X SEM MICROPHOTOGRAPH OF THE RCG
COATING/SUBSTRATE INTERFACE DISPLAYING A TYPICAL CRACK

4.3.1 Surface Cracking. Small surface cracks were noted on a number of the specimens after exposure to the 15kW laser. This cracking usually took the form of a circle slightly larger than the incident laser beam which is consistent with the large thermal gradients experienced around the perimeter. The cracks, when measured with the scanning electron microscope, averaged between .5 and 1 mil wide. Figure 43 is a microphotograph of the surface of a specimen displaying a typical cracking pattern. Figure 44 is a SEM microphotograph taken looking down at the RCG surface of a specimen and Figure 45 was taken looking at the cross section of the specimen. Note that these

microphotographs are to scale therefore accurate thickness and crack width measurements can be made. Note also that the chipping visible at the top of Figure 45 was a result of the preparation required for the SEM.

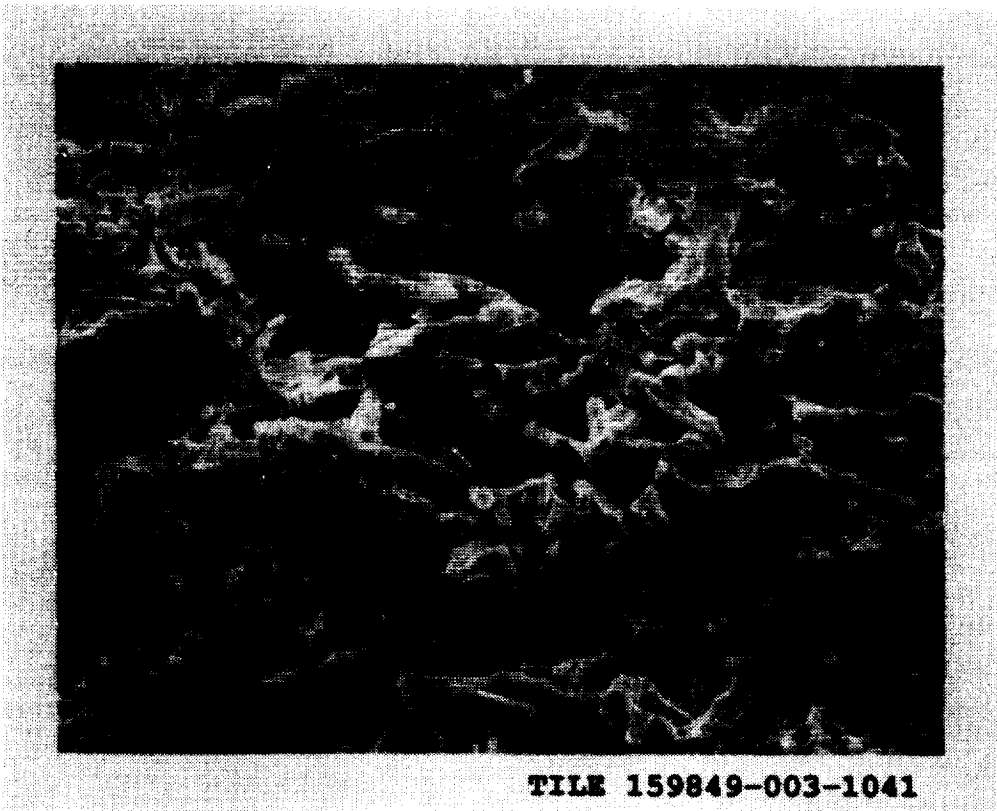
FIGURE 47 - 500X SEM MICROPHOTOGRAPH OF THE
SUBSTRATE MATERIAL DISPLAYING FIBER BREAKAGE

4.3.3 Surface Sag or Compression. This effect was also noted during the initial laser test but failure analysis revealed little about the mechanism. Microphotographs taken of the specimen subjected to the full laser potential show this effect more clearly. These microphotographs are presented in Figures 46 through 48. Note that in Figure 47 the RCG appears to have flowed into the substrate material and that the fiber lengths immediately under the RCG coating, Figure 47, are much shorter than the fiber lengths of a specimen taken from further into the substrate, Figure 48. It appears that thermal stress in the substrate caused fiber breakage and compaction and that the RCG material flowed into the substrate possibly causing further compaction.
