MEASUREMENT OF FLYING QUALITIES OF A DEHAVILLAND

MOSQUITO F-8 AIRPLANE (AAF NO. 43-334960)

I - LATERAL AND DIRECTIONAL STABILITY

AND CONTROL CHARACTERISTICS

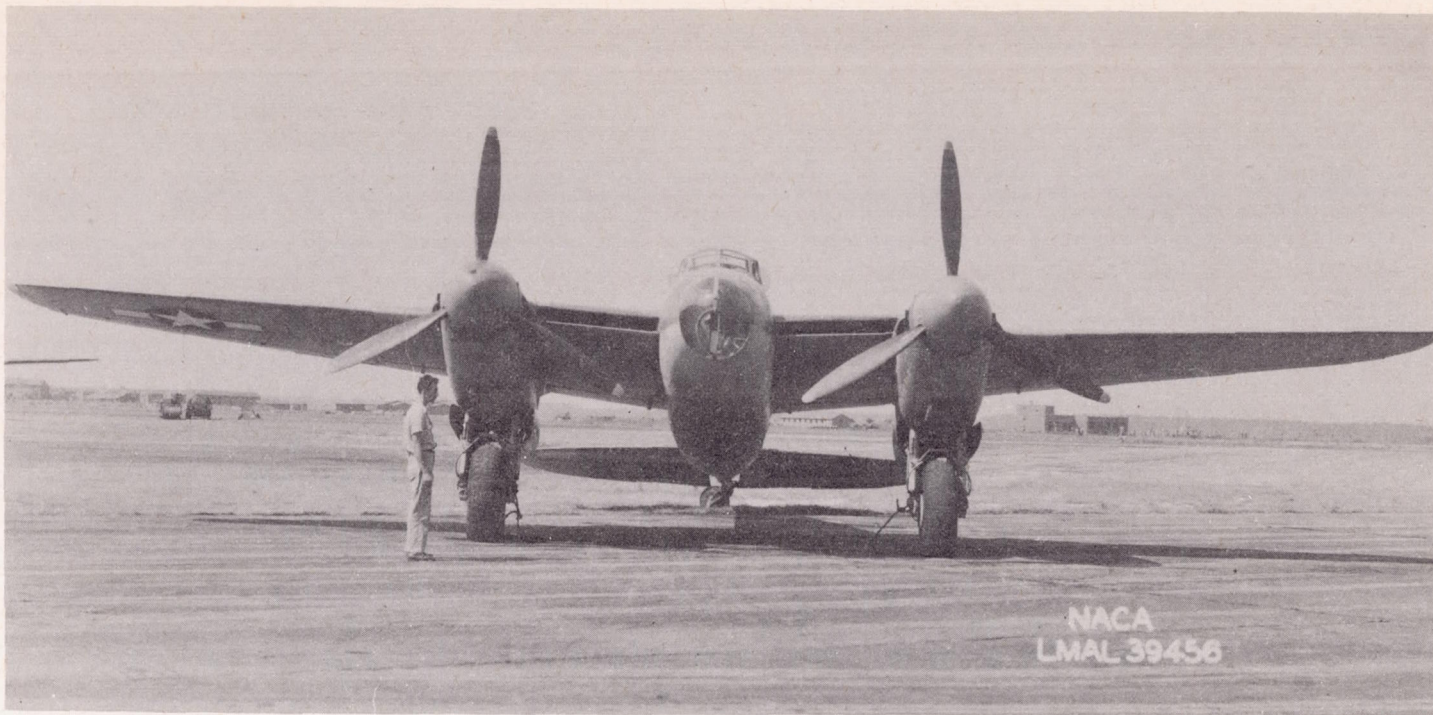
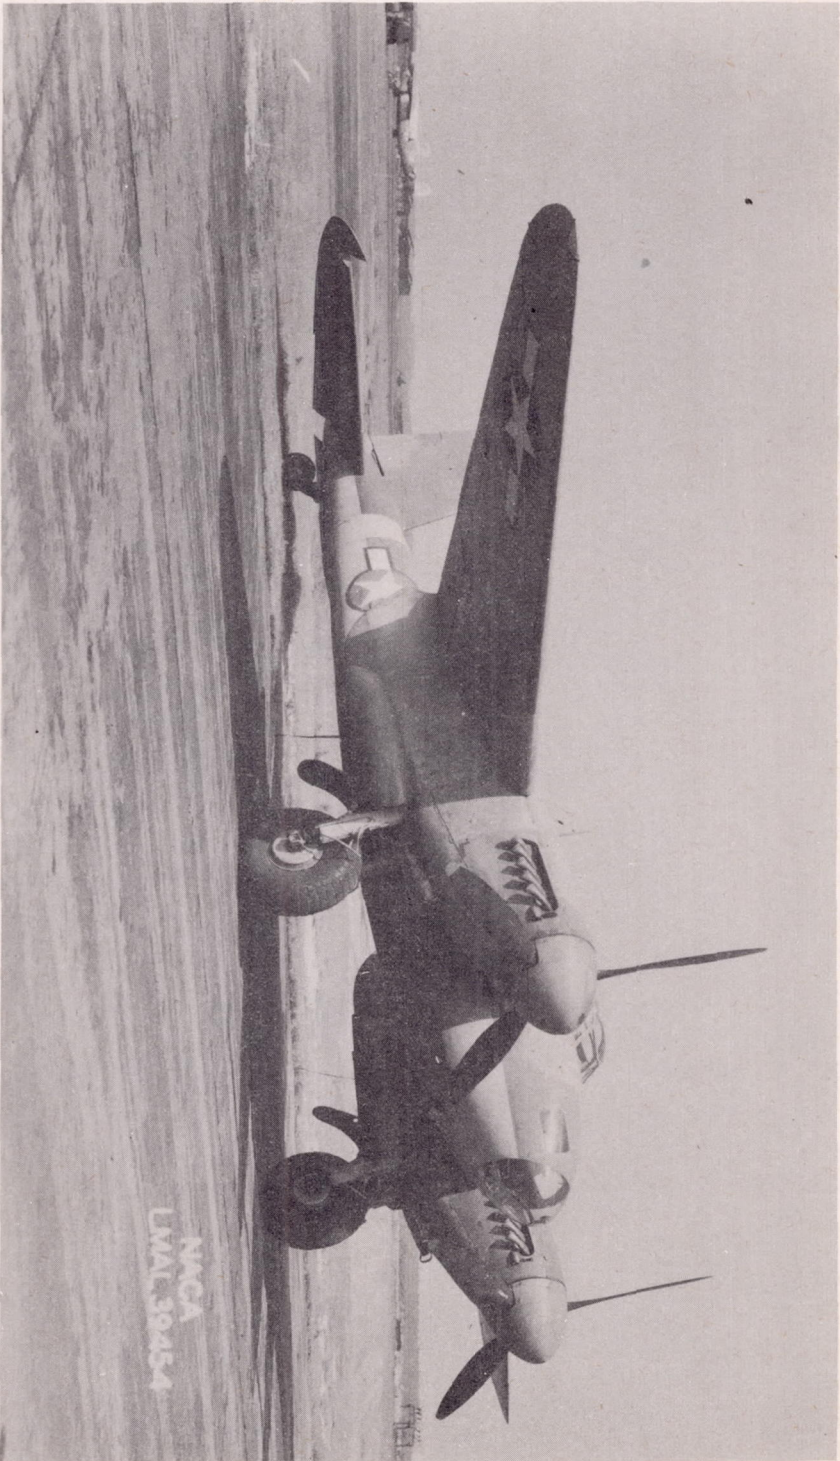
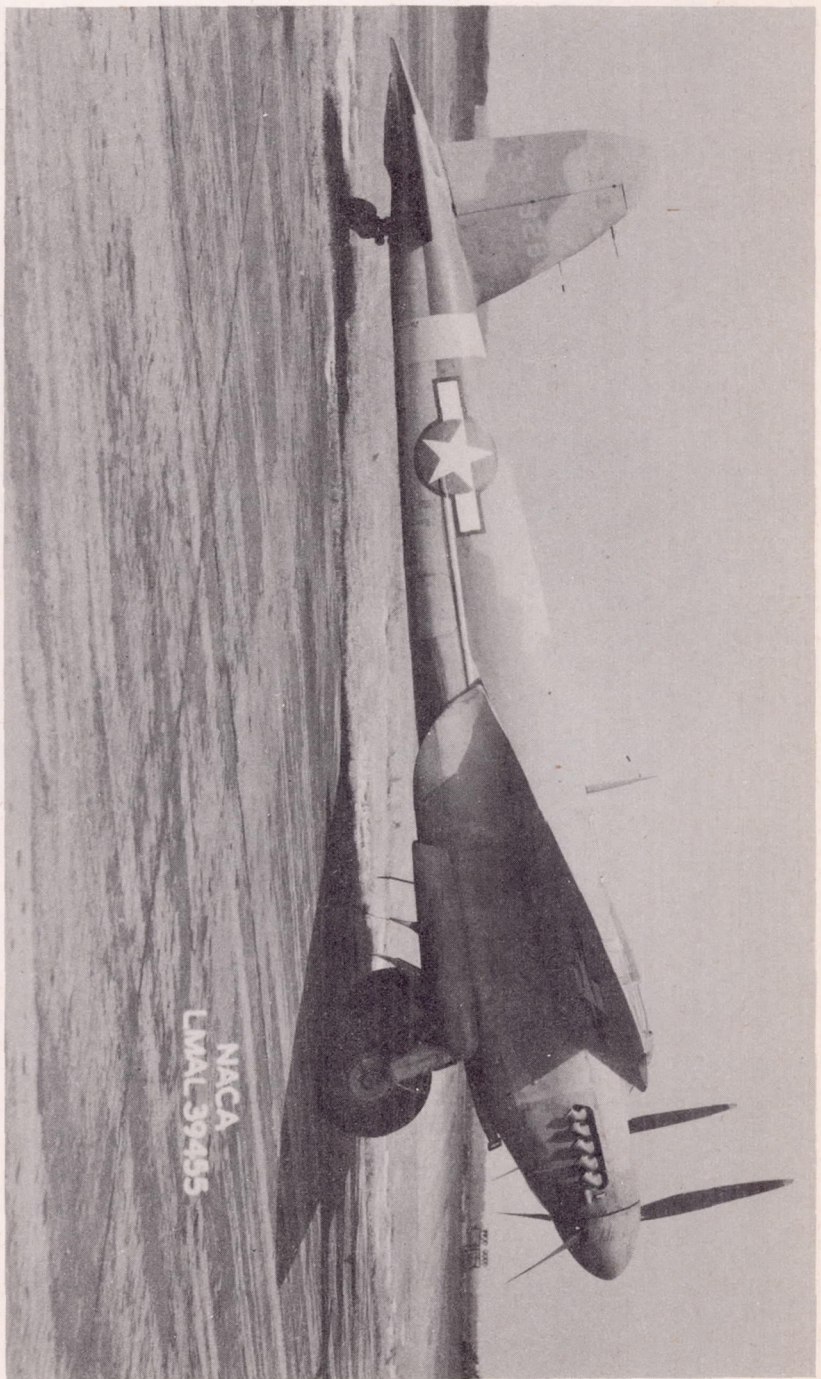
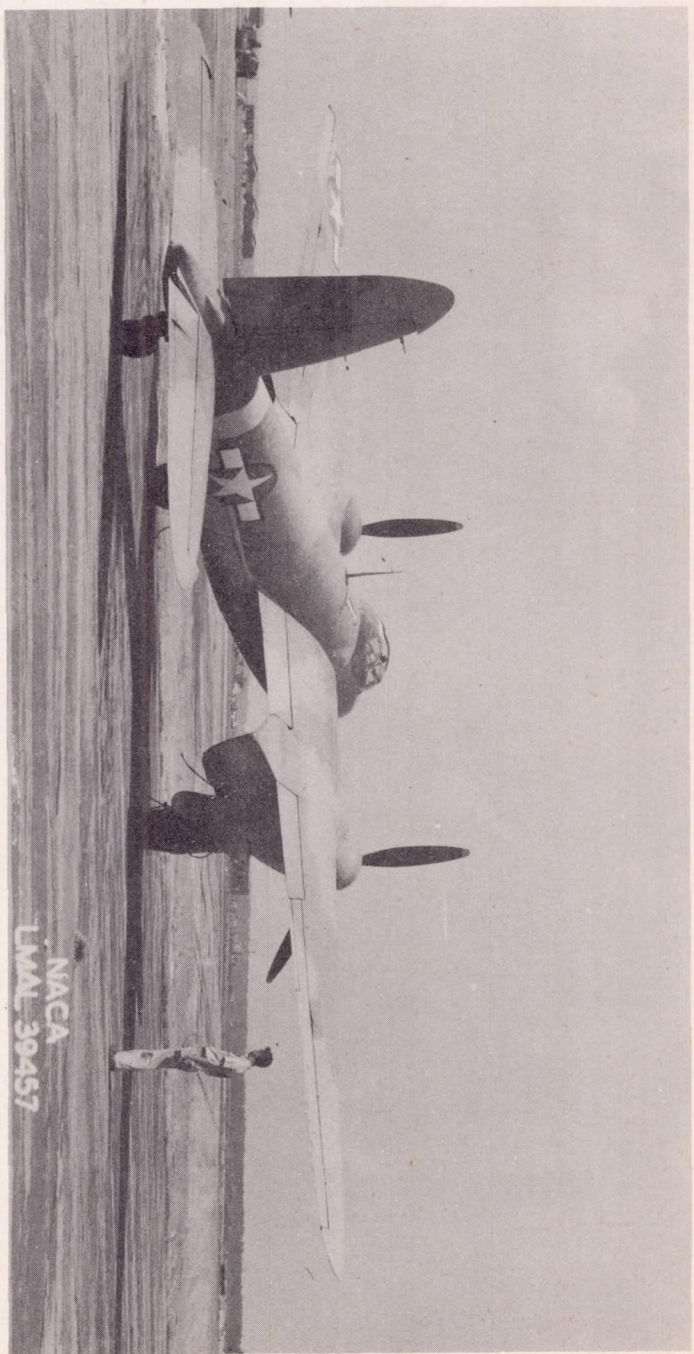
Figure 1.- Photographs of a DeHavilland Mosquito F-8 airplane.

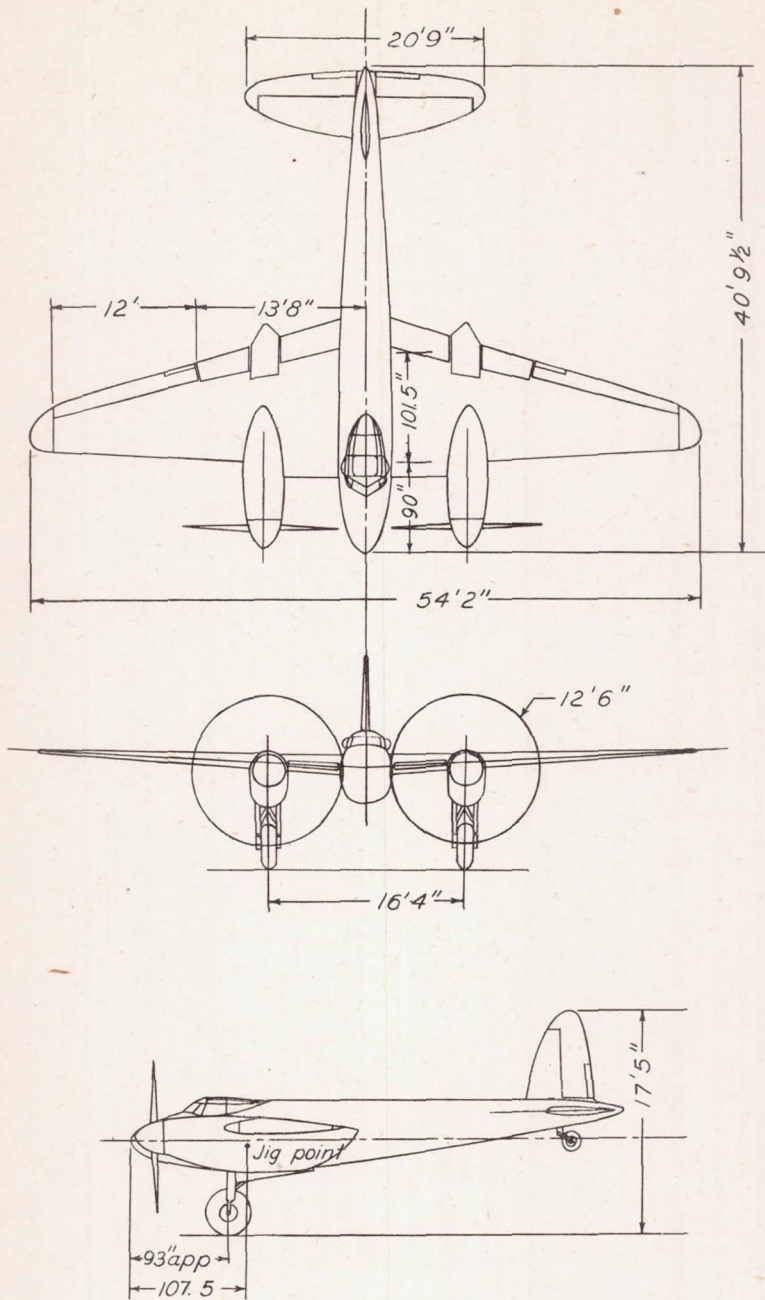
Figure 2. - Three-view drawing of DeHavilland Mosquito F-8 airplane.

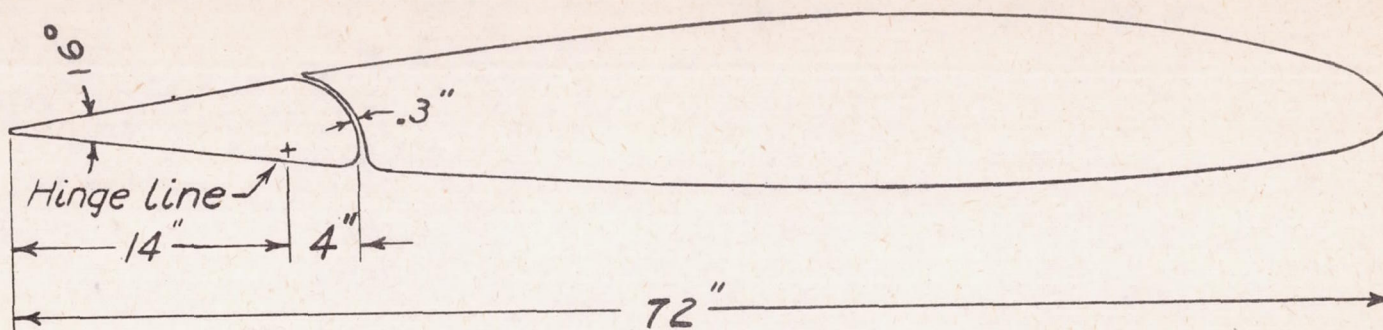
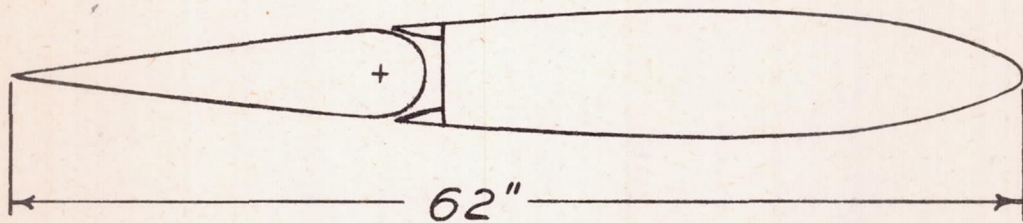
a. Wing and aileron
Figure 3. - Section views of control surfaces, De-
Havilland Mosquito F-8 airplane.

b. Horizontal and vertical surfaces
Figure 3. - Concluded.

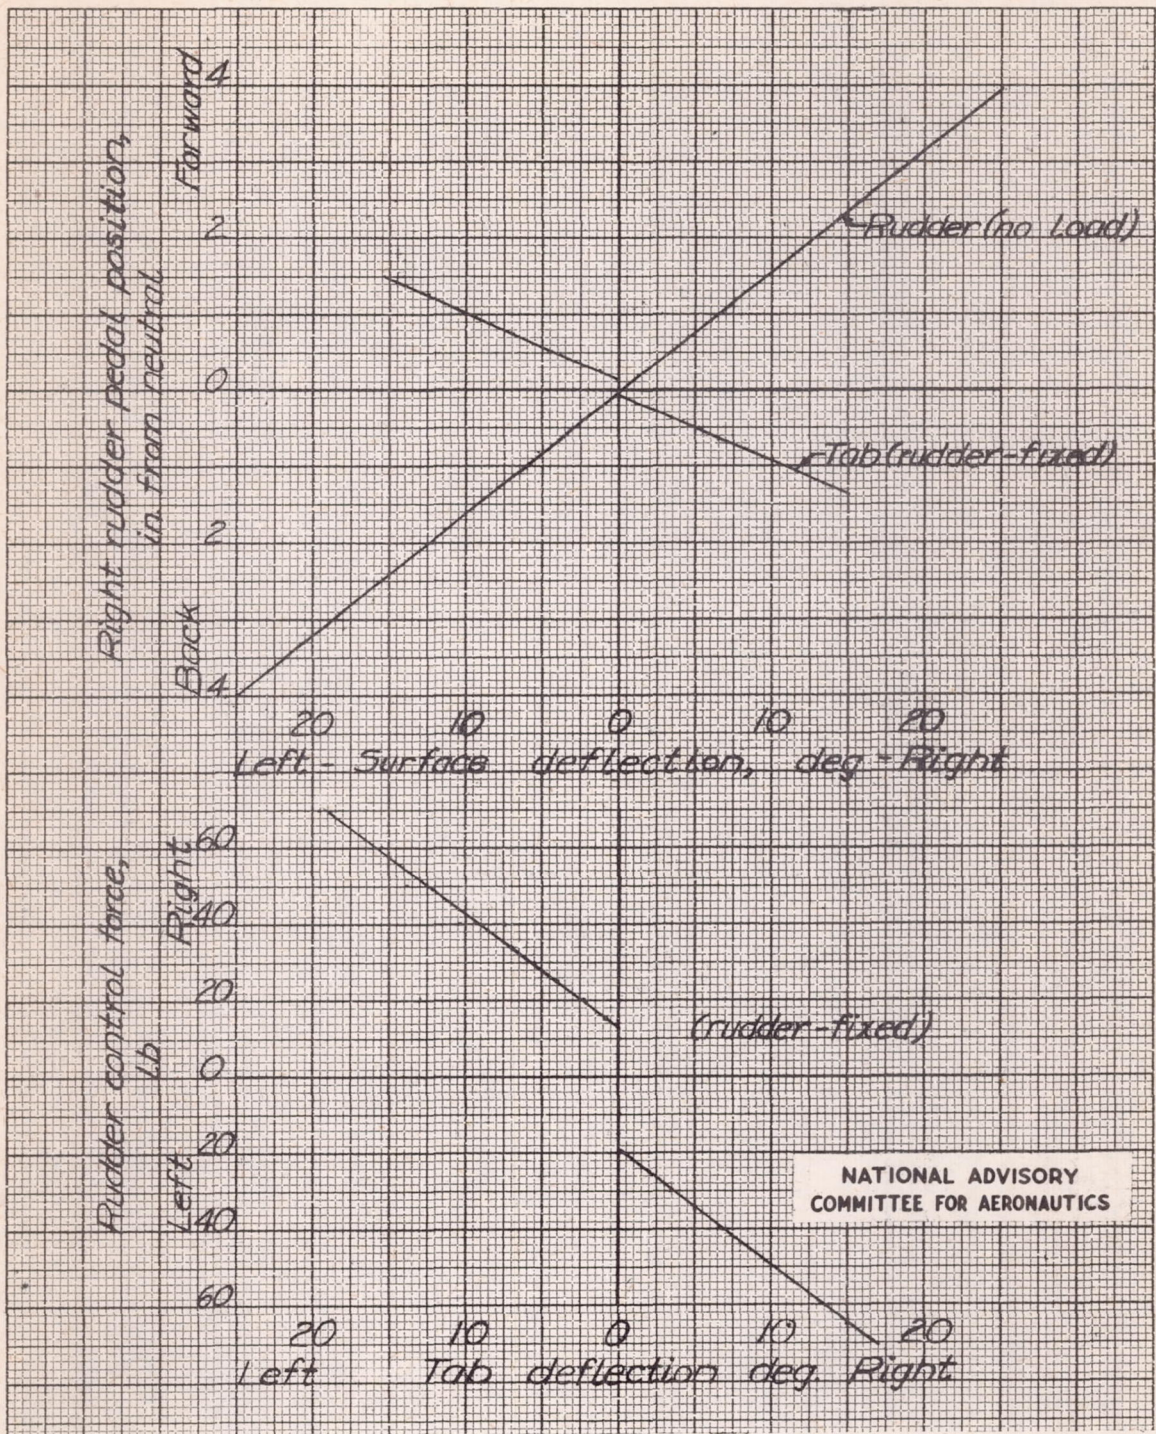
Figure 4. - Spring-tab rudder characteristics, DeHavilland Mosquito F-8 airplane.

Figure 4 presents the characteristics of the spring-tab rudder. Rudder deflection was measured with respect to the fin which was set parallel to the thrust axis. The friction of the rudder system amounted to ± 5 pounds of pedal force. Figure 5 shows the variation of aileron position with control-wheel deflection and figure 6, the variation of aileron balancing tab-position with aileron position. The friction in the aileron system was approximately ± 4 pounds for small deflections and increased slightly at large deflections.

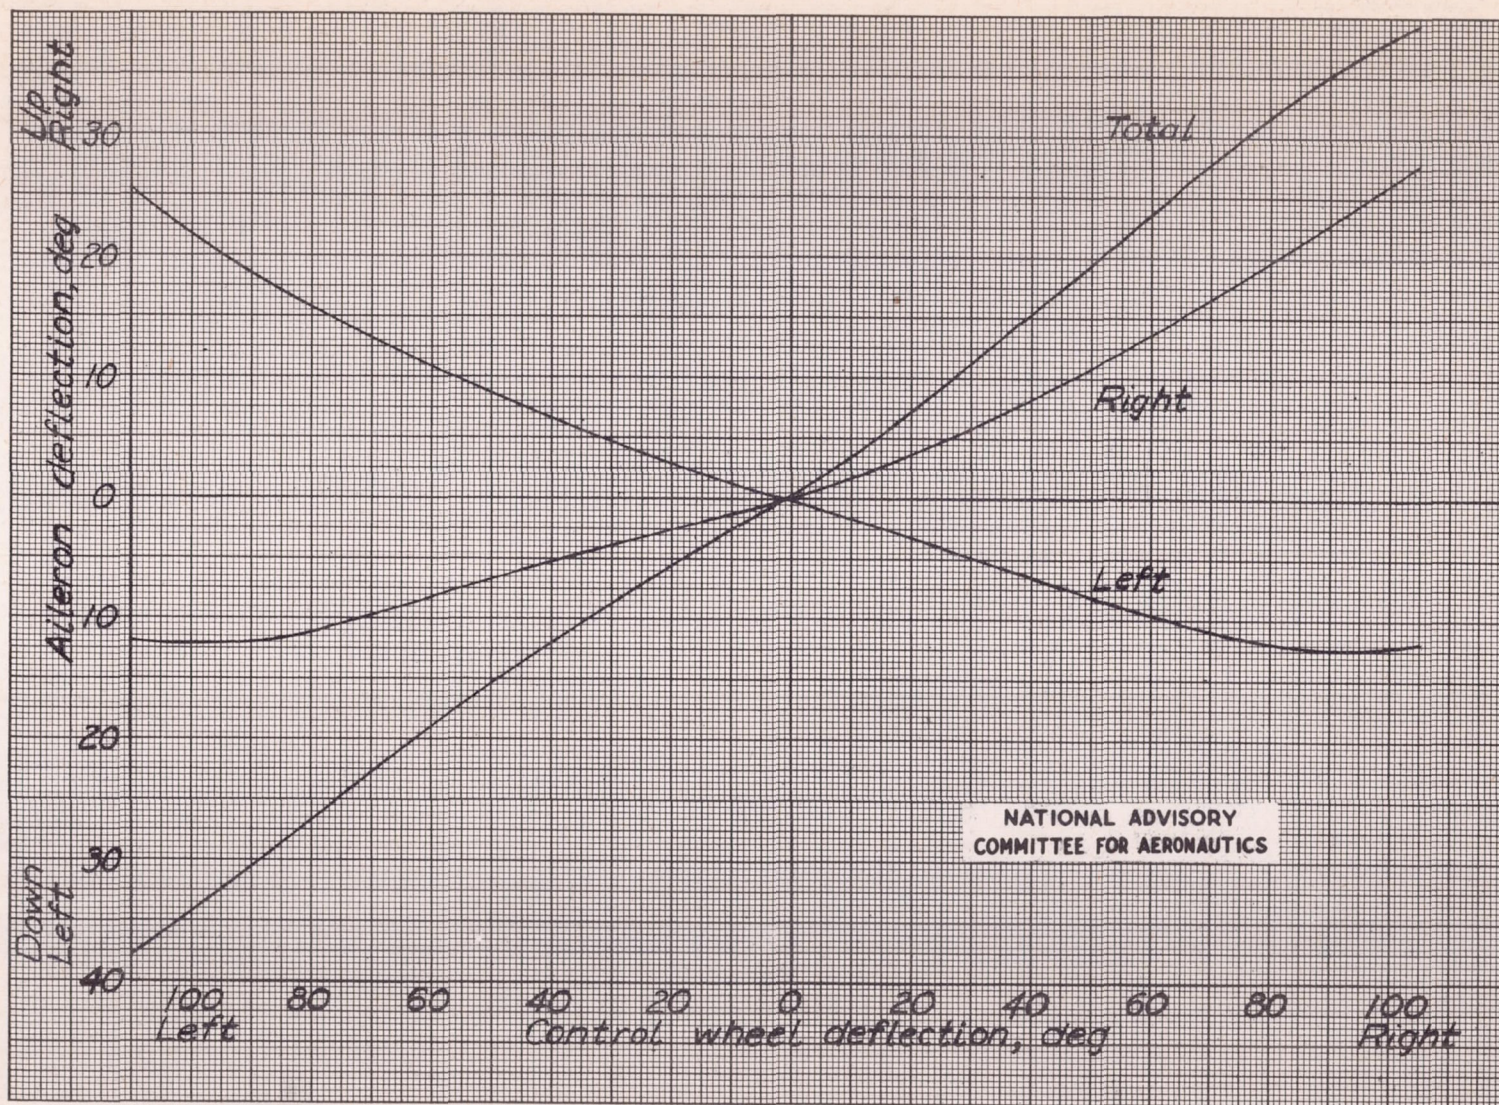
Figure 5. - Linkage between ailerons and control wheel, DeHavilland Mosquito F-8 airplane.

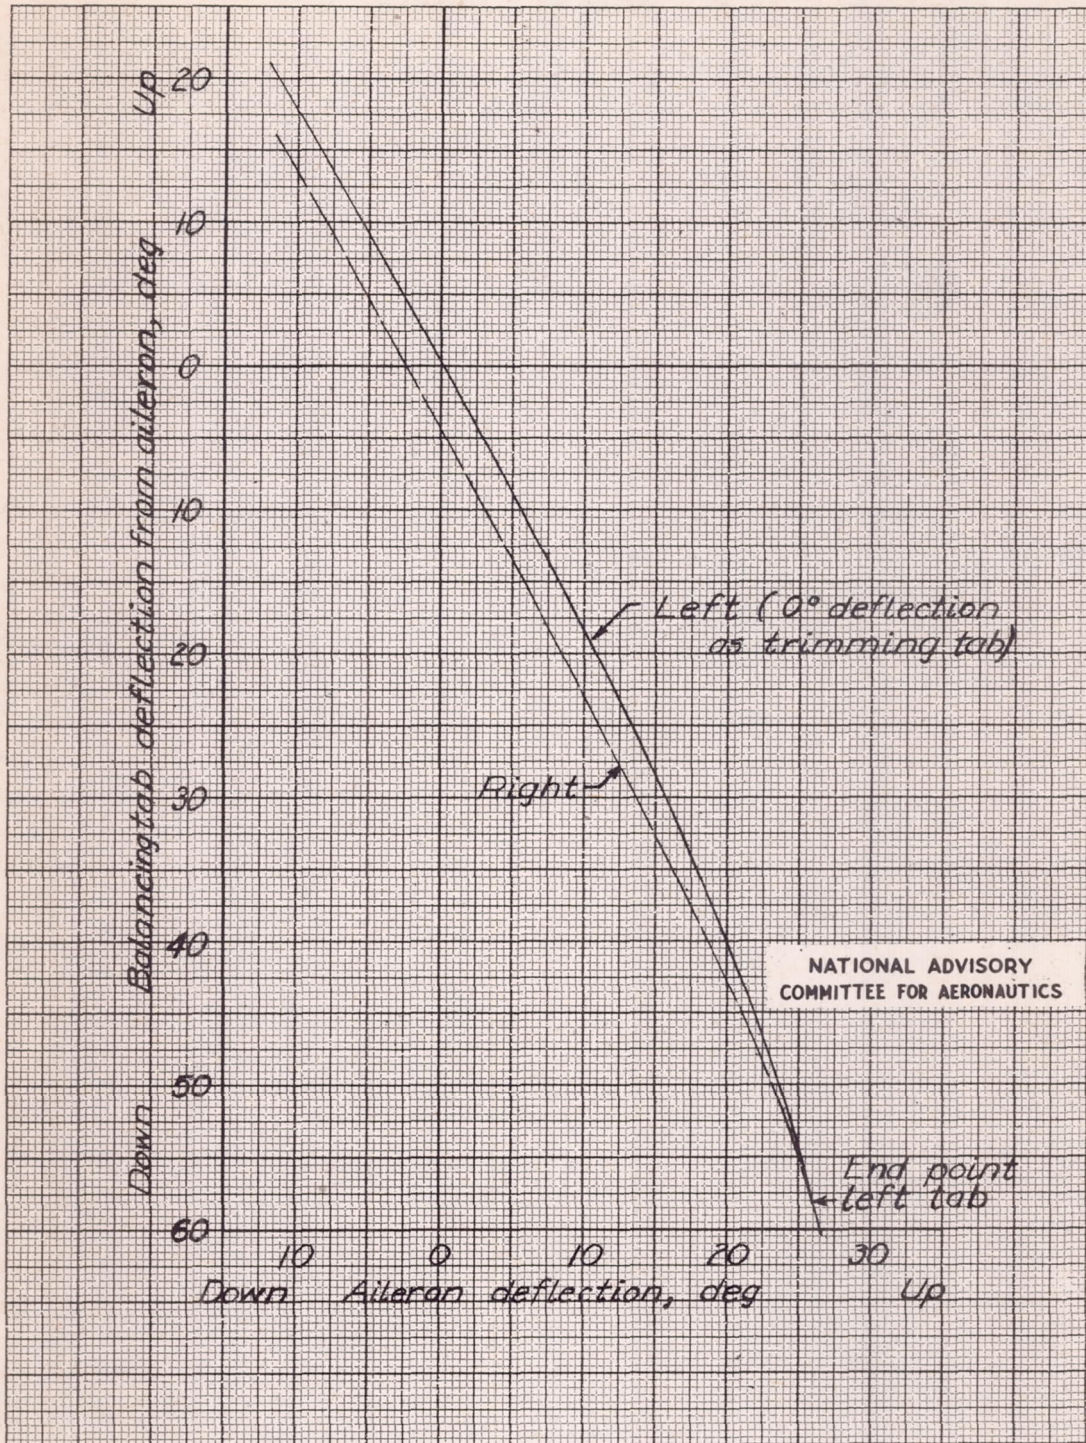
Figure 6. - Variation of balancing tab deflection with aileron deflection, DeHavilland Mosquito F-8 airplane.

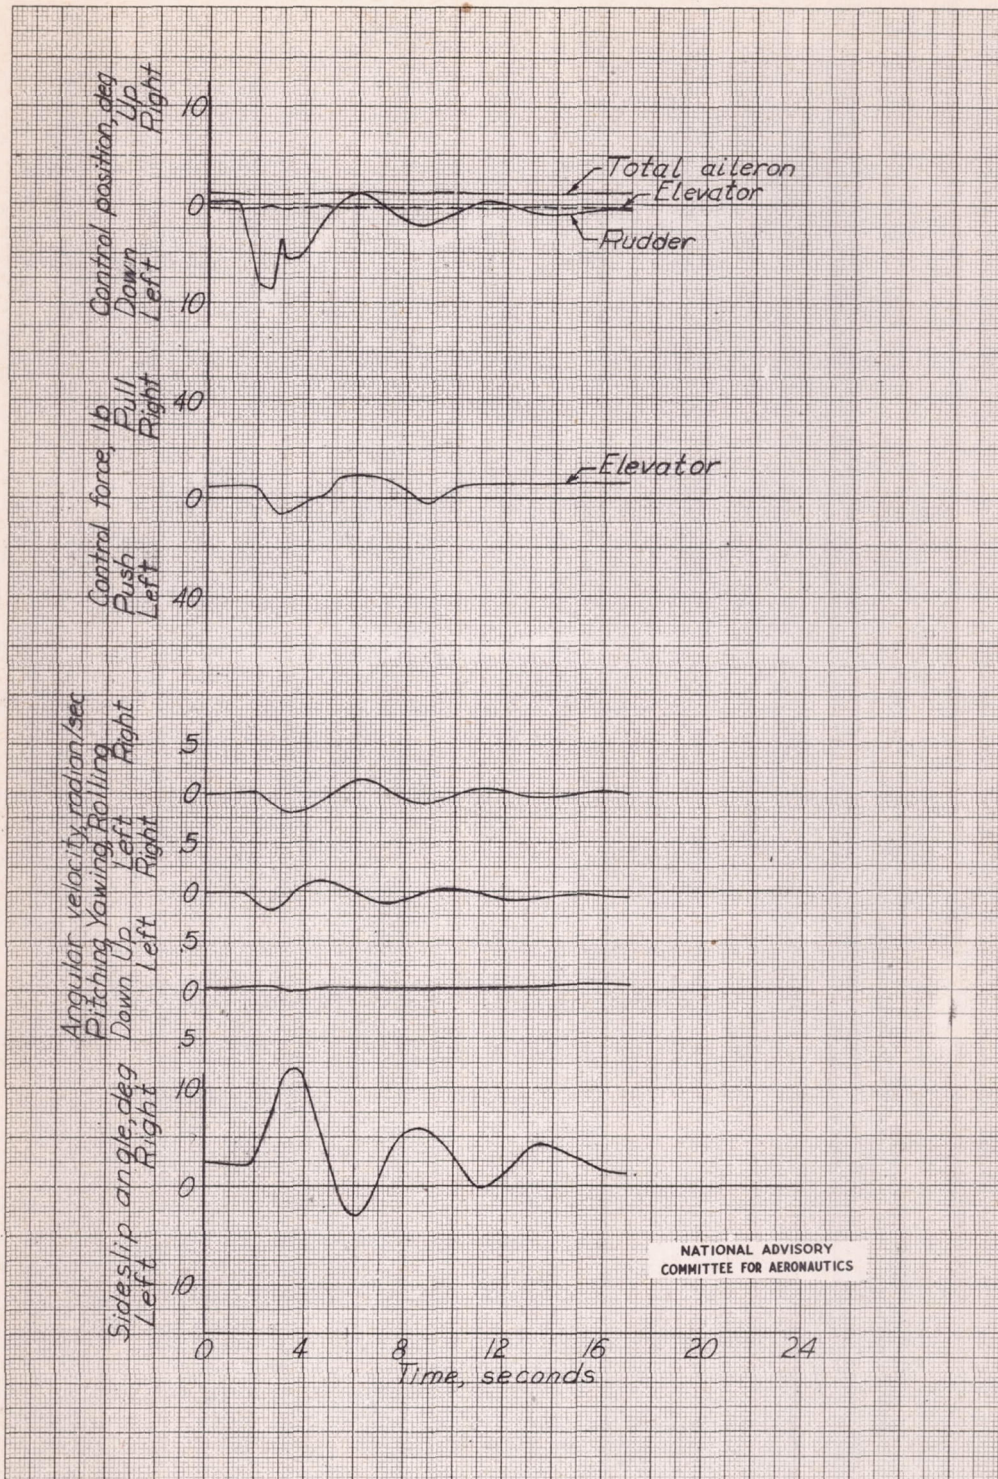
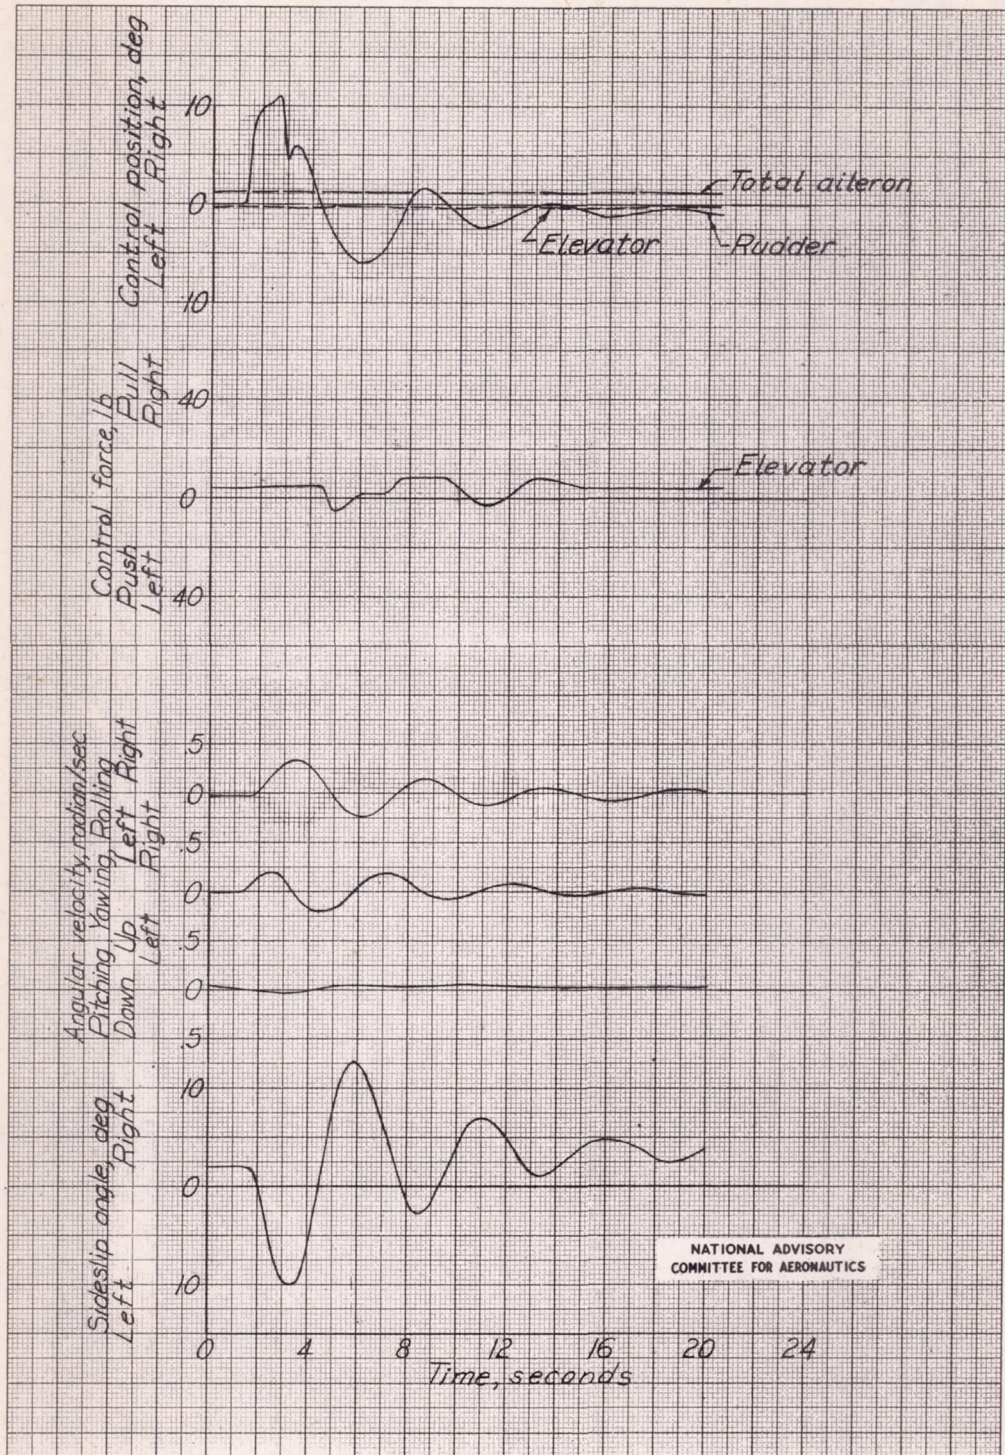
a. Left kick and release.
 Figure 7. - Lateral oscillations in the clean condition at 180 miles per hour with power for level flight (2650 rpm, 4 pounds boost), shutters closed, DeHavilland Mosquito F-3 airplane.

b. Right kick and release.
Figure 7. - Concluded.

causing the airplane to roll and turn. The oscillations were induced by kicking the rudder and releasing it while holding the elevator and the ailerons fixed. Time histories of oscillations due to a right and a left rudder kick at 180 miles per hour are presented in figure 1.

The lateral oscillations were damped to $1/2$ amplitude in 2 cycles and therefore met the requirements of reference 1. The short-period oscillation of the rudder, indicated in figure 7 by a slight tendency of the rudder to overshoot its equilibrium position when suddenly released, was completely damped in less than 1 cycle. The requirement of reference 1 that there should be no short-period oscillation of the rudder was therefore satisfied. The rudder showed a marked tendency to float with the relative wind, and continued to oscillate in phase with the airplane motion during the oscillation. Rudder kicks were also made in which the rudder was kicked, returned to zero, and held as well as possible while the elevator and the ailerons were held fixed. A time history of one such rudder kick at 180 miles per hour is given in figure 8. The pilot considered that the damping of the lateral oscillation was somewhat better than if the rudder were not fixed at zero; however, the rudder blew with the relative wind and because of the flexibility of the rudder-control system could not be held in a fixed position. A time history of a rudder kick and release at 280 miles per hour is given in figure 9. The increase in speed reduced the period, but had little effect on the damping of the oscillations. In all the oscillations the pitching moment due to yawing caused alternate push and pull forces on the control wheel, a characteristic which was objectionable to the pilot.

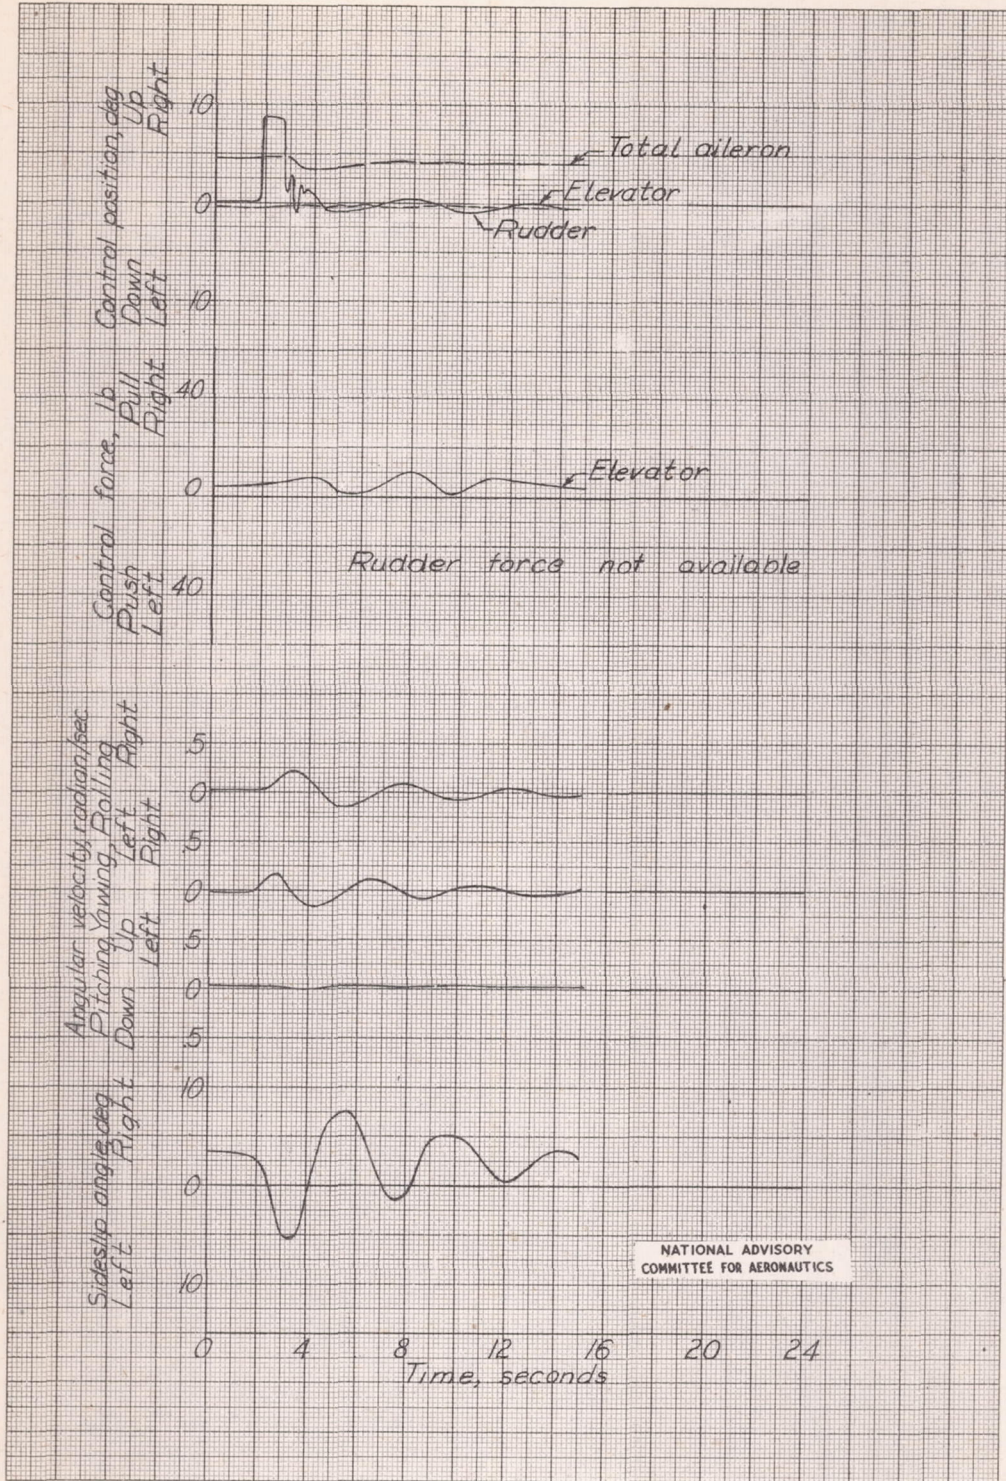
Figure 8. - Lateral oscillations in the clean condition at 180 miles per hour with power for level flight (2650 rpm, +4 pounds boost), shutters closed, caused by kicking the rudder and then fixing it in neutral, DeHavilland Mosquito, F-8 airplane.

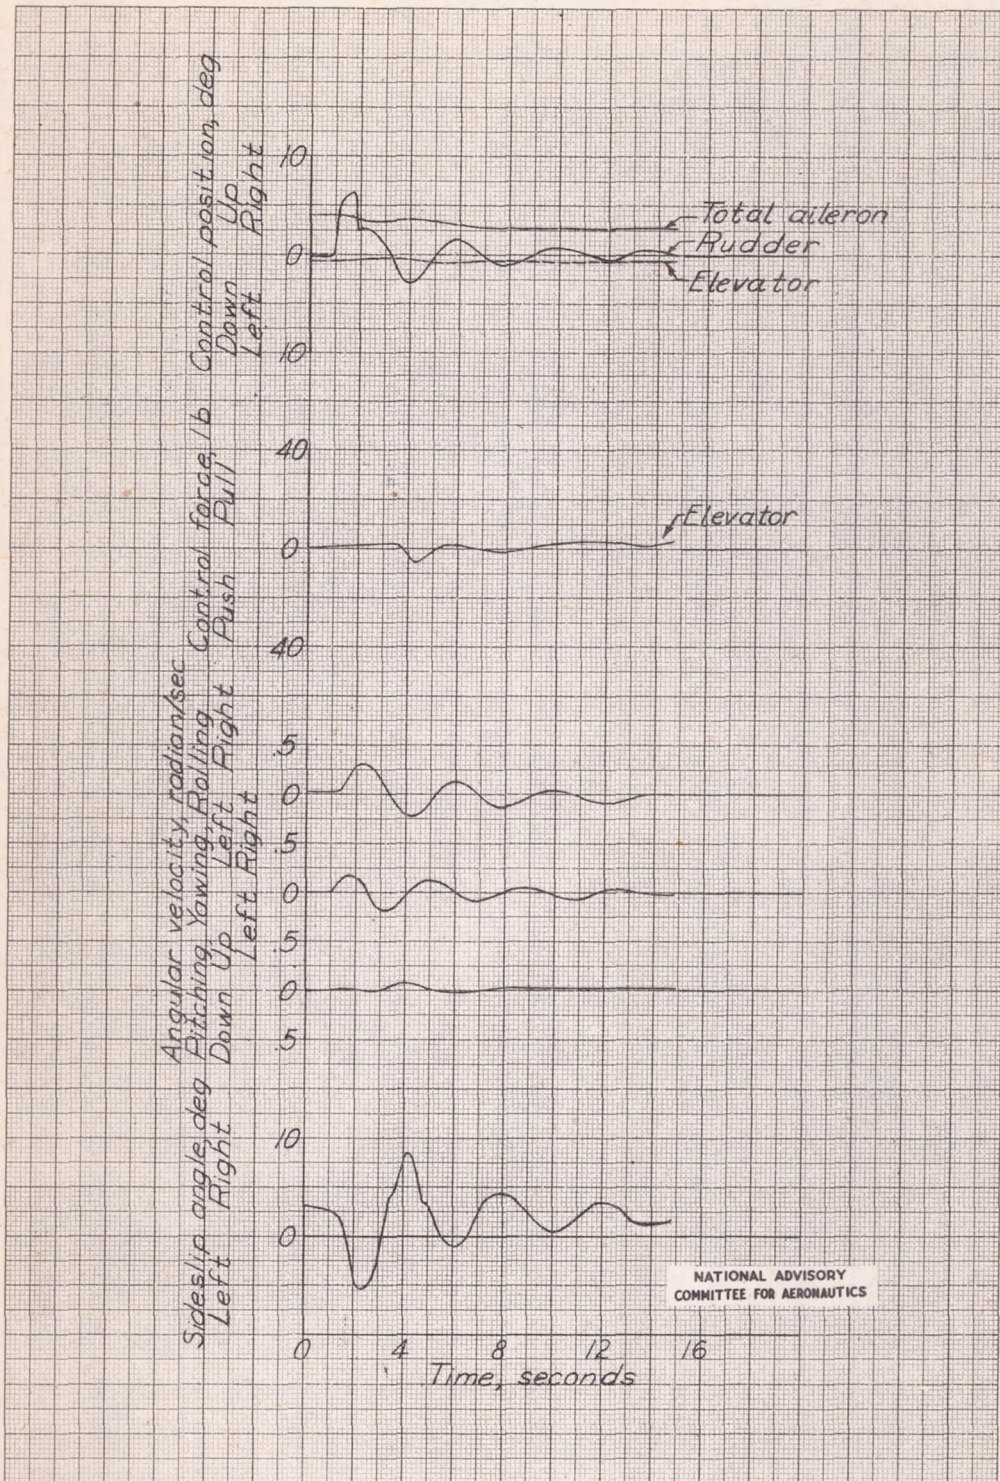
Figure 9. - Lateral oscillations in the clean condition at 280 miles per hour with rated power (2650 rpm, +7 pounds boost), shutters closed, caused by right rudder kick and release, DeHavilland Mosquito F-8 airplane.
