MEASUREMENT OF FLYING QUALITIES OF A DEHAVILLAND

MOSQUITO F-8 AIRPLANE (AAF NO. 43-334960)

I - LATERAL AND DIRECTIONAL STABILITY

AND CONTROL CHARACTERISTICS

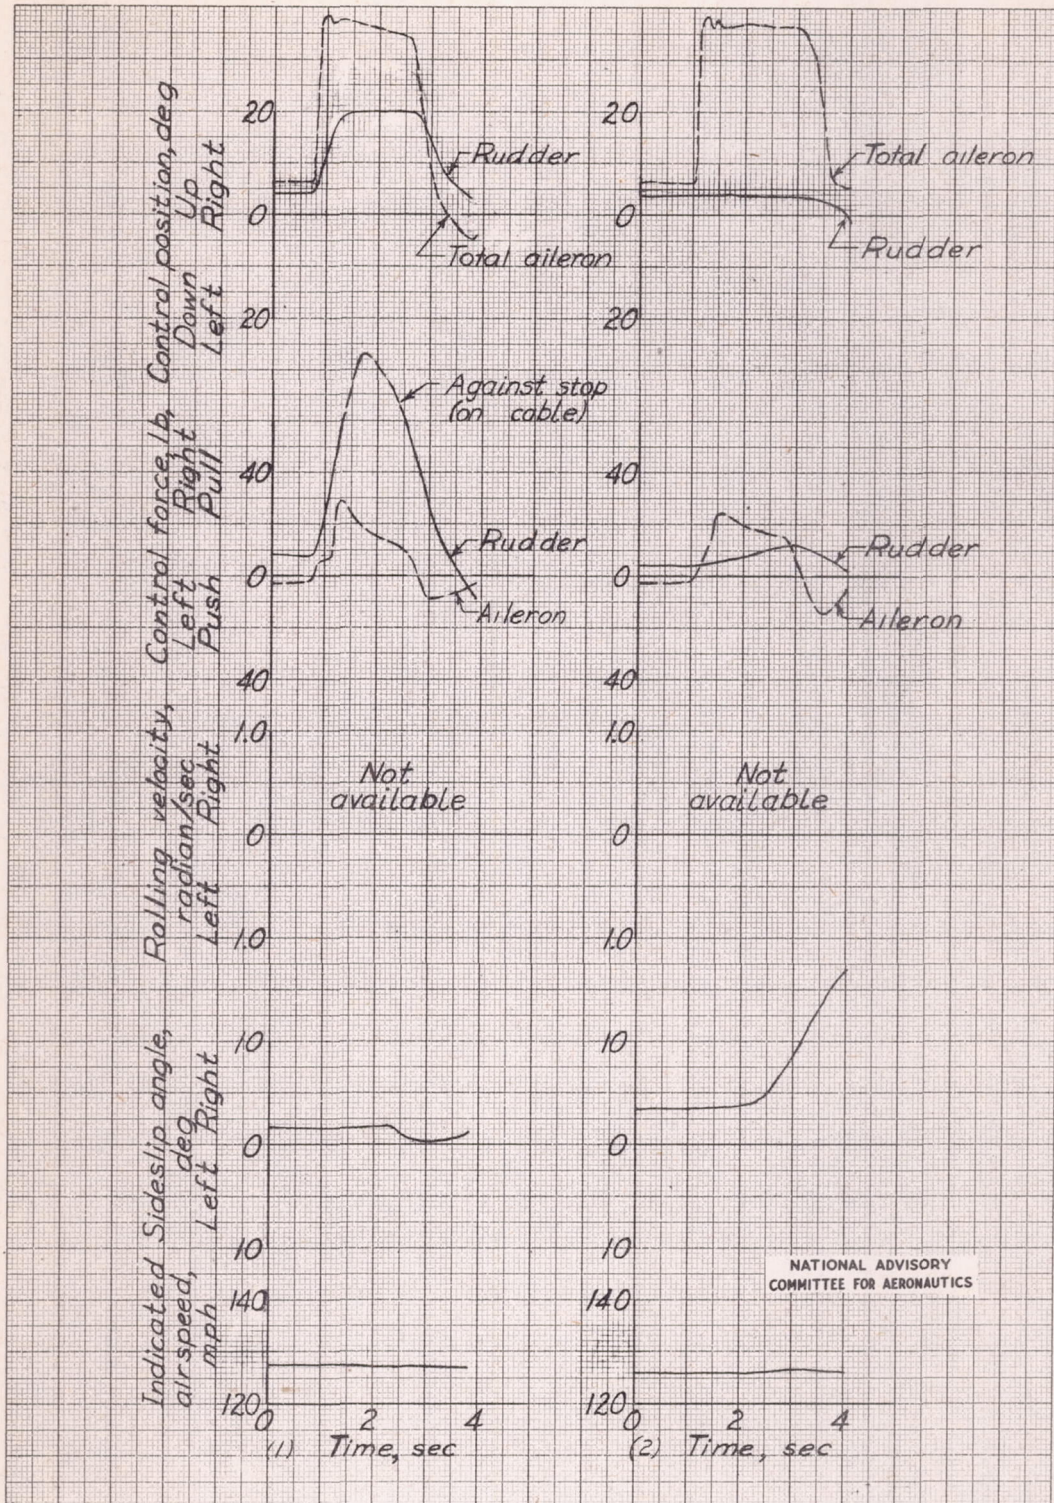
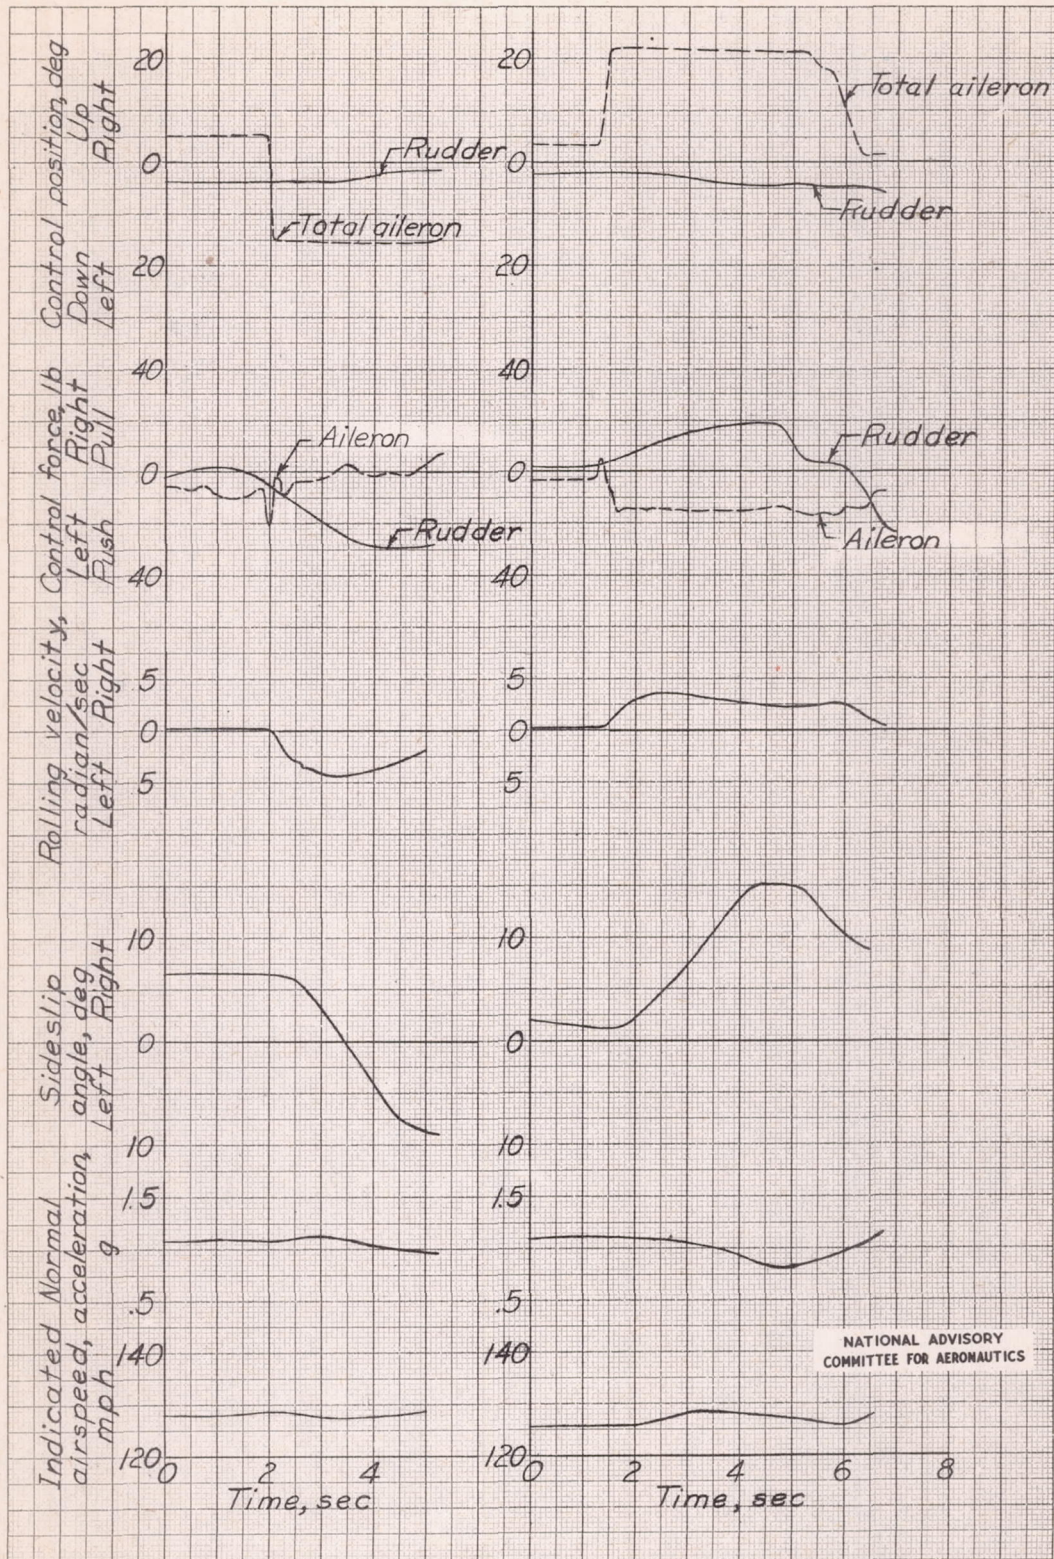
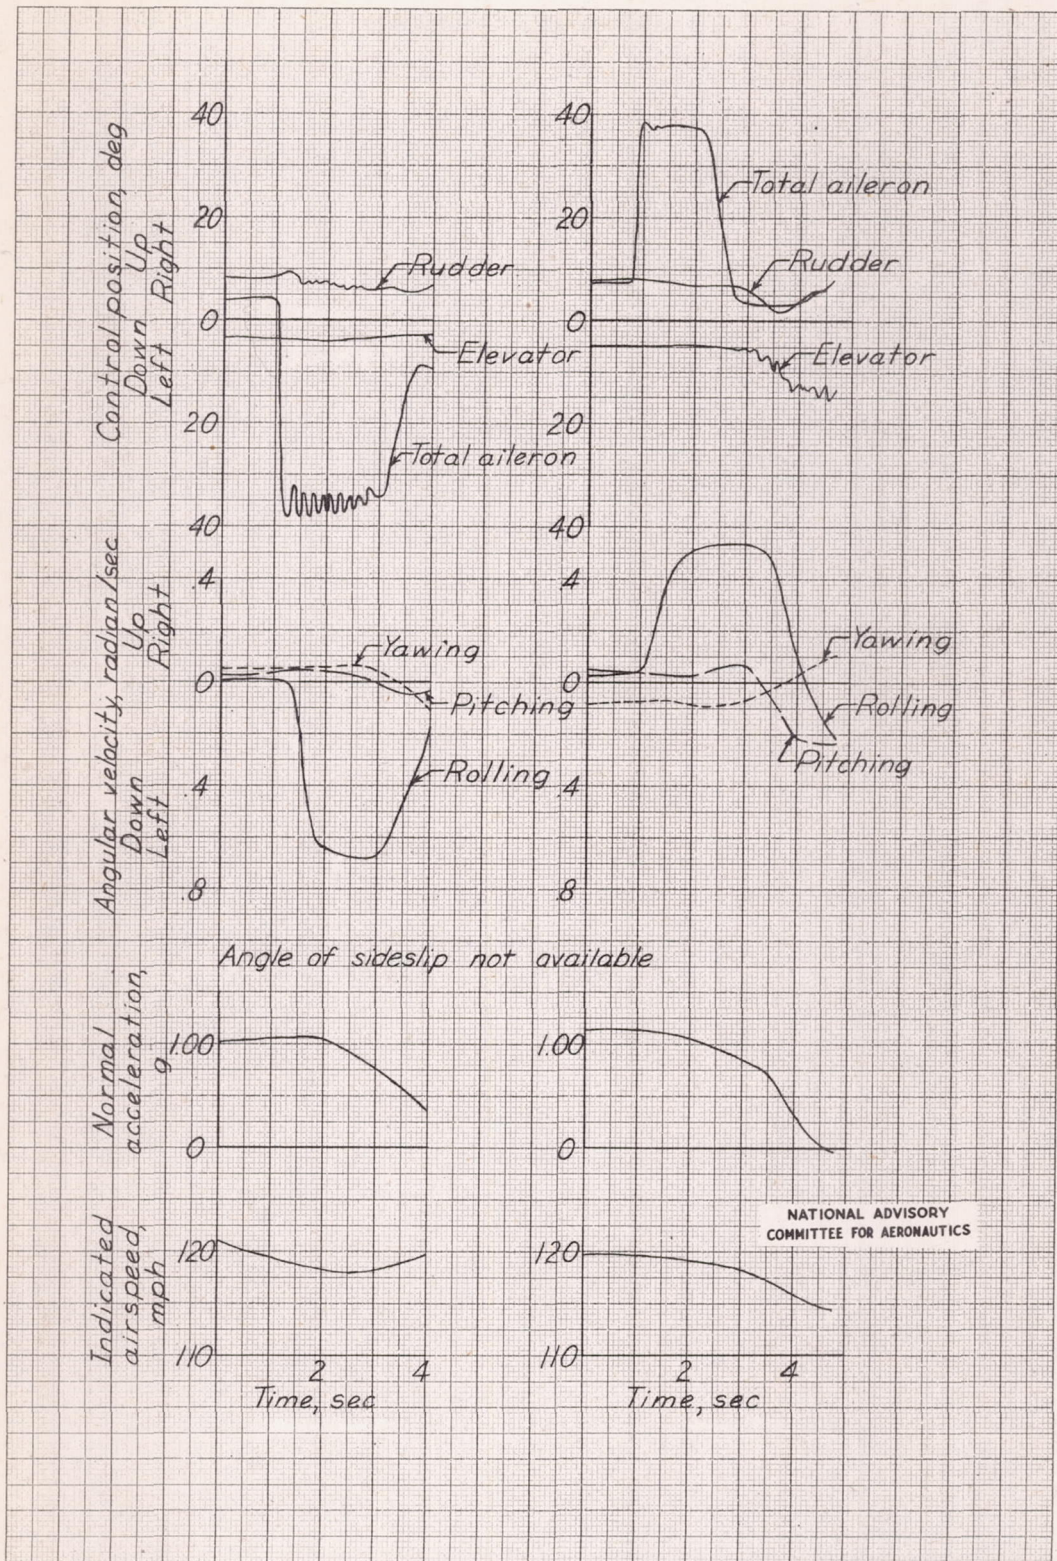
a. Right rollouts with flaps down, landing gear down, power for level flight, shutters open, at 125 miles per hour.

Figure 10 - Time histories of rolls out of turns, DeHavilland Mosquito F-8 airplane.

b. Rudder-fixed rollouts, with flaps up, landing gear up, engines idling, shutters closed, at 125 miles per hour.
Figure 10 - Continued.

c. Rudder-fixed left and right rollouts with flaps down, landing gear down, rated power, shutters open, at 115 miles per hour. Engines cut out during right roll when airplane pitched down.
 Figure 10 - Concluded.

coordinated rudder are given in figure 10. The variation of maximum angle of sideslip with total aileron deflection in rudder-fixed roll-outs at low speeds is presented for several conditions in figure 11. The directional stability as indicated by the data of figure 11 was about equal in the gliding and wave-off conditions and slightly greater in the landing condition. The maximum angle of sideslip due to aileron deflection reached in the gliding condition was over 20° and therefore the requirements of reference 1 were not met. It was not always possible for the pilot to continue the maneuver until a maximum angle of sideslip was reached because of the pitching moment due to yawing. In figure 10(c) two rudder-fixed roll-outs are presented for the wave-off condition at 115 miles per hour during which the airplane pitched down abruptly as indicated by the pitching velocity and normal acceleration and in the right roll caused both engines to cut out. This figure also shows aileron shaking which was often noticed when the ailerons were fully deflected.

Analysis of the data in figure 10 and other similar data indicates that nearly all of the available change of rudder deflection, approximately 15° right or 20° left, and approximately a 50-pound increment of rudder force were necessary to overcome the yaw due to full aileron deflection at 125 miles per hour with flaps and gear down, power for level flight. The requirement of reference 1 that the rudder be able to overcome the adverse yaw due to full aileron deflection with a rudder force of less than 180 pounds was satisfied, but the pilot commented that a considerable amount of pedal motion was required for the amount of aileron control applied.

figures 25 through 28 indicate that on this particular Mosquito aileron overbalance occurred in rolls in all conditions below 200 miles per hour over a considerable range of aileron deflections. It has been stated previously that the ailerons tended to shake when fully deflected and that an example of aileron shaking is presented in figure 10(c).

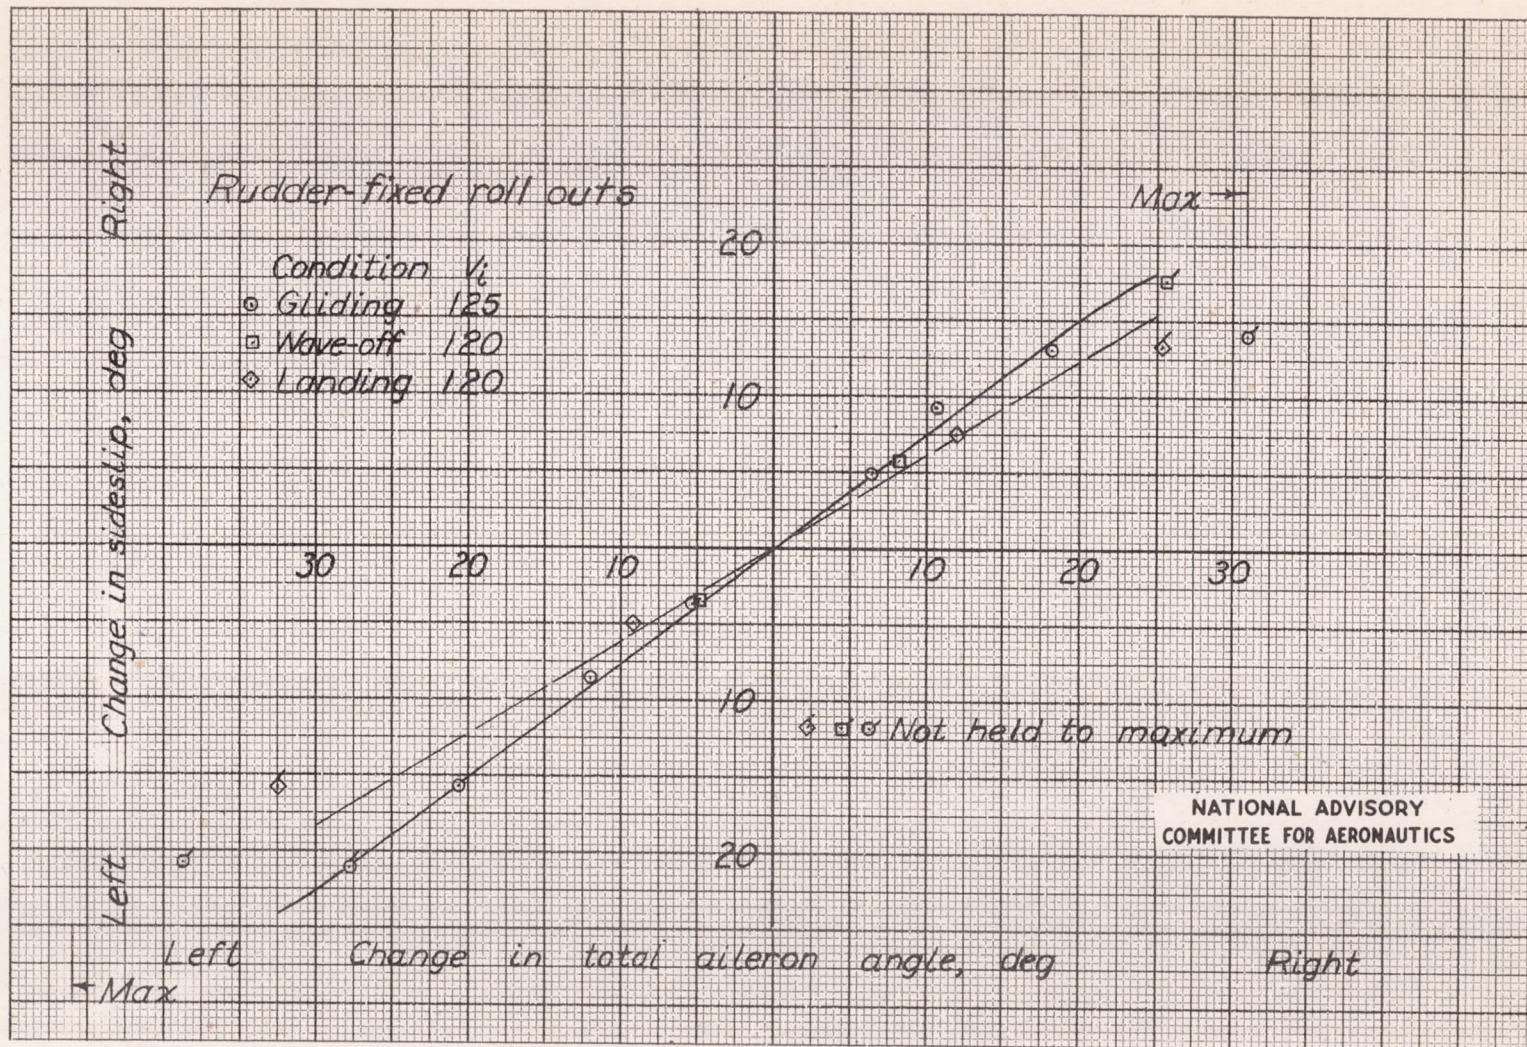
Figure 11. - Variation of maximum change in sideslip angle with change in total aileron angle for several flight conditions, DeHavilland Mosquito F-8 airplane.

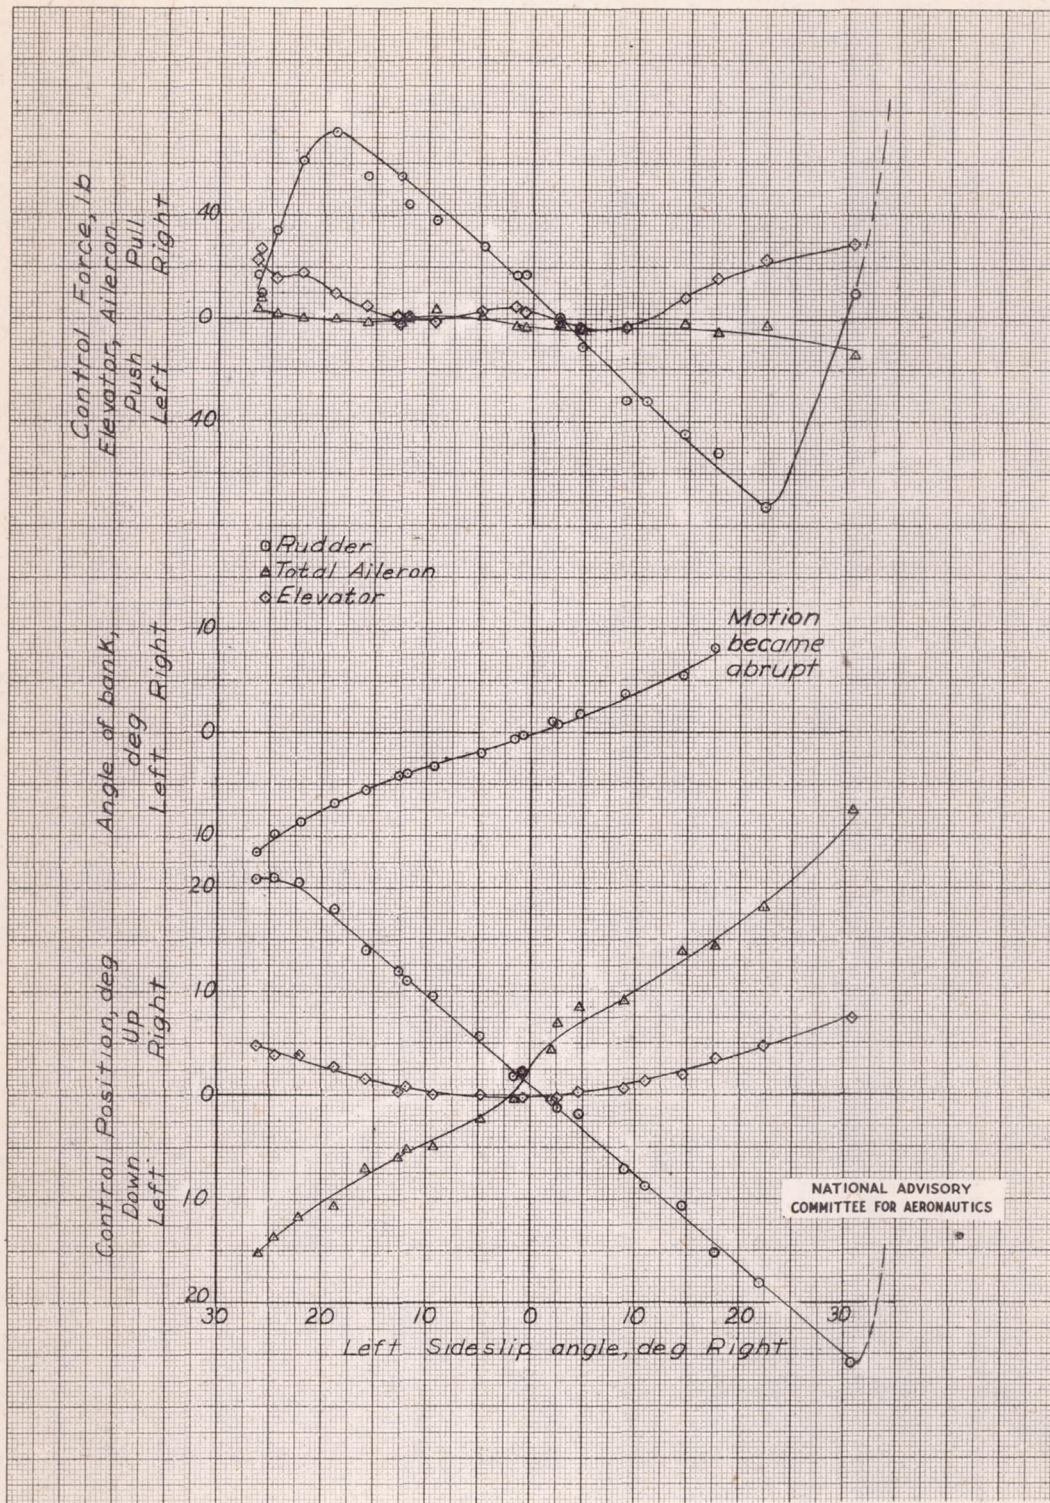
Figure 12. - Sideslip characteristics from continuous records in the clean condition at 115 miles per hour with power for level flight (2650 rpm, $-3\frac{1}{2}$ pounds boost) shutters open, DeHavilland Mosquito F-3 airplane.

The stick-fixed dihedral effect as shown by the variation of aileron angle with sideslip angle in figures 12 to 16 was positive in all conditions and met the requirements of reference 1. In the gliding condition the effective dihedral was 4.0° compared with 1.4° geometric dihedral at the top surface of the wing. The stick-free dihedral effect as shown by the variation of the aileron force with sideslip angle was marginal to slightly negative in all conditions; the stick forces were very light and hardly out of the range of the friction force in the aileron system which was approximately ± 4 pounds.

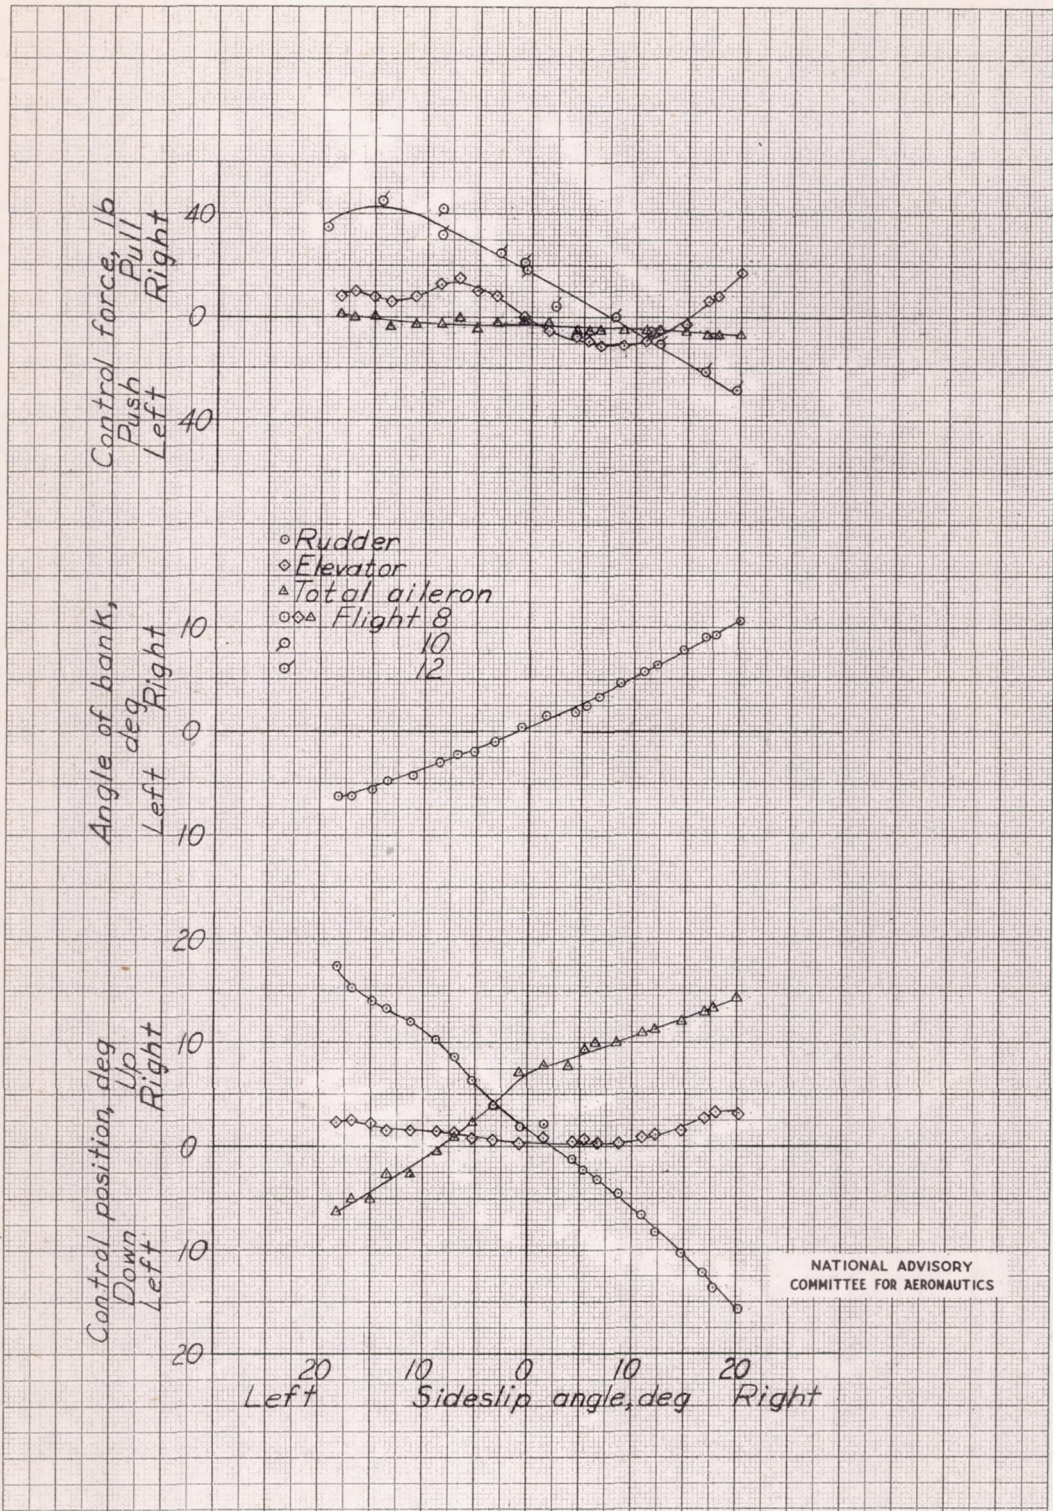
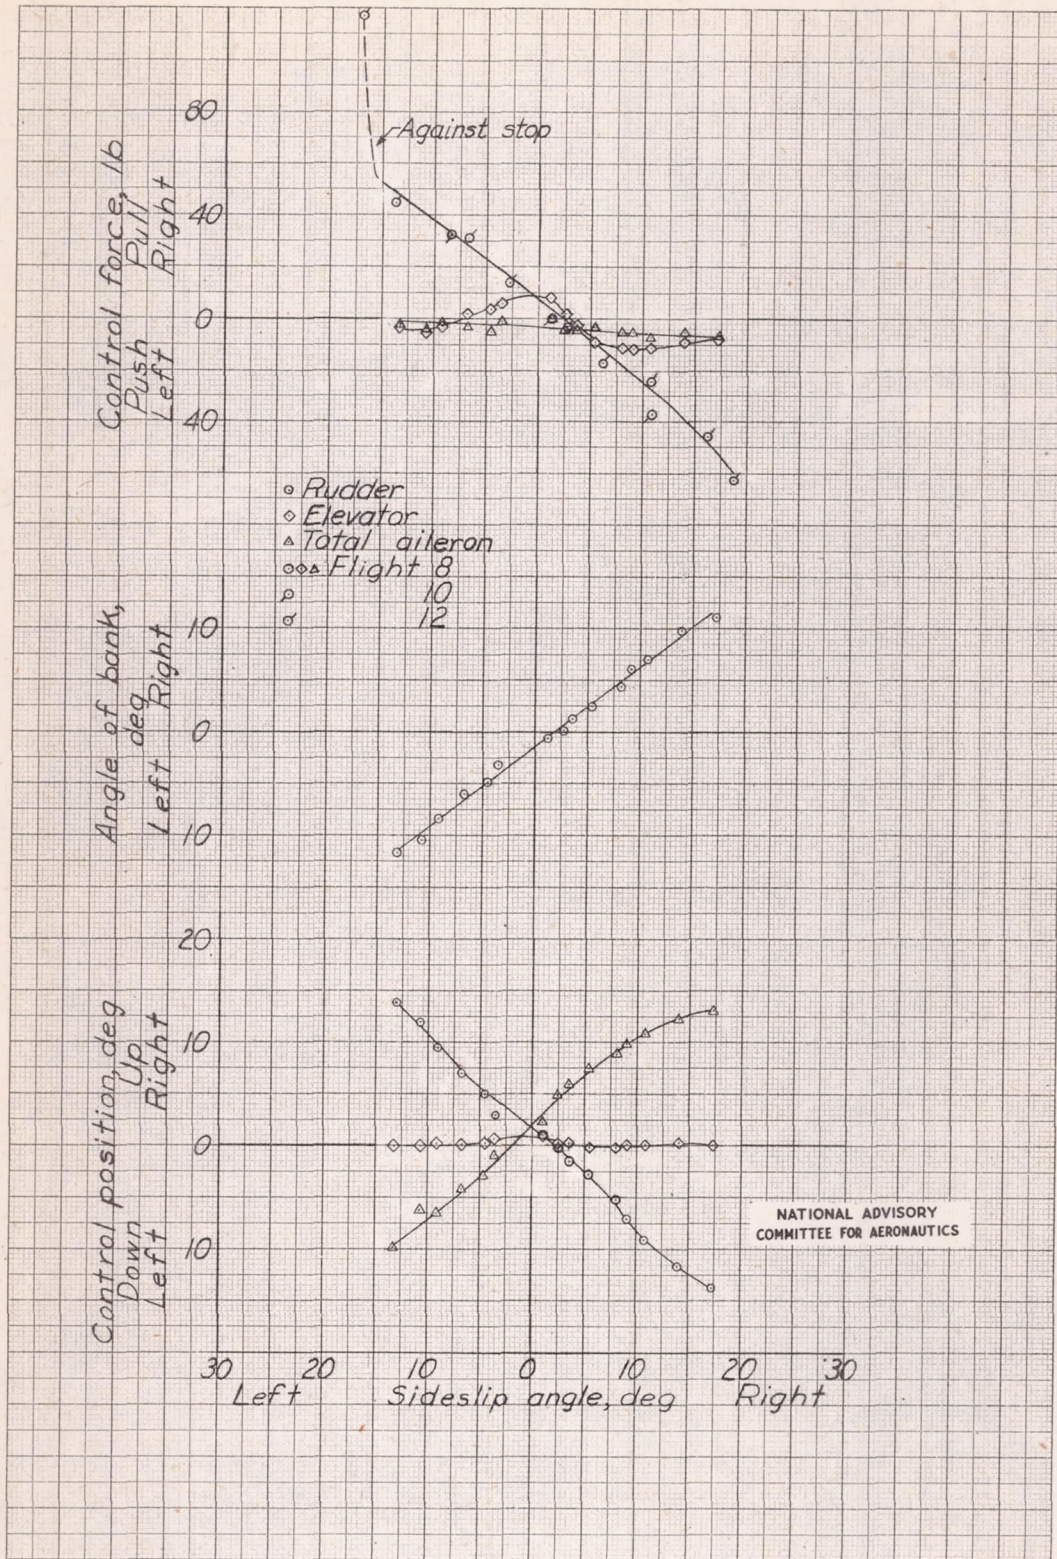
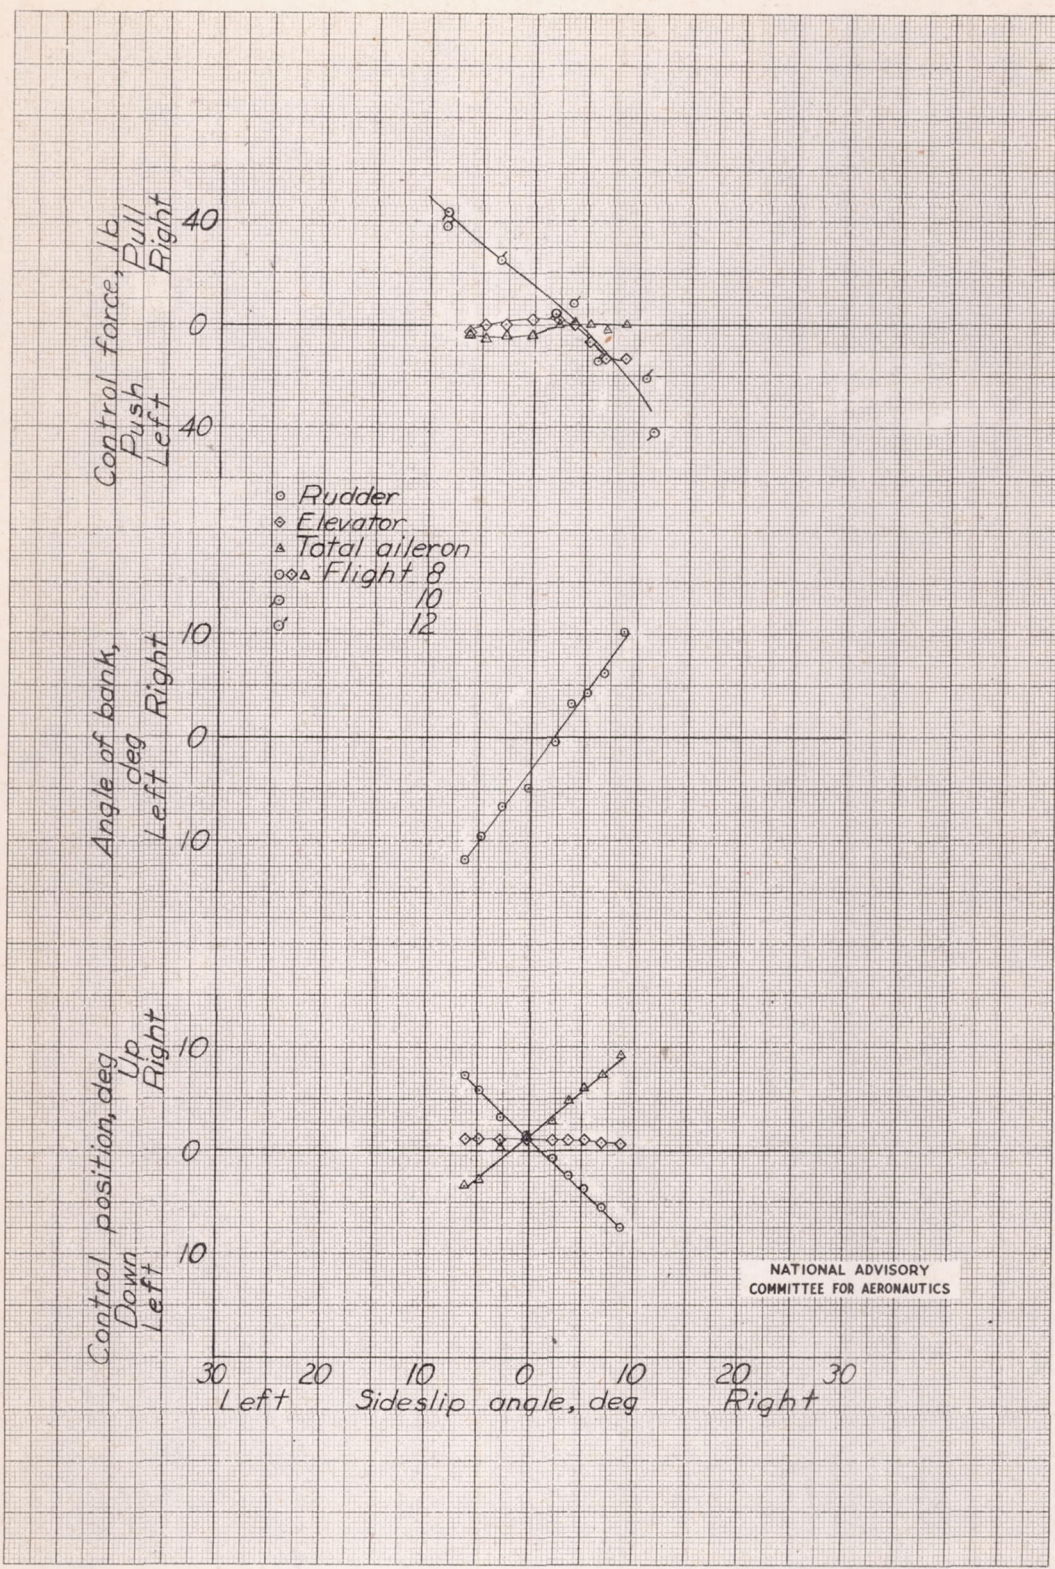
a. 120 miles per hour, shutters open.
 Figure 13. - Sideslip characteristics in the clean condition with rated power, DeHavilland Mosquito F-3 airplane.

b. 180 miles per hour shutters closed.
Figure 13. - Continued.

o. 240 miles per hour, shutters closed.
Figure 13. - Concluded.

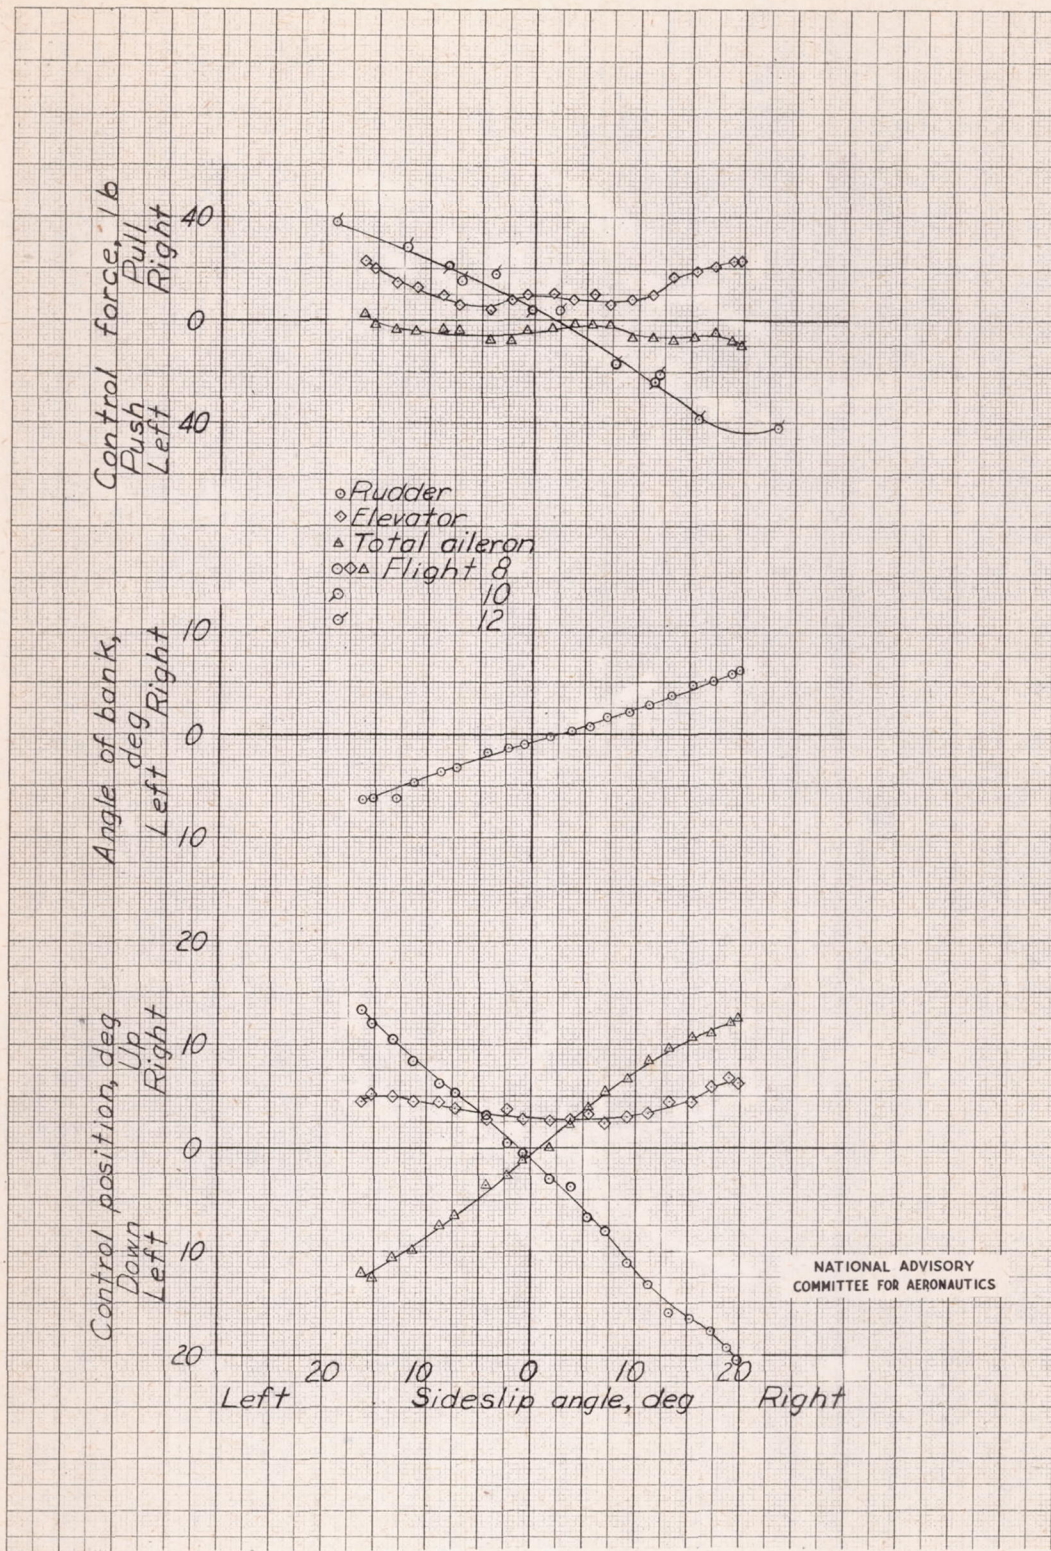
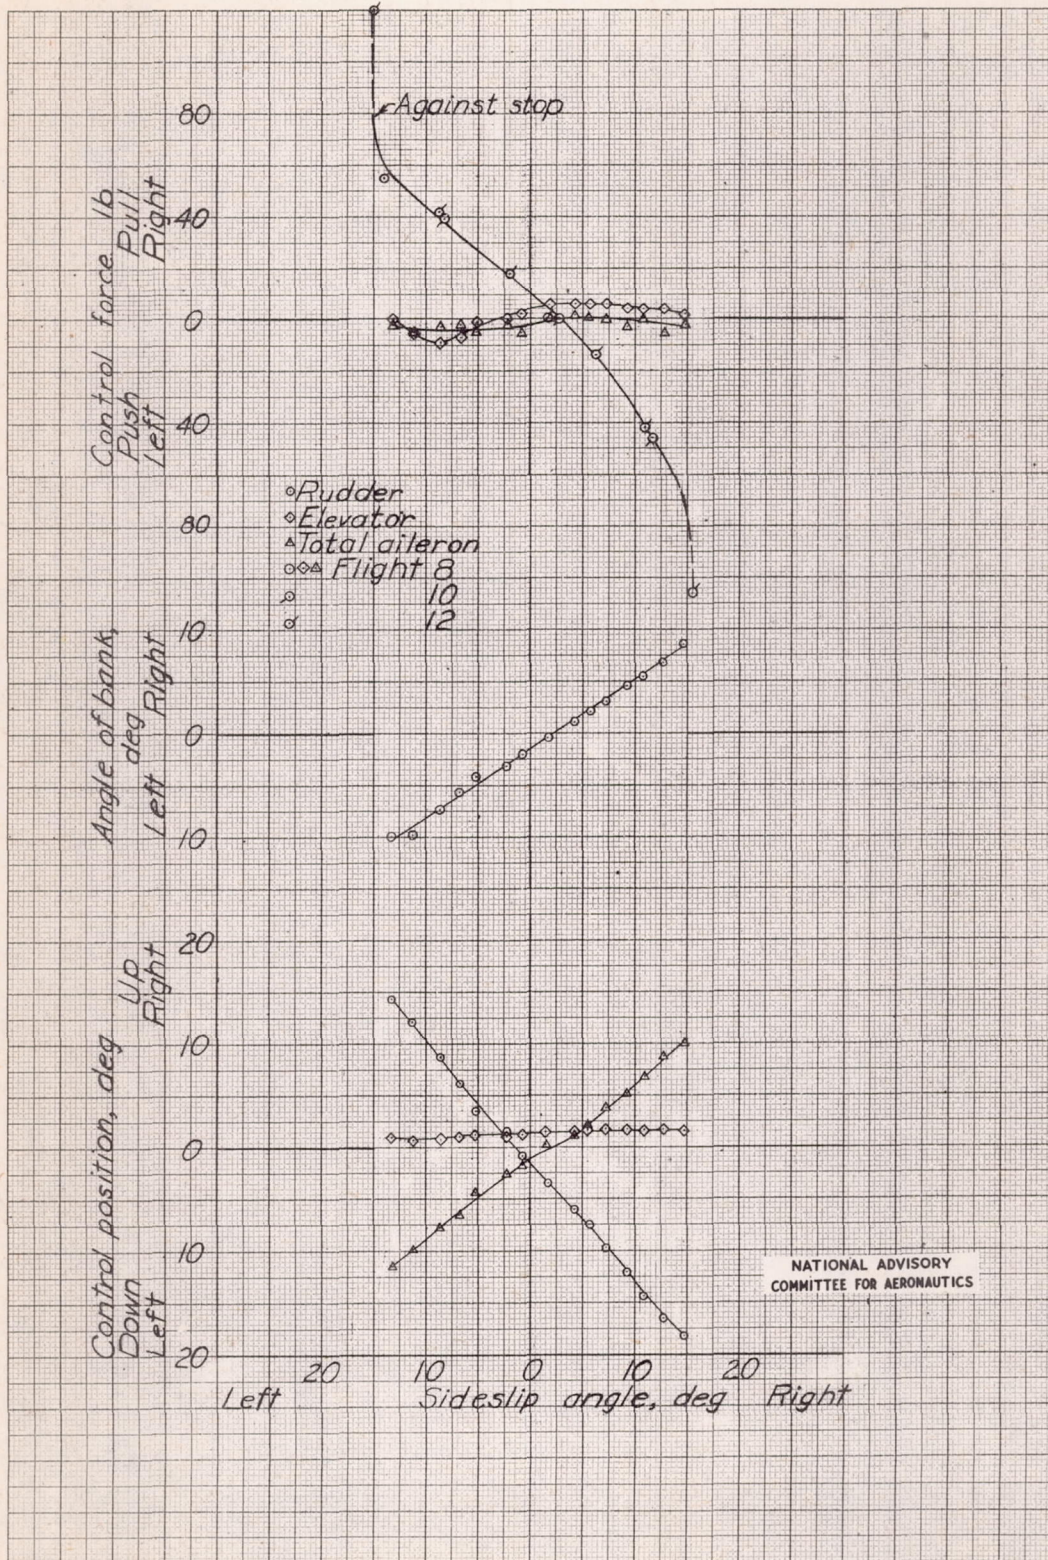
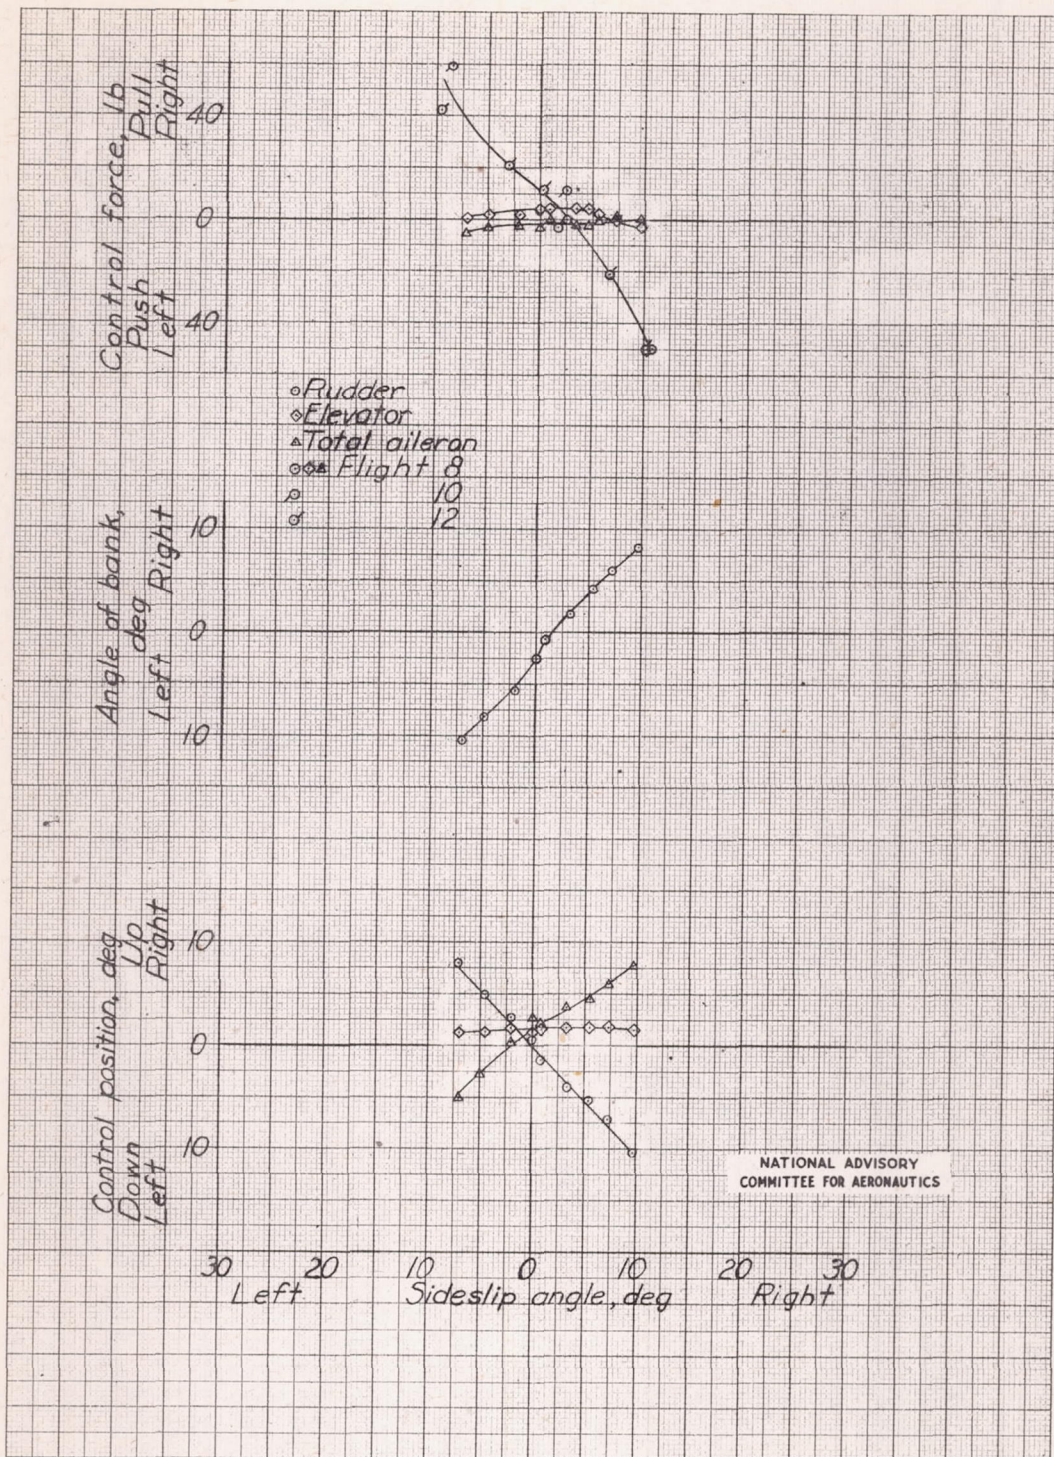
a. 120 miles per hour
 Figure 14. - Sideslip characteristics in the clean condition with engines idling, shutters closed, DeHavilland Mosquito F-8 airplane.

b. 180 miles per hour
Figure 14. - Continued.

c. 240 miles per hour
 Figure 14. - Concluded.

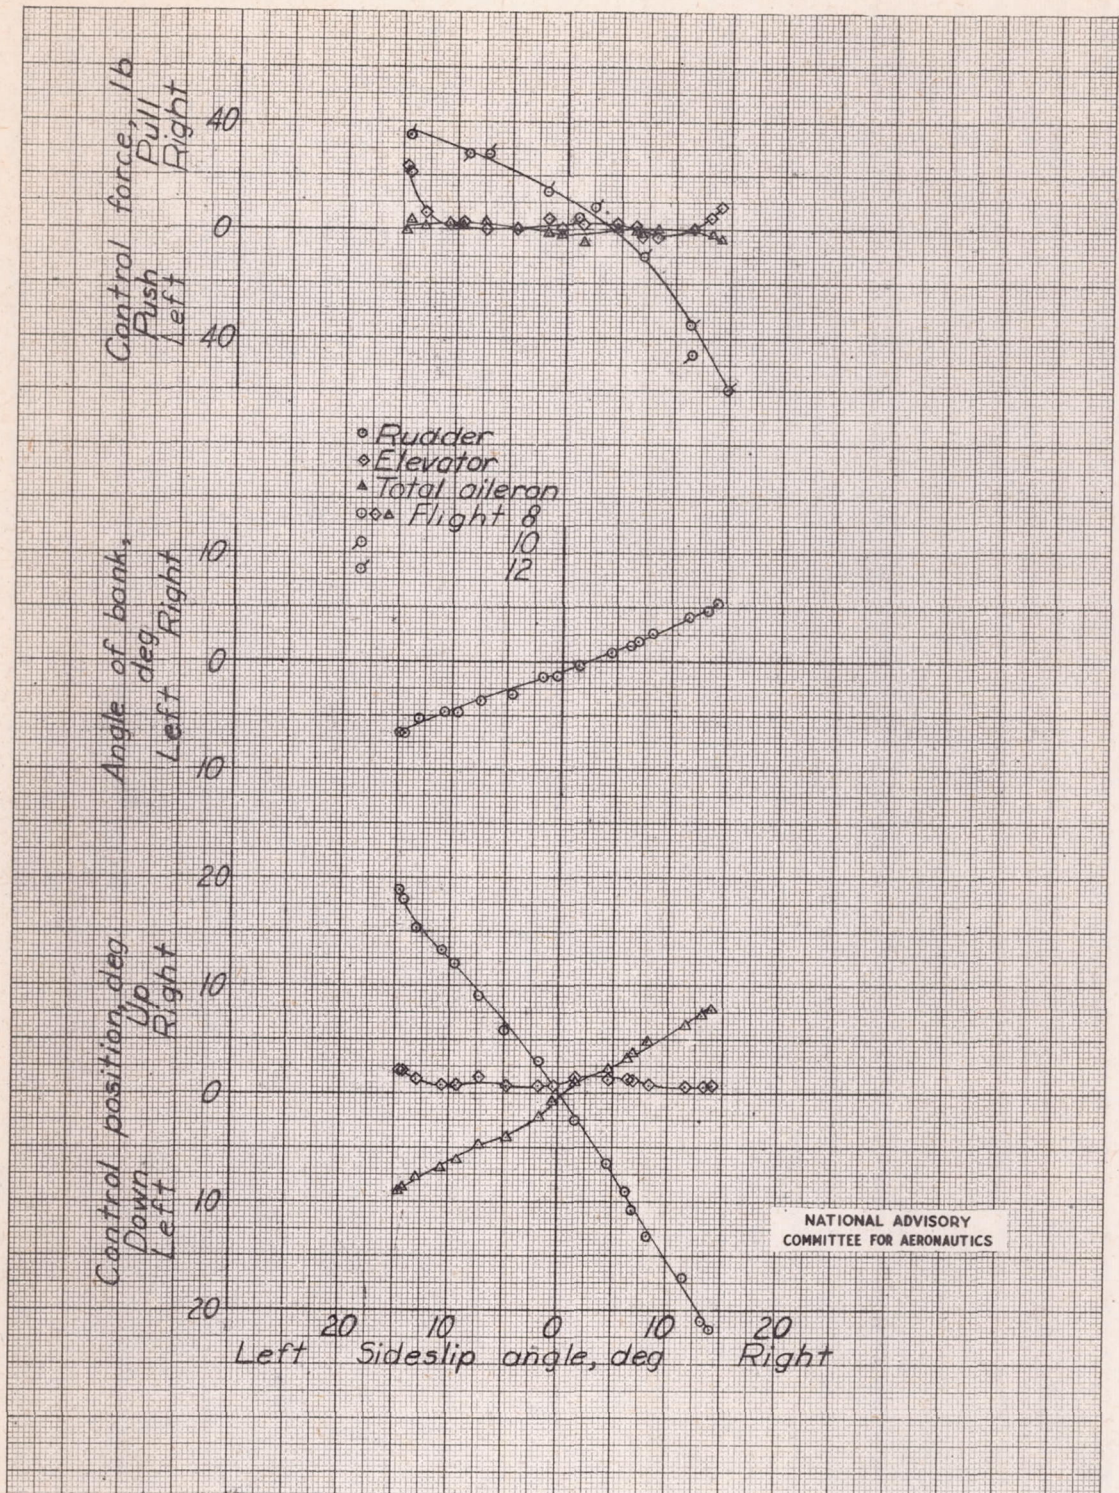
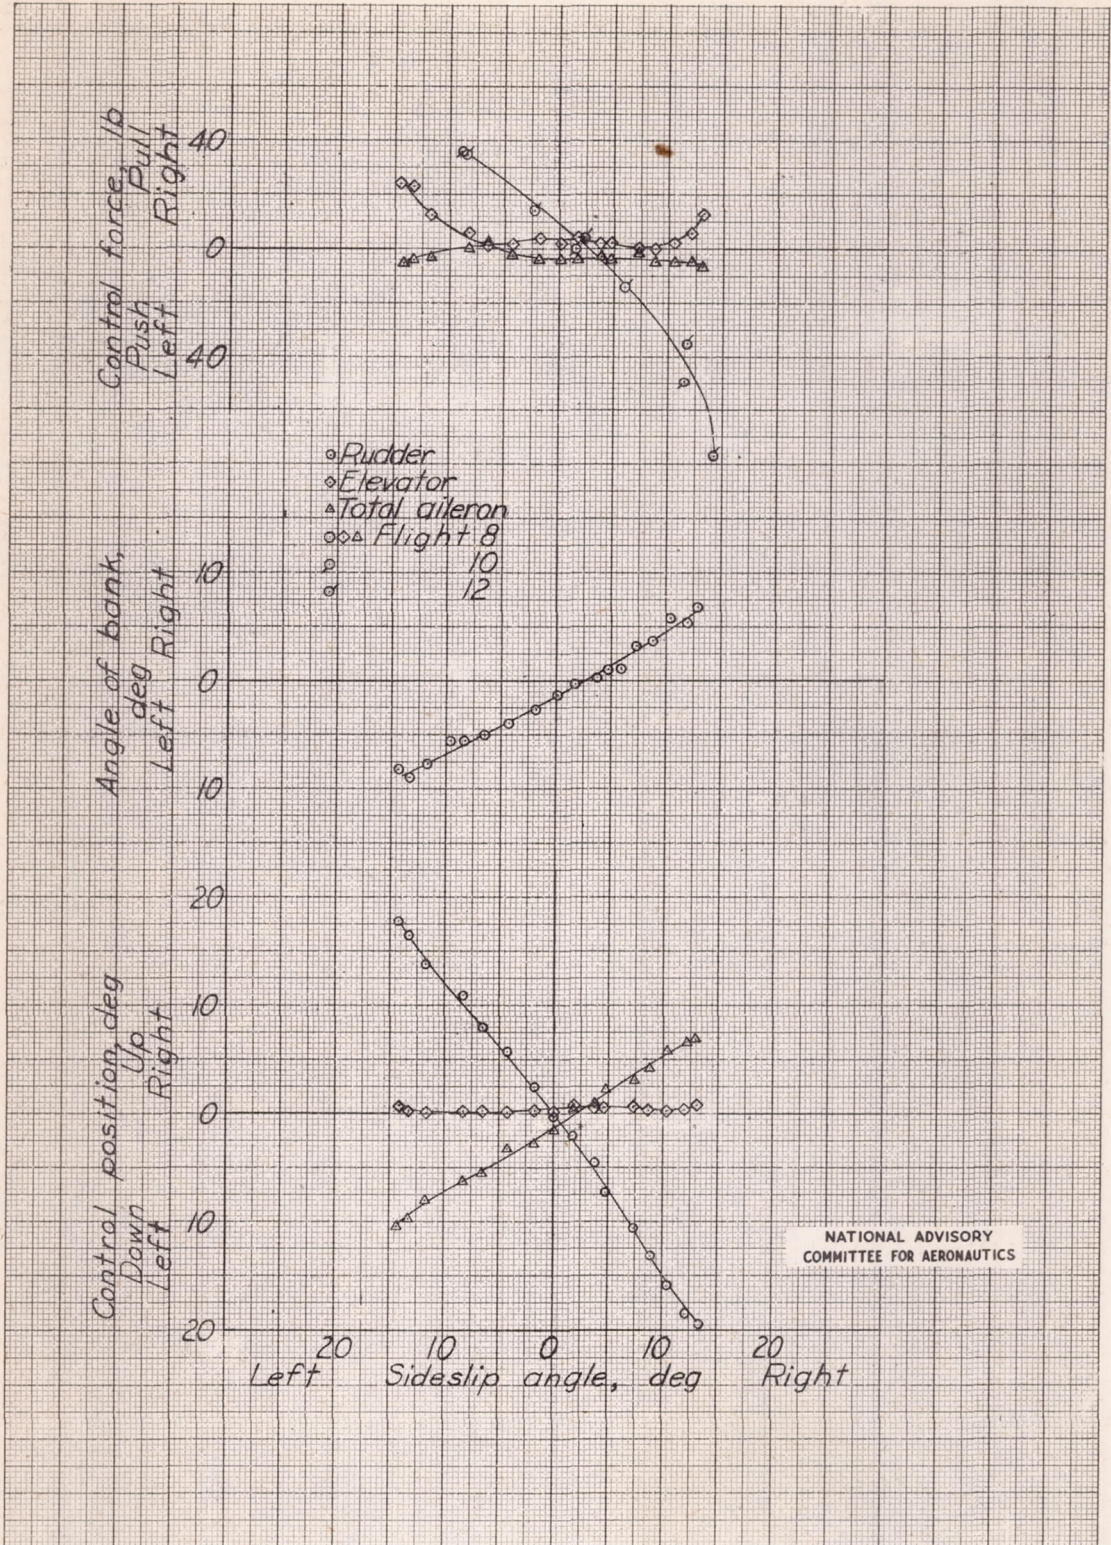
a. 115 miles per hour
 Figure 15. - Sideslip characteristics with flaps and landing gear down, engines idling, shutters open, DeHavilland Mosquito F-8 airplane.

b. 140 miles per hour
Figure 15. - Concluded.
