MEASUREMENT OF FLYING QUALITIES OF A DEHAVILLAND

MOSQUITO F-8 AIRPLANE (AAF NO. 43-334960)

I - LATERAL AND DIRECTIONAL STABILITY

AND CONTROL CHARACTERISTICS

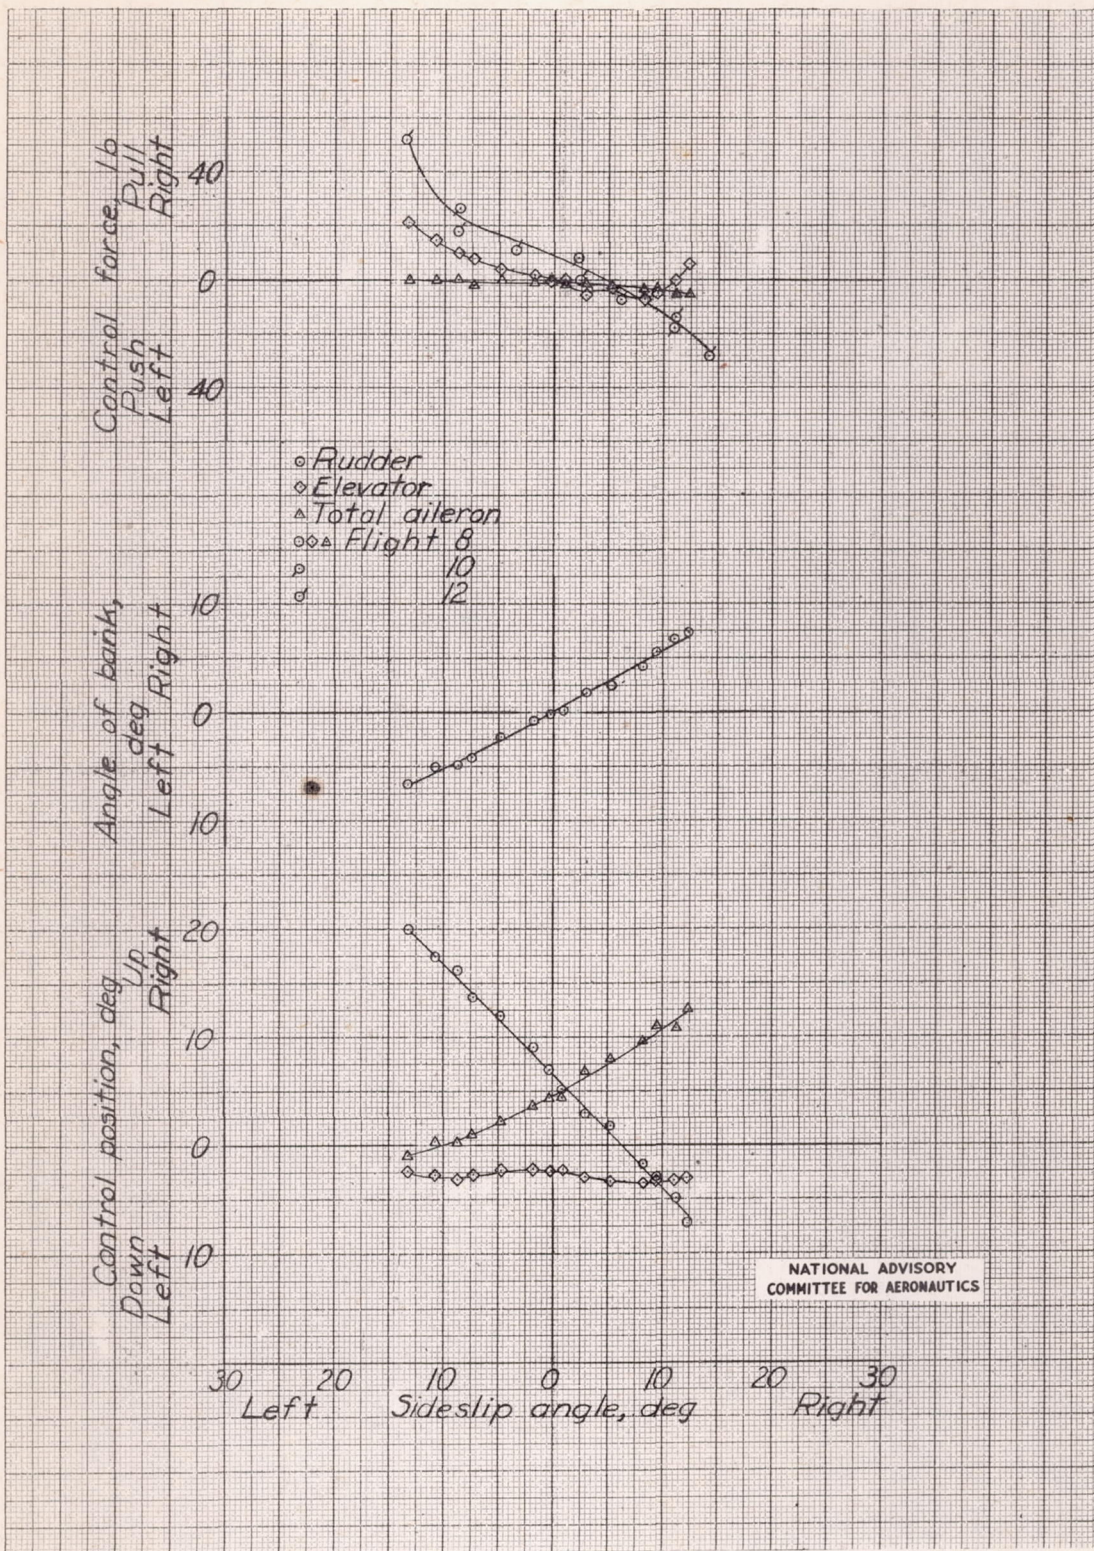
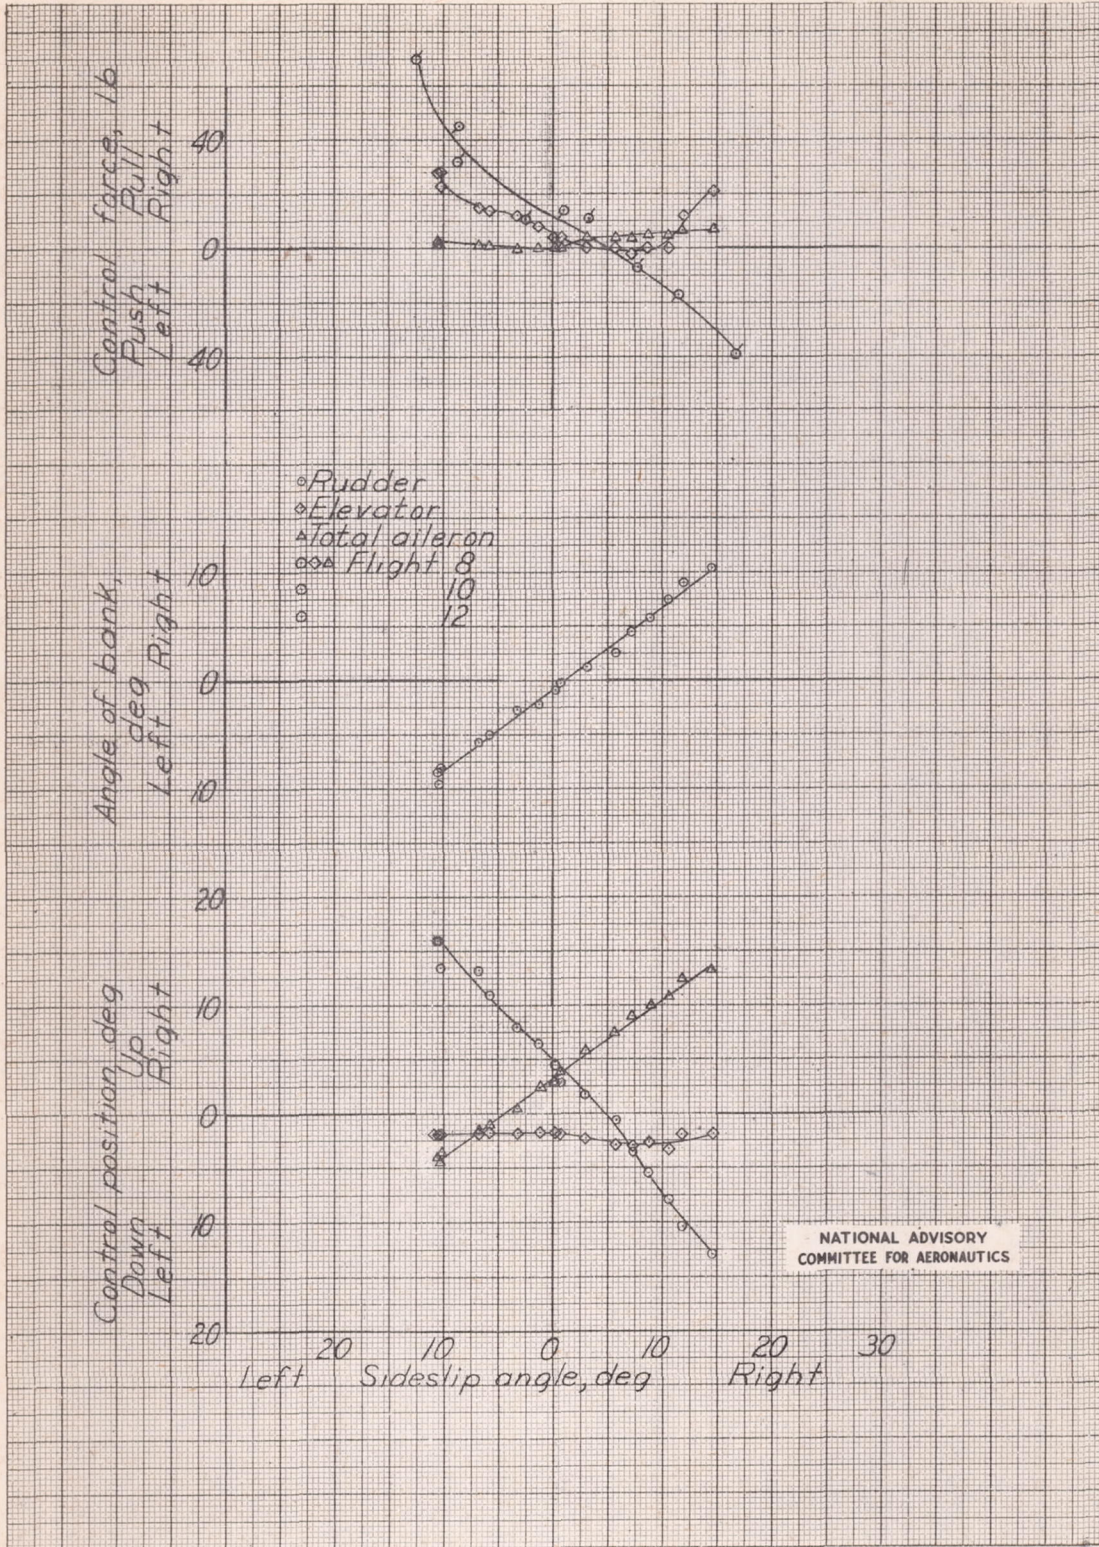
a. 110 miles per hour
Figure 16. - Sideslip characteristics with the flaps and landing gear down, rated power, shutters open, DeHavilland Mosquito F-8 airplane.

b. 140 miles per hour
Figure 16. - Concluded.

The stick-fixed dihedral effect as shown by the variation of aileron angle with sideslip angle in figures 12 to 16 was positive in all conditions and met the requirements of reference 1. In the gliding condition the effective dihedral was 4.0° compared with 1.4° geometric dihedral at the top surface of the wing. The stick-free dihedral effect as shown by the variation of the aileron force with sideslip angle was marginal to slightly negative in all conditions; the stick forces were very light and hardly out of the range of the friction force in the aileron system which was approximately ± 4 pounds.

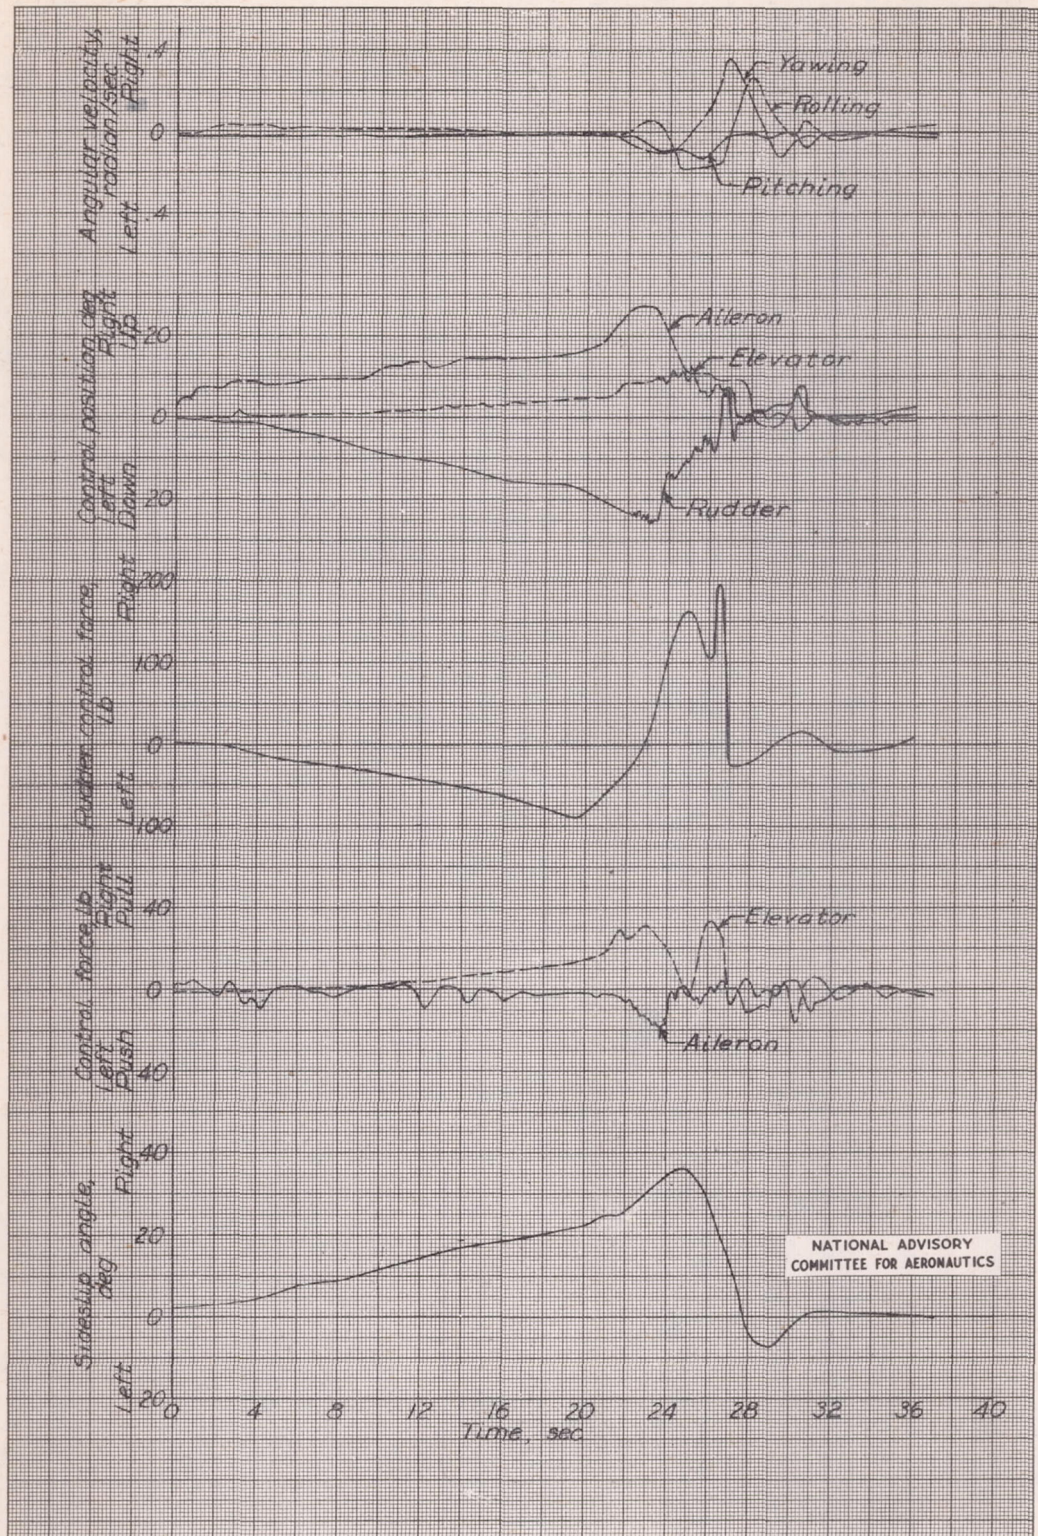
Figure 17. - Time history of right sideslip in the clean condition with power for level flight at 115 miles per hour, shutters open, in which rudder lock occurred, DeHavilland Mosquito F-3 airplane. Engines were cut to regain control.

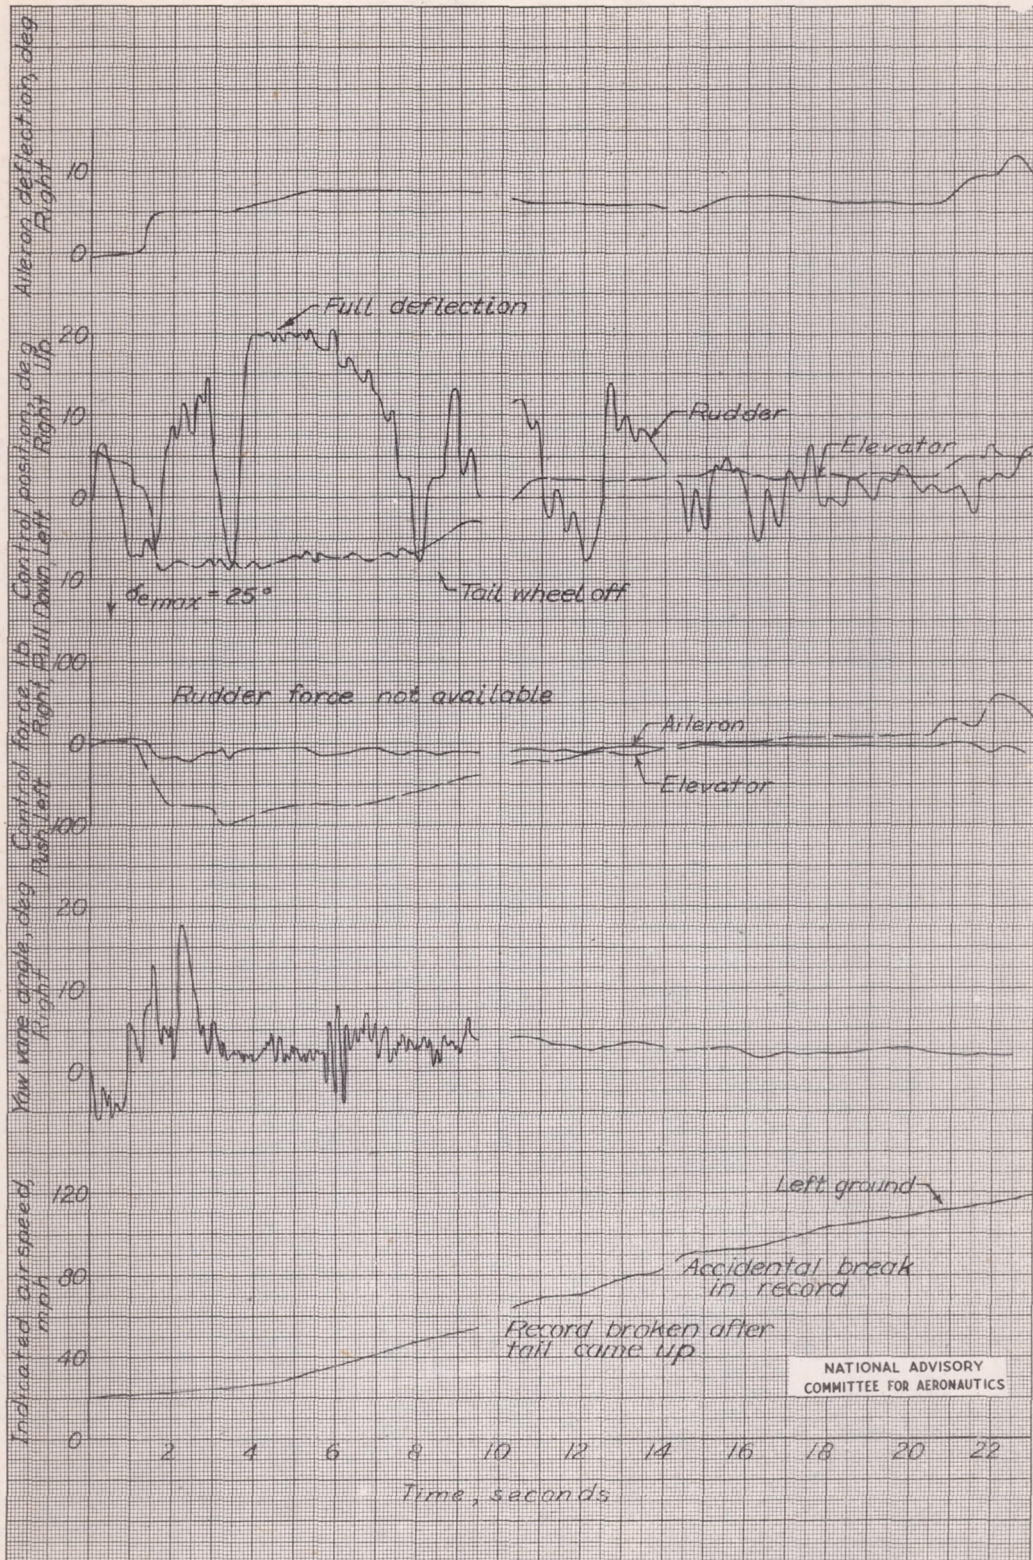
Figure 18. - Time history of a take-off using 10 pounds boost at 3000 rpm, shutters open, flaps up, center of gravity at 35 percent M.A.C., DeHavilland Mosquito F-8 airplane.

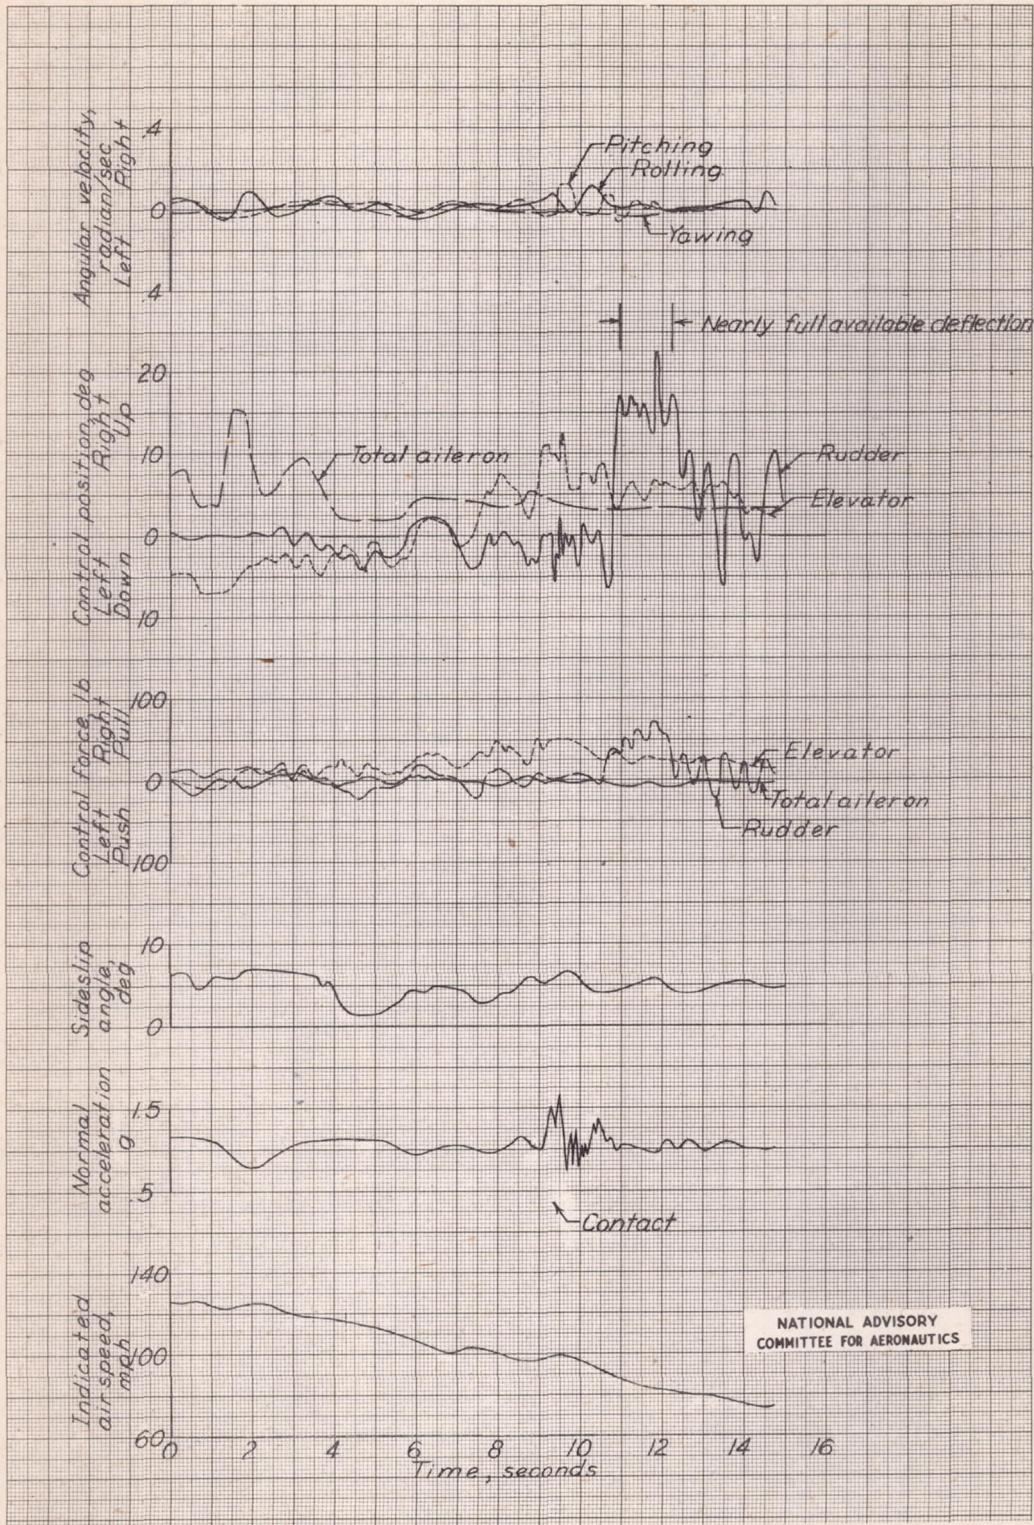
Figure 19. - Time history of a landing with the center of gravity at 35 percent M.A.C., flaps down, landing gear down, engines idling, De-Havilland Mosquito F-8 airplane.

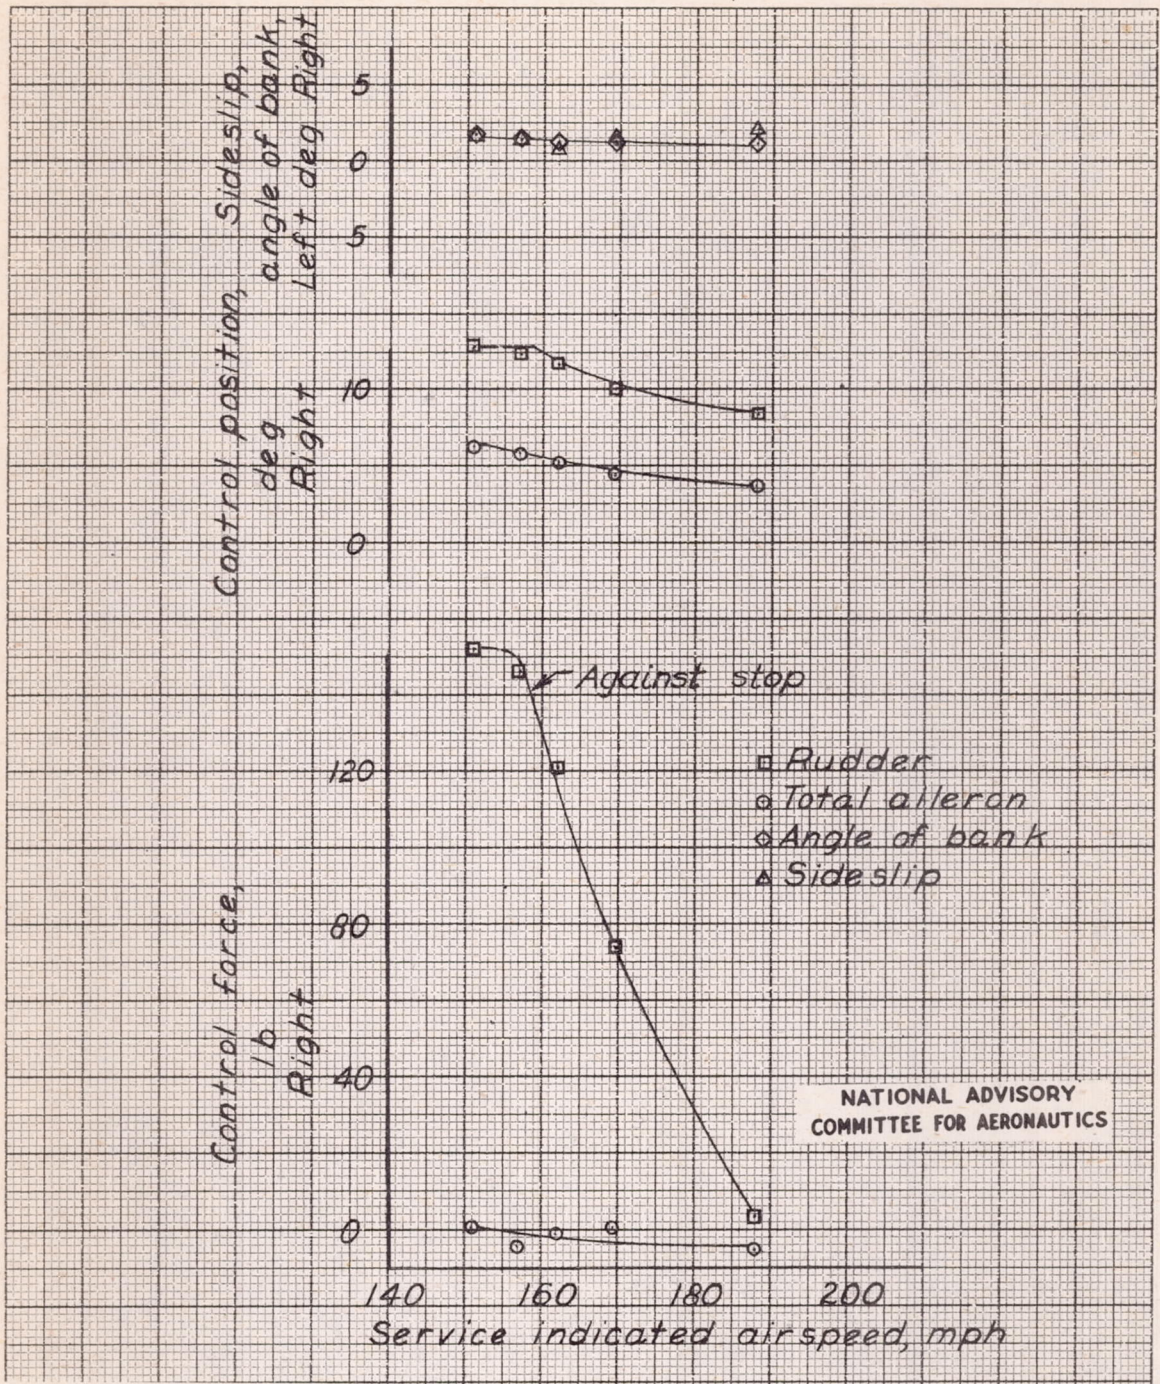
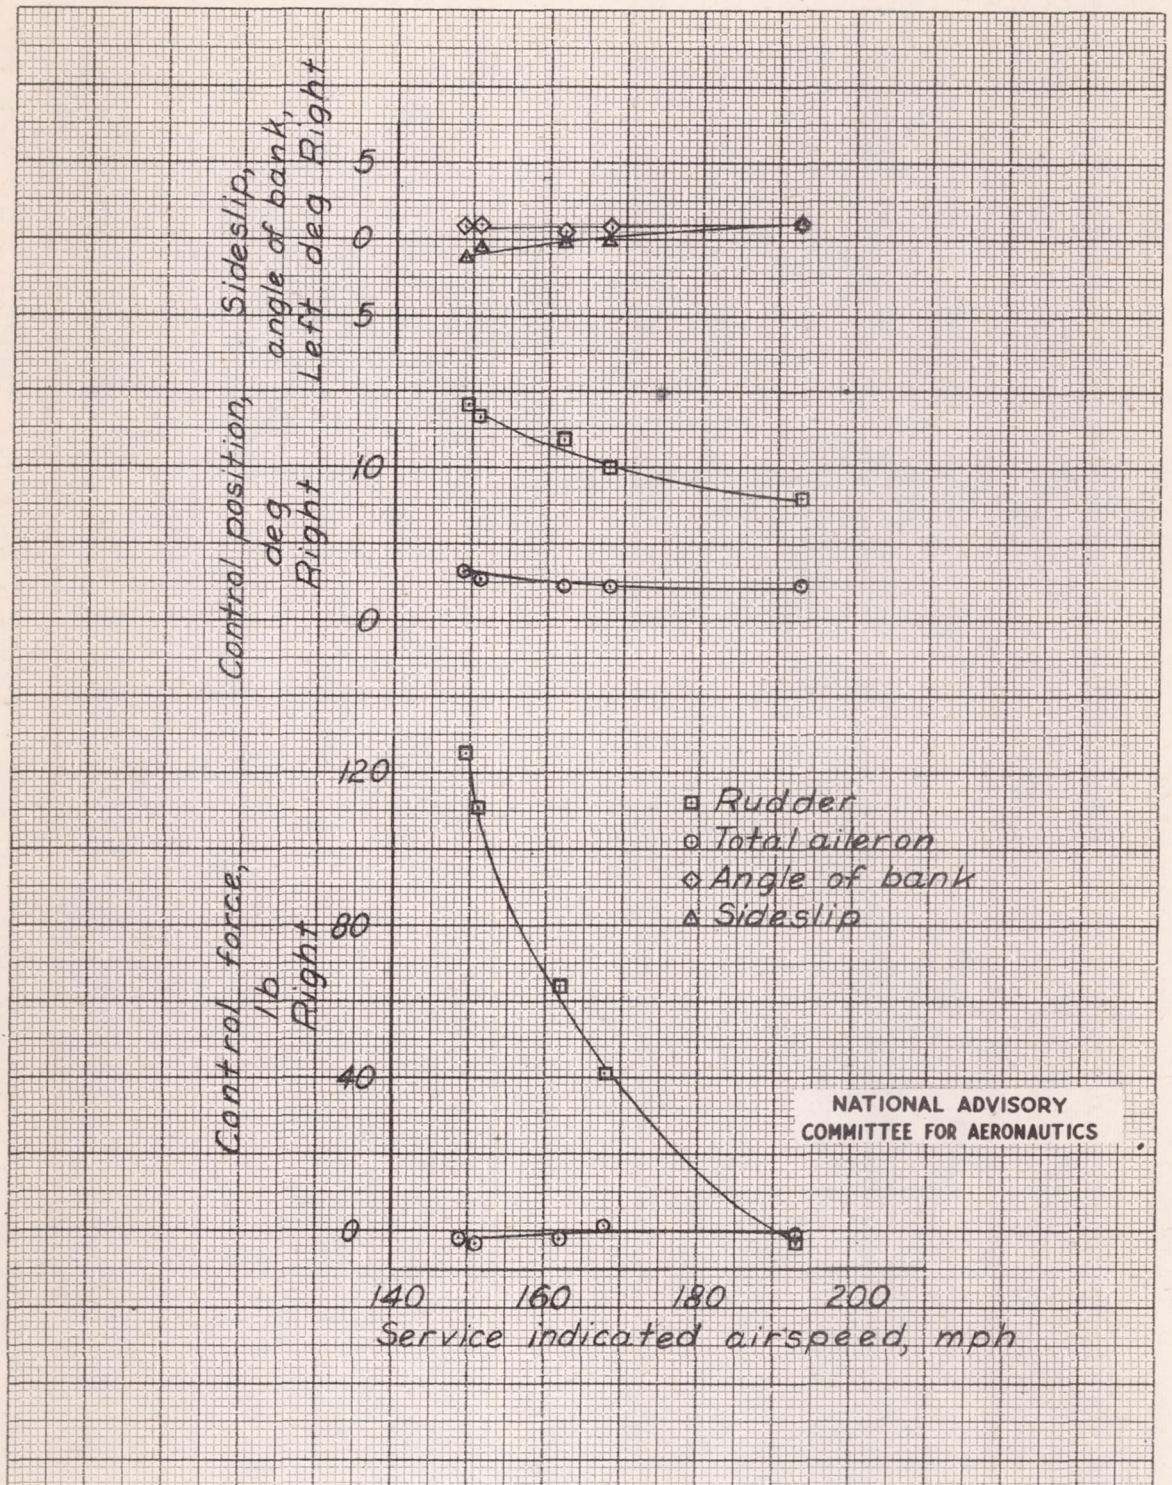
a. Left propellers windmilling with the governor set at 2650 rpm, rudder tab 18.8° full left from rudder.

Figure 20. - Directional trim characteristics for single engine operation in the rated power clean condition with left shutter closed and right shutter open, DeHavilland Mosquito F-8 airplane.

b. Left propeller feathered, rudder tab 13.5 degrees left from rudder.

Figure 20 presents the directional trim characteristics for single-engine operation in the rated-power, clean condition in straight flight with the wings level. Data were obtained with the left propeller windmilling with the governor set at 2650 rpm and also with the left propeller feathered. Figure 20 shows that full tab deflection, left from the rudder, was required to trim the rudder force to zero at 190 miles per hour with the left propeller windmilling, and about $1/3$ less, with the left propeller feathered. The rudder control was sufficient to maintain straight flight in either case with the wings level at 150 miles per hour. By holding a slight degree of bank it was possible to maintain

directional control to the stall in the clean condition. During single-engine flight with the wings level the rudder force increased rapidly with decreasing speed from 0 at 190 miles per hour to 120 pounds with the left propeller feathered, or 135 pounds with the left propeller windmilling at 150 miles per hour. Due to the deflection of the spring and the flexibility of the rest of the rudder system the available rudder deflection was reduced 1° per 10 pounds of control force. Over half of the available no-load deflection was lost at 150 miles per hour in the case illustrated in figure 20. Placing stops only on the rudder itself would remedy this situation. The rudder trimming tab was powerful enough to trim out the rudder-control forces with the wings level at 190 miles per hour with one propeller windmilling or at 170 miles per hour with one propeller feathered. No records were obtained of banked single-engine flight, but less rudder deflection would be required so that the minimum speed at which full tab deflection would produce zero rudder-control force would be reduced. The aileron-control forces were negligible and could easily have been trimmed out.

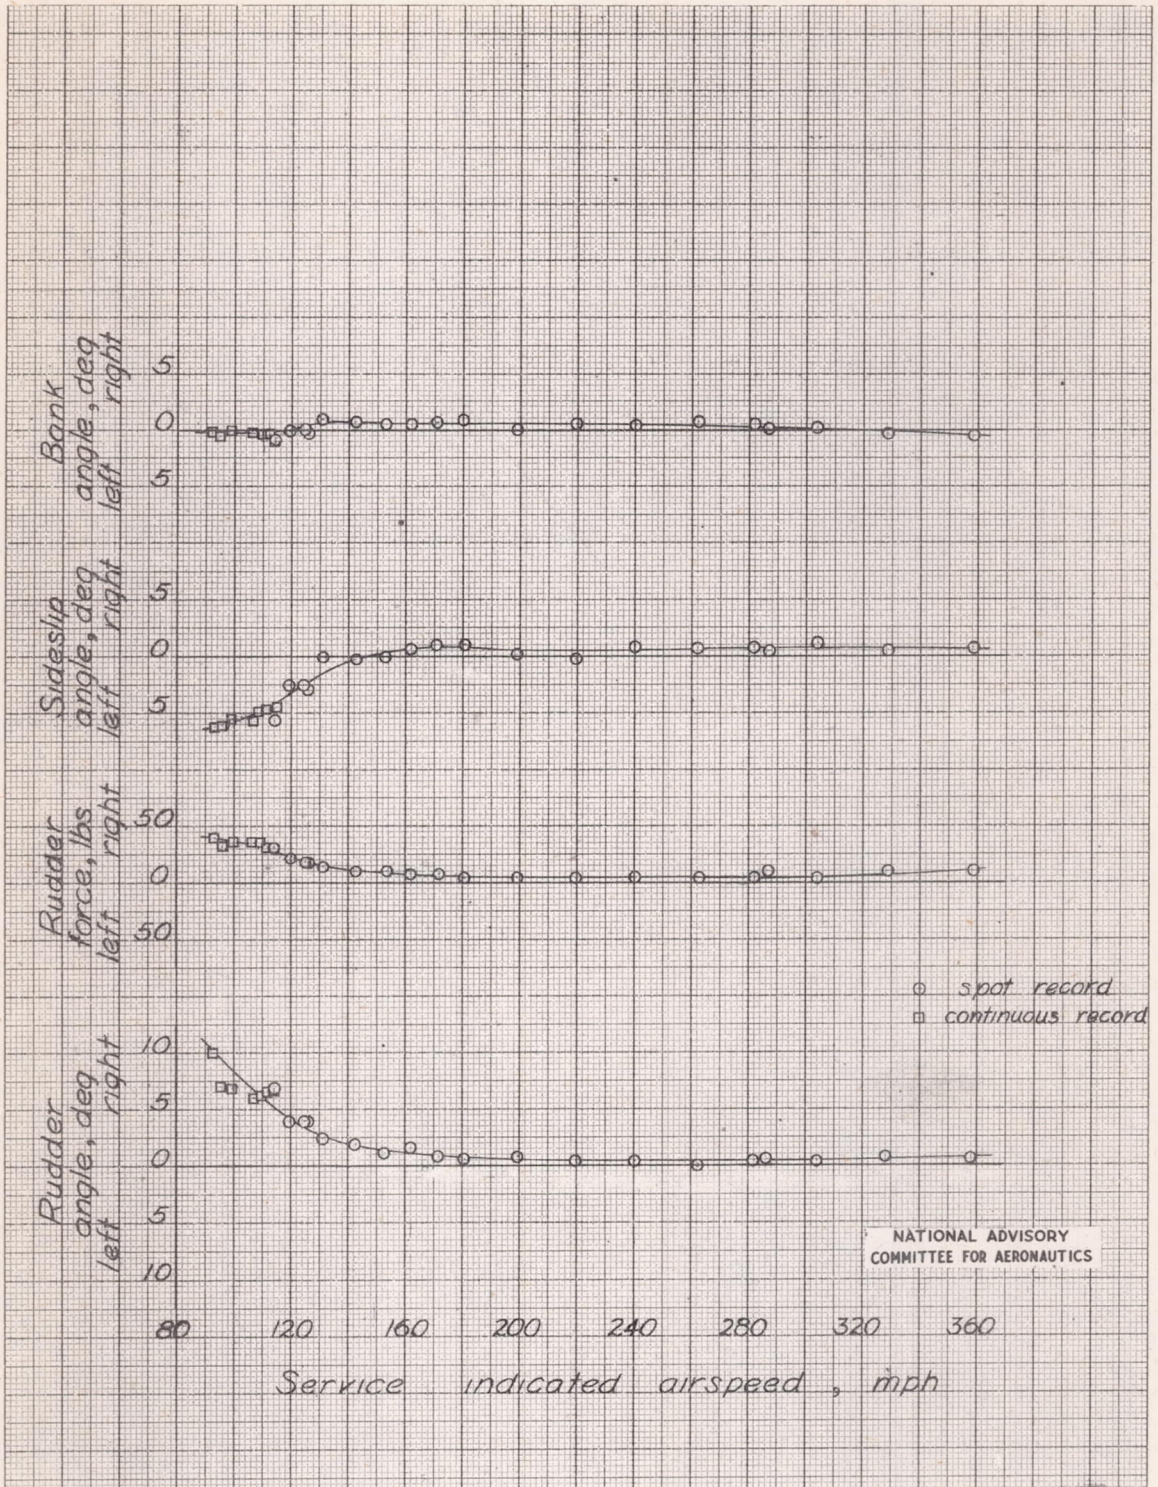
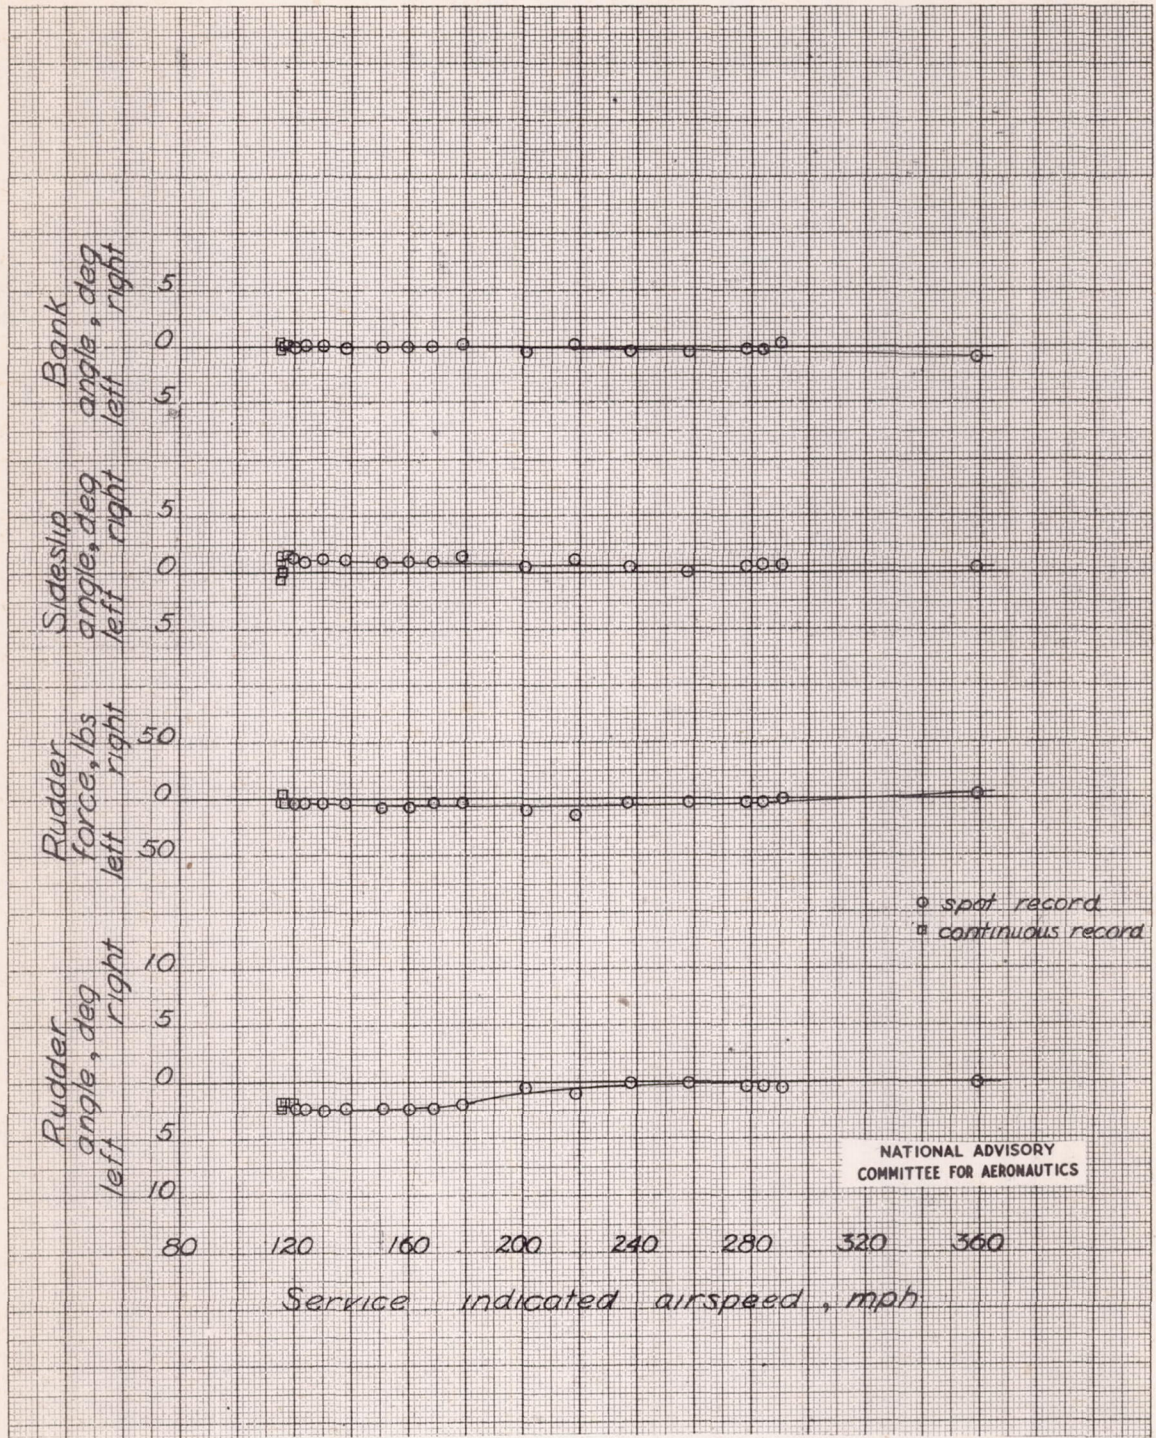
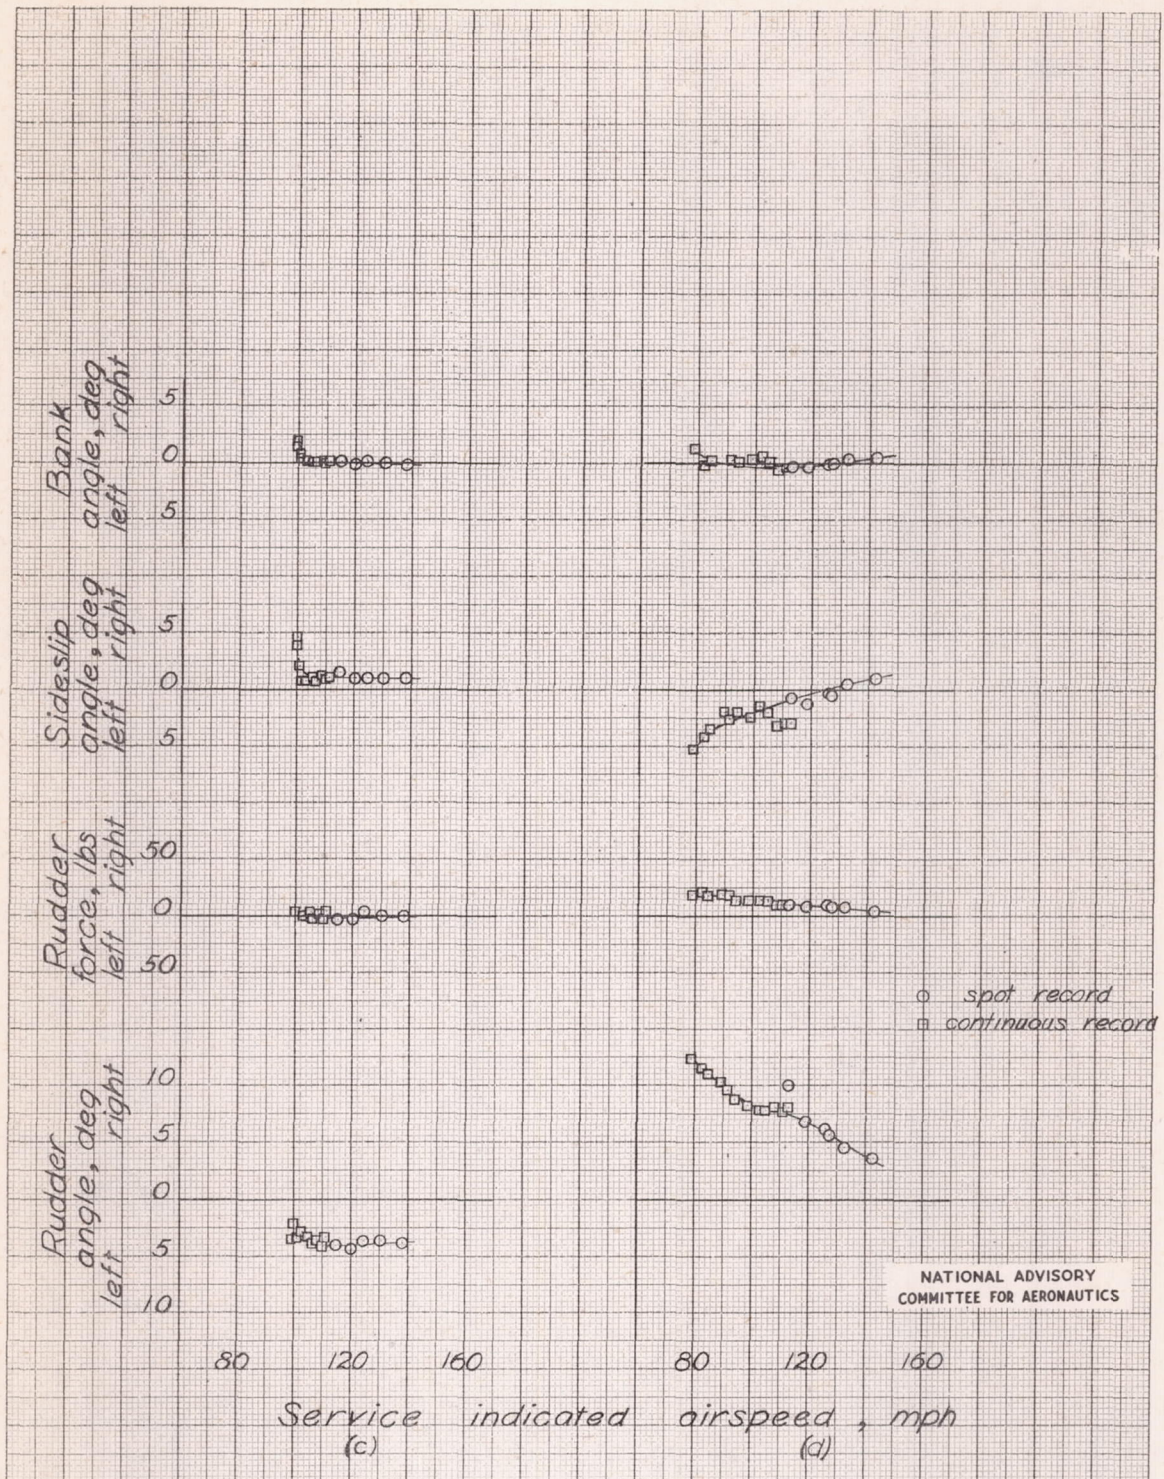
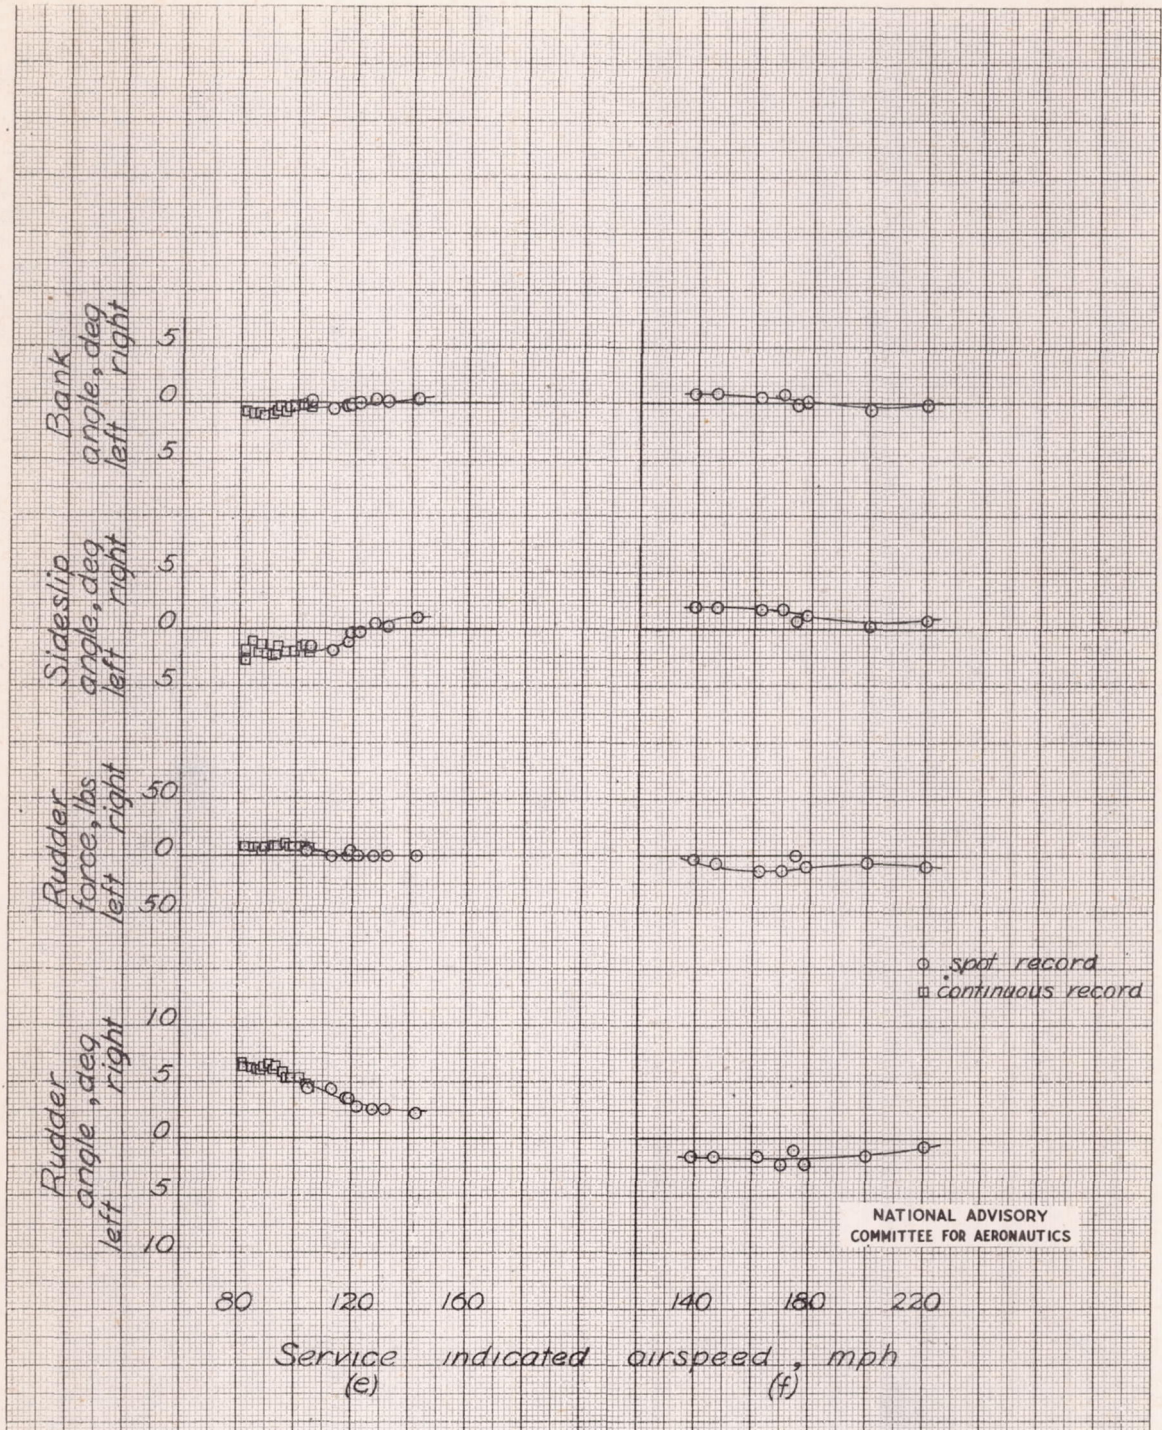
a. Rated power, clean condition, shutters closed (2650 rpm, 7 pounds boost), center of gravity at 38.3 percent M.A.C., rudder tab at 0 degrees.
 Figure 21. - Directional trim characteristics in various flight conditions, DeHavilland Mosquito F-8 airplane.

b. Engines idling, clean condition, shutters closed, center of gravity at 38.3 percent M.A.C., rudder tab 3.2 degrees right.
 Figure 21. - Continued.

c. Flaps and landing gear down, engines idling, shutters open, center of gravity at 36.8 percent M.A.C., rudder tab 6.5 degrees left.
 d. Flaps and landing gear down rated power (2650 rpm, 7 pounds boost), shutters open, center of gravity at 36.8 percent M.A.C., rudder tab 5.6 degrees left.

- e. Flaps and landing gear down, approach power (2650 rpm, 0 boost), center of gravity at 36.8 percent M.A.C., rudder tab 4.2 degrees left.
- f. Clean condition cruising power, (2650 rpm, 4 pounds boost) shutters open, center of gravity at 38.3 percent M.A.C., rudder tab at 0 degrees.

From trim at maximum level-flight speed with power on or trim at the same speed with the engines idling the rudder-control force changed only 10 pounds in going to 360 miles per hour, the maximum speed attained in these tests. This is shown in the directional-trim curves of figure 21, which indicate small variation of rudder force with speed in all conditions.

The power of the rudder trimming tab to trim the rudder forces to zero at any speed in any of the test conditions is also indicated by figure 21. The variation of aileron-control force with speed was small except in high-speed dives as shown in figure 22 and was easily trimmed out. The power of the trimming tabs during single-engine operation has been discussed in 3-B, 3.

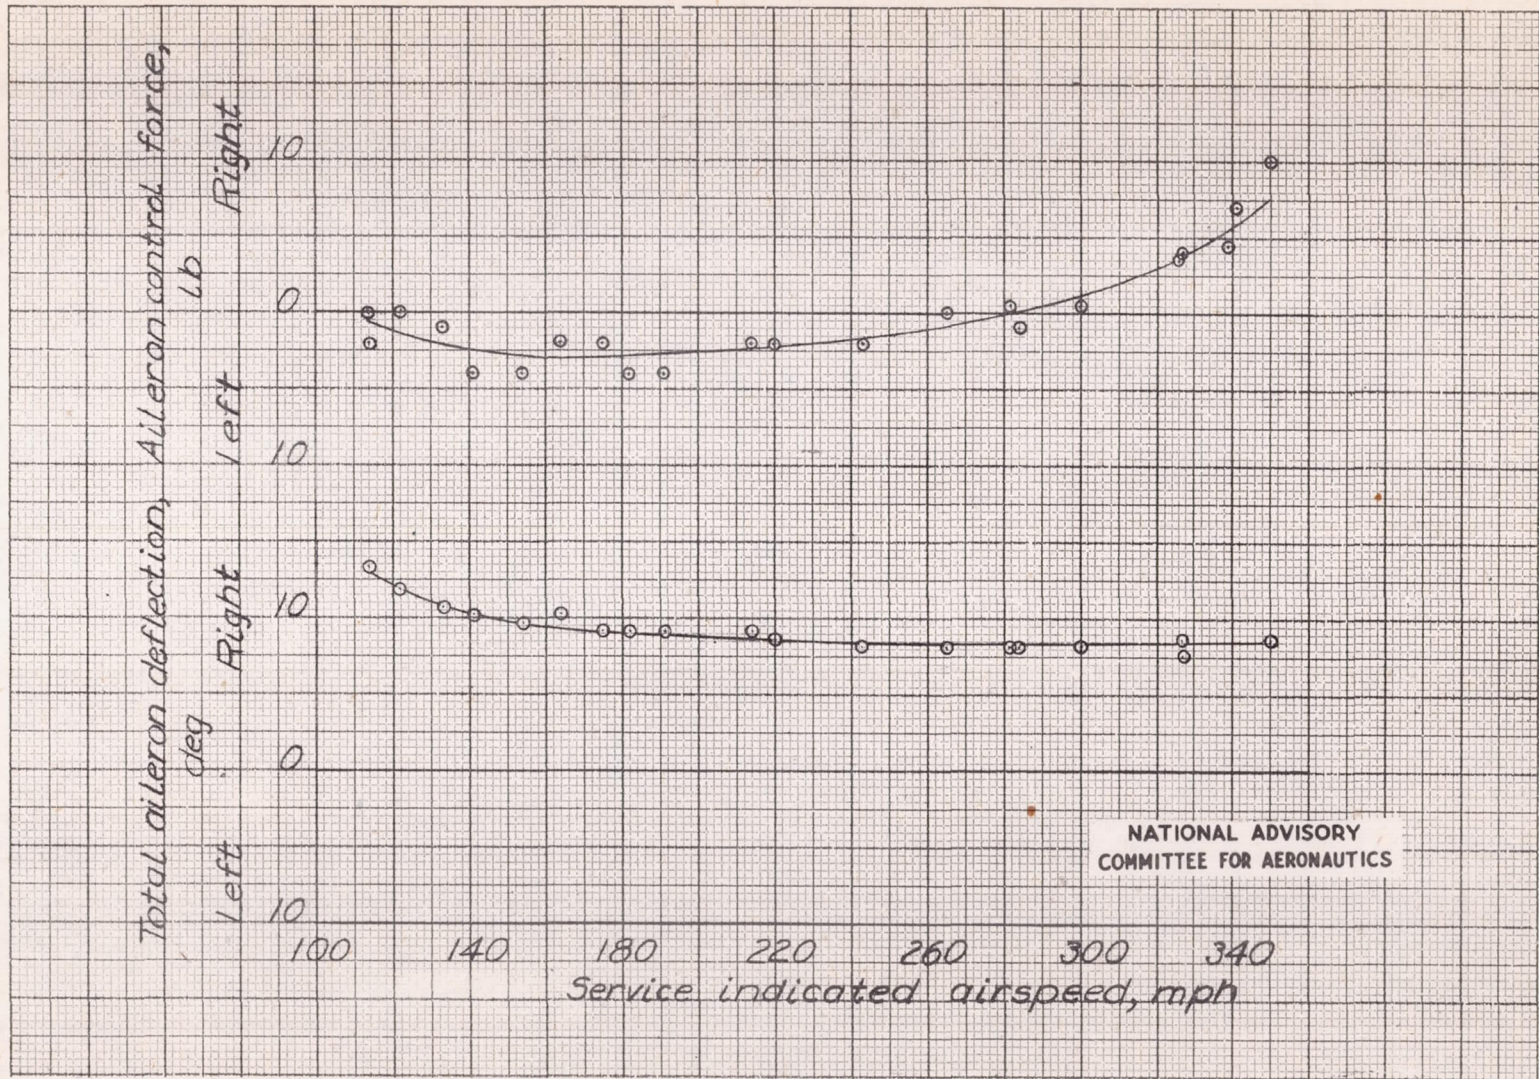
Figure 22. - Variation of aileron deflection and control force for trim with indicated airspeed, in the rated-power, clean condition, De-Havilland Mosquito F-8 airplane.

g. The variation with airspeed of aileron deflection and control force required to hold the wings level in the rated-power, clean condition is shown in figure 22. The amount of aileron deflection would vary with any variation of lateral loading, but fuel was always used symmetrically so that little variation of lateral loading occurred in the tests. The large amount of aileron deflection required for trim indicated that an effective twist was present in the wing structure. An effective twist of approximately 1° on each tip would be required to account for the amount of aileron deflection that was used for trim. A tendency for the force to increase rapidly to the right at high speeds would become objectionable before the maximum diving speed, 450 miles per hour, was reached.
