MEASUREMENT OF FLYING QUALITIES OF A DEHAVILLAND

MOSQUITO F-8 AIRPLANE (AAF NO. 43-334960)

I - LATERAL AND DIRECTIONAL STABILITY

AND CONTROL CHARACTERISTICS

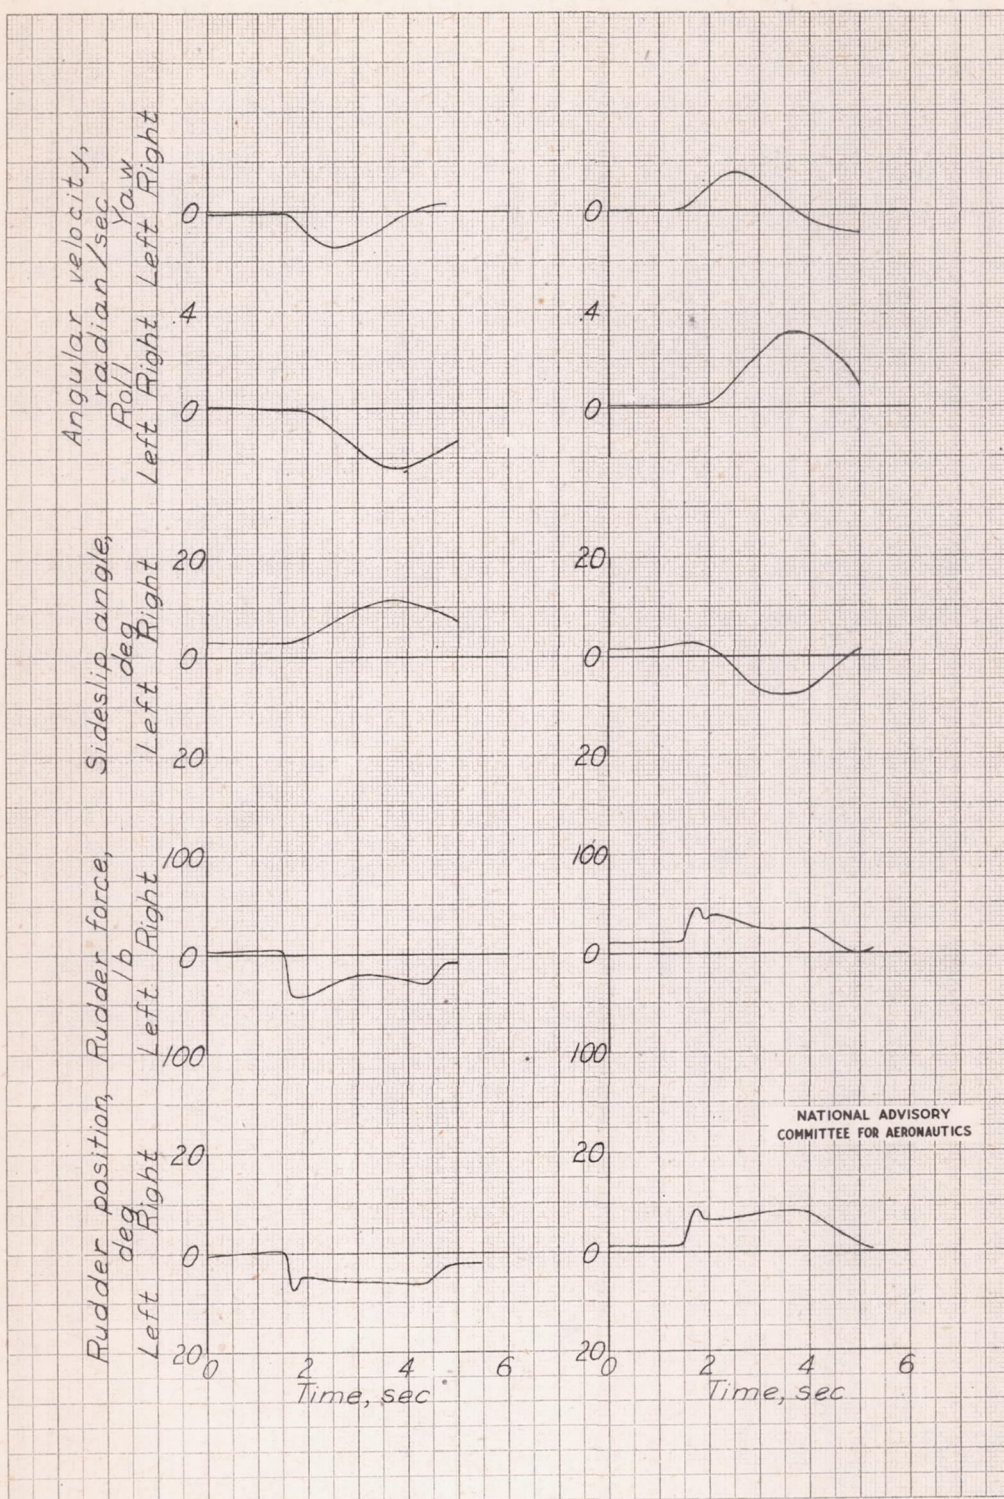
Figure 23. - Time histories of rudder kicks at 200 miles per hour in the clean condition with power for level flight in which deflection was held to maximum sideslip, DeHavilland Mosquito F-8 airplane.

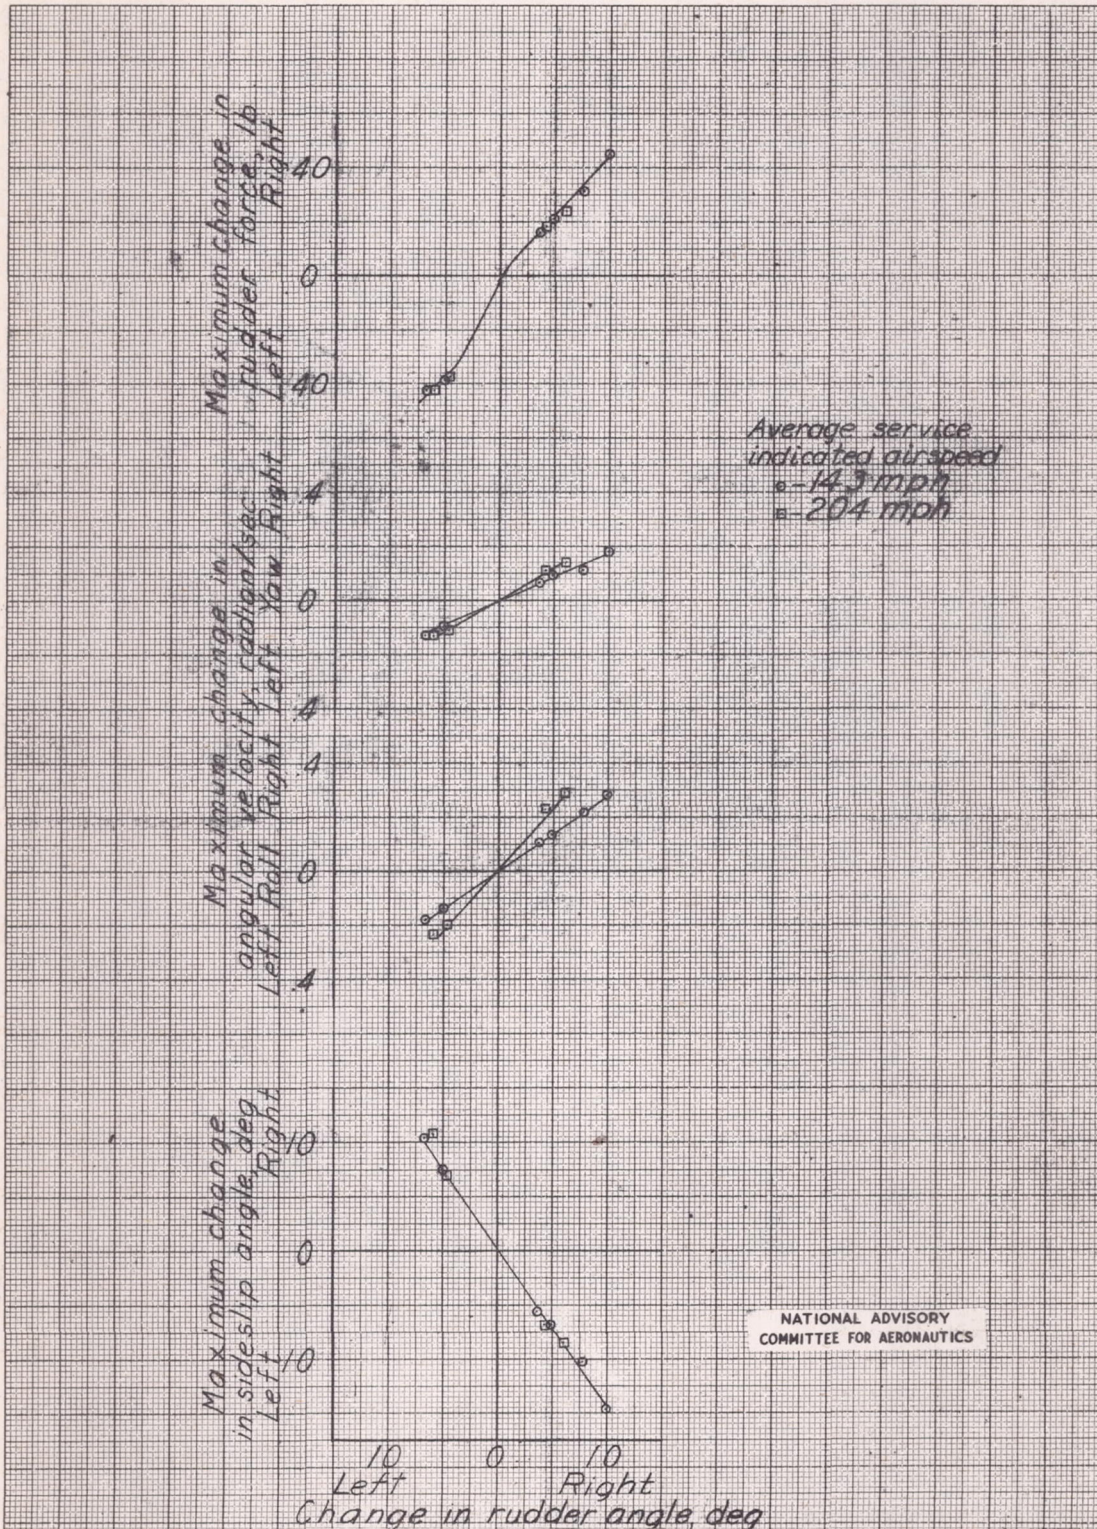
Figure 24. - Variation of maximum change in rudder force; rolling and yawing velocity, and sideslip angle with rudder position in rudder kicks at 140 and 200 miles per hour in the clean condition with power for level flight, DeHavilland Mosquito F-8 airplane.

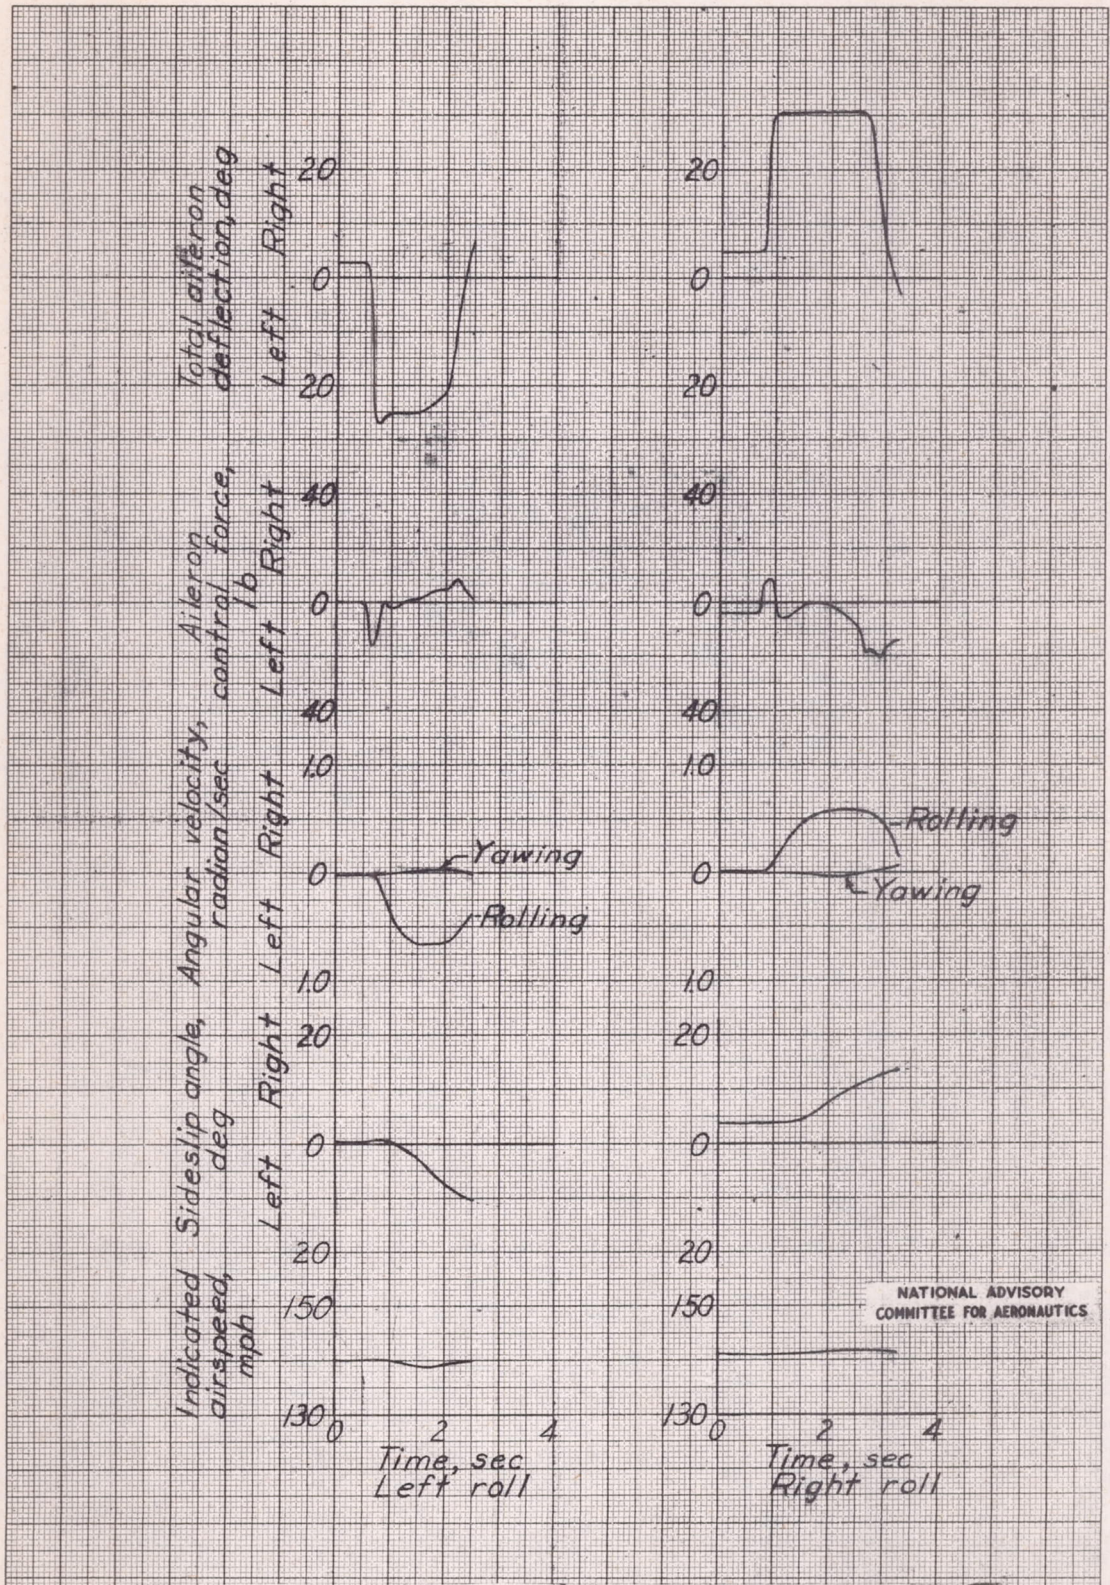
Figure 25. Time histories of rudder-fixed, abrupt aileron rolls at 140 miles per hour, indicated, in the clean condition using power for level flight shutters open, DeHavilland Mosquito F-8 airplane.

Time histories of typical left and right rolls at 140 miles per hour with level-flight power in the clean condition are presented in figure 25. The values of rolling effectiveness obtained and wheel forces required are plotted as a function aileron deflection in figures 26, 27, and 28. No information was available on permissible aileron deflections at high speed so aileron deflection was arbitrarily limited above 200 miles per hour.

figures 25 through 28 indicate that on this particular Mosquito aileron overbalance occurred in rolls in all conditions below 200 miles per hour over a considerable range of aileron deflections. It has been stated previously that the ailerons tended to shake when fully deflected and that an example of aileron shaking is presented in figure 10(c).

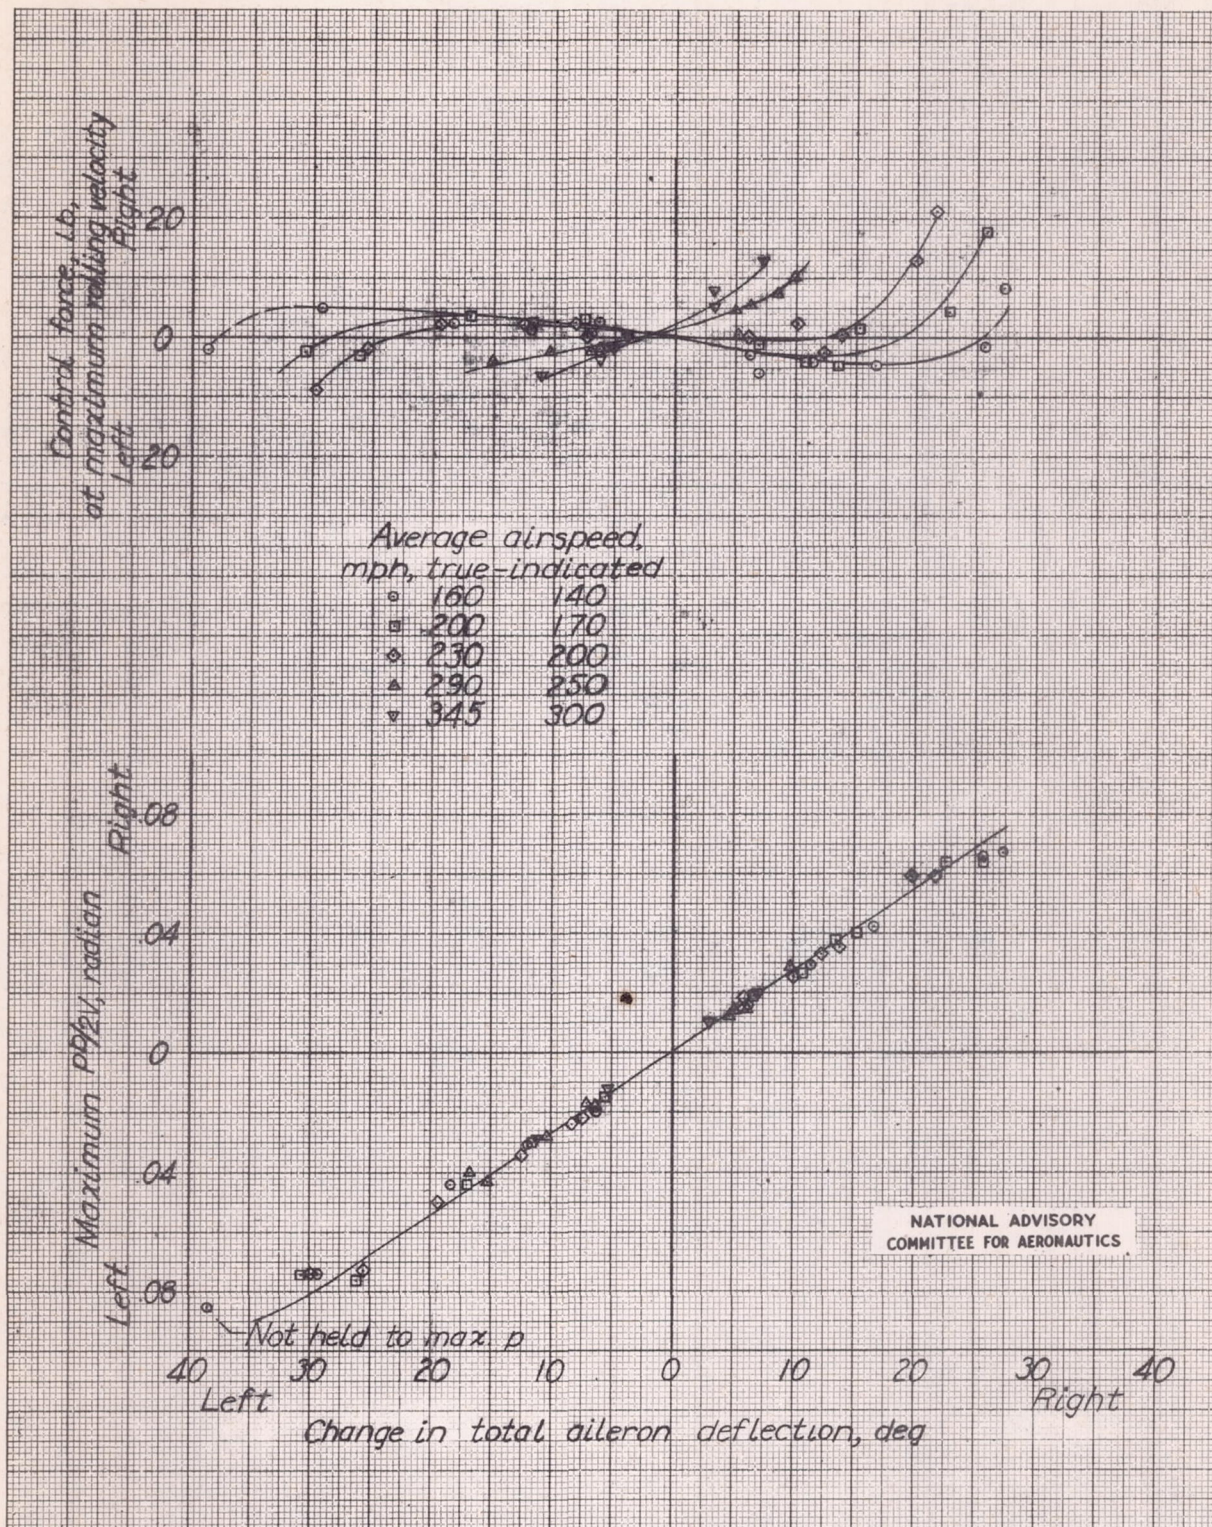
Figure 26. - Variation of aileron control force and effectiveness with total aileron deflection in the clean condition at various speeds using power for level flight or rated power, DeHavilland Mosquito F-8 airplane.

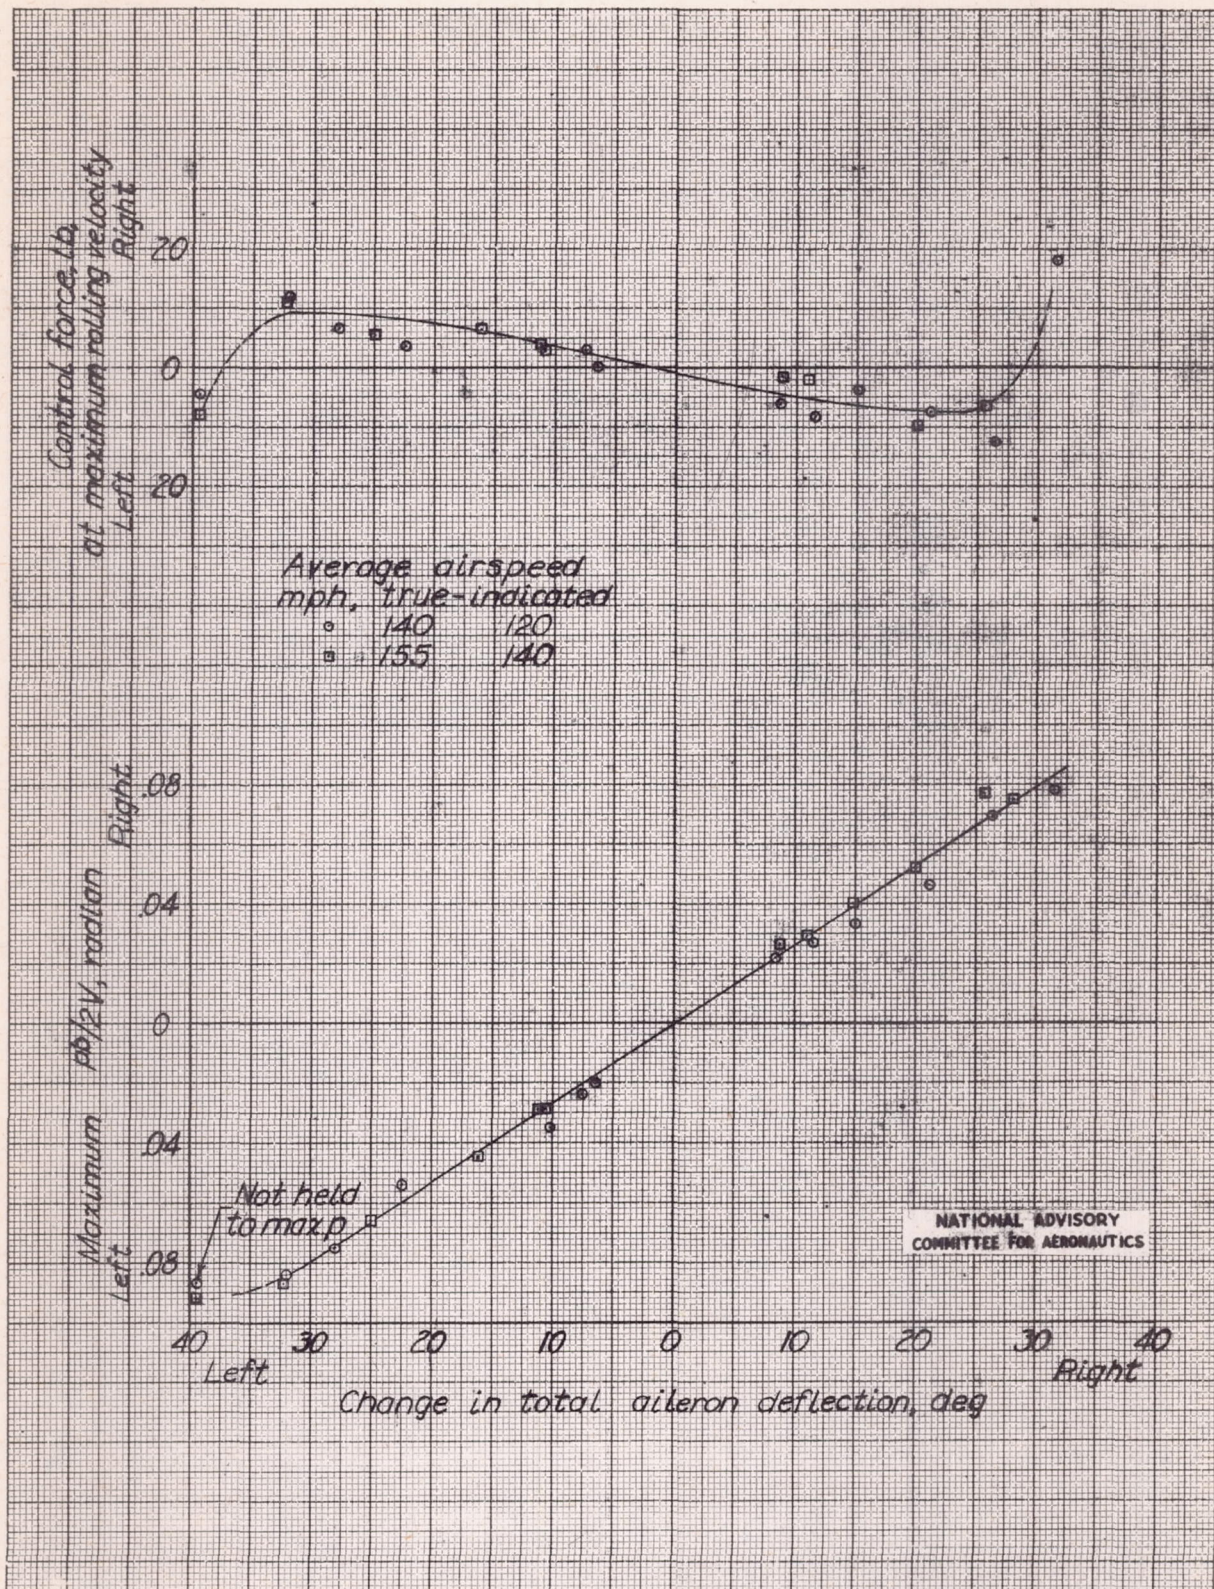
Figure 27. - Variation of aileron control force and effectiveness with total aileron deflection at 120 and 140 miles per hour with flaps down, landing gear down, and engines idling, DeHavilland Mosquito F-8 airplane.

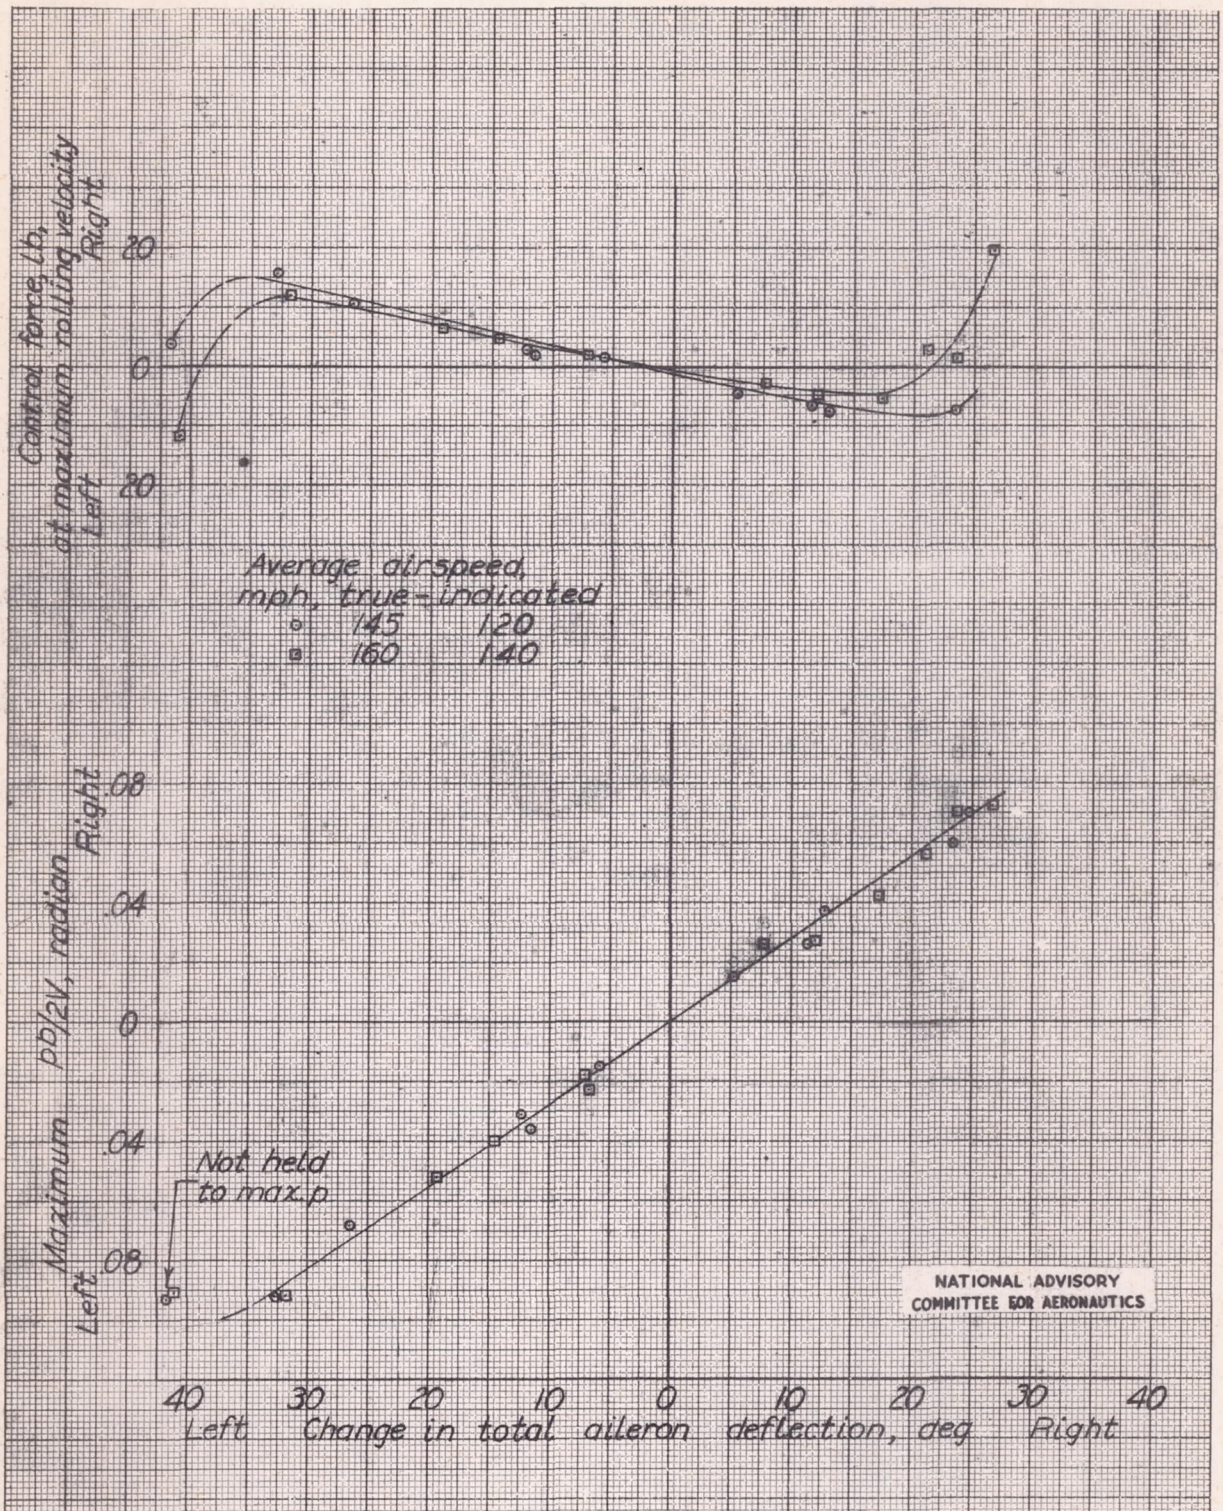
Figure 28, - Variation of aileron control force and effectiveness with total aileron deflection at 120 and 140 miles per hour with flaps down, and landing gear down using power for level flight, DeHavilland Mosquito F-8 airplane.
