March 1945 as
Memorandum Report L5C12c

HIGH-SPEED PHOTOGRAPHS OF A YR-4B PRODUCTION ROTOR
BLADE FOR SIMULATED FLIGHT CONDITIONS IN THE
LANGLEY FULL-SCALE TUNNEL

By Richard C. Dingeldein and Raymond F. Schaefer

Langley Memorial Aeronautical Laboratory
Langley Field, Va.

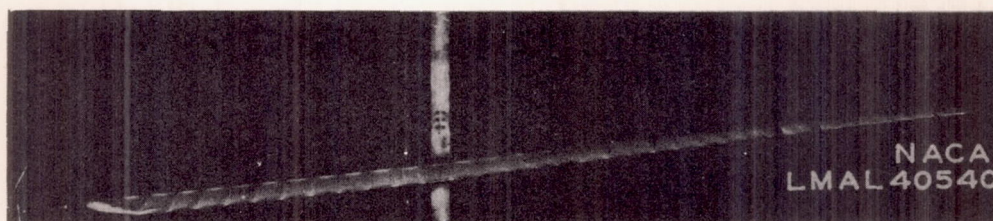
a. Condition 1.

b. Condition 2.

c. Condition 3.

d. Condition 4.

Figure 8.- High-speed photographs of a YR-4B production rotor blade in simulated flight conditions. ψ , 180° .

The test conditions for which the blade pictures were obtained are listed in table I. The high-speed photographs of a rotor blade taken in the plane of rotation for the four test conditions are presented in figures 5 through 10 for the six azimuth angles. The pictures taken for condition 1 by the overhead camera for these azimuth positions are shown in figure 11. The actual azimuth angles corresponding to 0° , 45° , 135° , 180° , 225° , and 315° are shown to be 0° , 47° , 131° , 181° , 223° , and 308° and are expected to be approximately the same for conditions 2, 3, and 4, inasmuch as the blades were photographed at the same rotor-shaft cam setting for all four conditions.

The photographs of figures 5 through 10 show the type of surface deformation that occurs on a fabric-covered rotor blade. Because of the nature of the external pressures which produce rotor-blade lift, internal pressures below free-stream static pressure will exist somewhat outboard of the point at which fabric sagging appears on the upper blade surface. Similarly, internal pressures greater than free-stream static pressure will exist somewhat inboard of the point at which fabric bulging is shown on the lower surface. The spanwise distribution of internal pressure has been roughly estimated from the photographs, which indicate that the internal pressure from the root to approximately the 77-percent radius (25th rib) is below free-stream static pressure. The fabric bulging on the lower surface is difficult to detect from the photographs; however, the internal pressures for approximately the outboard 10 percent of the radius appear to be greater than free-stream static pressure. Calculations prove that the difference in internal pressure between the blade root and the tip, assuming no intermediate venting, will be equal to the dynamic pressure at the tip. This amounts to approximately $3\frac{1}{4}$ inches of water in the present case. The results of the tests of rotor-blade sections in two-dimensional flow published in reference 2 indicate that the bulged portions of the blade will probably cause an increase in section drag coefficient, a decrease in maximum section lift coefficient, and a forward movement of the aerodynamic center. The effect of fabric sagging is indicated by the same

In almost all of the high-speed photographs the rotor blade droops distinctly near the tip. This effect may be the result of a loss of lift at the blade tip, together with the predominance of the centrifugal force at this point. It is not believed to be the result of inertia loads occurring during flapping since only a small part of the droop appears to be periodic.
