WARTIME REPORT

MEASUREMENTS OF FLYING QUALITIES OF

A CURTISS SB2C-1 AIRPLANE

(NO. 00014)

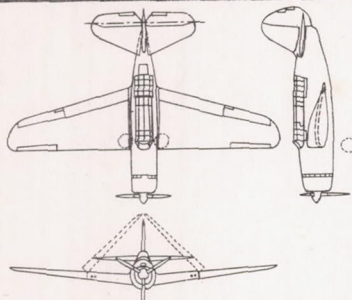
AIRPLANE AS TESTED	LONGITUDINAL	LATERAL

<table border="1" style="width: 100%; border-collapse: collapse;"> <thead> <tr> <th rowspan="2">FLIGHT CONDITION</th> <th rowspan="2">LIFT COEFFICIENT</th> <th colspan="2">C.G. POSITION FOR NEUTRAL STABILITY</th> </tr> <tr> <th>STICK FIXED</th> <th>STICK FREE</th> </tr> </thead> <tbody> <tr><td>GLIDING</td><td>1.0</td><td>34.0</td><td>30.2</td></tr> <tr><td>CLIMBING</td><td>0.3</td><td>30.2</td><td>26.9</td></tr> <tr><td>"</td><td>1.0</td><td>26.0</td><td>21.8</td></tr> <tr><td>"</td><td>1.6</td><td>28.2</td><td>--</td></tr> <tr><td>LANDING</td><td>1.0</td><td>30.8</td><td>30.1</td></tr> <tr><td>"</td><td>1.4</td><td>31.5</td><td>--</td></tr> <tr><td>APPROACH</td><td>1.0</td><td>28.1</td><td>25.0</td></tr> <tr><td>WAVE-OFF</td><td>1.0</td><td>27.8</td><td>23.2</td></tr> <tr><td>"</td><td>2.0</td><td>25.4</td><td>--</td></tr> <tr><td>DIVE FLAPS EXTENDED, POWER ON</td><td>0.6</td><td>29.1</td><td>25.1</td></tr> <tr><td>"</td><td>1.0</td><td>26.6</td><td>23.6</td></tr> <tr><td>DIVE FLAPS EXTENDED, POWER OFF</td><td>0.6</td><td>32.7</td><td>28.3</td></tr> </tbody> </table>	FLIGHT CONDITION	LIFT COEFFICIENT	C.G. POSITION FOR NEUTRAL STABILITY		STICK FIXED	STICK FREE	GLIDING	1.0	34.0	30.2	CLIMBING	0.3	30.2	26.9	"	1.0	26.0	21.8	"	1.6	28.2	--	LANDING	1.0	30.8	30.1	"	1.4	31.5	--	APPROACH	1.0	28.1	25.0	WAVE-OFF	1.0	27.8	23.2	"	2.0	25.4	--	DIVE FLAPS EXTENDED, POWER ON	0.6	29.1	25.1	"	1.0	26.6	23.6	DIVE FLAPS EXTENDED, POWER OFF	0.6	32.7	28.3	<p>AILERON POWER:</p>

(a) The stick-fixed neutral-stability point in the gliding condition was between 33 and 34 percent of the mean aerodynamic chord. Application of rated power (climbing condition) caused a large destabilizing effect, especially at speeds near that used for best climb. In the climbing condition at an airplane lift coefficient of 1.0, the stick-fixed neutral point was at 26 percent of the mean aerodynamic chord.

(b) The stick-fixed neutral-stability point in the landing condition was at about 31 percent of the mean aerodynamic chord. Application of power with flaps down as with flaps up caused a large destabilizing effect as shown by the curves for the approach and wave-off condition.

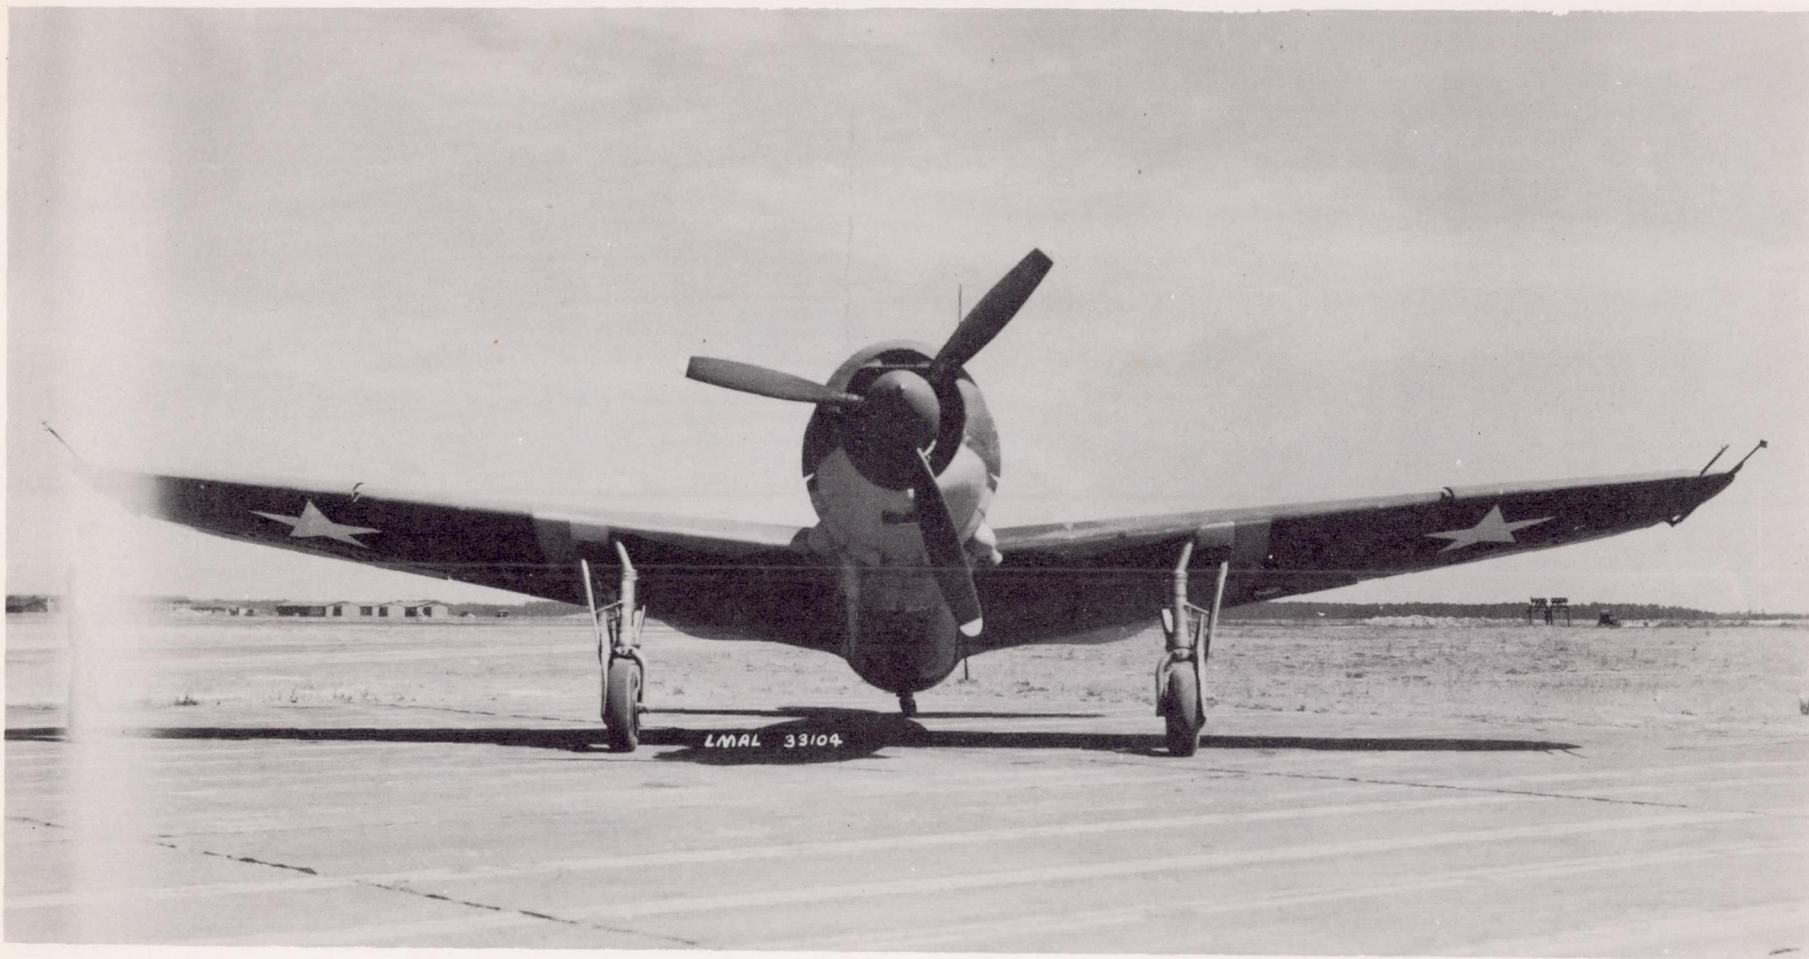
Figure 1.- Front view of Curtiss SB2C-1 airplane (Bureau of Aeronautics No. 00014).

The SB2C-1 airplane is a two-place, single-engine, low-wing cantilever monoplane with retractable landing gear and partial-span split flaps (figs. 1 to 4). All data given in this report apply to airplane No. 00014 unless otherwise noted. Airplane No. 00056 did not differ from No. 00014 except in minor details of the

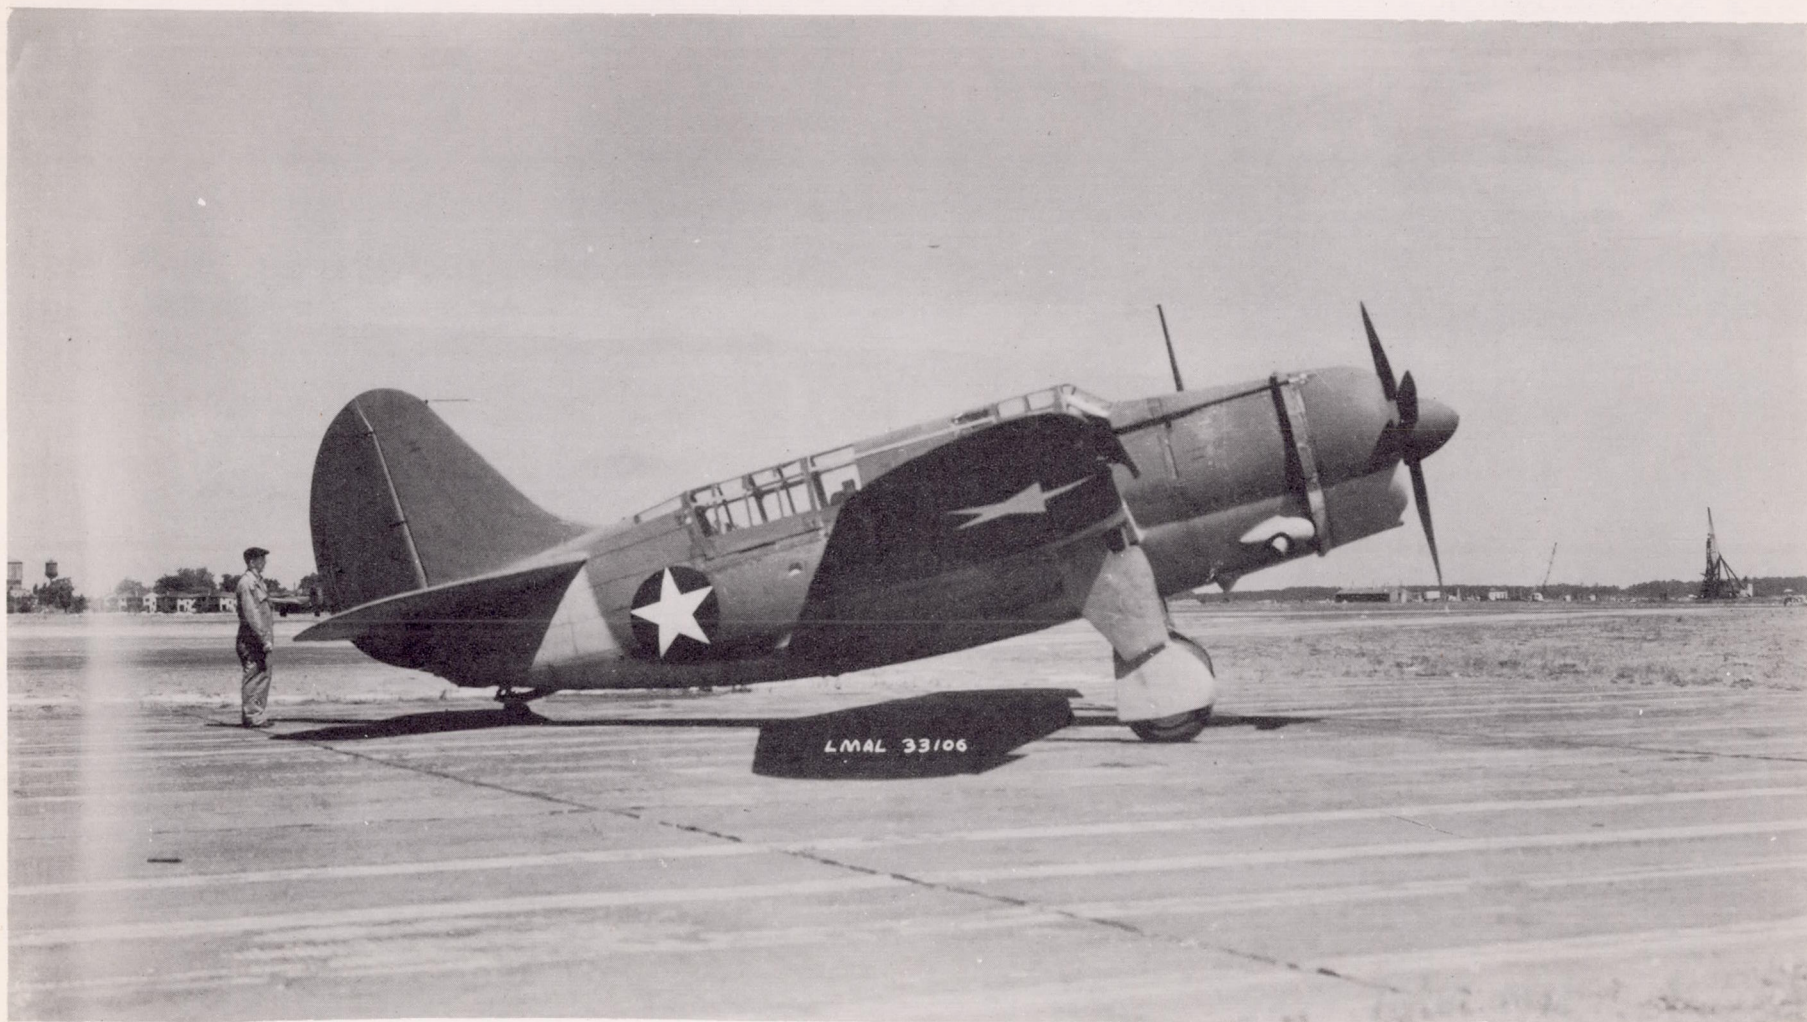
Figure 2.- Side view of Curtiss SB2C-1 airplane (Bureau of Aeronautics No. 00014).

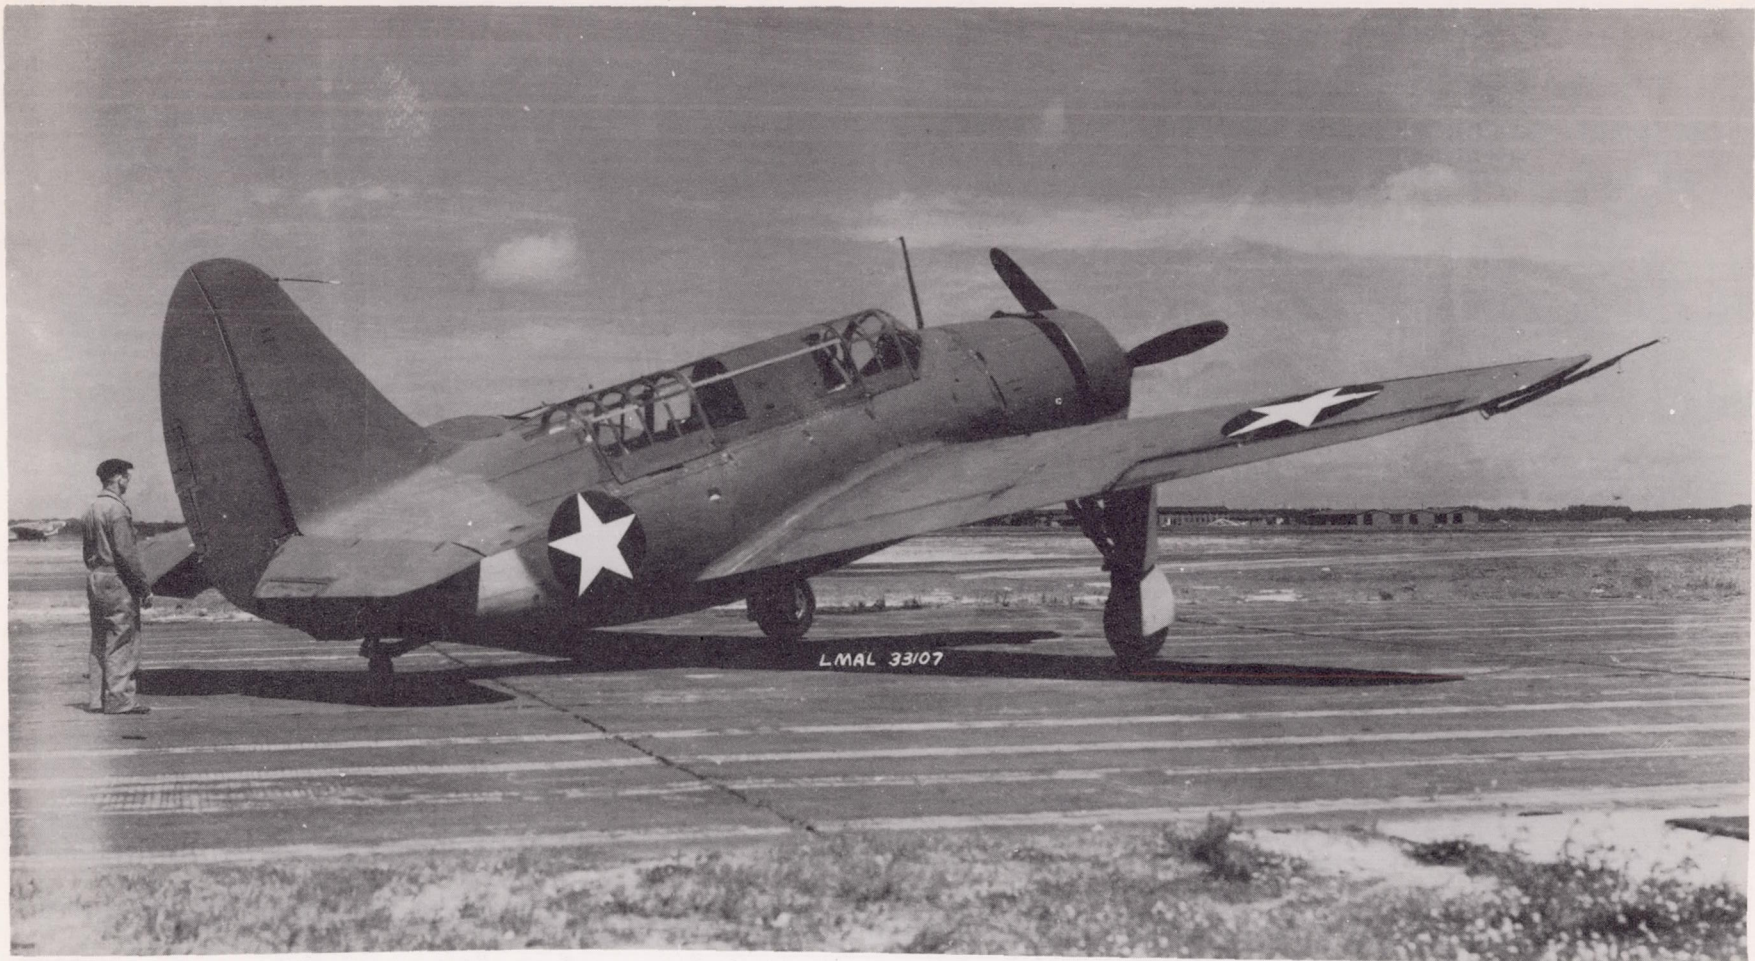
Figure 3.- Three-quarter rear view of Curtiss SB2C-1 airplane (Bureau of Aeronautics No. 00014).

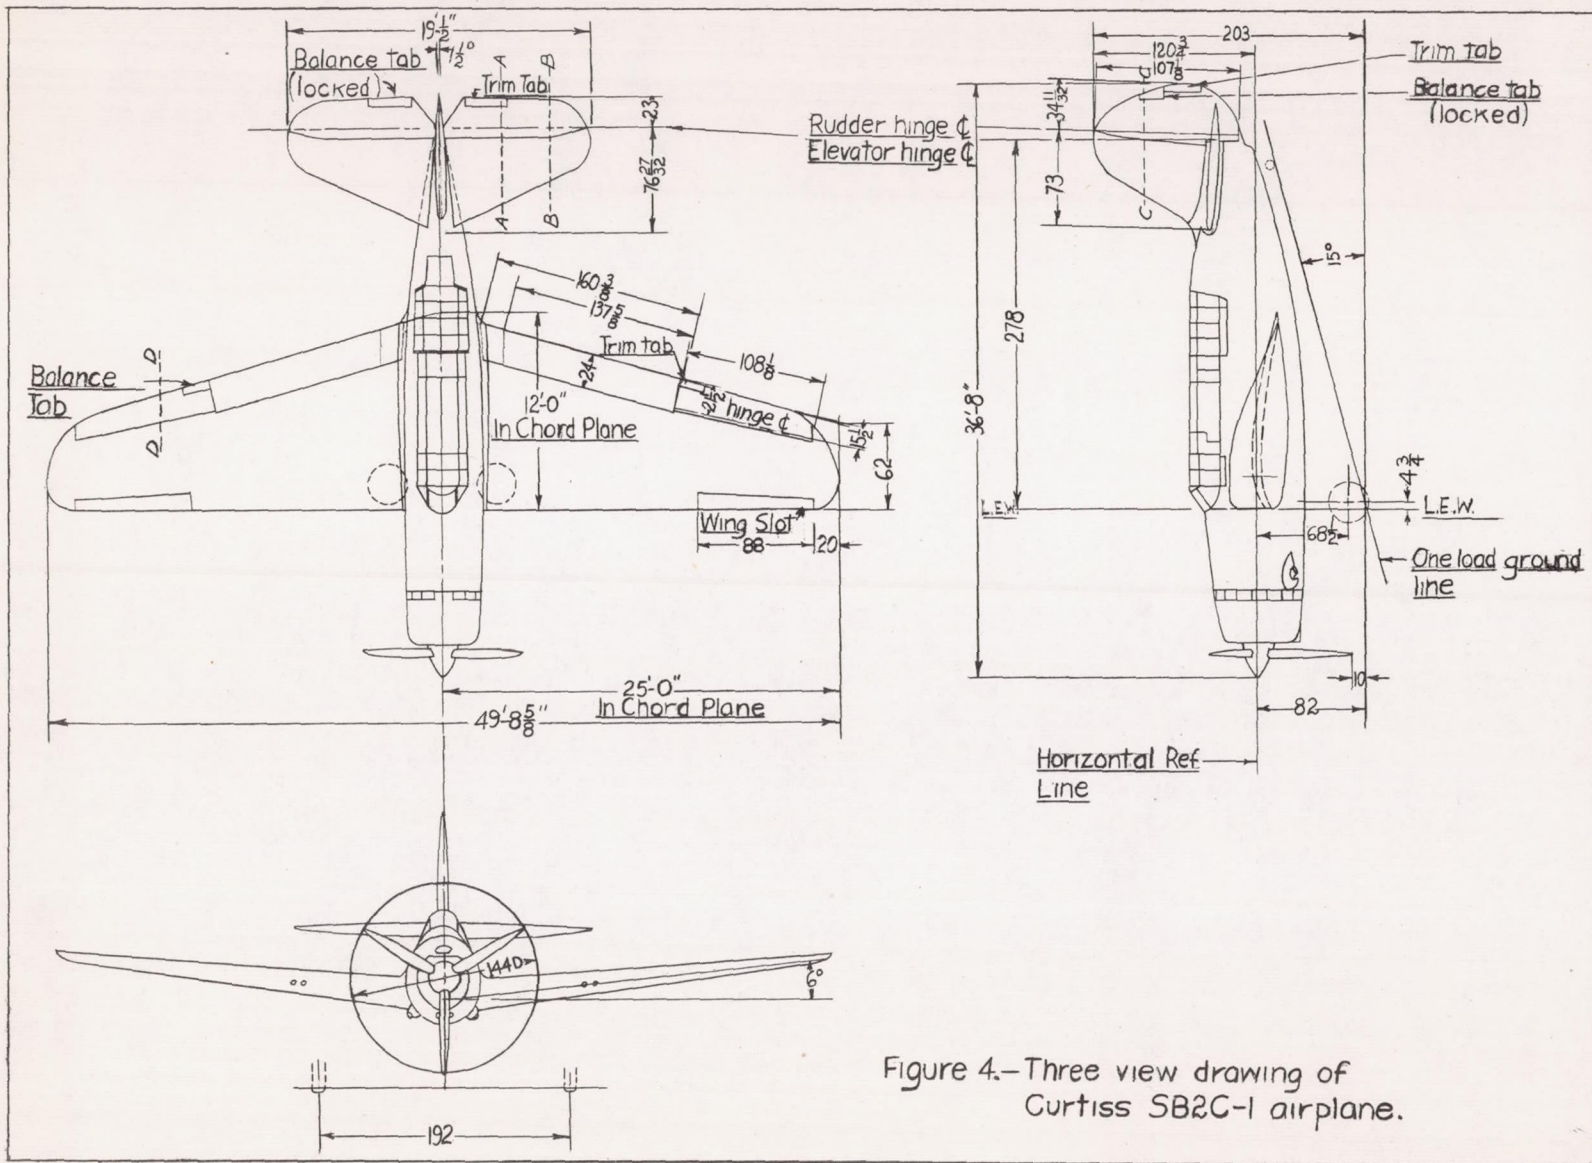
Figure 4.—Three view drawing of Curtiss SB2C-1 airplane.

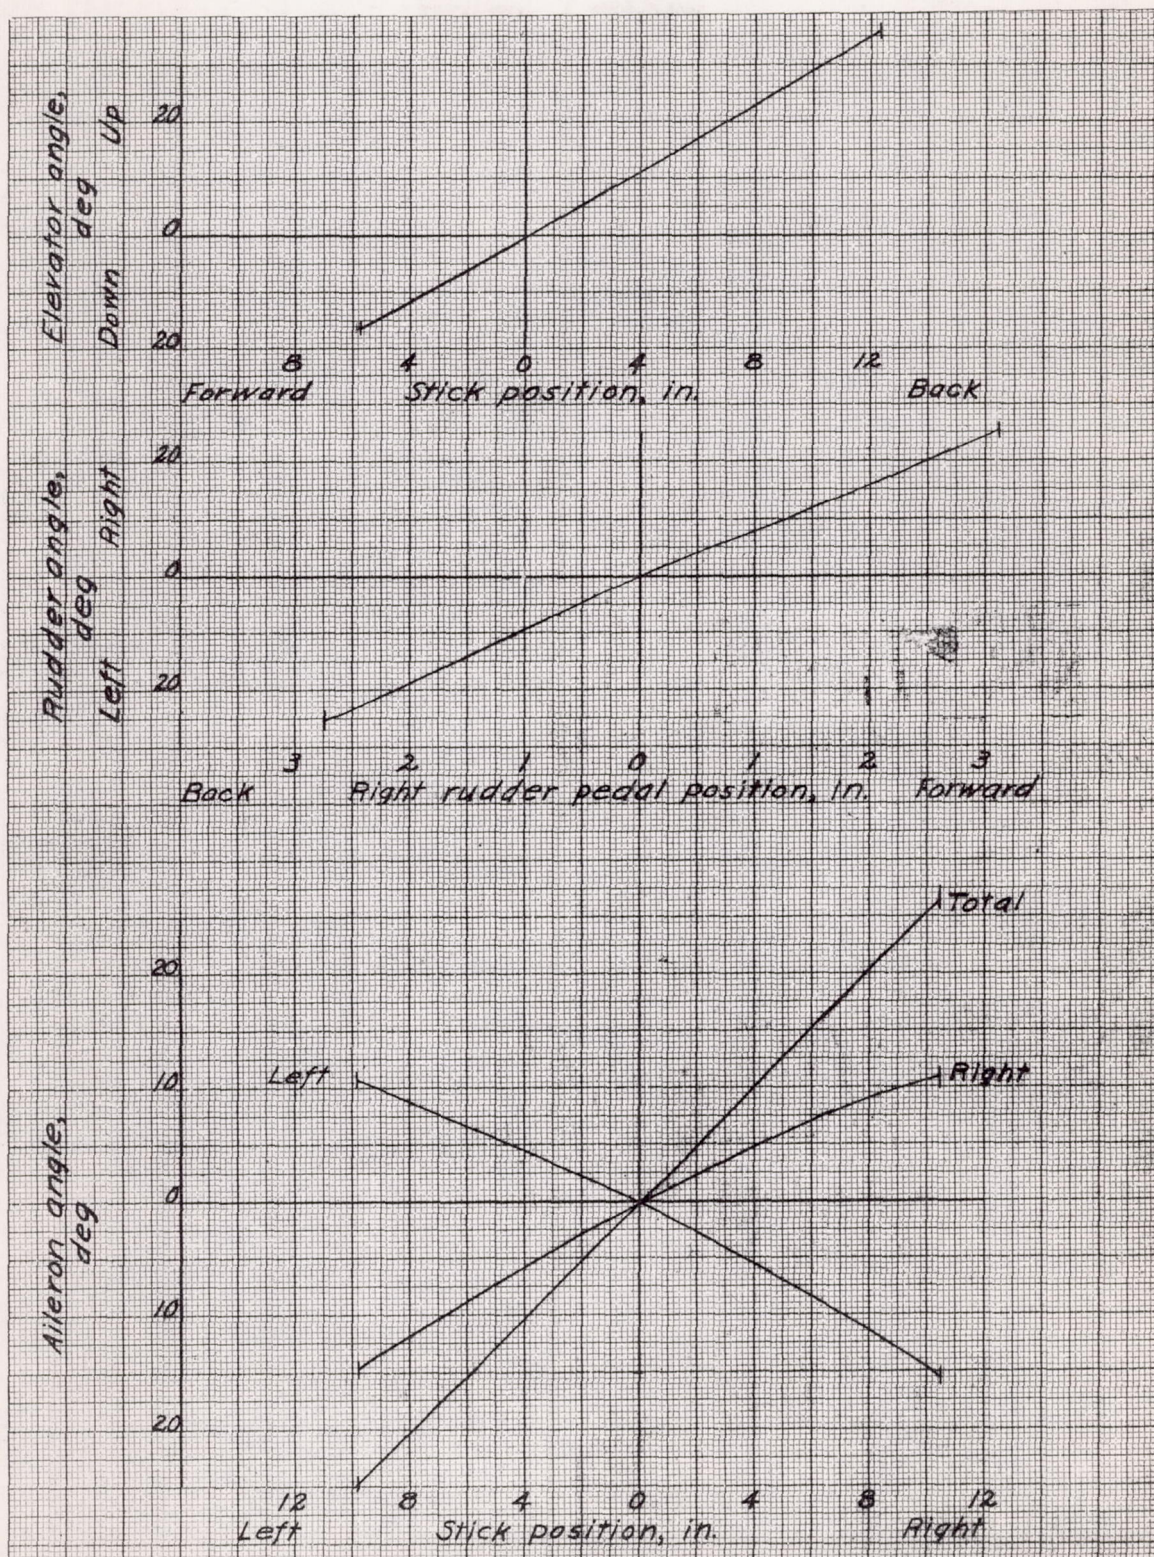
Figure 5.- Relation between control surface deflections and stick and rudder pedal positions. (Elevator and rudder angles with respect to thrust axis; ailerons with respect to their neutral position.) Curtiss SB2C-1 airplane.

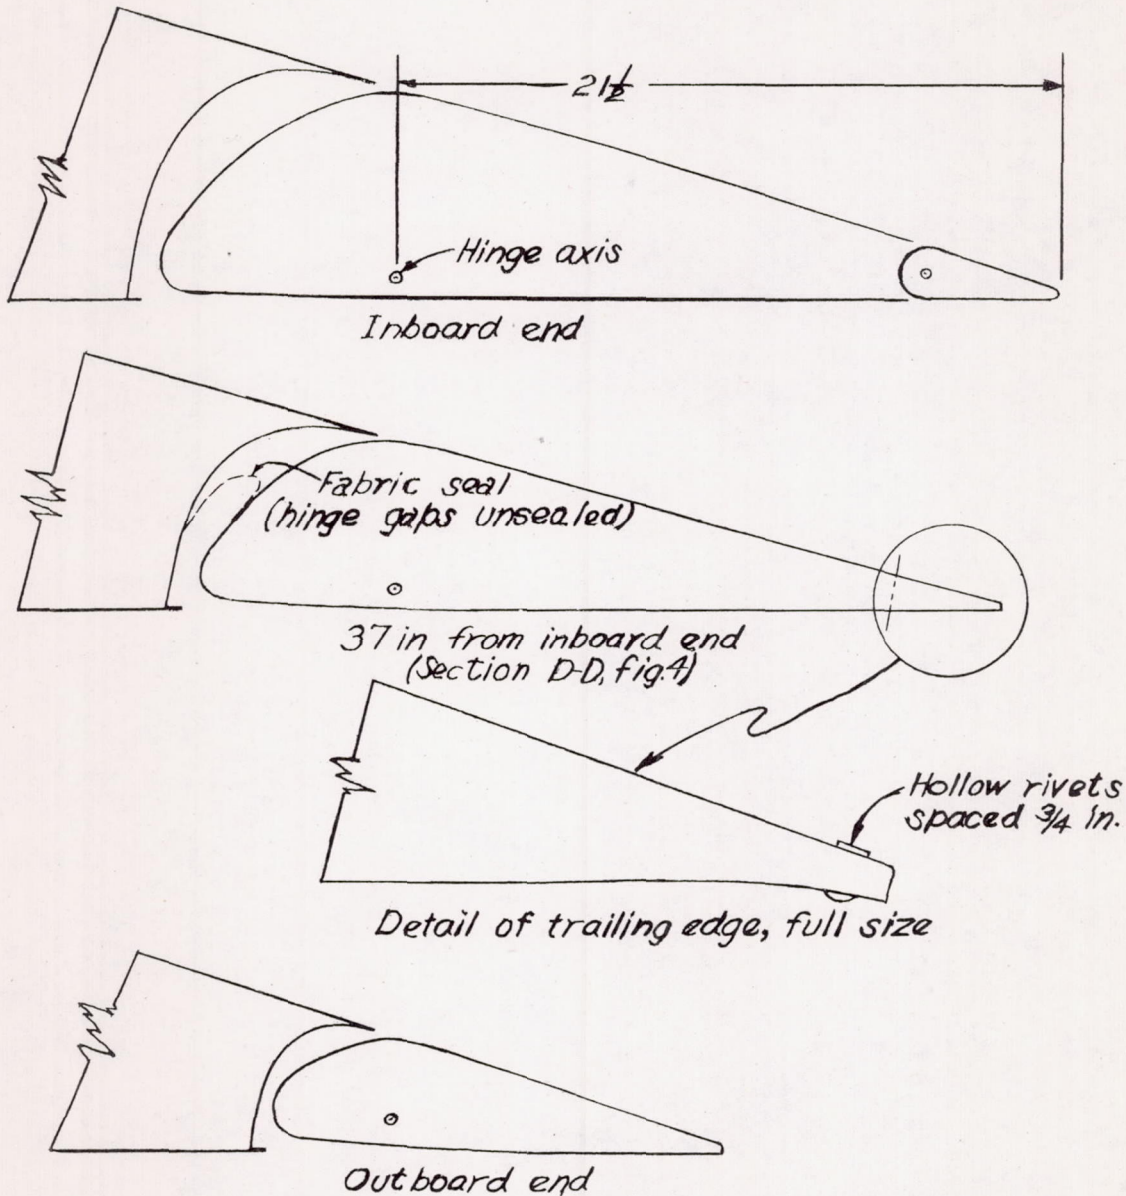
Figure 8.- Typical aileron sections, Curtiss SB2C-1 airplane.

Aileron metal covered except lower surface from spar to trailing edge, which is fabric covered

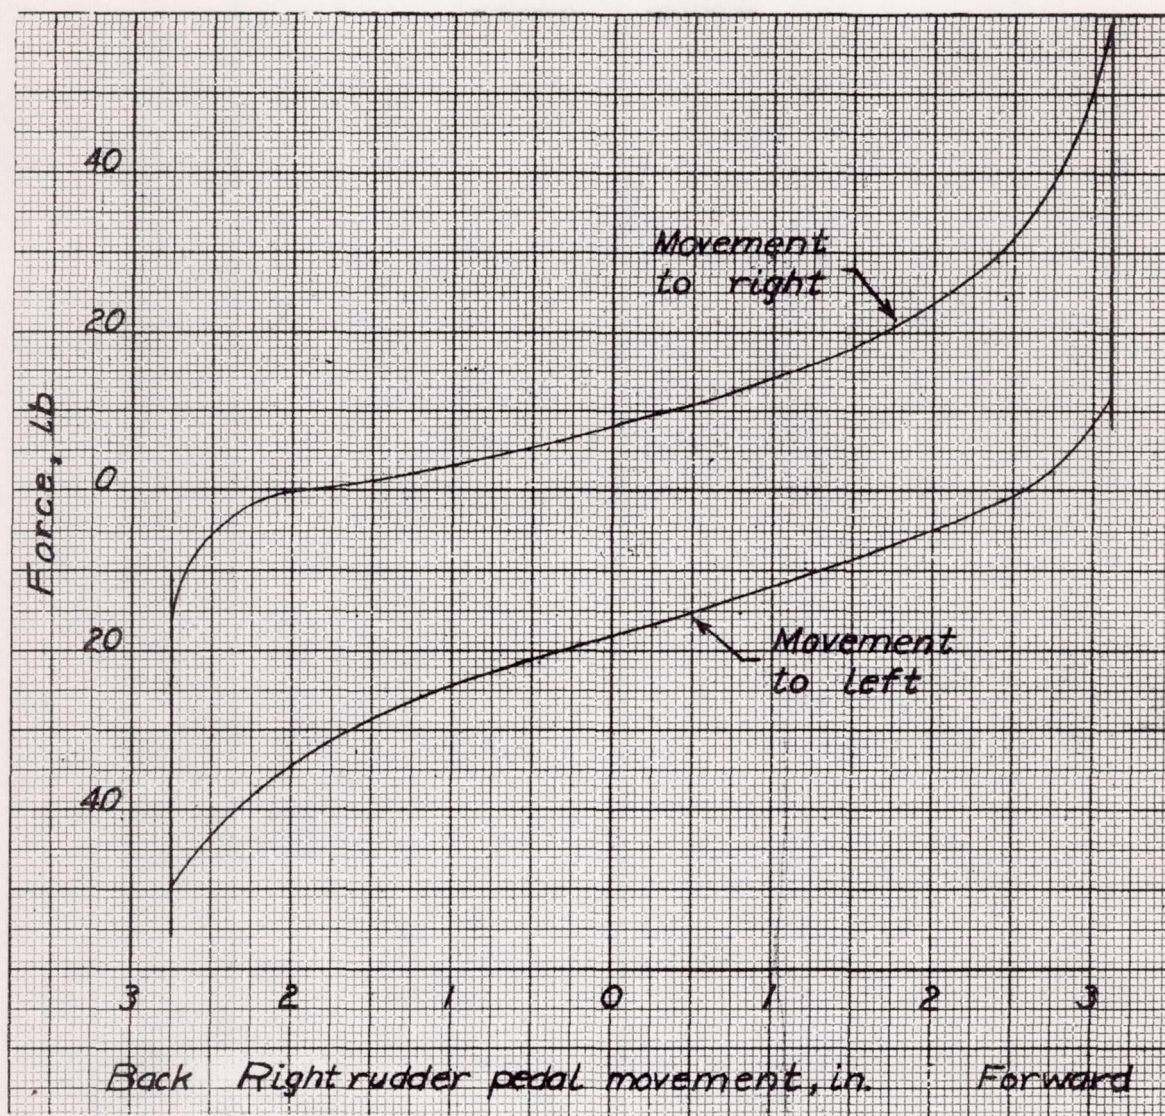
Figure 9.- Rudder pedal force required to move the rudder slowly as measured on the ground. Curtiss SB2C-1.

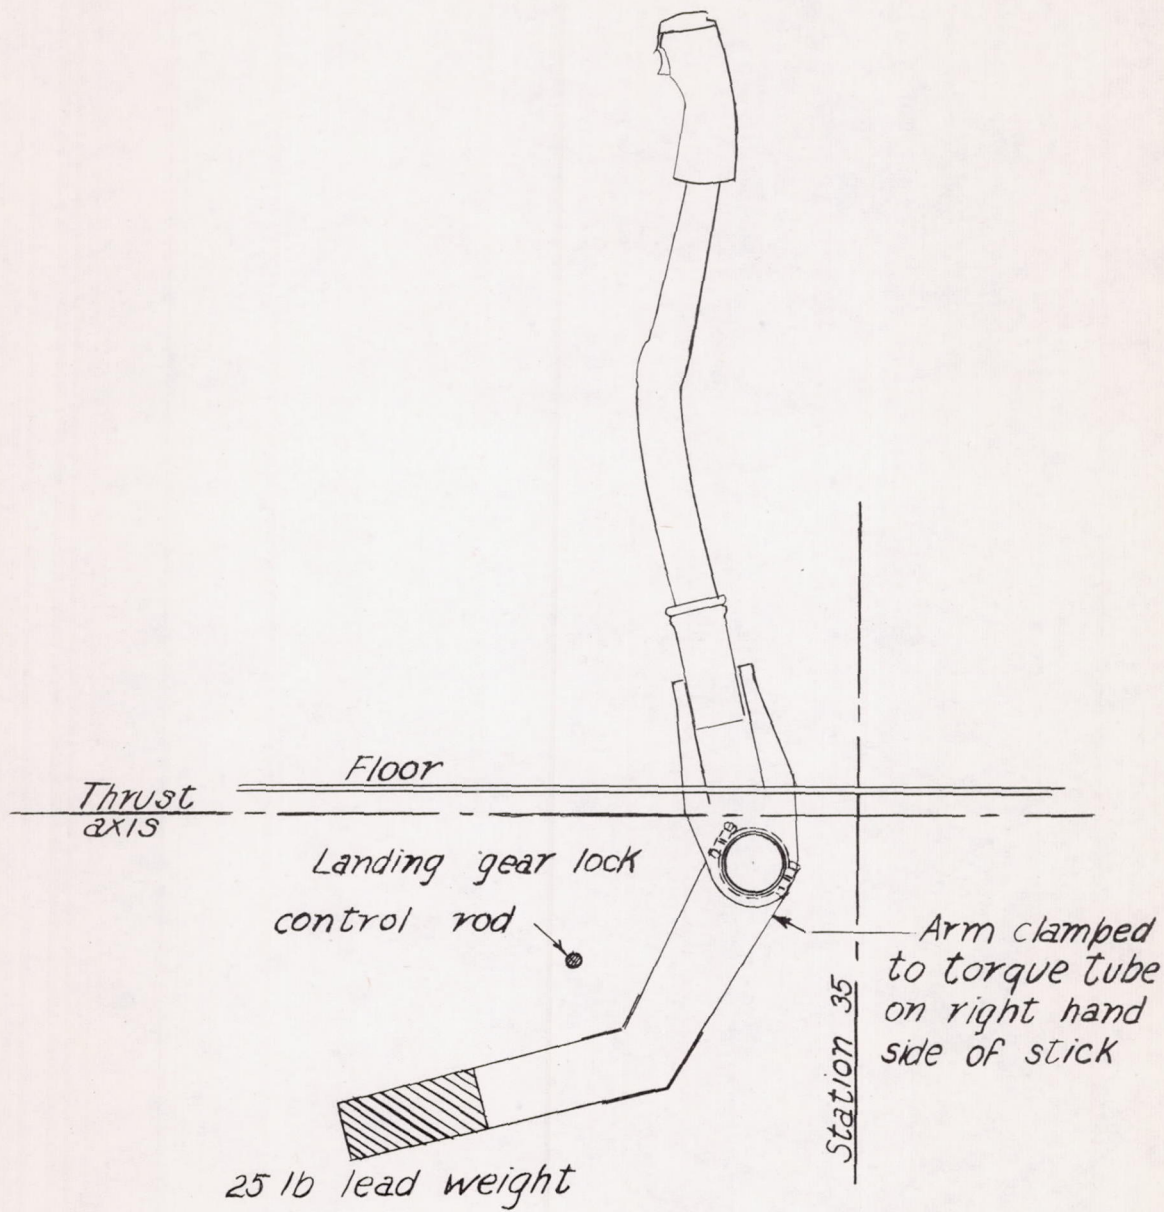
Figure 10.- Sketch of bobweight installation in Curtiss SB2C-1 airplane.

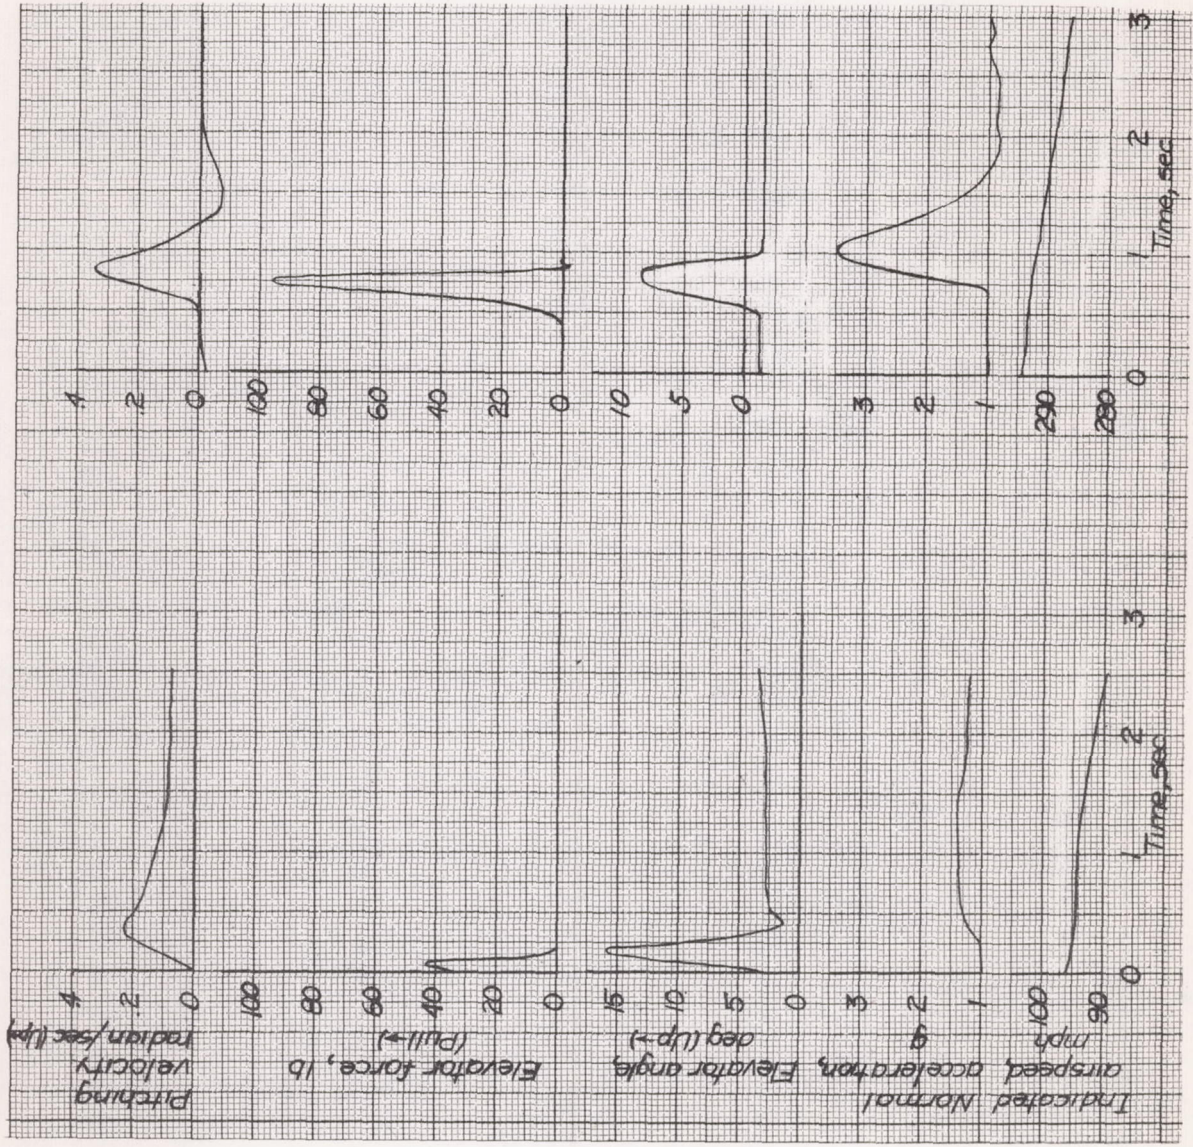
Figure 11.- Time histories of typical attempted longitudinal oscillations. SE2C-1 airplane (flaps up, landing gear up, rated power).

The characteristics of the uncontrolled longitudinal motion were investigated at various speeds through the speed range in the climbing and gliding condition. In these tests the airplane was trimmed at the given speed and continuous records were taken while the pilot abruptly deflected and released the elevator. No oscillation ensued in either condition at any speed tested. Typical time histories of this maneuver are given in figure 11. It should be noted from this figure that although the elevator did not oscillate, it did not return to trim because of the friction force.

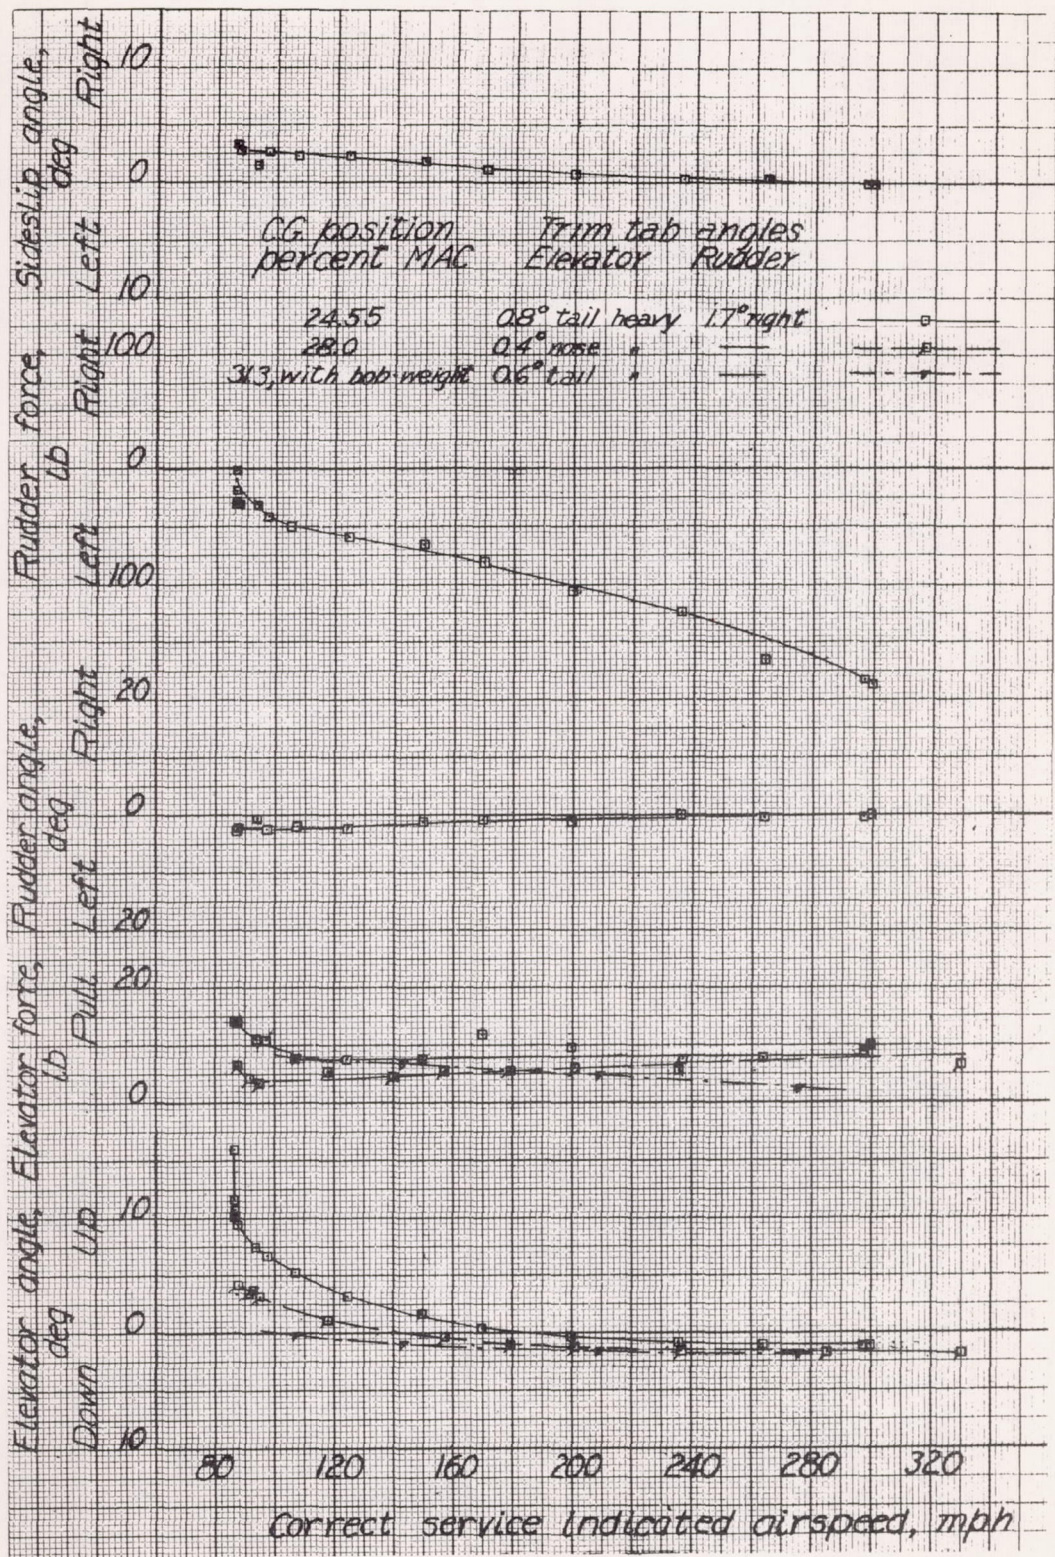
Figure 12.- Static longitudinal stability characteristics in the gliding condition (flaps up, landing gear up, power off) Curtiss SB2C-1 airplane.

Flight condition	Center-of-gravity position	Control system	Figure no.
Gliding	24.55 and 28.0	Normal	12
Gliding	31.3	Bobweight	12
Climbing	24.9 and 28.54	Normal	13
Climbing	31.6	Bobweight	13
Dive flaps open (power on)	24.4	Normal	14(a)
Dive flaps open (power on)	29.35	Bobweight	14(a)
Dive flaps open (power off)	24.4	Normal	14(b)
Dive flaps open (power off)	29.35	Bobweight	14(b)
Landing	23.7 and 26.8	Normal	14(c)
Approach	24.7 and 28.0	Normal	15(a)
Wave-off	24.0, 24.3, and 27.8	Normal	15(b)

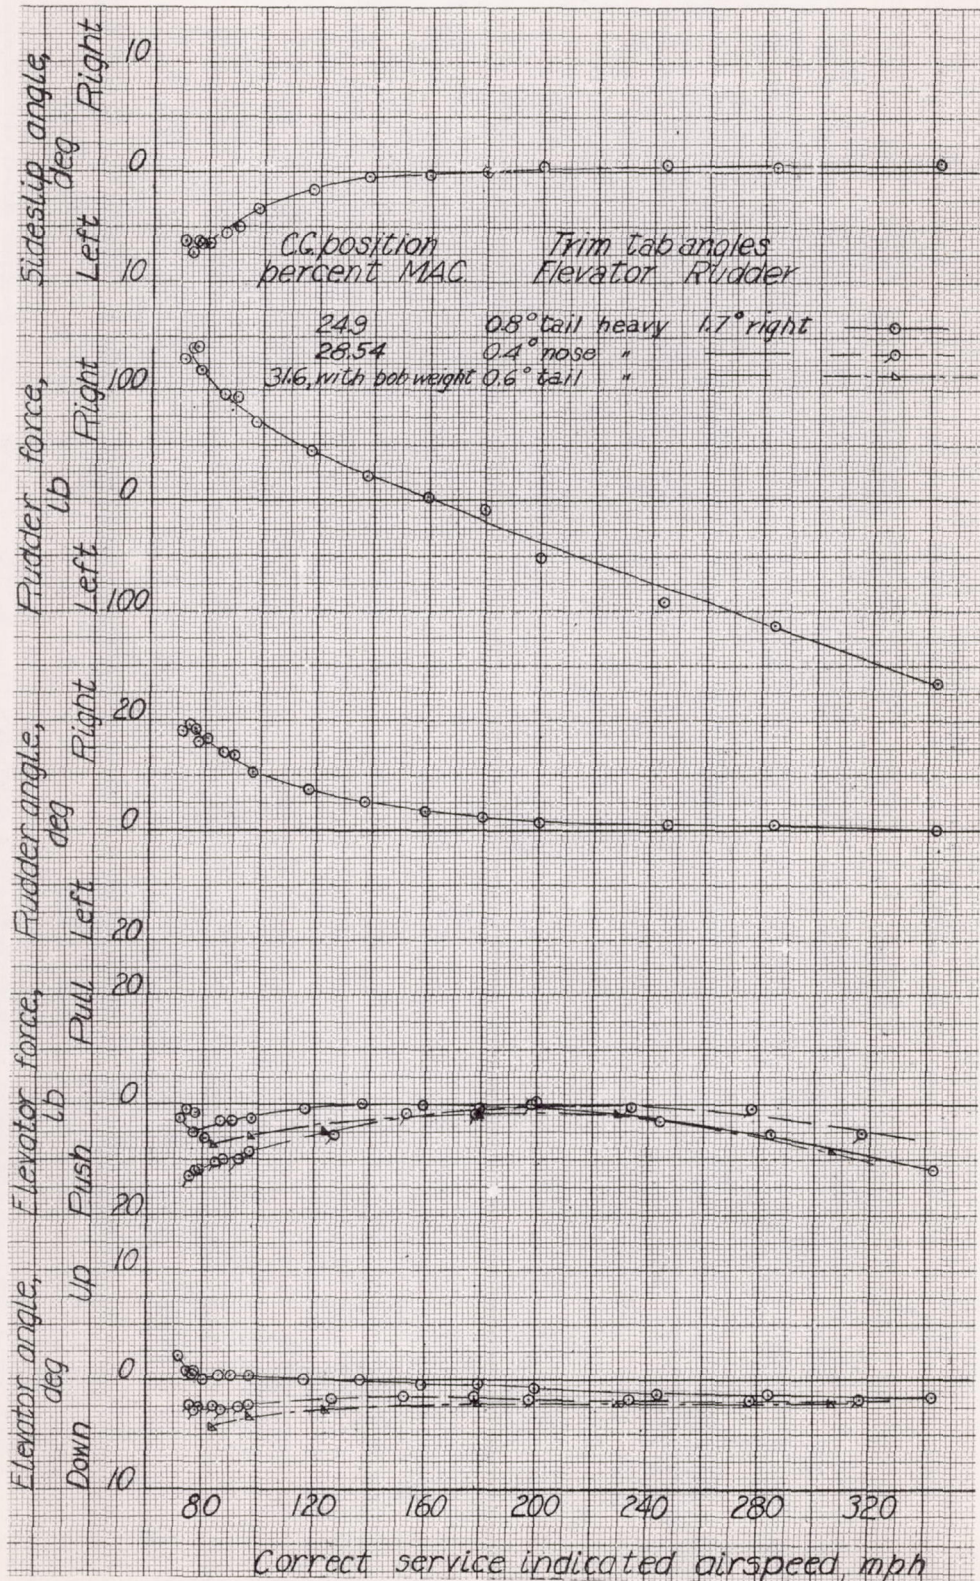
Figure 13.- Static longitudinal stability characteristics in the climbing condition (flaps up, landing gear up, rated power) Curtiss SB2C-1 airplane.

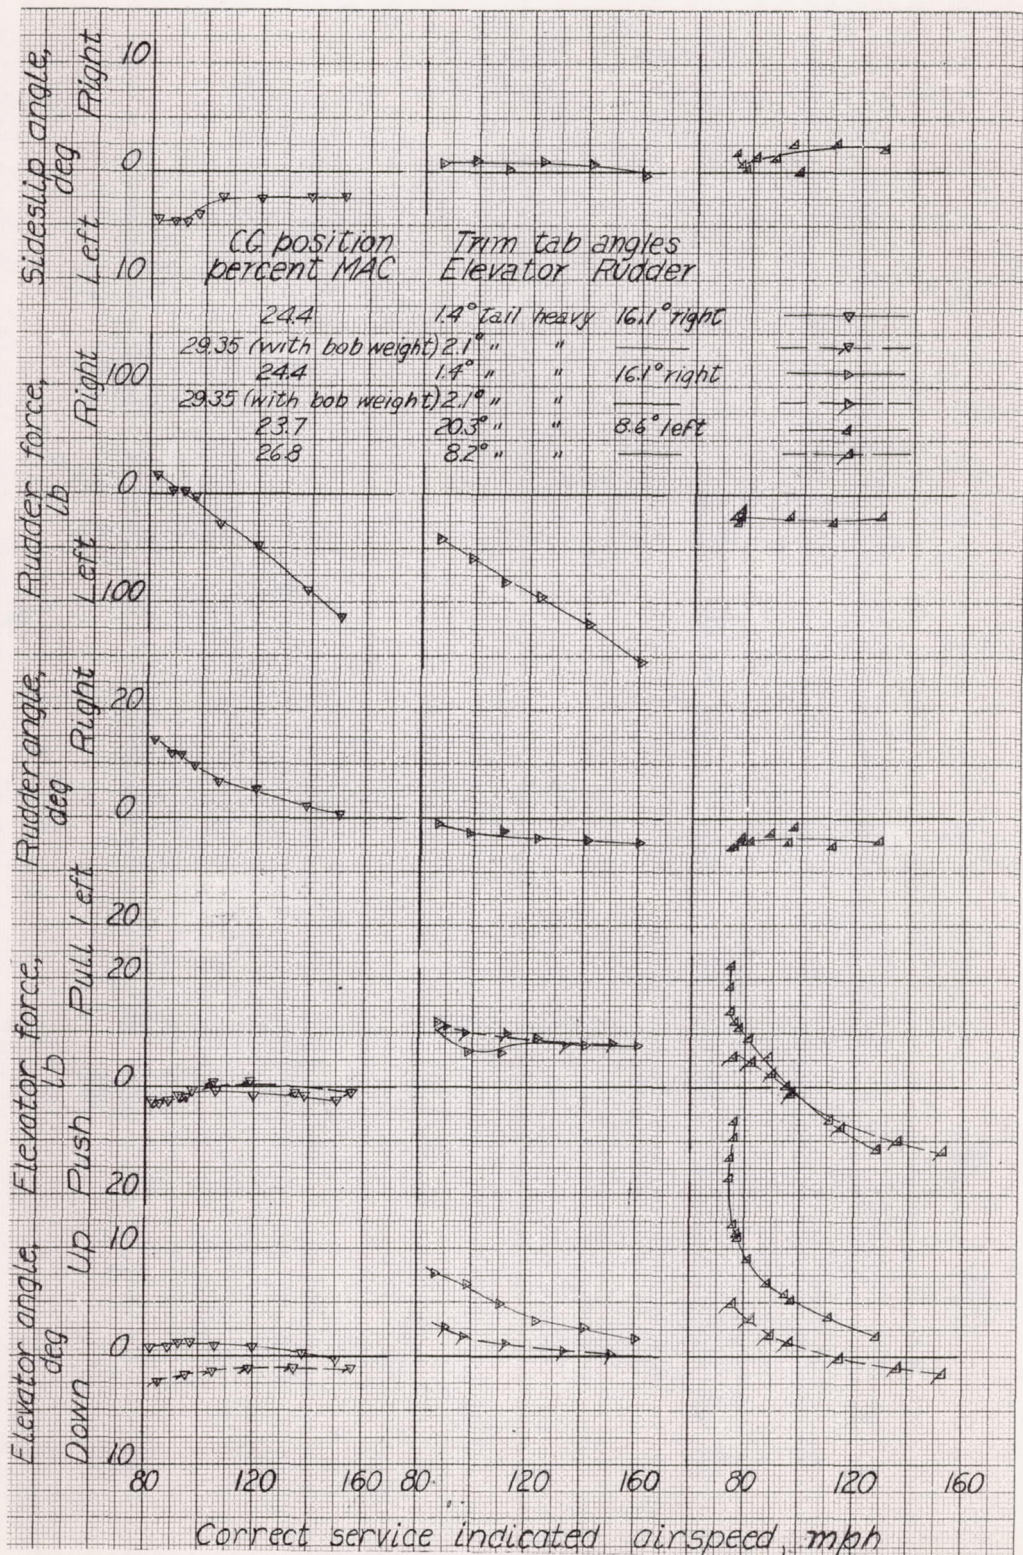
(a) Dive flaps extended, power on. (b) Dive flaps extended, power off. (c) Landing condition (flaps down, gear down, power off).

Figure 14.- Static longitudinal stability characteristics, Curtiss SB2C-1 airplane.

(c) With the dive flaps extended, power off, the static stability was almost the same as in the gliding condition. The most unstable condition encountered in the tests was with dive flaps extended, power on, at speeds near the stall. At higher speeds in this condition, the stability was almost the same as in the climbing condition.

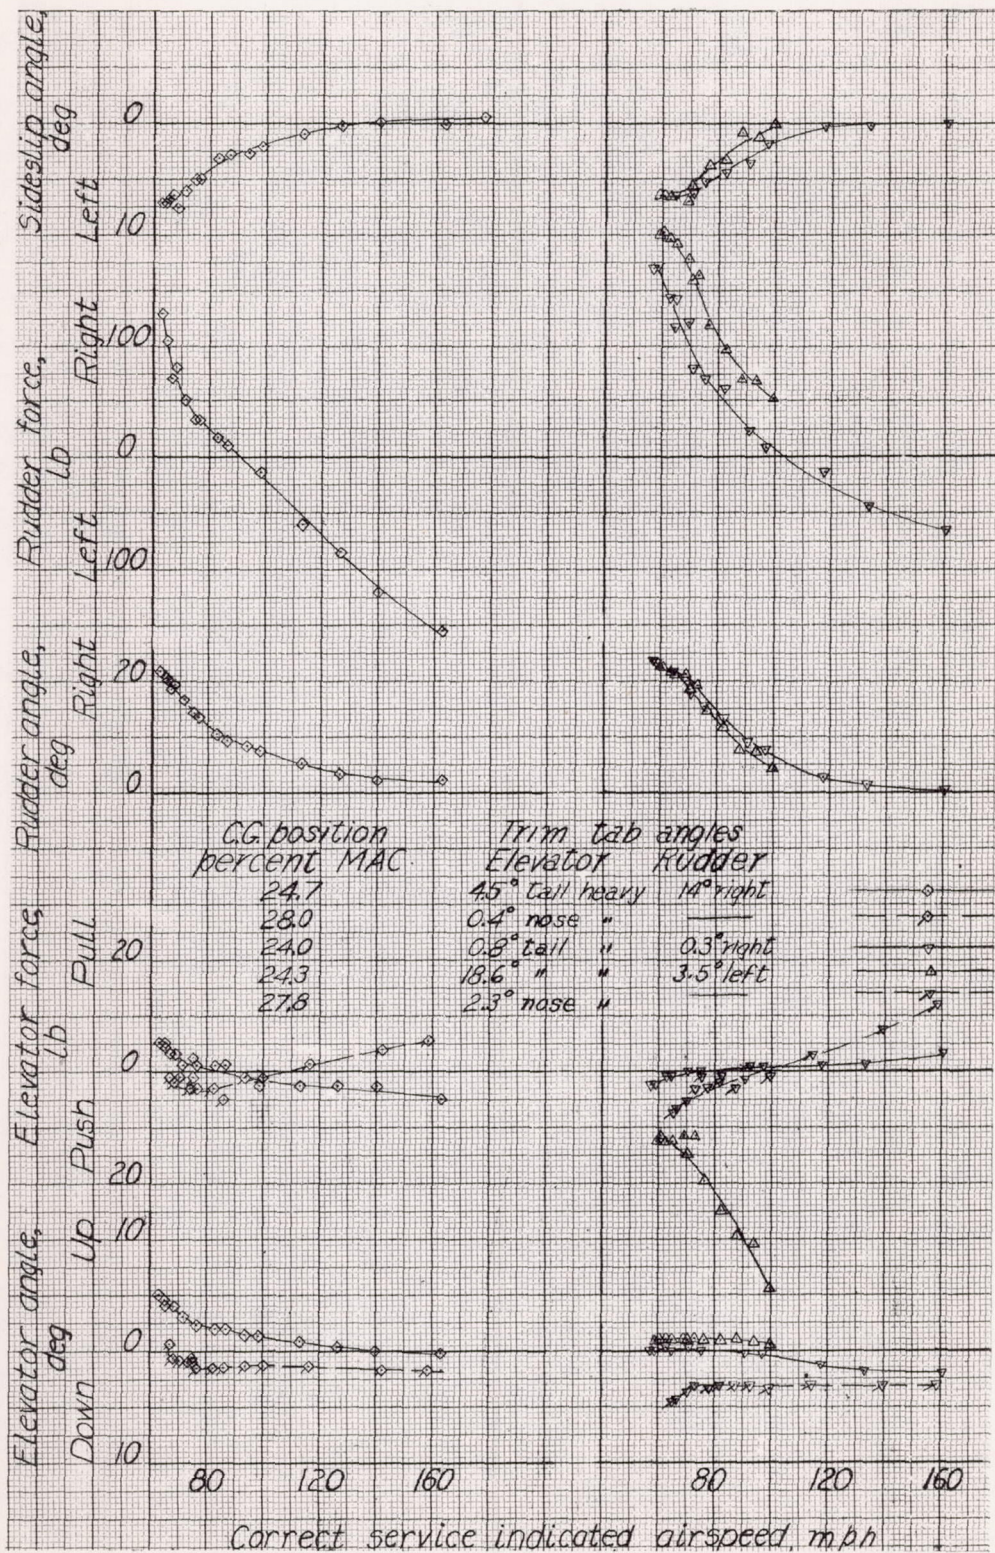
(a) Approach condition (flaps one-half down, landing gear down, partial power). (b) Wave-off condition (flaps down, landing gear down, rated power).

Figure 15.- Static longitudinal stability characteristics, Curtiss SB2C-1 airplane.

(b) The power of the elevator trim tabs was only one-third as great in the landing condition as in the wave-off condition. Therefore, if the airplane were trimmed full-tail heavy for a landing, and then rated power were applied for a wave-off, the push forces required for trim would become excessive as the speed increased. This characteristic is shown in figure 15(b) and in figure 31(b).
