WARTIME REPORT

MEASUREMENTS OF FLYING QUALITIES OF

A CURTISS SB2C-1 AIRPLANE

(NO. 00014)

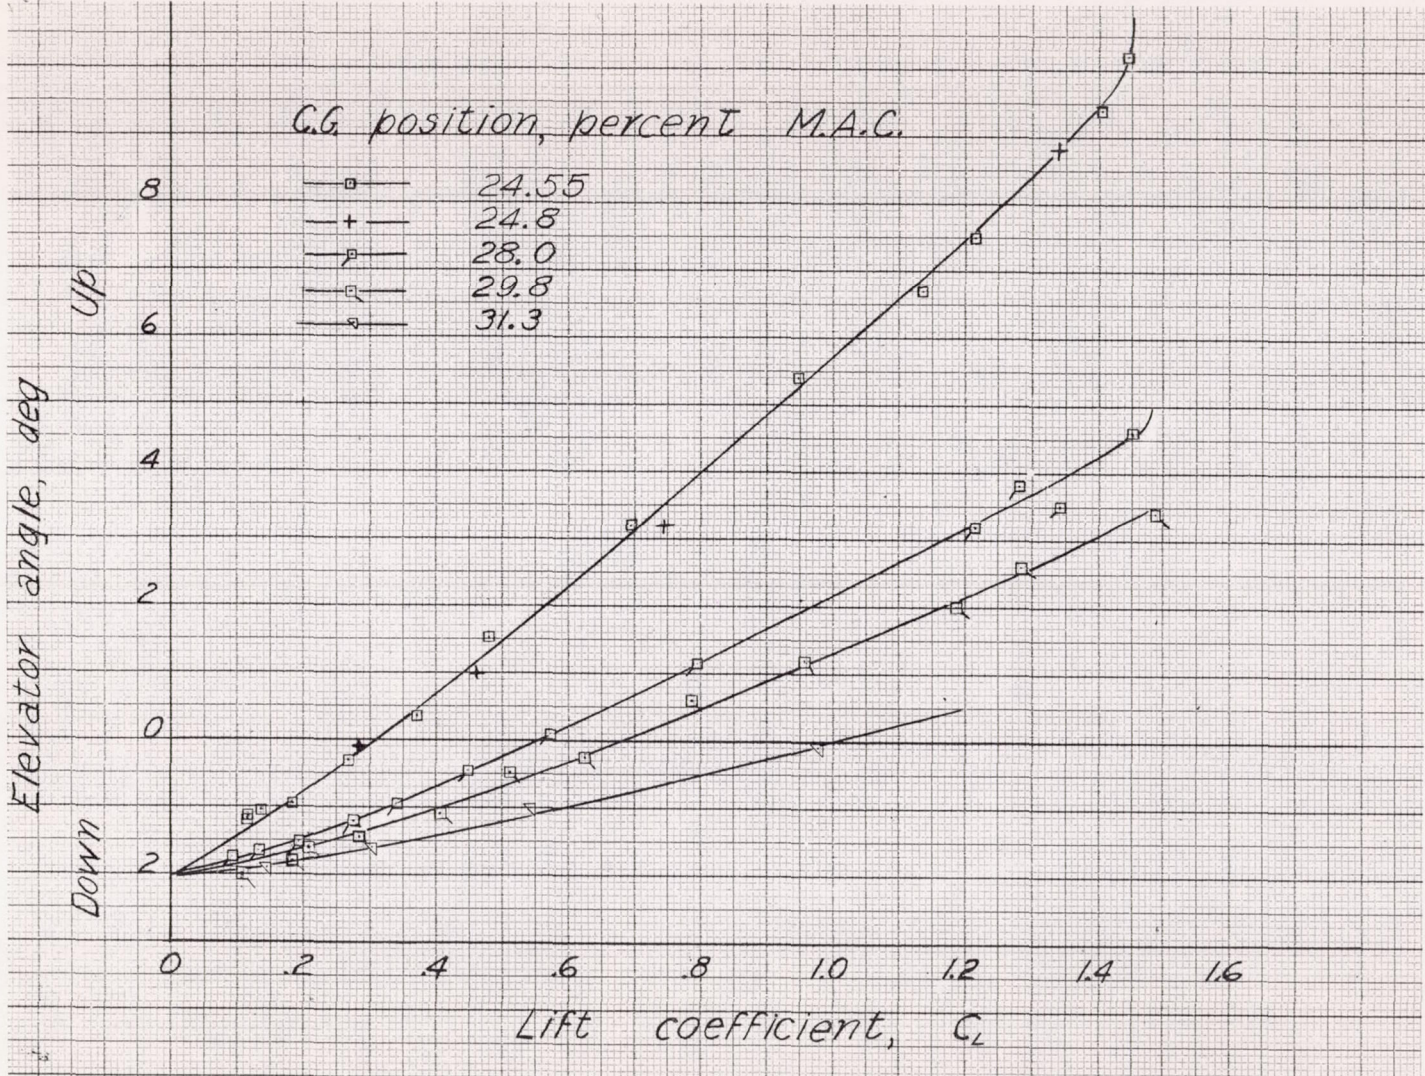
Figure 16.- Variation of elevator angle measured from thrust axis with lift coefficient in the gliding condition (flaps up, landing gear up, power off) Curtiss SB2C-1 airplane

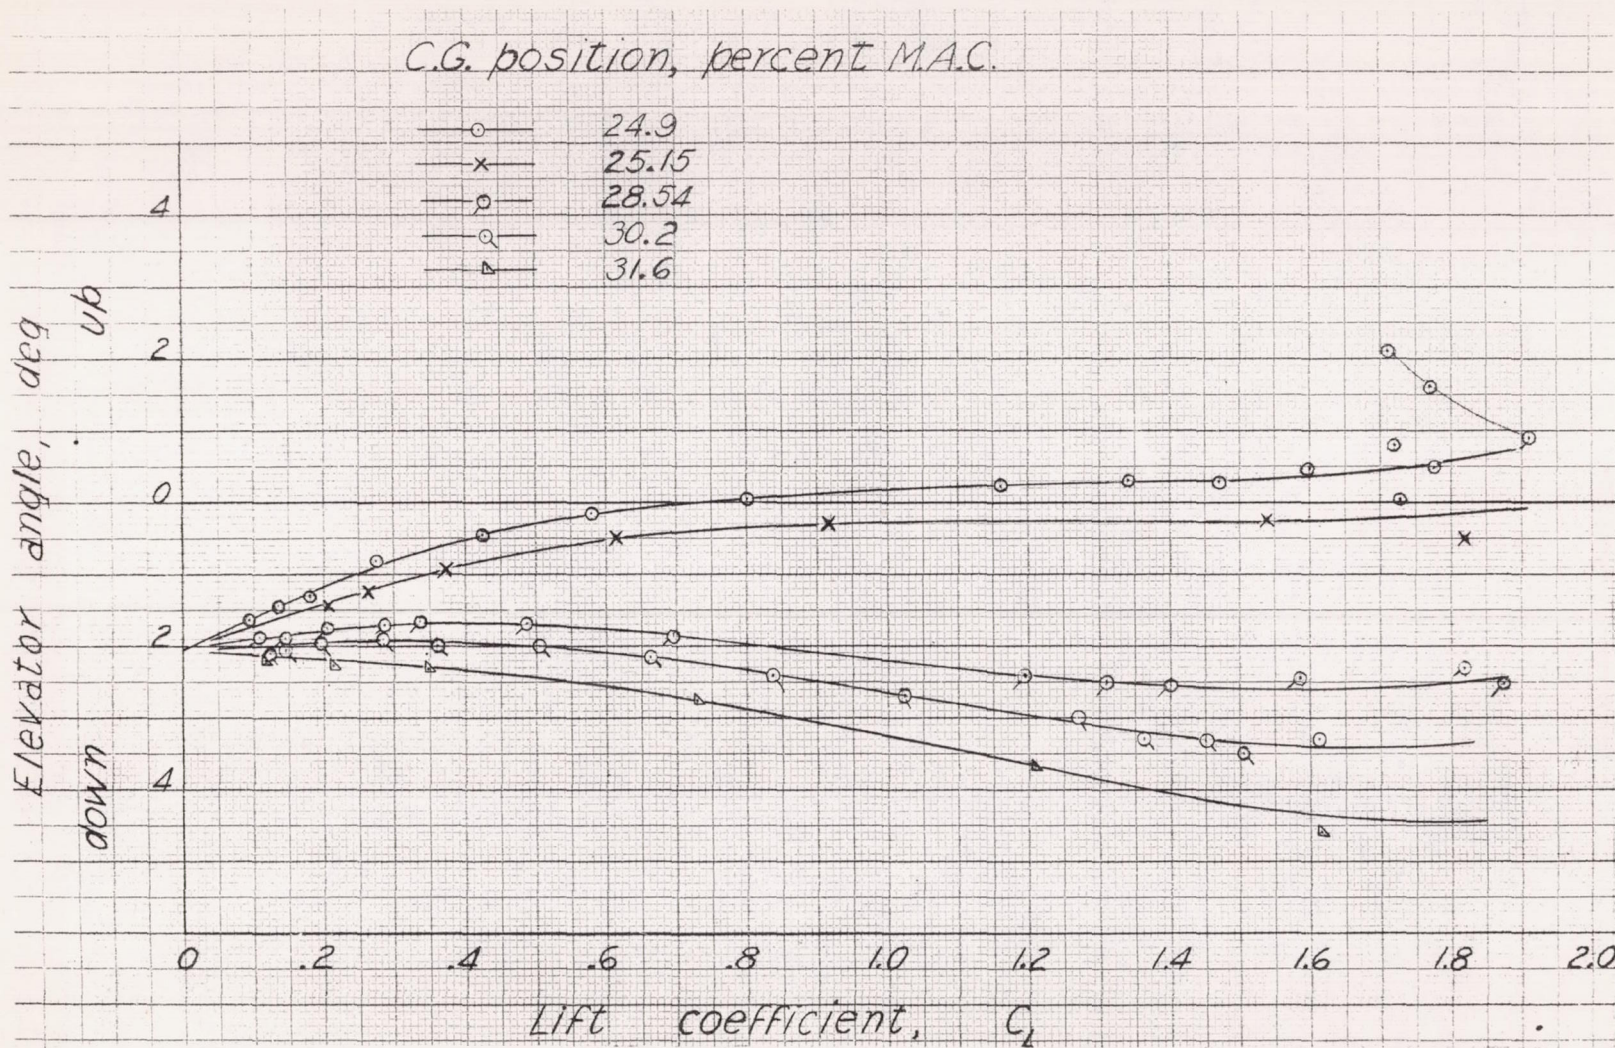
Figure 17.- Variation of elevator angle measured from thrust axis with lift coefficient in the climbing condition (flaps up, landing gear up, rated power) Curtiss SB2C-1 airplane.

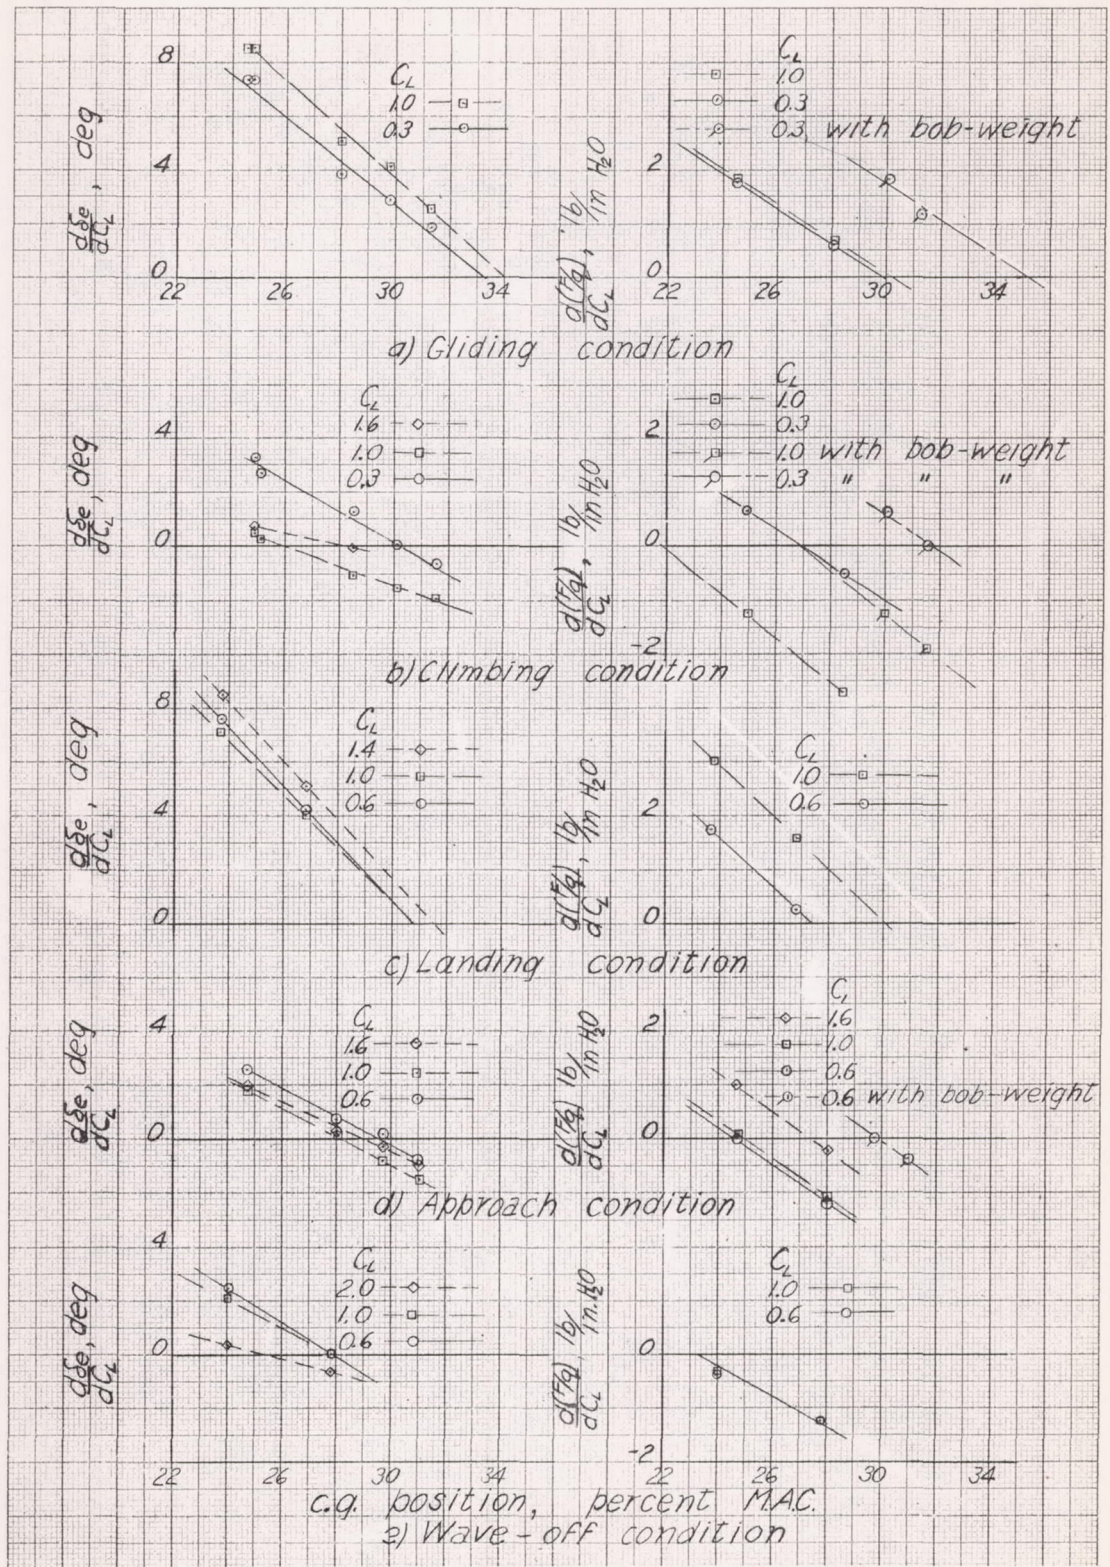
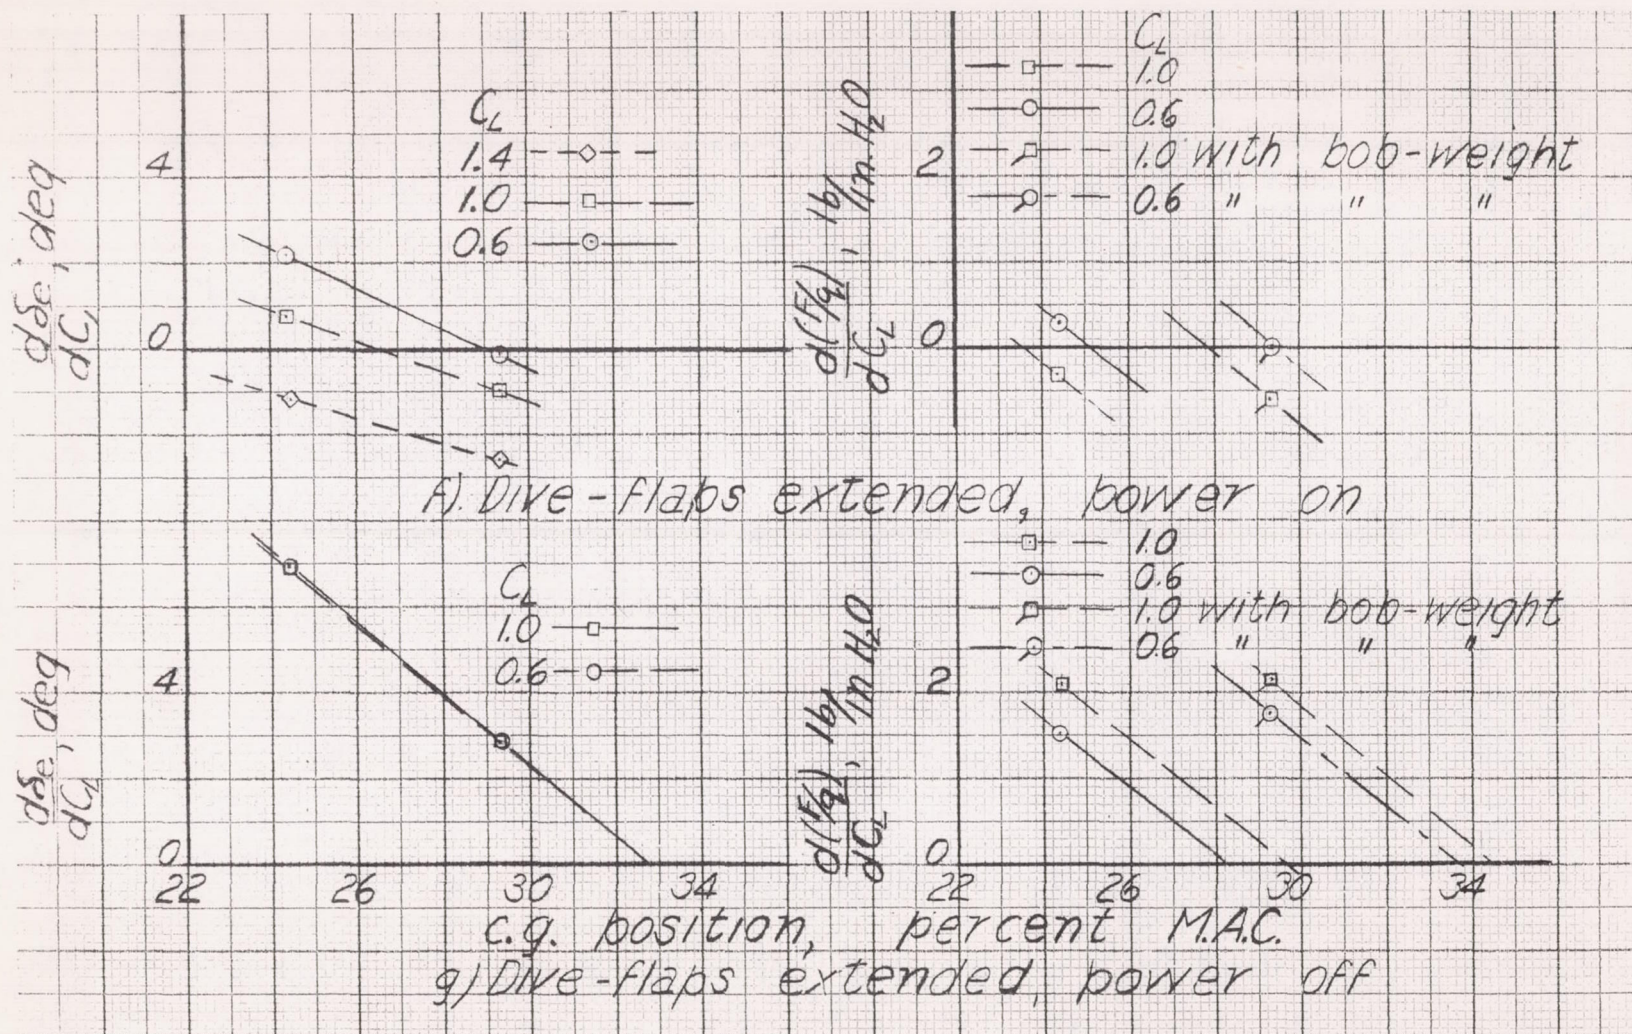
Figure 18.- Plots showing stick-fixed and stick-free neutral points for the various airplane conditions tested. Curtiss SB2C-1 airplane.

Figure 18.- (concluded) Plots showing stick-fixed and stick-free neutral points for the various airplane conditions tested. Curtiss SB2C-1 airplane.

(a) The stick-fixed neutral-stability point in the gliding condition was between 33 and 34 percent of the mean aerodynamic chord. Application of rated power (climbing condition) caused a large destabilizing effect, especially at speeds near that used for best climb. In the climbing condition at an airplane lift coefficient of 1.0, the stick-fixed neutral point was at 26 percent of the mean aerodynamic chord.

(e) The stability with stick free was less than with stick fixed. The stick-free neutral point was between 3 and 4 percent of the mean aerodynamic chord forward of the stick-fixed neutral point in most flight conditions.

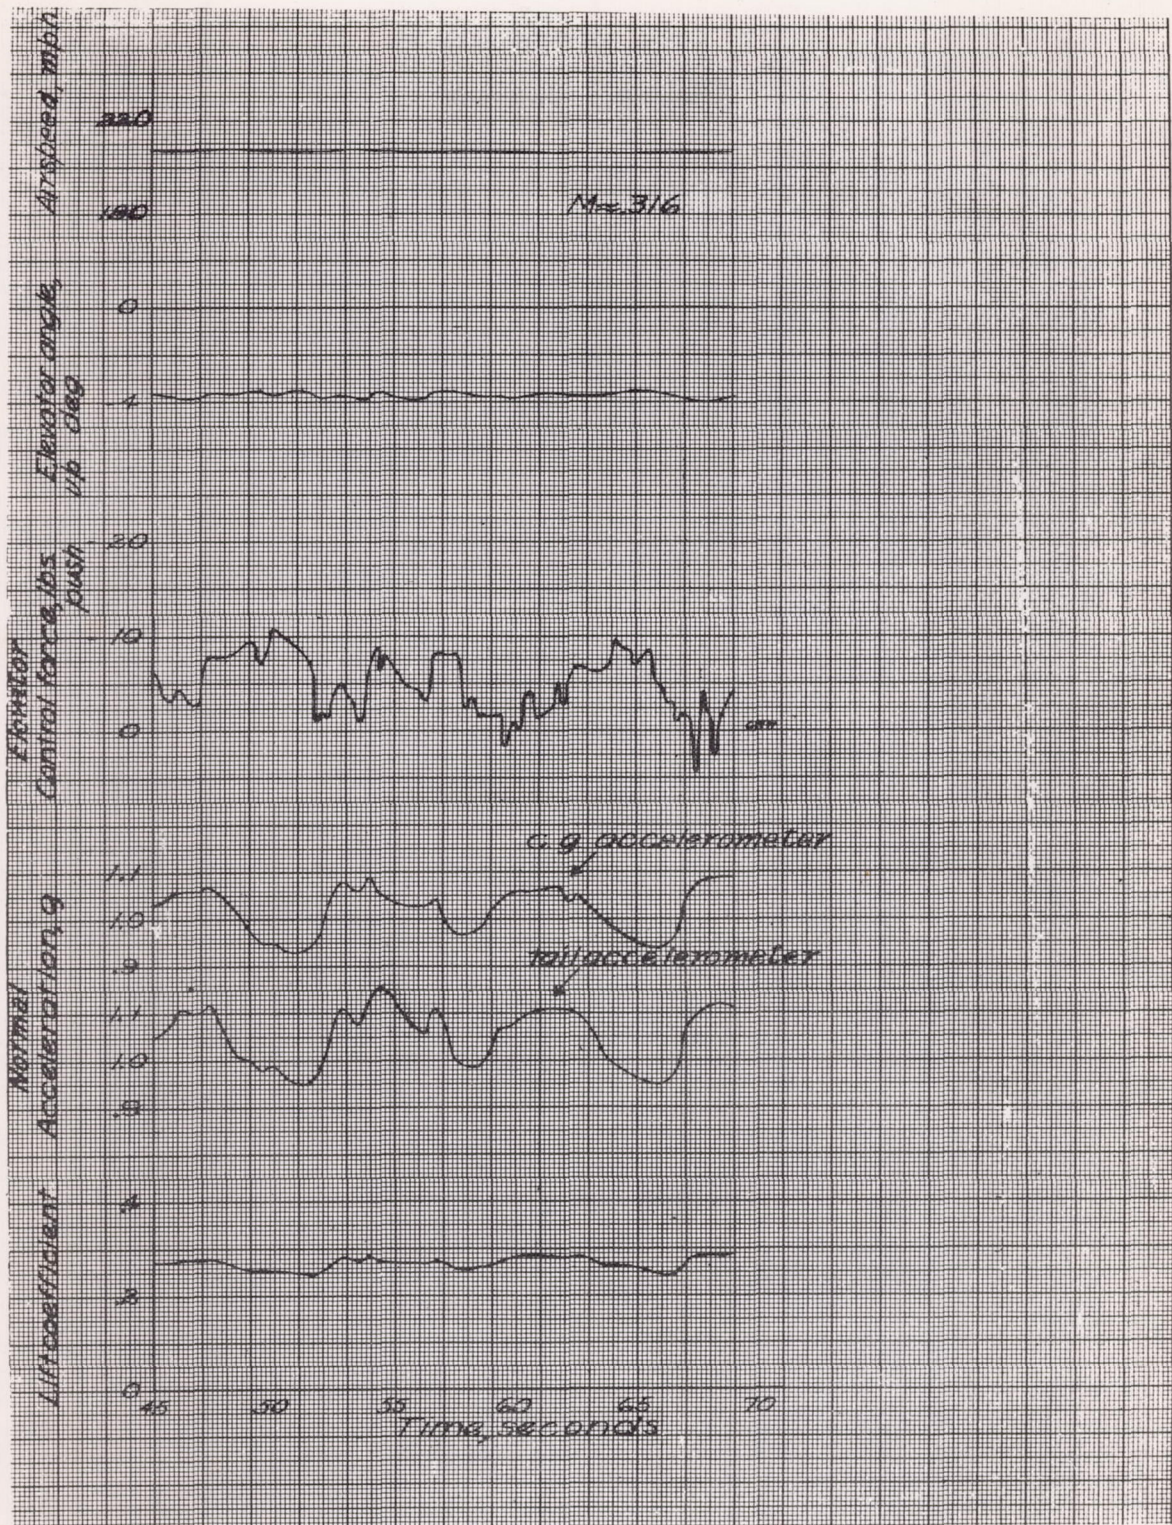
Figure 19.- Time history of straight flight in the gliding condition (flaps up, landing gear up, power off). Note control force variation used by pilot in holding a speed of 207 miles per hour. Curtiss SB2C-1 airplane Nc. OC140.

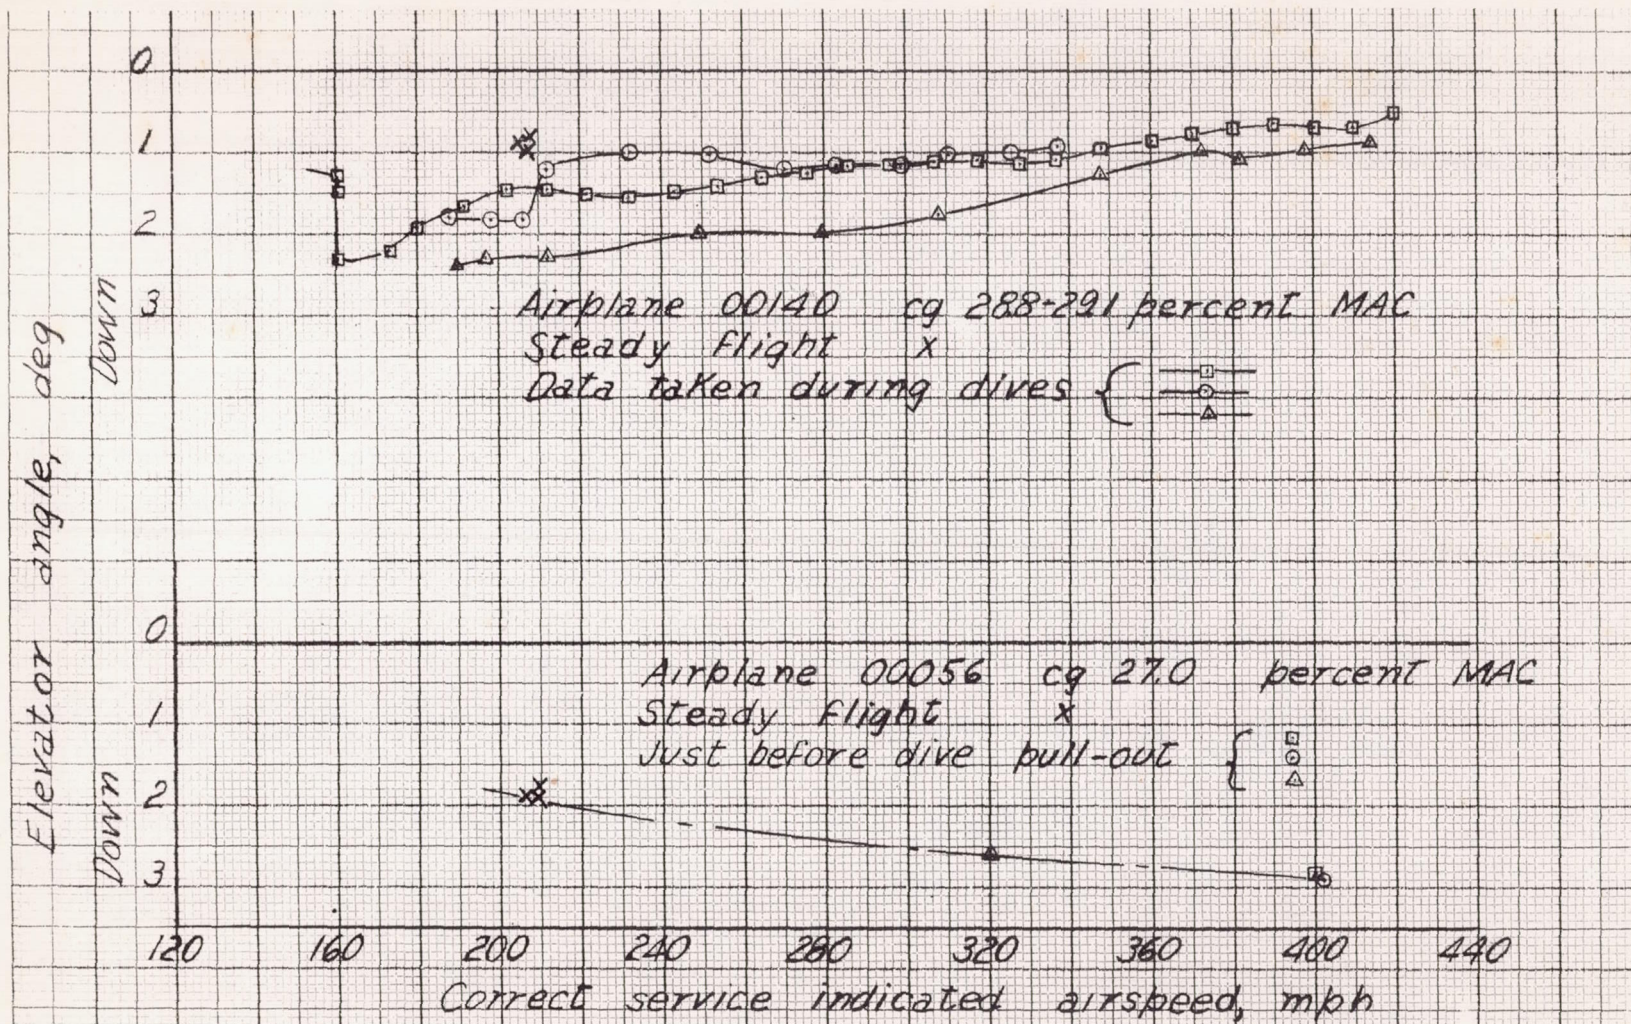
Figure 20.- Variation of elevator angle with speed in dives. Curtiss SB2C-1 airplane, flaps up, landing gear up, front hood open, rear hood closed, power off.

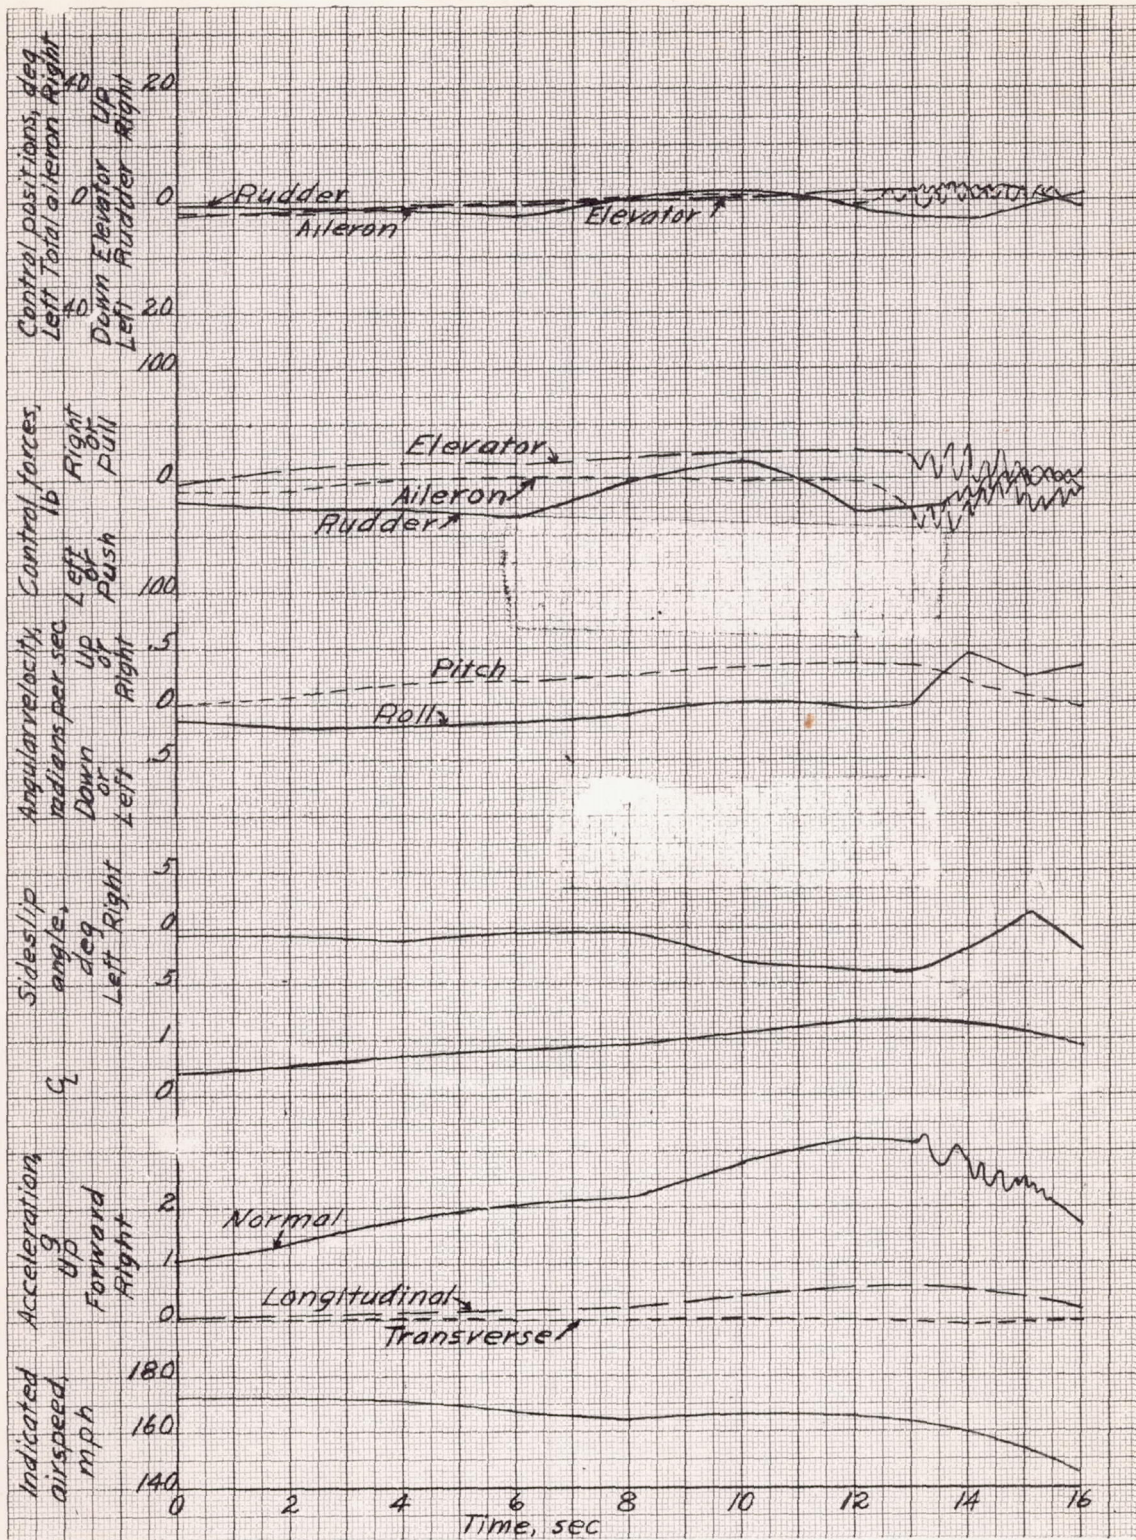
Figure 21.- Time history of a left turn started at 172 miles per hour in which a stall occurred (flaps up, landing gear up, hoods closed, cowl flaps closed, power for level flight). Center of gravity at 31.3 percent of the mean aerodynamic chord, bobweight installed. Curtiss SB2C-1 airplane.

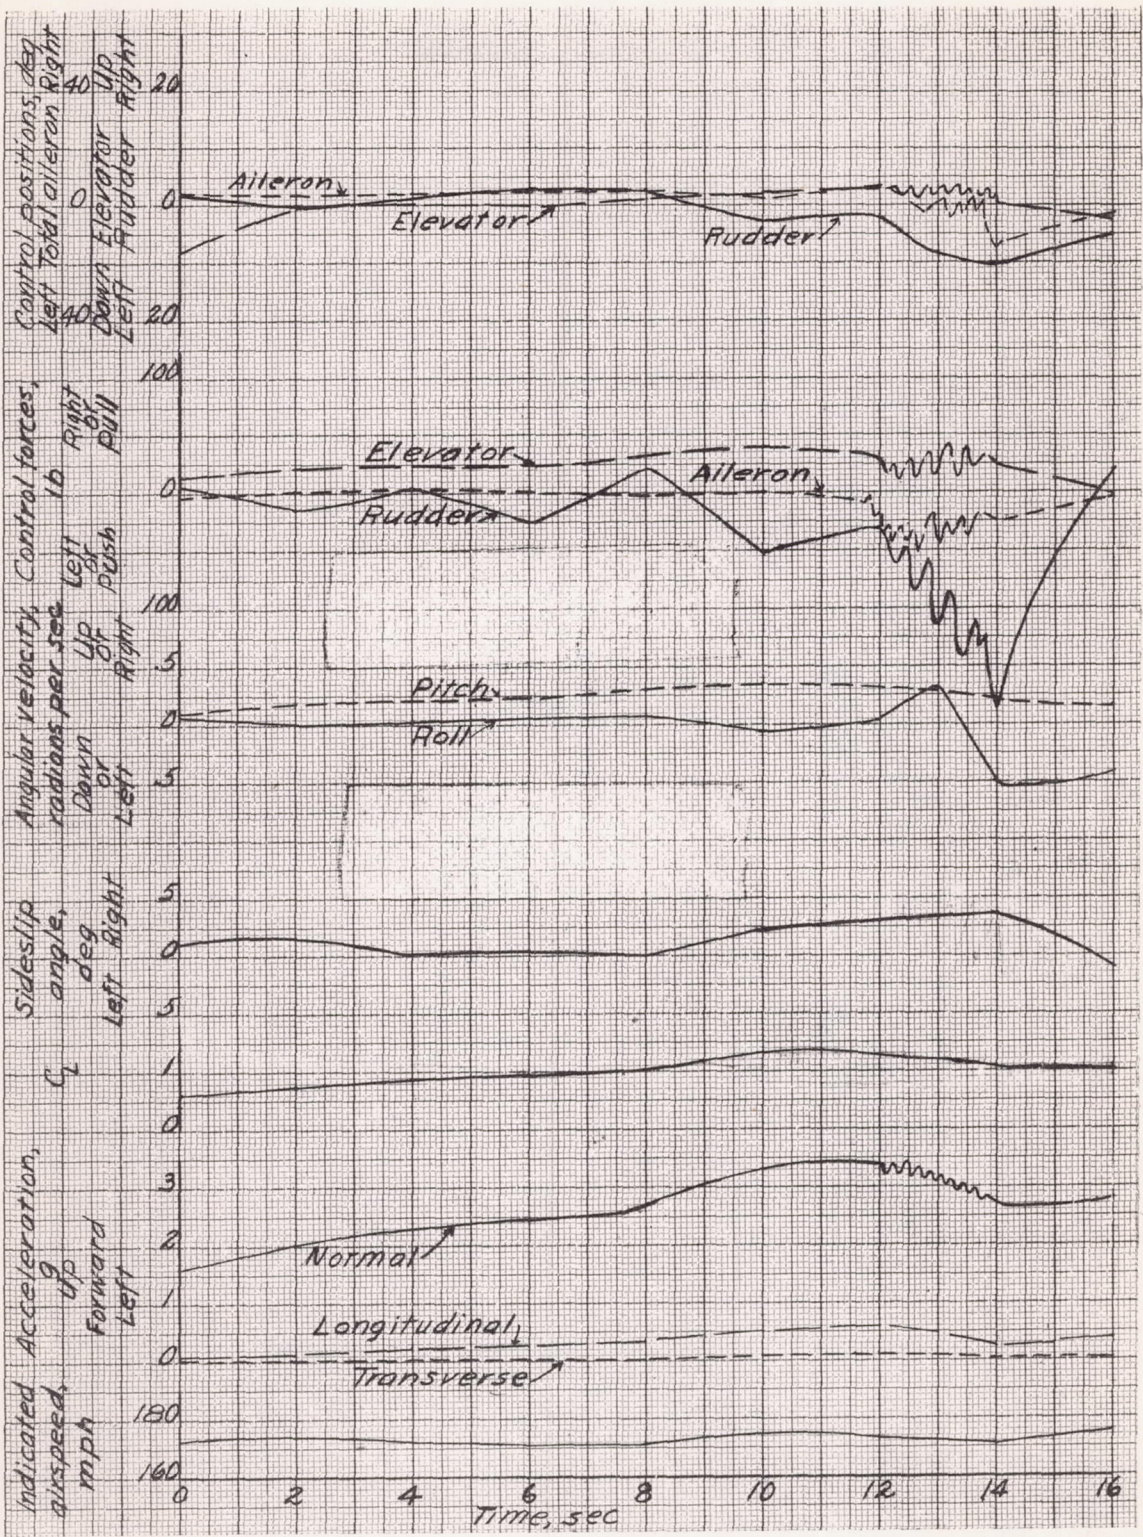
Figure 22.- Time history of a right turn started at 173 miles per hour in which a stall occurred (flaps up, landing gear up, hoods closed, cowl flaps closed, power for level flight). Center of gravity at 31.3 percent of the mean aerodynamic chord, bobweight installed. Curtiss SB2C-1 airplane.

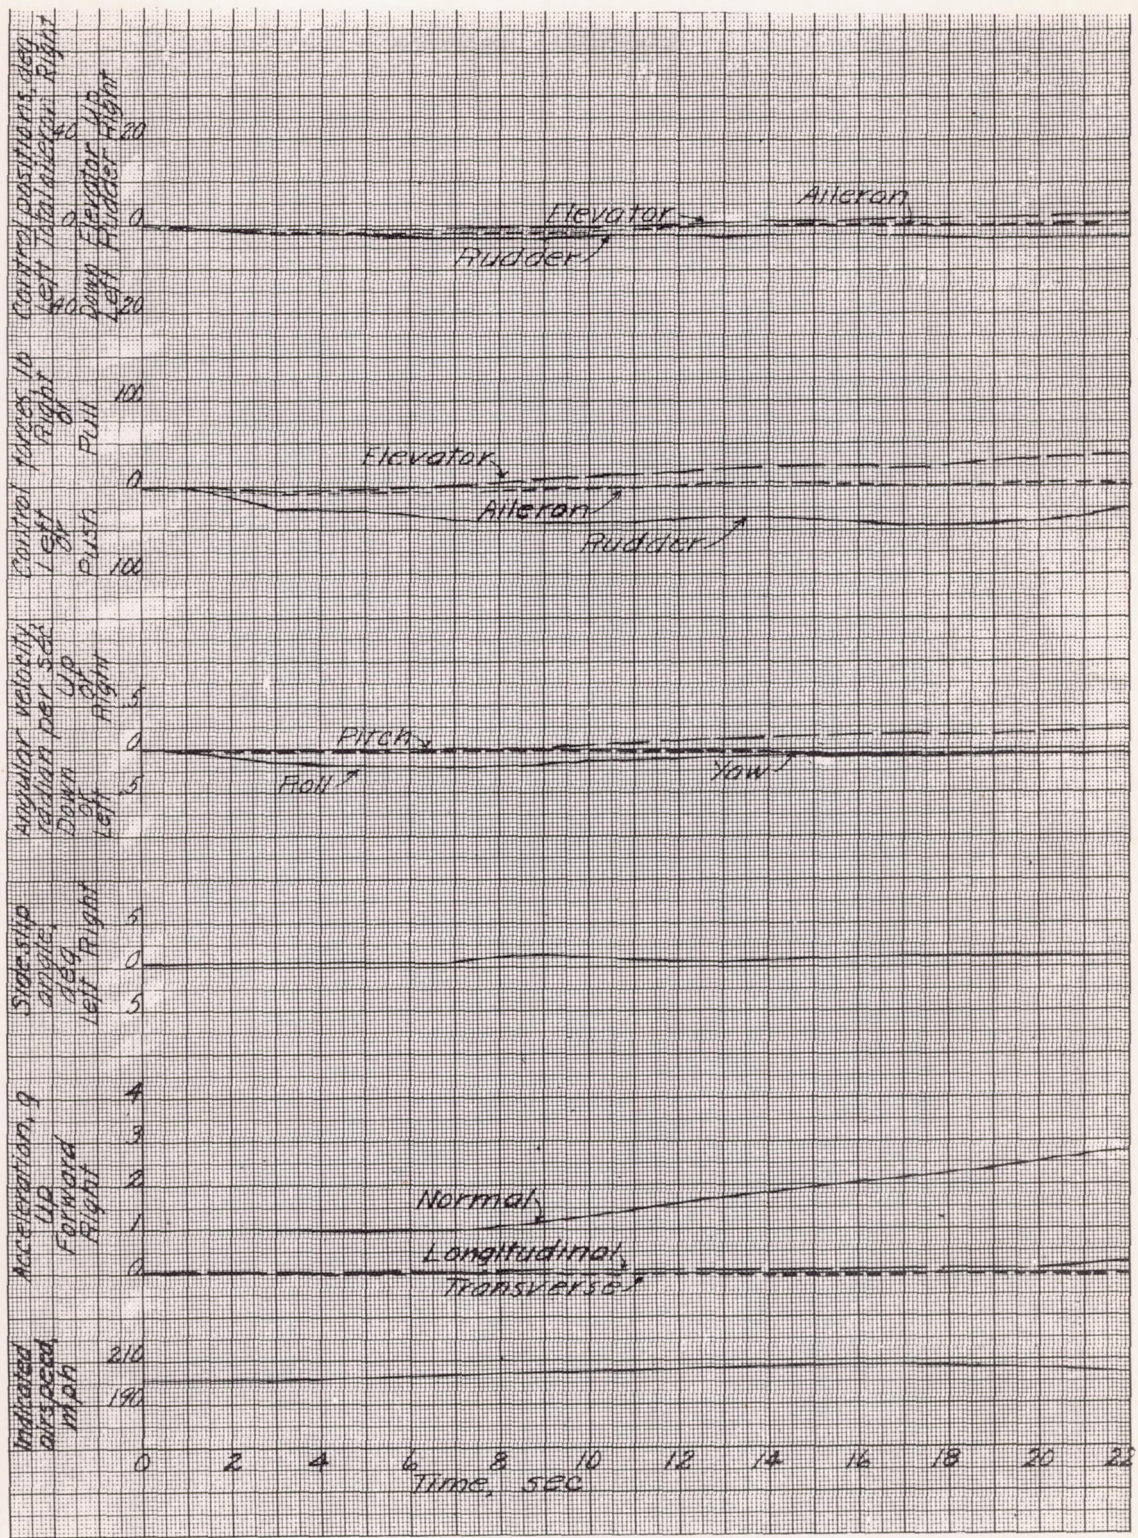
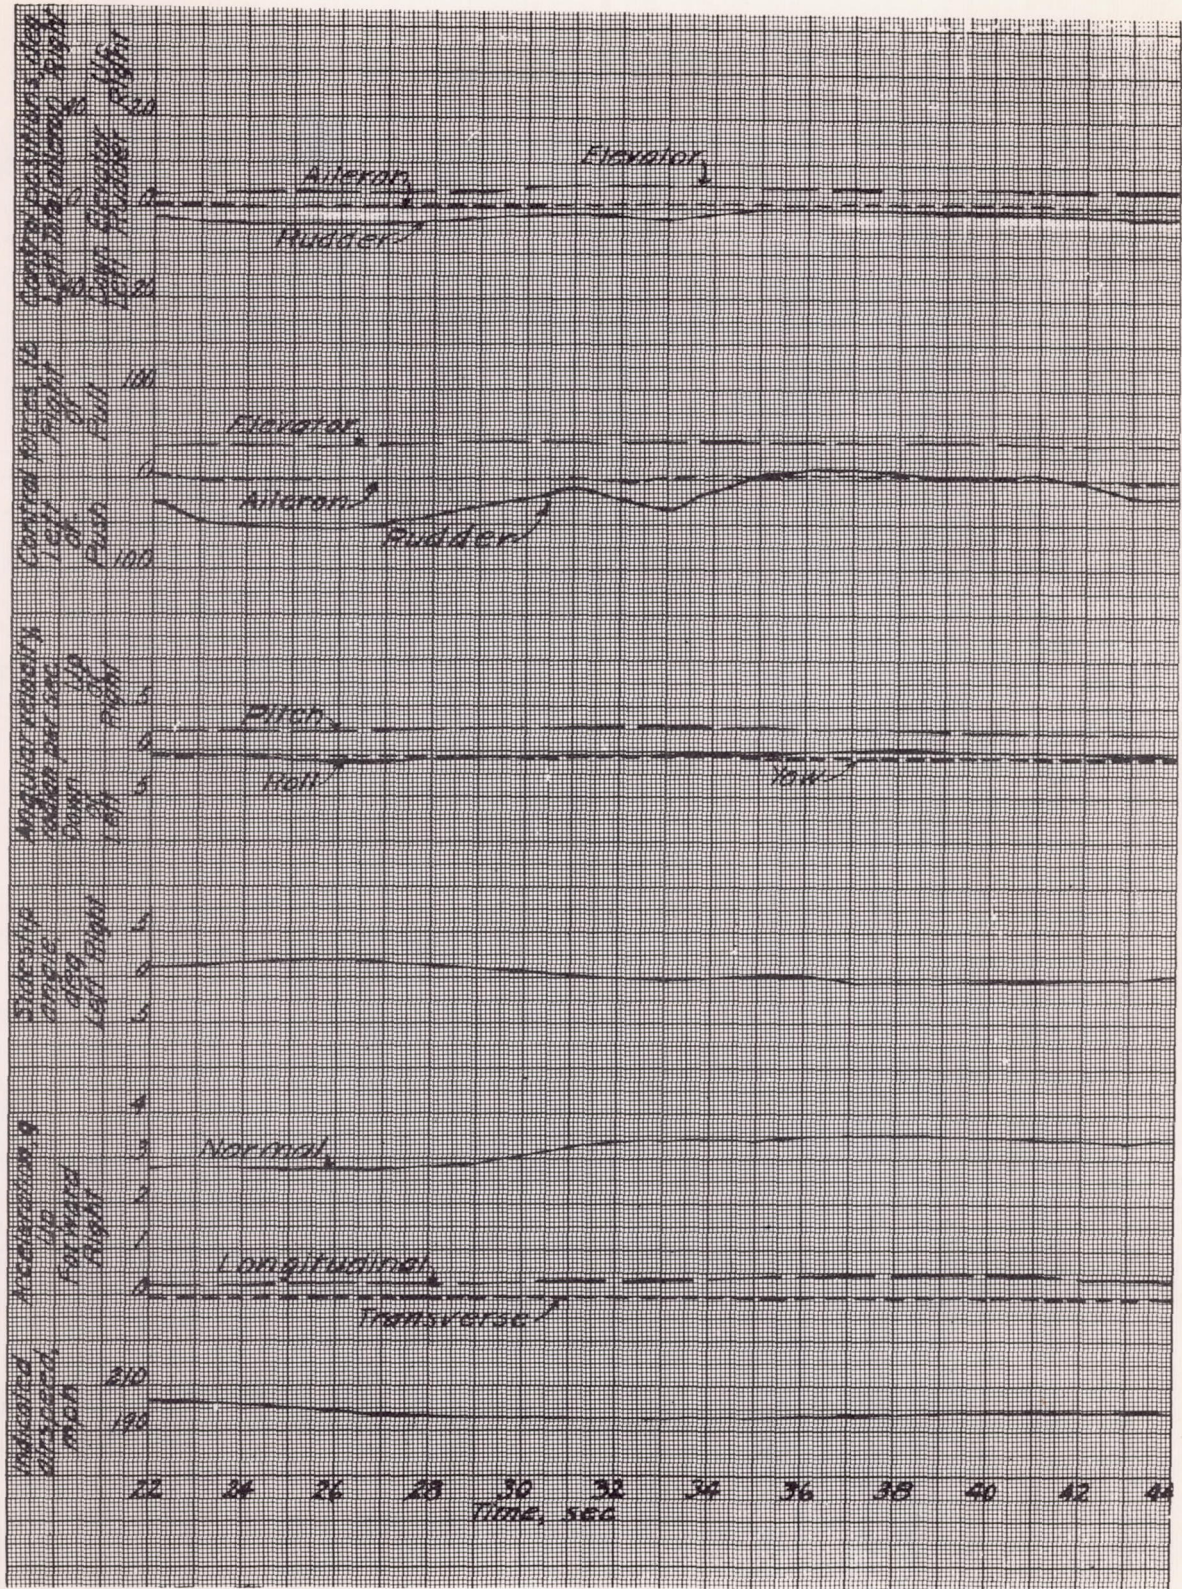
Figure 23.- Time history of a steady turn started at 201 miles per hour. Curtiss B2C-1 airplane (flaps up, landing gear up, hoods closed, cowl flaps closed, power for level flight) center of gravity at 24.1 percent of the mean aerodynamic chord, no bobweight.

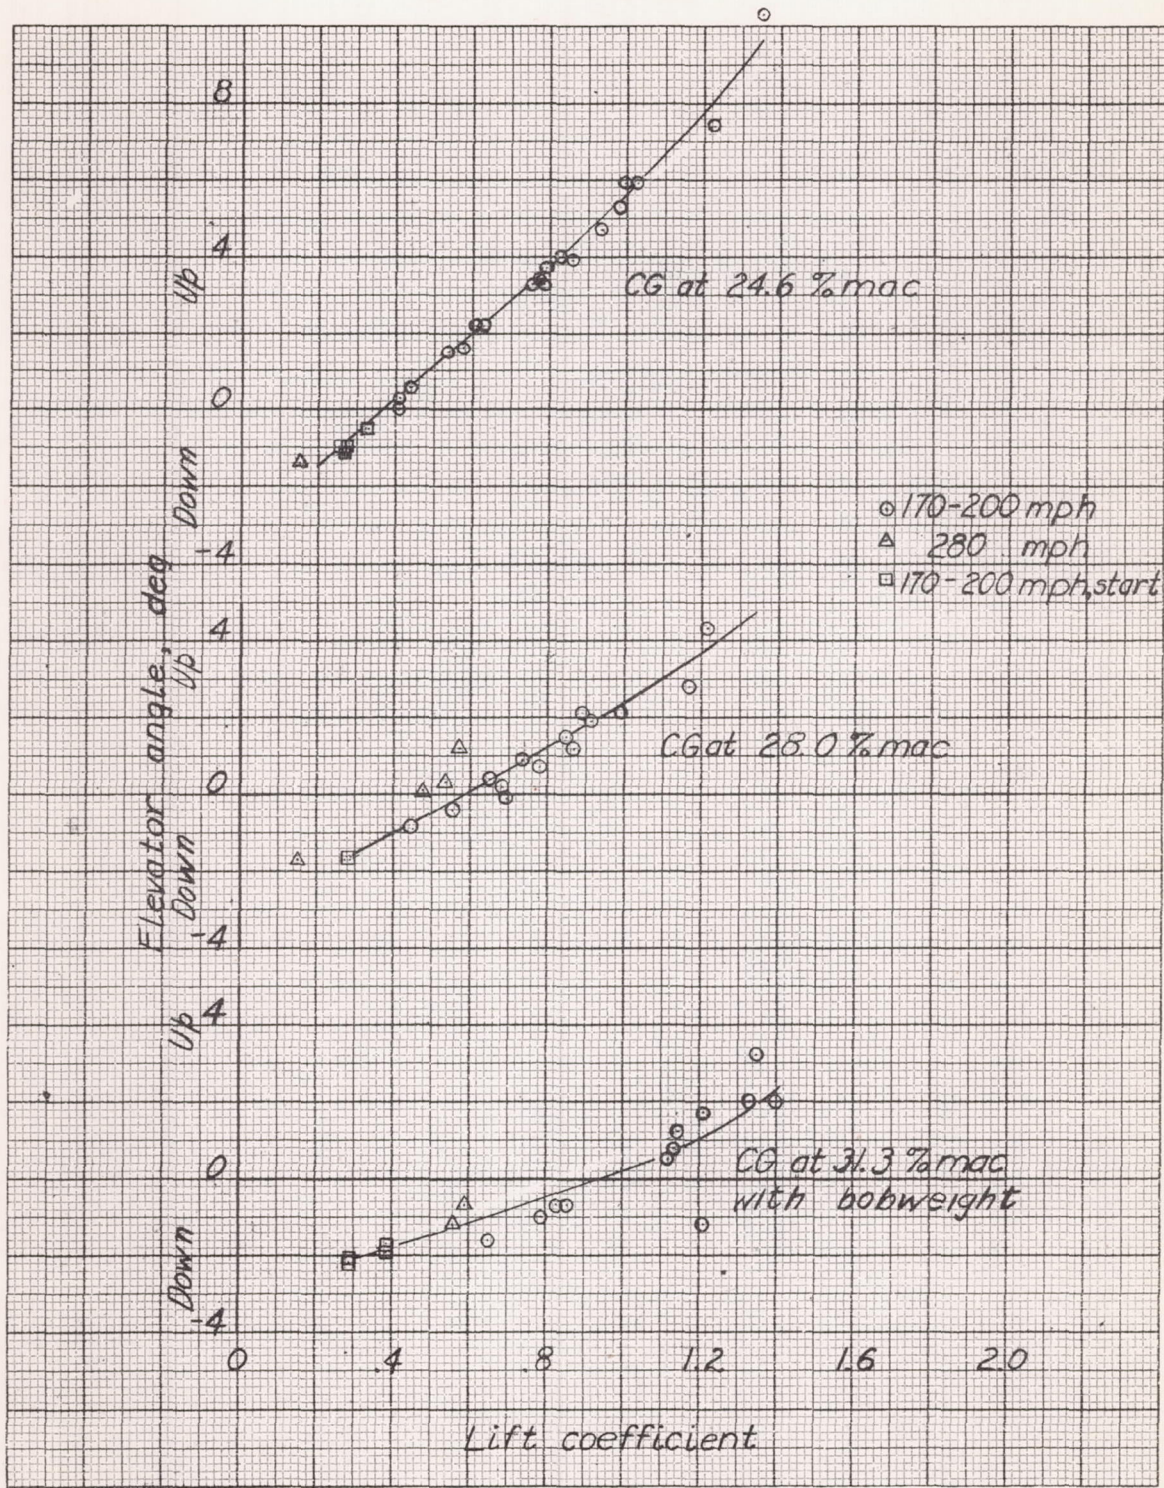
Figure 24.- Variation of elevator angle with lift coefficient in turns. Curtiss SB2C-1 airplane.

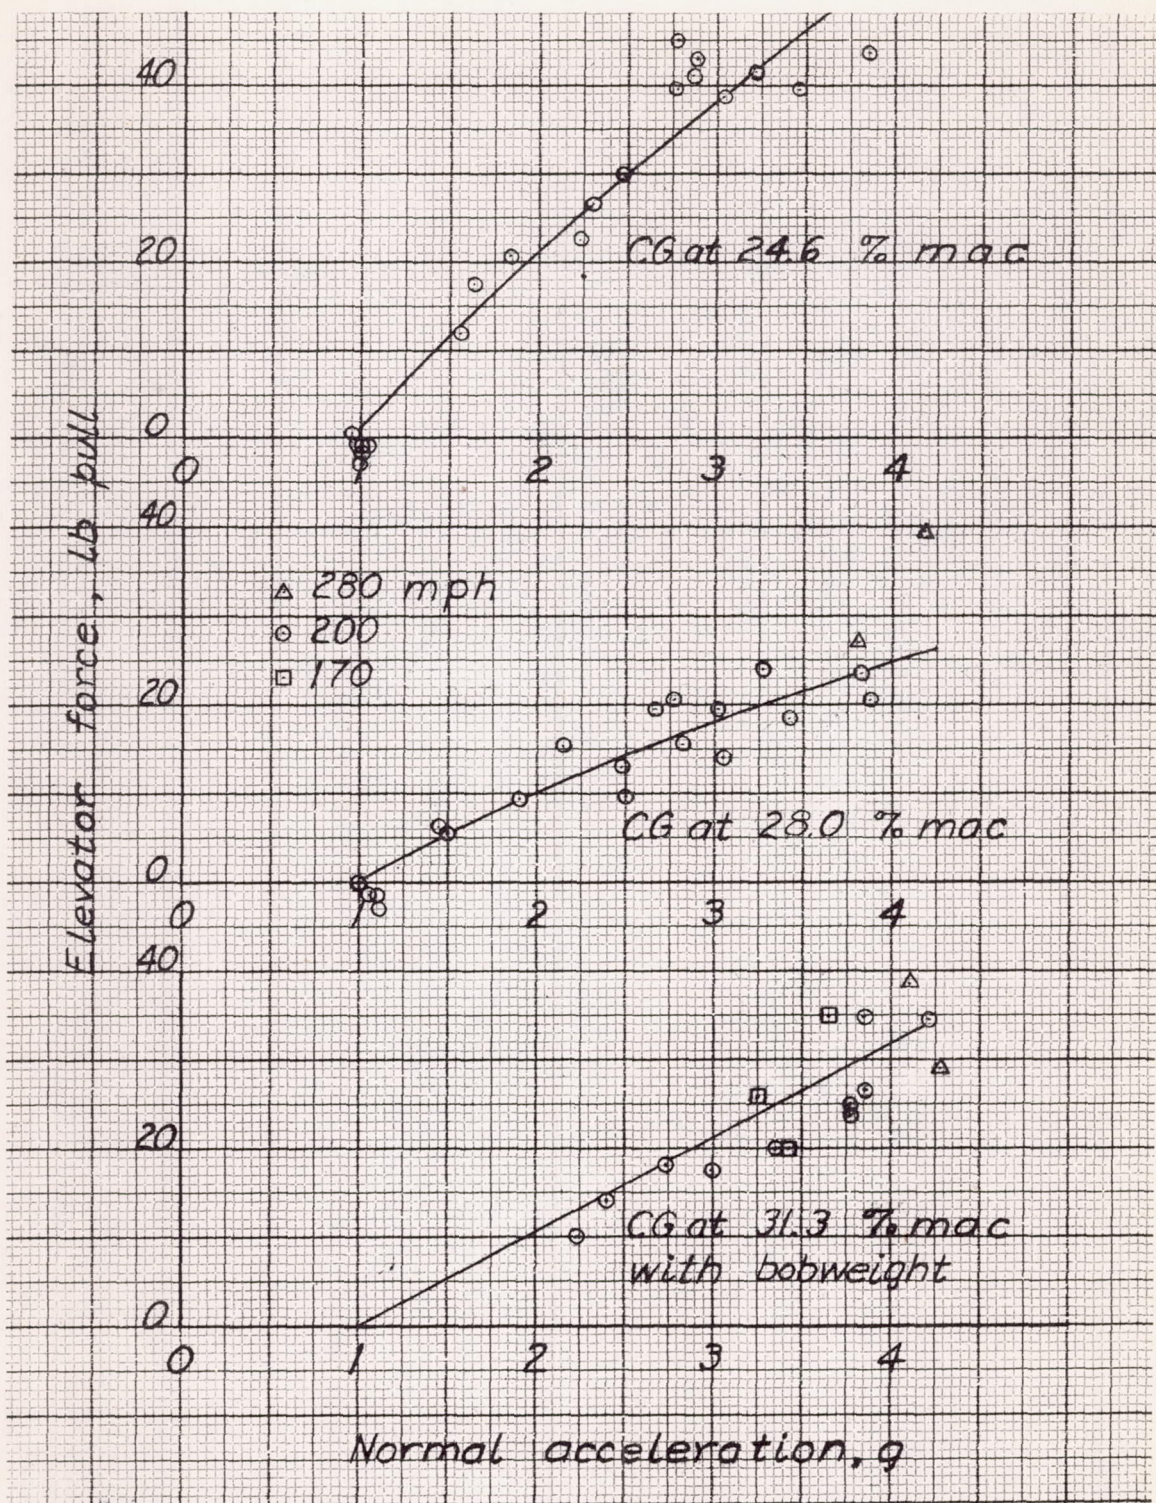
Figure 25.- Variation of elevator force with normal acceleration in turns. Curtiss SB2C-1 airplane.

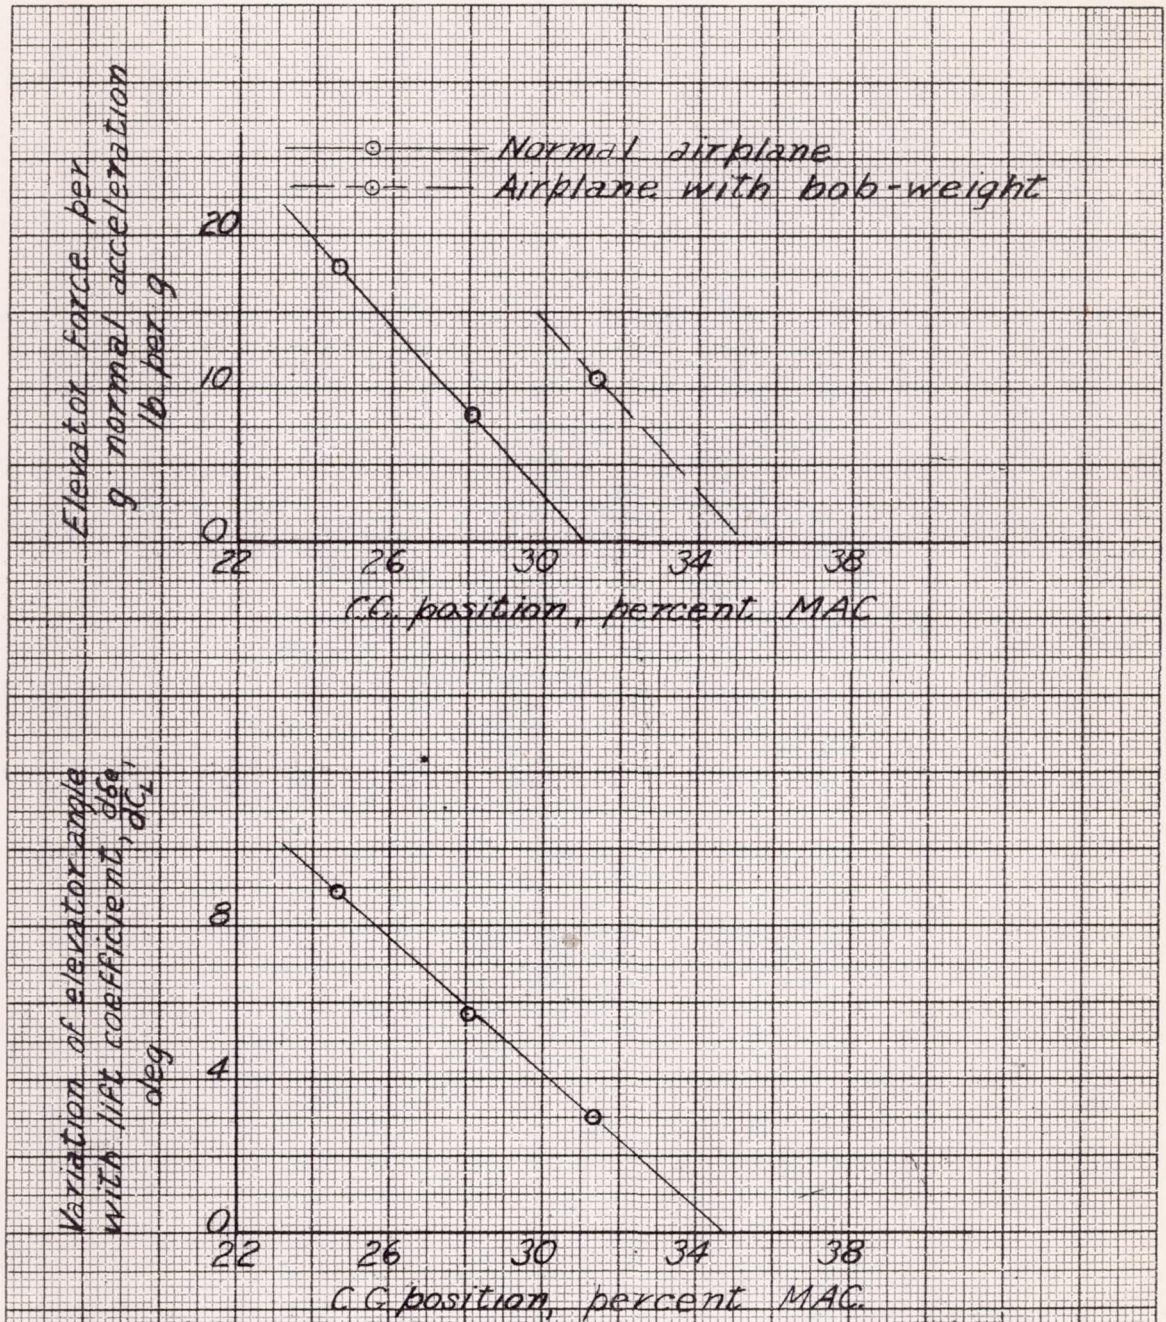
Figure 26.- Characteristics of Curtiss SB2C-1 airplane in steady turns.
