WARTIME REPORT

MEASUREMENTS OF FLYING QUALITIES OF

A CURTISS SB2C-1 AIRPLANE

(NO. 00014)

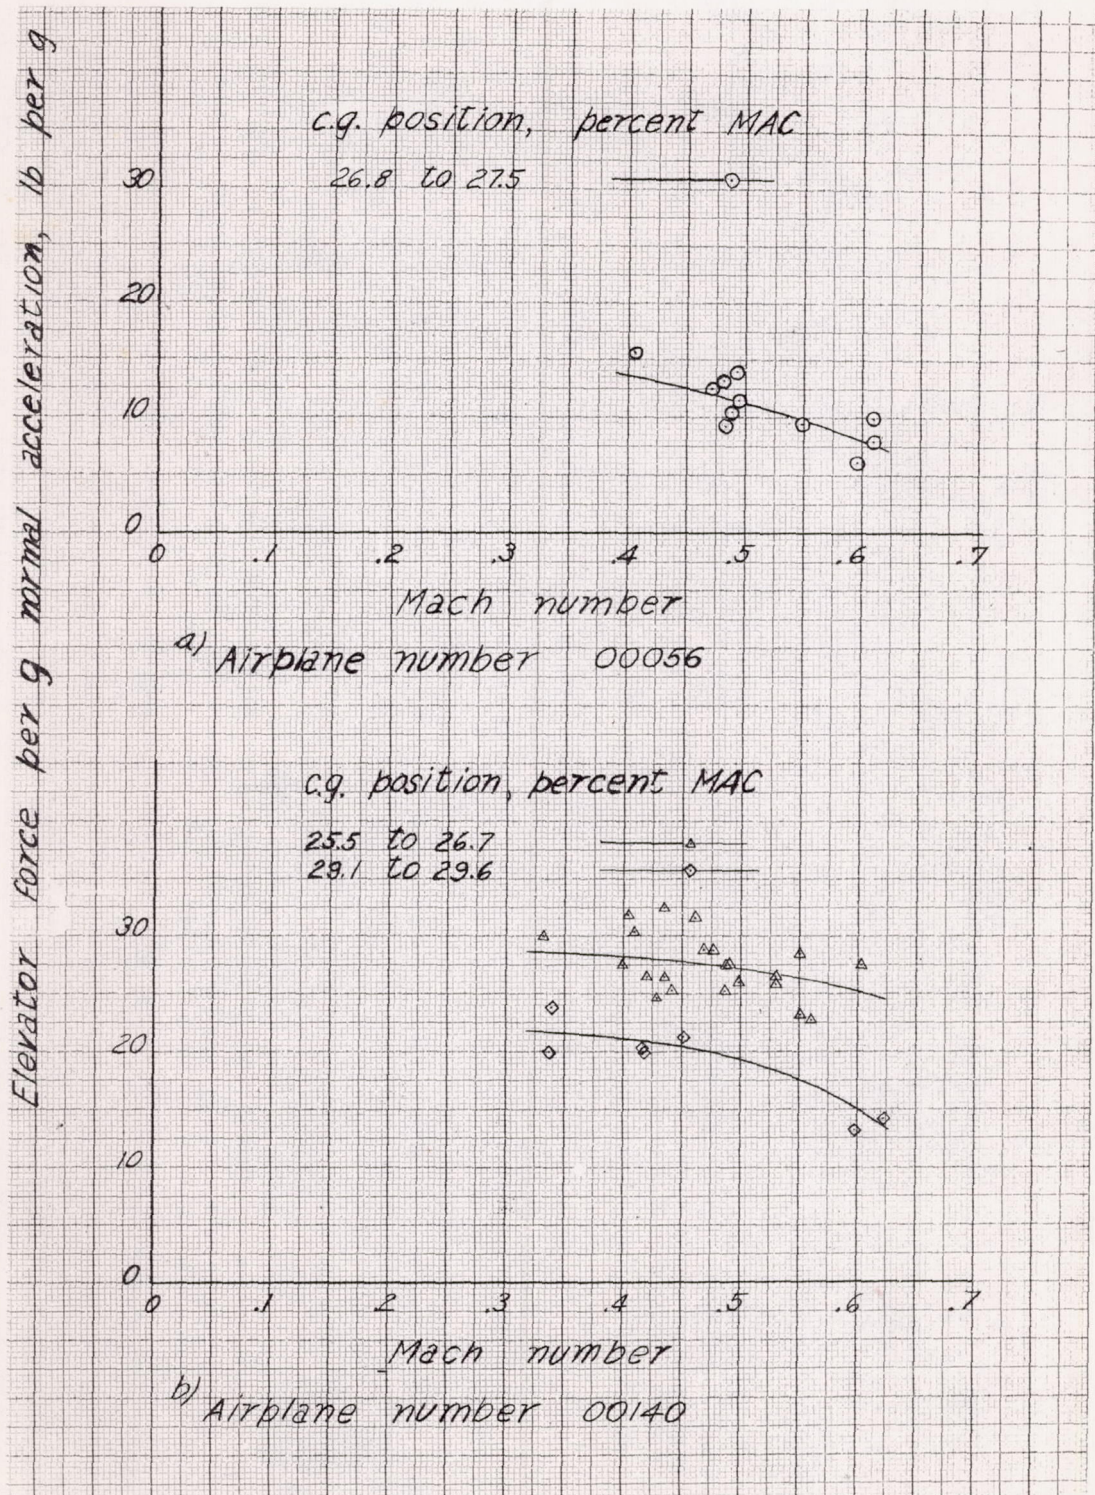
Figure 27.- Variation of elevator force per g normal acceleration with Mach number in pull-outs from dives. Curtiss SB2C-1 airplanes number 00056 and 00140, flaps up, landing gear up, front hood open, rear hood closed, power off.

The characteristics of airplanes 00056 and 00140 in accelerated flight at high speeds were determined in pull-outs from power-off dives. The stick force per g normal acceleration is plotted as a function of Mach number in figure 27(a) for airplane 00056 and in figure 27(b) for airplane 00140 with two center-of-gravity positions. It will be noted that the stick-force gradient for airplane 00056 shows a tendency to decrease with increasing Mach number. The stick-force gradient for airplane 00140 is considerably greater than that for airplane 00056 even with a more rearward center-of-gravity position. This difference may be due to the modified elevator nose shape. The stick-force gradient again tends to decrease as the Mach number increases, especially with the more rearward center-of-gravity position. Though the stick-force characteristics are plotted against Mach number, it is not implied that compressibility effects were entirely responsible for the observed changes, inasmuch as considerable distortion of the elevator fabric resulting from negative pressure inside the surface was observed to occur at high speeds.

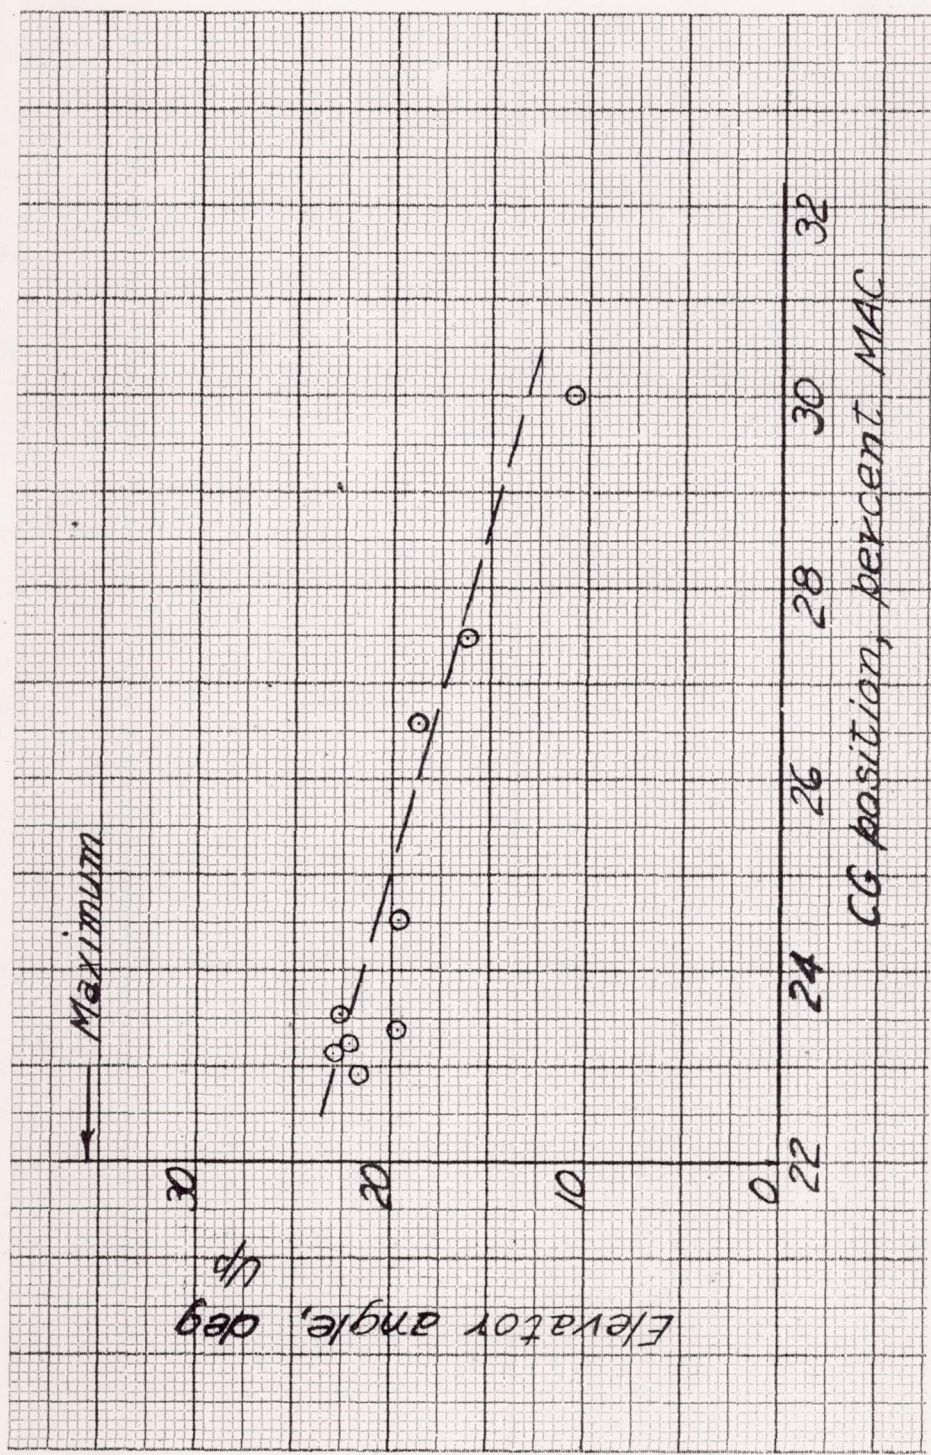
Figure 28.- Variation of elevator angle required to make a three-point landing with center-of-gravity position. Curtiss SB2C-1 airplane.

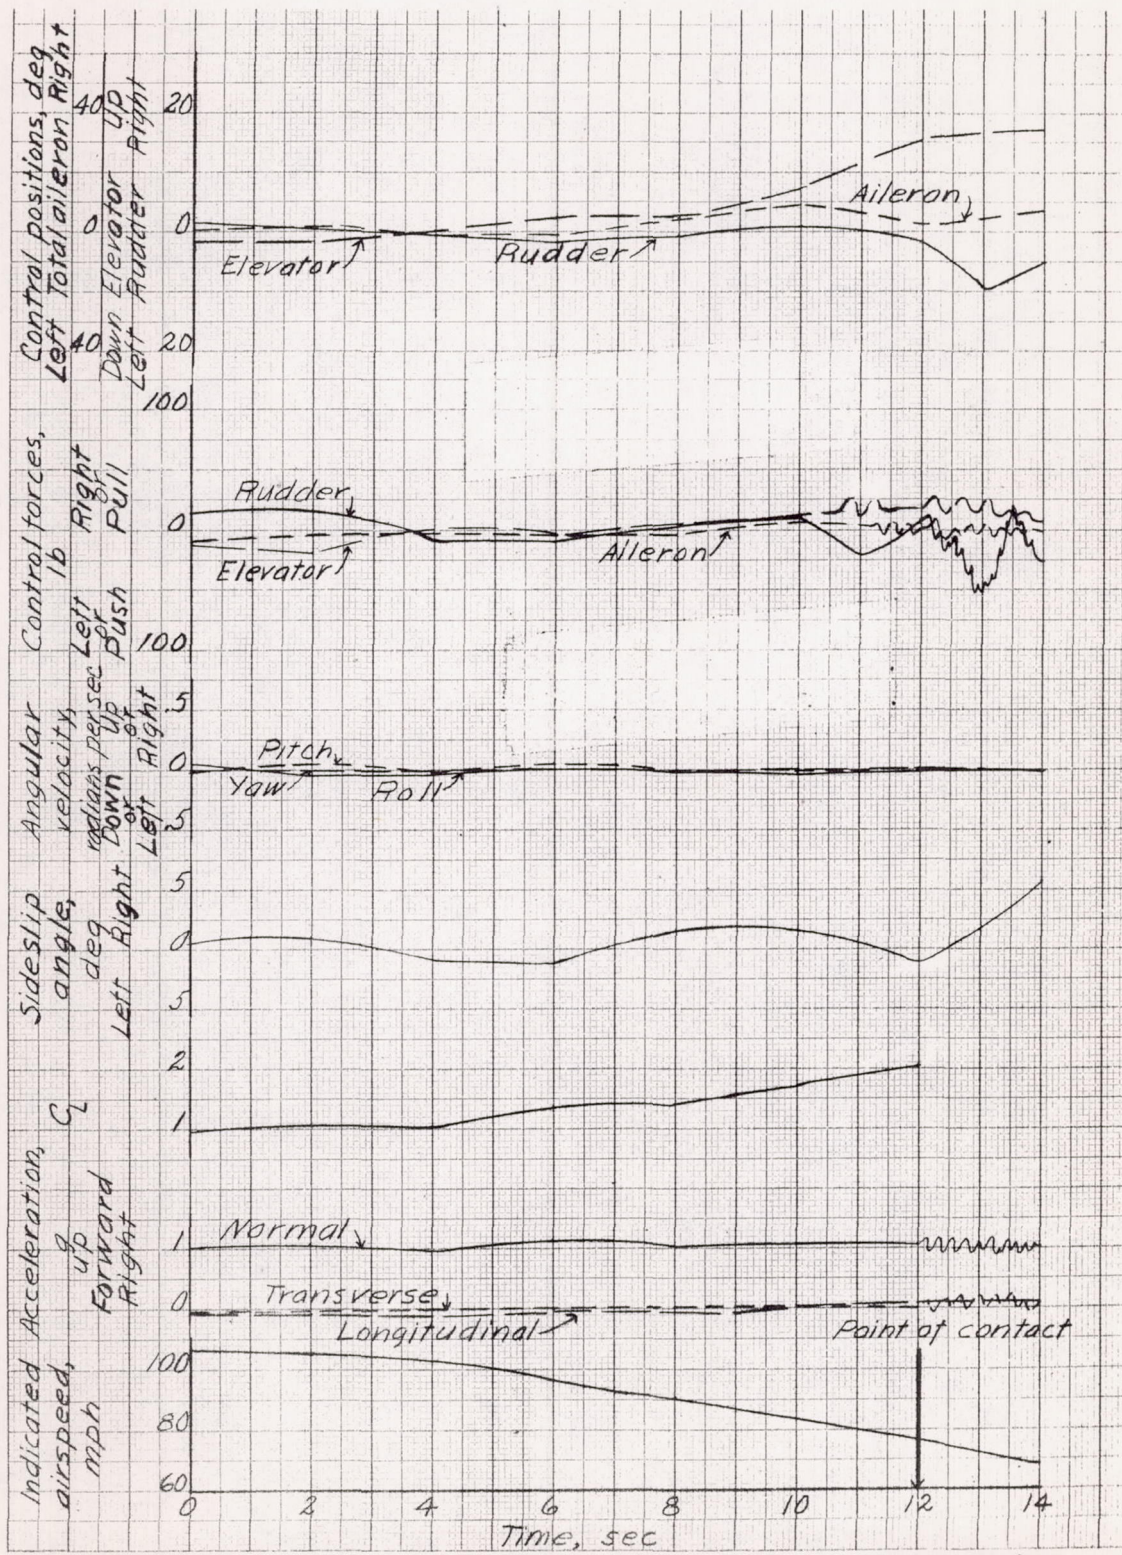
Figure 29.- Time history of a three-point landing (flaps down, landing gear down, power off). Center of gravity at 27.2 percent of the mean aerodynamic chord. Curtiss SB2C-1 airplane.

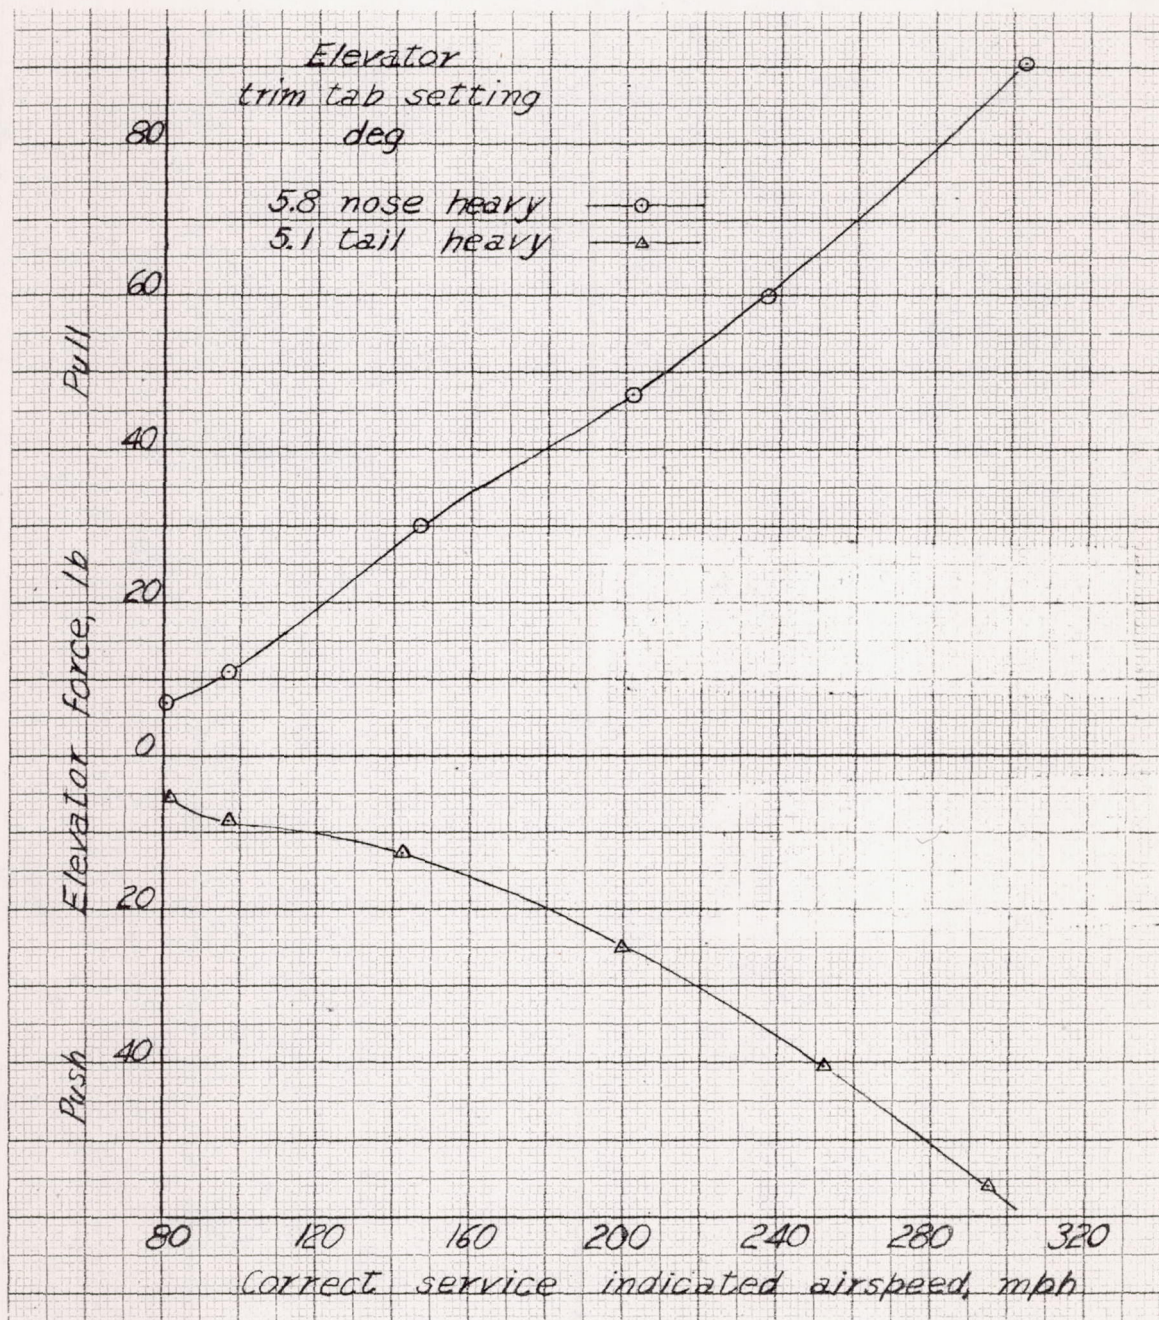
Figure 30.- Variation of elevator force with speed for two trim tab settings in the climbing condition (flaps up, landing gear up, rated power) Curtiss SB2C-1 airplane.

The power of the elevator trim tabs was determined in three flight conditions (climbing, wave-off, and landing) by measuring the stick forces at various speeds with two trim tab deflections. The results of these tests are given in figures 30 and 31. The data were evaluated to obtain the force per degree trim tab change as a function of speed (fig. 32). The change in elevator hinge-moment coefficient per degree change in trim-tab angles was calculated and is given as a function of speed in figure 33. The hinge-moment coefficients are based on free-stream dynamic pressure and on the same value of the product of the span and chord squared as used in section I-C.

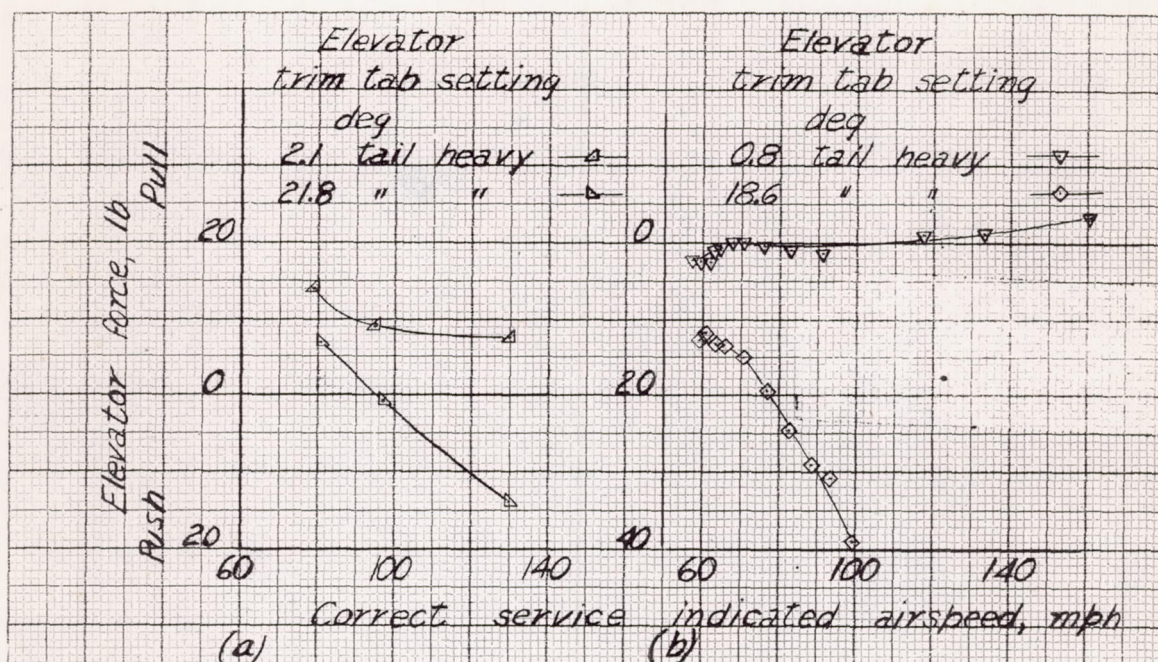
- (a) Landing condition (flaps down, landing gear down, power off).
- (b) Wave-off condition (flaps down, landing gear down, full power).

Figure 31.- Variation of elevator force with speed for two trim-tab settings. Curtiss SB2C-1 airplane.

(b) The power of the elevator trim tabs was only one-third as great in the landing condition as in the wave-off condition. Therefore, if the airplane were trimmed full-tail heavy for a landing, and then rated power were applied for a wave-off, the push forces required for trim would become excessive as the speed increased. This characteristic is shown in figure 15(b) and in figure 31(b).

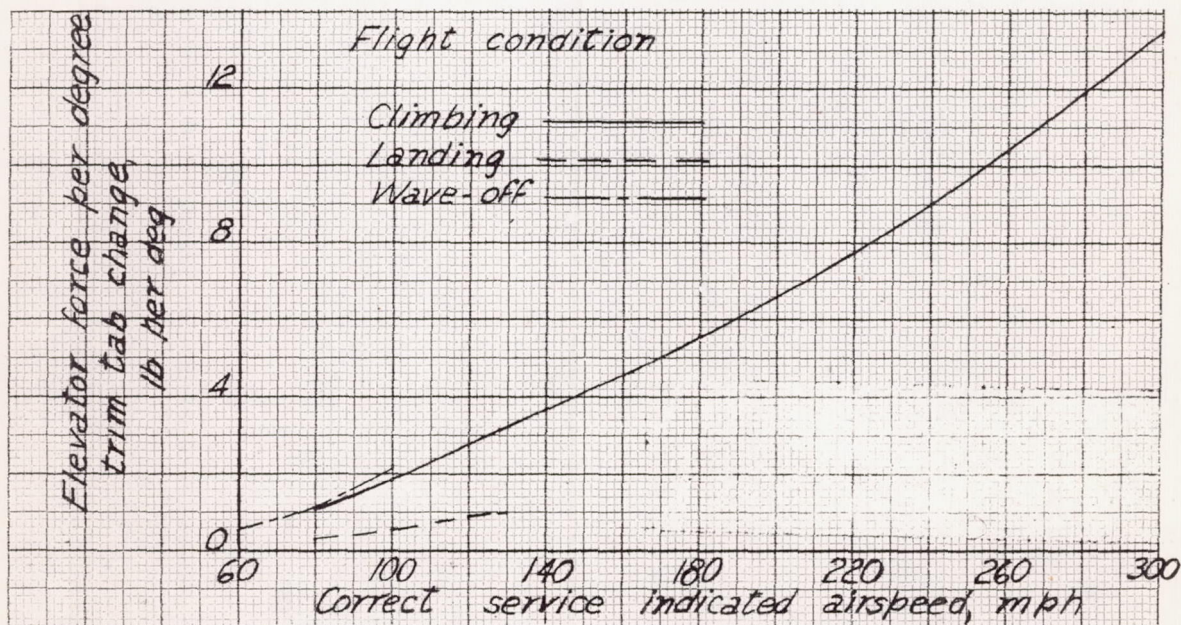
Figure 32.- Variation of power of elevator trim tab with speed. Curtiss SB2C-1 airplane.

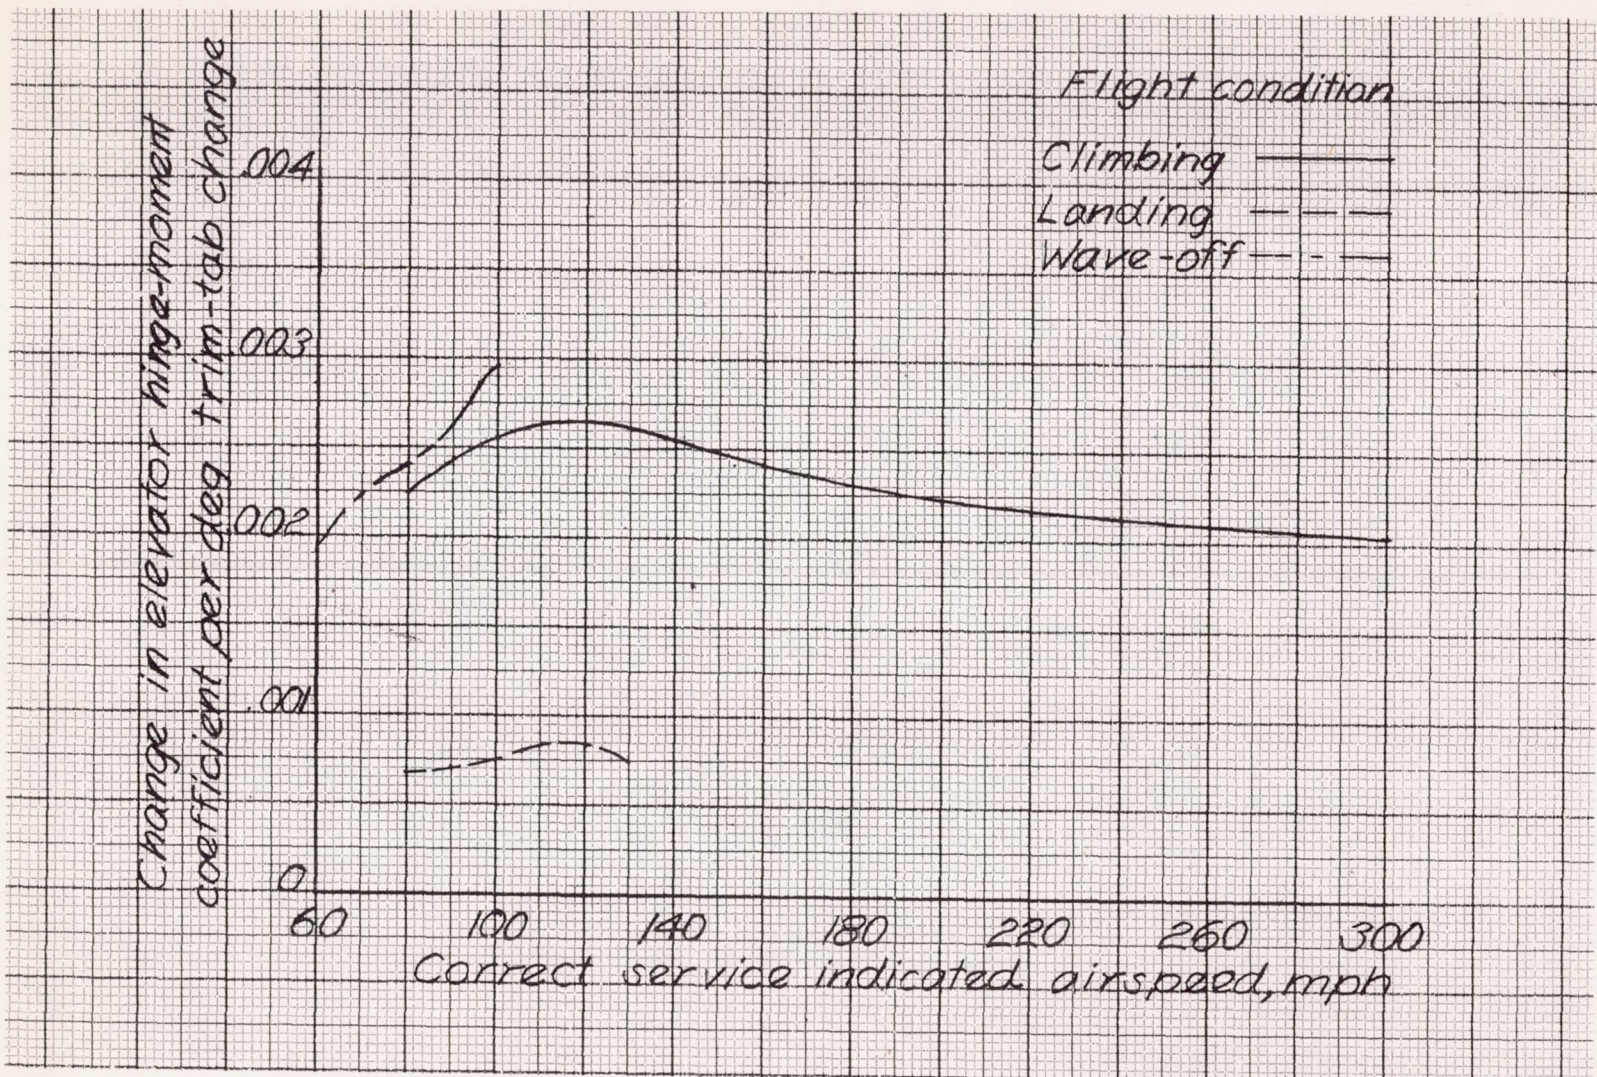
Figure 33.- Variation of change in elevator hinge moment coefficient per degree trim-tab deflection with indicated airspeed. Curtiss SB2C-1 airplane.

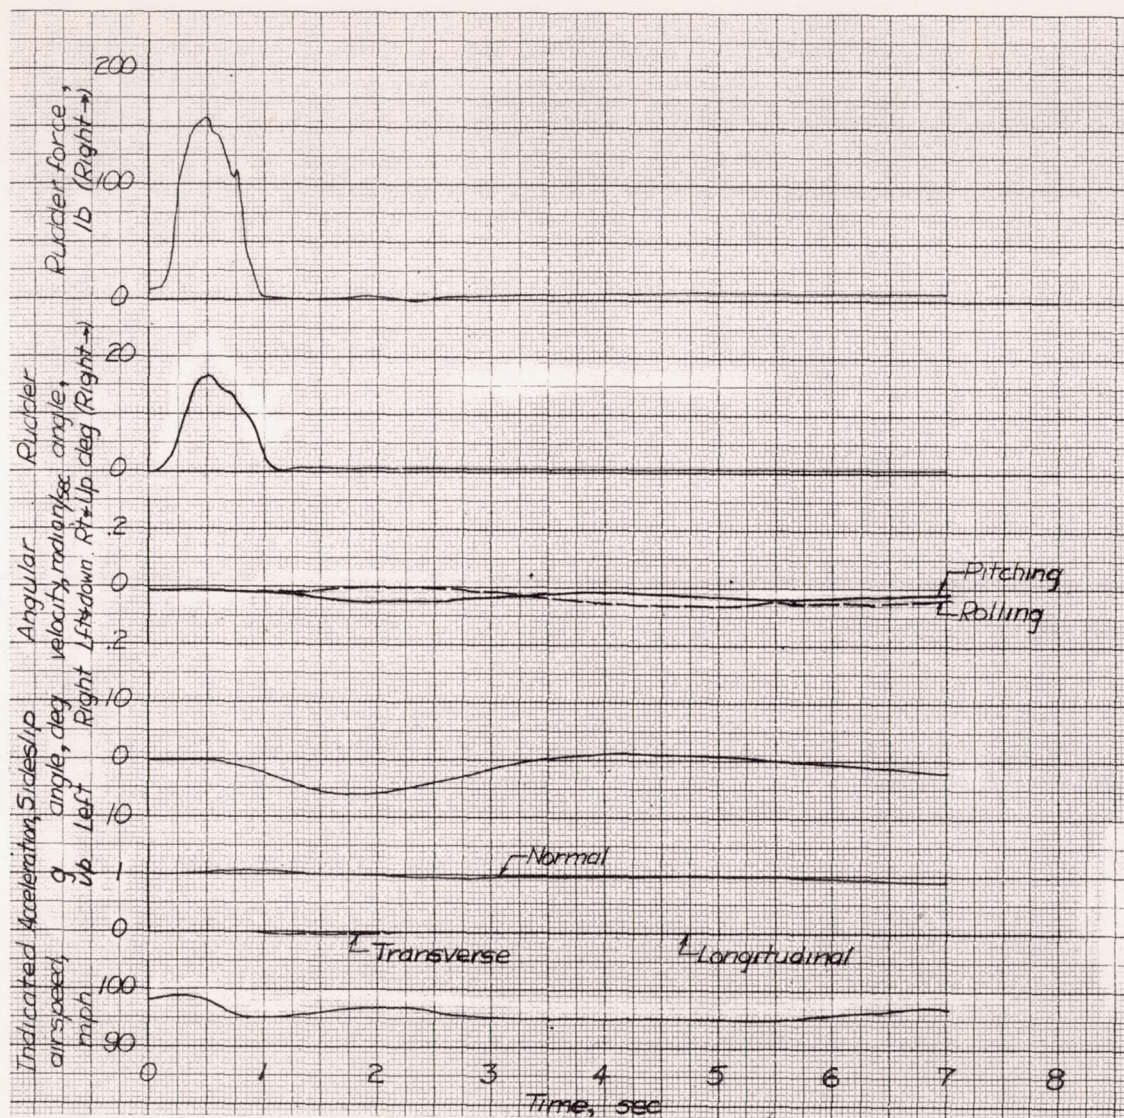
Figure 34.- Time history of a typical lateral oscillation at approximately 98 mph. Curtiss SB2C-1 airplane, flaps up, landing gear up, power off.

The characteristics of the uncontrolled lateral and directional motion were determined in the speed range from 100 to 300 miles per hour for the gliding and climbing condition and from 90 to 130 miles per hour in the landing condition. In these tests, the airplane was trimmed for laterally level flight and continuous records were taken while the pilot abruptly deflected the rudder then released all controls. Typical time histories of this maneuver are given in figures 34 and 35. The variation of the period and number of cycles to damp to half amplitude with indicated airspeed for the flight conditions tested is given in figure 36. Inspection of this figure shows that the oscillations damped to half amplitude within two cycles in all conditions tested. The amplitude of the sideslip angle variation in these tests was between 2° and 10° . For these amplitudes, therefore, the requirements of reference 1 were satisfied. The pilot noted, however, that in some runs at high speed the lateral oscillations appeared to be poorly damped and that a continuous oscillation of small amplitude might exist. As shown in figure 36, the damping of the oscillations was becoming poorer as the speed increased.

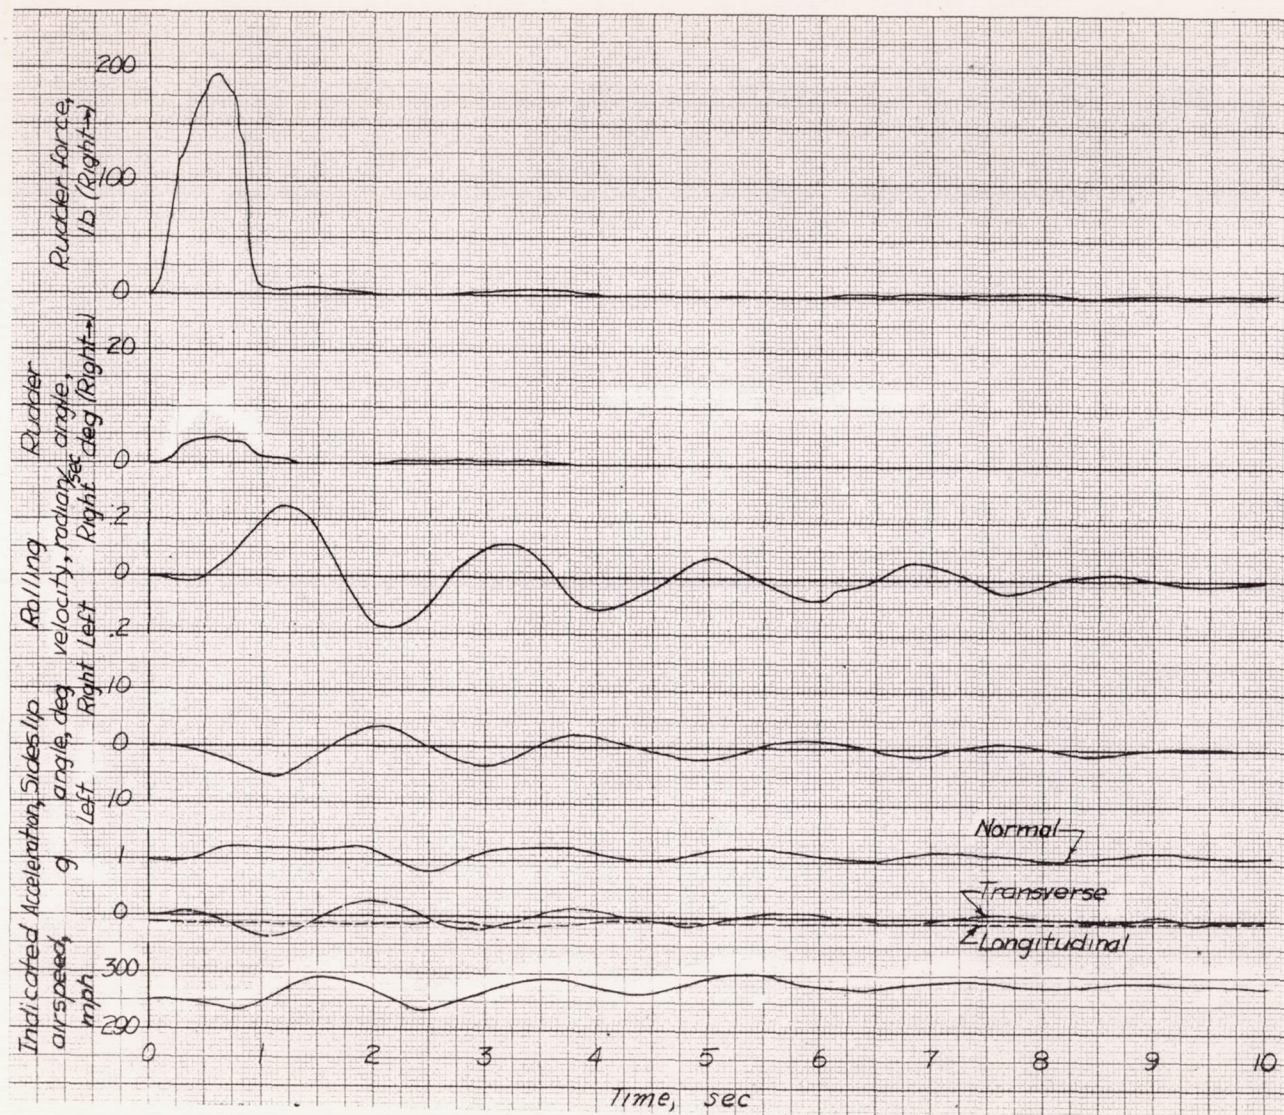
Figure 35.- Time history of a typical lateral oscillation at approximately 295 mph.
Curtiss SB2C-1 airplane, flaps up, landing gear up, rated power.

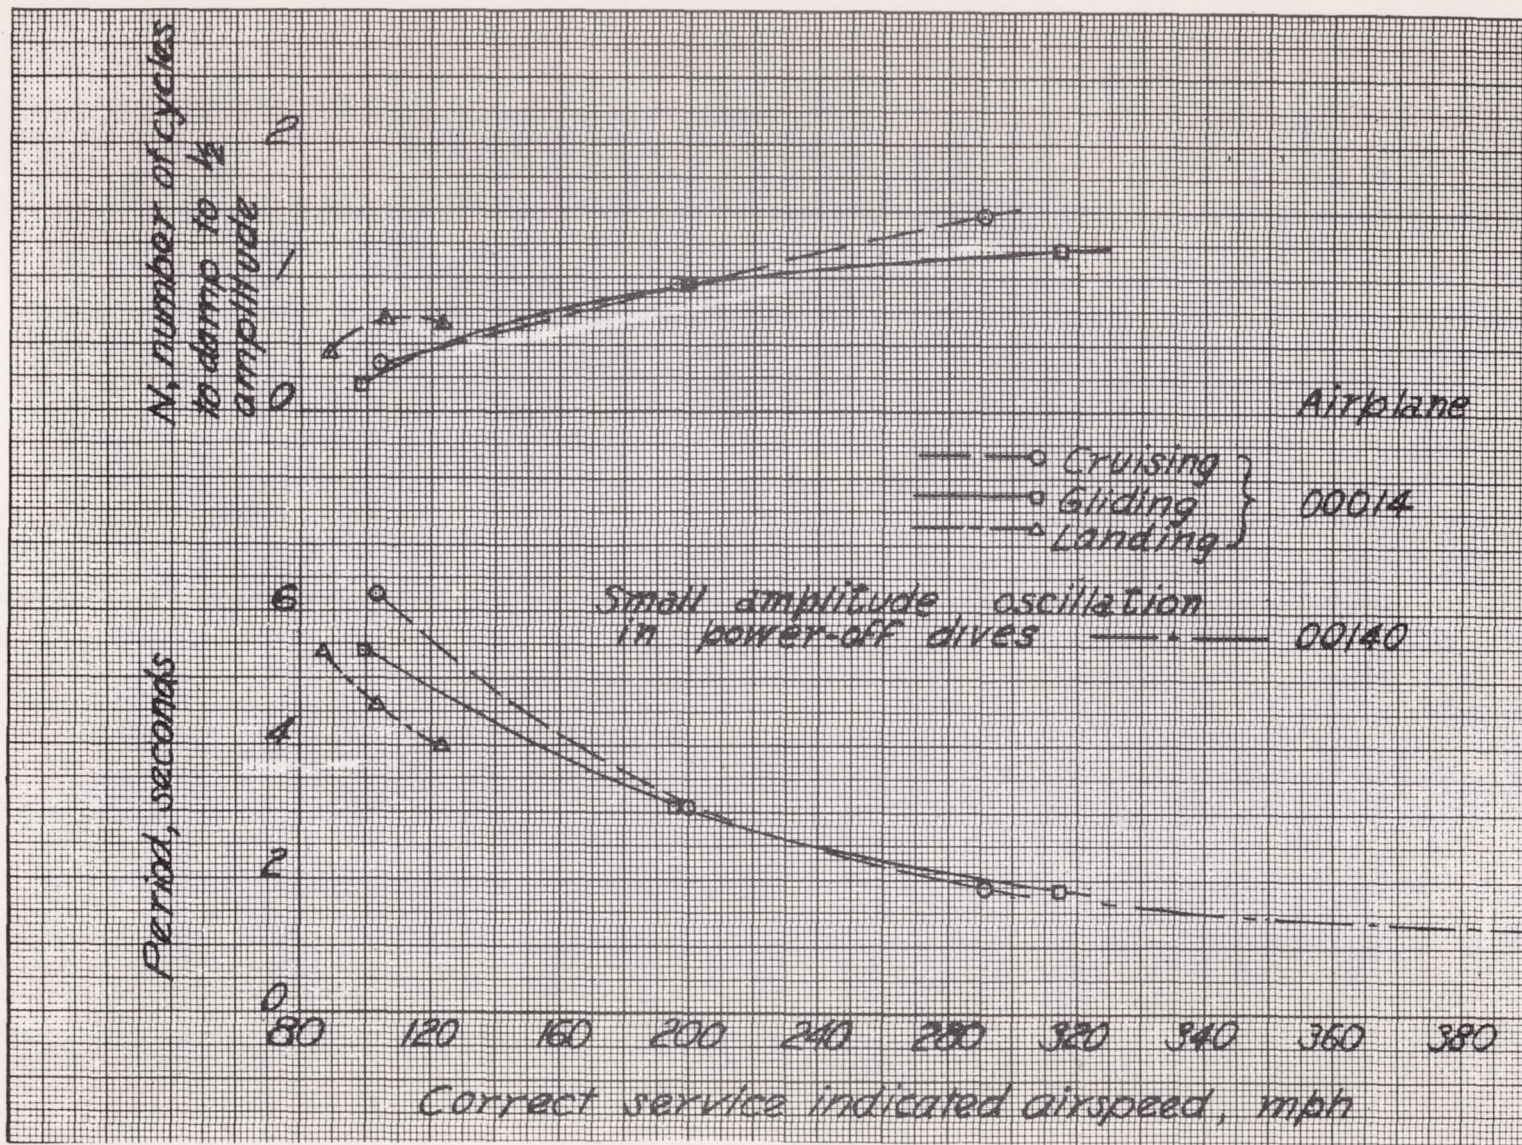
Figure 36.- Period and damping of lateral oscillations. Curtiss SB2C-1 airplane.

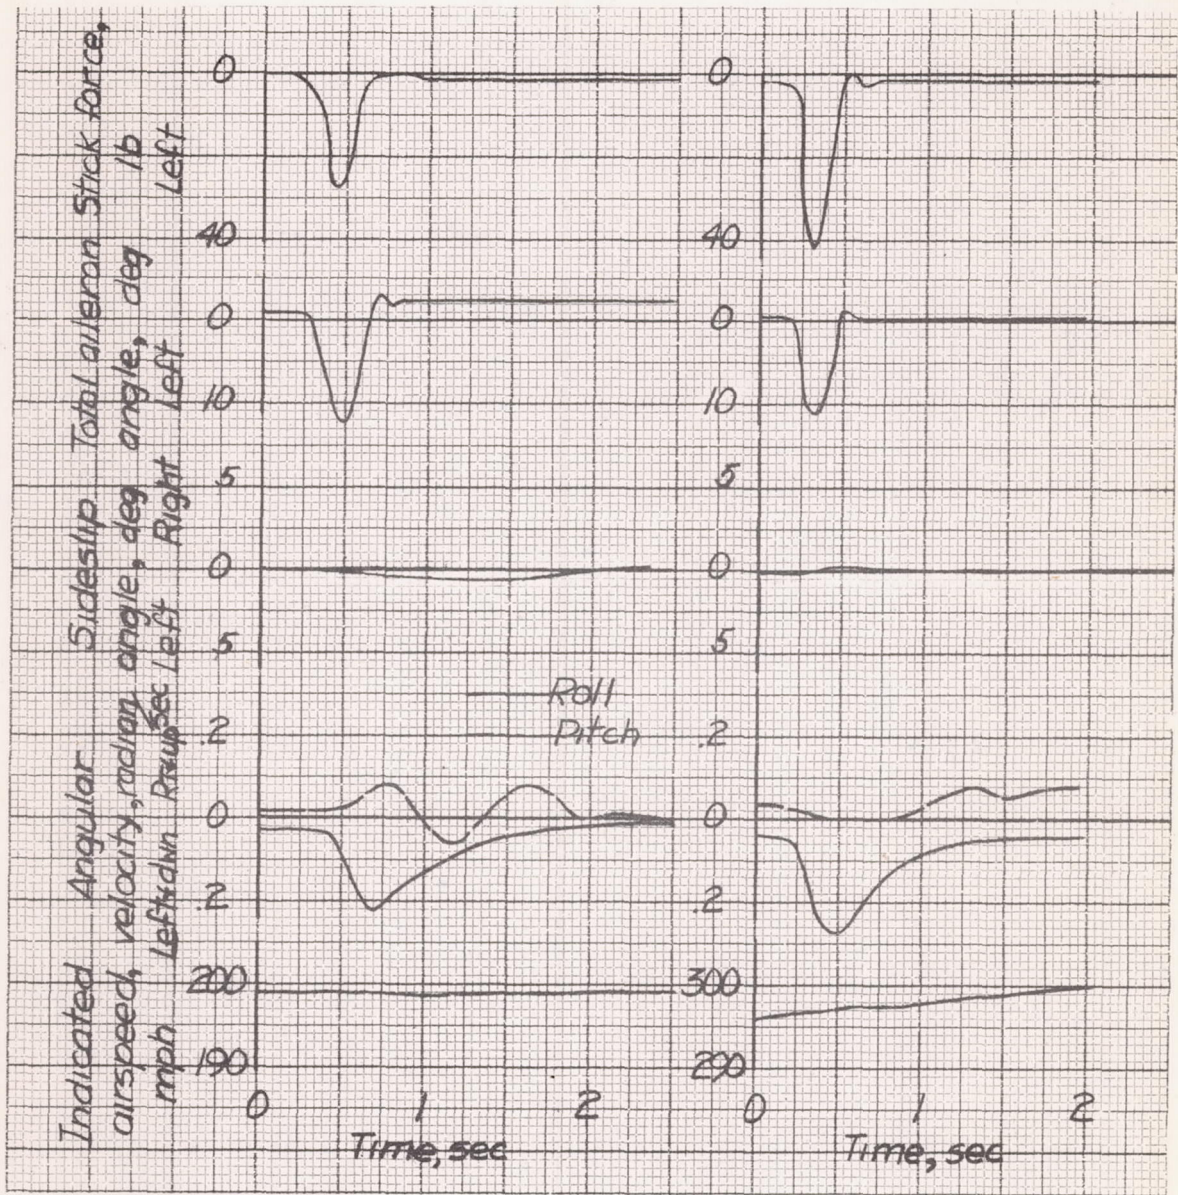
Figure 37.- Time histories of typical attempted aileron oscillations. Curtiss SB2C-1 airplane, flaps up, landing gear up, rated power.

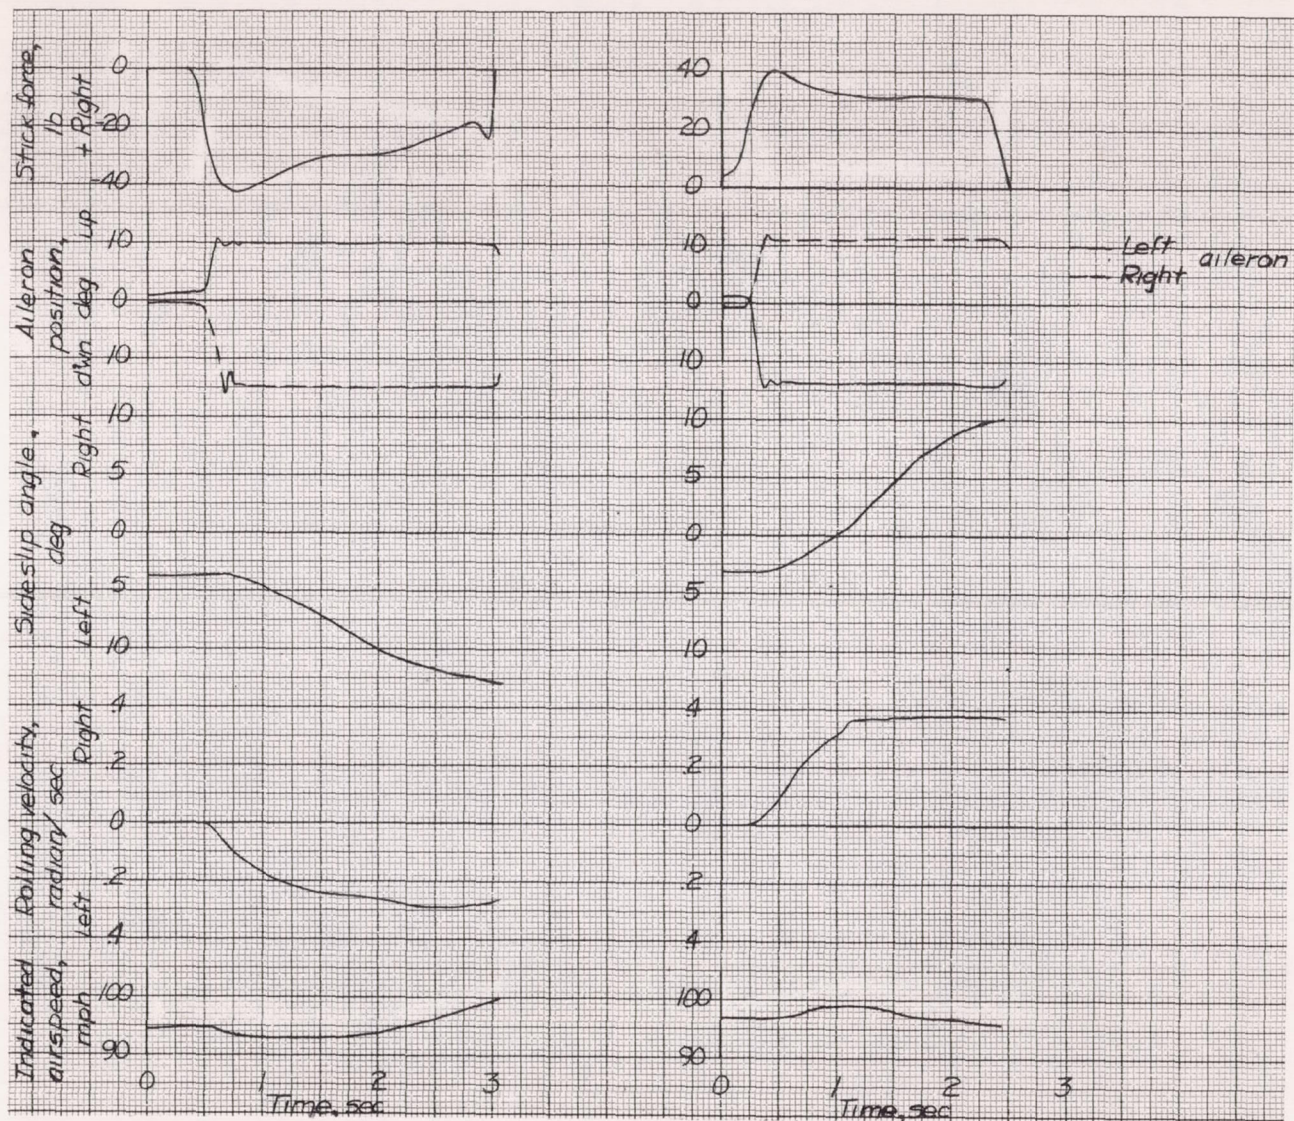
Figure 38.- Time histories of typical abrupt aileron rolls (rudder fixed) Curtiss SB2C-1 airplane, flaps up, landing gear up, power for level flight.

Figure 38 gives time histories of typical aileron rolls. The data obtained from the aileron rolls were evaluated to determine the variation of aileron effectiveness $pb/2V$ and change in aileron stick force with change in total aileron angle. These data are presented in figures 39 to 42. Figures 39 and 40 give data for the clean condition of flight with the aileron unsealed and sealed, respectively. Figures 41 and 42 pertain to aileron rolls made in the landing condition, ailerons unsealed and sealed, respectively. From these data, it was possible to determine the helix angle $pb/2V$, total aileron deflection, and rolling velocity obtainable with any stick force through the speed range of the tests. Figure 43 gives values of these quantities obtainable with a 30-pound stick force as a function of speed. The rolling velocity in this figure is corrected to 10,000 feet altitude.

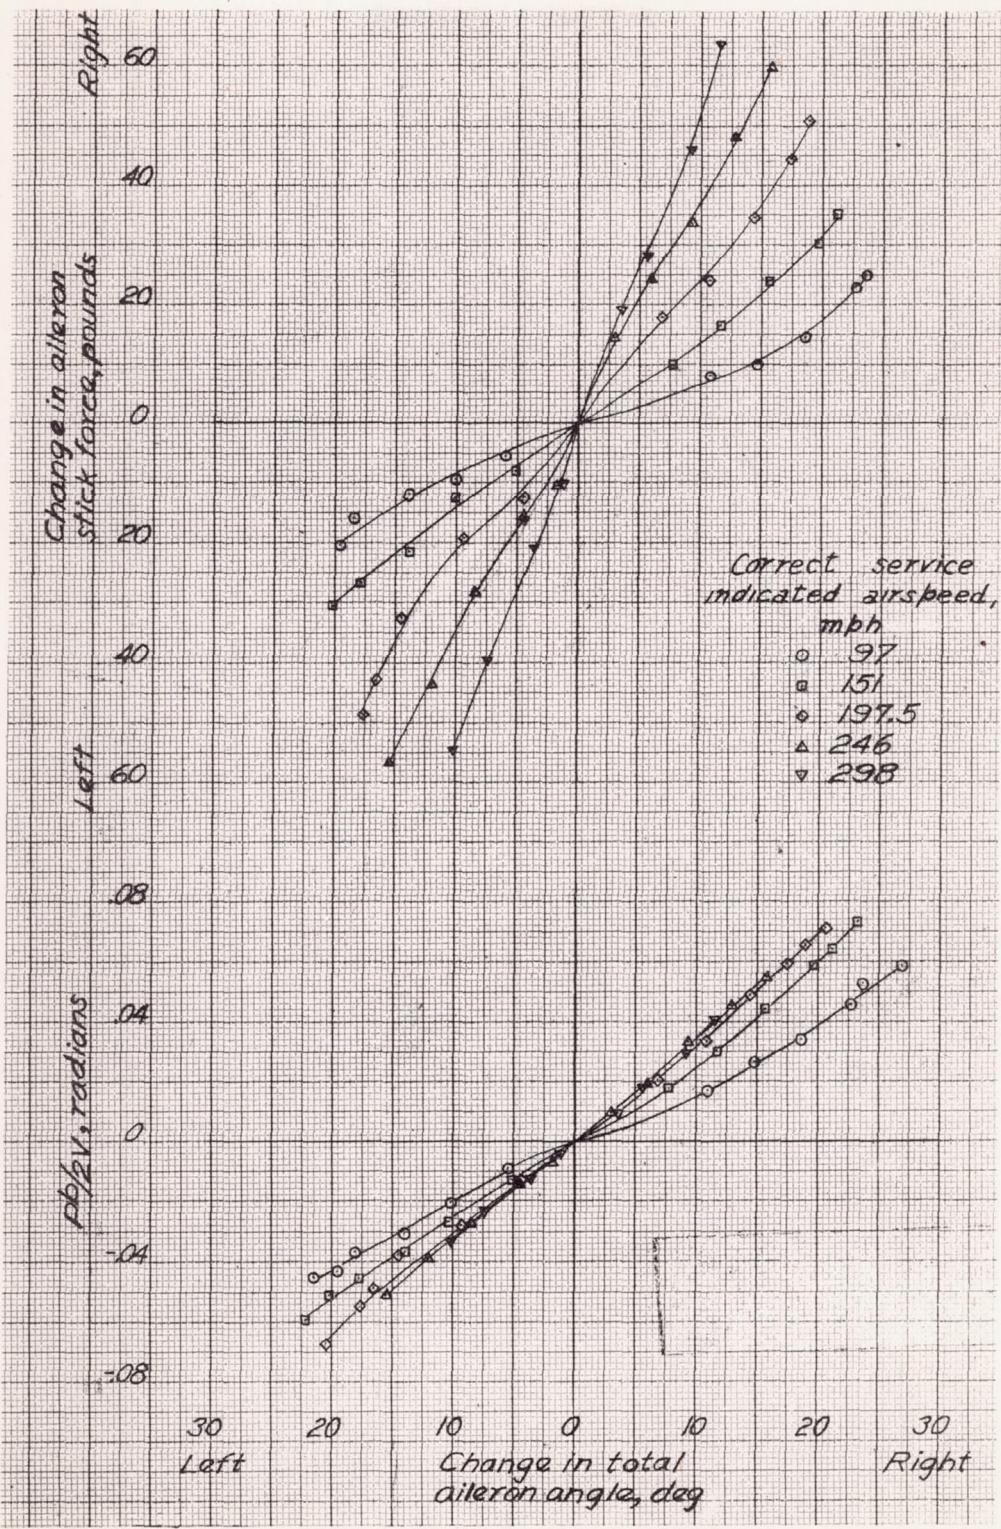
Figure 39.- Variation of aileron stick force and helix angle, $pb/2V$, with change in total aileron angle in rolls made at various speeds; flaps up, landing gear up, power for level flight, aileron gap unsealed, Curtiss SB2C-1 airplane.

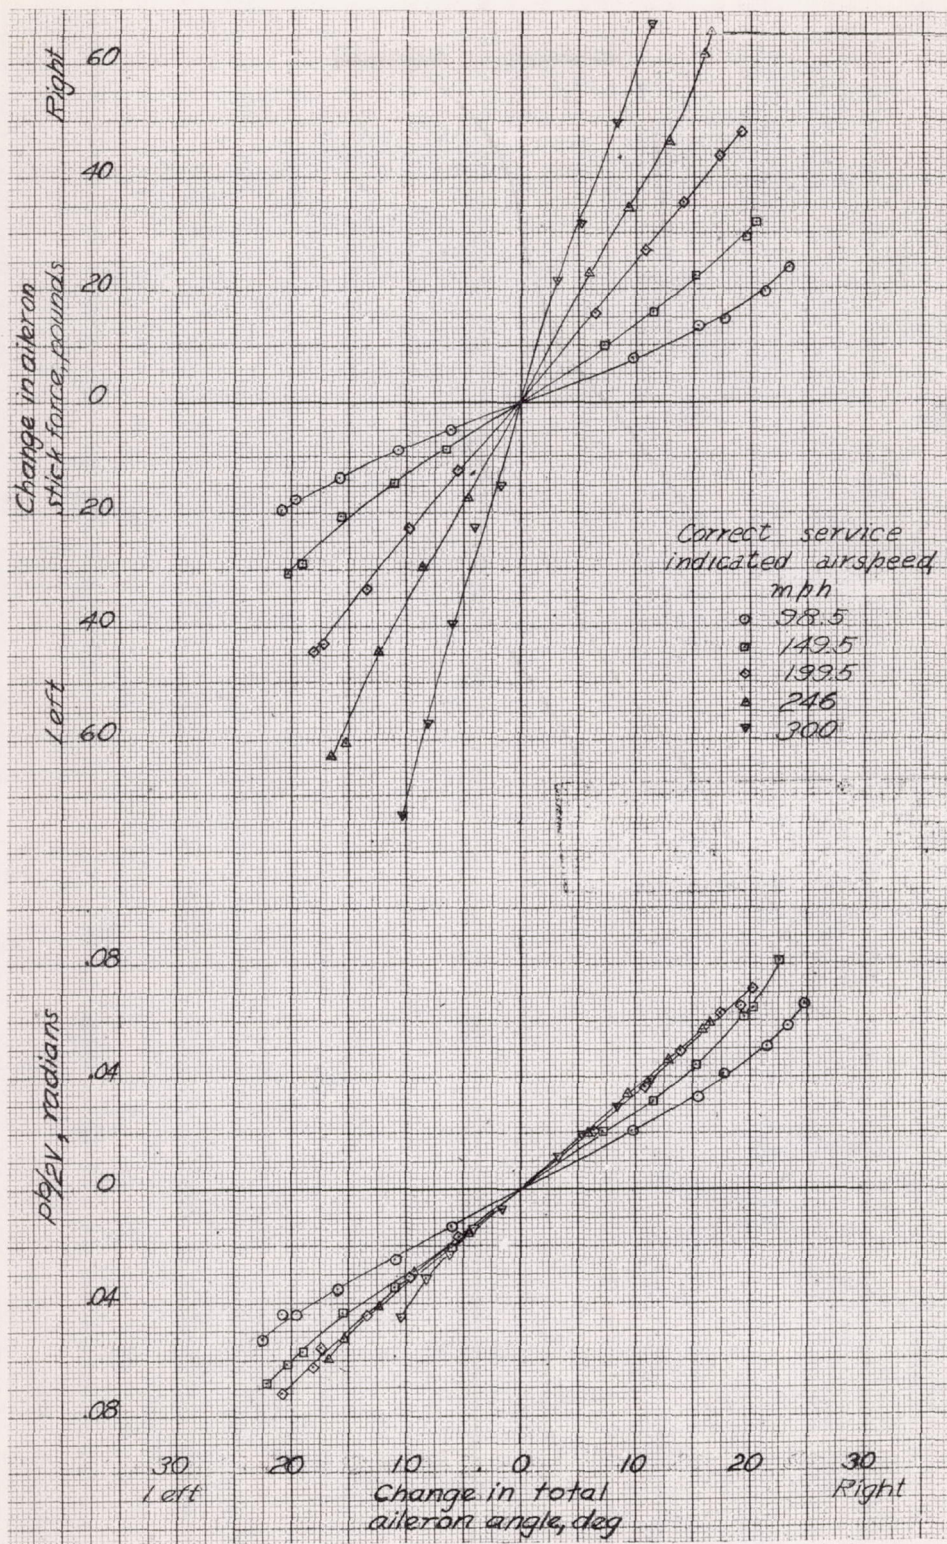
Figure 40.- Variation of aileron stick force and helix angle, $pb/2V$, with change in total aileron angle in rolls made at various speeds; flaps up, landing gear up, power for level flight, aileron gap sealed, Curtiss SB2C-1 airplane.
