WARTIME REPORT

MEASUREMENTS OF FLYING QUALITIES OF

A CURTISS SB2C-1 AIRPLANE

(NO. 00014)

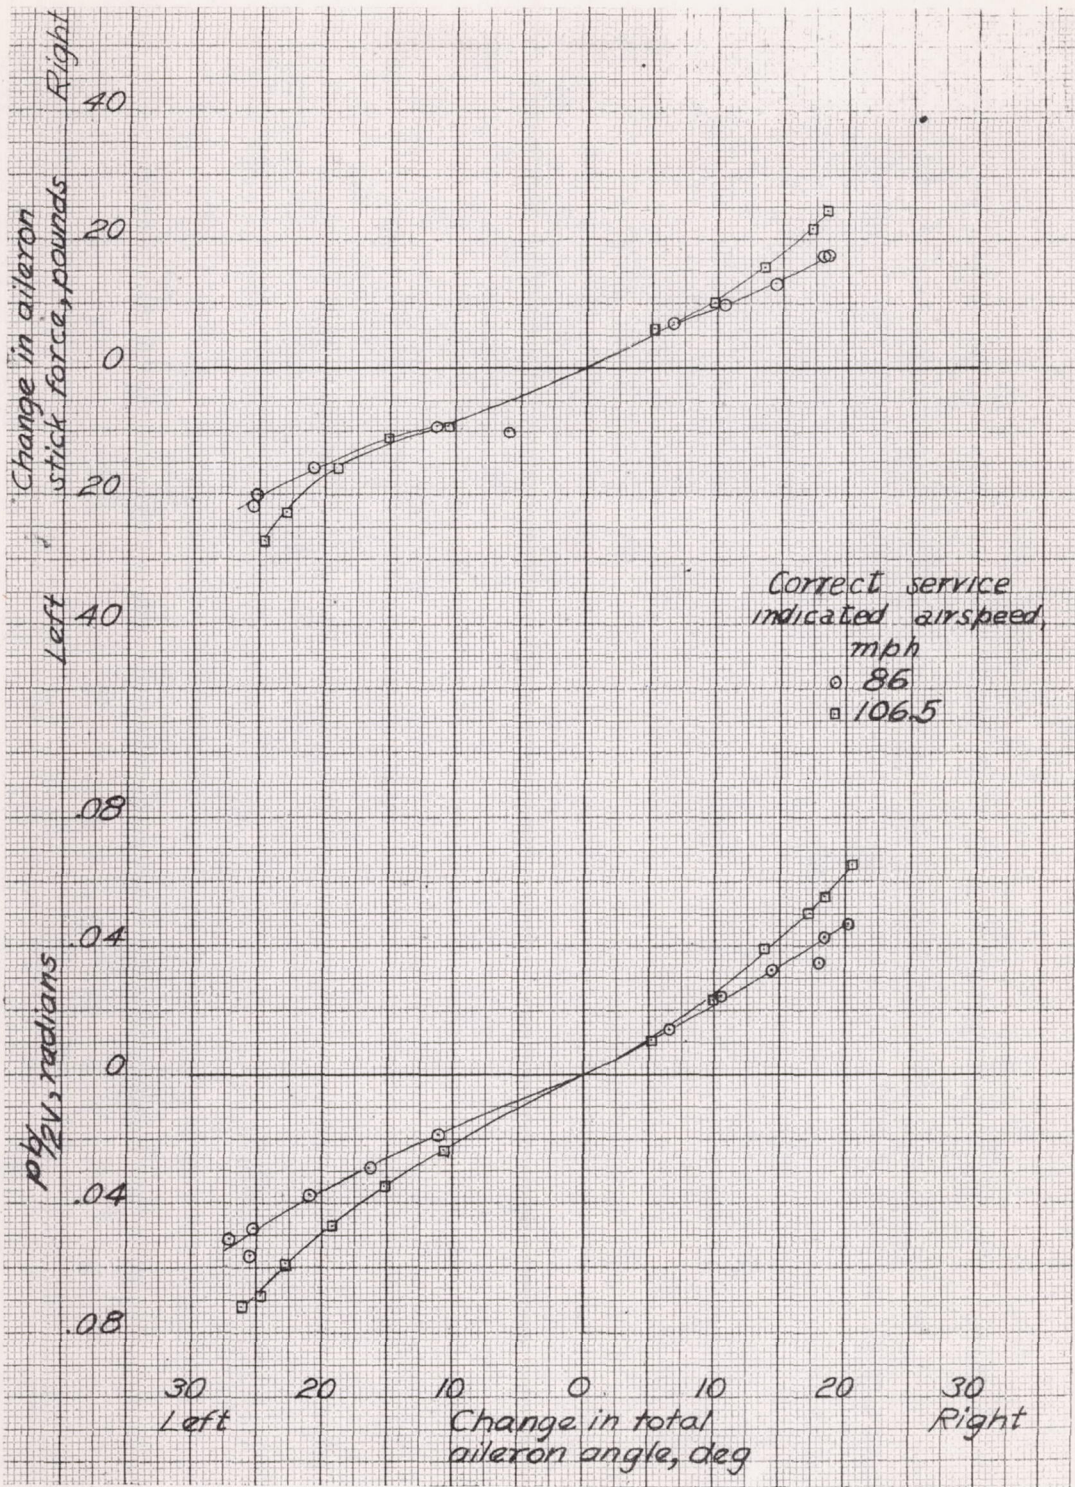
Figure 41.- Variation of aileron stick force and helix angle, $pb/2V$, with change in total aileron angle in rolls made at two speeds; flaps down, landing gear down, leading-edge slots open, power off, aileron gap unsealed, Curtiss SB2C-1 airplane.

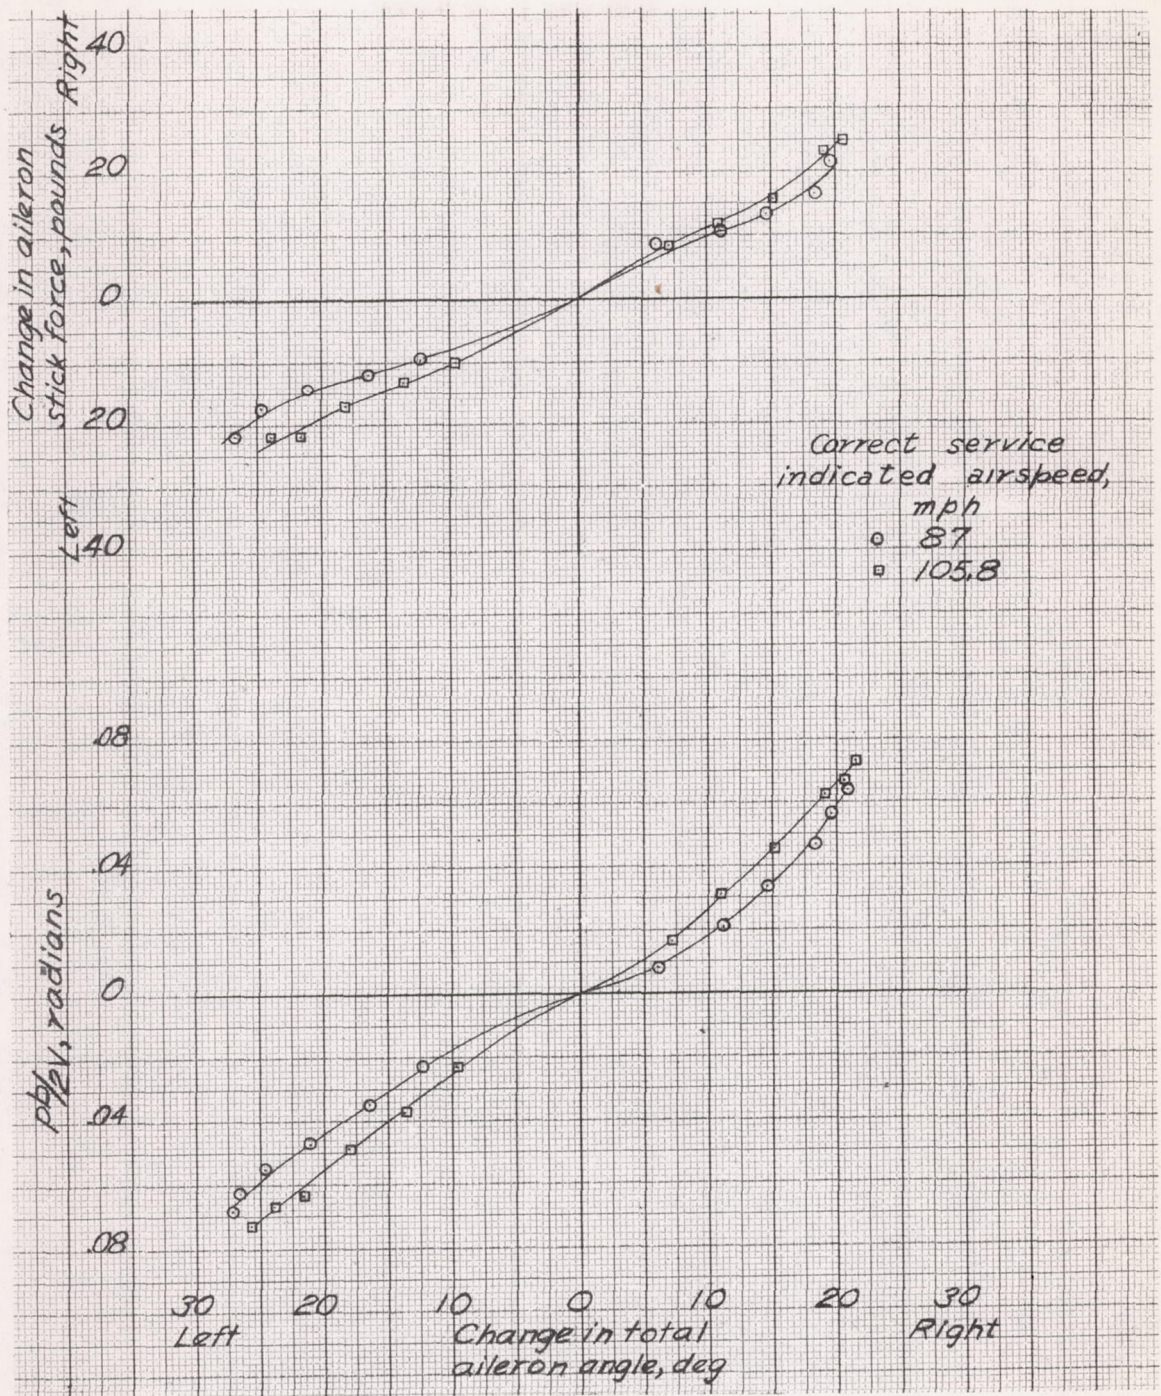
Figure 42.- Variation of aileron stick force and helix angle, $pb/2V$, with change in total aileron angle in rolls made at two speeds; flaps down, landing gear down, leading-edge slots open, power off, aileron gap sealed, Curtiss SB2C-1 airplane.

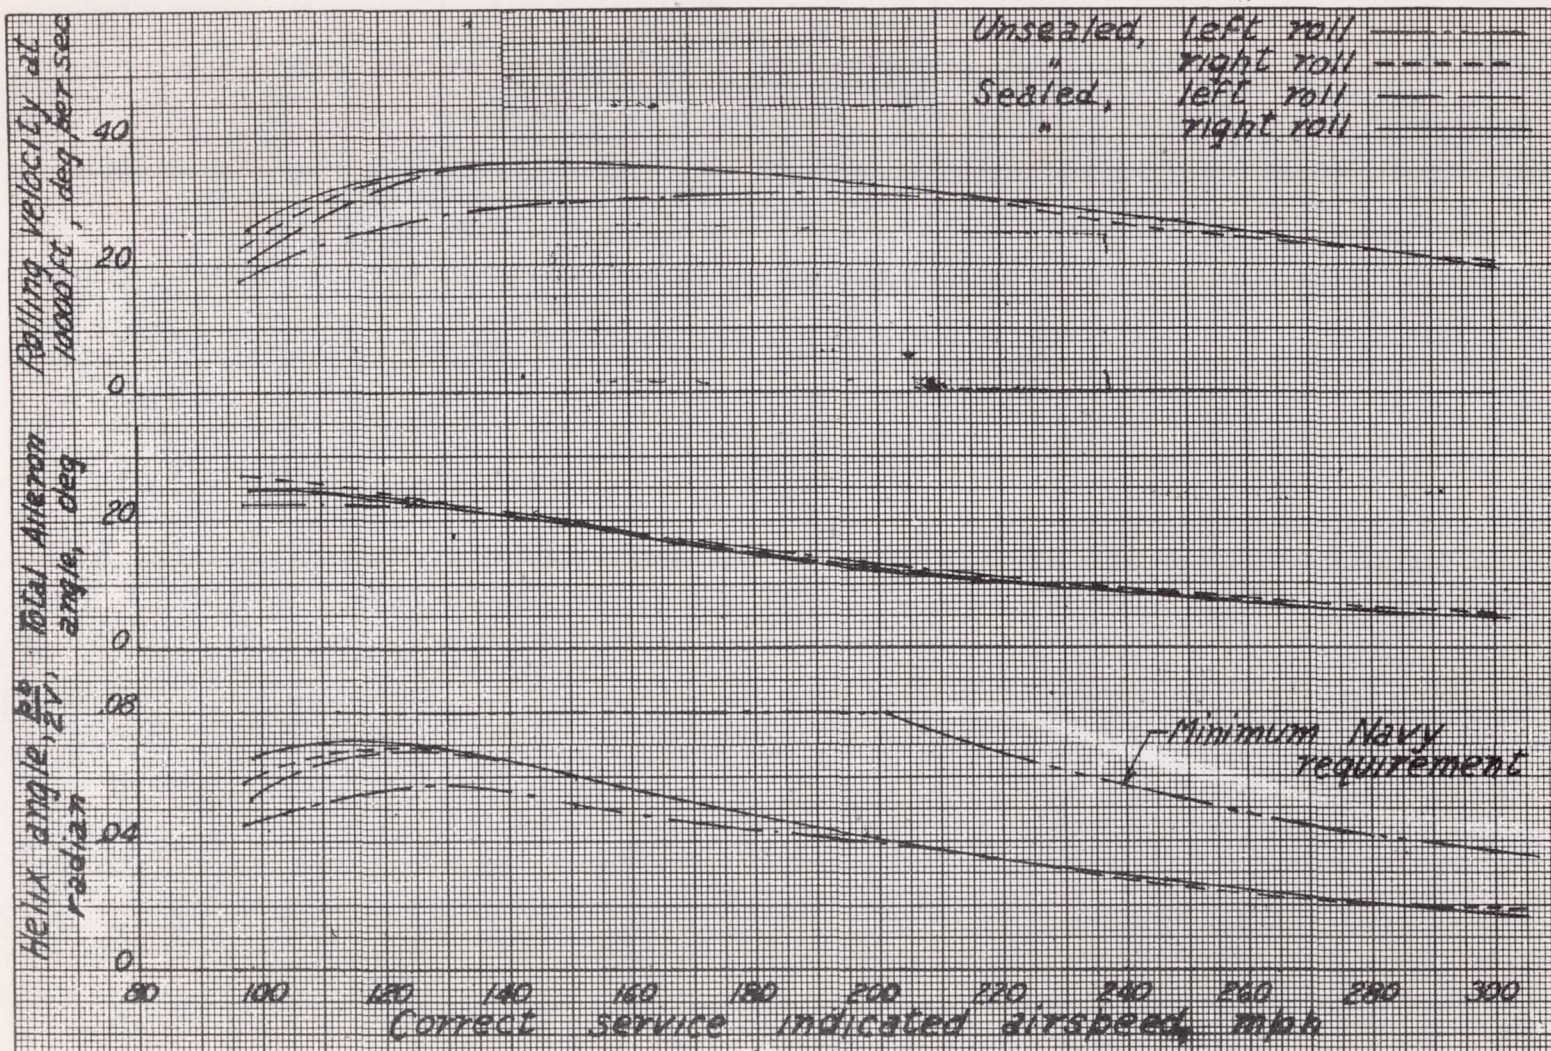
Figure 43.- Variation of helix angle, $\frac{pb}{2V}$, total aileron angle, and rolling velocity at 10,000 feet altitude obtainable with 30 pounds stick force as a function of speed. Flaps up, landing gear up, power for level flight, Curtiss SB2C-1 airplane.

Figure 38 gives time histories of typical aileron rolls. The data obtained from the aileron rolls were evaluated to determine the variation of aileron effectiveness $pb/2V$ and change in aileron stick force with change in total aileron angle. These data are presented in figures 39 to 42. Figures 39 and 40 give data for the clean condition of flight with the aileron unsealed and sealed, respectively. Figures 41 and 42 pertain to aileron rolls made in the landing condition, ailerons unsealed and sealed, respectively. From these data, it was possible to determine the helix angle $pb/2V$, total aileron deflection, and rolling velocity obtainable with any stick force through the speed range of the tests. Figure 43 gives values of these quantities obtainable with a 30-pound stick force as a function of speed. The rolling velocity in this figure is corrected to 10,000 feet altitude.

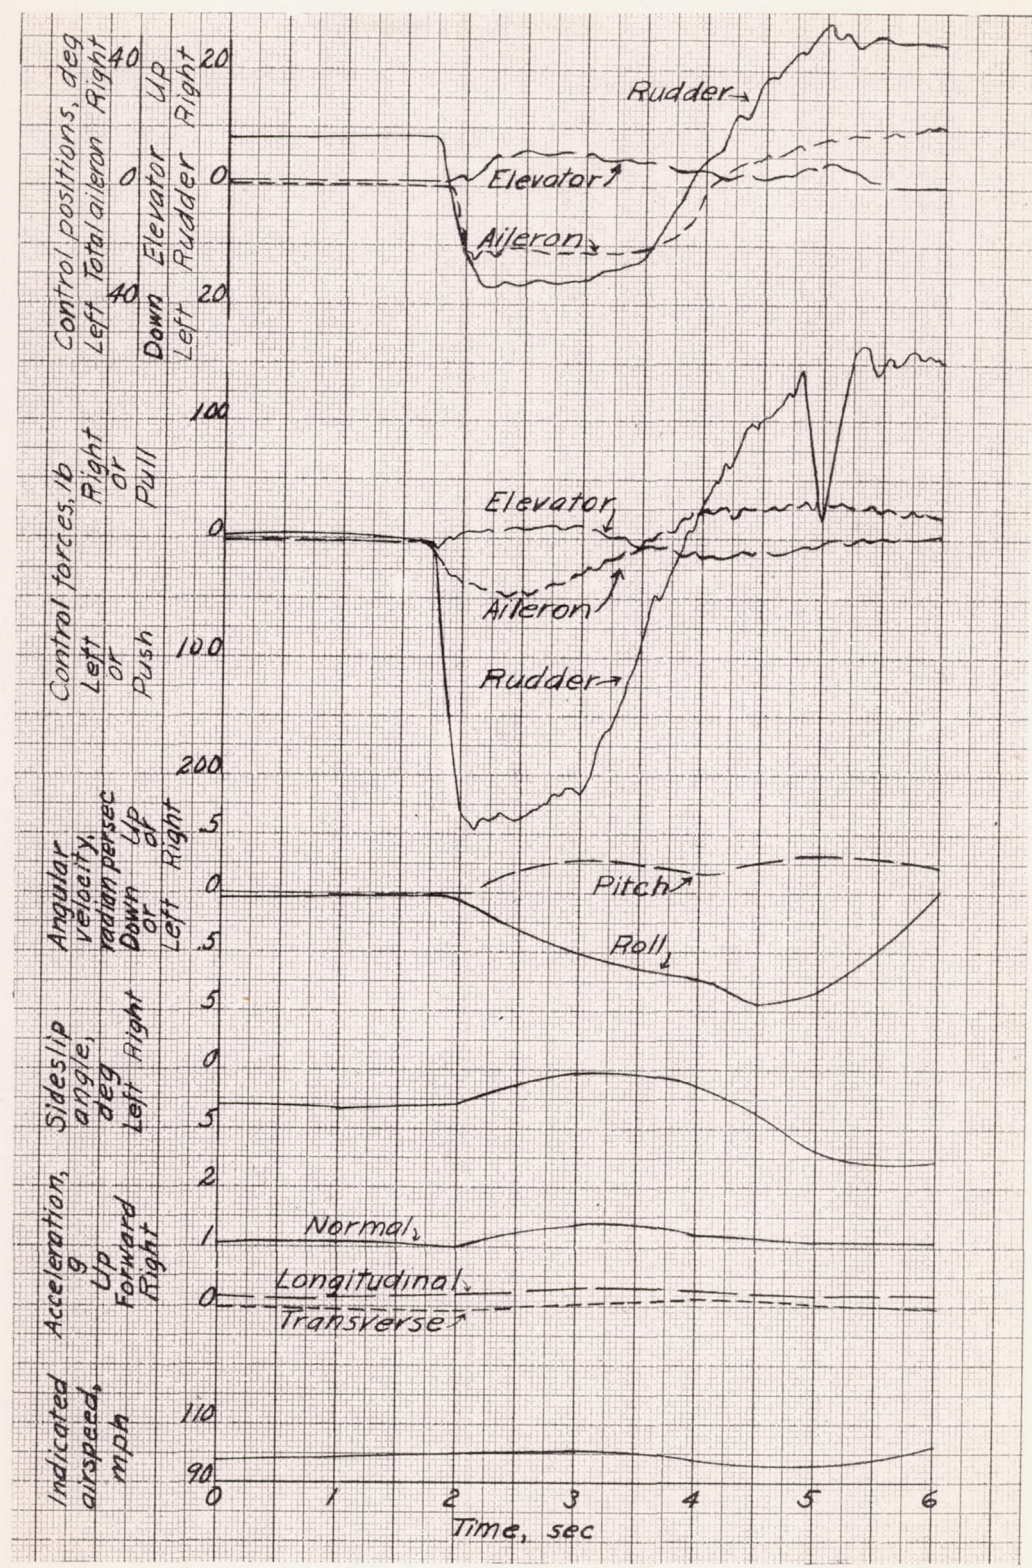
Figure 51.- Time history of a roll into a turn in which the rudder was used in an attempt to maintain zero sideslip. Curtiss SB2C-1 airplane, flaps up, landing gear up, power for level flight.

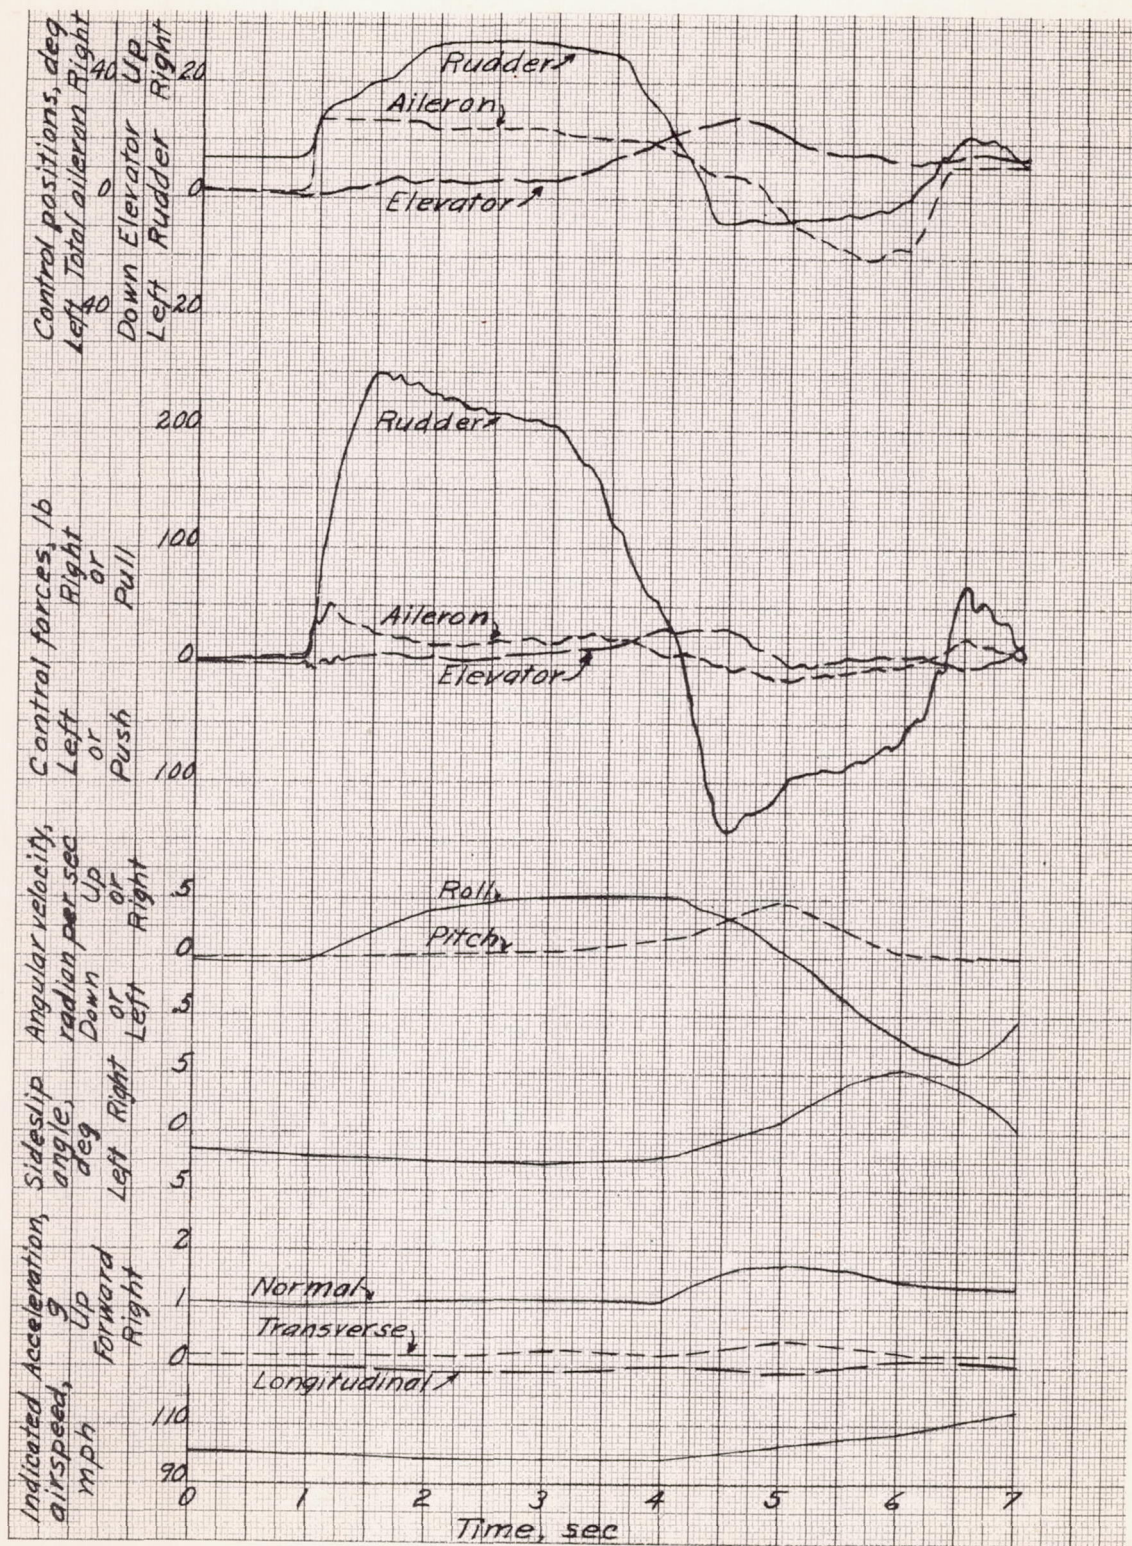
Figure 52.- Time history of a roll into a turn in which the rudder was used in an attempt to maintain zero sideslip, Curtiss SB2C-1 airplane, flaps up, landing gear up, power for level flight.

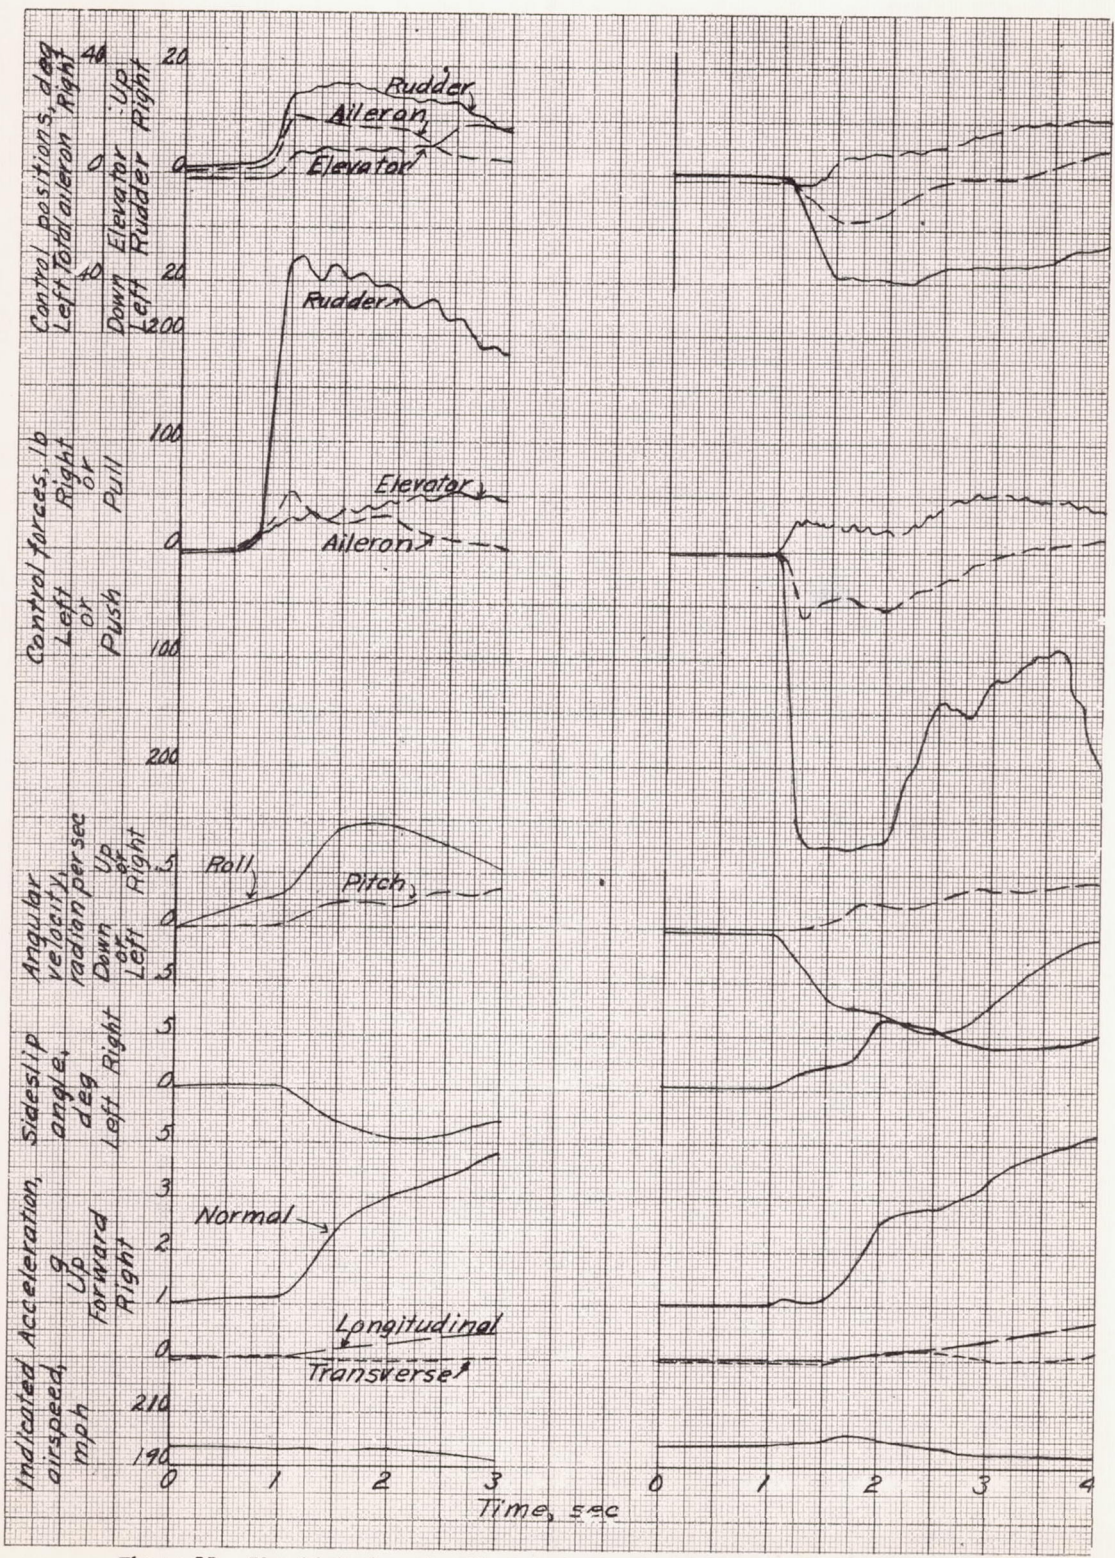
Figure 53.- Time histories of rolls into left and right turns in which the rudder was used in an attempt to maintain zero sideslip. Note that too much rudder deflection was used. Curtiss SB2C-1 airplane, flaps up, landing gear up, power for level flight.

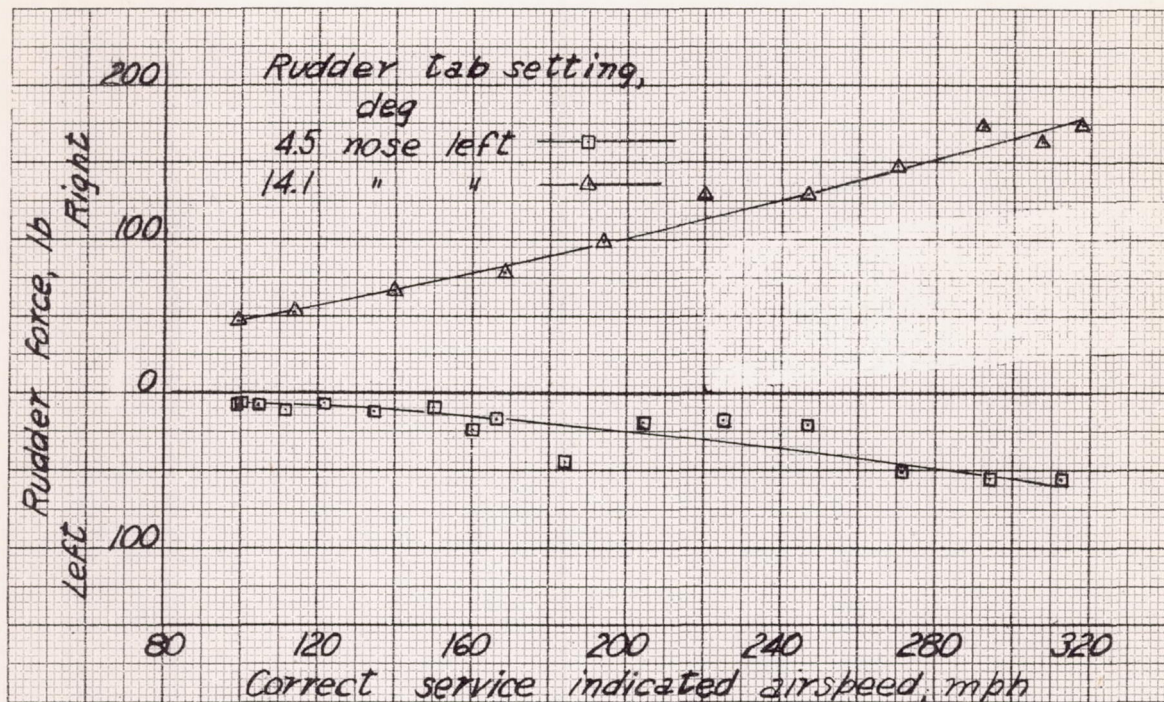
Figure 54.- Variation of rudder force with speed with two rudder trim tab settings; flaps up, landing gear up, front hood closed, rear hood open, power off. Curtiss SB2C-1 airplane.

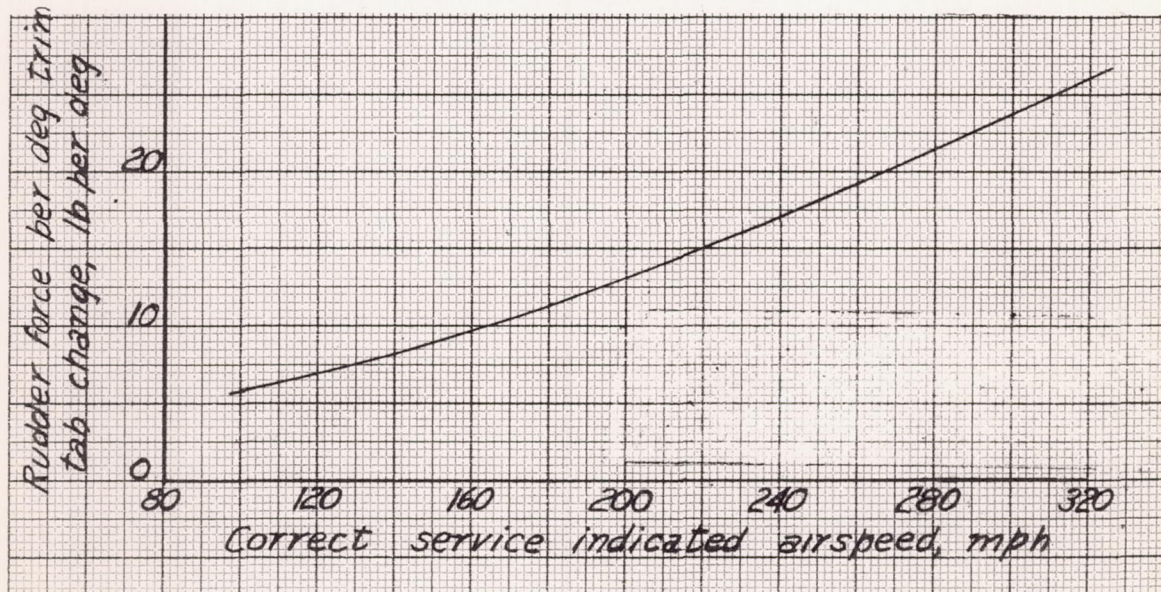
Figure 55.- Variation of power of rudder trim tab with speed. Curtiss SB2C-1 airplane.

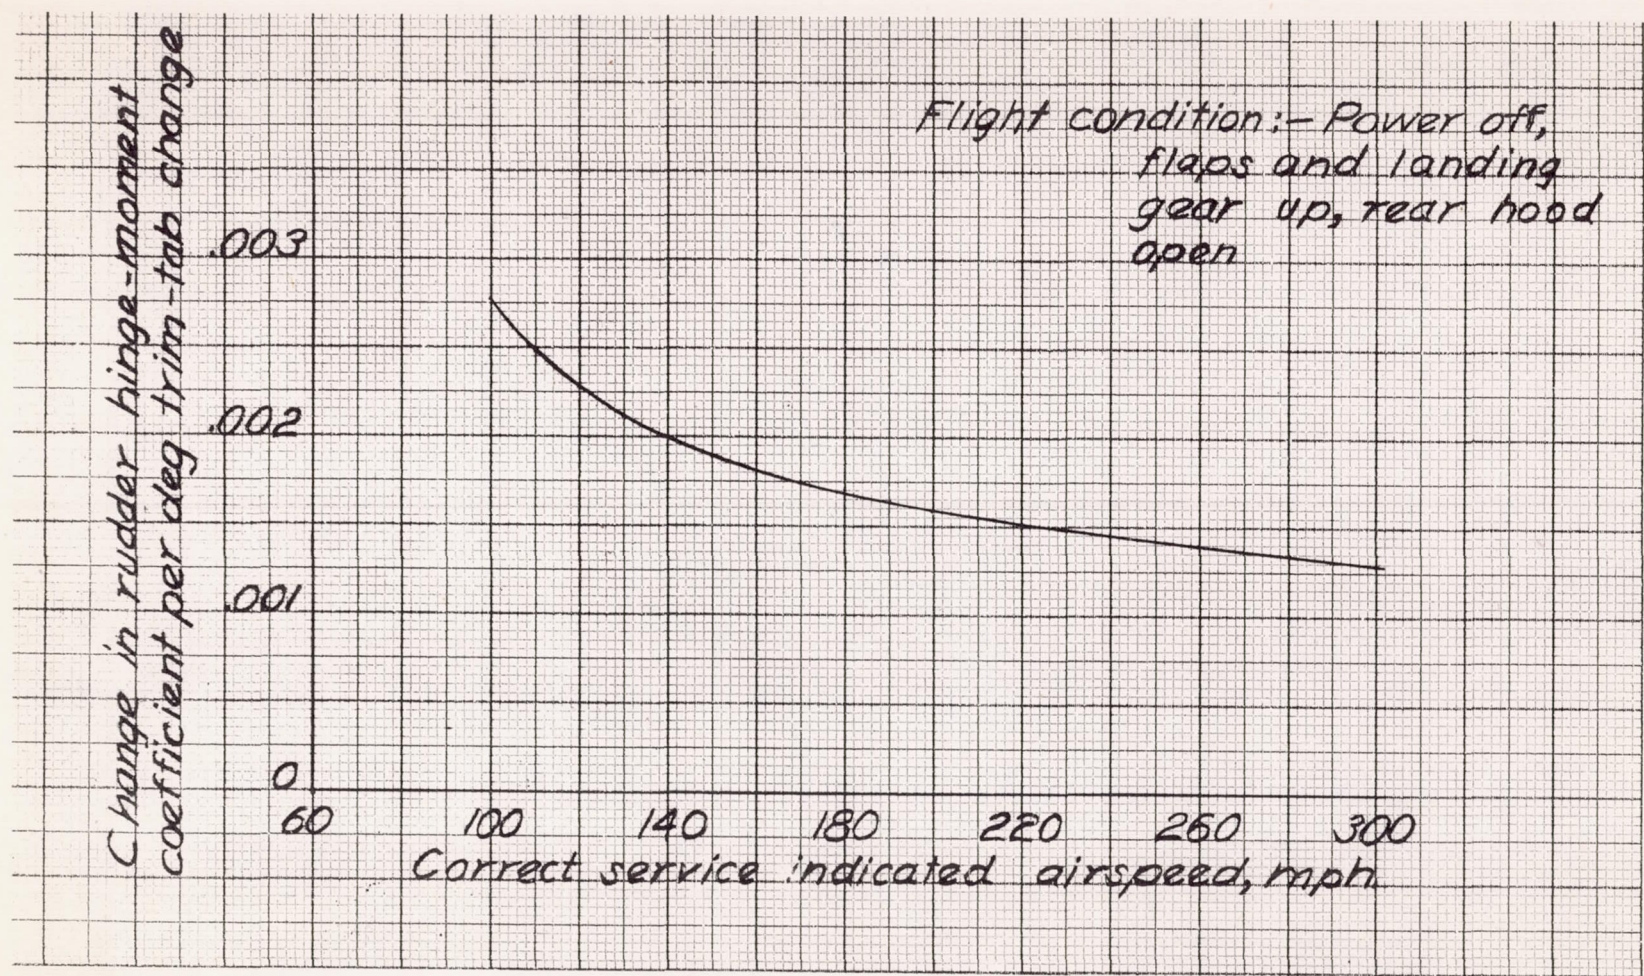
Figure 56.- Variation of changes in rudder hinge-moment coefficient per degree trim-tab deflection with indicated airspeed. Curtiss SB2C-1 airplane.

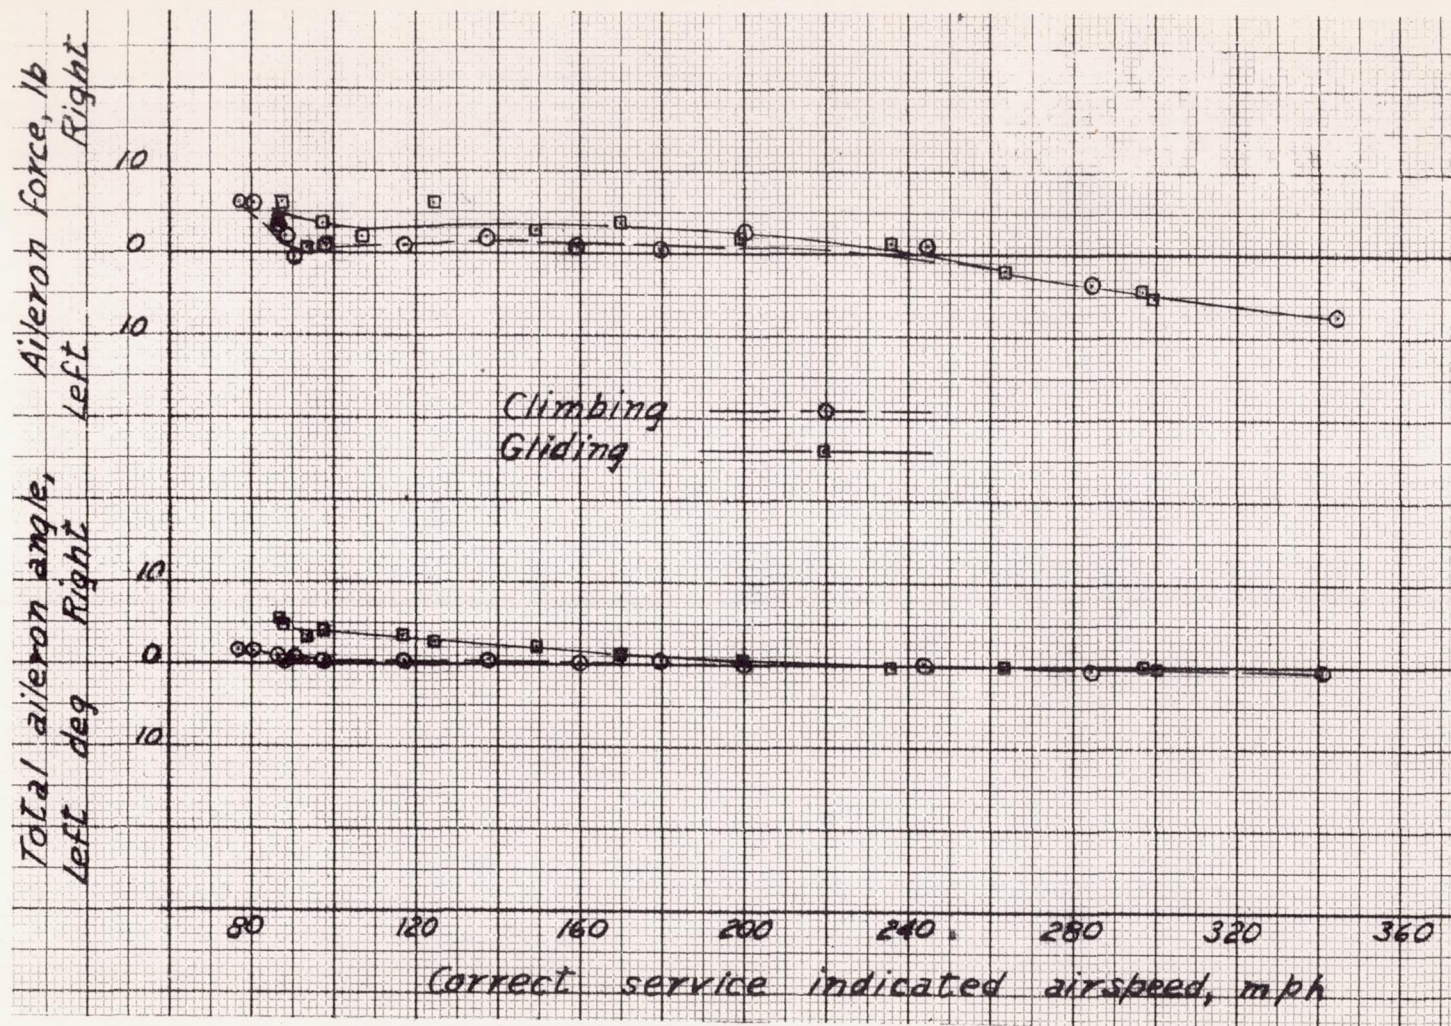
Figure 57.- Variation with speed of aileron angle and aileron force required for trim; aileron gap unsealed, Curtiss SB2C-1 airplane.

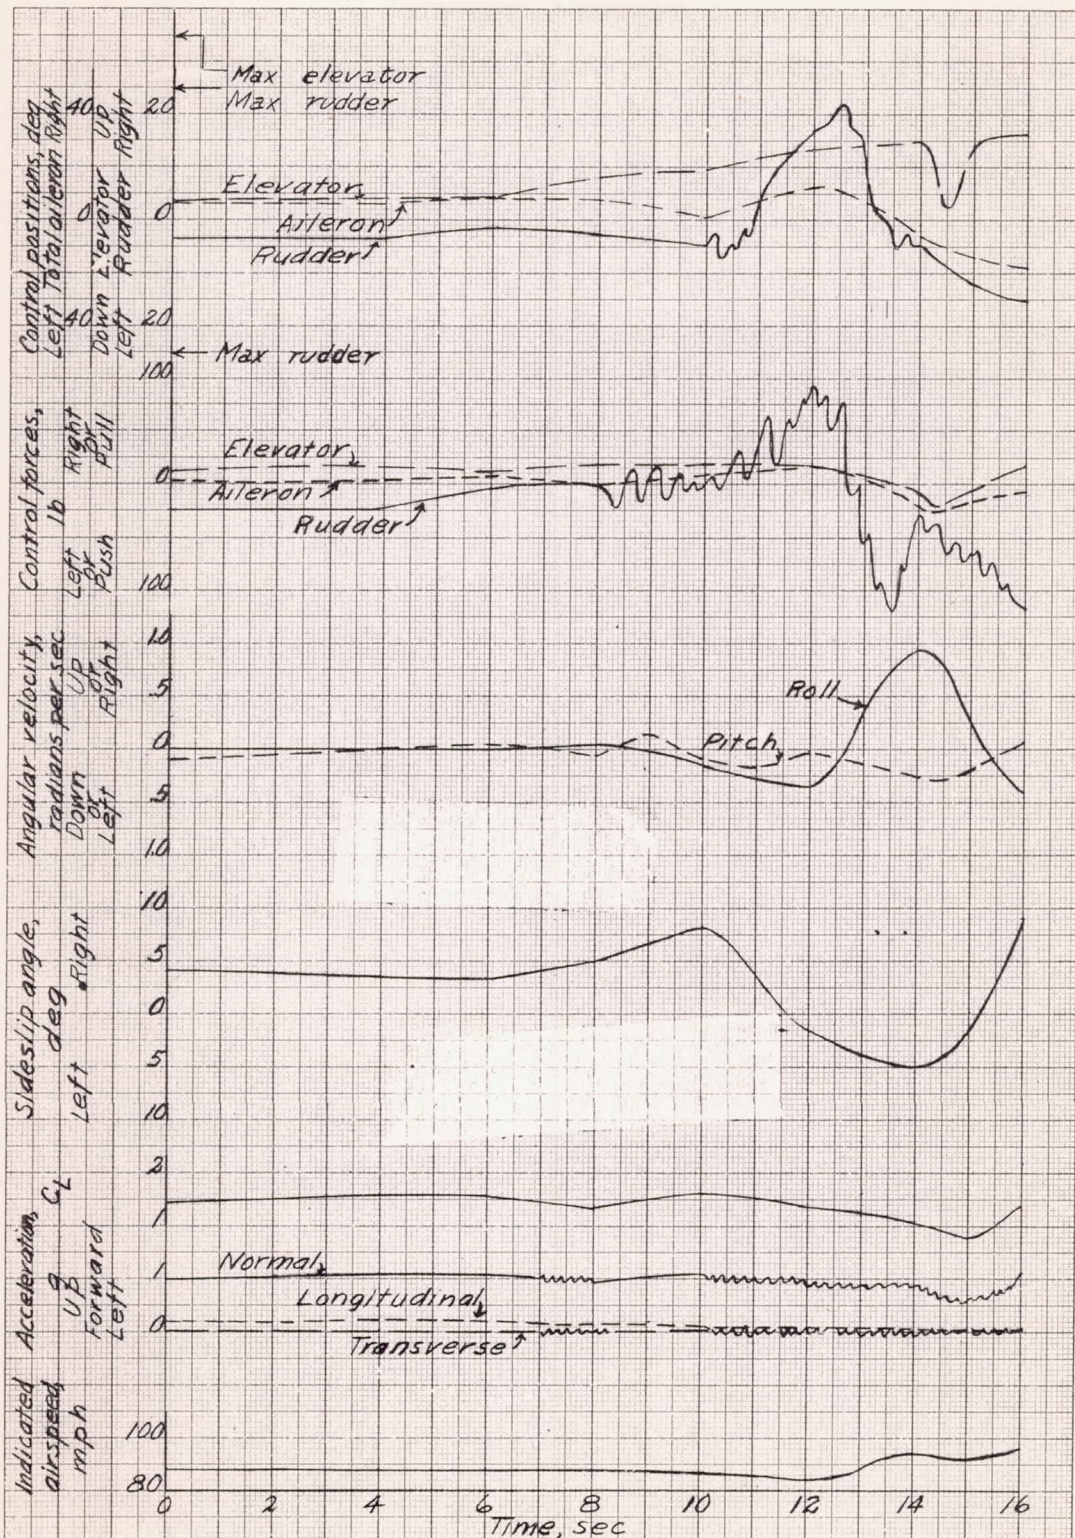
Figure 58.- Time history of a stall in the gliding condition (flaps up, landing gear up, hoods closed, cowl flaps closed, power off) center of gravity at 29.8 percent of the mean aerodynamic chord, bobweight installed, Curtiss SB2C-1 airplane.

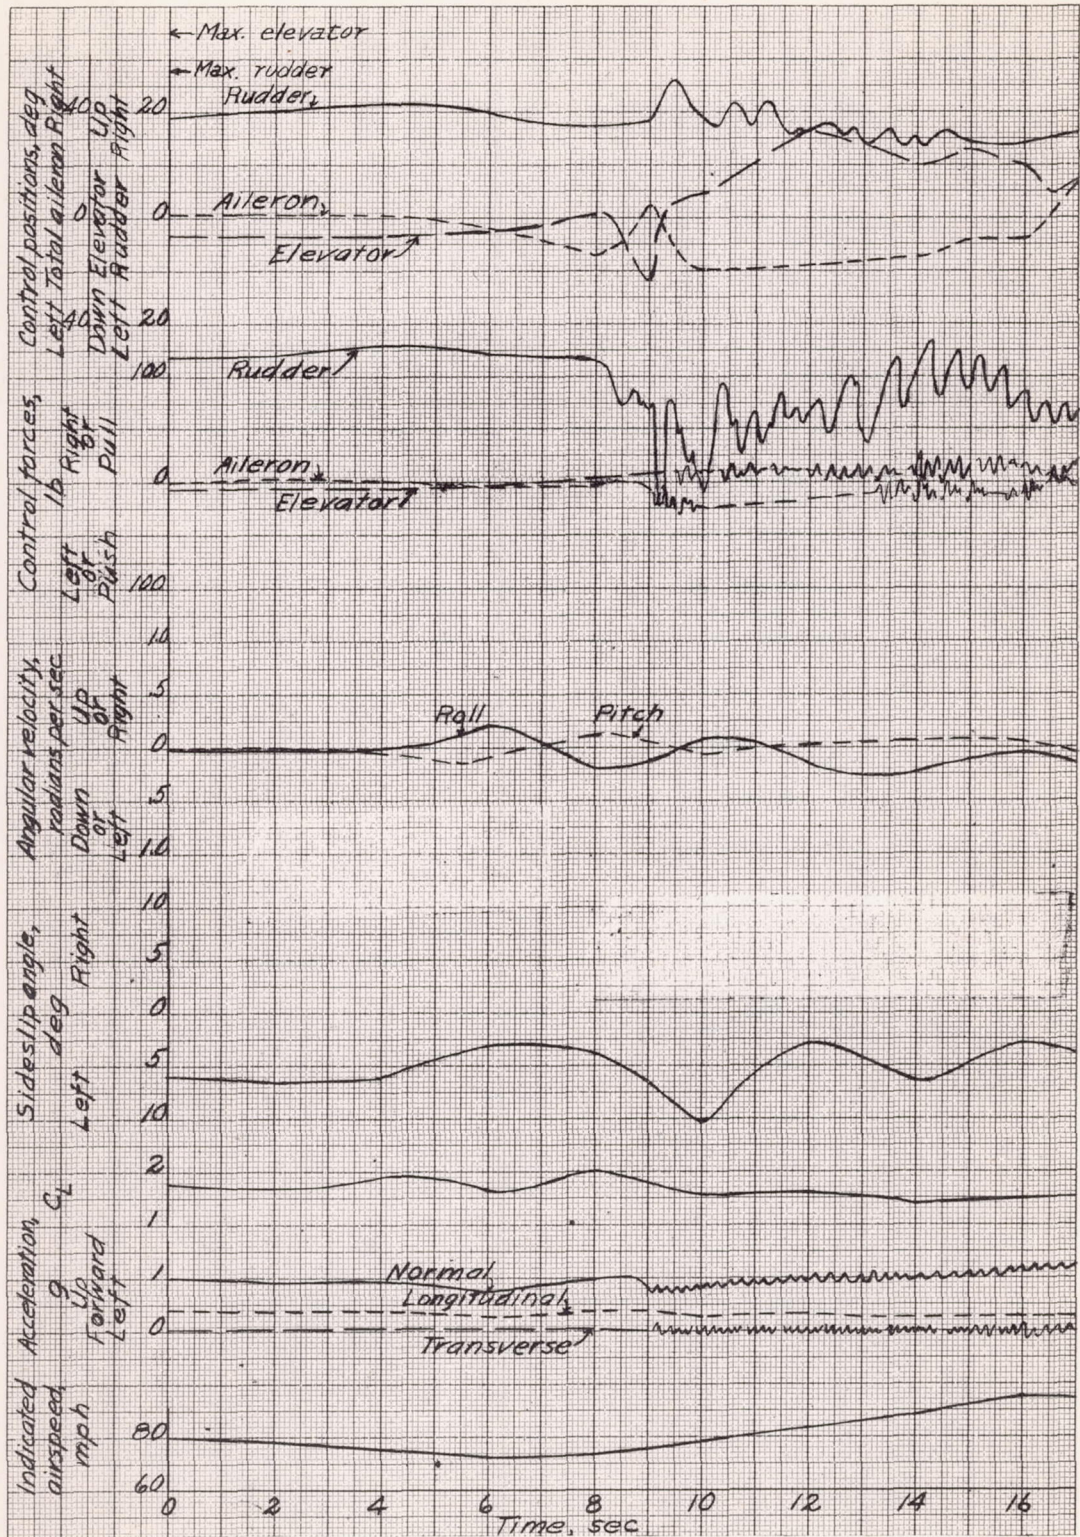
Figure 59.- Time history of a stall in the climbing condition (flaps up, landing gear up, hoods closed, cowl flaps open, rated power) center of gravity at 30.2 percent of the mean aerodynamic chord, bobweight installed, Curtiss SB2C-1 airplane.

(b) In the climbing condition (fig. 59), the stall was preceded by mild rolling and pitching motions of the airplane. An initial tendency to

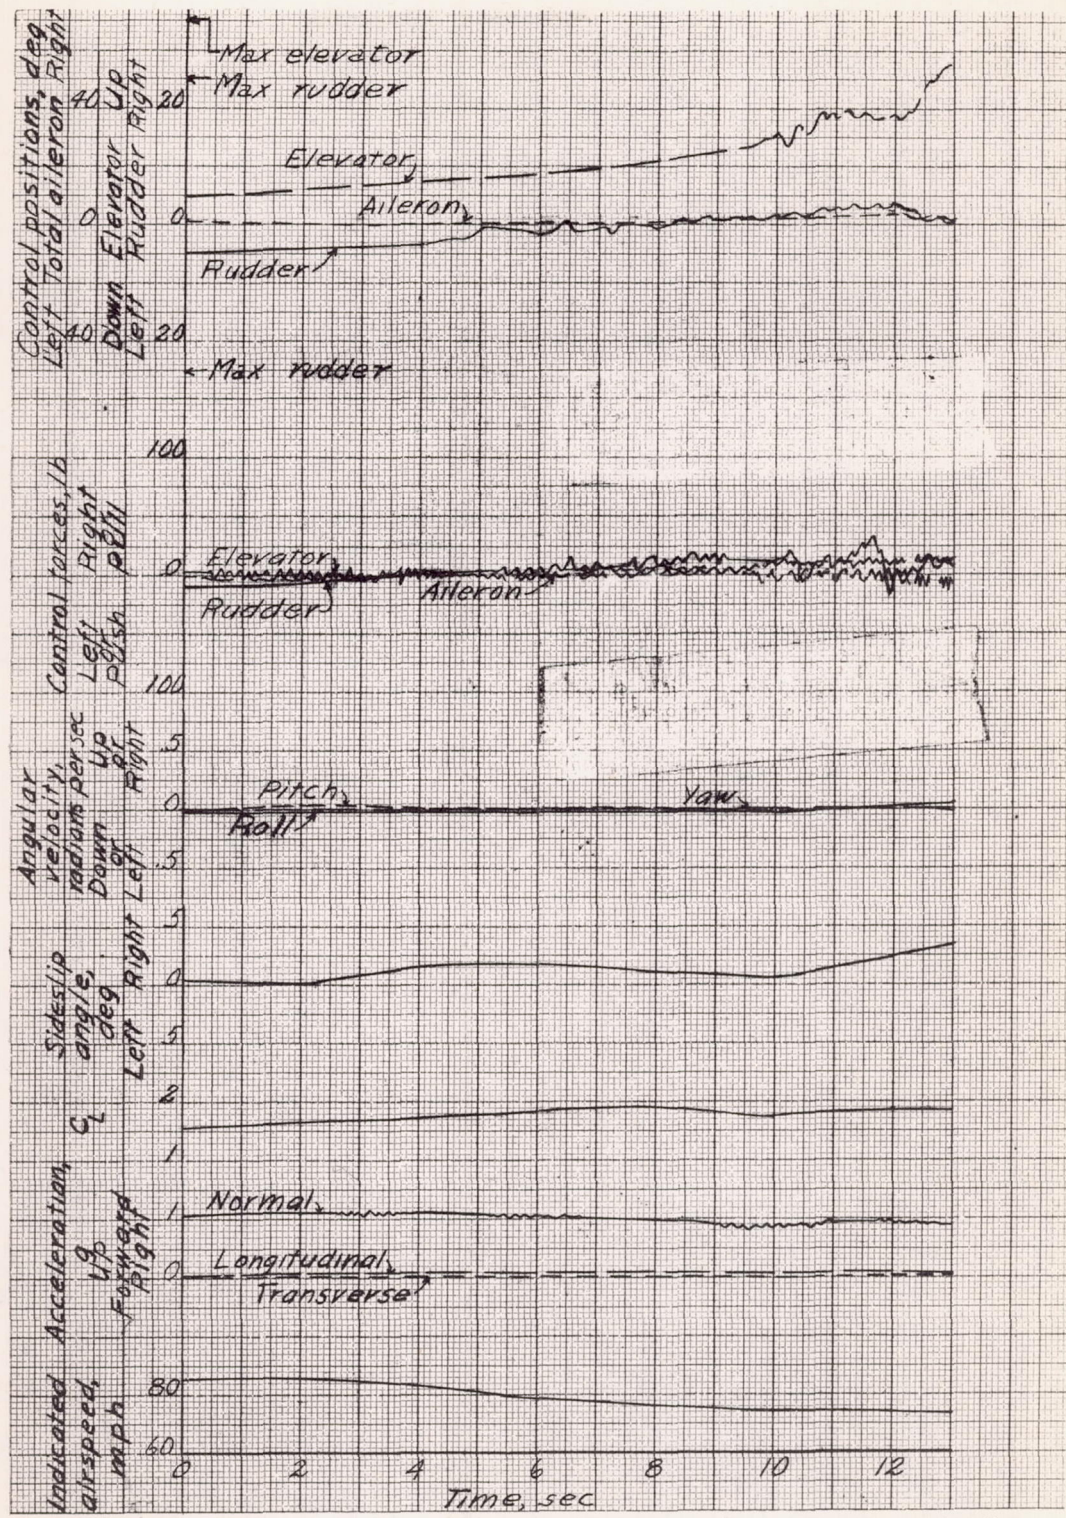
Figure 60.- Time history of a stall in the landing condition (flaps down, landing gear down, front hood open, rear hood closed, cowl flaps one-third open, power off) center of gravity at 26.8 percent of the mean aerodynamic chord. Curtiss SB2C-1 airplane.

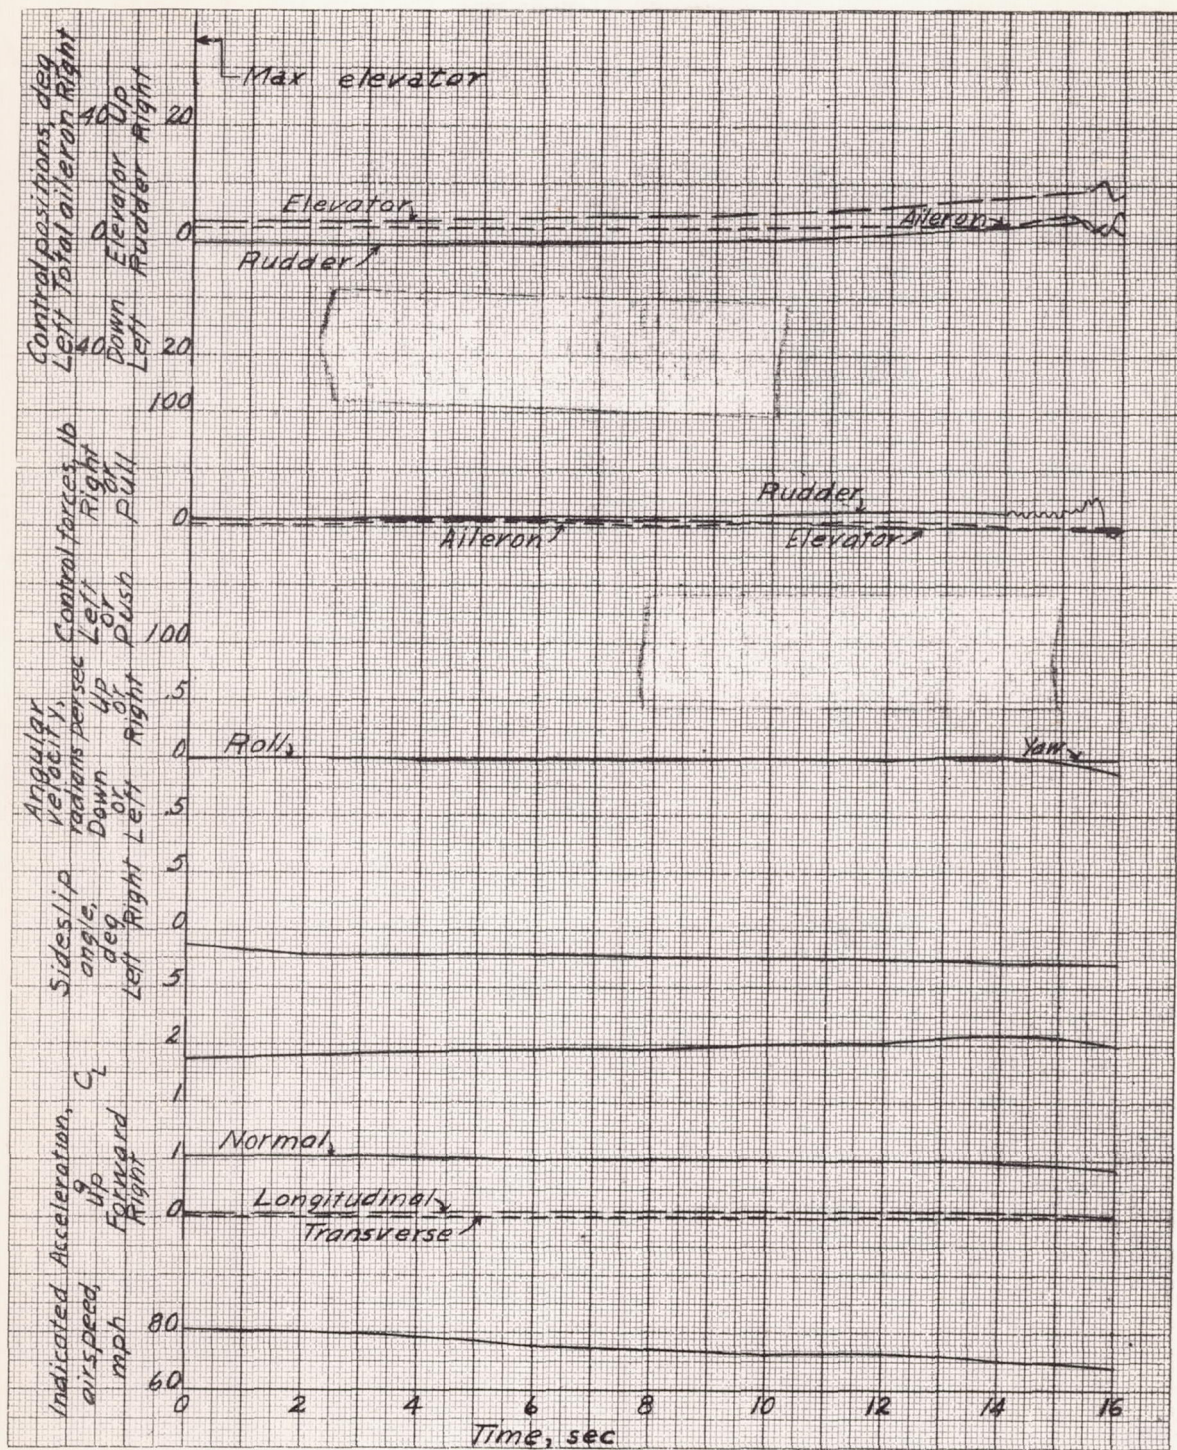
Figure 61.- Time history of a stall in the landing condition (flaps down, landing gear down, hoods closed, cowl flaps closed, power off) center of gravity at 26.8 percent of the mean aerodynamic chord. Curtiss SB2C-1 airplane.
