WARTIME REPORT

MEASUREMENTS OF FLYING QUALITIES OF

A CURTISS SB2C-1 AIRPLANE

(NO. 00014)

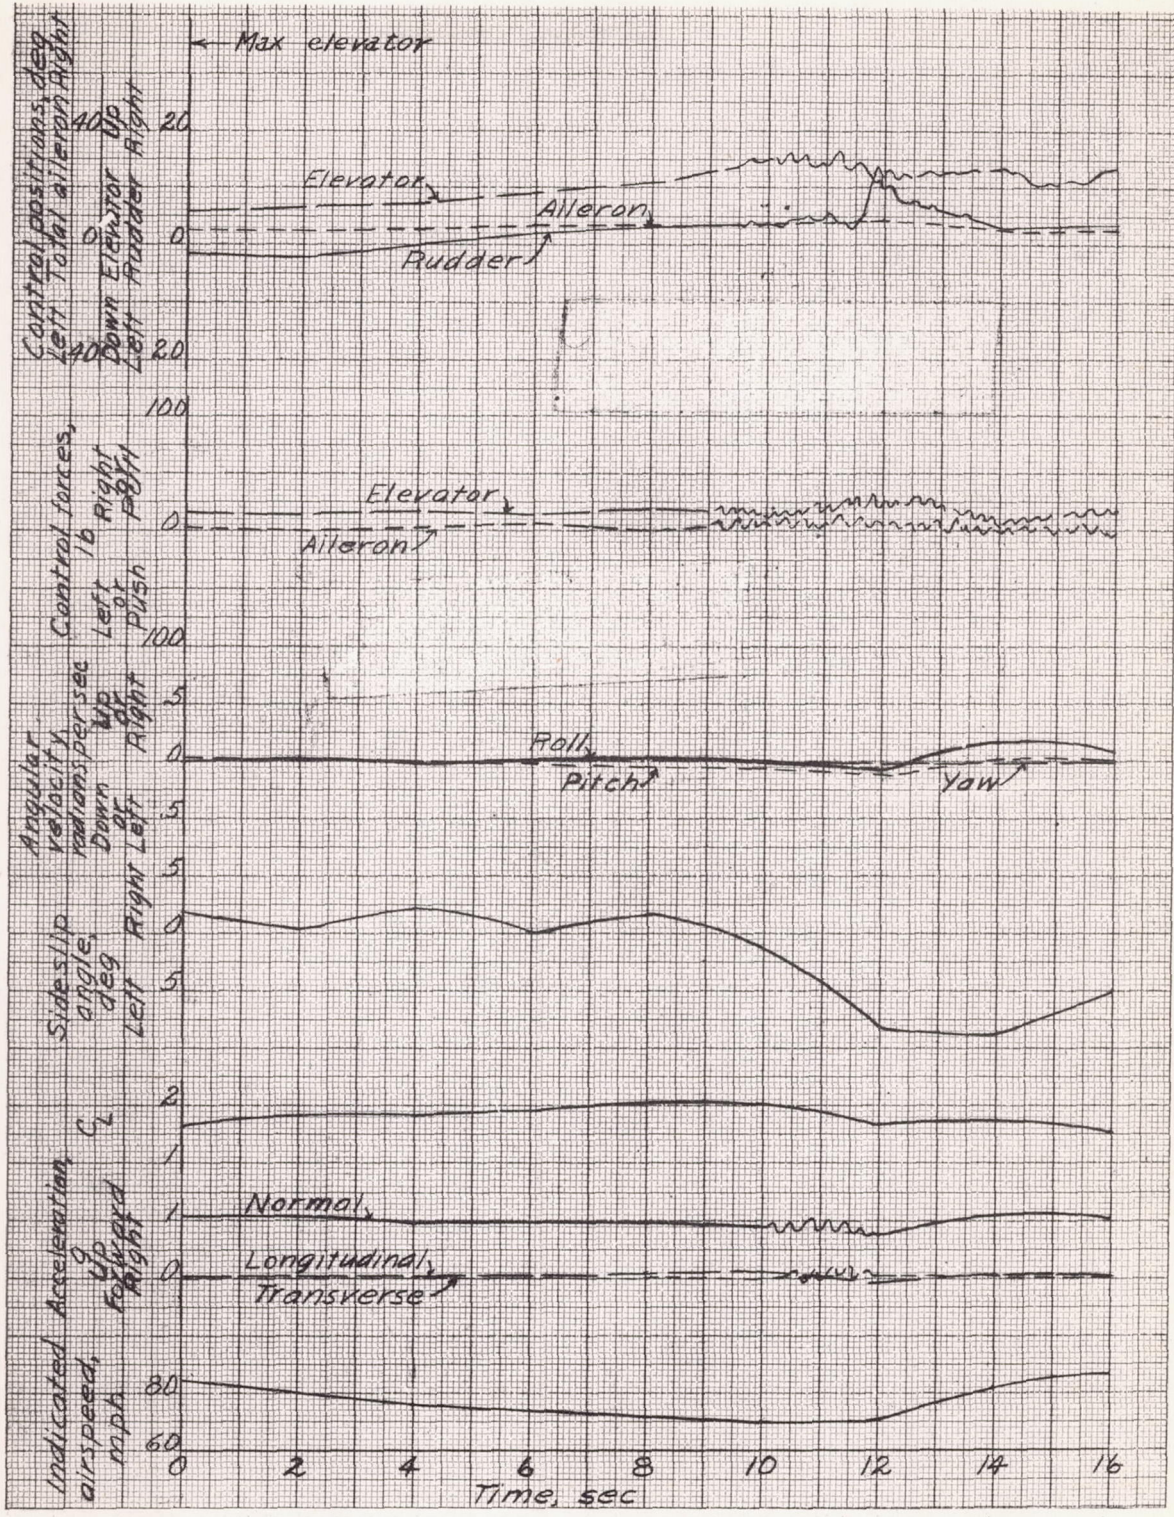
Figure 62.- Time history of a stall in the landing condition (flaps down, landing gear down, front hood closed (?), rear hood closed, cowl flaps open, power off) center of gravity at 24.8 percent of the mean aerodynamic chord. Curtiss SB2C-1 airplane.

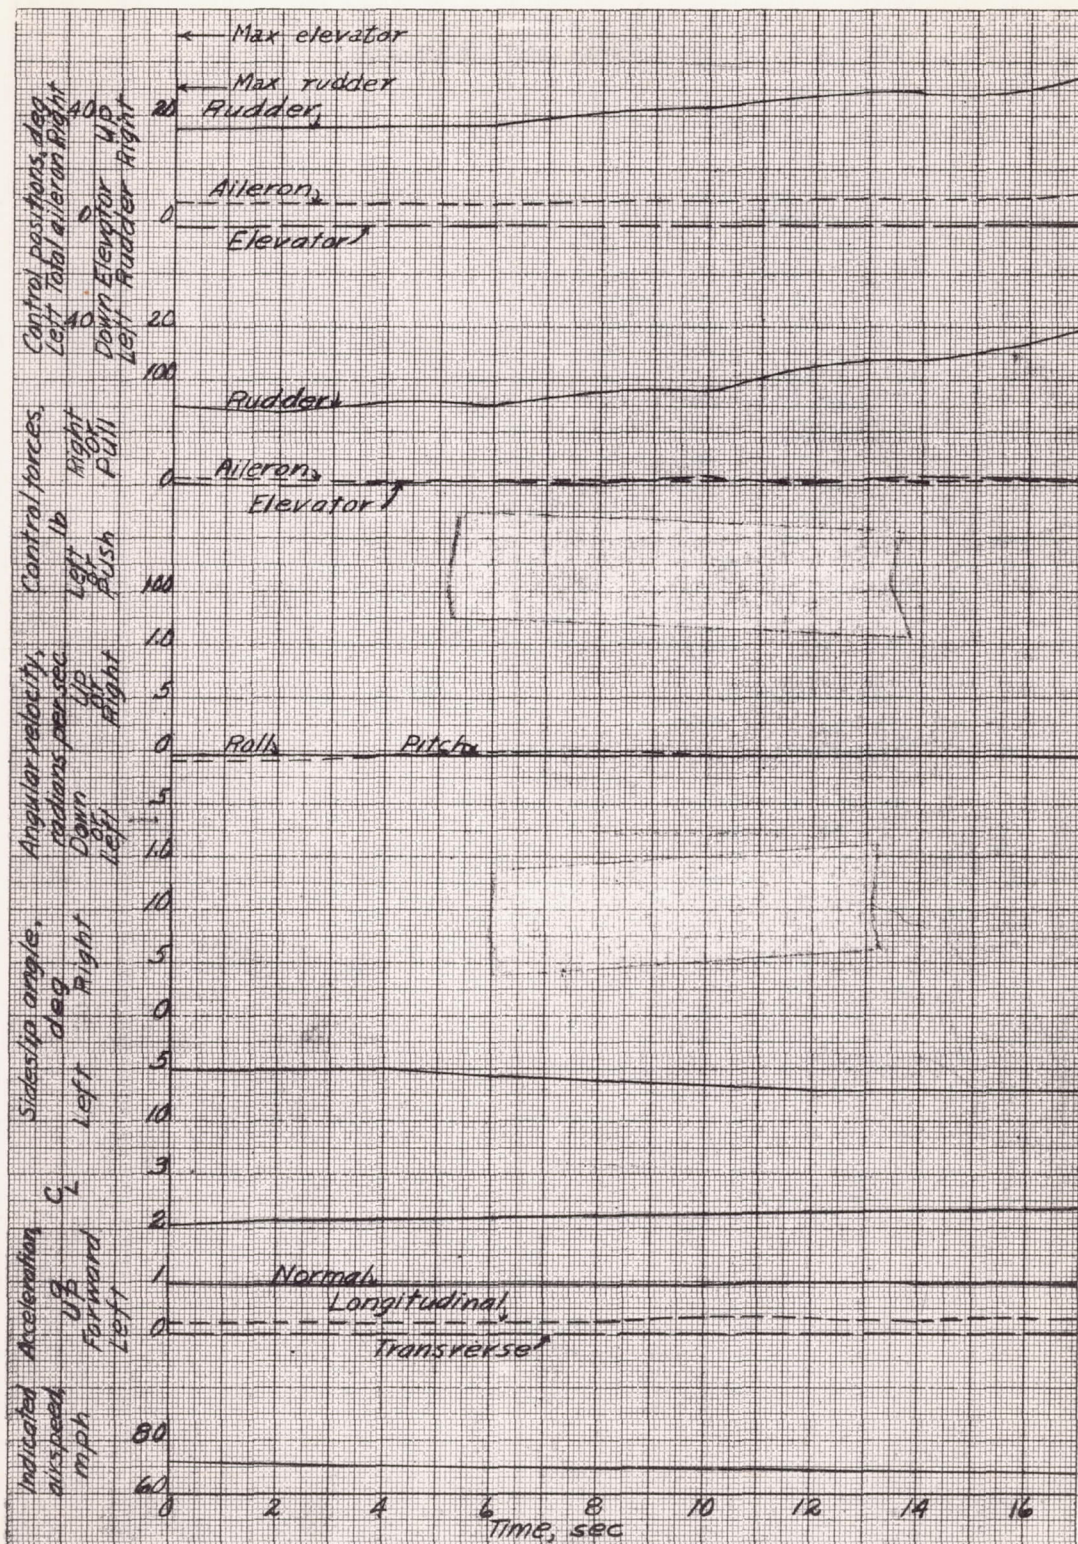
Figure 63.- Time history of a stall in the approach condition (flaps one-half down, landing gear down, front hood open, rear hood closed, cowl flaps closed, partial power) center of gravity at 29.0 percent of the mean aerodynamic chord, bobweight installed. Curtiss SE2C-1 airplane.

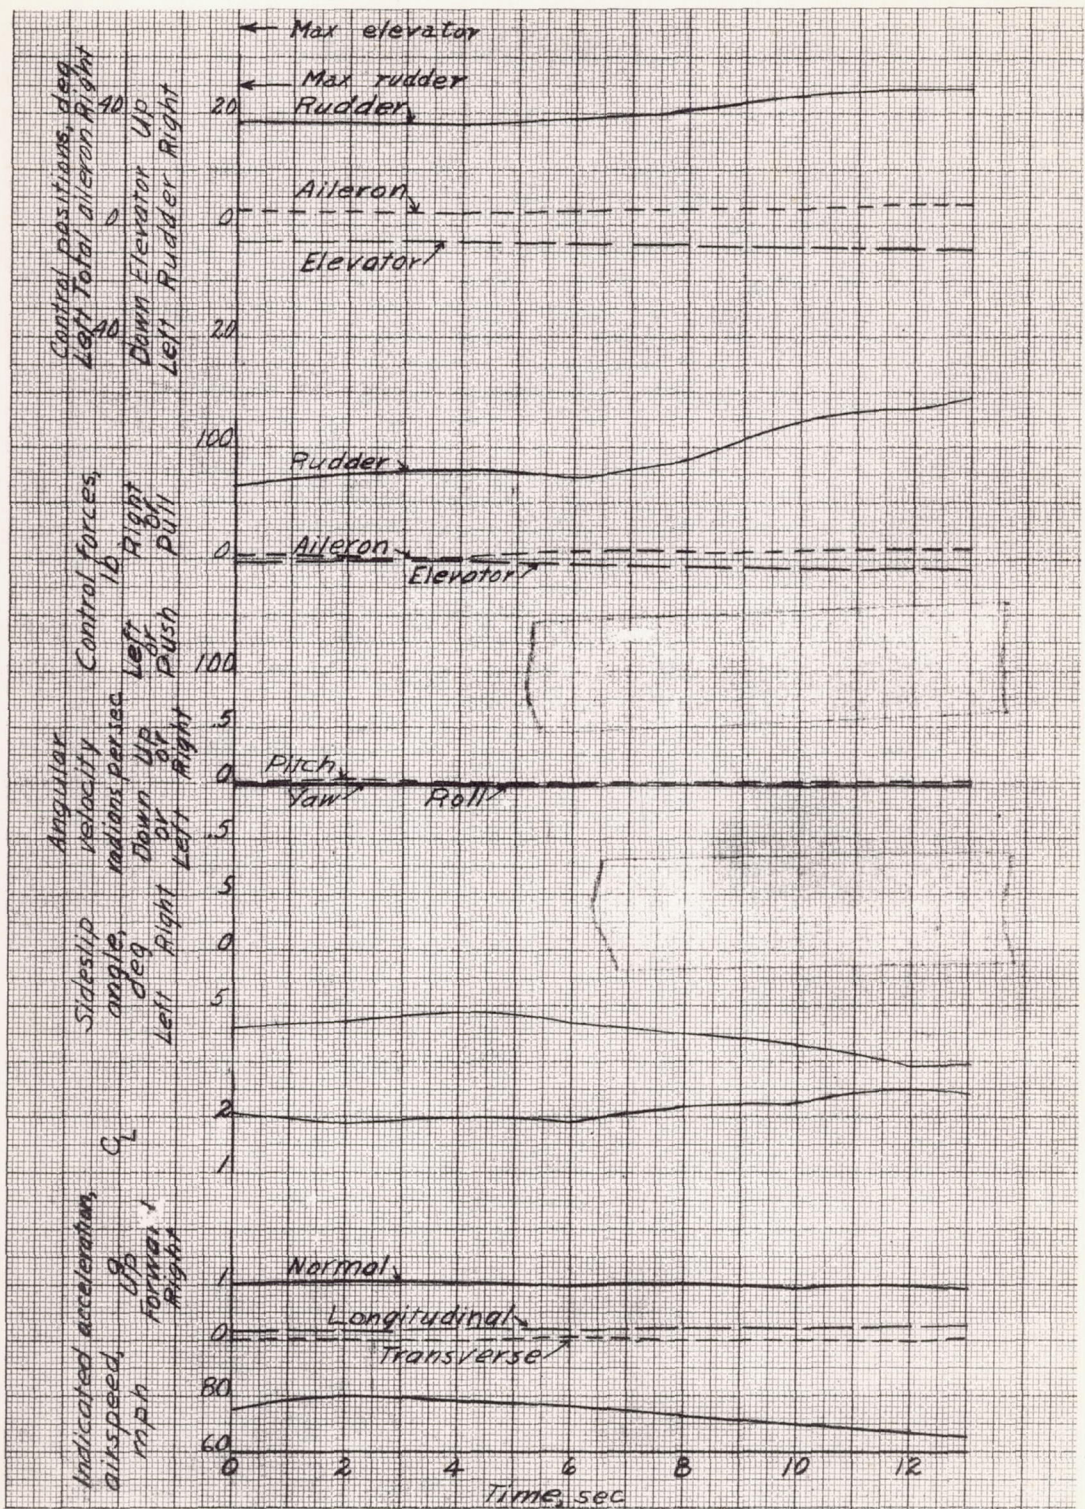
Figure 64.- Time history of a stall in the wave-off condition (flaps down, landing gear down, front hood open, rear hood closed, cowl flaps closed, rated power). Center of gravity at 27.8 percent of the mean aerodynamic chord. Curtiss SB2C-1 airplane.
