NATIONAL ADVISORY COMMITTEE FOR AERONAUTICS

MEASUREMENTS OF THE FLYING QUALITIES OF A

SUPERMARINE SPITFIRE VA AIRPIANE

By William H. Phillips and Joseph R. Vensel

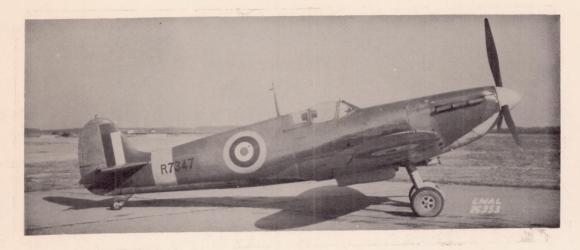
Figure 1.- Side view of the Supermarine Spitfire airplane.

The Supermarine Spitfire is a single-place, single-engine, low-wing, cantilever monoplane with retractable landing gear and partial-span split flaps (figs. 1, 2, 3, and 4). The general specifications of the airplane are as follows:

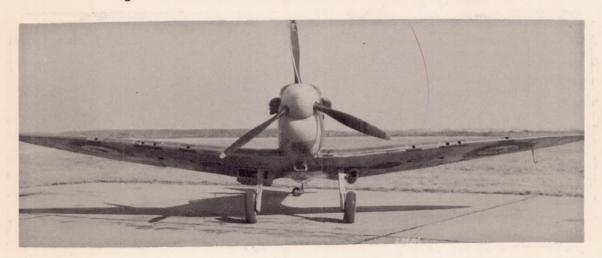
Figure 2.- Front view of the Supermarine Spitfire airplane.

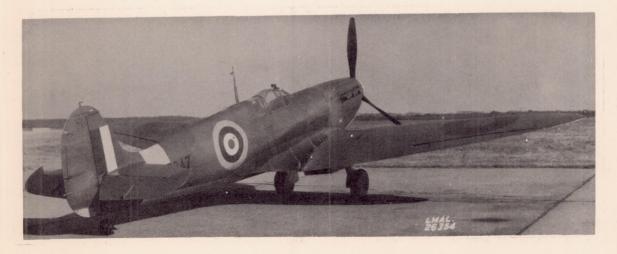
Figure 3.- Three-quarter rear view of the Supermarine airplane.

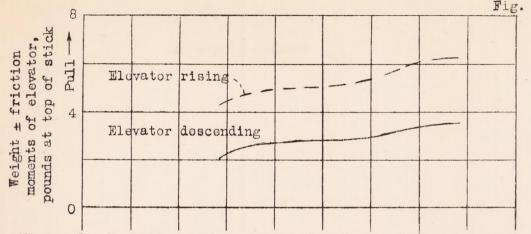
Figure 5 .- Variation with control-stick angle of elevator angle and stick force caused by elevator friction and

The relation between the control-stick position and the angles of the controls is shown on figures 5 and 6. Figure 5 also shows the unbalance and friction in the elevator system as measured with the airplane on the ground. A stick force of 2 pounds to the right and 3 pounds to the left was required to overcome aileron friction. The friction in the rudder linkage varied from 7 pounds near the neutral position to 20 pounds near the limits of the rudder travel.

3. The friction in the elevator system was such that a force of 2 pounds was required to reverse the motion of the stick, as shown in figure 5. This friction was small enough that, in the flight conditions where a stable stick-force gradient existed, the control would return to its trim position.

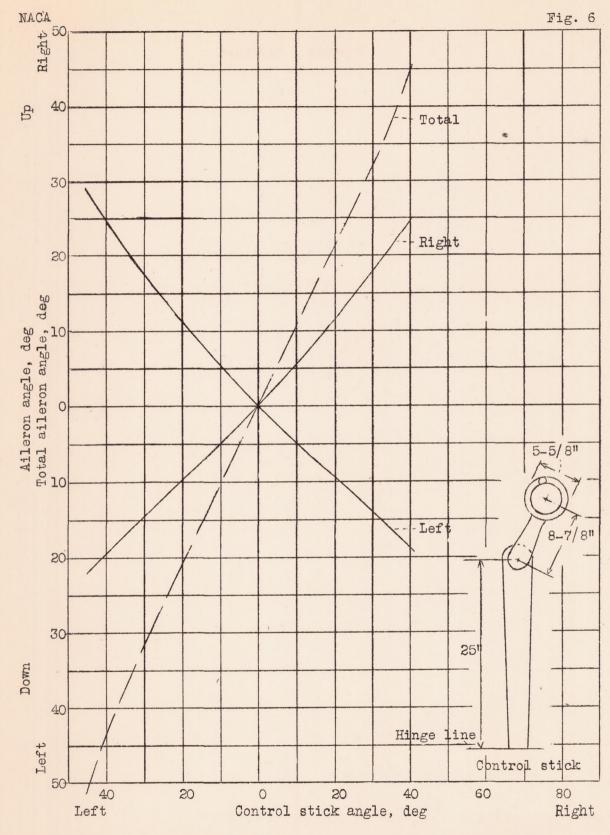
Figure 6.- Variation of left, right, and total-aileron angles with control stick angle. Supermarine Spitfire airplane.

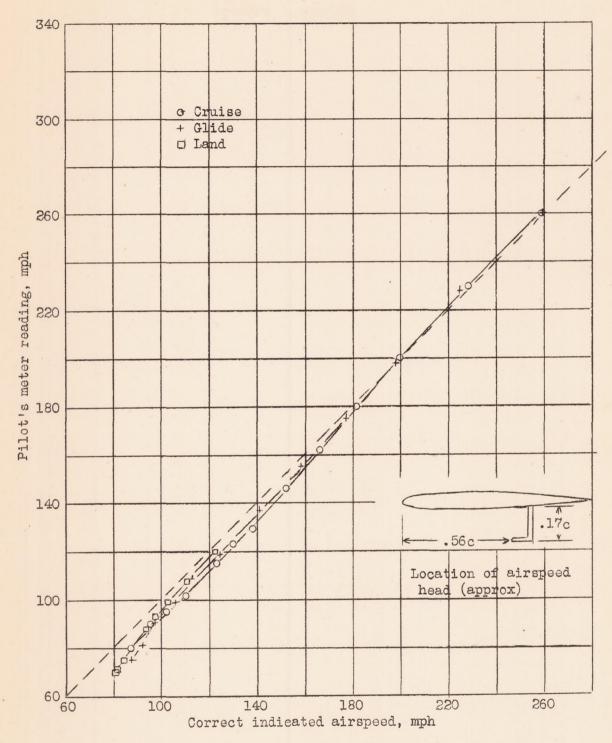
Figure 7.- Calibration of the pilot's airspeed indicator in the Supermarine Spitfire airplane.

The readings of the pilot's meter as compared to the correct indicated airspeed in the cruising, gliding, and landing conditions of flight are plotted on figure 7.

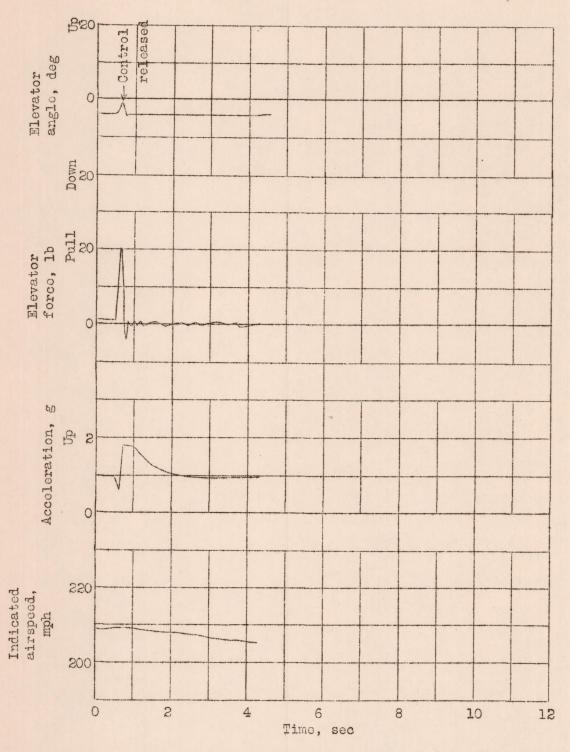
Figure 8.- Time history of a short-period oscillation started by suddenly pulling back the control stick and releasing it in level flight; flaps and gear up. Supermarine Spitfire airplane.

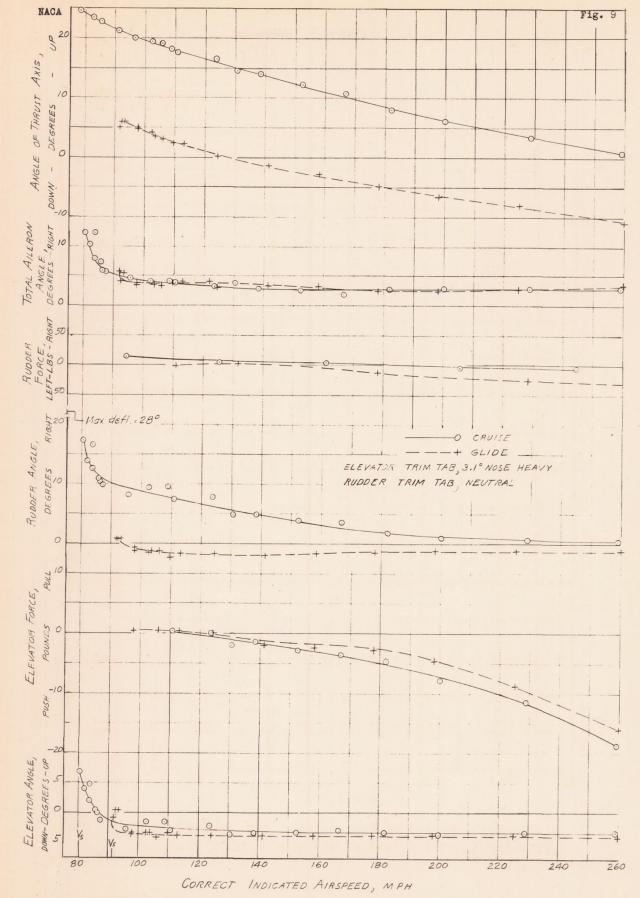
Figure 9. - Static longitudinal-stability characteristics of the Supermarine Spitfire airplane in the cruising and gliding conditions.

2. In spite of the neutral stick-fixed static stability with flaps up, the airplane had a slightly stable stick-force variation with airspeed throughout the speed range (fig. 9). This stable stick-force gradient is attributed to the unbalanced elevator. If a completely mass-balanced elevator had been employed, the stick-force variation would have been slightly unstable, a condition consistent with neutral stick-fixed stability. In the flap-down condition with power on, the stick-force variation for the trim-tab setting used was unstable and, with power off, the stick-free stability was neutral. If the airplane had been trimmed for zero stick force at low speed, the variation might have been slightly stable with

4. The limits of elevator motion were not reached in steady flight from the minimum speed to the highest speeds tested. Figures 9, 10, and 11 show that in all conditions only a few degrees of elevator motion were required to trim throughout the speed range.

The rudder forces required for trim throughout the speed range with the rudder trim tab neutral are plotted for the gliding and cruising conditions on figure 9. These rudder forces were unusually light.

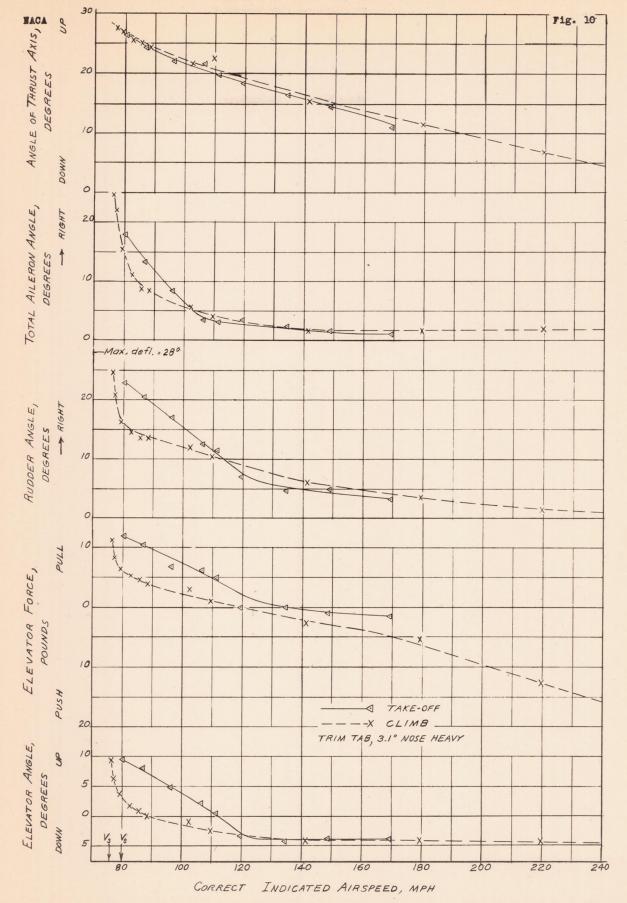
Figure 10. - Static longitudinal-stability characteristics of the Supermarine Spitfire airplane in the climbing and take-off conditions.

Considerable deflection of the rudder to the right was required in the power-on conditions in steady flight near minimum speed as shown on figures 9, 10, and 11. The limits of rudder travel were never exceeded, however. The rudder deflection is needed partly to offset the yawing moment caused by angularity of the flow due to the slipstream, and partly to balance the left yawing moment of the propeller itself that results from the high angle of attack of the propeller axis. The side force on the rudder necessary to maintain equilibrium of yawing moments

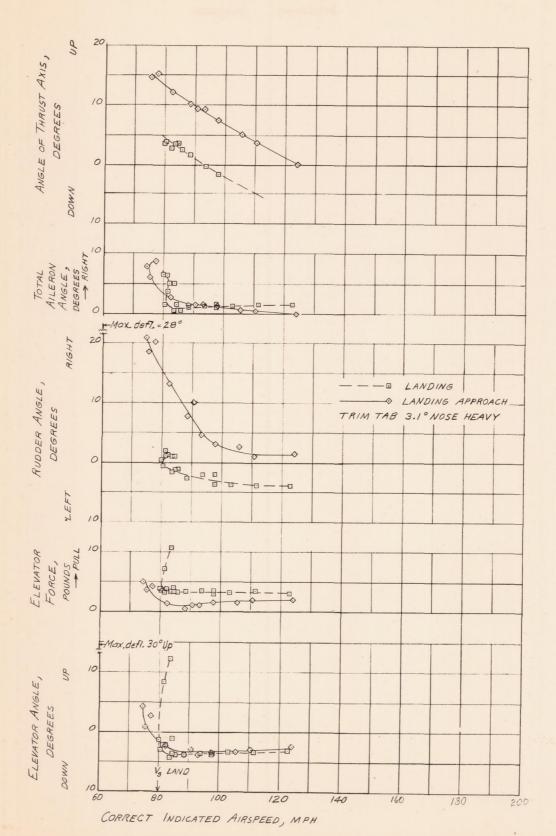
Figure 11. - Static longitudinal-stability characteristics of the Supermarine Spitfire airplane in the landing and landing-approach conditions.

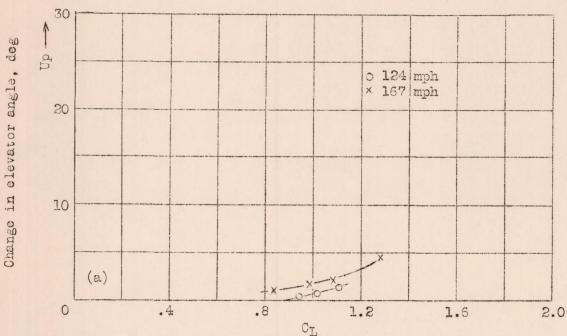
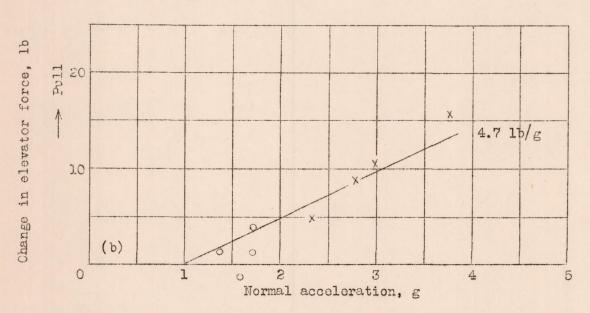
(a) Variation of change in elevator angle with lift coefficient in pull-ups.

(b) Variation of elevator force with normal acceleration in in pull-ups.

Figure 12.- Elevator characteristics in pull-ups. Supermarine Spitfire airplane.

The elevator control was found to be powerful enough to develop either the maximum lift coefficient or the allowable load factor at any speed. As shown in figure 12(a), less than 5° movement of the elevator was used in reaching maximum lift coefficient in pull-ups from level flight. In these maneuvers, the elevator was abruptly deflected a small amount and then held fixed with the aid of a graduated tape in the cockpit. In pull-ups made at high speed; the elevator was always eased forward before maximum acceleration had been developed, in order to avoid overloading the structure.

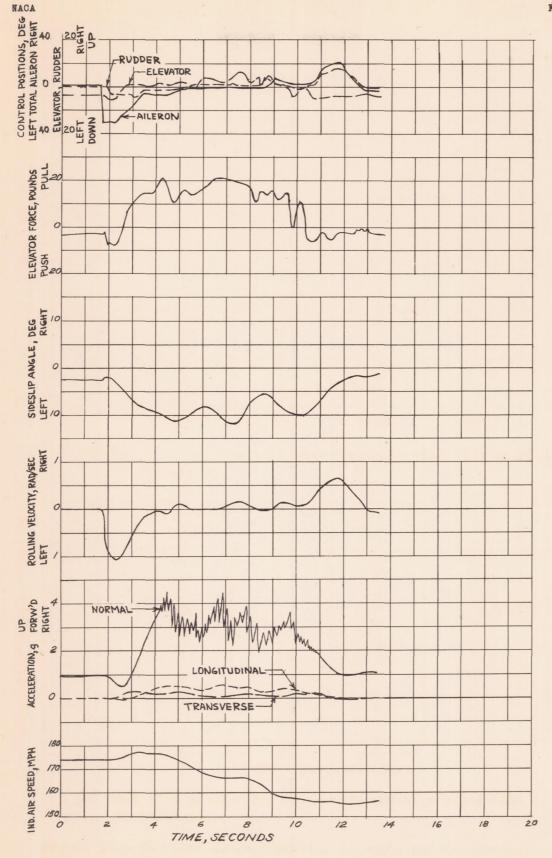
Figure 13. - Time history of a rapid 180° turn to the left started at 174 miles per hour, in which the stall was reached. Supermarine Spitfire airplane; gun perts covered.

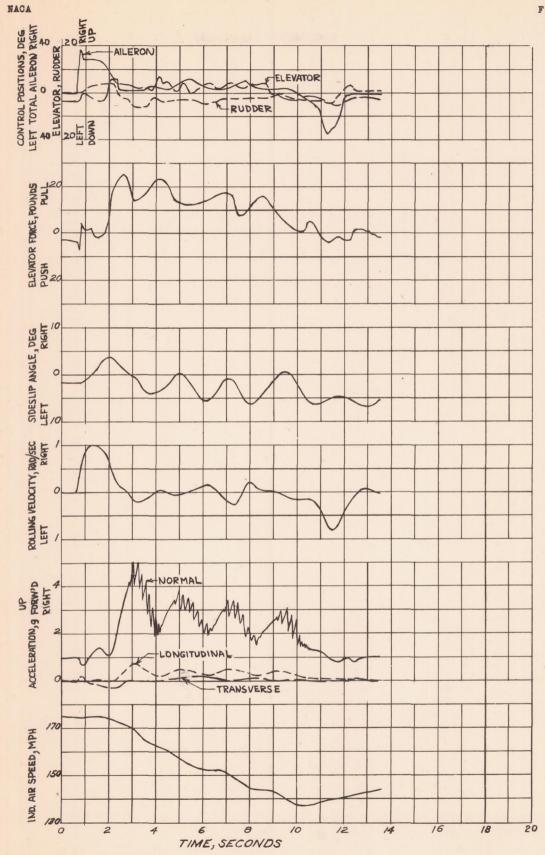
Figure 14. - Time history of a rapid 180° turn to the right started at 175 miles per hour, in which four stalls occurred. Supermarine Spitfire airplane with gun parts covered.

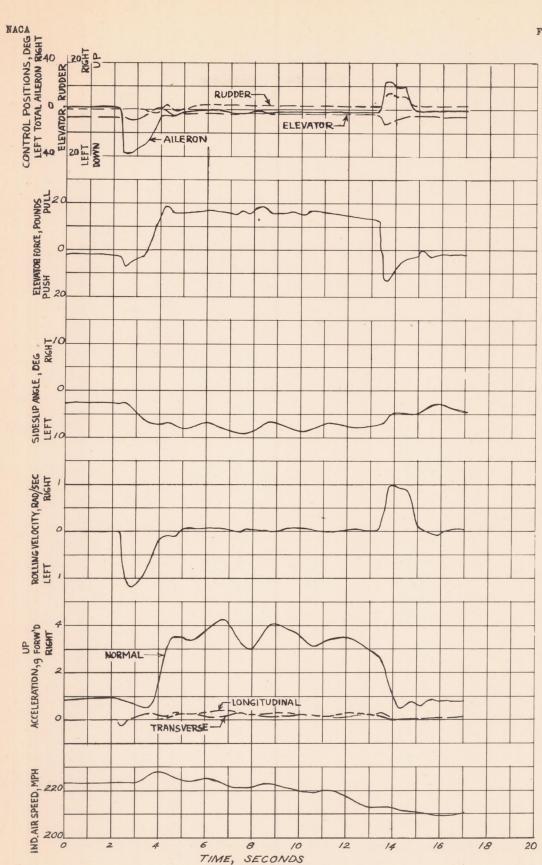
Fig. 15

Figure 15. - Time history of a rapid 180° turn to the left started at 223 miles per hour. Supermarine Spitfire airplane with gun perts covered.

the static stability of an airplane is sufficiently large. By careful flying, the pilot was able to make smooth turns at high speed, as shown by figures 17 and 18. Ordinarily, however, small movements of the stick caused appreciable variations in the normal acceleration, as shown in figures 15 and 20.

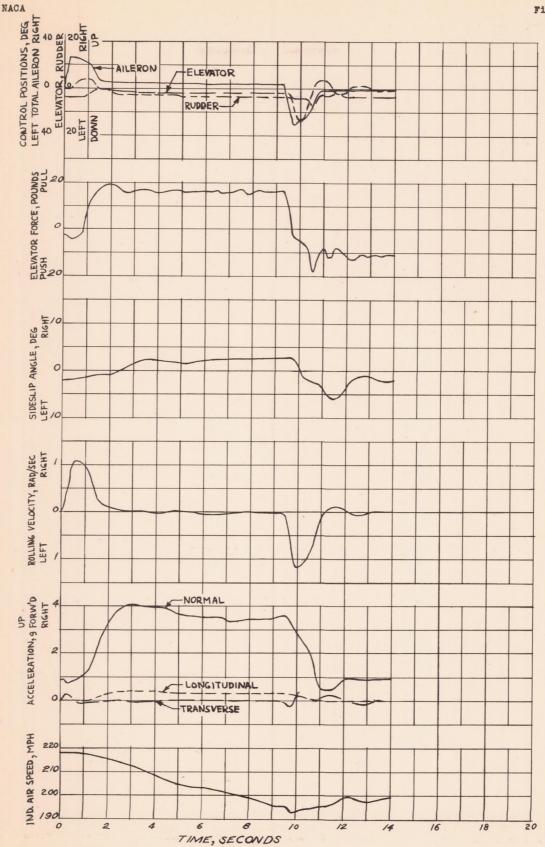
Fig. 16

Figure 16. - Time history of a rapid 180° turn to the right started at 218 miles per hour. Supermarine Spitfire airplane with gun perts covered.

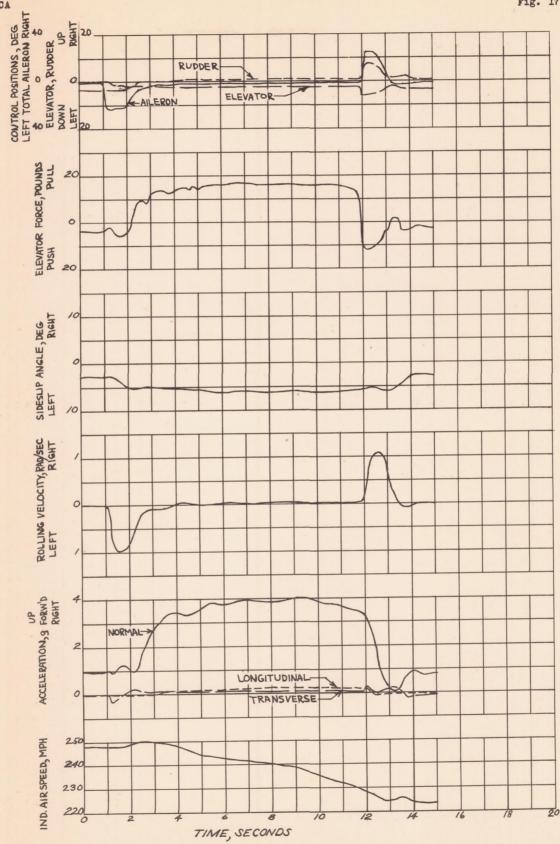
Figure 17. - Time history of a rapid 180° turn to the left started at 248 miles per hour. Supermarine Spitfire airplane with gun ports covered.

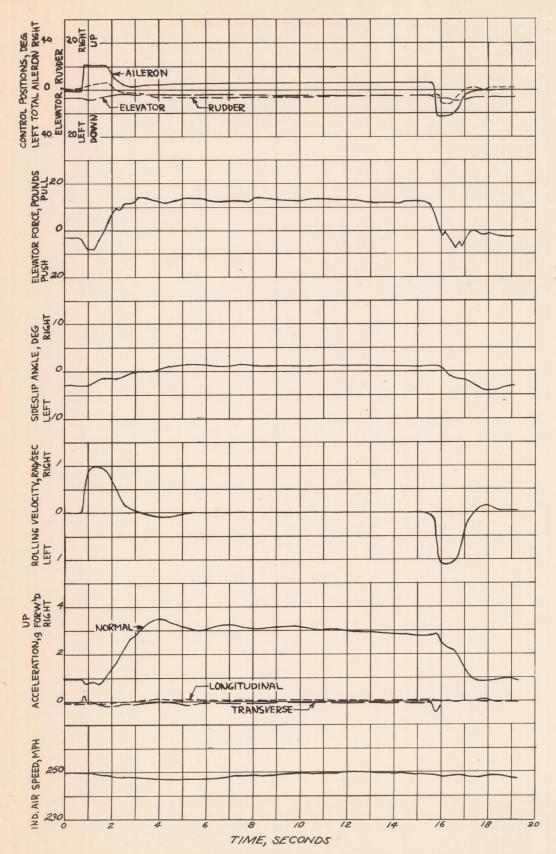
Figure 18. - Time history of a rapid 180° turn to the right started at 250 miles per hour. Supermarine Spitfire airplane with gun ports covered.

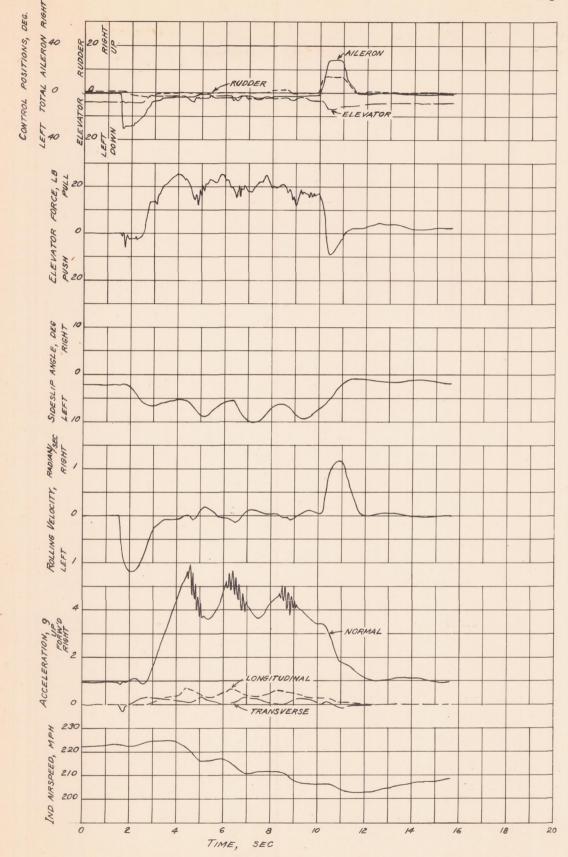
Figure 19. - Time history of a highly accelerated left turn in which the stall was reached three times. Supermarine Spitfire airplane with gun ports covered.

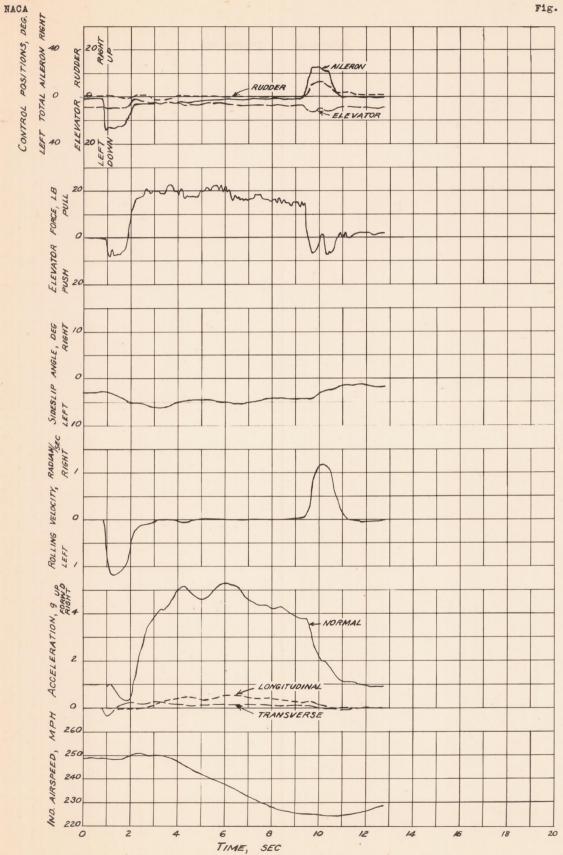
Figure 20. - Time history of a highly accelerated left turn started at 249 miles per hour. Supermarine Spitfire airplane with gun ports covered.

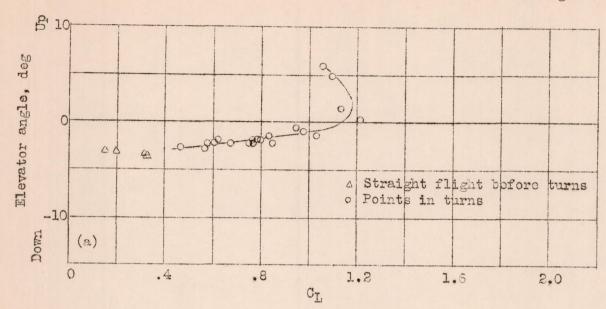
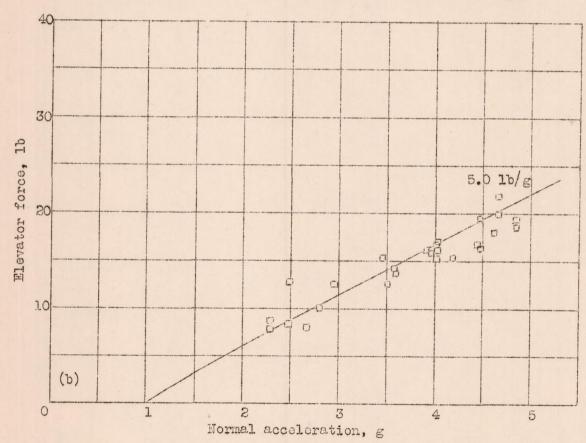
(b) Variation of stick force with normal acceleration in turns.

Figure 21.- Elevator characteristics in turns. Supermarine Spitfire airplane.

The variation of stick force with normal acceleration in turns is plotted in figure 21(b). The stick-force gradient of 5.0 pounds per g was considered a little too light by most of the pilots. It is lower than the value of 6 pounds per g recommended as an upper limit in reference 1. Inasmuch as the elevator mass unbalance under static conditions gave a force of 4.0 pounds on the stick, it is apparent that the stick force required in accelerated flight came almost entirely from the statically unbalanced elevator. Practically no stick force would be required in turns if the elevator were mass balanced. This suggests that the airplane would appear definitely unstable in turns if the elevator were mass balanced, as is required for flutter prevention on American pursuit airplanes.

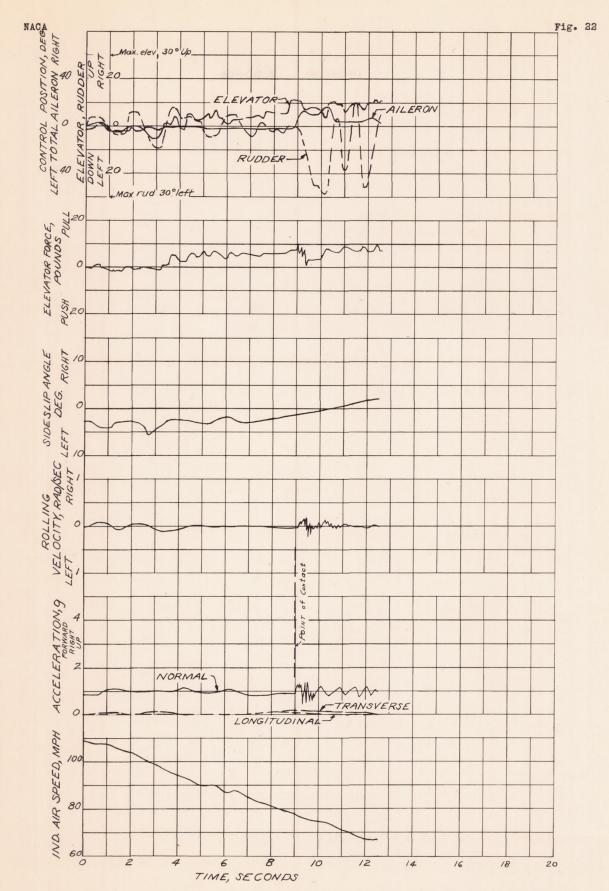
Figure 22. - Time history of a three-point landing (trim tab, 2.30 nose heavy). Note unsteadiness of airplane and controls caused by tail buffeting and instability in the approach. Supermarine Spitfire airplane.

wash at the tail caused by separation of the flow at the wing root was probably combined with that due to ground effect in the three-point landings. A time history of a three-point landing, shown in figure 22, illustrates the unsteadiness of the airplane and controls as the landing attitude was approached.

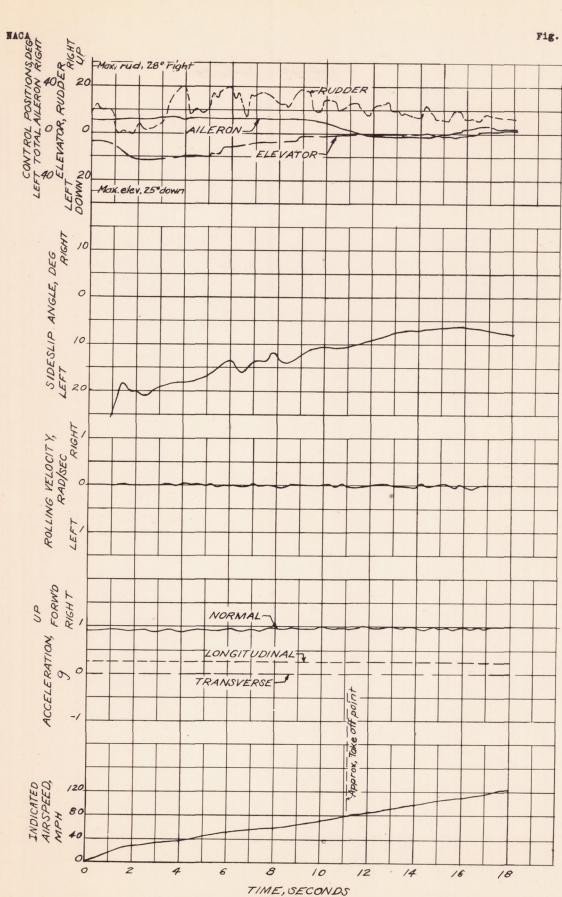
Figure 23. - Time history of a tail-high take-off made with 48 in. Hg manifold pressure. Supermarine Spitfire airplane.

The rudder control, in conjunction with the brakes, was sufficiently powerful to maintain directional control in take-off and landing. A time history of a take-off (fig. 23) shows that some rudder deflection was required to overcome a tendency to turn to the left. The rudder force required for this purpose, however, was observed to be relatively light.

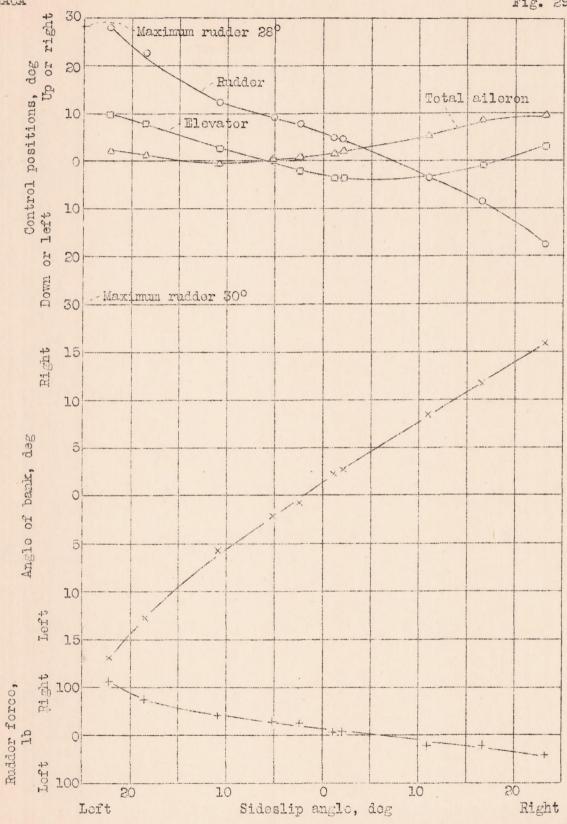
Figure 29 .- Steady sideslip characteristics in the cruising condition (flaps up, goar up, power on) at 120 miles per hour. Supermarine Spitfire airplane.

Rolling moment due to sideslip.— The rolling moment due to sideslip of the Spitfire airplane was determined by recording the aileron angles required in steady sideslips. The results of these measurements are presented in figures 29 to 34, where the rudder, elevator and aileron angles, angle of bank, and rudder force are plotted as functions of the sideslip angle. The dihedral effect was stable in all conditions, with the exception that in left sideslips in the cruising condition the dihedral effect was practically neutral. The requirement of reference 1 was therefore met in all conditions except in left sideslips with power on.

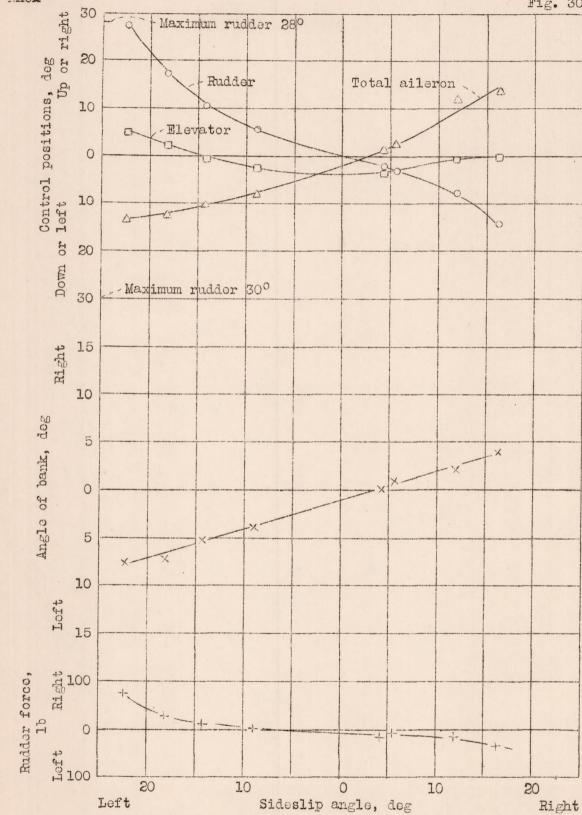
Figure 30 .- Steady sideslip characteristics in the gliding condition (flaps up, gear up, power off) at 107 miles per hour. Supermarine Spitfire airplane.

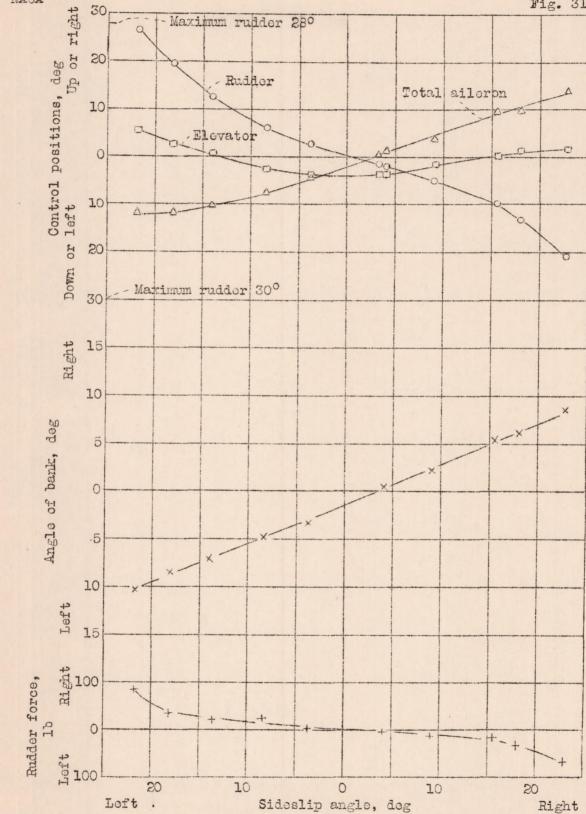
Figure 31 .- Steady sideslip characteristics in the gliding condition (flaps up, goar up, power off) at 122 miles per hour. Supermarine Spitfire airplane.

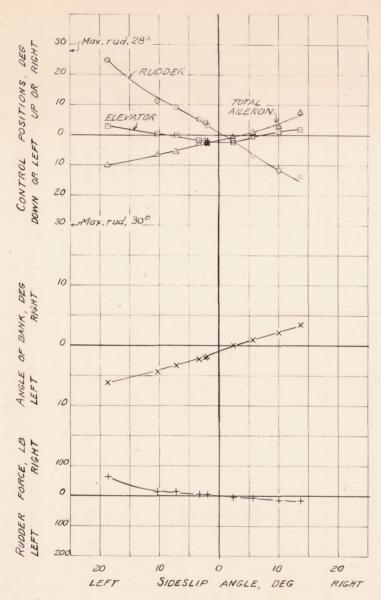
Figure 32. - Steady sideslip characteristics in the landing condition (flaps down, gear down, power off) at 95 miles per hour. Supermarine Spitfire airplane.

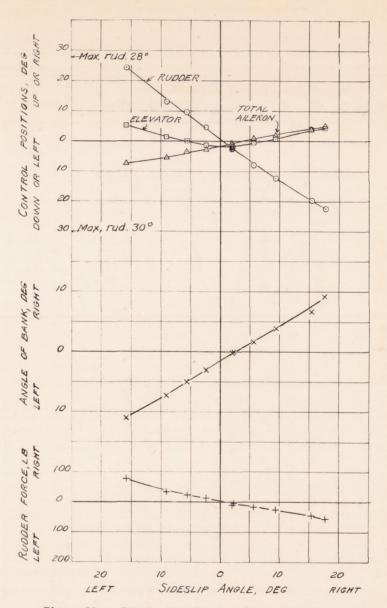
Figure 33. - Steady sideslip characteristics in the landing condition (flaps down, gear down, power off) at 124 miles per hour. Supermarine Spitfire airplane.

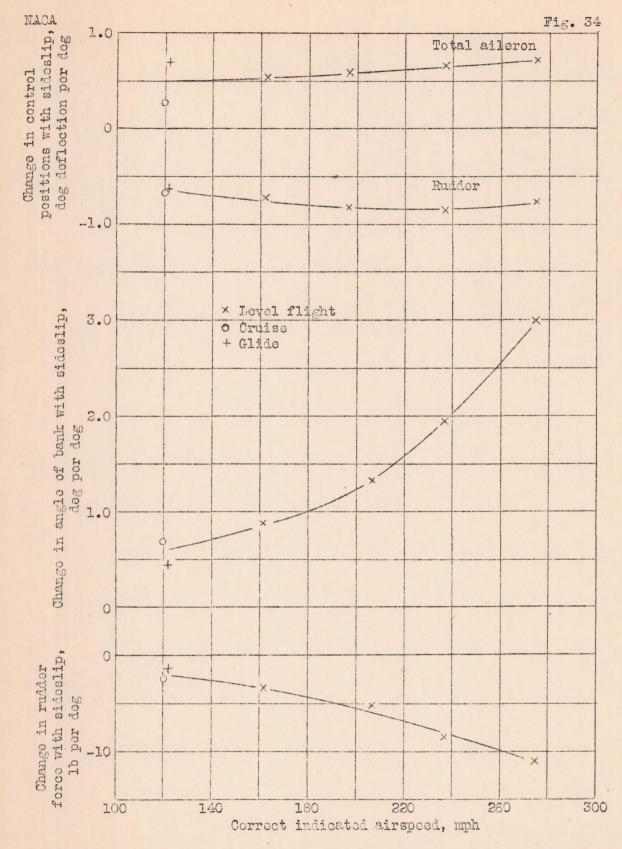
Figure 34.- Steady sideslip characteristics for small rudder deflections at various speeds in level flight with flaps and gear up, hood closed. Supermarine Spitfire airplane.

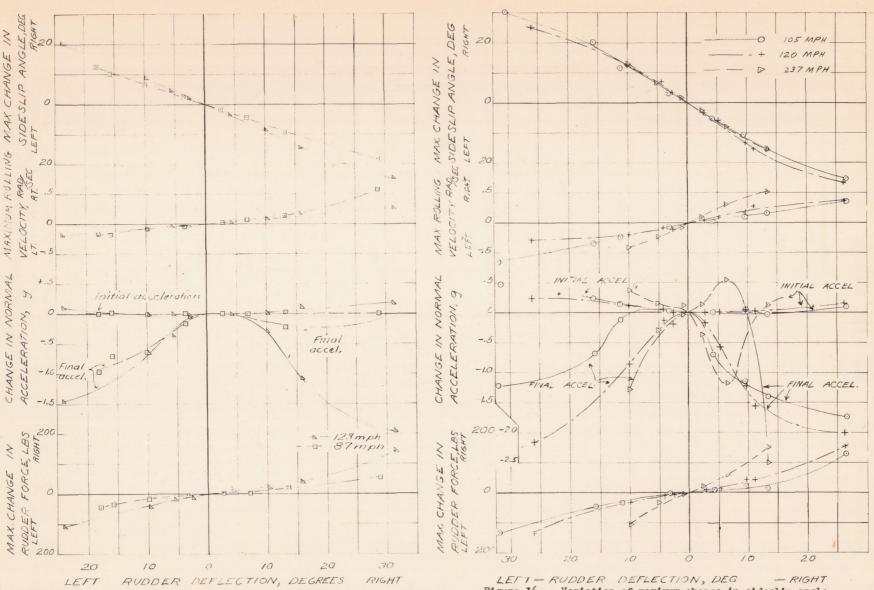
35.36

Figure 35. - Variation of maximum change in sideslip angle,
rolling velocity, change in normal acceleration,
and change in rudder force, with rudder deflection
in abrupt rudder kicks in the landing condition.
Supermarine Spitfire airplane.

Figure 36. - Variation of maximum change in sideslip angle,
rolling velocity, change in normal acceleration,
and change in rudder force, with rudder deflection
in abrupt rudder kicks in level flight. Supermarine Spitfire airplane.

A further indication of the rolling moment due to sideslip is given by the rolling velocities caused by aburupt deflections of the rudder (figs. 35 and 36). The airplane always rolled in the correct direction. The rolling moment due to yawing velocity is combined with that due to sideslip in these tests.

The initial values of rudder force in rudder kicks, plotted in figures 35 and 36, show that the rudder was desirably light. The floating tendency of the rudder caused the pedal force to drop to about one-third of its initial value after the sideslip had built up. No reversal of rudder force ever occurred, however. The requirement of reference 1, which states that left rudder force should always be required for left rudder deflections and right rudder force for right rudder deflections, was therefore satisfied.

The violence of the pitching motions of the airplane in rudder kicks is shown by the variation of normal acceleration with rudder angle (figs. 35 and 36). Because the large accelerations made it difficult for the pilot to hold the elevator angle constant, the normal acceleration plotted on these figures may be partly the result of elevator motion. Nevertheless, the plotted values give a qualitative idea of the pitching motions caused by rudder
