REPORT No. 248

THE CORROSION OF MAGNESIUM AND OF THE
MAGNESIUM ALUMINUM ALLOYS
CONTAINING MANGANESE

By J. A. BOYER

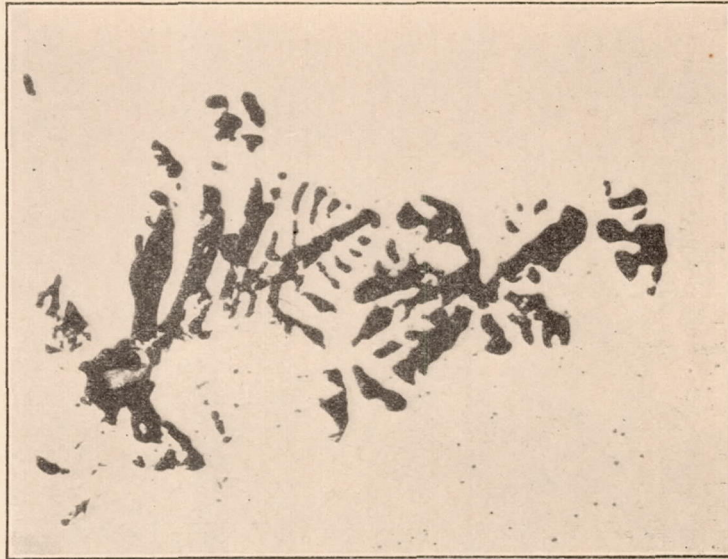
FIG. 9.—Mag. 100 X. Dendritic corrosion pits in magnesium-aluminum alloy after repolishing

Figure 9 shows an almost perfect dendrite in a specimen which has been repolished to remove the tarnish pattern. The polishing was then carried further to see if any constituent would be found at the bottom of the pits from which hydrogen could be liberated, but none was found. A typical area is shown in Figure 10. During the eating out of the magnesium-rich dendrites both silicide and aluminum constituents were inactive, as had been previously observed in the formation of the tarnish pattern.

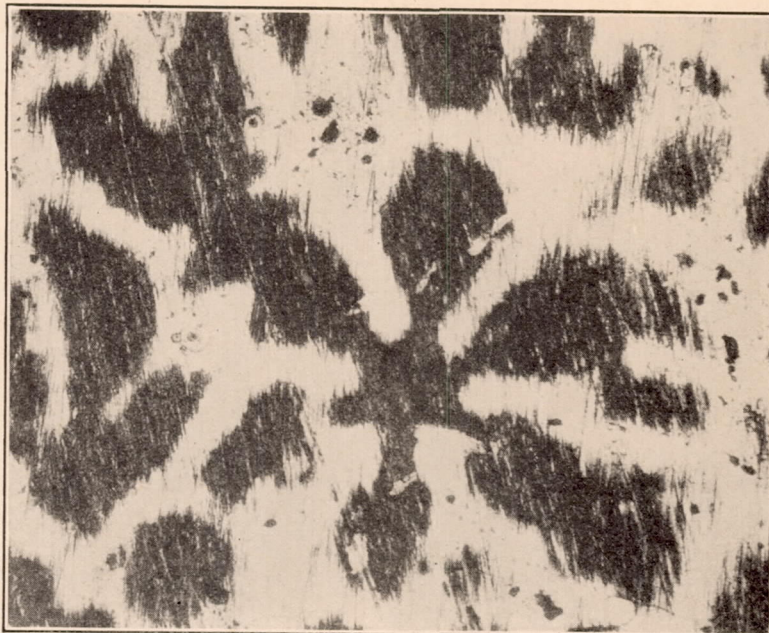
FIG. 13.—Mag. 100 X. Tarnish pattern on polished surface of solid solution alloy (3 per cent aluminum) after immersion in salt water. Compare with Figure 11

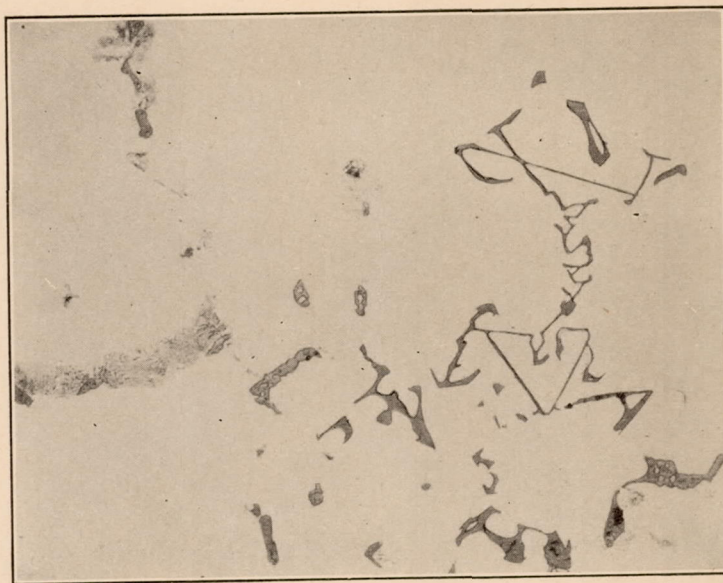
FIG. 15.—Mag. 200 \times . Microstructure of an alloy containing 5 per cent aluminum, 0.3 per cent silicon, balance magnesium

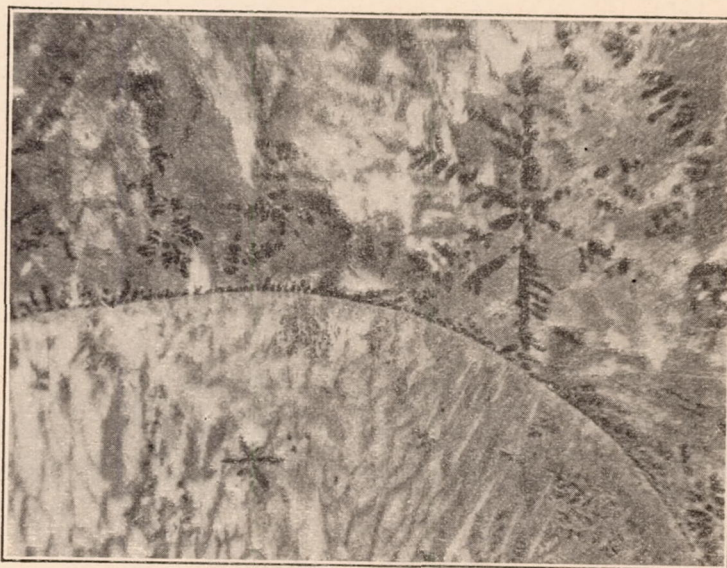
FIG. 18.—Mag. 50 X. Primary dendrite of magnesium in an alloy containing 3 per cent silicon. Note the identical form with corrosion pit of Figure 17

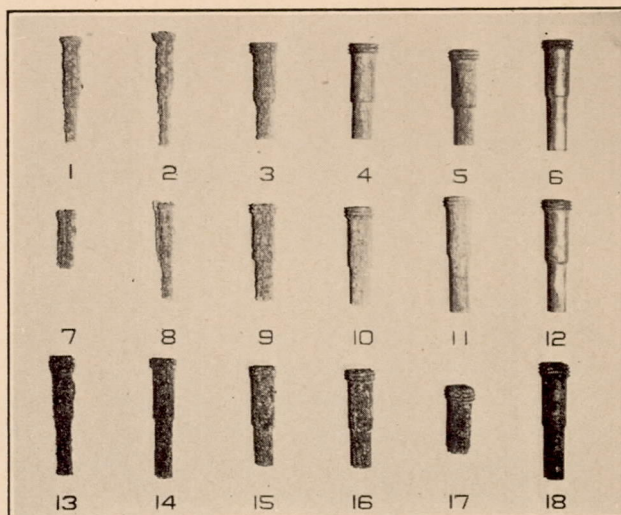
FIG. 35.—Corrosion tests of 12 per cent aluminum alloy containing varying amounts of manganese

Spec. No.	Al	Mn
1	12.05	0.08
2	12.54	.11
3	12.75	.20
4	12.76	.33
5	12.88	.51
6	12.38	.83
