### NACA

### RESEARCH MEMORANDUM

STALL CHARACTERISTICS OBTAINED FROM FLIGHT 10 OF

NORTHROP X-4 NO. 2 AIRPLANE (USAF NO. 46-677)

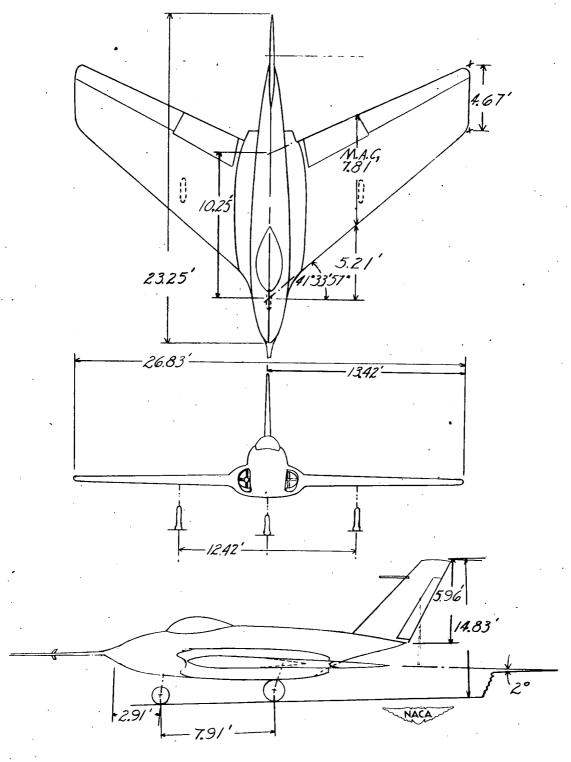
Figure 2.- Three-view drawing of X-4 Airplane.

three—view drawing is included as figure 2. The physical characteristics of the test airplane are listed in table I.

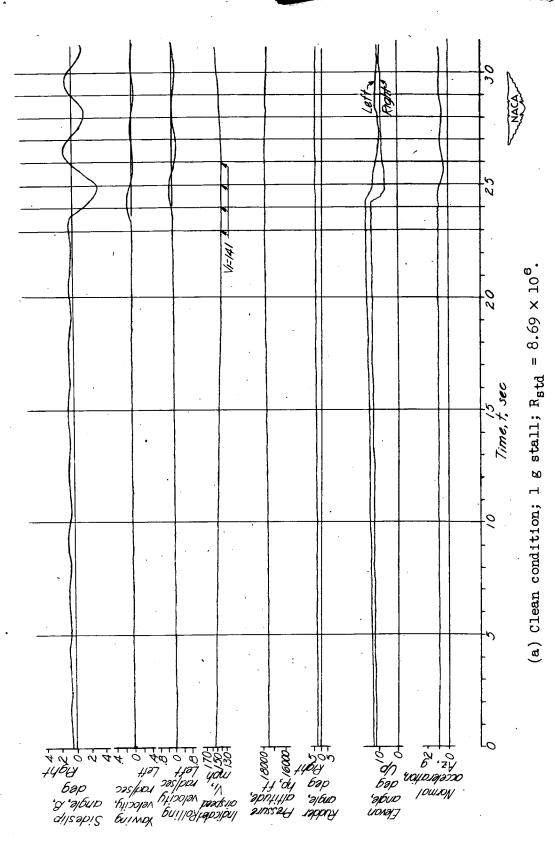
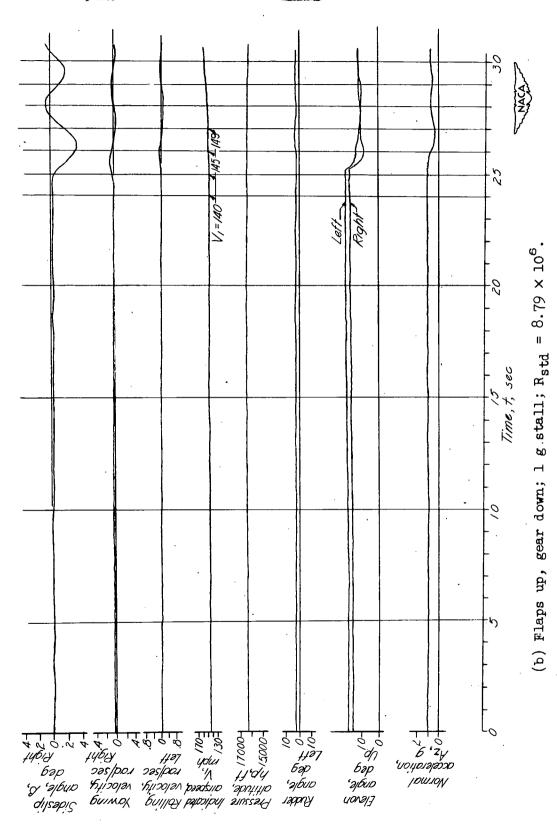
Time histories of stalls on Northrop X-4 Airplane. Figure 3.-

Typical time histories of the motion of the airplane and controls during the stall maneuvers are presented in figure 3.

The time histories of the gradual stall maneuvers in nominally unaccelerated flight (figs. 3(a) and 3(b)) show that as stall was approached the right wing dropped mildly and slight buffeting occurred. However, the pilot commented that the right wing dropped sharply with no warning. Recovery was easily and rapidly effected by the use of small down—elevon angles.

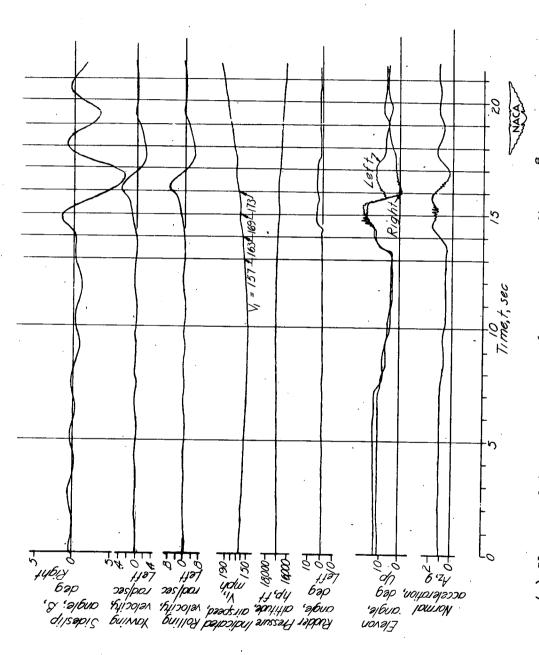
Figure 3.- Concluded.

(c) Clean condition; stall at 1.60 g;  $R_{std} = 9.84 \times 10^6$

The time history of the abrupt stall in accelerated flight (fig. 3(c)) indicates fairly rapid right roll at the stall and moderate buffeting, although the stall is regarded as being relatively mild. The buffeting persisted throughout the recovery. The pilot commented that the characteristics in the abrupt stall were similar to those in the gradual stall,

with the exception that noticeable buffeting, which was considered as a positive warning, occurred just prior to the actual stall. Recovery of the abrupt stall was rapid and complete following the use of down-elevon deflection.

The more abrupt stall (fig. 3(c)) was believed to be complete since the roll-off was pronounced, and increasing up-elevon at the stall had no effect in increasing  $C_{N_{\max}}$  above about 0.85. As shown in figure 4, the value of  $C_{N_{\max}}$  obtained in the abrupt stall is in better agreement with the wind-tunnel values, although this comparison also is not strictly valid because of the difference in elevon deflection and because of the effect on the flight value of  $C_{N_{\max}}$  of the relatively rapid change in angle of attack as the stall was approached. The effect of this latter factor in the gradual stalls is probably very small.

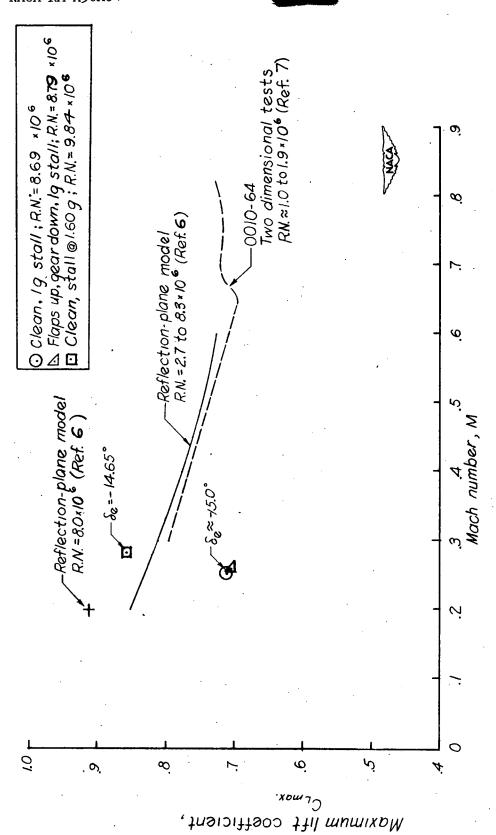
obtained in flight on Northrop X-4 Airplane with values wre  $^{\text{4.-}}$  Comparison of  $^{\text{C}}_{\text{max}}$  obtained in flight on Northrop X-4 Airp obtained from two-dimensional and three-dimensional wind-tunnel tests. Figure 4.-

A comparison of the maximum values of normal-force coefficient obtained in flight with the values of  ${\rm CL_{max}}$  obtained from three-dimensional and two-dimensional wind-tunnel tests (references 6 and 7, respectively) is presented in figure 4. The gradual stall values are considerably lower than the values obtained from wind-tunnel tests even though the wind-tunnel values of Reynolds number were considerably lower in general. However, since the wind-tunnel values were for zero elevon angle and the flight values were for elevons deflected about -150, the discrepancy is not as large as it would appear. The -150 elevon deflection corresponds to a  $\Delta C_N$  of about -0.08. Thus for zero elevon deflec- $\mathbf{c}^{\mathbf{M}^{\text{max}}}$ tion the flight values of would be about 0.79. This value is still considerably below the wind-tunnel values that are indicated in figure 4 for flight Reynolds numbers, although it is above the value of about 0.60 at which, as indicated in figure 5 obtained from reference 8, separated flow occurred on the outboard portion of the right wing of the model during the wind-tunnel tests. It is believed, however, that the effect of separation on lateral trim and stability would not be apparent in actual flight until CN was somewhat higher than 0.60, because of the higher Reynolds numbers of the flight tests. The value of which could be obtained in flight would no doubt depend upon the pilot's ability to hold wings level by use of the controls after initial separation occurred over part of the wing.

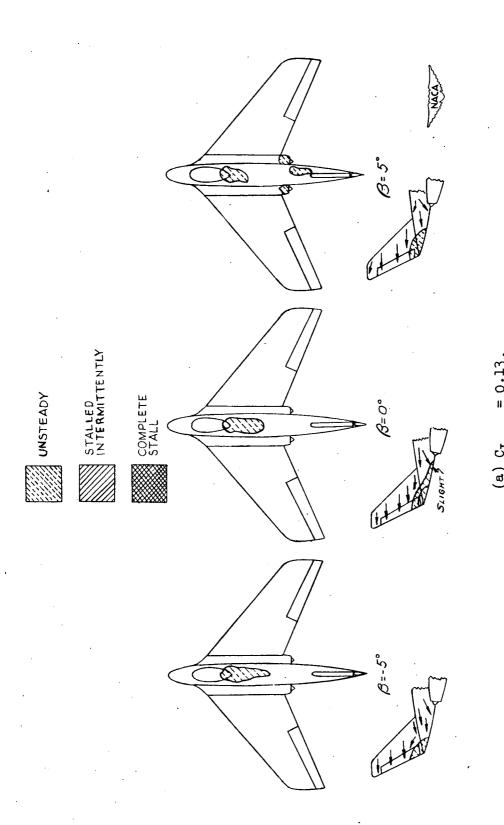
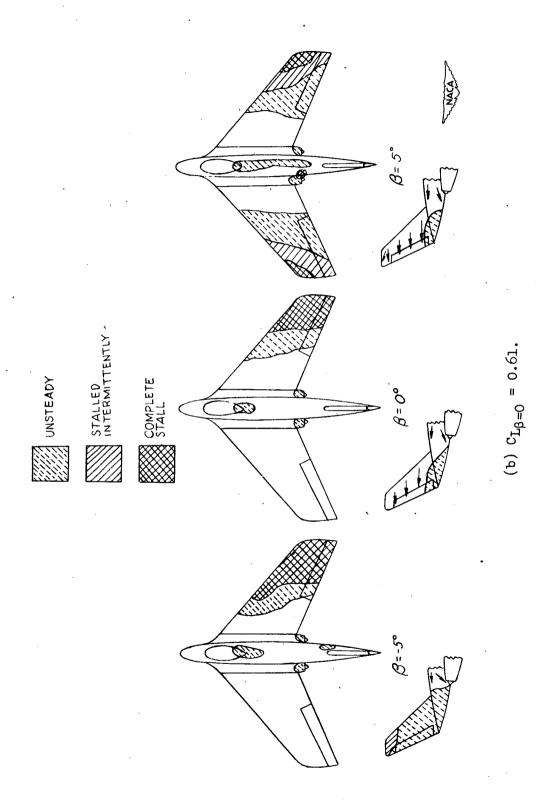
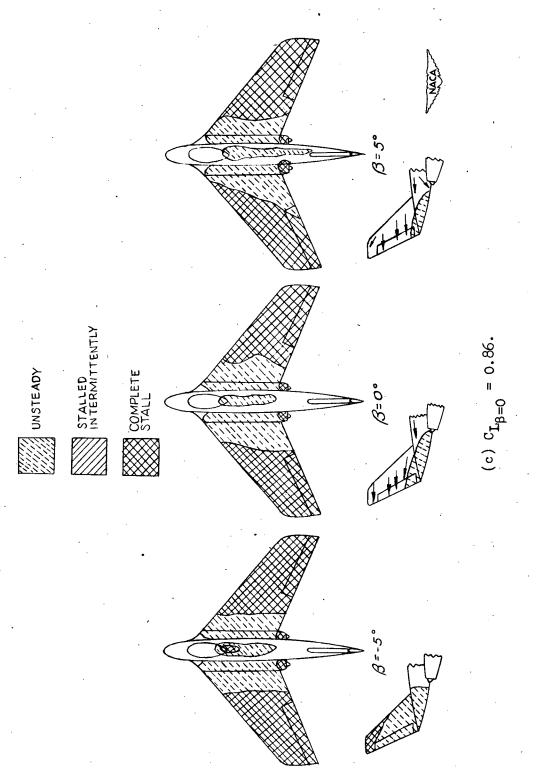
Figure 5.- Stall progression on Northrop X-4 1/4-scale model; Reynolds number = 2.1  $\times$  10<sup>6</sup> (reference 8).

airfoil section, the plan form of the wing, and to the effect of sideslip on the stalling characteristics. The lift curves for the 0010-64 airfoil section and for a 1/4-scale model of the X-4 airplane are shown in figure 6 for several values of Mach number. Even though breakdown of flow first occurs at the tip sections of a swept-back wing, the use of airfoil sections and plan forms which maintain their lift beyond initial separation tends to reduce the magnitude of the rolling and pitching moments that are applied. Also, during roll-off at the stall sideslip occurs which reduces the asymmetry causing the roll. The effect of sideslip on the separated flow conditions over the wing is shown in figure 5.

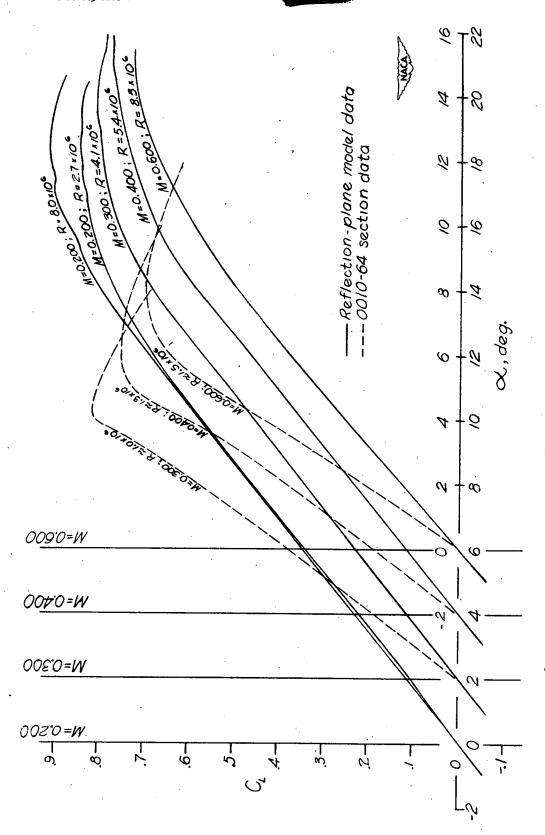
Figure 6.- Lift coefficient as a function of angle of attack at several Mach numbers. Reflection-plane model data (reference 6) and 0010-64 section data (reference 7).

The relative mildness of the abrupt stall is probably due to the nature of the variation of lift with angle of attack for the 0010-64

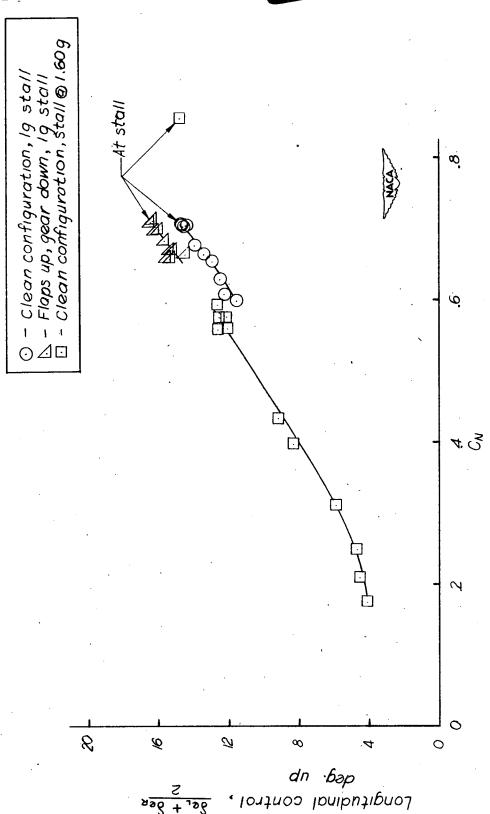
Figure 7.- Stick-fixed longitudinal-stability characteristics near the stall. Northrop  $X \! \to A$  Airplane.

The stick-fixed and stick-free longitudinal-stability characteristics near the stall are presented in figures 7 and 8, respectively. The data were obtained in steady straight flight with the exception of the point at  $C_{\mathrm{Nmax}}$  for the abrupt stall. The stick-fixed data indicate an apparent increase in stability as the normal-force coefficient is increased. This increase in stability which persists to values of  $C_{\mathrm{N}}$  approaching the stall is a desirable characteristic, since it reduces the danger of inadvertent stalling. The corresponding stick-free characteristics (fig. 8) show positive and nearly constant stability up to values of  $C_{\mathrm{N}}$  approaching those at the stall.

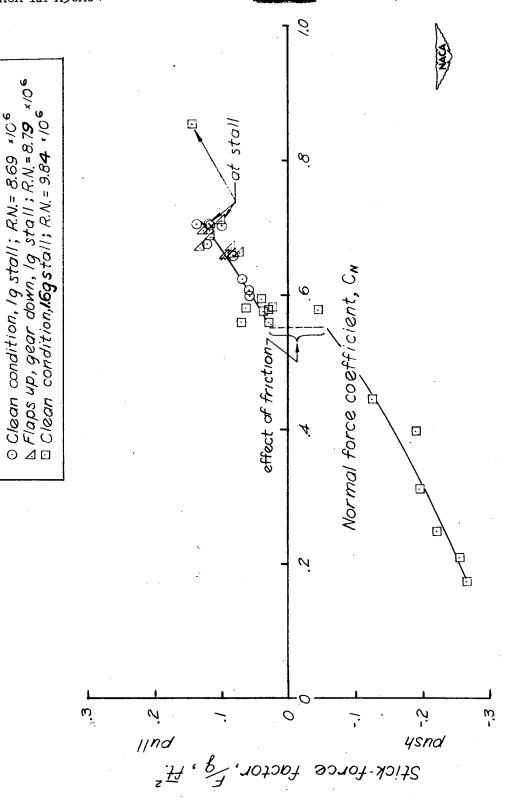
Stick-free longitudinal-stability characteristics near stall, Figure 8.-
