# RESEARCH MEMORANDUM

LANDING AND TAXIING TESTS OVER VARIOUS  
TYPES OF RUNWAY LIGHTS

By Robert C. Dreher and Sidney A. Batterson

Langley Aeronautical Laboratory  
Langley Field, Va.

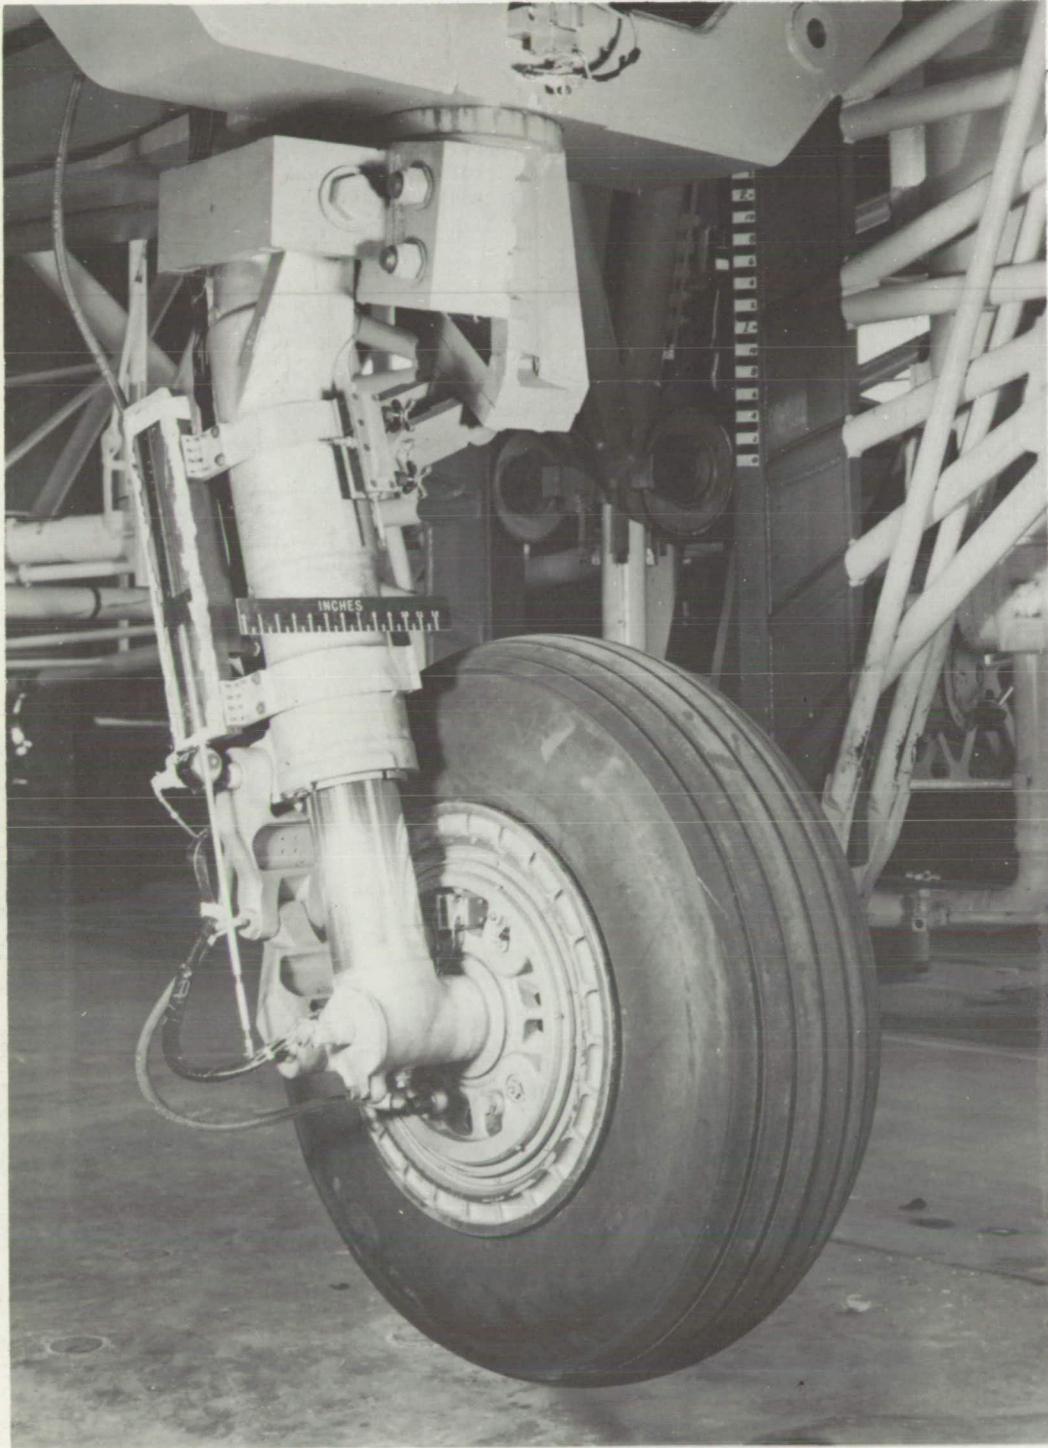
Figure 14.- B-57 main landing gear mounted for test. L-57-1338

A limited investigation, consisting only of taxi tests, was made with the B-57 main landing gear. Figure 14 is a photograph of this gear mounted on the carriage. The static weight on the tire was 20,000 pounds, and the weight of the lower or unsprung portion of the gear was 534 pounds. The landing gear was equipped with a 44x13, type VII, 26-ply-rating tire. The tire pressure was 140 pounds per square inch, and the pressure in the oleo-pneumatic shock strut when fully extended was 292 pounds per square inch. All runs were made with this landing gear arbitrarily inclined forward at a fixed angle of  $15^{\circ}$  to the vertical. The horizontal and vertical loads between the tire and the lights were measured by a dynamometer built into the main carriage. Appropriate inertia corrections were made through the use of accelerometers mounted on the landing gear.

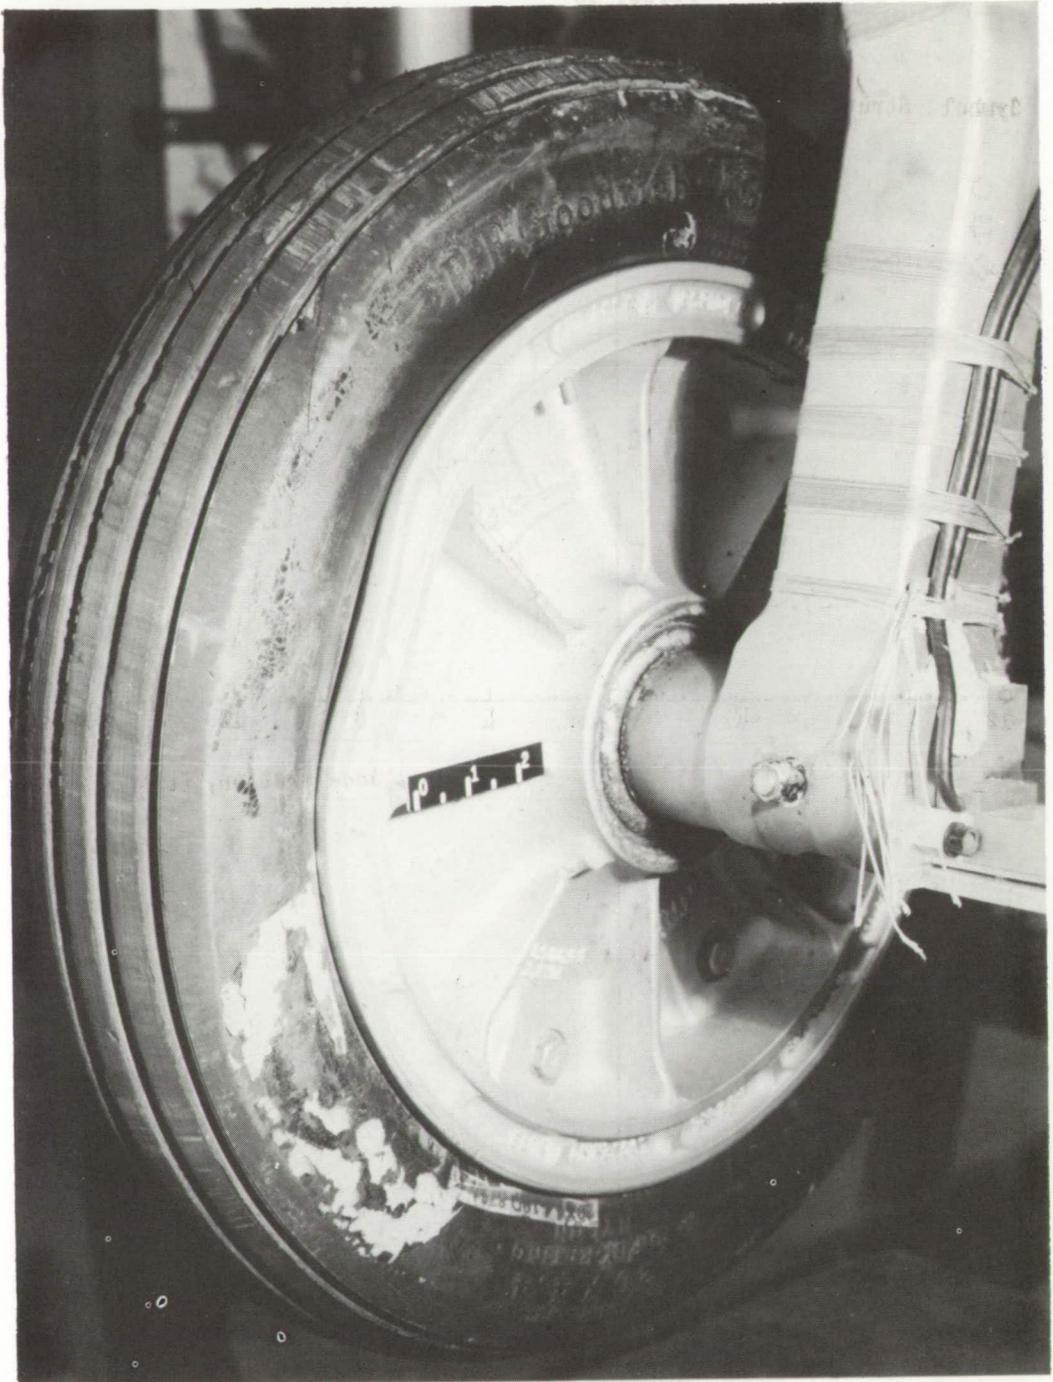
L-57-3717

Figure 25.- View of damage sustained by F-94C nose wheel after striking AN-L-9 light.

ANL-9 edge light.- One taxi test was made over the ANL-9 semiflush light. During this run the rim of the landing gear wheel was bent while passing over the light. Figure 25 is a photograph of the wheel damage which occurred during the run.
