FABRICATION AND ENDURANCE OF AIR-COOLED STRUT-
SUPPORTED TURBINE BLADES WITH STRUTS
CAST OF X-40 ALLOY

By Eugene F. Schum, Francis S. Stepka, and Robert E. Oldrieve

Lewis Flight Propulsion Laboratory
Cleveland, Ohio

April 11, 1956
Declassified April 15, 1958

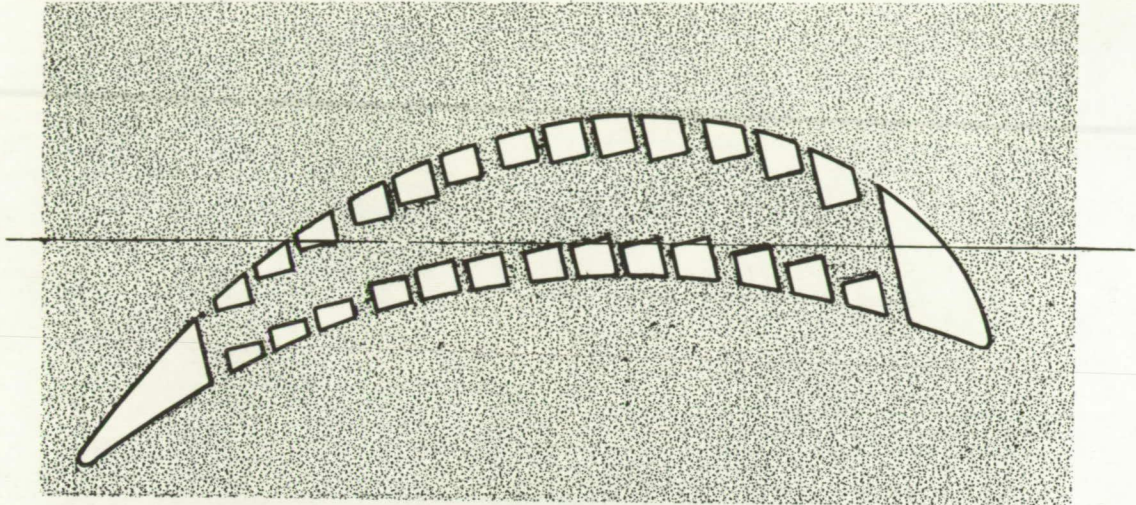
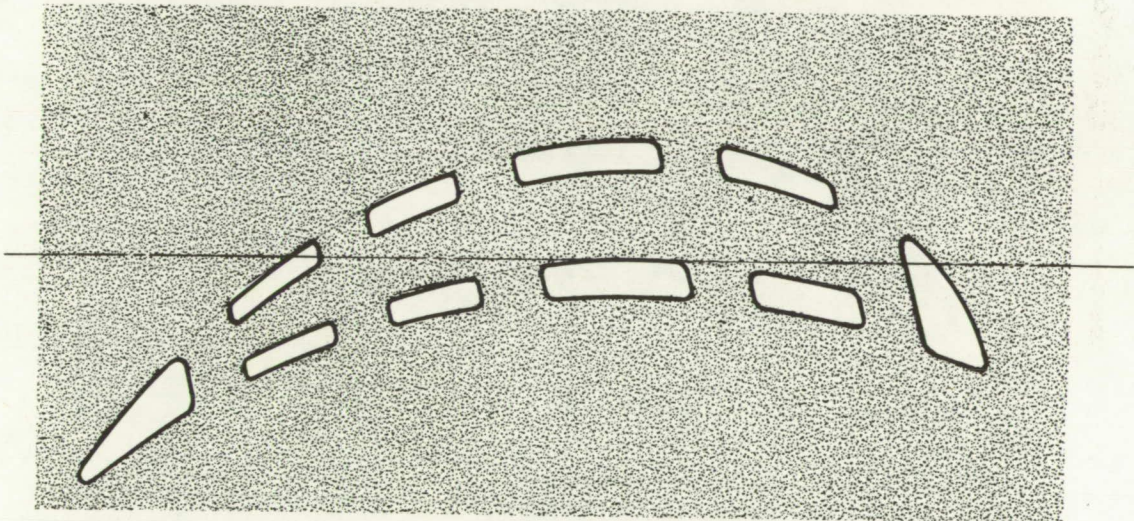
Figure 4. - Comparison of blade cross sections at base (1/16 in. below platform) before and after modification required to eliminate casting difficulty.

(a) Primary and secondary fins extending into base.

(b) Only primary fins extending into base.

The first integral strut-base castings (which were not used for the blades reported herein) had the 0.020- and 0.040-inch secondary and primary fins, respectively, extending into and through the blade base. Because of the resulting small rectangular passages and the thin fins (both primary and secondary) at the base (fig. 4(a)), some shifting of the passage cores and shrinkage cracks in the fillet in the primary fins at the blade root occurred. Changes in the original dies were then made to remedy these casting difficulties. To provide larger passages the thin secondary fins were terminated $3/16$ inch above the base platform and the thickness of the primary fins as they entered the base was increased to 0.100 inch (figs. 1 and 4(b)). The increase in primary-fin thickness was to compensate for the loss of the shear area previously provided by the secondary fins. Shrinkage cracks in the fillet were eliminated by the increased primary-fin thickness and by increasing the radius of the fillet in these fins at the root from $1/16$ to $1/8$ inch (fig. 1). The acceptability of castings was determined by inspections with X-ray.

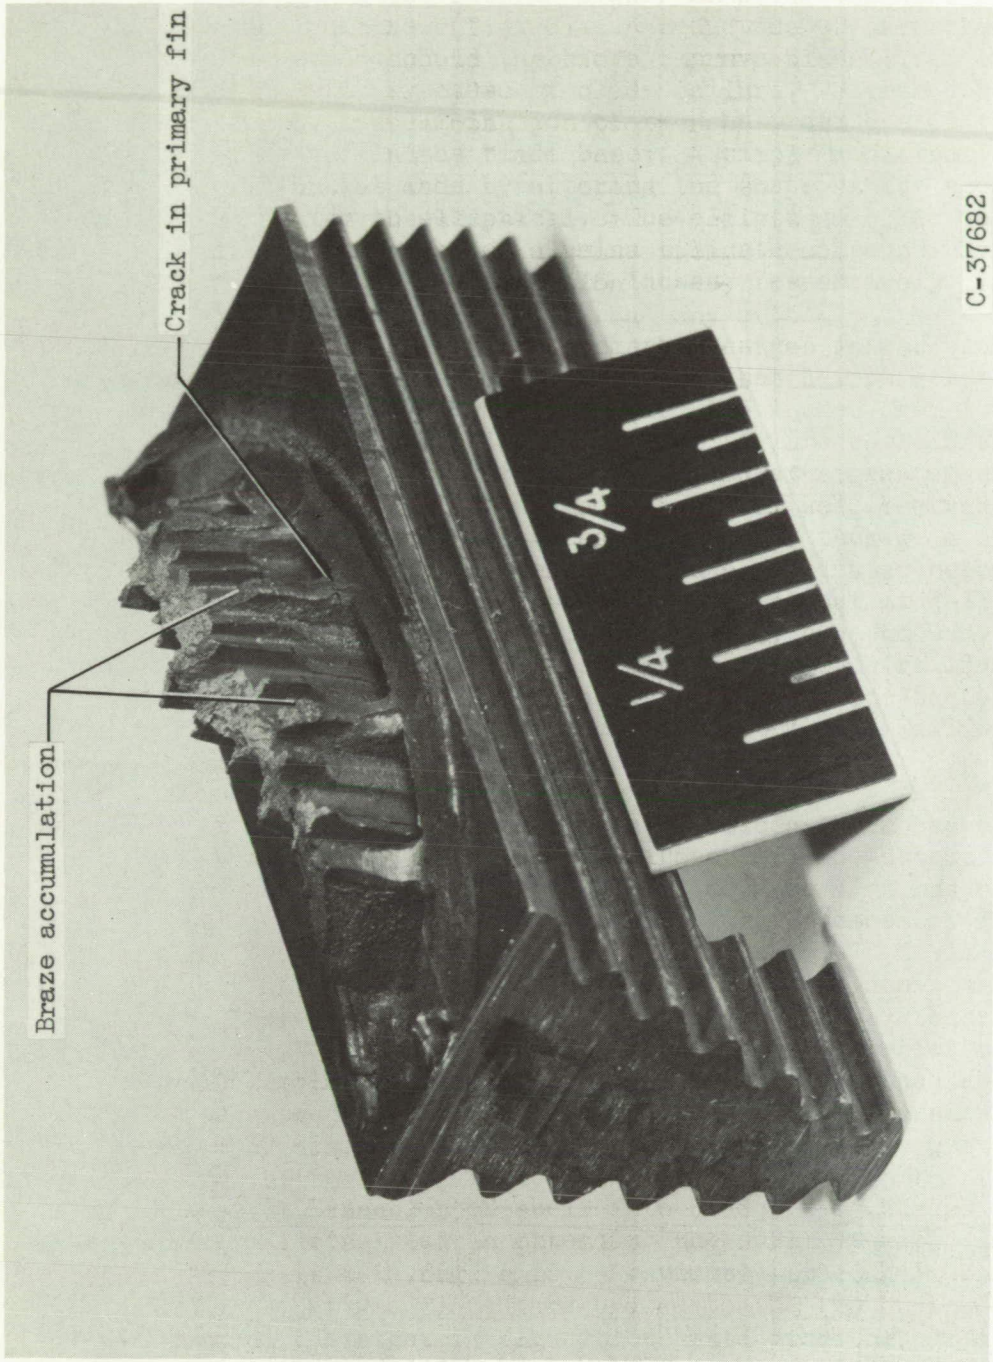
Figure 6. - Typical blade failure (blade 5).

Endurance results. - Nominal blade root stress of 35,000 psi (blades 1 to 9): The life of the nine blades operated at the 35,000-psi root stress level ranged from minutes to a few hours. The lives of the individual blades are tabulated in table II. The blades generally failed in the root region of the strut, as shown in figure 6 (blade 5), which was typical of the failures.

fins of the strut, there was a tendency for the blade to fail through the area with the accumulated braze. The proximity of the braze accumulation to the location of strut failure is shown in figure 6 (blade 5). Failures of this type were not observed on the blades that were brazed with braze compound II.

transfer the centrifugal load of the strut to the blade base. Stresses are expected to be high in the fins as evidenced by cracks in the primary fins in several blade failures (fig. 6). A reduction of any stress concentrations in this region should therefore improve blade life, if this transfer of load is a primary cause of blade failure. Stress concentrations can be reduced by the elimination of the sharp corners in the rectangular coolant passages in the blade base. A simple modification to the strut configuration was made by altering the shape of the coolant passages from rectangular to elliptical. The elliptical holes were obtained by using elliptical cores of alumina silicate compound having major and minor diameters of $1/8$ and $1/16$ inches, respectively.

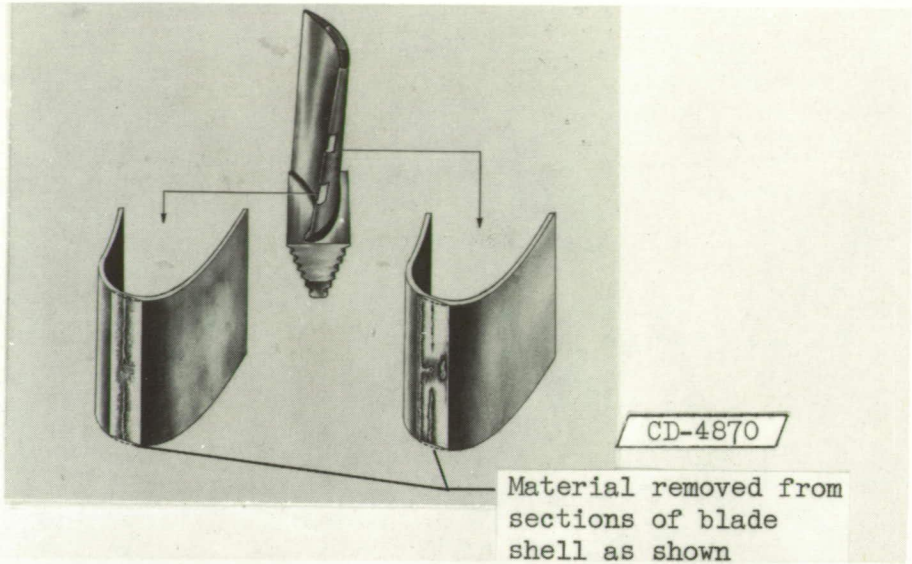
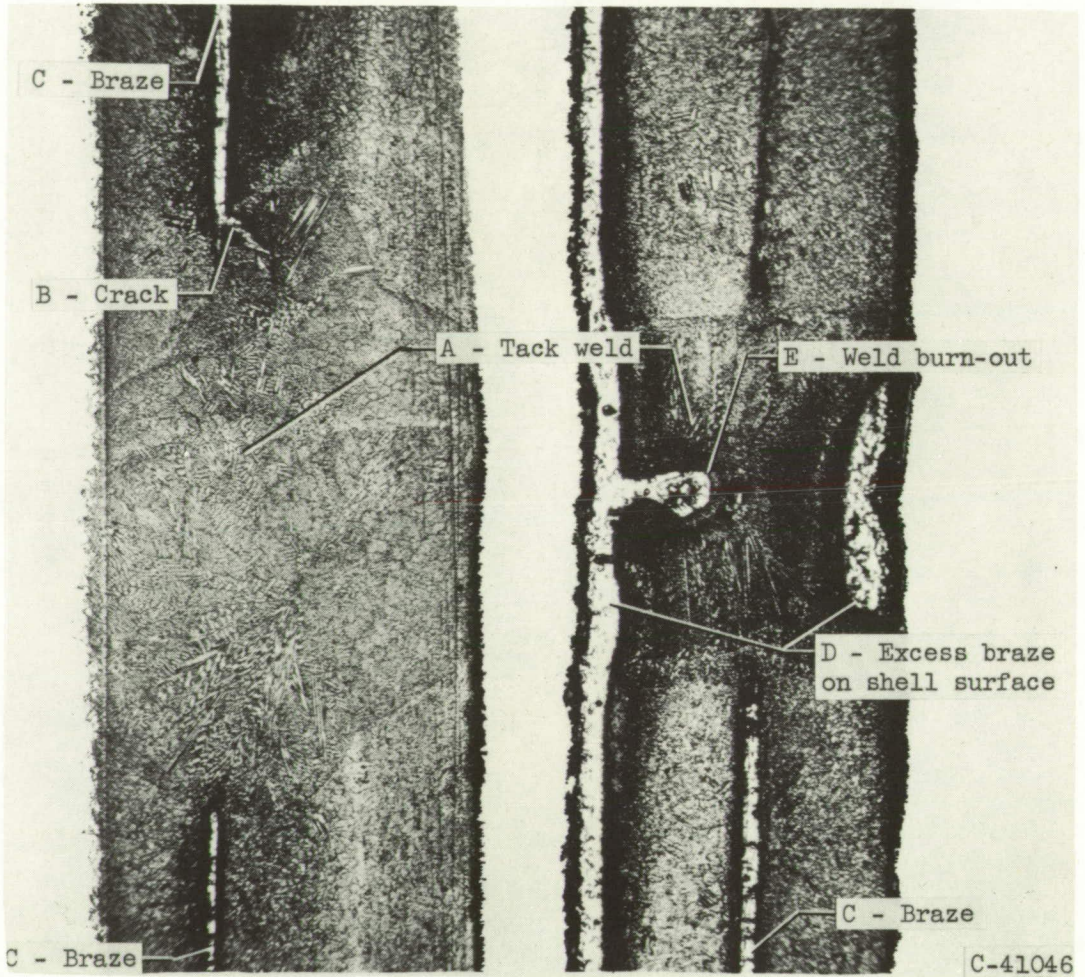
Figure 7. - Photomicrograph (30X) of tack-welded region on shell leading edge.

As mentioned earlier, tack-welding of the shell was used in the fabrication of some of the blades. Failure patterns observed on several blades indicated that tack-welding was one of the causes for shell failures. Photomicrographs of two tack-welded regions of the leading edge of a typical blade shell are shown in figure 7. Shown are sections through the leading edge of the shell halves as viewed upstream of the turbine blade. The region surrounding point A in figure 7(a) is the tack weld,

B is a slight crack in the shell material, and C is the braze that bonds the shell halves. Figure 7(b) illustrates another tack weld, observed on the same blade. The letter designations are the same as for figure 7(a). An excess of braze that flowed over a portion of the outer shell surface is designated D. The pockets or weld burn-outs (E) are filled by braze. The resulting stress concentration at this point could cause blade failure.

(a) Lower tack weld.

(b) Upper tack weld.

Six of the blades listed in table II (9 to 14) had the blade shell halves bonded by welding along the length of the leading and trailing edges of the blades. Complete welding of the shell was used in order to eliminate the use of tack-welding and perhaps to reduce cracking of the shell. Shell failures and complete blade failures, however, were obtained for all but the two blades tested at a root stress level of 15,000 psi. Typical of the blades with a shell failure was blade 12 (fig. 8), which was tested at a root stress of 27,000 psi. A crack first developed in the fillet region after 12 hours of operation as shown in the view in figure 8(a). To establish whether shell failures were causing strut failures, a thin metal patch was brazed over the crack to prevent the crack from spreading. This patch extended from the leading to the trailing edge on the suction surface and had a width of 1/2 inch. After 10 additional hours of operation, another crack developed in the shell but in the trailing-edge region and on the pressure surface (fig. 8(b)). It should be noted that the crack extended from a region immediately adjacent to a large weld build-up (point A). It is thought that stress concentrations in these regions cause the cracks to originate. To further extend the blade operation, this crack was brazed shut and operation continued for an additional 25 hours (a total of 47 hr), when failure of the blade (fig. 8(c)) terminated the tests. Examination of the failure indicated that the crack that caused the blade to fail originated at a weld build-up in the leading edge (point A), then progressed to the strut, and was followed by a fatigue failure.

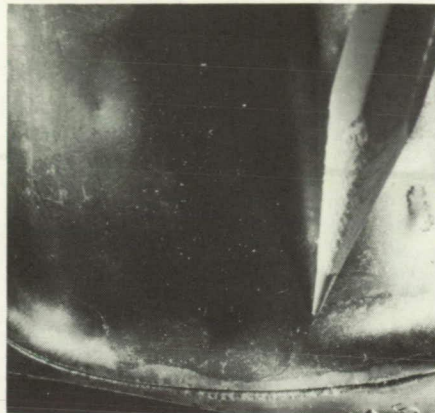
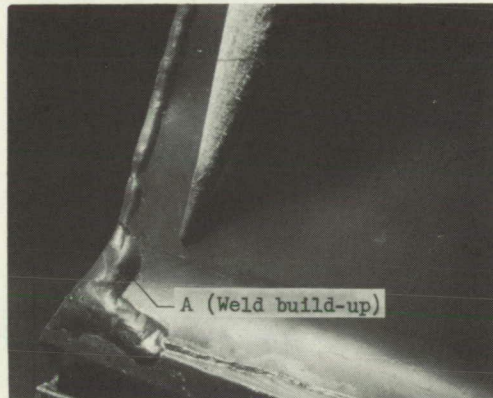
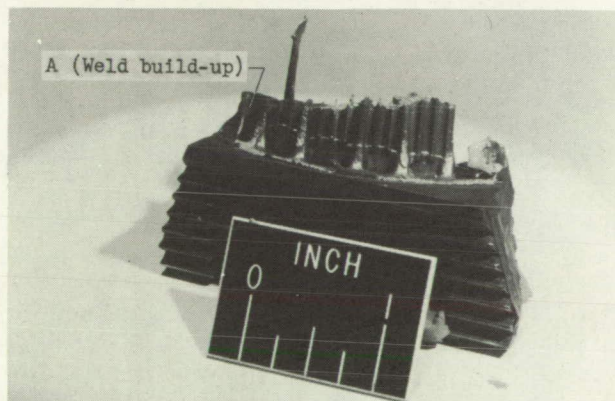
Figure 8. - Failure of blade 12.

6, 22, and 47 hours. The lives of the latter two blades were extended by repairing cracks in the blade shell that developed during the endurance test. The repairs are discussed in more detail later. The general location of the failures was the same as for the higher stressed blades (35,000 psi).

(a) Midchord crack in fillet region of shell on suction surface of blade 12 after 12 hours of operation.

(b) Trailing-edge crack in fillet region of shell after 22 hours of operation.

(c) Strut and shell failure after 47 hours of operation.

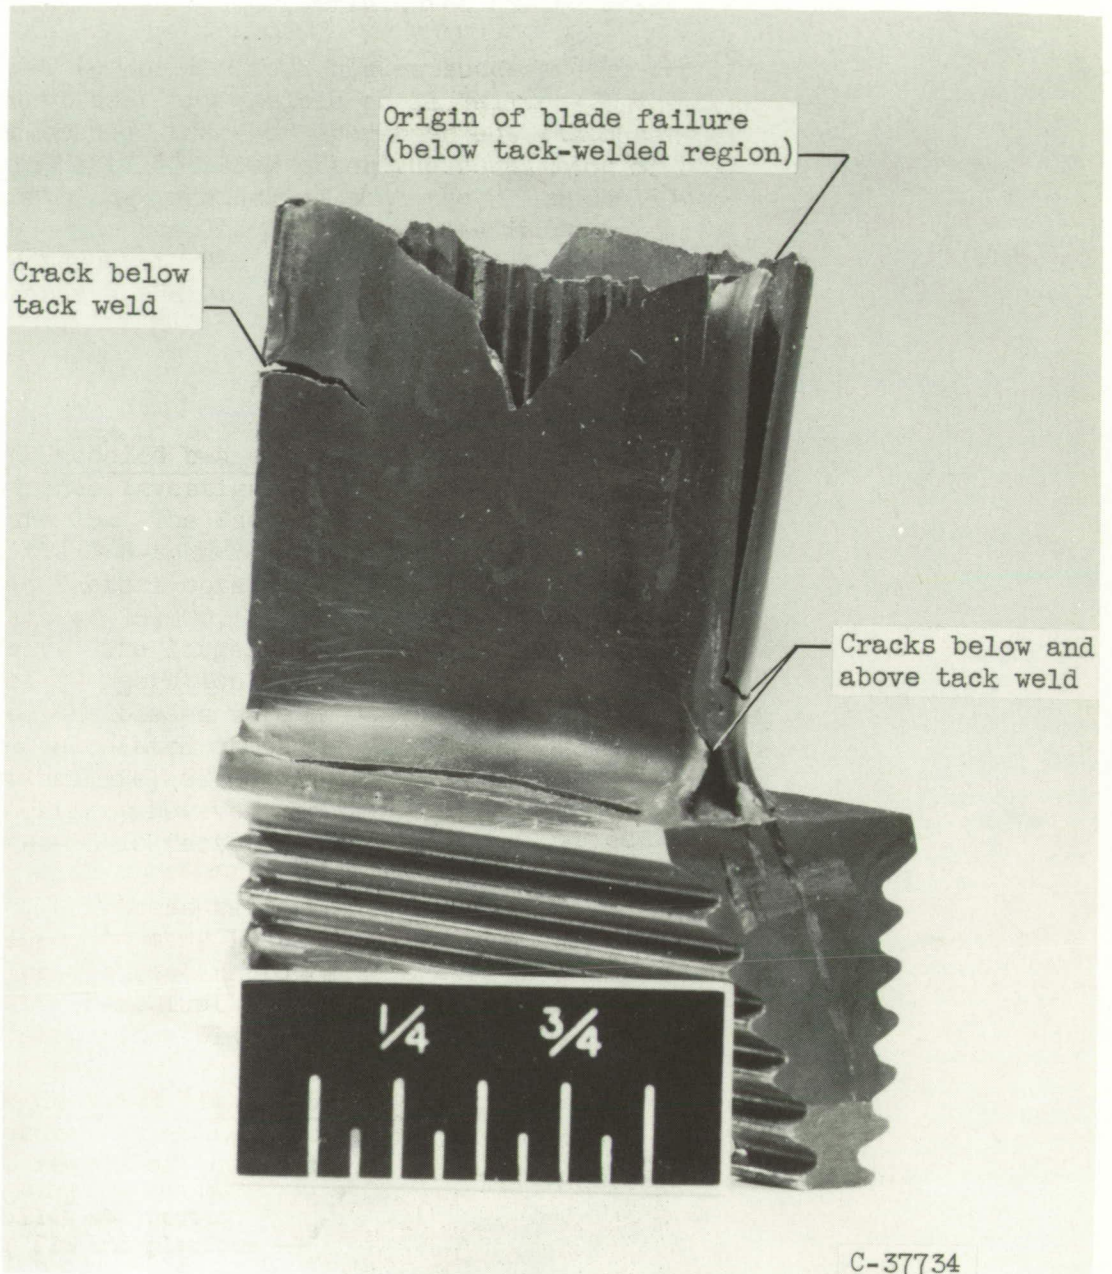
Figure 9. - Failure of blade 18 (modification 3) after 3 hours of operation.

Two blades containing elliptical coolant passages in the blade base failed in 2 and 3 hours, a life comparable with that before strut modifications. The 3-hour blade (blade 18) failed 1.5 inches from the blade platform ($3/8$ span) as shown in figure 9. This failure was different from the earlier failures in that the blade failed at a greater distance from the blade base and severe cracking of the shell was observed. The cracks shown on the leading edge progressed through a tack-welded region. The failure at the 1.5-inch span appeared to have originated below a tack-welded region. Examination of the strut showed that it failed in fatigue in the strut leading edge. This fatigue may have been due to a shell crack progressing to the strut and causing a fatigue failure. This type of blade failure provides additional evidence that the tack-welding of the shell may have a detrimental effect on blade life. Failure of the 2-hour blade occurred $3/8$ inch from the blade base.

Since the life of the two blades with the strengthened bases was comparable with that without this strut modification, the stress concentration caused by the transfer of the load in the base fins may not be a primary cause of strut blade failure. Nevertheless, the use of fillets in the rectangular coolant passages in the blade base is a desirable feature in any design. As a result, subsequent blades contained fillets of approximately $1/32$ -inch radius in the coolant passages. These fillets were obtained by dipping the strut and base wax assembly (prior to insertion in the casting molds) into molten wax to a depth $3/4$ inch above the base platform for a predetermined length of time. This immersion of the wax pattern assembly also provided a smoother surface on the pattern.

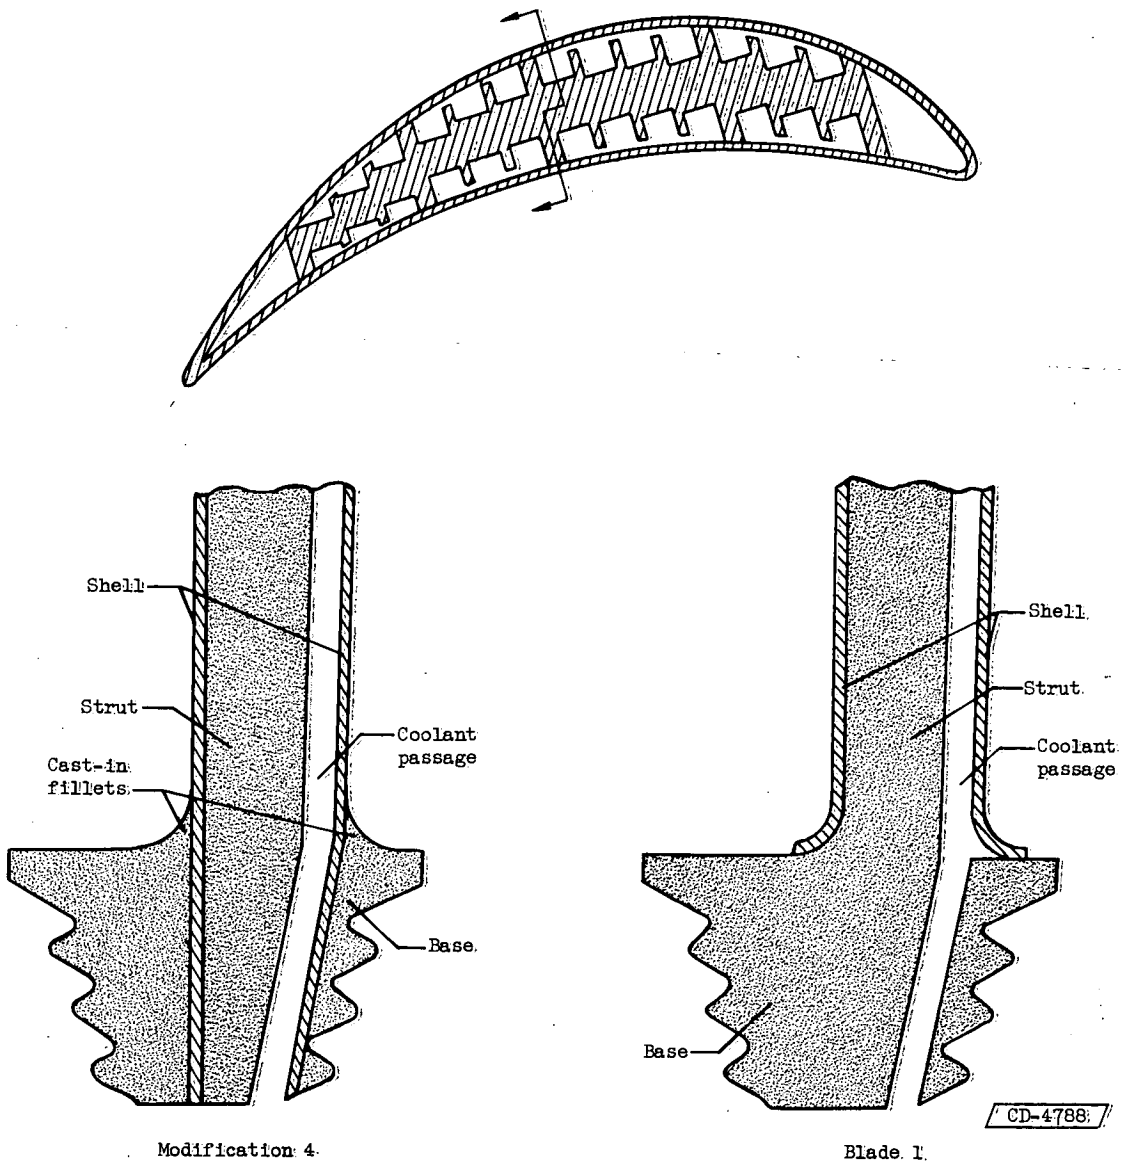
Figure 10. - Comparison of modification 4. (extension of shell into base) with blade 1.

Modification 4: Extension of shell into blade base (blades 19 to 21). - Modification 4 consisted in extending the shell directly into the base as shown on the left in figure 10. Previously, the shell did not extend into the base but was flared and brazed to the top of the blade platform as shown on the right in figure 10. Extending the shell into the base eliminated the need for the closing of the holes in the fillet region of the blade base and shell at the leading and trailing edges. As mentioned earlier, this welding may have been a cause for shell failures. In addition, with modification 4 the shell in the fillet region is in the direction of the centrifugal loading on the blade, which may provide more rigidity.

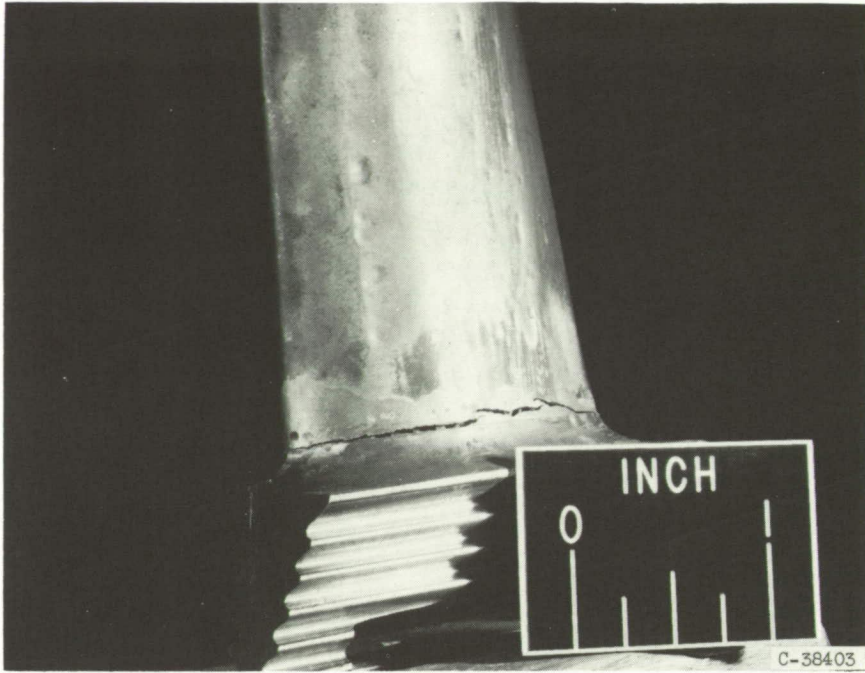
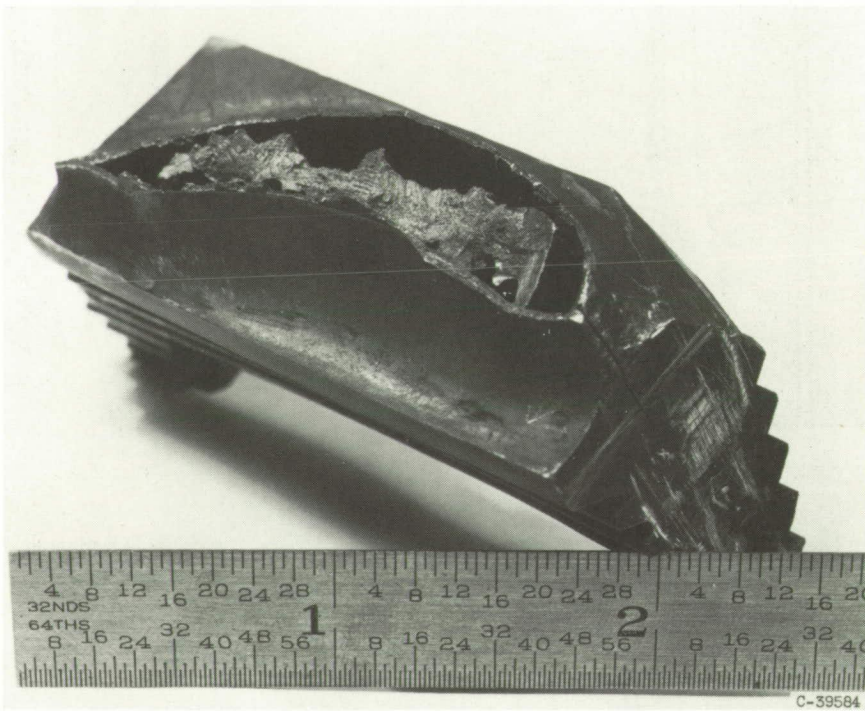
Figure 11. - Failures of blades with modification 4.

The life of the three blades tested (blades 19, 20, and 21) with this modification ranged from 12 to 53 hours. These results indicate that the modification increased blade lives over those previously tested. Tests on blade 19 were concluded when a shell failure (shown in fig. 11(a)) occurred after 12 hours. The failure occurred at the top of the cast fillet. A microscopic examination of the blade, which was sectioned, showed that the brazed joint between the shell and the strut along the suction surface was poor. The results of this examination also showed that the shell necked down under the tensile load. The second blade (blade 20) failed completely at the top of the fillet after 24 hours of operation (fig. 11(b)). Tests on the third blade (blade 21) were terminated after the blade completed 53 hours of operation. A very small crack on the suction surface and at the top of the fillet, however, was observed in this blade. The notch effect at the junction of the shell and the top of the fillet may have been the cause of the failure of the shell.

(a) Blade 19, shell failure after 12 hours of operation.

(b) Blade 20, failure after 24 hours.

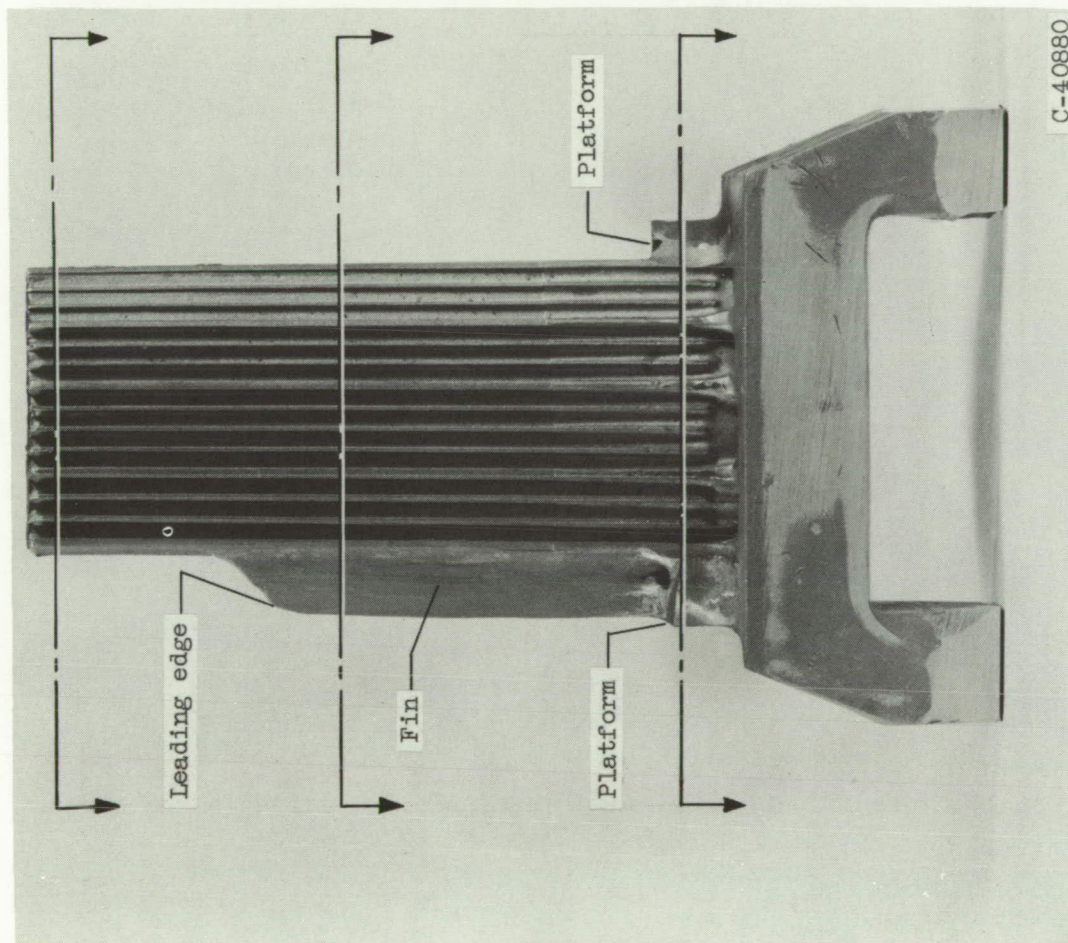
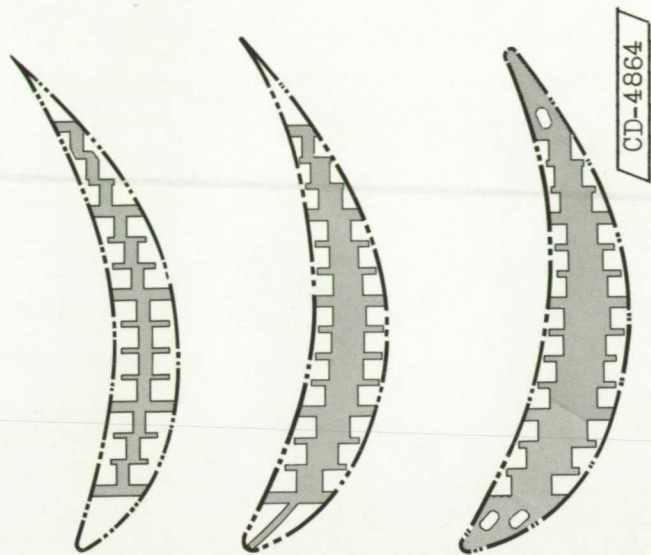
Figure 12. - Modification 5: Platform at strut leading and trailing edges and supporting fin.

Modification 5: Platform at leading and trailing edges and supporting fin at leading edge (blades 22 and 23). - Modification 5 was intended to reduce shell failures by the addition of a supporting platform at the base of the leading- and trailing-edge regions and by a supporting fin extending from the strut to the leading edge of the shell (fig. 12). The platform had a height of $3/8$ inch and was cast integrally with the strut and blade base. Passages were provided in the platforms for coolant. The blade shell, which was flared in the usual manner in the fillet region, was brazed to the sides of the platforms. This method of fabrication eliminated welding in these regions. The fin in the leading edge, which was brazed to the shell, provided added support to the shell. For the two blades tested, the shells were of one-piece construction, so formed that only the trailing edge needed heliarc welding. The two blades successfully completed 50 and 66 hours of engine operation, after which testing was terminated. During the testing of the blades a $1/2$ -inch spanwise crack developed at the trailing edge of the shell at the blade tip. This crack was rewelded and operation continued. The test results indicate that the use of the support platform, the supporting fin, and the one-piece shell with a welded trailing edge (no welding at the leading edge) had a significant effect on increasing blade life. It appears that a further improvement could be made if a blade shell could be fabricated without welding of either the leading or the trailing edge.

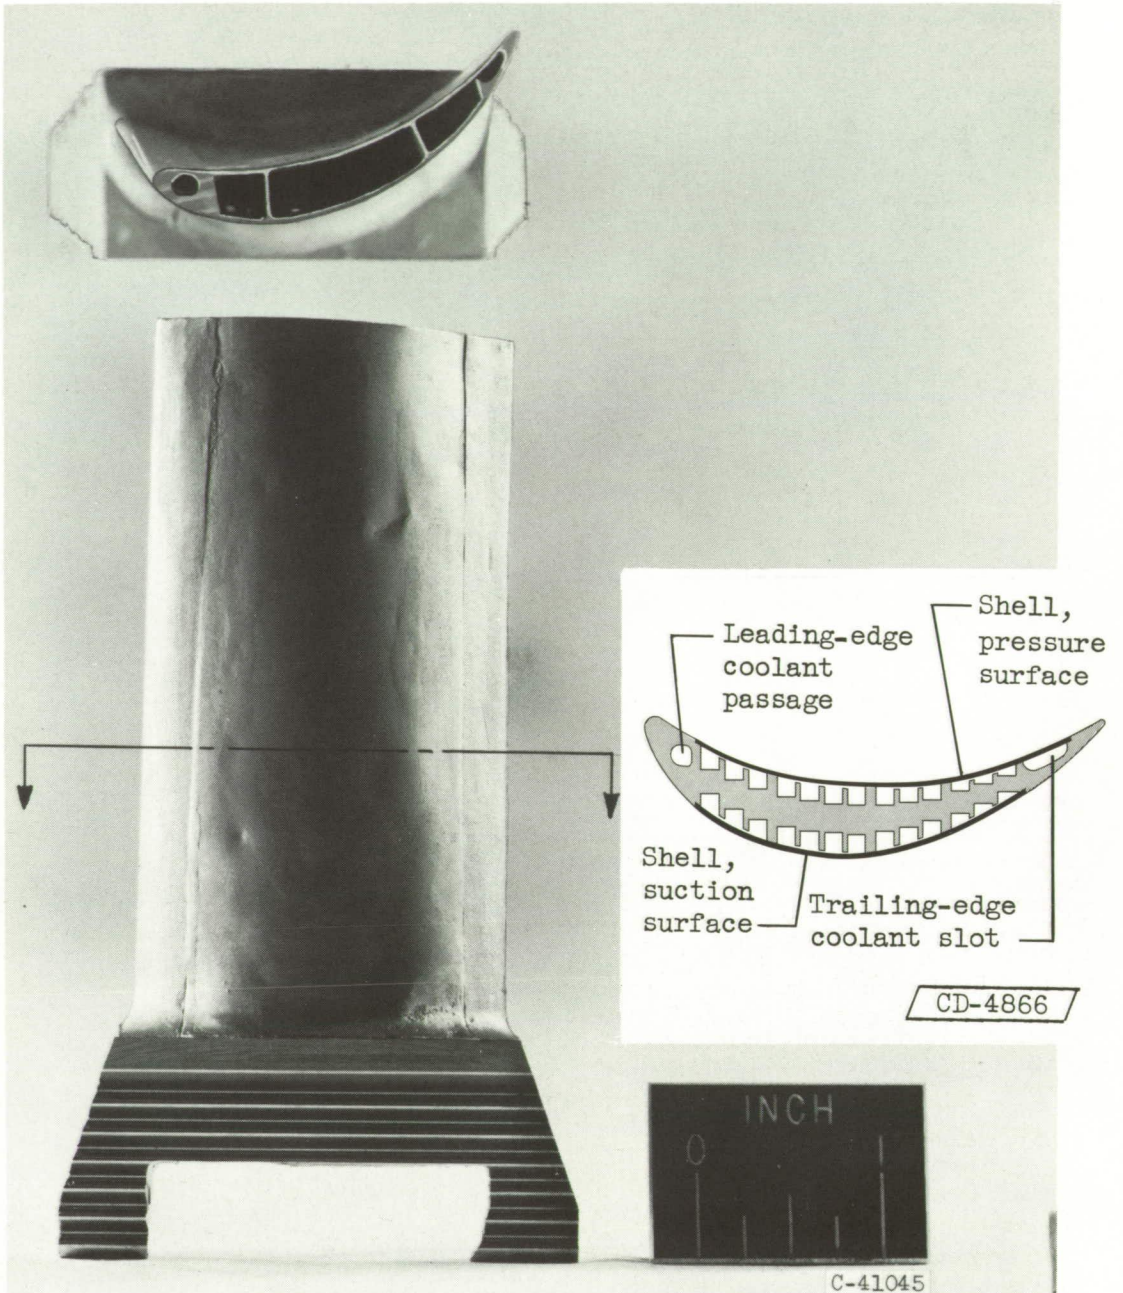
Figure 13. - Modification 6: Cast leading and trailing blade edges.

the weld cracks was attempted by casting the leading and trailing edges integrally with the strut. A photograph of a blade having this modification is shown in figure 13 along with a sketch illustrating the general assembly of the shell halves to the strut. The elliptically shaped leading-edge coolant passage (fig. 13) was obtained by the use of a shaped core of alumina silicate in the wax pattern. The rectangular trailing-edge coolant passage was obtained by hand removal of the wax from the wax pattern. The shell half that served as the pressure surface of the blade also served to enclose the trailing-edge cooling passage. For cooled-blade operation this modification would result in higher leading- and trailing-edge blade temperatures as compared with the preceding blades.

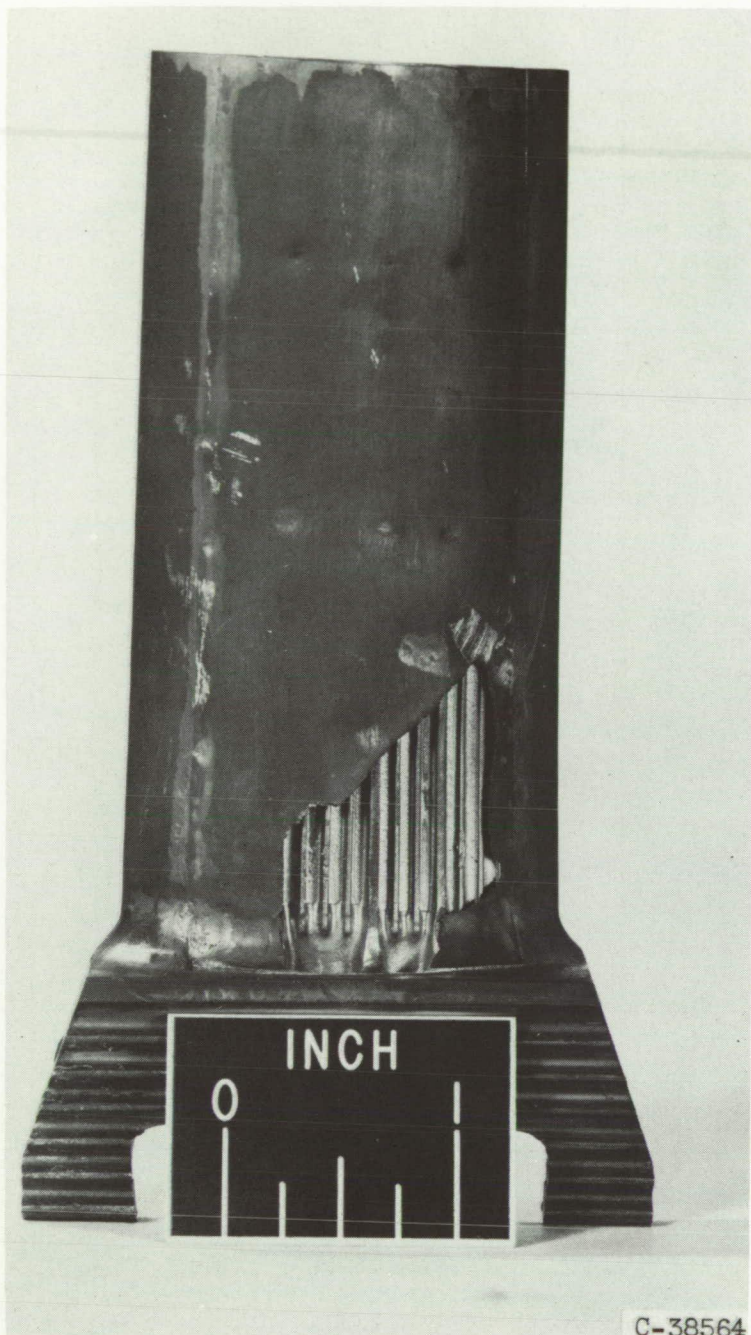
Figure 14. - Shell failure of blade 24 (modification 6) after 18 hours of operation.

The life of the three blades of this configuration (blades 24, 25, and 26) ranged from 18 to 54 hours. A shell failure in blade 24 after 18 hours (fig. 14) due to poor braze of the shell to the strut, terminated the tests of the blade. The two other blades completed 54 hours of operation, which was considered adequate to indicate the merits of this configuration. One of the two blades (blade 25) had a slight shell crack in the fillet region on the suction surface. This crack was also a result of a poor braze. Because the failures of the shells of blades 24 and 25 were due to poor brazing, the shell failures should not be considered in the evaluation of this modification. The lives obtained with the blades of this modification are attributed to the elimination of the welding of the shells, as well as possible reduction in vibratory stresses due to the sturdier leading- and trailing-edge sections of the blade.
