ENGINE PERFORMANCE OF OVERTEMPERATURE

HEAT-TREATED S-816 BUCKETS

By R. A. Signorelli, F. B. Garrett, and J. W. Weeton

March 2, 1956

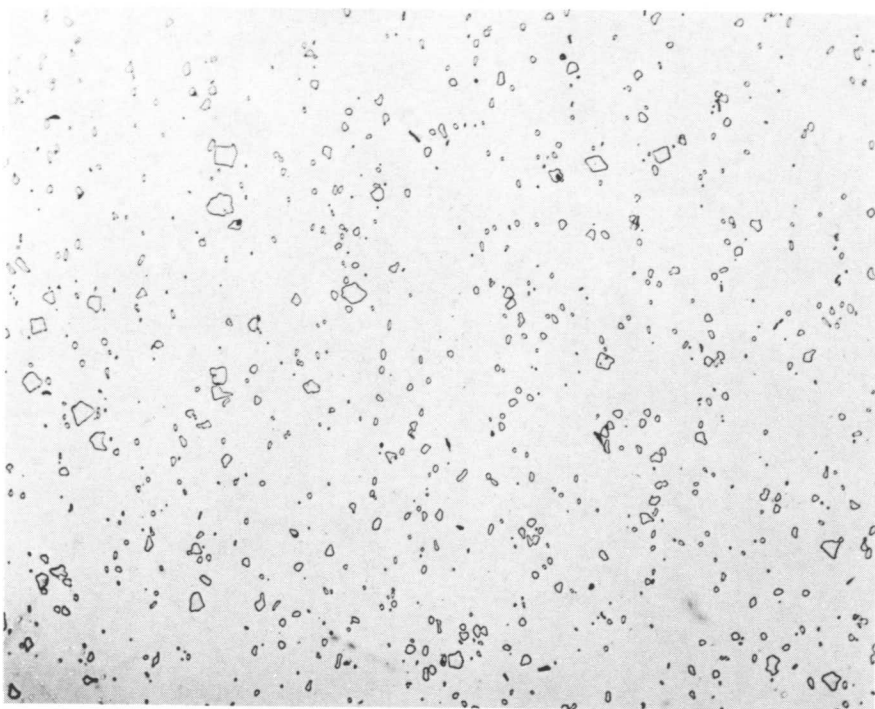
Figure 12. - Microstructure of S-816 after 15 minutes at 2350° F. Etchant, 25 percent aqua regia plus 75 percent glycerol.

Microstructure. - Photomicrographs of standard and as-overtemperated S-816 structures are shown in figures 4 to 13. These figures show the microstructures produced from the slight over-age at 1550° F to complete solution of grain-boundary precipitates at 2150° and at 2350° F. There is indication of slight spheroidization of grain-boundary precipitates with the 1550° F treatment. Agglomeration and spheroidization of the precipitates increased with increasing temperature from 1700° to 1900° F. At 2000° F, the precipitates began to dissolve. The 2150° and 2350° F treatments dissolved all precipitates except the massive, stable (Cb, Ta)C. There was evidence of eutectic melting in the specimens heat-treated at 2350° F, although it is not shown in the photomicrographs. The over-etched structures shown in figures 11 and 13 reveal the grain boundaries and grain size of the solution-treated structures that were not visible when the same specimens were etched normally (figs. 10 and 12).

The 2150° and 2350° F treatments, however, are solution treatments rather than over-aging treatments, as indicated in figures 10 to 13. Precipitation of minor phases during engine operation probably strengthened the materials so treated and increased creep resistance. The elongation curves of figure 3 for the 2150° F treatment buckets are in agreement with this. Unfortunately, elongation data for the 2350° F treatment buckets were not obtained.
