NACA RM E52J15

PRELIMINARY INVESTIGATION OF COMPRESSOR BLADE

VIBRATION EXCITED BY ROTATING STALL

By Merle C. Huppert, Donald F. Johnson, and Eleanor L. Costilow

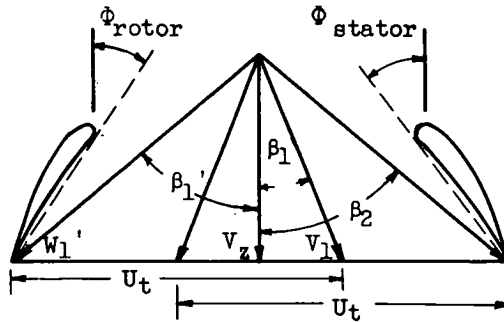
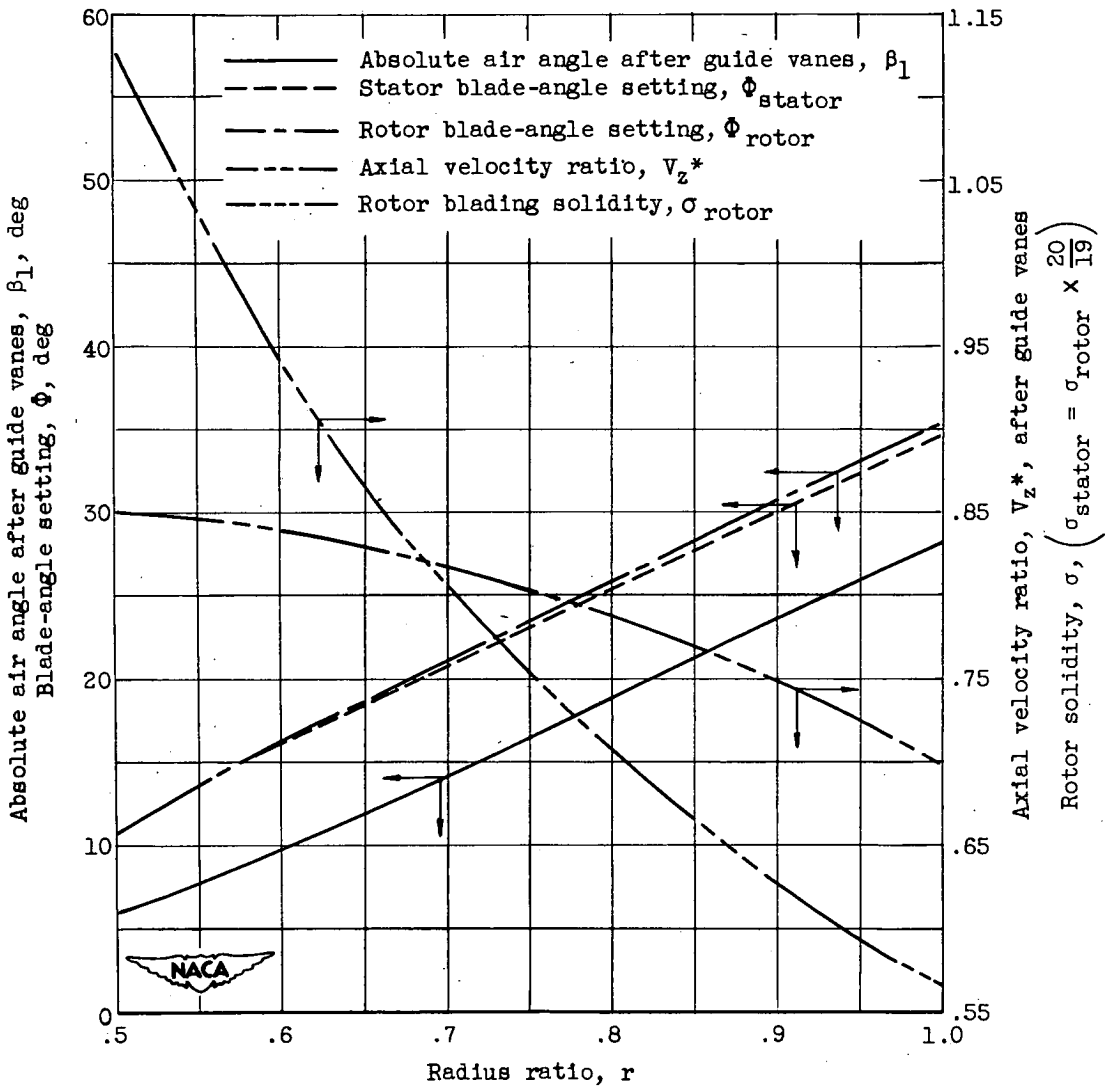
Figure 1. - Blading configuration details.

The single-stage compressor used in this investigation consisted of 40 steel inlet guide vanes, 19 steel rotor blades, and 20 cantilevered aluminum stator blades. The stage had a hub-tip ratio at the rotor inlet of 0.5, representative of the inlet stage of a multistage compressor. The guide-vane-discharge angle, the rotor and stator setting angles, the rotor and stator solidity, and the design ratio of axial velocity to rotor tip speed at the outlet of the guide vanes are shown in figure 1.

The guide vanes were variable-chord circular-arc sheet-metal vanes. The rotor and stator blades had NACA 65 series blower blade profile 65(12)-10 at all radii. The chord length was 1.31 inches at all radii for both rotor and stator blades. The stator-blade natural frequency in bending  $f_b$  was experimentally determined to be 420 cycles per second. The vector diagrams computed from experimental data obtained at approximately the maximum efficiency operating point at the design operating speed are presented in figure 2; for this operating point the flow coefficient  $\phi$  is 0.565 and the rotor speed  $N/\sqrt{\theta}$  is 202 rps.

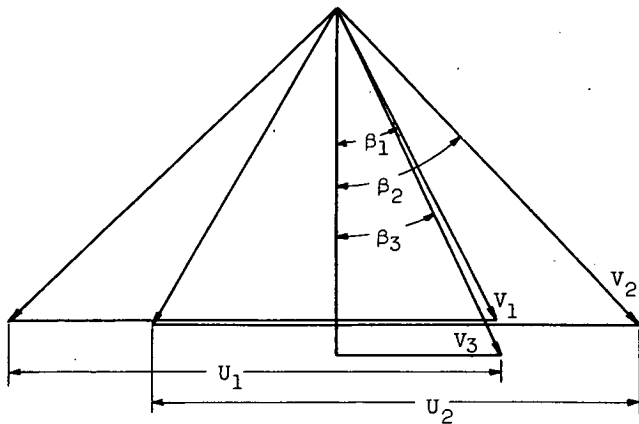
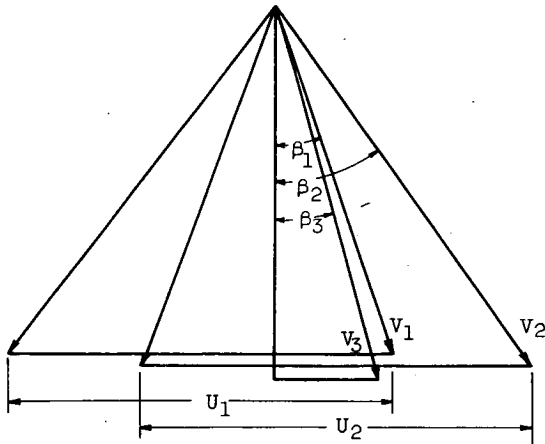
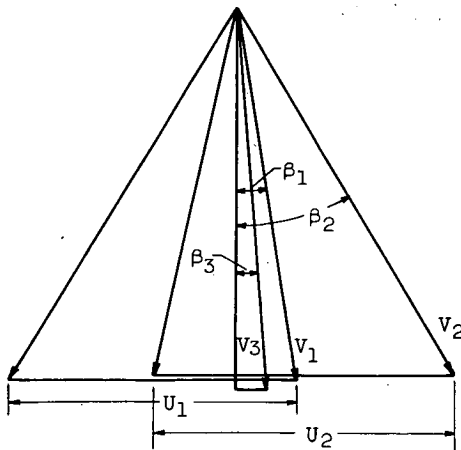
Figure 2. - Vector velocity diagram at design speed for blade tip, mean, and hub radii. Flow coefficients, 0.565; rotor speed, 202 rps.

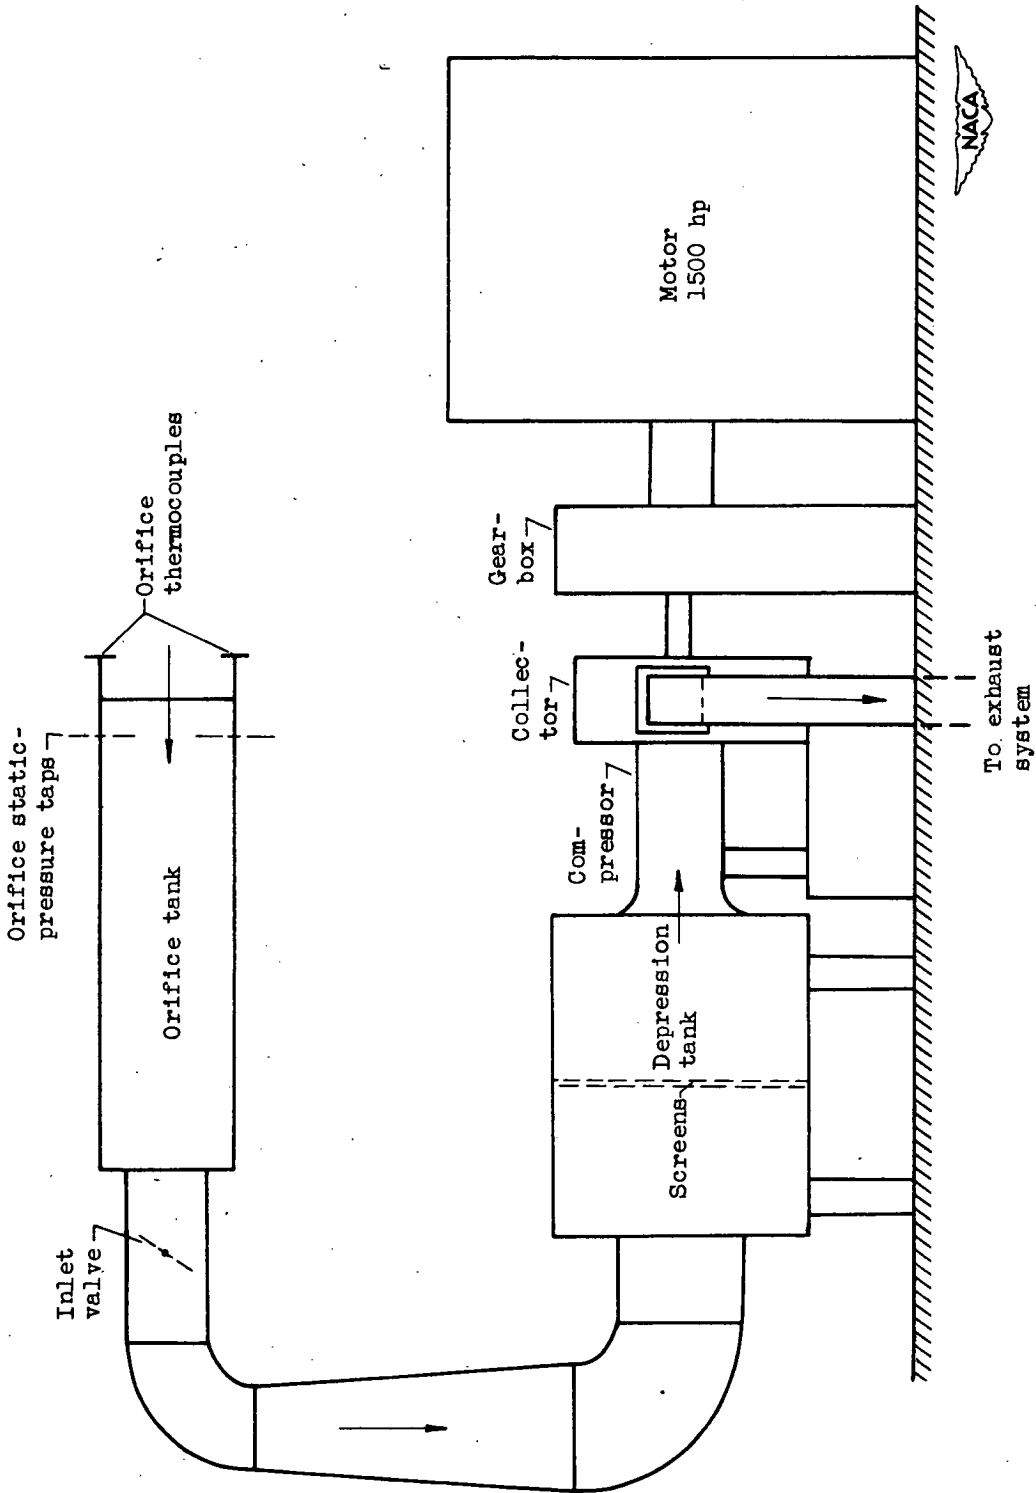
Figure 3. - Schematic diagram of compressor installation.

A schematic diagram of the single-stage compressor installation is shown in figure 3. Air enters through the orifice tank and a motor-operated inlet throttle into a depression tank equipped with screens to provide a uniform distribution of air at the compressor inlet. Air was discharged from the compressor into a collector connected to the laboratory altitude-exhaust system by two outlet pipes. A motor-operated throttle was installed in the outlet pipe. The compressor was driven by a 1500-horsepower variable-frequency motor through a step-up gearbox.

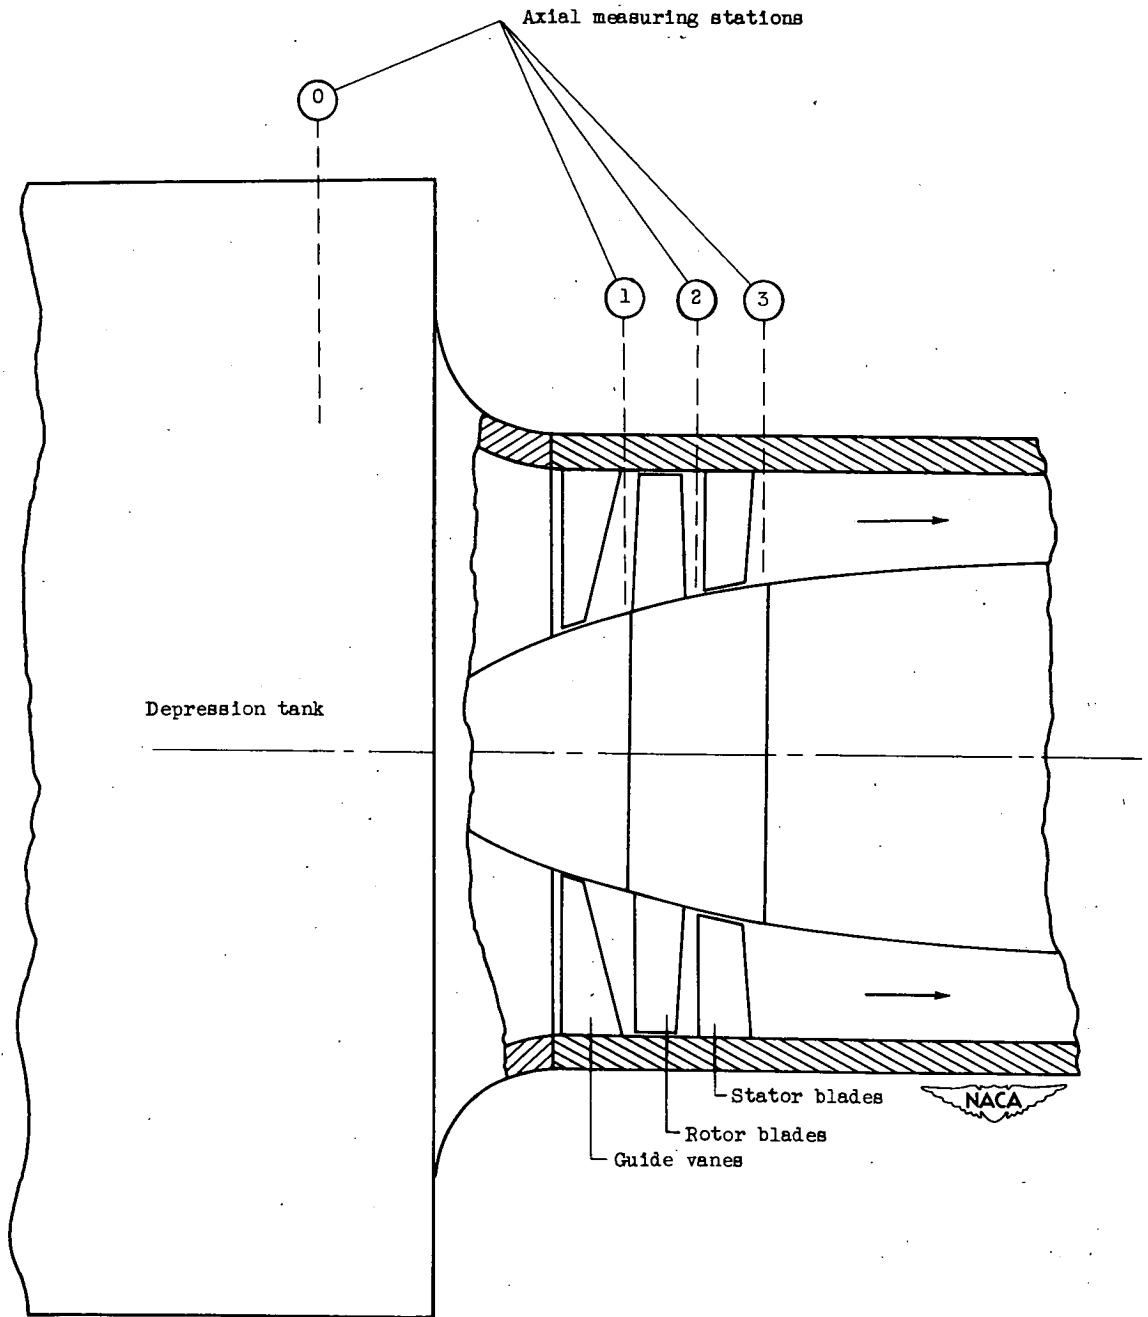
Figure 4. - Sketch showing instrumentation stations.

The instrumentation used to obtain over-all performance was similar to that described in reference 14. The instrumentation station locations are shown in figure 4.

Two anemometer probes were installed in radial traversing mechanisms about 1/2 inch downstream of the stators (station 3, fig. 4). One of the anemometer probes was installed in a circumferential survey pad, so that the angle between the two probes could be varied. This provision was necessary to permit the determination of the number of stalls (reference 13).

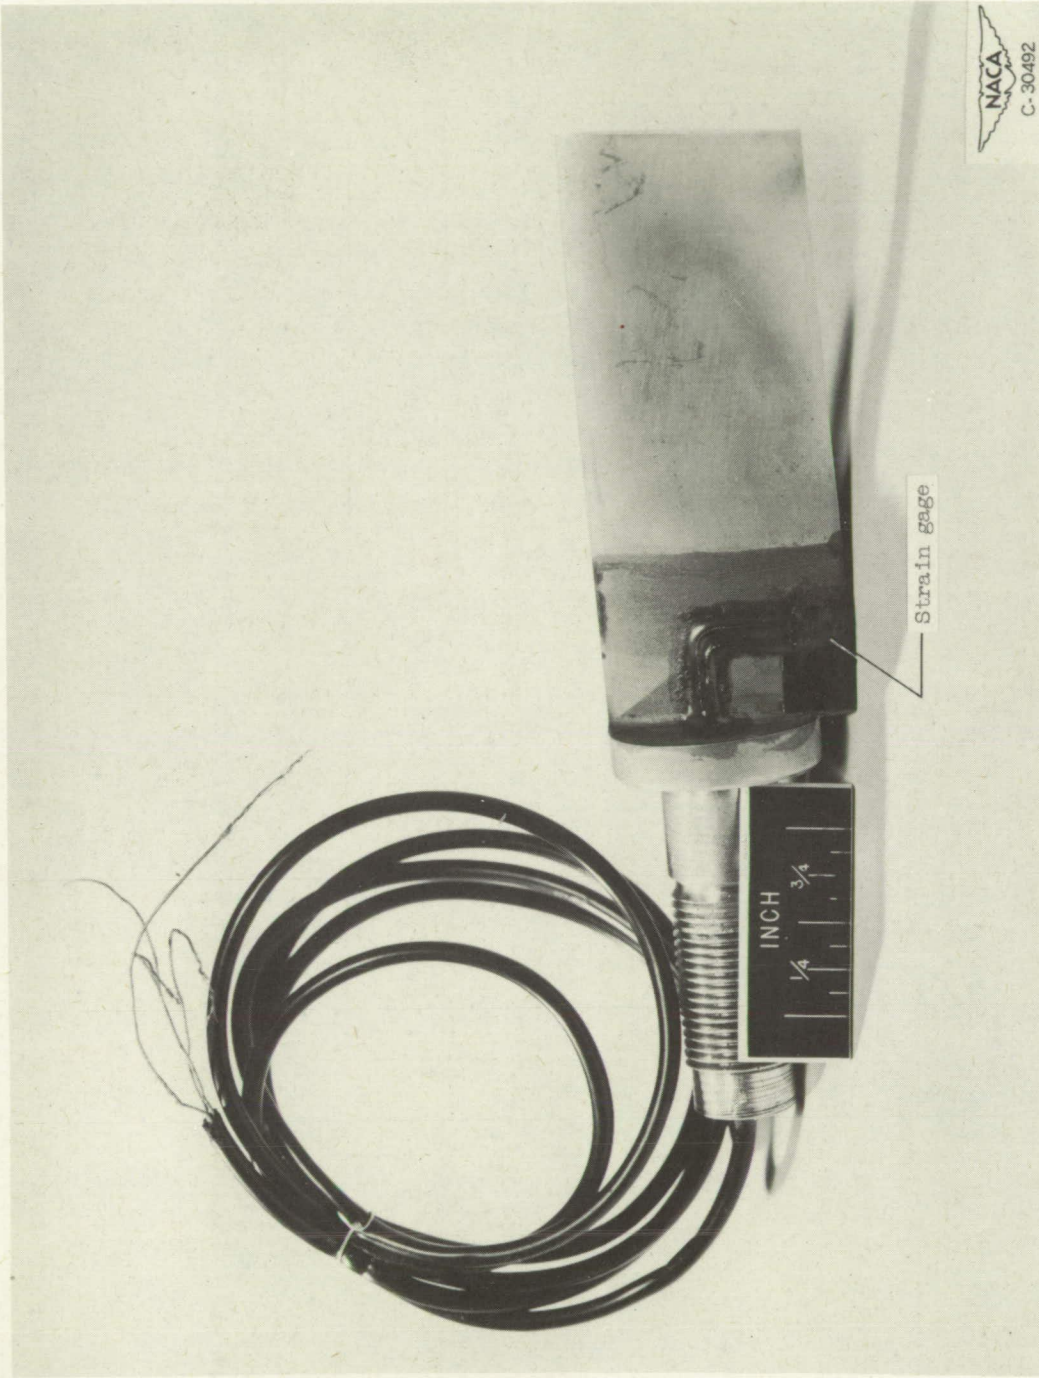
Figure 5. - Stator blade showing mounting of strain gage.

Resistance-wire strain gages were mounted on 3 of the 20 stator blades. A photograph of a stator blade with the strain gage attached is shown in figure 5. The gages were attached to the blades with Bake-lite cement, with the resistance-wire filaments parallel to the blade span. Gages were installed on both the suction and pressure surfaces at the blade base near the trailing edge, so that both bending and torsional vibration could be detected. Subsequent bench tests indicated that the ratio of bending stress at midchord to that at the strain-gage location was 1.35, and this factor was used in computing the bending stress from the strain-gage signals. The strain-gage signals were amplified and recorded photographically or viewed from a four-beam cathode-ray oscilloscope.

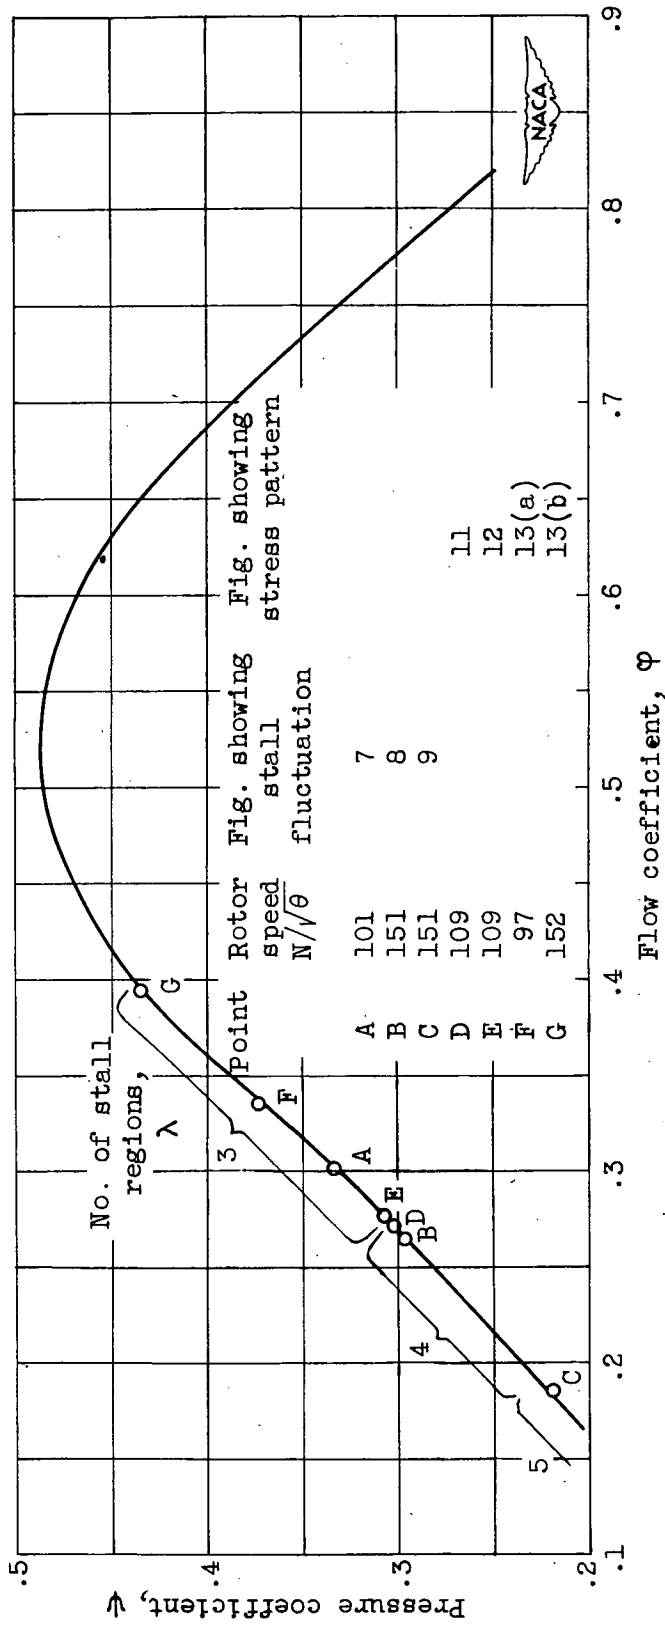
Figure 6. - Variation of pressure coefficient with flow coefficient of single-stage compressor. Hub-tip ratio, 0.5.

The performance parameters chosen to represent the performance characteristics of the compressor are flow coefficient  $\phi$  and pressure coefficient  $\psi$ . Figure 6 shows the variation in pressure coefficient  $\psi$  with flow coefficient  $\phi$ .

Rotor tip stall was experienced near the peak value of pressure coefficient. As the flow coefficient was further reduced, rotating stall was detected by the hot-wire anemometers at station 3 (fig. 4). The first rotating-stall pattern obtained when the weight flow was decreased consisted of three equally spaced stall regions rotating in the direction of rotor rotation. Oscillograms of the signals from the two anemometer probes displaced angularly  $36^\circ$  and at three radial positions of the probes are shown in figure 7 (compressor operating at point A, fig. 6). The amplitude of the flow fluctuations varied somewhat with radius, as shown. As the flow coefficient was further reduced to point B, figure 6, the number of stall regions changed from three to four. Oscillograms of this stall pattern at three radial positions with an angular separation of the probes of  $94^\circ$  are shown in figure 8. (Only one anemometer signal is shown at the stator root position.) The variation in amplitude of the flow fluctuations with radius is less than that indicated for the pattern with three stall regions shown in figure 7. As the flow coefficient was reduced to point C (fig. 6), the stall pattern changed. Five or a multiple of five stalls were indicated. The data obtained were insufficient to distinguish between five and a multiple of five stalls, but, inasmuch as there were only 19 rotor blades, the number five seemed the most likely. Consequently, this pattern is considered to consist of five stall regions. Oscillograms of this stall pattern at three radial positions with an angular separation of the probes  $\alpha$  of  $94^\circ$  are shown in figure 9. With this stall pattern the largest flow fluctuations occurred near the hub position.

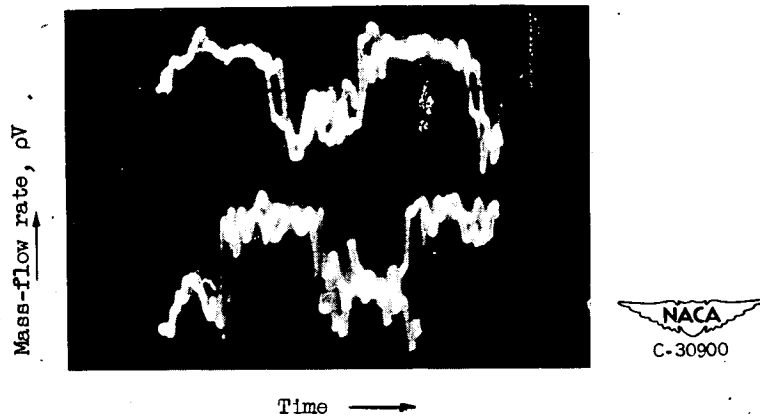
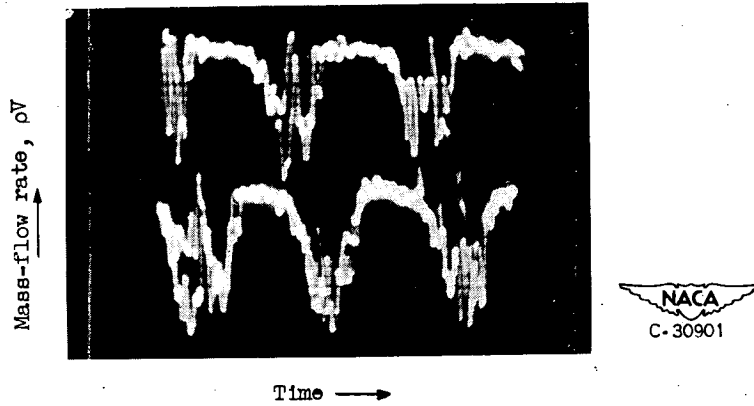
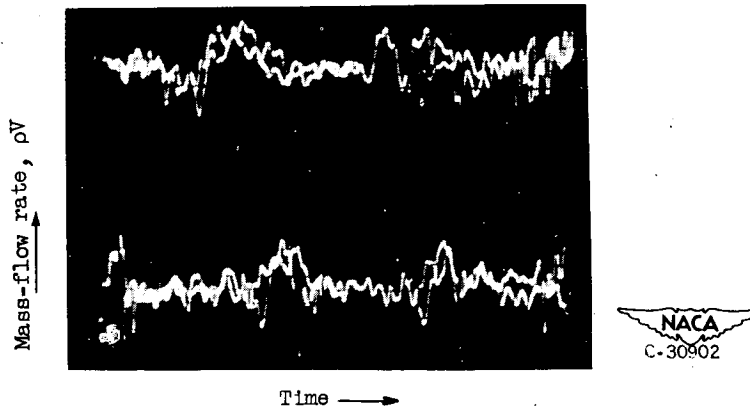
(a) Ratio of local radius to tip radius,  $0.946 \frac{\Delta \rho V}{\rho V} = 1.30$ ; angle between hot-wire-anemometer probes,  $36^\circ$ .

(b) Ratio of local radius to tip radius,  $0.781 \frac{\Delta \rho V}{\rho V} = 1.47$ ; angle between hot-wire-anemometer probes,  $36^\circ$ .

(c) Ratio of local radius to tip radius,  $0.615 \frac{\Delta \rho V}{\rho V} = 0.39$ ; angle between hot-wire-anemometer probes,  $36^\circ$ .

Figure 7. - Oscillograms of three propagating stalls at three radial positions after stator. Rotor speed, 101 rps; stall frequency, 127 cycles per second. (Point A, fig. 6.)

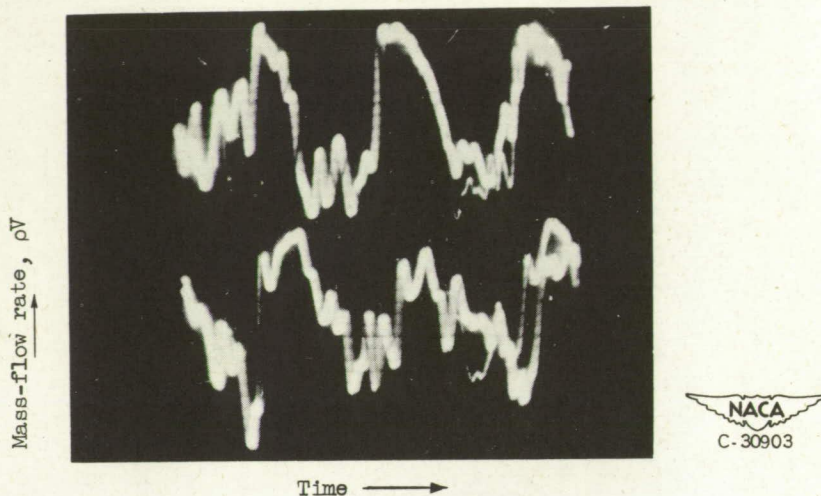
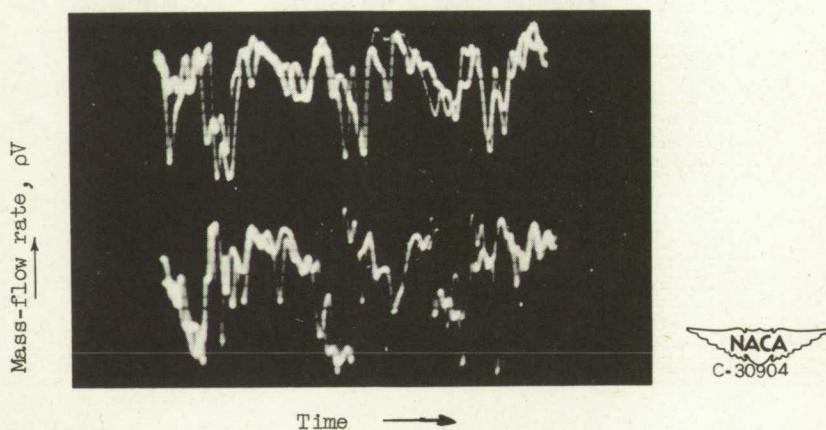
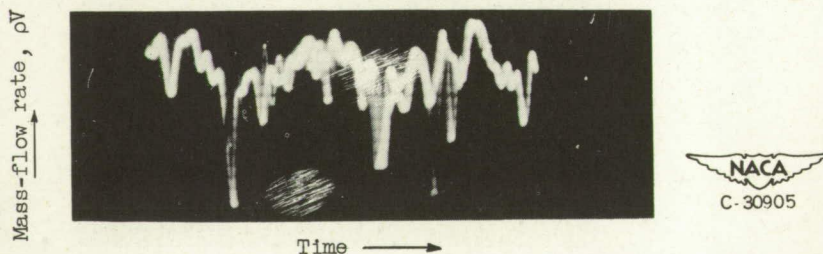
(a) Ratio of local radius to tip radius,  $0.946 \frac{\Delta\rho V}{\rho V} = 2.14$ ; angle between hot-wire-anemometer probes,  $94^\circ$ .

(b) Ratio of local radius to tip radius,  $0.781 \frac{\Delta\rho V}{\rho V} = 1.47$ ; angle between hot-wire-anemometer probes,  $94^\circ$ .

(c) Ratio of local radius to tip radius,  $0.615 \frac{\Delta\rho V}{\rho V} = 1.32$ ; angle between hot-wire-anemometer probes,  $94^\circ$ .

Figure 8. - Oscillograms of four propagating stalls at three radial positions after stator. Rotor speed, 151 rps; stall frequency, 286 cycles per second. (Point B, fig. 6.)

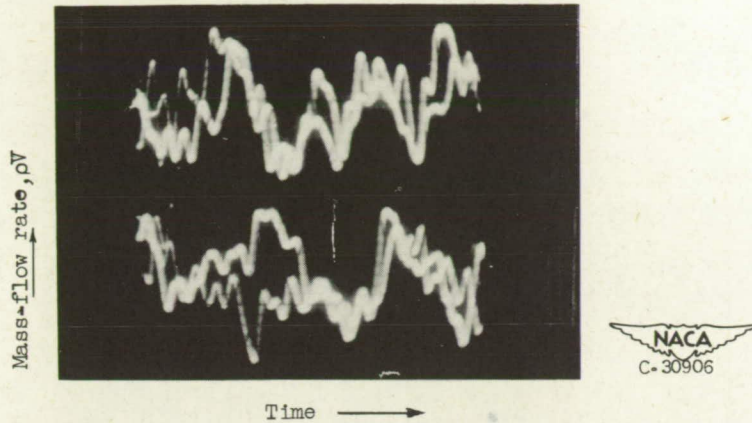
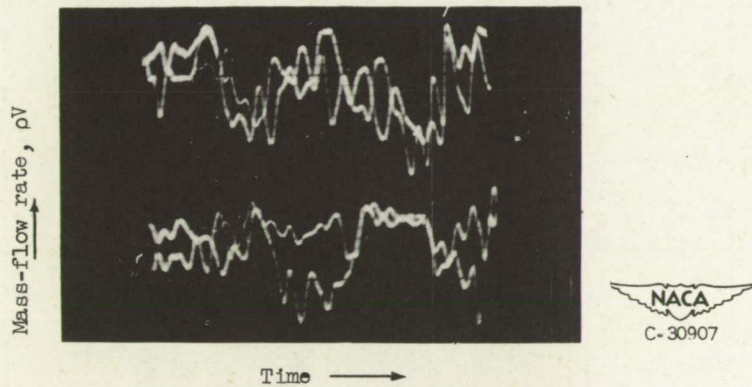
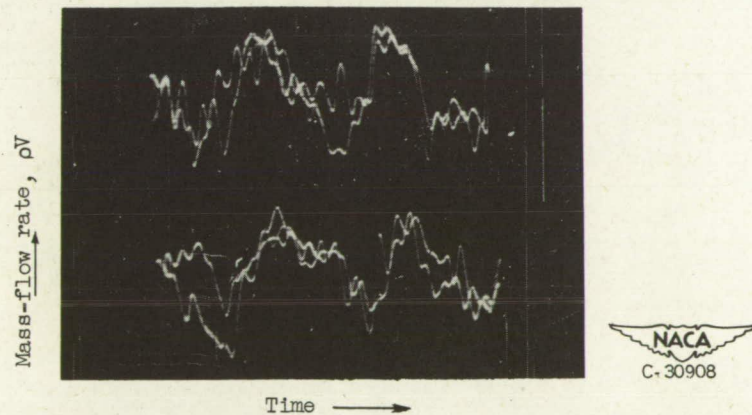
(a) Ratio of local radius to tip radius,  $0.946 \frac{\Delta \rho V}{\rho V} = 1.66$ ; angle between hot-wire-anemometer probes,  $94^\circ$ .

(b) Ratio of local radius to tip radius,  $0.781 \frac{\Delta \rho V}{\rho V} = 1.39$ ; angle between hot-wire-anemometer probes,  $94^\circ$ .

(c) Ratio of local radius to tip radius,  $0.615 \frac{\Delta \rho V}{\rho V} = 2.29$ ; angle between hot-wire-anemometer probes,  $94^\circ$ .

Figure 9. - Oscillograms of five propagating stalls at three radial positions after stator. Rotor speed, 151 rps; stall frequency, 400 cycles per second. (Point C, fig. 6.)

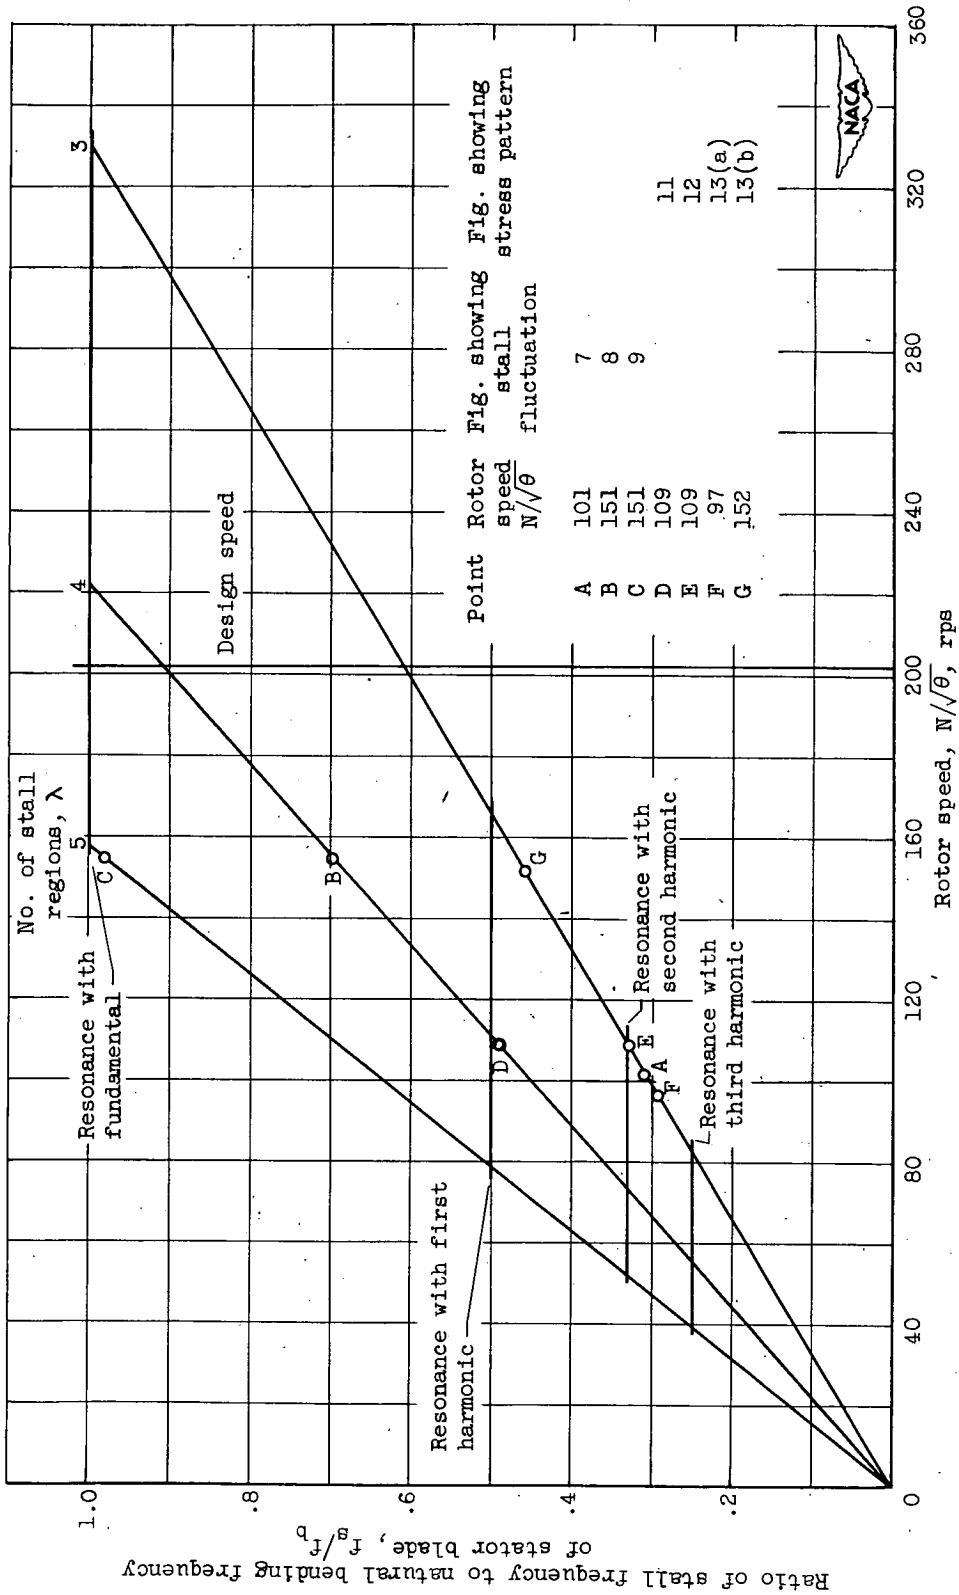
Figure 10. - Variation of stall frequency with rotor speed for the three stall patterns. Natural frequency of blade in bending, 420 cycles per second.

The strain-gage data indicate that under certain conditions large vibratory stresses were excited in the blades. The stall data obtained indicate that the frequency with which a stall region passes a stator blade  $f_s$  increases linearly with rotor speed. The rate of increase, however, depends on the stall pattern. Figure 10 is a plot of the ratio of stall frequency  $f_s$  to fundamental bending frequency of the stator blade  $f_b$  ( $f_b = 420$  cps) plotted against the rotor speed  $N/\sqrt{\theta}$  for the three stall patterns obtained, that is,  $\lambda = 3, 4,$  and  $5$ . Figure 10 shows that resonance with the first harmonic of the fundamental frequency of the flow pattern with four stalls and the second harmonic of the fundamental frequency of the flow pattern with three stalls can occur at  $N/\sqrt{\theta}$  of 110 rps.

Strain-gage data with the blades not vibrating at resonance were taken prior to the strain-gage indication of a blade crack (fig. 12). The data were taken at compressor speeds indicated by points F and G in figure 10 and at the flow coefficients indicated on figure 6. At these conditions there were three stalls in the rotating stall pattern. The strain-gage signals obtained at these conditions are shown in

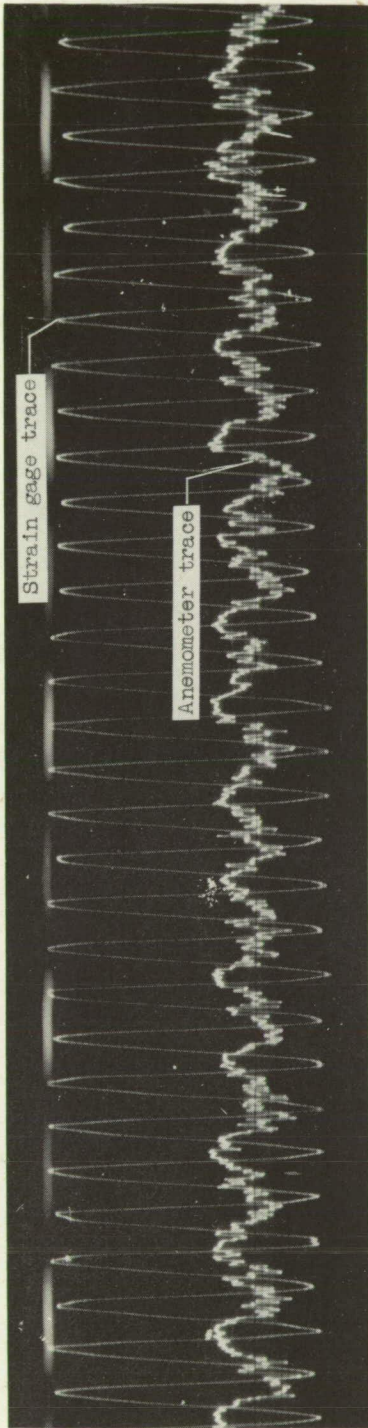
NACA  
C-30909

Figure 11. - Oscillogram of hot-wire anemometer at ratio of local radius to tip radius of 0.946, and strain gage on stator root (point D, fig. 10). Maximum stress, 16,000 pounds per square inch. Compressor operating at point D of figure 6: stall frequency =  $\frac{1}{2}$  natural frequency of blade in bending; number of stall regions, 4; rotor speed, 109 rps.

With the compressor operating at a rotor speed  $N/\sqrt{\theta}$  of 109 at point D of figure 6, where a slight change in weight flow would change the stall pattern from one with four stalls to one with three stalls, motion pictures were taken of hot-wire-anemometer and strain-gage traces on the same oscilloscope. The strain-gage pattern of the vibratory stress excited by the flow fluctuations of rotating stall ( $\lambda = 4$ , point D, fig. 10) is shown in figure 11. The maximum stress indicated is 16,000 pounds per square inch, and there are two strain-gage cycles per stall. At a slightly higher weight flow (point E, fig. 6), such that the stall pattern consisted of three stall regions, the stress pattern was as shown in figure 12. There are three stress cycles per stall, and the maximum stress indicated is about 7500 pounds per square inch; however, the discontinuities in the strain-gage signal indicate that the blade had cracked prior to the time the photographs were taken, and, consequently, the magnitude of the stress is somewhat questionable.

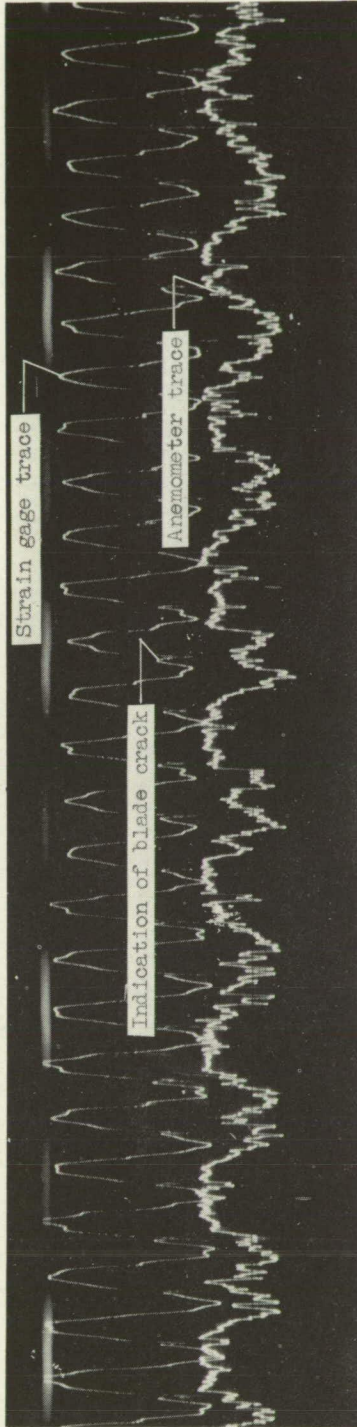
NACA  
C-30910

Figure 12. - Oscillogram of hot-wire anemometer and strain gage after blade failure (point E, fig. 10). Compressor operating at point E of figure 6: stall frequency =  $\frac{1}{2}$  natural frequency of blade in bending; number of stall regions, 3; rotor speed, 109 rps.

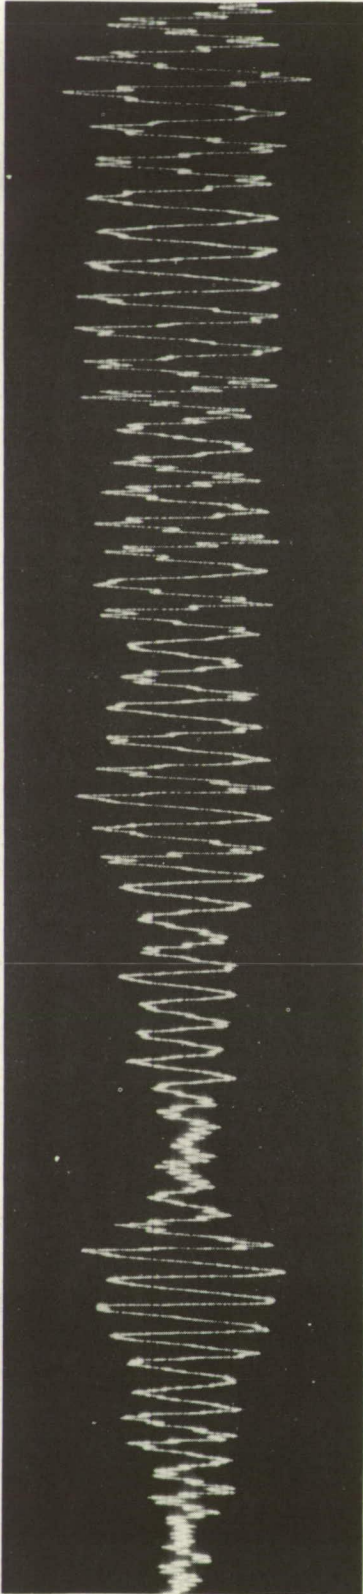
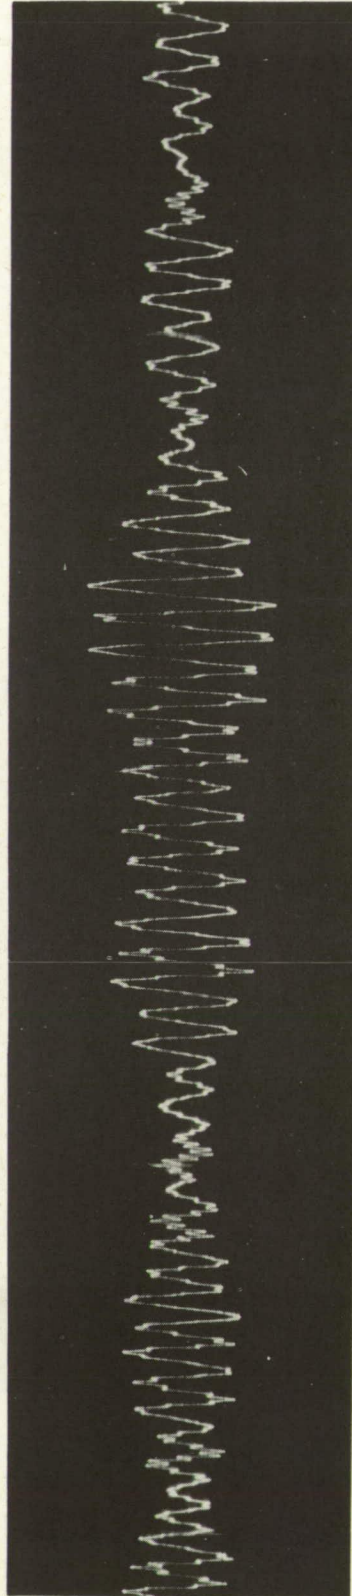
(a) Point F of figures 6 and 10. Stall frequency = 0.29 natural frequency of blade in bending; number of stall regions, 3; rotor speed, 97 rps.

(b) Point G of figures 6 and 10. Stall frequency = 0.46 natural frequency of blade in bending; number of stall regions, 3; rotor speed, 152 rps.

Figure 13. - Oscillograms of strain-gage record. Strain gage at stator root.

figure 13. The "beating" effect is believed to be caused by interaction of the forced vibrations due to the rotating stall and the transient vibrations due to the rather random variation of the amplitude and wave form of the exciting force. If the exciting force were of constant amplitude and wave form, the transients would be damped and no beating would occur. From the theory of beating (reference 16) the beat frequency should be approximately equal to the difference between the frequency of the exciting force and natural frequency of the blade. At point F of figure 10, the exciting force was the second harmonic of the stall frequency  $f_s$ ; therefore, the beat frequency divided by the natural frequency of the blade in bending  $F$  is

$$F = 1 - \frac{3f_s}{f_b} = 1 - (3)(0.29) \\ = 0.13$$

or about eight blade vibration cycles per beat.

At point G of figure 10, the exciting force was the first harmonic of the stall frequency  $f_s$ ; therefore,

$$F = 1 - \frac{2f_s}{f_b} = 1 - (2)(0.46) \\ = 0.08$$

or about 12 blade vibrations per beat. The blade vibrations per beat shown in figure 13 are approximately the same as indicated by theory.

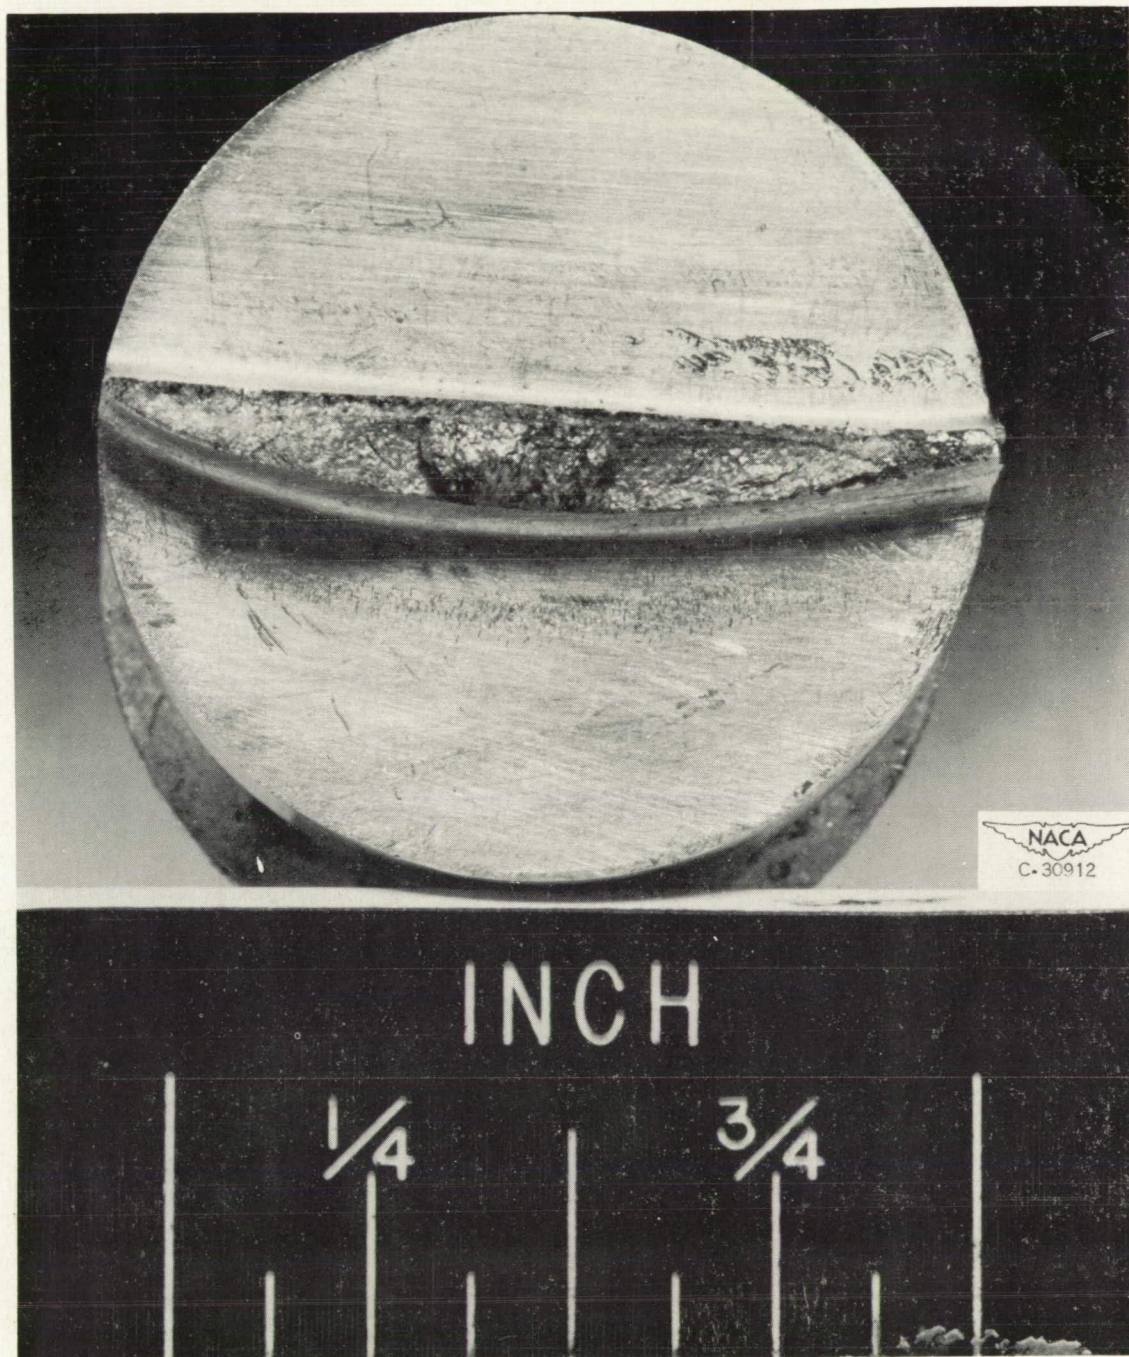
After the strain-gage signals indicated a failed blade, the compressor was disassembled for inspection. One stator blade was broken off, and a photograph of the broken end is shown in figure 14. All the stators were cracked in the region of maximum bending stress, as shown in figure 15. The stator blade that broke off damaged the rotor blades by making a notch in the trailing edges near the roots. A crack emanated from the notch in each rotor blade, in some cases extending to 3/4 chord length.

Figure 14. - Fatigue failure at root of stator blade.

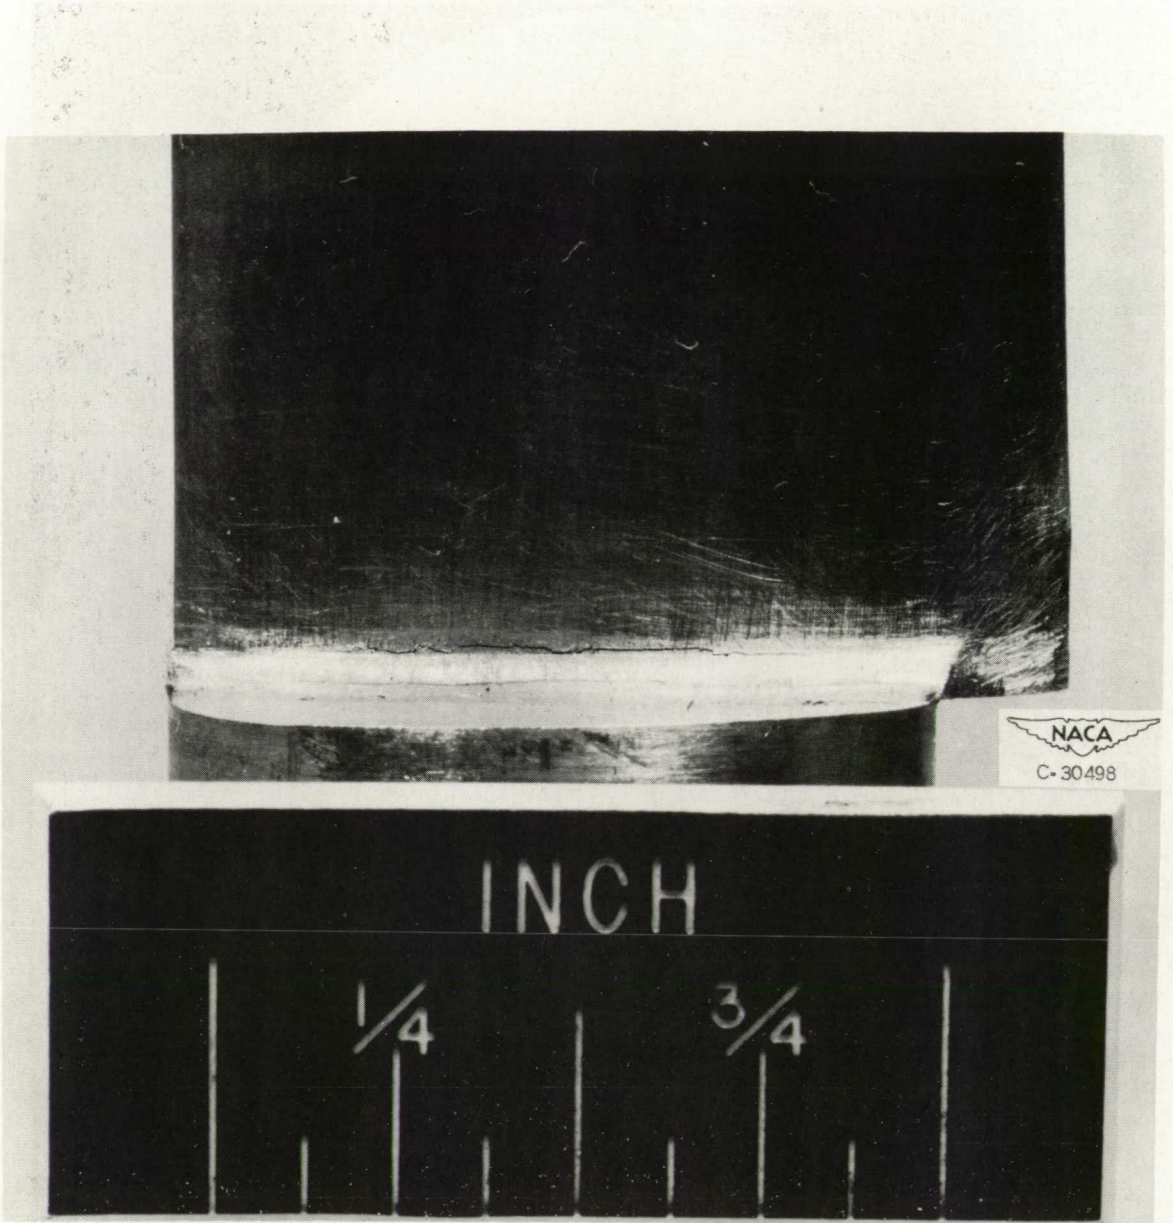
Figure 15. - Crack at stator root caused by vibratory bending stress.

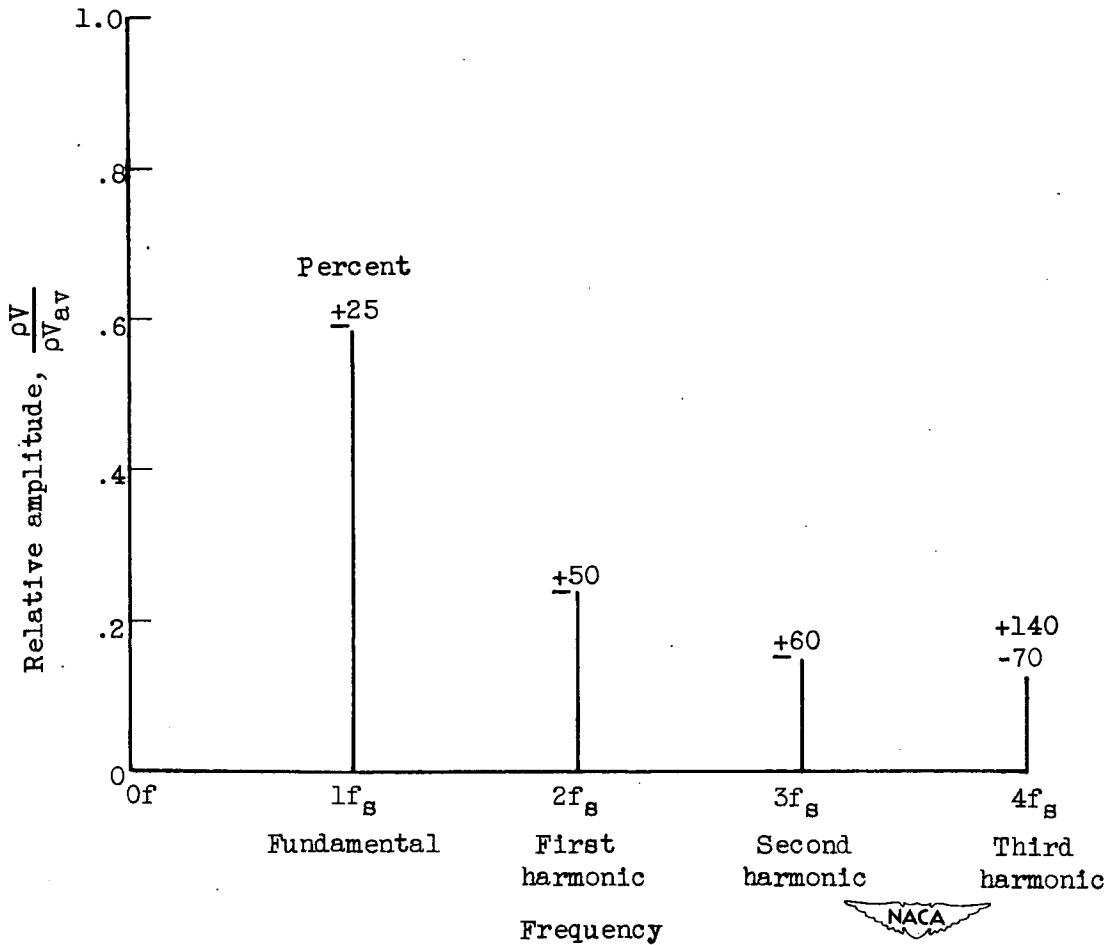
Figure 16. - Frequency spectra of stall fluctuations in percent of time average mass-flow rate. Number of stall regions, 4; stall frequency, 210; ratio of local radius to tip radius, 0.946.

The numerical method used for the Fourier analysis was that presented in reference 17. The average-frequency spectrum and the maximum variation from the average of several individual cycles are shown in figure 16. All values are divided by  $\rho V_{av}$ . For the wave form analyzed,  $\rho V_{av}/\bar{\rho V}$  was 1.1; that is, the time average mass-flow rate passing the anemometer probe was 10 percent greater than that indicated by the average wire current  $\bar{\rho V}$  (reference 13). Although the line spectrum of the fluctuations at the tip radius with the four stall patterns is not necessarily representative of that at other radii or with other stall patterns, it indicates harmonics of appreciable amplitude and considerable variation in the amplitude of the fundamental and its harmonics. Also, the ratio of amplitudes of the first to second harmonics is of the same order of magnitude as the ratio of the stresses measured.

Although the stator blade failure at resonance with the first harmonic of the fundamental stall frequency  $f_s$  with the four-stall-region pattern prevented further investigation, the line spectra of the stall pattern (fig. 16) indicate that higher stresses could be excited by the fundamental. At present the relation between the fluctuations in mass-flow rate  $\rho V$  and the fluctuations in blade vibration exciting force is not known, so that it is not possible to predict the amplitude of stress that would be excited by the fundamental frequency. Until such information is available, more complete analysis of the data seems unjustified.
