Copy 347
RM E54L29a

AN EVALUATION OF ELECTROPOLISHED AND NONELECTROPOLISHED
BLADES OF ALLOYS REFRACTALLOY 26, M-252, AND
WASPALLOY IN A J33-9 TURBOJET ENGINE

By F. J. Clauss, R. A. Signorelli, and J. R. Johnston

Lewis Flight Propulsion Laboratory
Cleveland, Ohio

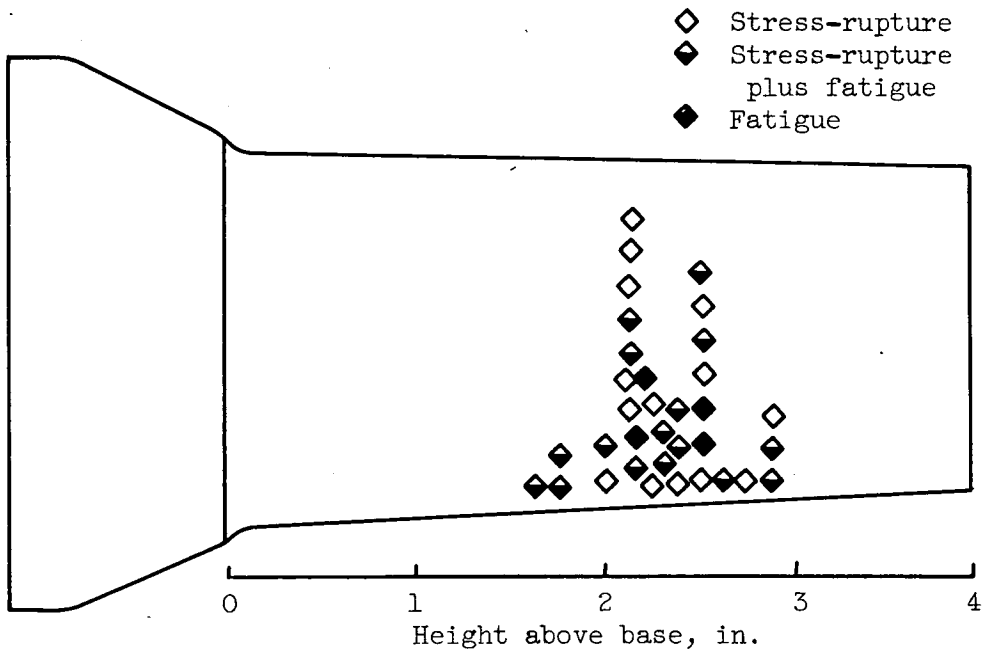
Figure 7. - Distance of failure above base for alloys Refractaloy 26, M-252, and Waspaloy.

Macroexamination of failed blades. - The distance of the failure above the base of the blade for the three alloys is shown in table II and figure 7, in which the damage failures are omitted. Seventy-five percent of all blade failures occurred in the zone from 2 to $2\frac{1}{2}$ inches above the base, which is about the zone of minimum stress-rupture life of the blades. The failures above and below this group were divided, with 15 percent occurring from $2\frac{1}{2}$ to $2\frac{7}{8}$ inches above the base and 10 percent from $1\frac{5}{8}$ to 2 inches above the base. The failure mechanisms, excluding failure by damage, were as follows: Stress rupture, 38 percent; stress rupture plus fatigue, 53 percent; and fatigue, 9 percent.

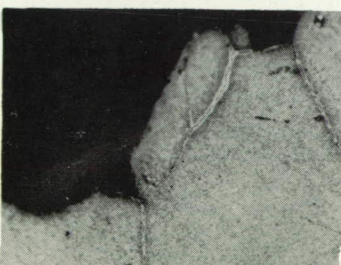
Electropolished, last failure (stress-rupture) after 67 hr

(c) Refractaloy 26.
