RESEARCH MEMORANDUM

BEHAVIOR OF FORGED S-816 TURBINE BLADES IN STEADY-STATE
OPERATION OF J33-9 TURBOJET ENGINE WITH STRESS-RUPTURE
AND METALLOGRAPHIC EVALUATIONS

NATIONAL ADVISORY COMMITTEE
FOR AERONAUTICS

WASHINGTON
February 12, 1953

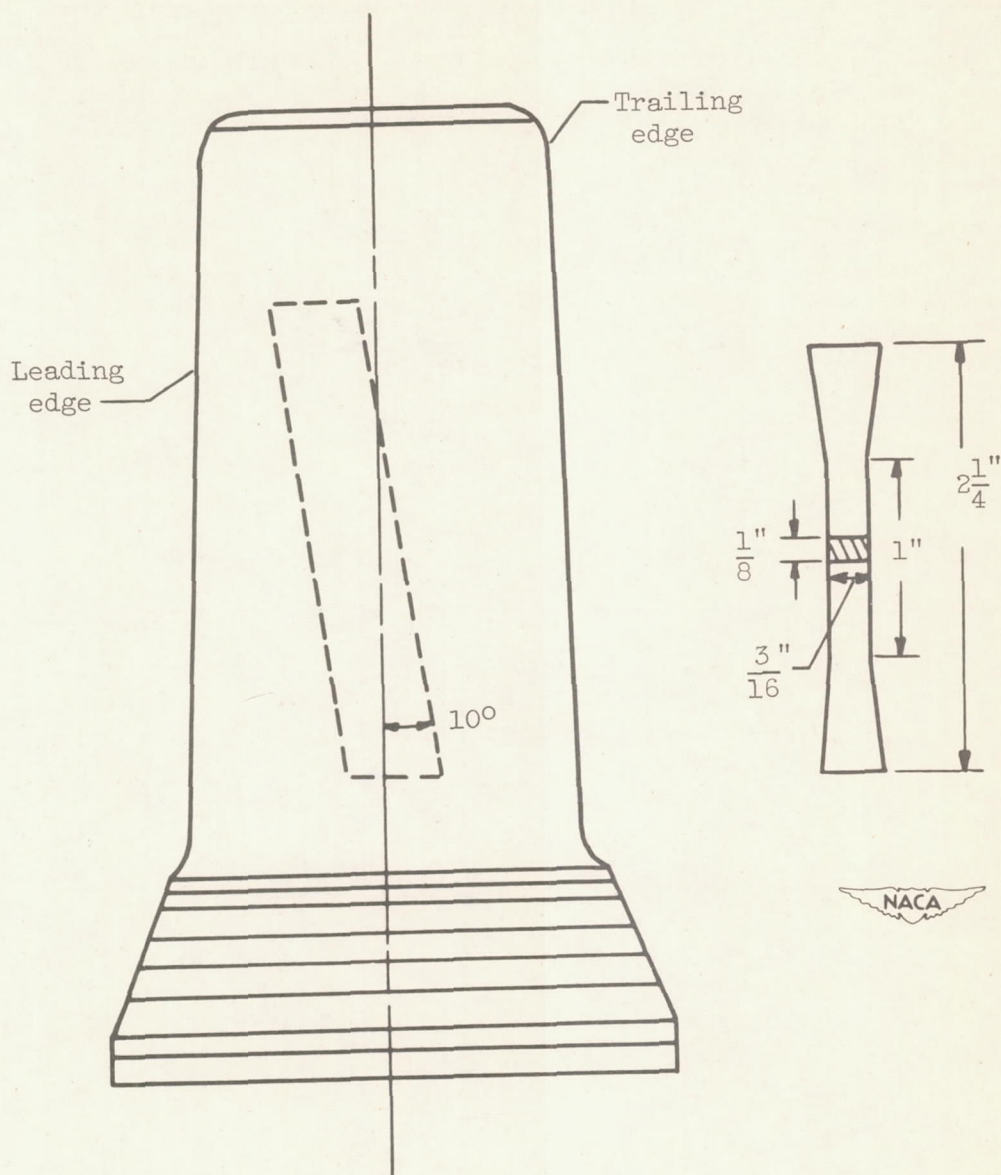
Figure 1. - Blade stress-rupture specimen and zone from which it was machined.

Stress-rupture strengths and other physical properties of blade airfoils. - Test specimens of rectangular cross section (1/8 by 3/16 in.) were machined from the airfoil portions of several blades. The shape of the specimen and the zone from which it was machined are shown in figure 1. Stress-rupture tests were run at 1500° F at various stresses; however, the majority of data were obtained at 20,000 pounds per square inch. Specimen temperatures were so controlled that there was less than a 5° F variation along the length of the specimen with the average temperature varying only $\pm 5^{\circ}$ F. Total elongation measurements were made after testing, and hardness measurements were made before testing.

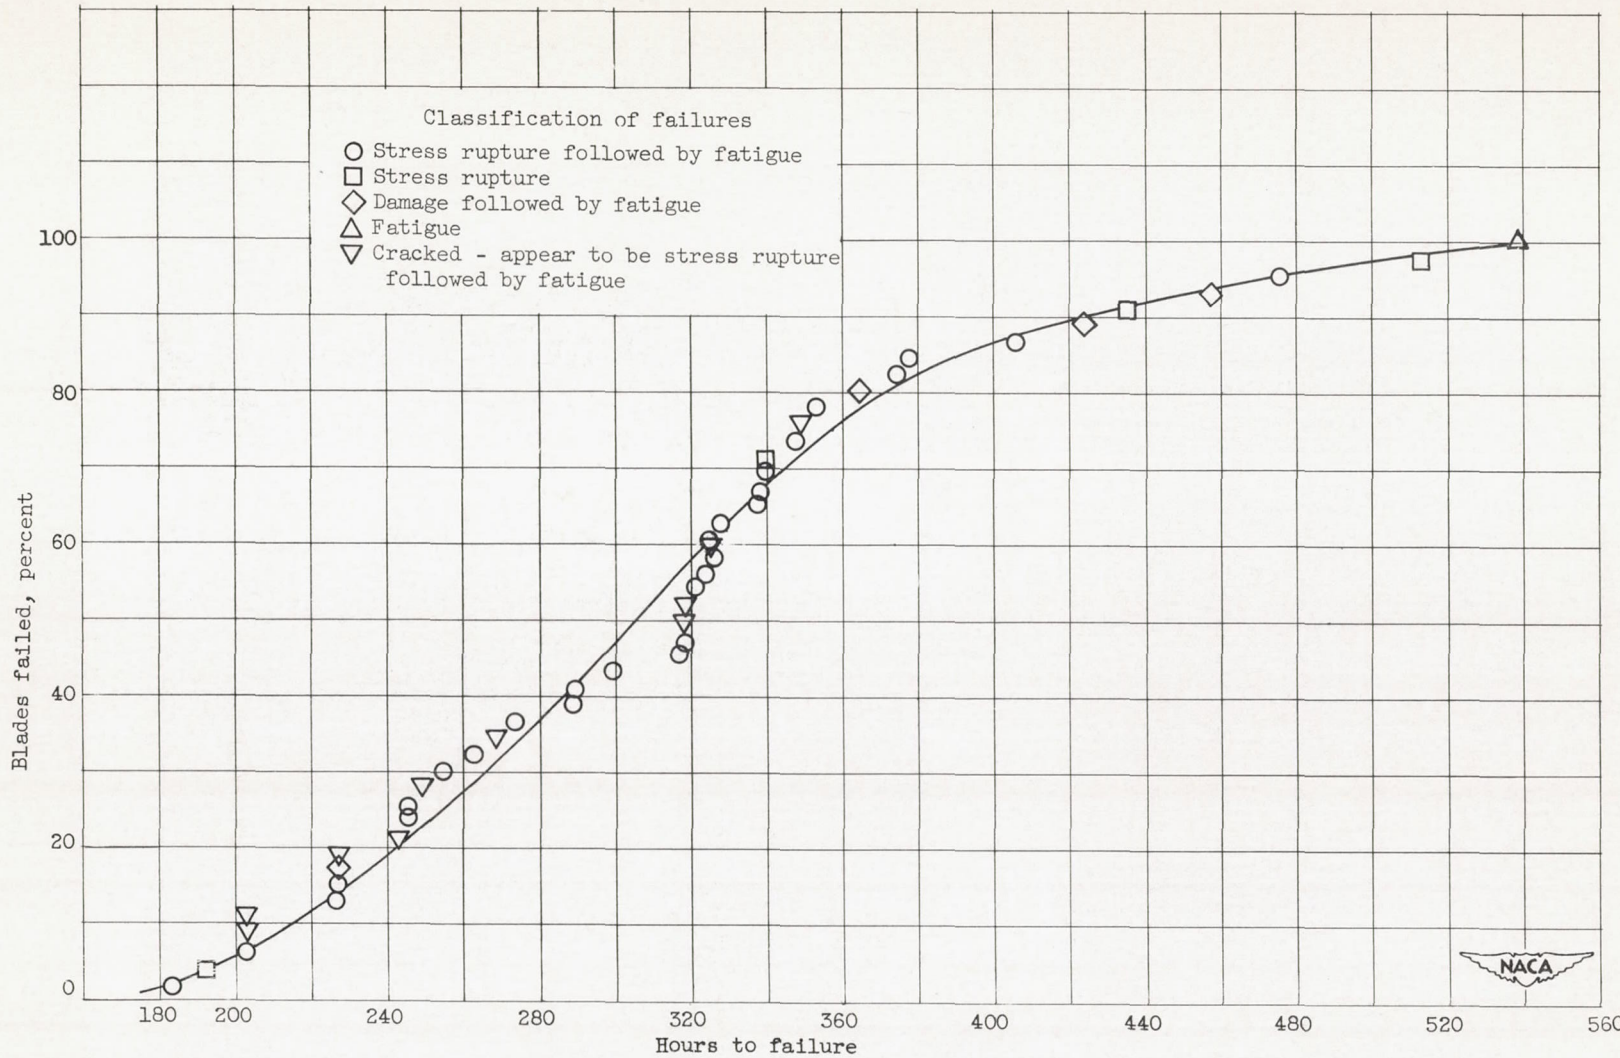
Blade failures are plotted on the cumulative-frequency curve shown in figure 2. The first failure occurred in 181 hours, and the last failure in 539 hours, a range of 358 hours.

Figure 2. - Performance of forged S-816 blades in steady-state engine operation as shown by cumulative-frequency curve.

It should also be observed that the cumulative-frequency distribution of the blade failures would indicate that replacement of failed blades in service, unless the failure has occurred in abnormally short times, would be relatively useless for additional failures would be expected in very short times.

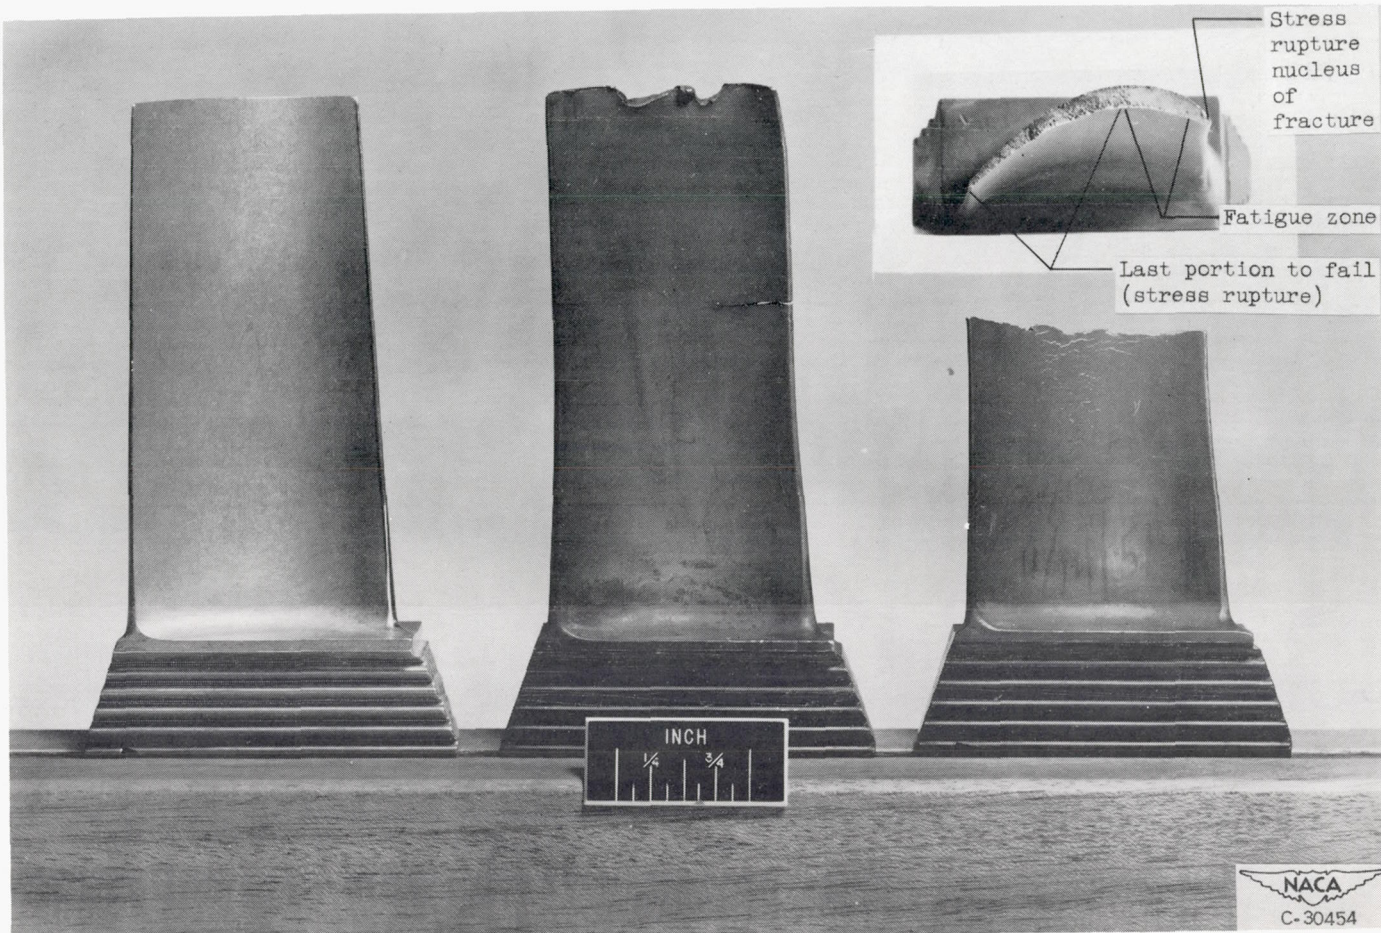
Photographs of an as-received blade and typical failed blades are shown in figure 3. The fractured blade which failed by stress rupture followed by fatigue is labeled to show the nucleus of the failure, the fatigue zone, and the last portion to fail. Stress-rupture cracks are present in the last portion to fail. The origins of failures are shown in figure 4. Of the 23 blades selected for macroexamination, 65 percent of the failures originated at the trailing edge, 35 percent at the leading edge, and 74 percent of the failure origins occurred in a zone between 2 to $2\frac{3}{8}$ inches from the blade roots. The average distance from the roots to the failure origins was 2.11 inches, and the centrifugal stress calculated for this distance was 21,500 pounds per square inch.

Figure 3. - As-received blade and typical failed blades.

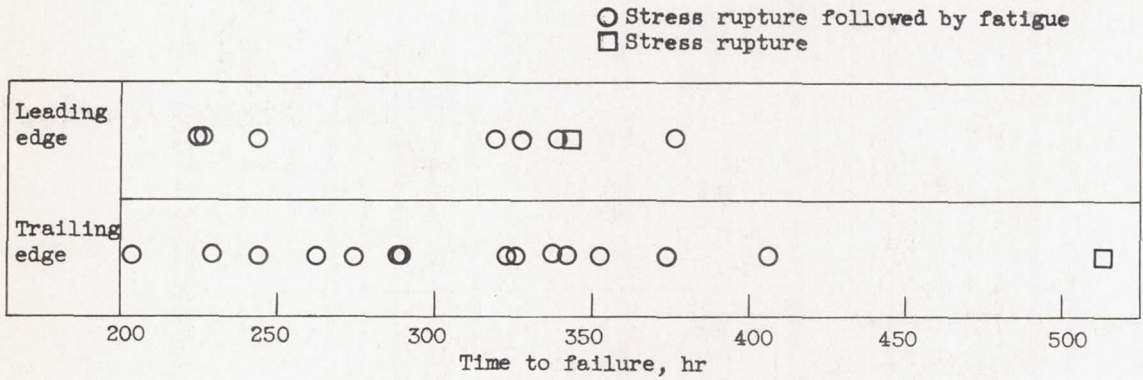
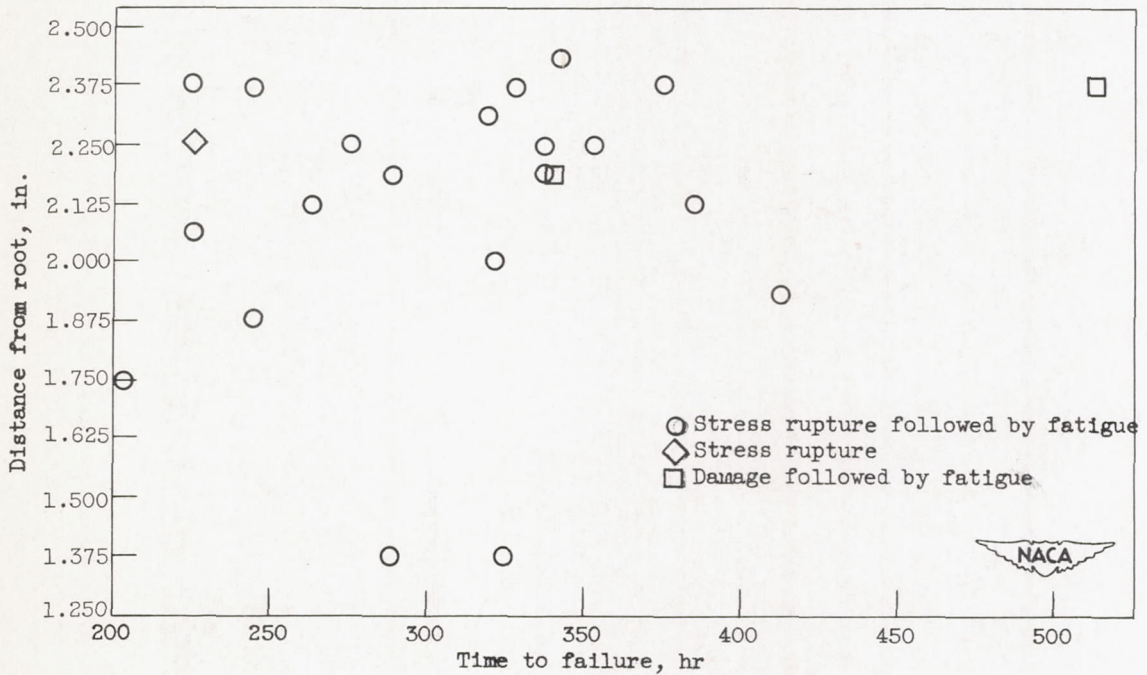
(a) Origin of blade failures

(b) Origin of fracture edges relative to blade roots.

Figure 4. - Failure origins in blades.

4. Of the blades that failed in the engine, 23 were selected for macro-examination; 65 percent of the failures originated at the trailing edges, 35 percent originated at the leading edges, and 74 percent of the failure origins occurred in a zone between 2 to $2\frac{3}{8}$ inches from the blade roots. The average distance from the roots to the failure edges was found to be 2.11 inches.

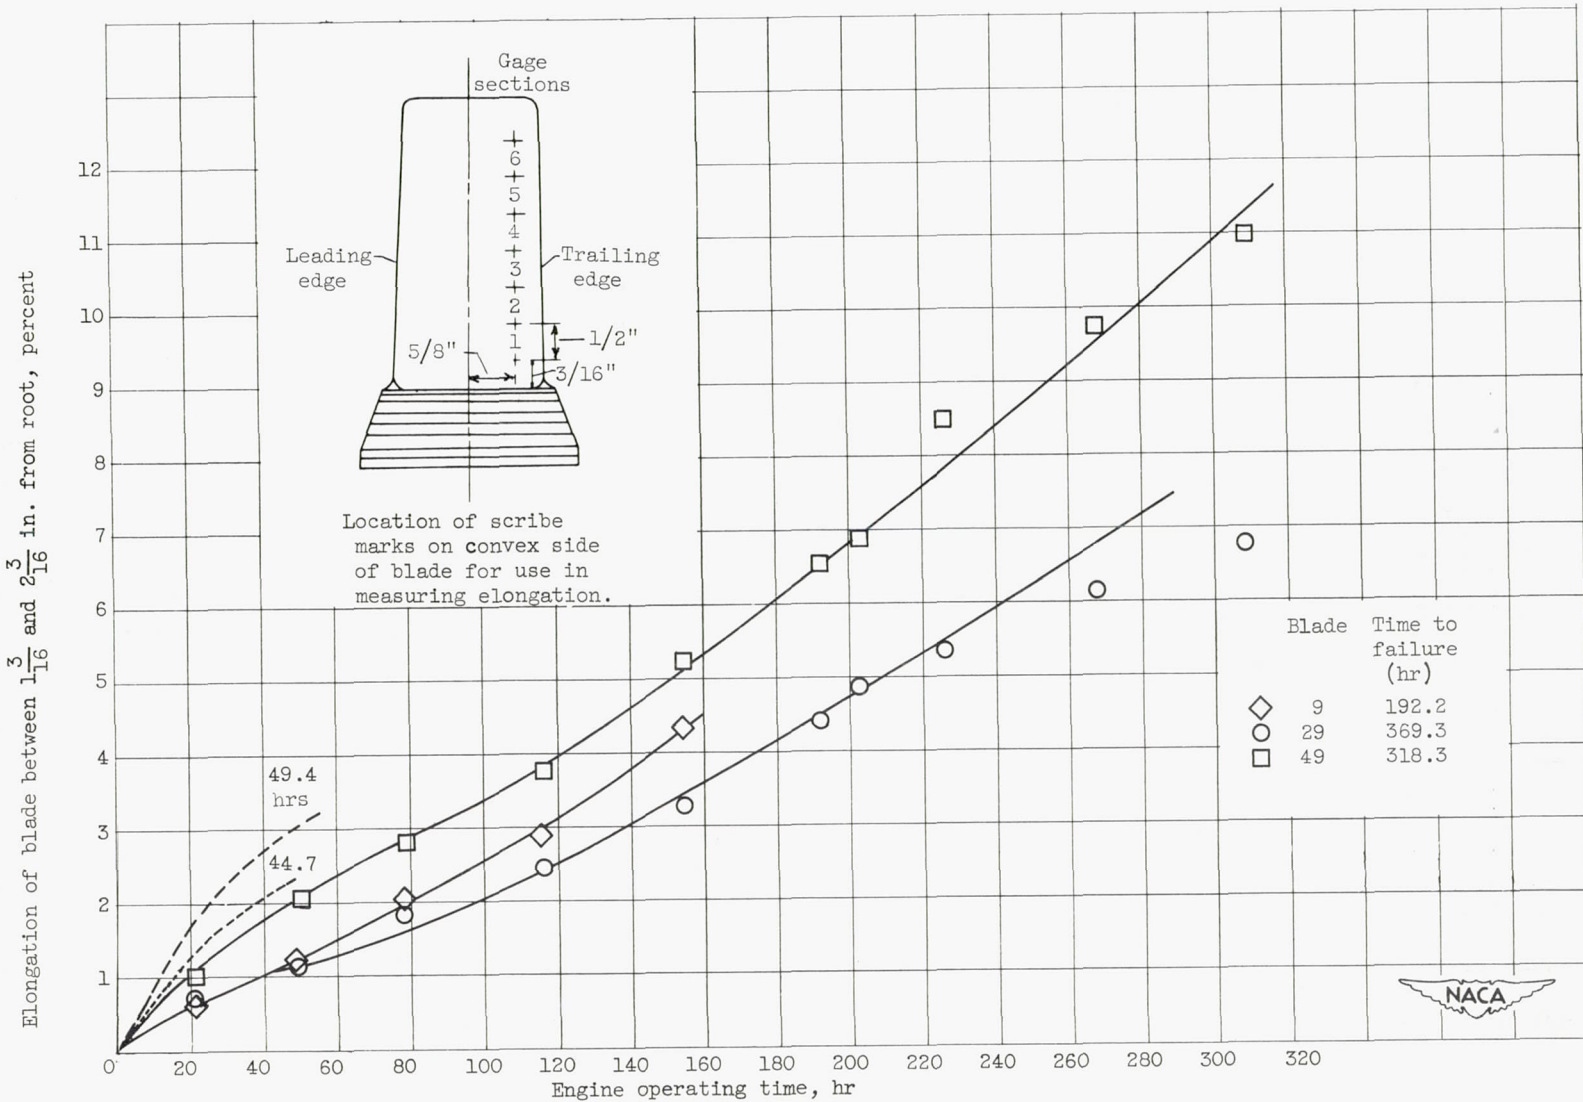
The solid curves of figure 5 show the elongation of three blades in the portion of the airfoil between $1\frac{3}{16}$ to $2\frac{3}{16}$ inches from the root; the dashed curves are similar data taken from reference 1. The blades of reference 1 were run in cyclic tests and failed in 44.7 and 49.4 hours. It is readily seen that the creep rates of the blades being investigated are lower than those of the previously investigated blades.

Figure 5. - Elongation of portions of blades during engine operation (gage sections 3 and 4). Dashed curves represent forged S-816 blades from reference 1. (Points shown on curves represent inspection periods.)

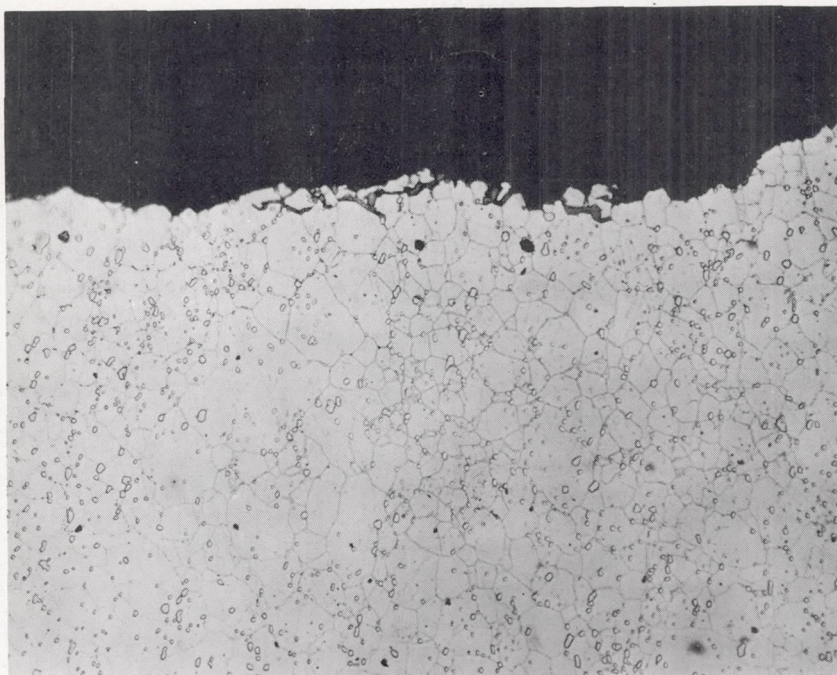
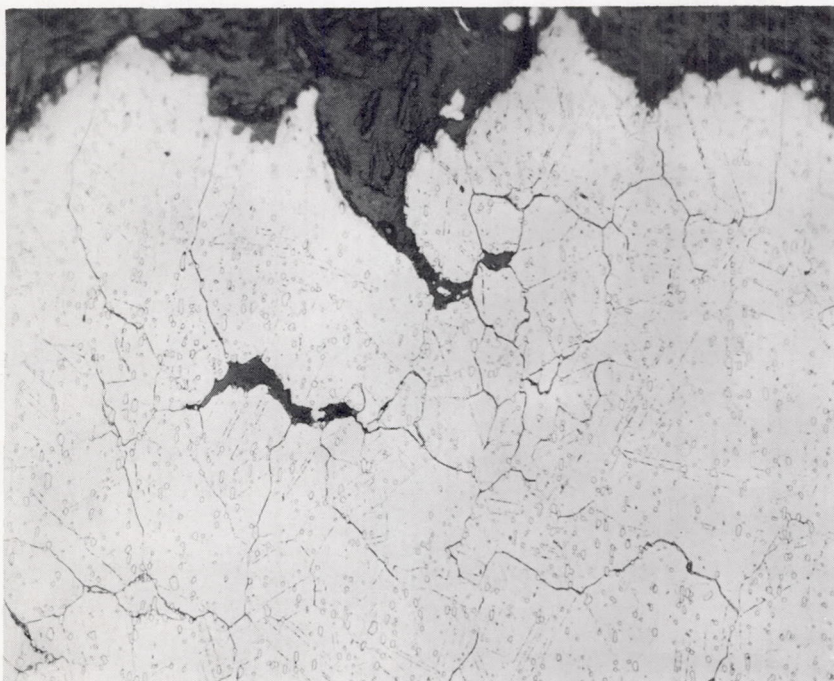
Grain size. - The specimens examined metallographically are listed in table I along with grain-size measurements. The blade that failed in the shortest time (181.2 hr) had a variable grain size near the fracture edge (fig. 6). The grain size in the immediate vicinity of the fracture was coarse near the center of the blade (A.S.T.M. 1-4-7) and fine at the trailing edge (A.S.T.M. 6-7-8). The blade that failed in the second shortest time (192 hr) had only slight differences in grain size while the remaining blades including those that failed in the longest periods were fine grained and relatively uniform in grain size.

(a) Microstructure near trailing edge of blade.

(b) Microstructure of area in center of blade.

Figure 6. - Microstructural differences in blades that failed in shortest time. (Failure time, 181.2 hr.) Etchant, 10 percent HCl; electrolytic; X250.

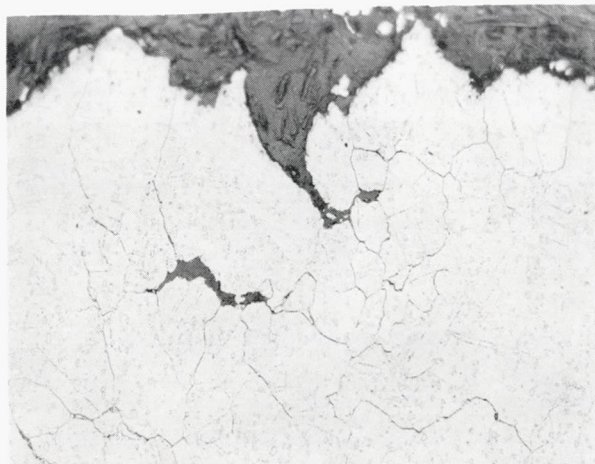
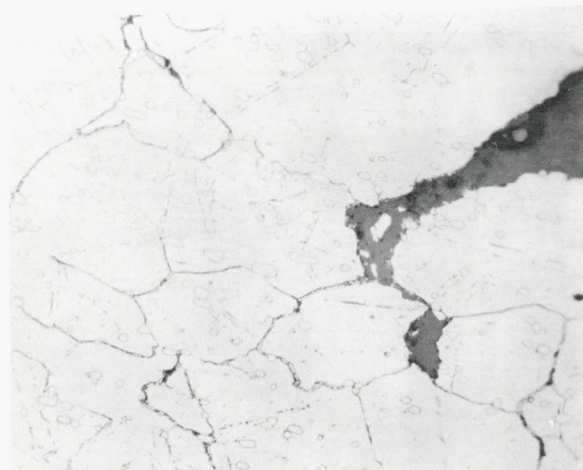
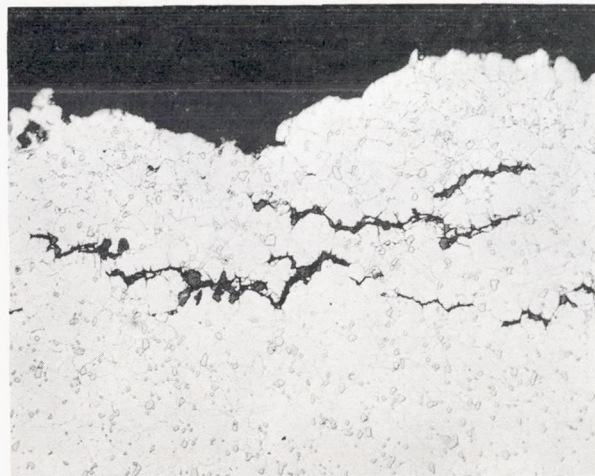
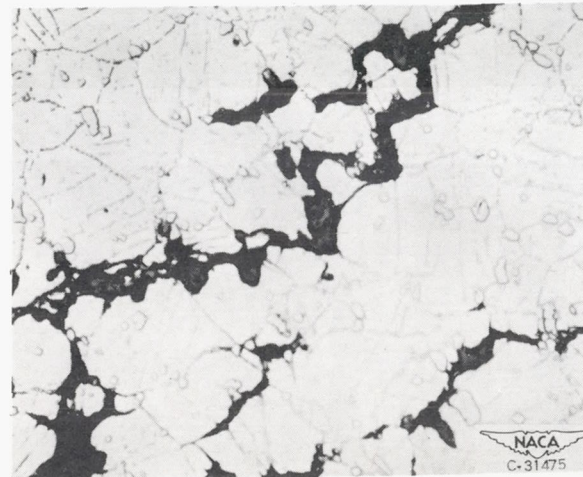
Metallographic examinations of blade structure. - Photomicrographs showing areas at fracture edges and cracks in blades are presented in figure 7. In addition to the grain-size differences that are evident in figure 6, several other differences in the structures of the blades were observed. For example, the poorest blade (failed in 181 hr) contained more oxide penetrations, particularly at the tip of the trailing edge than did the other blades, (fig 8(c)). Such penetrations may have caused the shorter life relative to the other blades.

The failure zone of the blade that failed in 254 hours originated at the leading edge and, although figure 7 does not show it, there were several microvoids in this locality which may have nucleated the failure. None of the other blades contained such flaws. One of the best blades that was examined metallographically failed by cracking in 434 hours. Only a few intergranular cracks were visible at the trailing edge, although a small segregation of dirt (slag inclusions) and a slag stringer were found near the zone of the crack.

Fracture edge near center of blade 1. Failure time, 181.2 hours; grains coarsest here.

Fracture edge near leading edge of blade 3. Failure time, 254.6 hours.

Figure 7. - Microstructures of fractured or cracked blades at or near areas of failures.
Etchant, 5 percent aqua regia in water followed by 10 percent hydrochloric acid in ethyl alcohol; both electrolytic.

Metallographic examinations of fracture edges of the specimens that failed in 181, 254, and 317 hours confirmed that fatigue cracking took place over a portion of the fracture edges. The blades failed by stress rupture followed by fatigue. Fatigue was indicated by transcrystalline portions of the fracture edges.

Changes in blade microstructure with operating time. - The changes in the microstructure with increasing engine operating time are also shown in figure 7. An increase in carbide precipitation with time, particularly in slip lines and twin boundaries, and the subsequent agglomeration of these carbides appears to have occurred. This tendency is more readily visible in the stress-rupture specimens as will subsequently be described.

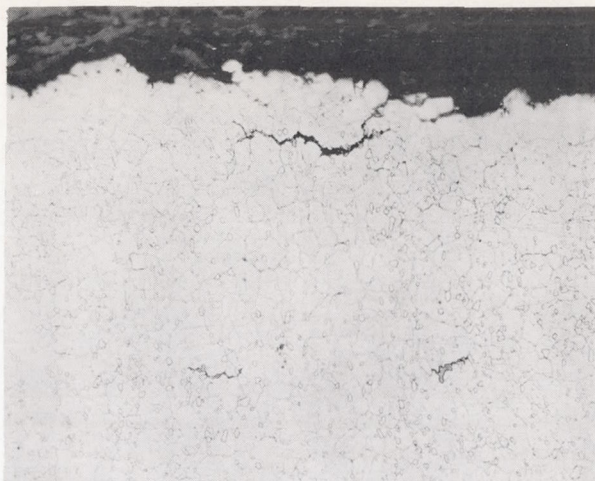
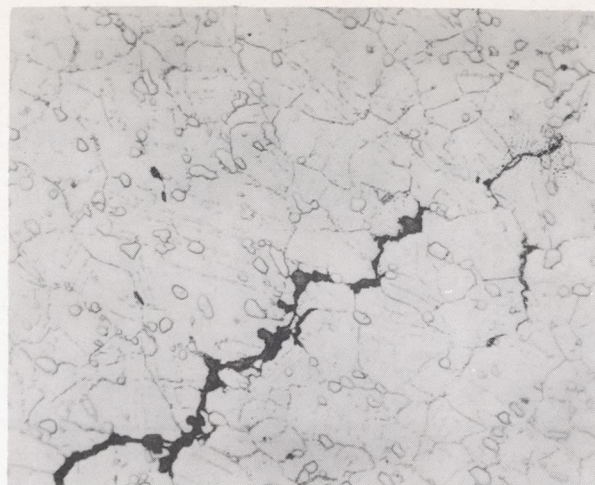
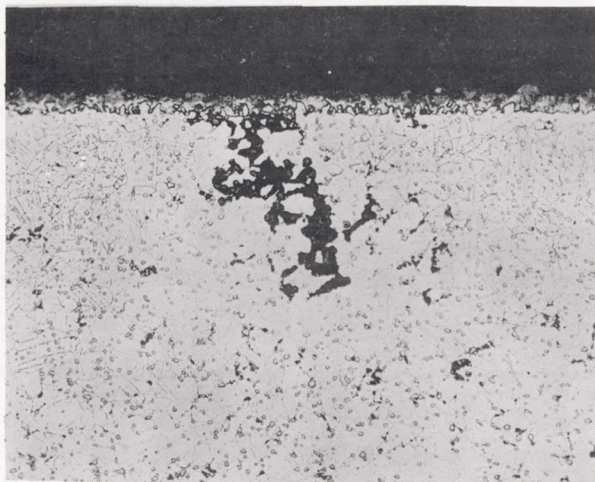
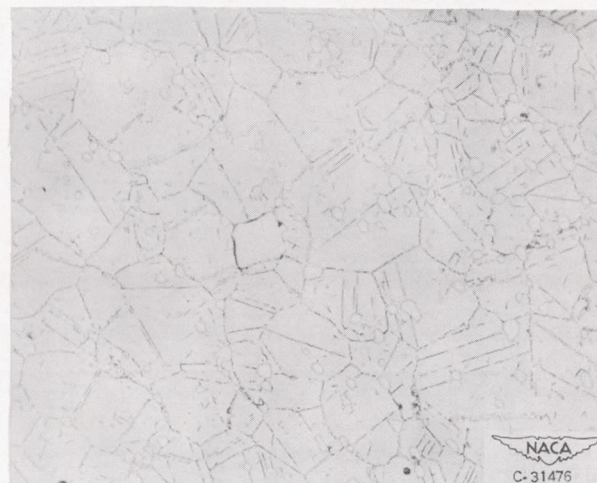
Fracture edge near trailing edge of blade 4. Failure time, 316.7 hours.

Crack near trailing edge of blade 5. Failure time, 434.2 hours.

Figure 7. - Concluded. Microstructures of fractured or cracked blades at or near areas of failures. Etchant, 5 percent aqua regia in water followed by 10 percent hydrochloric acid in ethyl alcohol; both electrolytic.

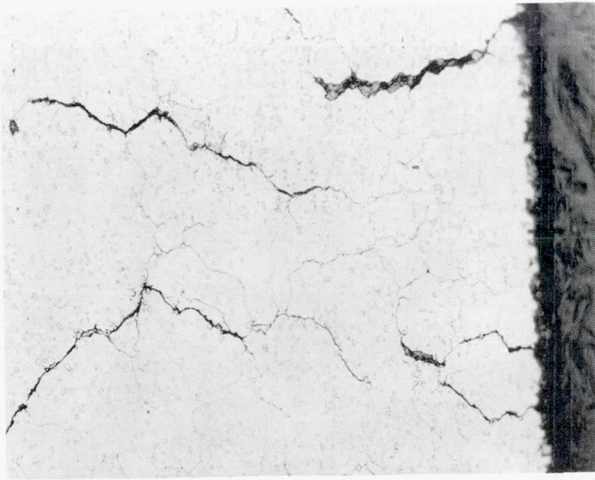
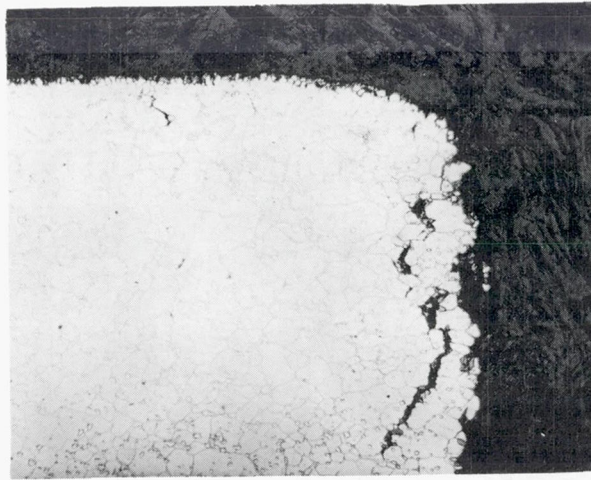
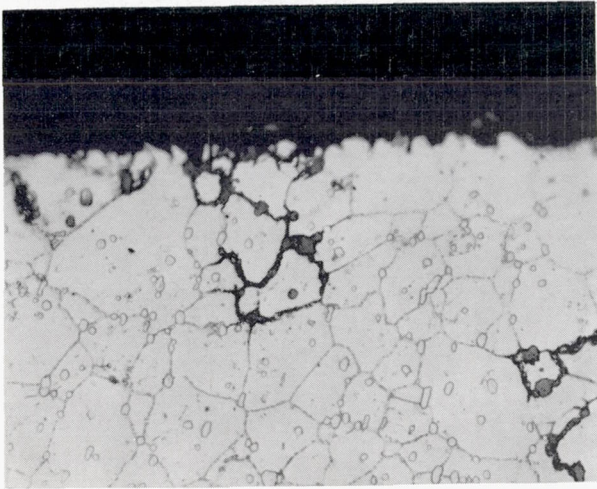
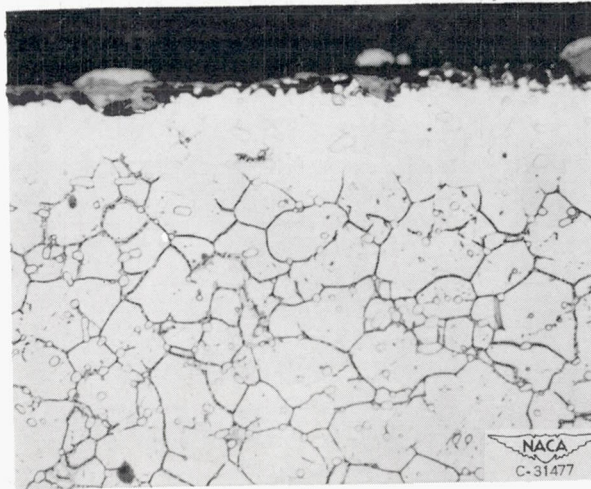
The edge conditions shown in figures 8(a) to 8(c) were evident in several of the blades, and the depletion zone shown in figure 8(d) was found in varying degrees in all blade segments examined. Examinations of as-received blades did not reveal this zone which is probably a decarburization zone formed during engine operation. The massive carbides were not visibly disturbed.

(a) Near fractured edge at center of air foil. X250. (b) Fracture and trailing edges in fine grained, trailing edge portion of blade. X250.

(c) Tip of trailing edge showing oxide penetration. X750. (d) Depletion zone on concave surface, (0.0012 in. deep). X750.

Figure 8. - Surface conditions present in blade that failed in 181.2 hours. Etchant, 10 percent HCl in ethyl alcohol; electrolytic.

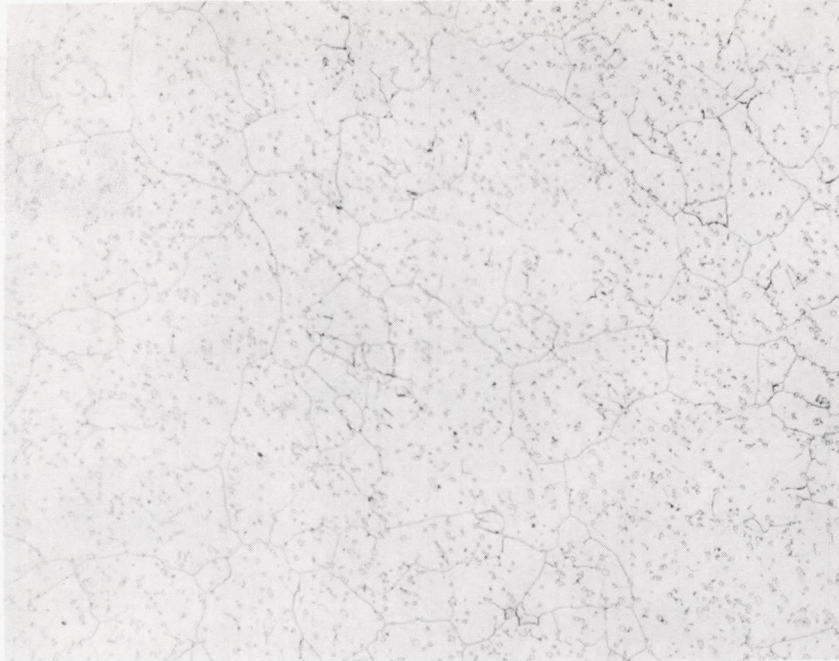
The microstructure of the blade previously run in steady-state operation (failure at 78.9 hr) was different in several respects from the structures of the blades being investigated (fig. 9). For example, except for one blade (the blade that failed in 181 hr) the grain size was more heterogeneous in the older alloy (investigated in ref. 1). In the older alloy the carbides were distributed in finer, more numerous dispersions; both salt and pepper carbides and massive carbides were more thickly distributed within the grains. The oxide penetrations in these blades seemed to be much deeper and more extensive than those found in the blades used in the present investigation. Figures 10(a) and 10(b) show, respectively, a very severe crack at the trailing edge and extensive oxide penetrations (possibly but probably not associated with cracks).

(a) General structure near leading edge showing heterogeneity in grain size and large number of carbides per unit of area. X250.

(b) General structure near trailing edge showing salt and pepper precipitates, probably carbides. X750.

Figure 9. - Microstructure of older forged S-816 blades for comparison with structures of blades used in present investigation. Etchant, 5 percent aqua regia in water followed by 10 percent hydrochloric acid in ethyl alcohol; both electrolytic.

7. A previously run S-816 turbine blade was examined and compared with the blades of the present investigation. This blade was the best of several blades run; it failed in 78.9 hours, which is appreciably lower than the minimum failure time obtained in the present investigation. Microstructural differences between the older and newer blades were found, and these differences may explain the superior behavior of the newer alloy. For example, the structures of the newer blades contained fewer visible precipitates than the structure of the older blade. Furthermore, the grain size of the newer alloy was finer and more uniform, and oxide penetrations were less extensive.

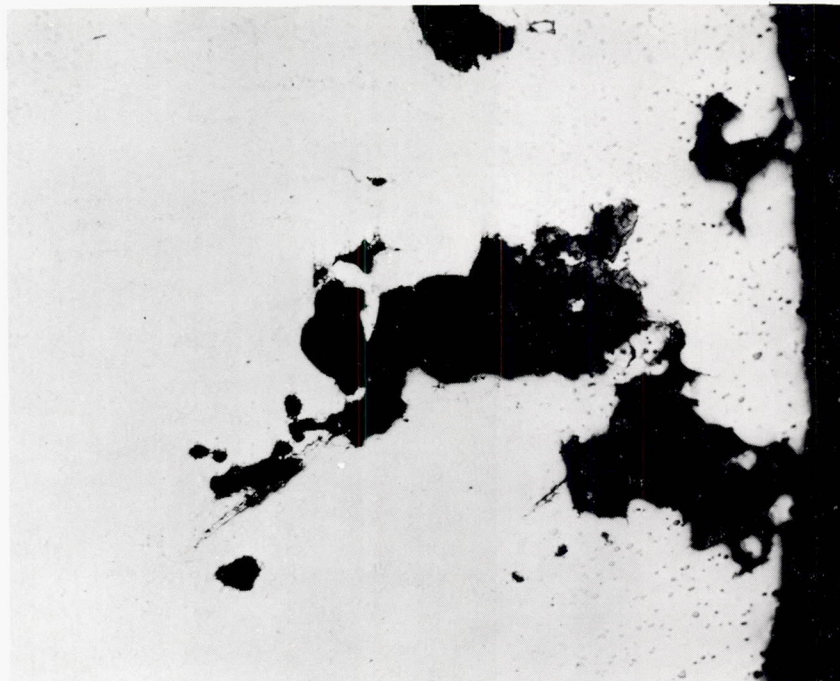
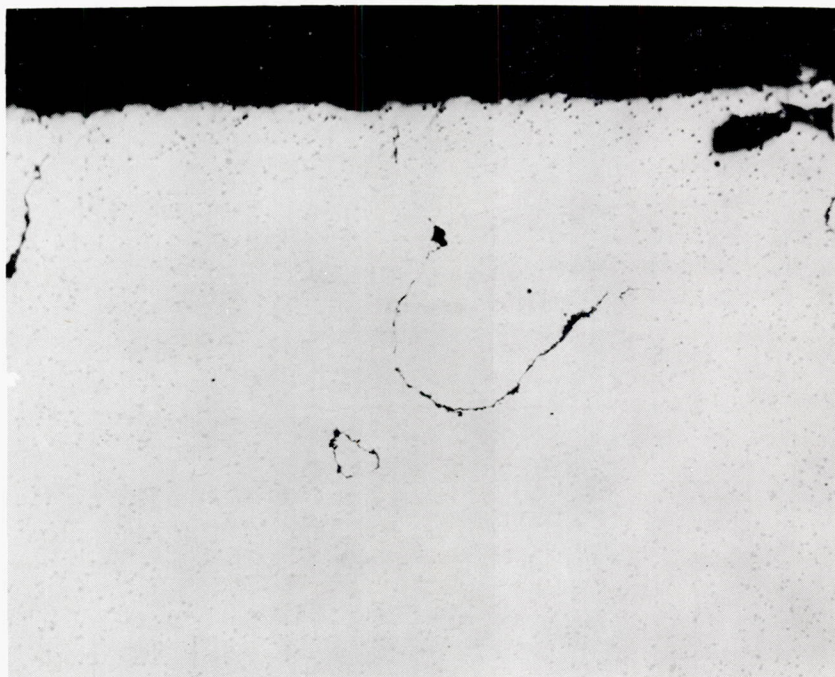
(a) Stress-rupture crack below actual fracture-edge: cross section of airfoil.

(b) Probable oxide penetration near trailing edge on concave edge of airfoil.

Figure 10. - Edges of older blade run in steady-state operation for 78.9 hours before failure. Structures shown for comparative purposes.) Etchant, none. X250.

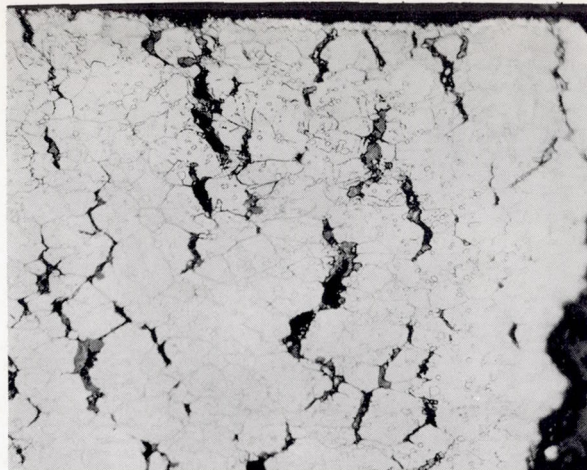
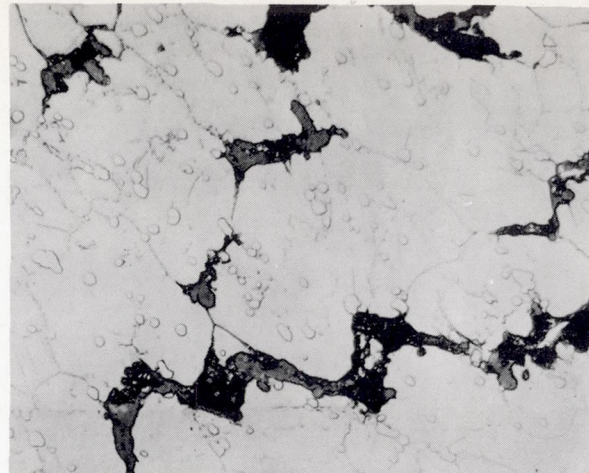
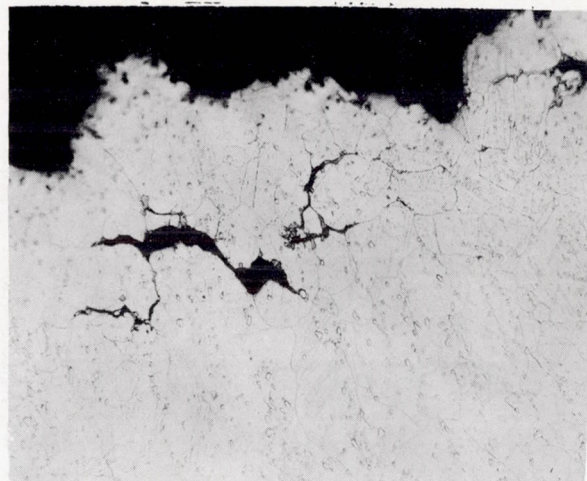
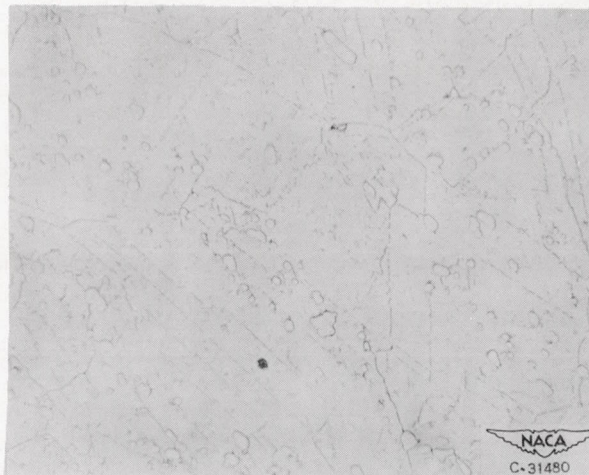
The photomicrographs of figure 11 were taken at or near the failure zones of the rupture bars. Cracks, intergranular tears, and fracture edges are evident.

Specimen 11; failure time, 89.5 hours.

Specimen 9; failure time, 218.8 hours.

Figure 11. - Microstructures of fractured stress-rupture specimens showing intergranular tears and changes with time at temperature of 1500° F and stress of 20,000 pounds per square inch. Etchant, 5 percent aqua regia in water followed by 10 percent hydrochloric acid in ethyl alcohol; both electrolytic.

Changes in microstructure of stress-rupture specimens with time at temperature of 1500° F. - If the structures of the untested specimens shown in figure 12 and the structures shown in figure 11 are compared, it may be seen that, as the time at the test temperature increases, the precipitation within the grains, in slip lines and in twin boundaries, increases until at the longer times these precipitates tend to spheroidize. Furthermore, the matrices do not become spotted with salt and pepper precipitates such as those found in the older alloy (fig. 9). It is, of course, possible that the large number of agglomerated carbides etches rapidly and prevents subsequent satisfactory etching of the matrix carbides, although this is not believed to be the case.

Additional metallographic information not fully revealed by photomicrographs shown. - The fracture edges of the stress-rupture bars were intergranular and the usual intergranular tears below the fracture zone were also present. Twin and deformation bands, containing no visible precipitation, were observed under oblique light on a specimen that was cut from the same airfoil as one of the stress-rupture bars. Such deformation effects could have been caused by the water quenching that followed the solution treatment given the blades after forging. The aging treatment of 16 hours at 1400° F produced no visible precipitation within the twin bands and slip lines; in fact, figure 11(a) shows that after an additional aging treatment of 89.5 hours at 1500° F, relatively little precipitation occurred in these areas. When the specimens were tested for longer times at 1500° F, extensive precipitation occurred in these planes as evidenced by several photomicrographs shown in figure 11.

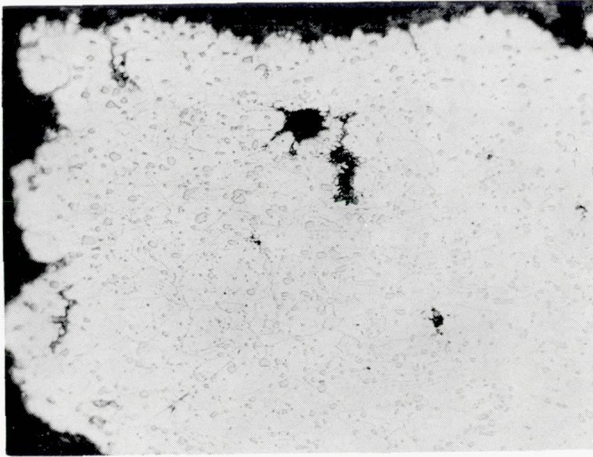
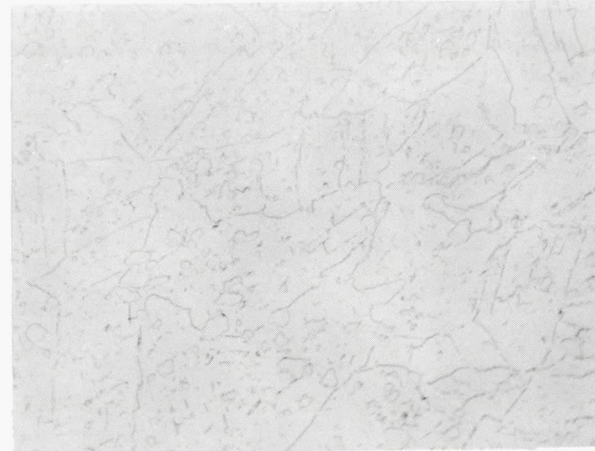
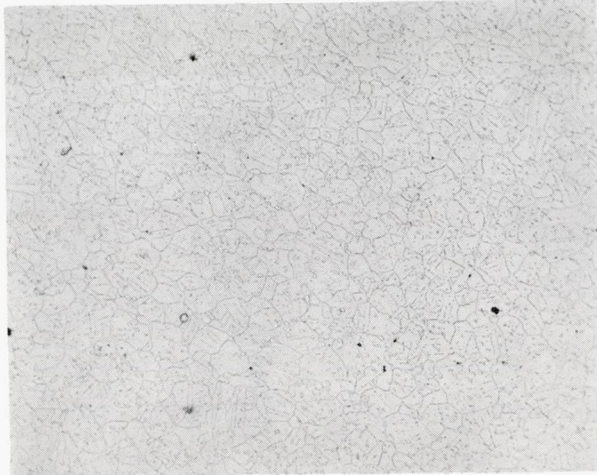
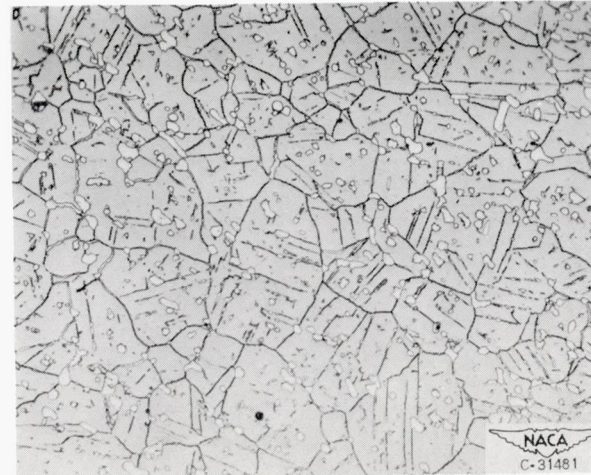
Specimen 6; failure time, 618.0

Specimen 1; failure time, 1346.3 hours.

Figure 11. - Concluded. Microstructures of fractured stress-rupture specimens showing intergranular tears and changes with time at temperature of 1500° F and stress of 20,000 pounds per square inch. Etchant, 5 percent aqua regia in water followed by 10 percent hydrochloric acid in ethyl alcohol; both electrolytic.

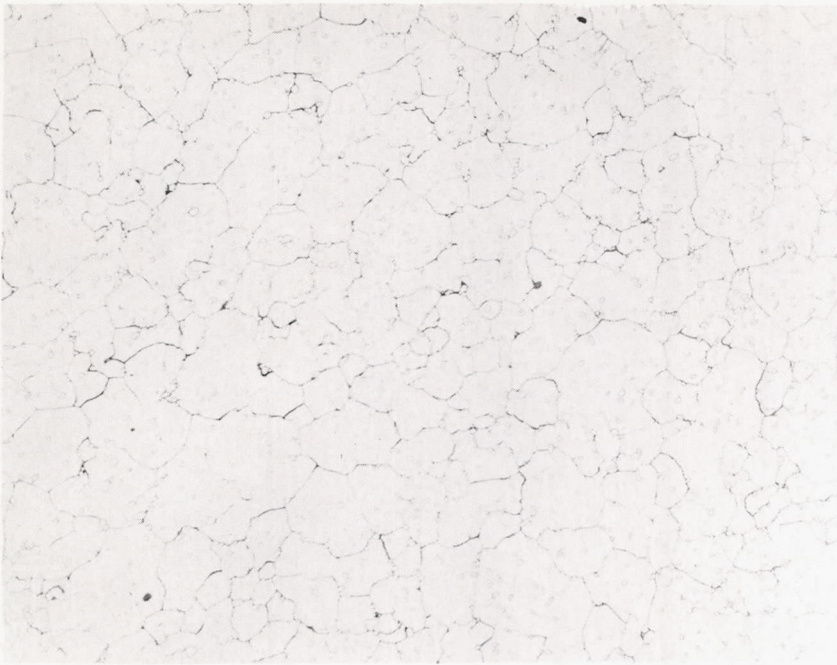
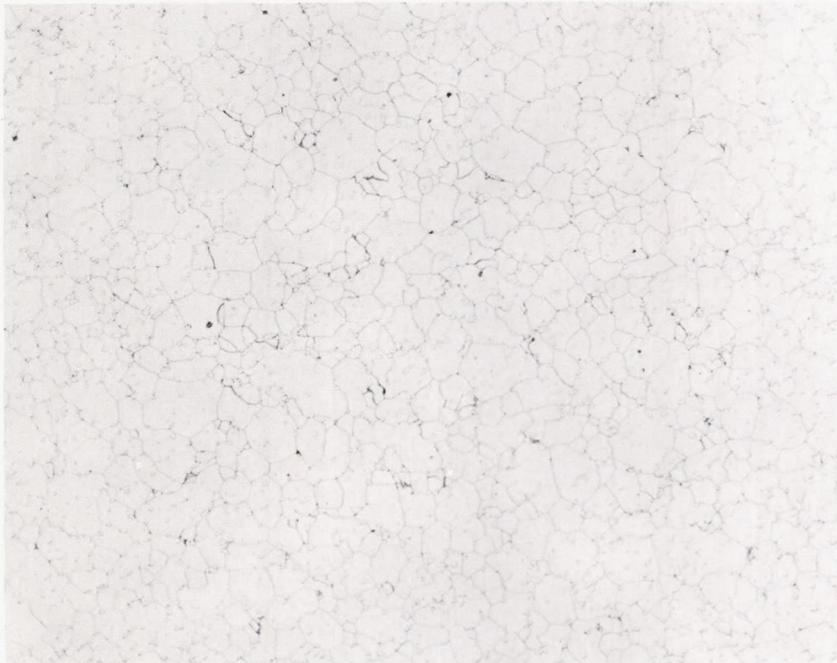
Grain size of fractured bars. - The grain size of the bar that did not fail after 1346 hours in the stress-rupture test was somewhat smaller than that of the other specimens (A.S.T.M. 6-7-8 against A.S.T.M. 4-6-8). Similar differences in grain sizes were found in the remnants of the blade airfoils from which the stress-rupture bars were cut (fig. 12).

(a) Microstructure of untested segment of blade from which stress-rupture specimen that fractured in 89.5 hours was obtained.

(b) Microstructure of untested segment of blade from which stress-rupture specimen that did not fracture after 1346 hours was obtained.

Figure 12. - Differences in microstructures of untested segments of blades from which the poorest and best stress-rupture specimens were obtained. Etchant, 5 percent aqua regia in water; electrolytic. X250.
