# RESEARCH MEMORANDUM

EXPERIMENTAL INVESTIGATION OF AIR-COOLED

TURBINE BLADES IN TURBOJET ENGINE

X - ENDURANCE EVALUATION OF SEVERAL

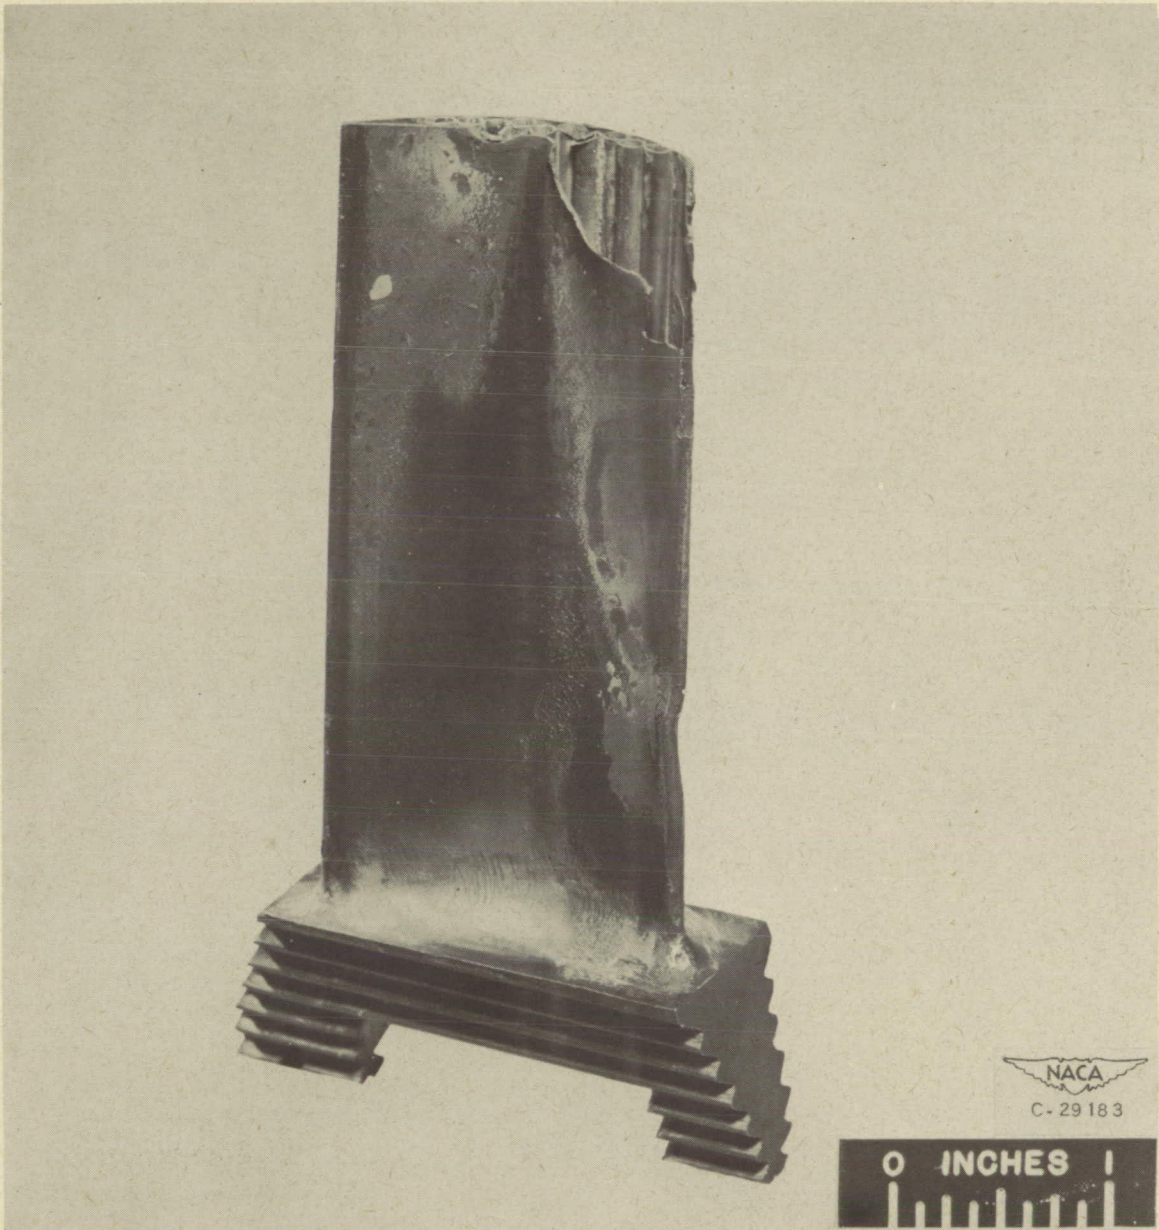
Figure 7. - Blade 14 after a total of  $51\frac{1}{4}$  hours of rated-speed endurance test. Failure caused by vibration and erosion in area where there was poor brazing between tubes and shell.

brazing between the tubes and the shell on the pressure surface of the blade, consequently an evaluation of the coating durability on this blade was impossible. Blade 14, which was used to replace blade 13, was not coated. After completing approximately 25 hours of endurance on the coated blade and 21 hours on the uncoated blade, both blades were removed from the turbine wheel for zygo inspection. At that time the nickel had started to wear away from the leading edge and near the tip of the blade on the pressure surface of blade 12. Blade 14, which was not coated, was oxidized quite badly particularly at the leading edge. It was necessary to clean the blades thoroughly for the zygo inspection. This cleaning by vapor blast removed the nickel coating. Both blades were then nickel coated and the endurance test was continued. After approximately 10 hours of the endurance test on the new coatings, blisters began to appear under the coating with some scaling present. These second coatings apparently were not as durable as the first coating on blade 12. The deterioration of the coatings continued until at the completion of the endurance test all the coating was gone from the blade leading edges and part of the coating was missing from other portions of the blades. Some of the areas where the coating failed are shown in figures 7 and 8.

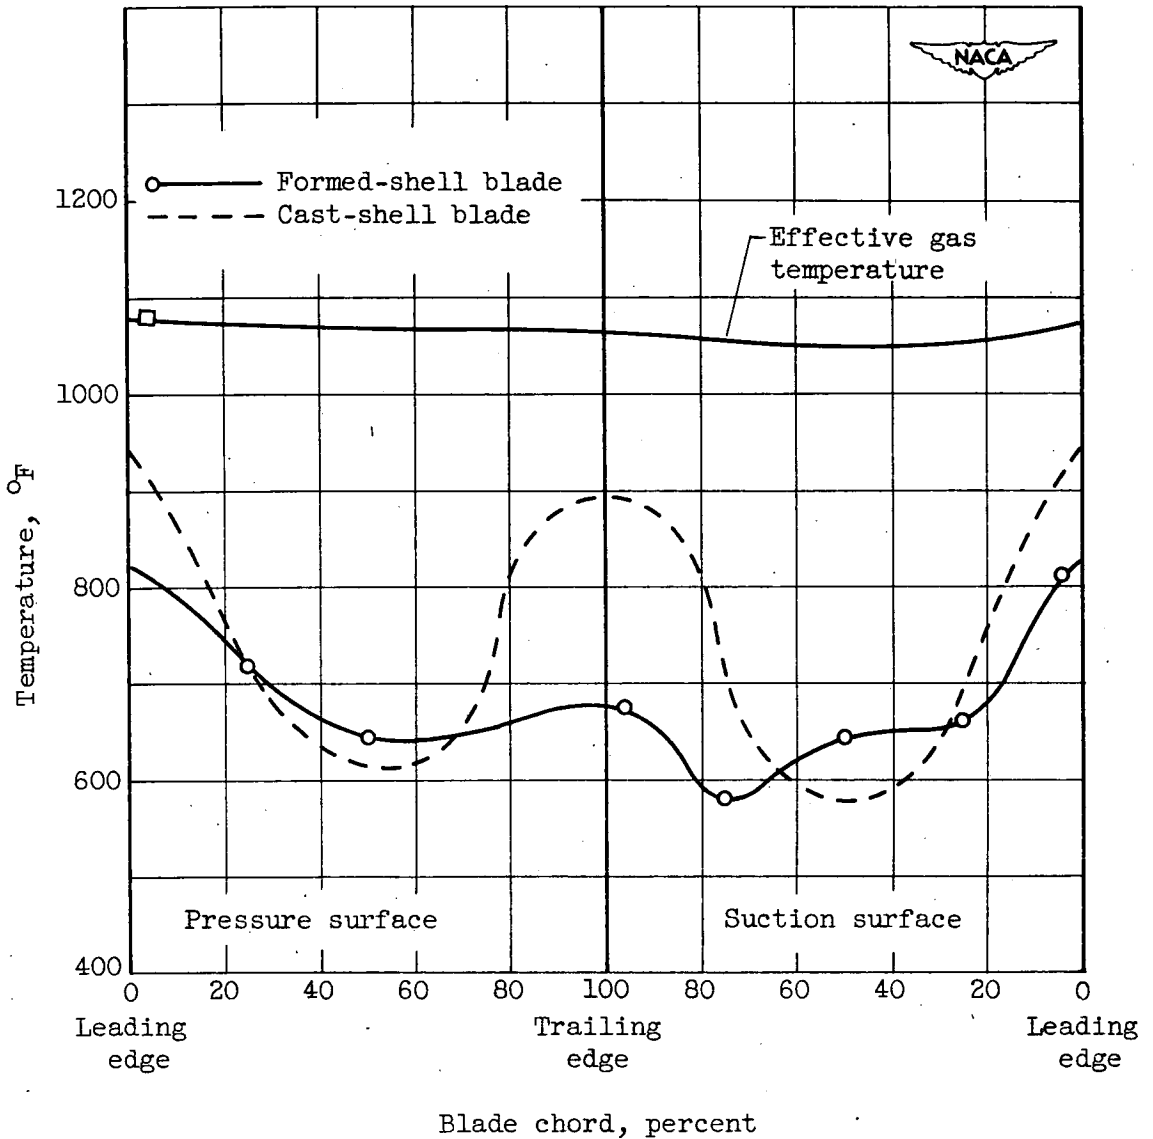
Figure 10. - Comparison of chordwise temperature distribution for cast-shell blade (reference 1) and formed-shell blade 12. Gas flow, 60.6 pounds per second (engine speed approximately 10,000 rpm); coolant-flow ratio, 0.029; cooling-air temperature at blade root, 133° F.

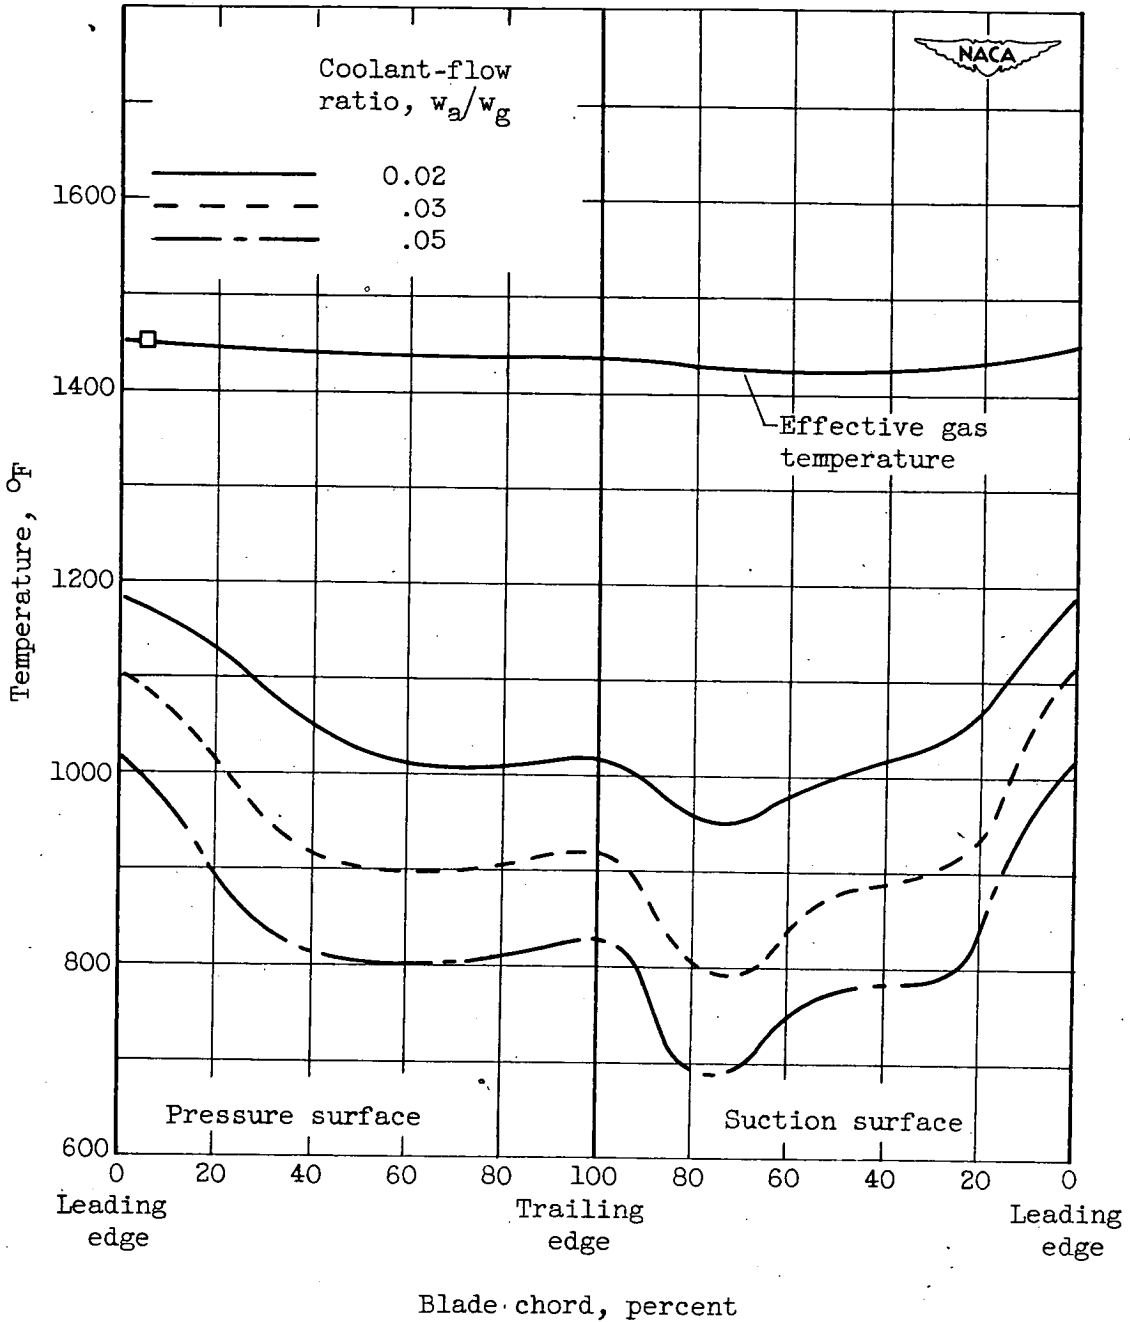
Figure 11. - Blade 12 temperature distributions for three coolant-flow ratios at rated engine speed of 11,500 rpm. Cooling-air temperature, 180° F.

The blade temperatures at rated engine speed for coolant-flow ratios of 0.02, 0.03, and 0.05 are shown in figure 11. These curves were obtained from cross plots of temperature data shown in table V. The fact that it was possible to run a blade containing seven thermocouples at these engine conditions and at a coolant-flow ratio as low as 0.02 is a good indication of the high blade-cooling effectiveness.
