RESEARCH MEMORANDUM

LATERAL AND DIRECTIONAL STABILITY AND CONTROL
CHARACTERISTICS OF A C-54D AIRPLANE

Donald B. Talmage and John P. Reeder

March 24, 1949

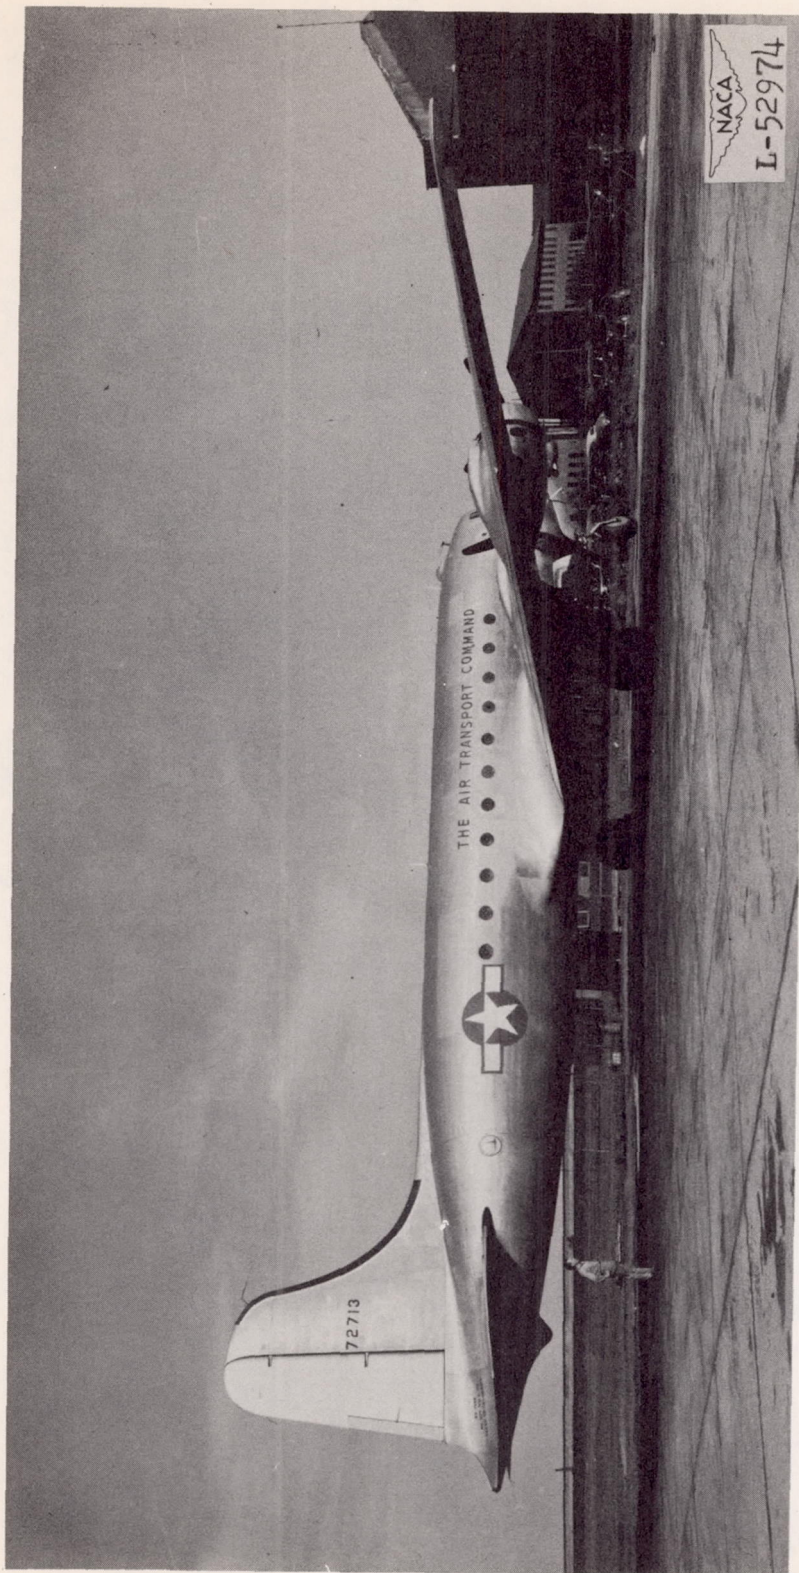
Figure 1.- Photographs of the C-54D airplane on which the tests were conducted.

(a) Front view.

(b) Three-quarter front view.

(c) Side view.

(d) Three-quarter rear view.

Several photographs of the test airplane are shown as figure 1. The variations of the pilot's control position with control-surface angle for the elevator, aileron, and rudder are shown in figure 2. The characteristics of the rudder spring tab (or flying tab) are presented in figure 3; the ratio between rudder-pedal position and tab position with the rudder fixed could not be measured accurately because of stretch in the control system. It was estimated, however, that the pedal moved 0.02 inch per degree movement of the tab. The investigation was conducted with the automatic-pilot servo-units installed. In this condition, the friction in the control systems was ± 15 pounds for the elevator, ± 12 pounds for the ailerons, and ± 30 pounds for the rudder as measured in flight. The servo-units were responsible for about ± 10 pounds friction in each control system. The effects of this friction are discussed in references 1 and 2.
