TECHNICAL NOTE 3927

PRELIMINARY INVESTIGATION OF THE EFFECT OF SURFACE
TREATMENT ON THE STRENGTH OF A TITANIUM CARBIDE -

30 PERCENT NICKEL BASE CERMET

By Leonard Robins and Edward M. Grala

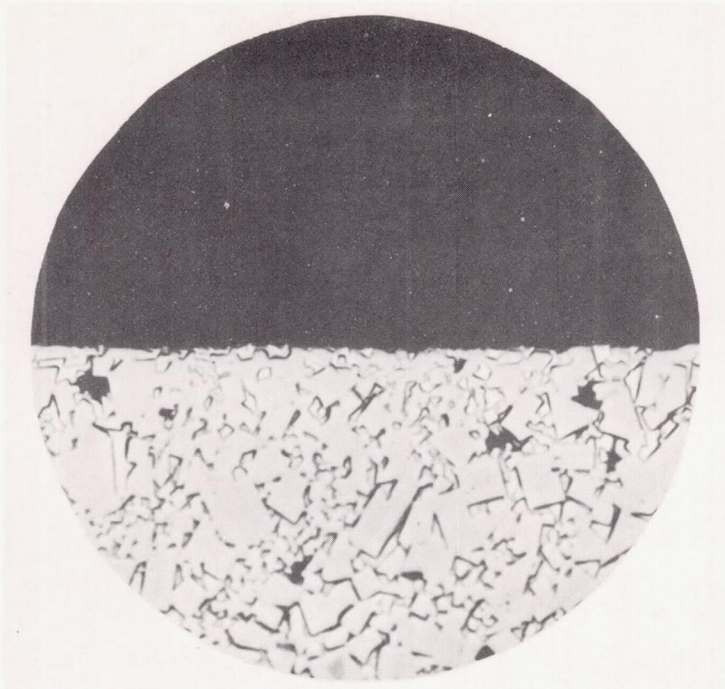
(a) 220-Grit diamond-abrasive ground.

Figure 1. - Microstructure of surface-treated specimens. No etch; X1000.

Microstructure. - Photomicrographs of the edges of transverse sections are shown in figure 1. The sections were cut from fractured test specimens.

(3) Significant differences were revealed by the inspections of the diamond-ground and vapor- or grit-blasted surfaces, particularly in the microstructure (figs. 1(a), (b), (e), and (f)) and the surface roughness (table II). As stated previously, there is no significant difference between the strengths after treatment. Possible reasons for this are:

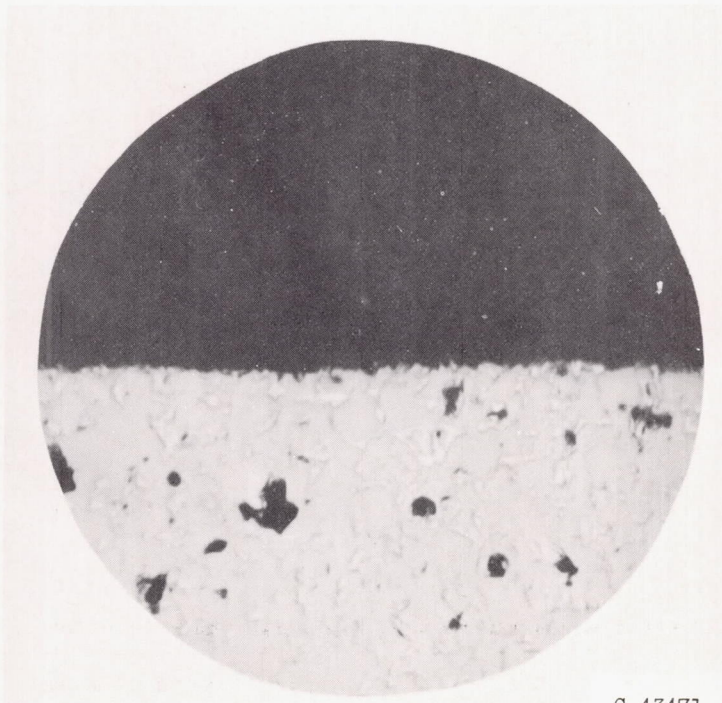
(b) 100-Grit diamond-abrasive ground.

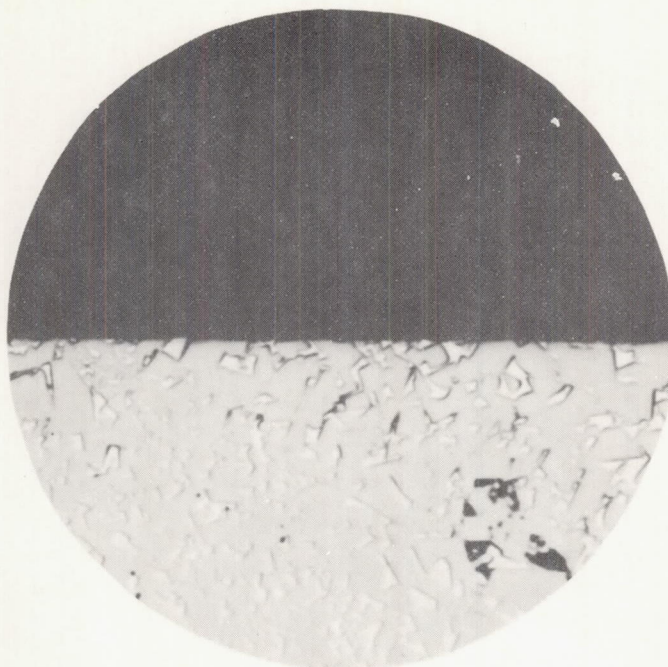
(c) Diamond lapped.

Figure 1. - Continued. Microstructure of surface-treated specimens. No etch; X1000.

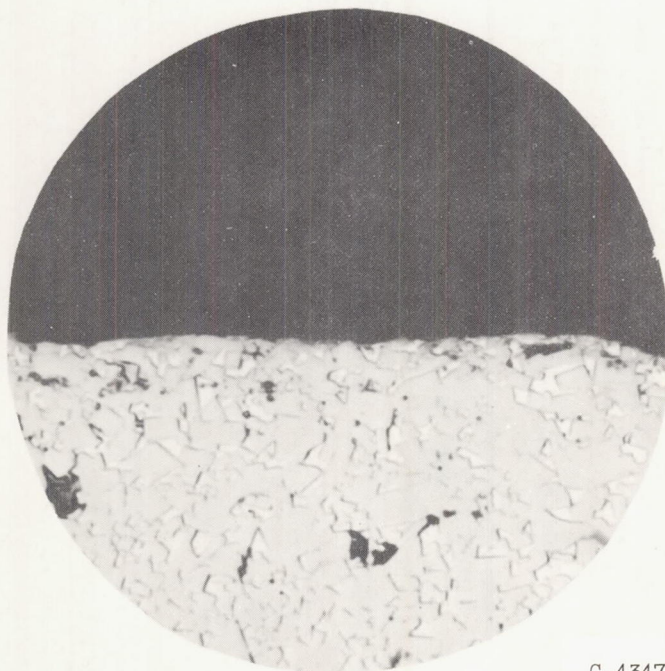
(d) Severe silicon carbide abrasive ground.

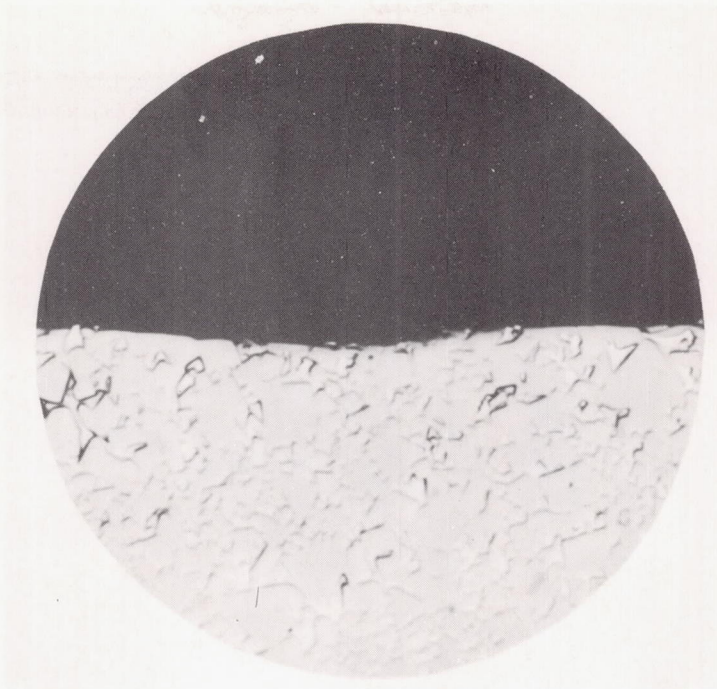
(e) Vapor blasted.

Figure 1. - Continued. Microstructure of surface-treated specimens. No etch; X1000.

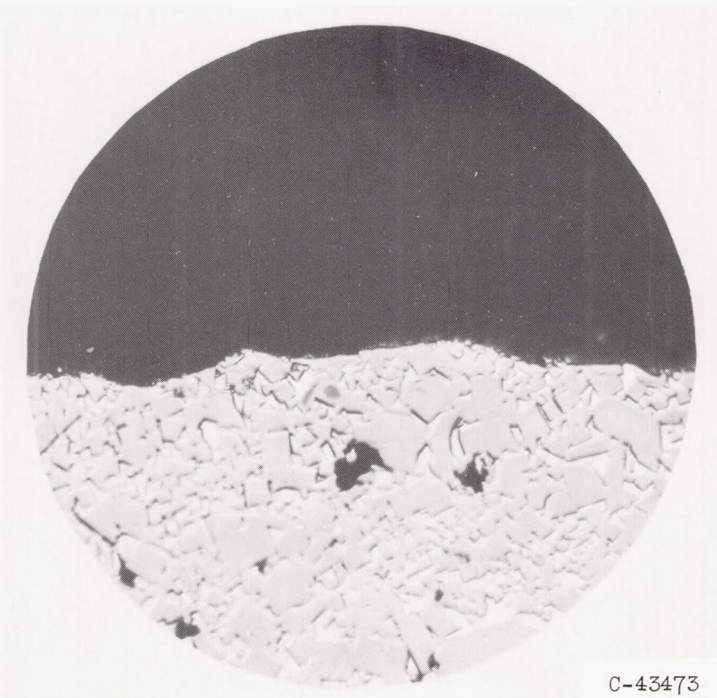
(f) Steel grit blasted.

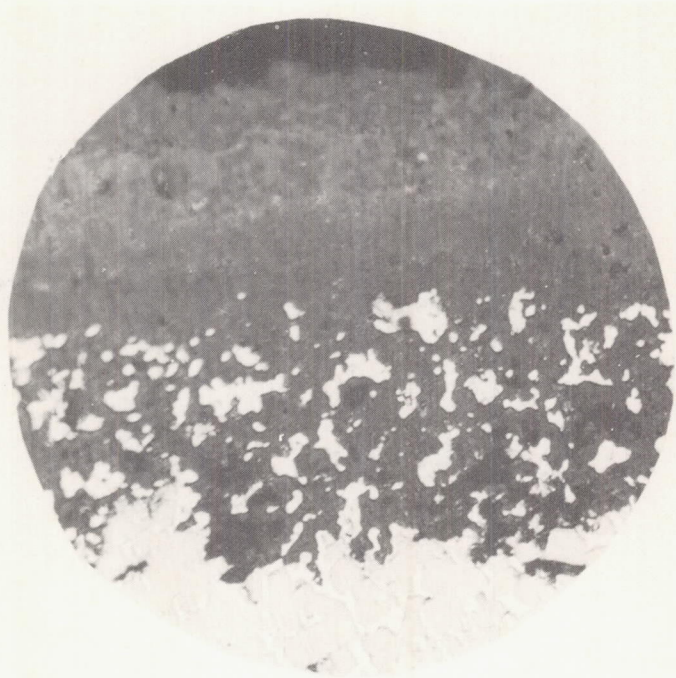
(g) Oxidized for 100 hours at 1600° F.

Figure 1. - Concluded. Microstructure of surface-treated specimens. No etch; X1000.

The low strength of the oxidized specimens is of special importance since cermet turbine blades are exposed to oxidation during service in jet engines; this result will be considered further. As stated in table II, no microstructural changes appear to occur after 100 hours at 1600° F in the zone below the oxidized layers. This is in agreement with reference 4, which states that no age hardening was observed and the properties are unchanged by heat treatment. Therefore, the low modulus-of-rupture and impact strength must be due to the oxidation. This strength loss due to oxidation may explain the steep stress-to-rupture curves for this material (ref. 5, pp. 1, 3, and 76). The preceding hypothesis differs from a tentative theory, based on a solution-precipitation mechanism resulting in coalescence of the carbide particles, which has been advanced to explain the relatively steep slope (ref. 5, pp. 1-23). The detrimental effect of oxidation on the strength of metal-bonded titanium carbide cermets has, however, also been noted by others (ref. 6, p. 988). In this reference, on the basis of a few tests, the decrease in modulus of rupture after oxidation was demonstrated to be proportional to the thickness increase.

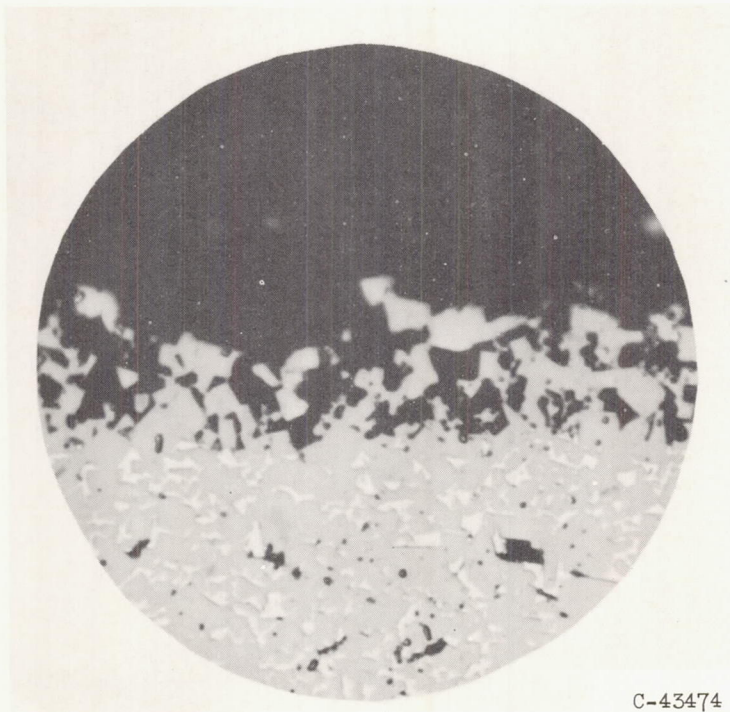
(h) Roughened with aqua regia.

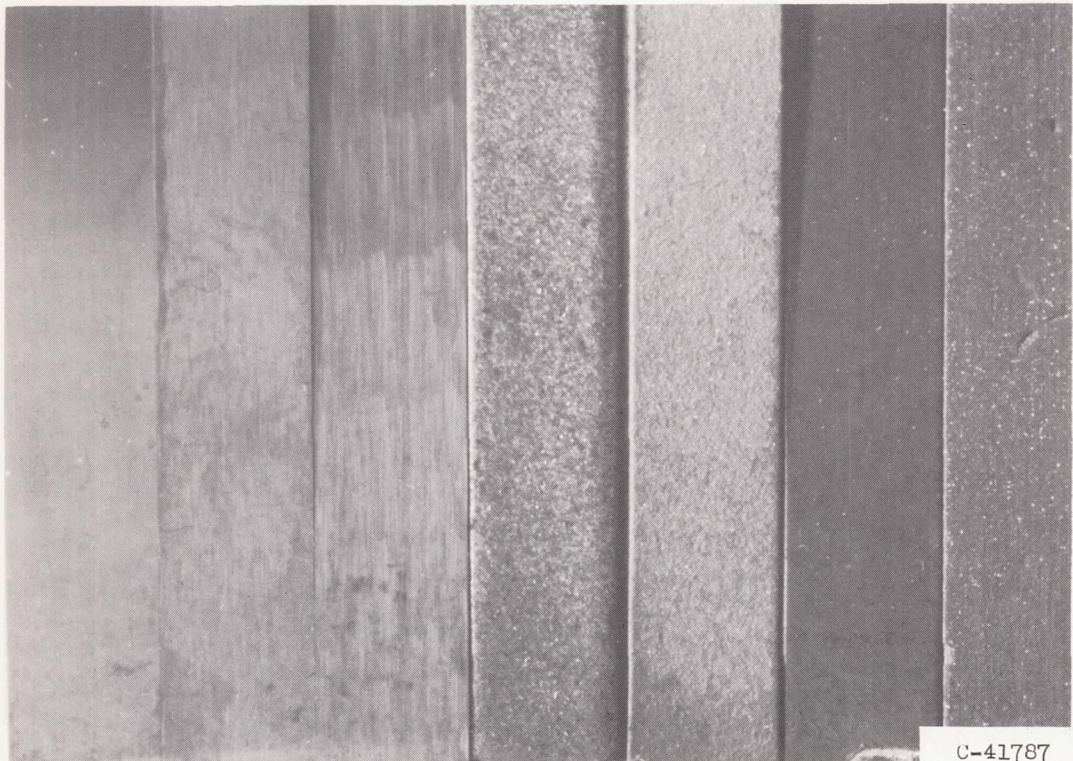
- (a) Diamond lapped (III).
- (b) Diamond-abrasive ground (I).
- (c) Severe silicon carbide abrasive ground (IV).
- (d) Grit blasted (VI).
- (e) Vapor blasted (V).
- (f) Oxidized (VII(A)).
- (g) Acid roughened (X).

Figure 2. - Surface-treated test specimens; X5. (Treatment numbers refer to table I.)

Macroappearance. - A photograph of the magnified surfaces of fractured specimens is shown in figure 2. Since luster should, to some extent, depend on the surface roughness of the specimens (except in the case where the specimen was oxidized or etched), figure 2 has been arranged, from left to right, in order of visually apparent decreasing luster.

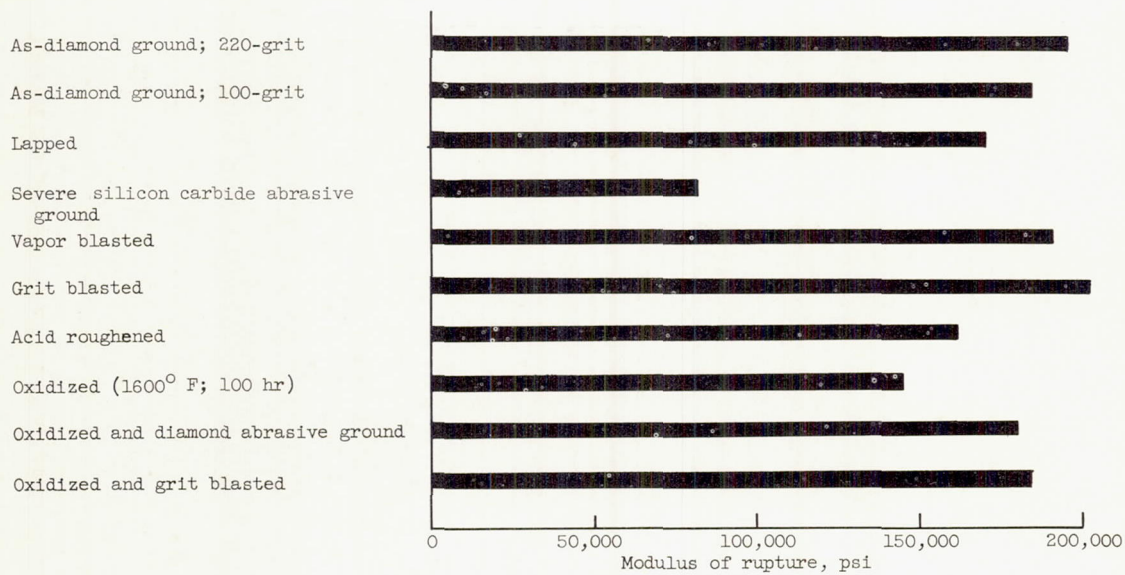
(a) Average modulus of rupture.

Figure 3. - Effect of surface treatment on the strength of titanium carbide - nickel base cermet (K152B).

Modulus-of-rupture and impact-strength data are given in table III, and the average strength values are graphically shown in figure 3. The results are as follows:

(1) There is little difference among the modulus-of-rupture and impact strengths after lapping, diamond-abrasive-grinding, vapor-blasting, or grit-blasting treatments. The strengths after these treatments are the highest obtained in this study.

(4) As expected on the basis of the surface inspections, oxidizing or acid roughening both result in a low modulus of rupture and the lowest impact strengths.

(6) Severe grinding (with silicon carbide abrasive), which caused chatter marks and considerable surface scratching, results in the lowest modulus of rupture for any of the treatments, while the impact strength was about the same as the high values of those in result (1).

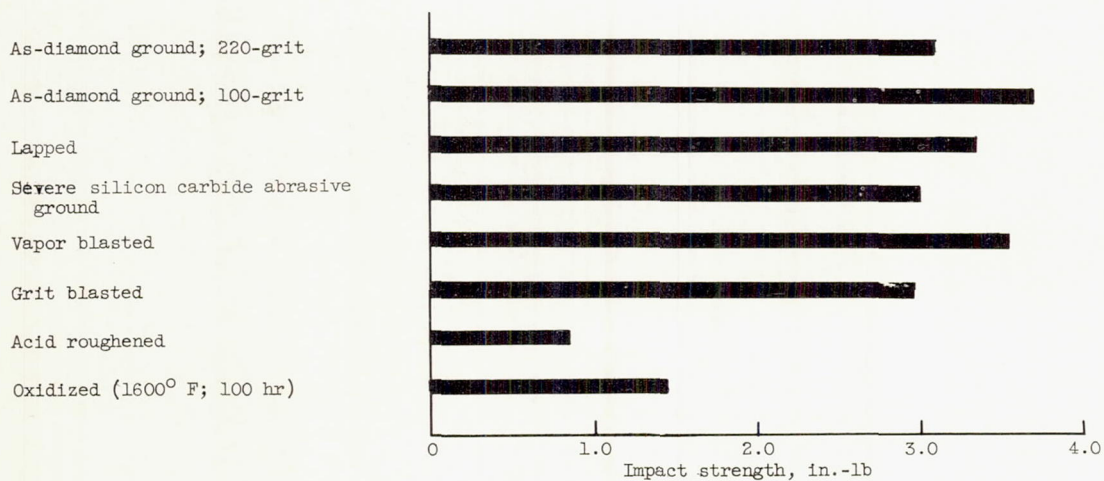
(b) Average impact strength.
