NACA TN 3775

CRASH INJURY

By Gerard J. Pesman and A. Martin Eiband

Lewis Flight Propulsion Laboratory
Cleveland, Ohio

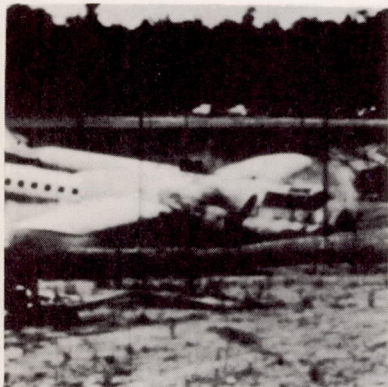
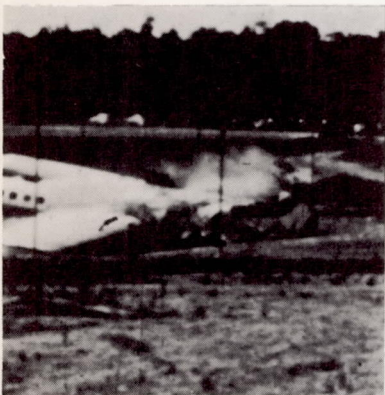
Figure 2. - Hinging action of crew compartment.

The action of this cargo airplane structure during a crash impact is shown by the sequence of photographs in figure 2. When the nose of the airplane struck the ground, the weak understructure crumpled until the floor of the crew compartment was reached (figs. 2(a) to (c)). The strong floor structure prevented further crumpling. Instead, the crew compartment hinged upward, lifting at the front and hinging at a point near the wing leading edge (fig. 2(d)). The hinging action lifted the compartment so that it was not in the direct line between the main mass of the airplane and the ground. The compartment thus was not subjected to the total force decelerating the airplane and consequently was not crushed.

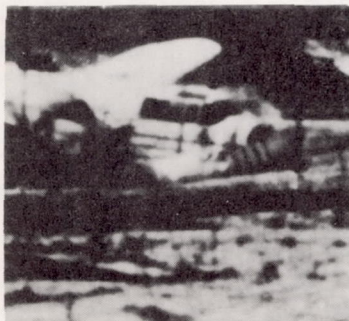
Figure 4. - Successive stages of fuselage structure being pulled under sliding airplane.

Although hinging action would help to protect the occupants during the initial impact, there is an additional problem. As the airplane slides along, it tends to ride up and over the crumpling lower structure. Since the lower structure is fastened to that above, the upper structure is also pulled down and under the sliding hulk. In the crash of the cargo airplane, however, the strong floor structure of the crew compartment combined with the weaker lower structure allowed the metal to tear at the floor line. Consequently, the crew compartment was not pulled down and under as was expected. The undertow and tearing action are apparent in figure 4. Figure 4(a) shows the nose of the airplane just before it touched the ground. Soon after the first impact (fig. 4(b)) a large wrinkle had formed in the fuselage skin (point A), and the parallel lines painted on the nose were bent showing that the nose structure was being pulled down. An instant later (fig. 4(c)), the understructure had been crushed up to the bottom of the Y painted on the side of the fuselage. The nose structure had separated from the main bulkhead (point B). Crushing of the understructure and pulling under of the nose structure progressed rapidly (fig. 4(d)) until the understructure was crushed and torn away almost up to the floor level (point C, fig. 4(e)). The nose section had been pulled completely under the sliding hulk.

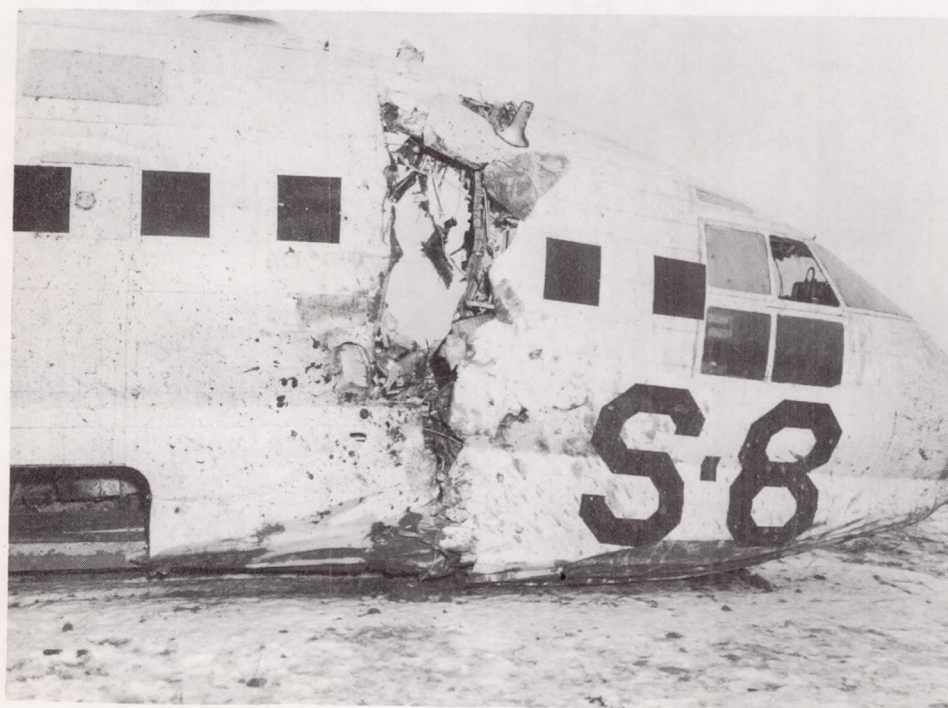
CS-12051

Figure 16. - Hole cut in fuselage by propeller blades.

Propeller blades and fragments of blades that are broken off when propellers strike an obstacle can appear as missiles inside the airplane. The action of steel propeller blades is shown by the photographs in figure 15. Three propeller blades were detached from the propeller hub (fig. 15(b)) and cut through the fuselage (fig. 15(c)). They can be seen against the sky in figure 15(d). An indication of the damage such missiles can do can be gained from figure 16, which shows the holes cut in the fuselage walls. Each opening is about 1 foot wide and 4 feet high.

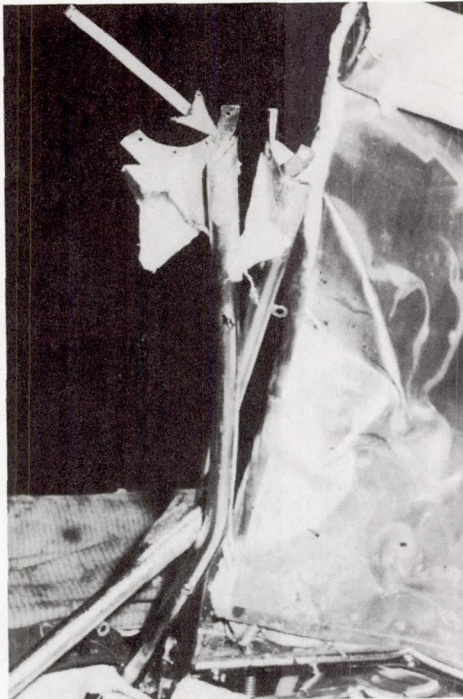
CS-12032

Figure 23. - Spear-like point formed by broken seat back tubing.
(Photograph supplied by Aviation Crash Injury group of Cornell University.)

When people and seats are torn loose and become free bodies in a sliding hulk, they can strike sharp, pointed, or solid obstacles. Broken seat parts are examples of obstacles that can cut and puncture people as they are thrown about. An example of such a spear, a broken tube from the seat back, is shown in figure 23. A similar spear in the same

crash produced a wound about 3 inches long that extended from the bridge of the victim's nose to beyond his eyebrow. The cross section was roughly semicircular and was about 1/4 inch deep.
