TECHNICAL NOTE 3685

FATIGUE CRACK PROPAGATION IN SEVERELY NOTCHED BARS

By W. S. Hyler, E. D. Abraham, and H. J. Grover

Battelle Memorial Institute

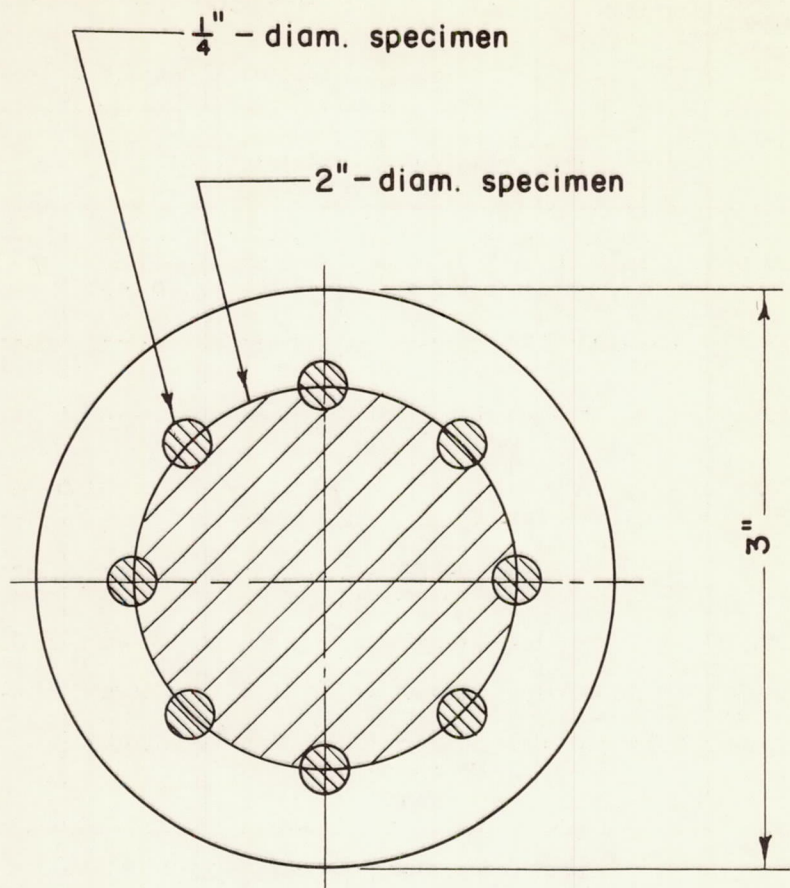
Figure 1.- Location of specimens in 3-inch-diameter round bars.

The specimens were notched with V-grooves with root diameters of 1/4 inch or 2 inches. Specimens were sectioned from the 3-inch-diameter round bars as shown in figure 1. Note that the 1/4-inch-diameter specimens were sectioned so that the axis of the specimens passed through a circle 2 inches in diameter (equivalent to the large-specimen minimum diameter).

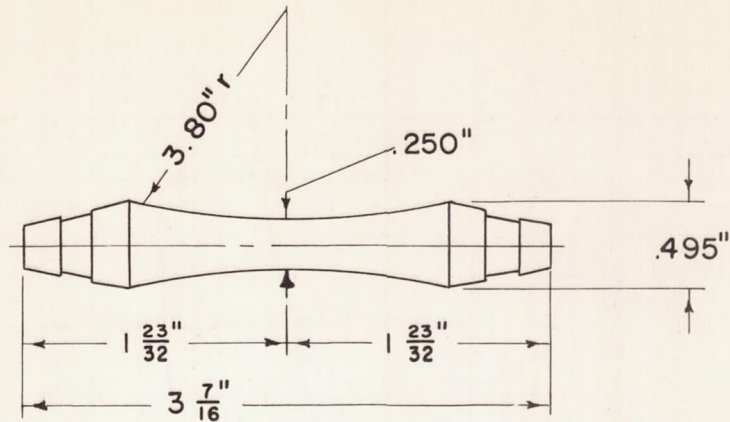
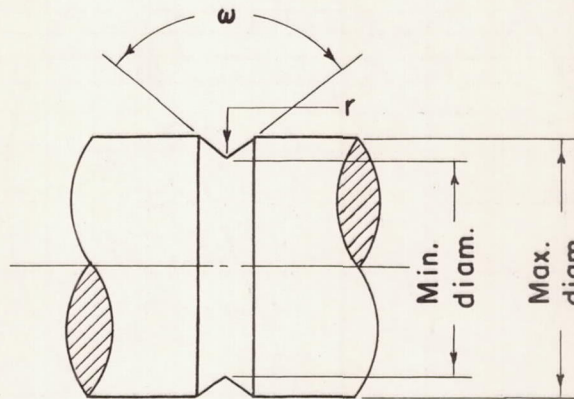
(a) 1/4-inch-diameter unnotched specimen.

Minimum diameter	Maximum diameter	r	ω , deg
0.250	0.312	0.002	60
2.000	2.500	.016	60
2.000	2.500	.002	60

(b) Notched configuration (see table for dimensions).

Figure 2.- Unnotched and notched 1/4-inch-diameter specimens and notched 2-inch-diameter specimens

In the derivation of K_n , the flank angle ω is assumed to be zero. Other details of the test specimens are shown in figure 2.

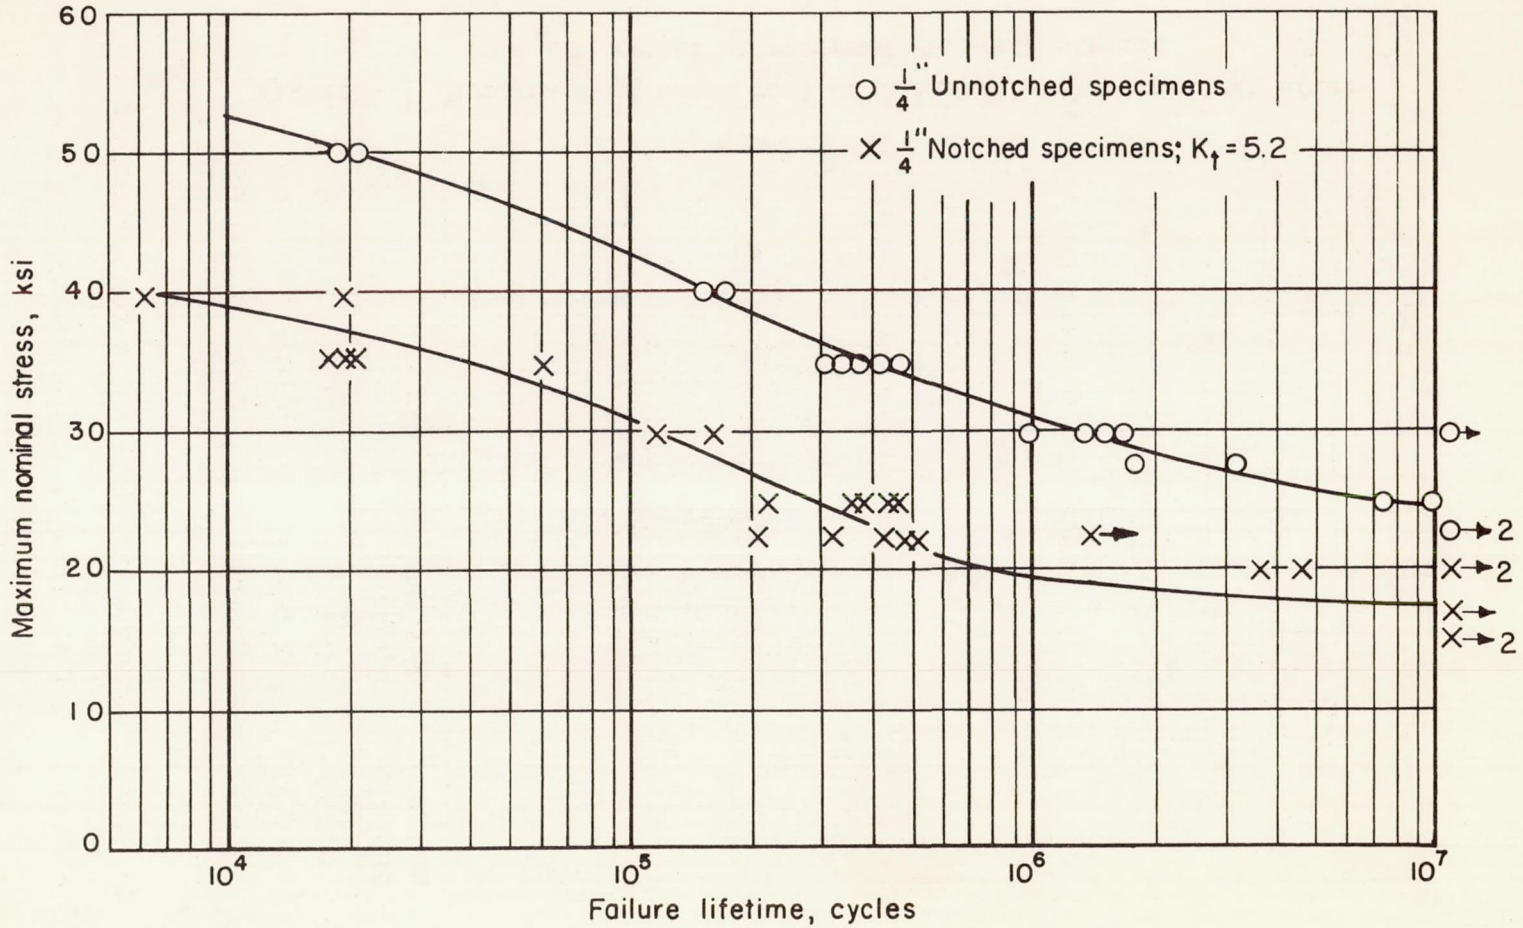
Figure 3.- Fatigue-test results on 1/4-inch-diameter specimens.

Initial fatigue tests on 1/4-inch-diameter specimens were run to block out S-N curves for unnotched specimens and notched specimens ($K_t = 5.2$, $r = 0.002$ inch). Data obtained on the initial tests are listed in table II and are shown in figure 3.

Estimated fatigue limits at 10^7 cycles of unnotched specimens and of notched specimens were 24.5 ksi and 17.0 ksi, respectively. The fatigue notch factor K_f computed from these values was 1.45 which was somewhat lower than anticipated.

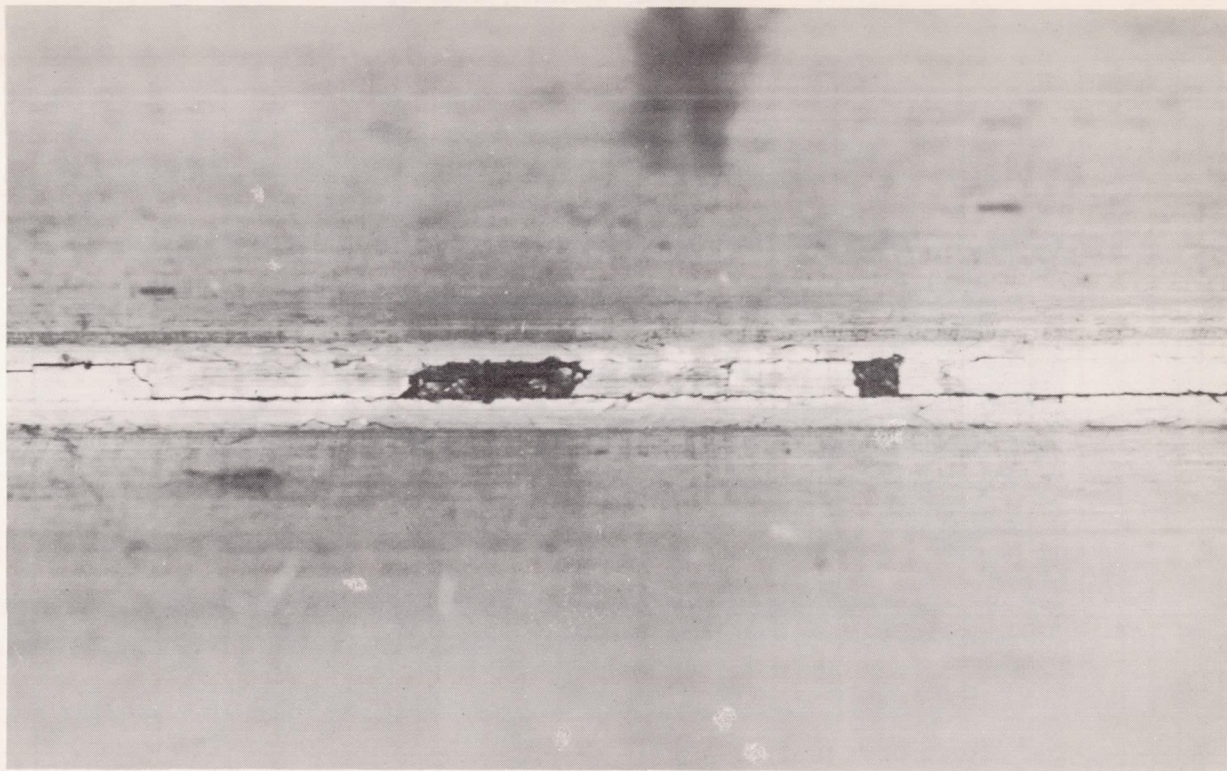
Figure 4.- Photograph of notch root of 2-inch-diameter specimen after 5×10^6 cycles of reversed 22.5-ksi stress.

At about 5×10^6 cycles, the test was stopped to examine the notch root. Considerable debris was observed at the notch root and also direct evidence of a gaping crack. The notch root was photographed and the specimen was sectioned and examined metallographically. Figures 4 and 5 show the nature of the notch root after about 5×10^6 cycles of reversed 22.5-ksi stress. The following observations summarize essential details of the three photographs:

- (1) Two almost continuous cracks traverse the notch root circumferentially.
- (2) Occasional areas exist at the notch root from which large pieces of material appear to have fallen out.
- (3) Fatigue cracks initiated on the surface some distance away from the minimum section diameter.
- (4) Propagation of the cracks was toward the center of the bar and in some cases was such that cracks joined, enabling material between the cracks to fall out.
- (5) As a result of deformation during cyclic stressing the contour of the notch root was changed from circular to U-shaped as shown in figures 5(a) and 5(b).

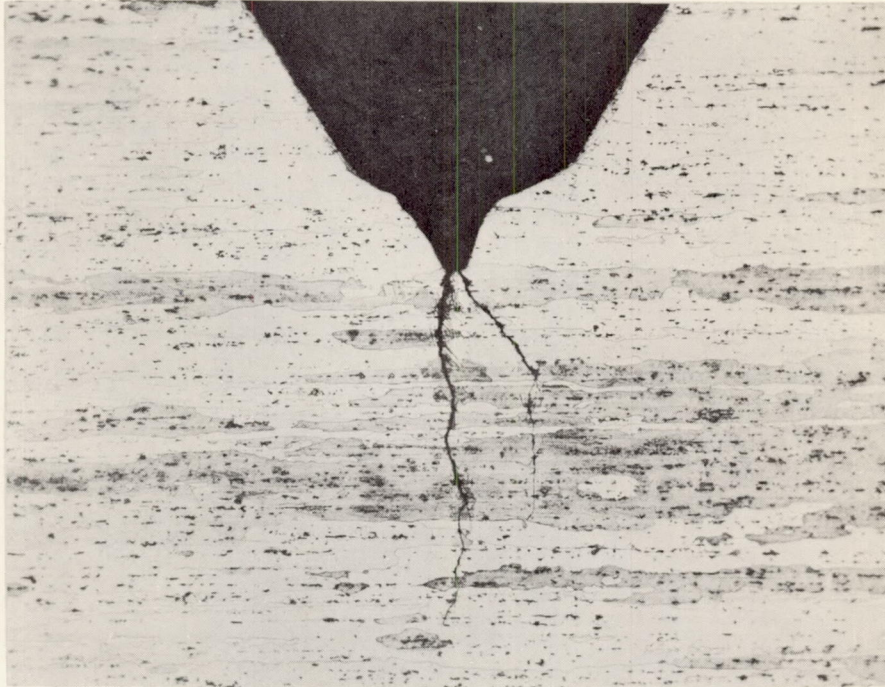
(a) Section showing cracks traversing notch root.

Figure 5.- Photomicrograph of notch root of 2-inch-diameter specimen after 5×10^6 cycles of reversed 22.5-ksi stress.

The depth of crack penetration was found to be in the range 0.040 to 0.044 inch. The average crack depth (from two measurements) was 0.042 inch.

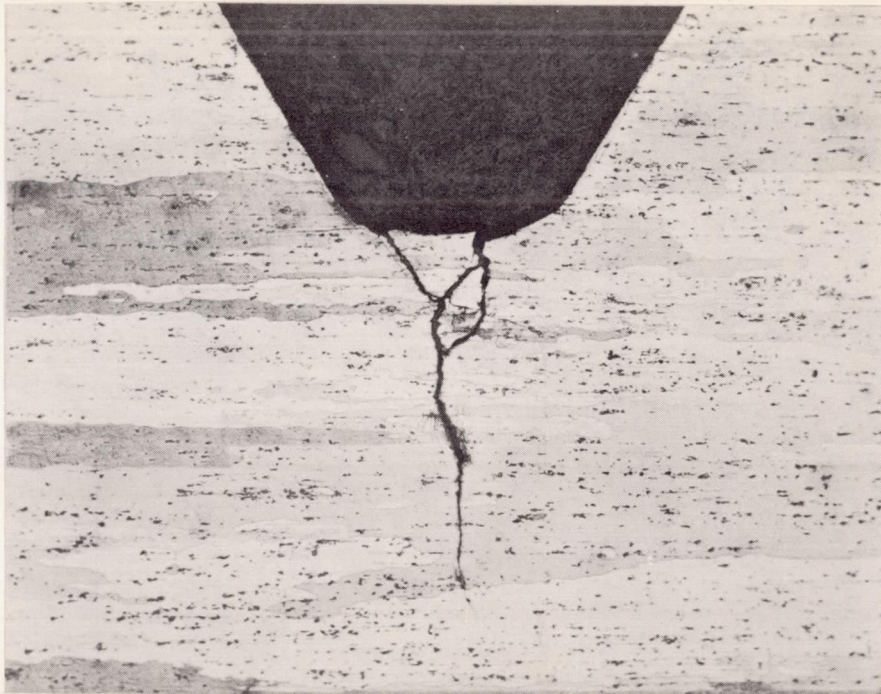
(b) Section showing crack propagation and separation of pieces of material.

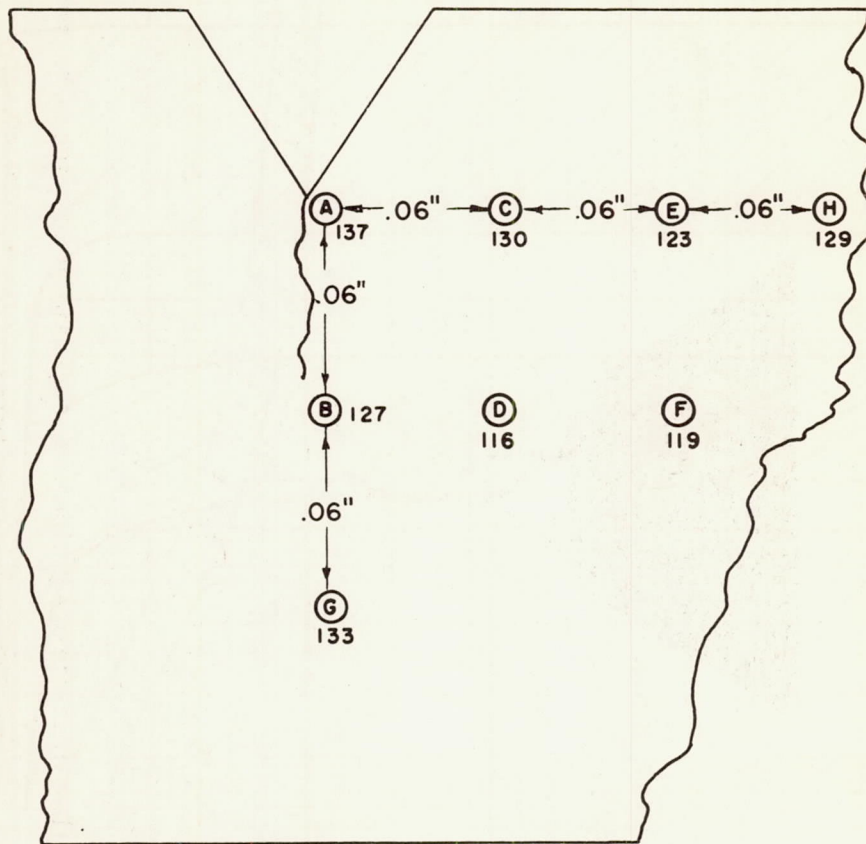
Figure 6.- Knoop hardness numbers on cross section of notched specimen shown in figure 4.

It was thought that extreme fibering of structure might produce the observed behavior. However, examination of a typical section of the structure yielded no proof of such a markedly fibered material. Other metallographic study (for example, hardness measurements) did not disclose positive reasons for observed behavior. Figure 6 shows Knoop hardness numbers taken at various locations on the section observed in figure 4. No trend in hardness gradient was observed in any direction.

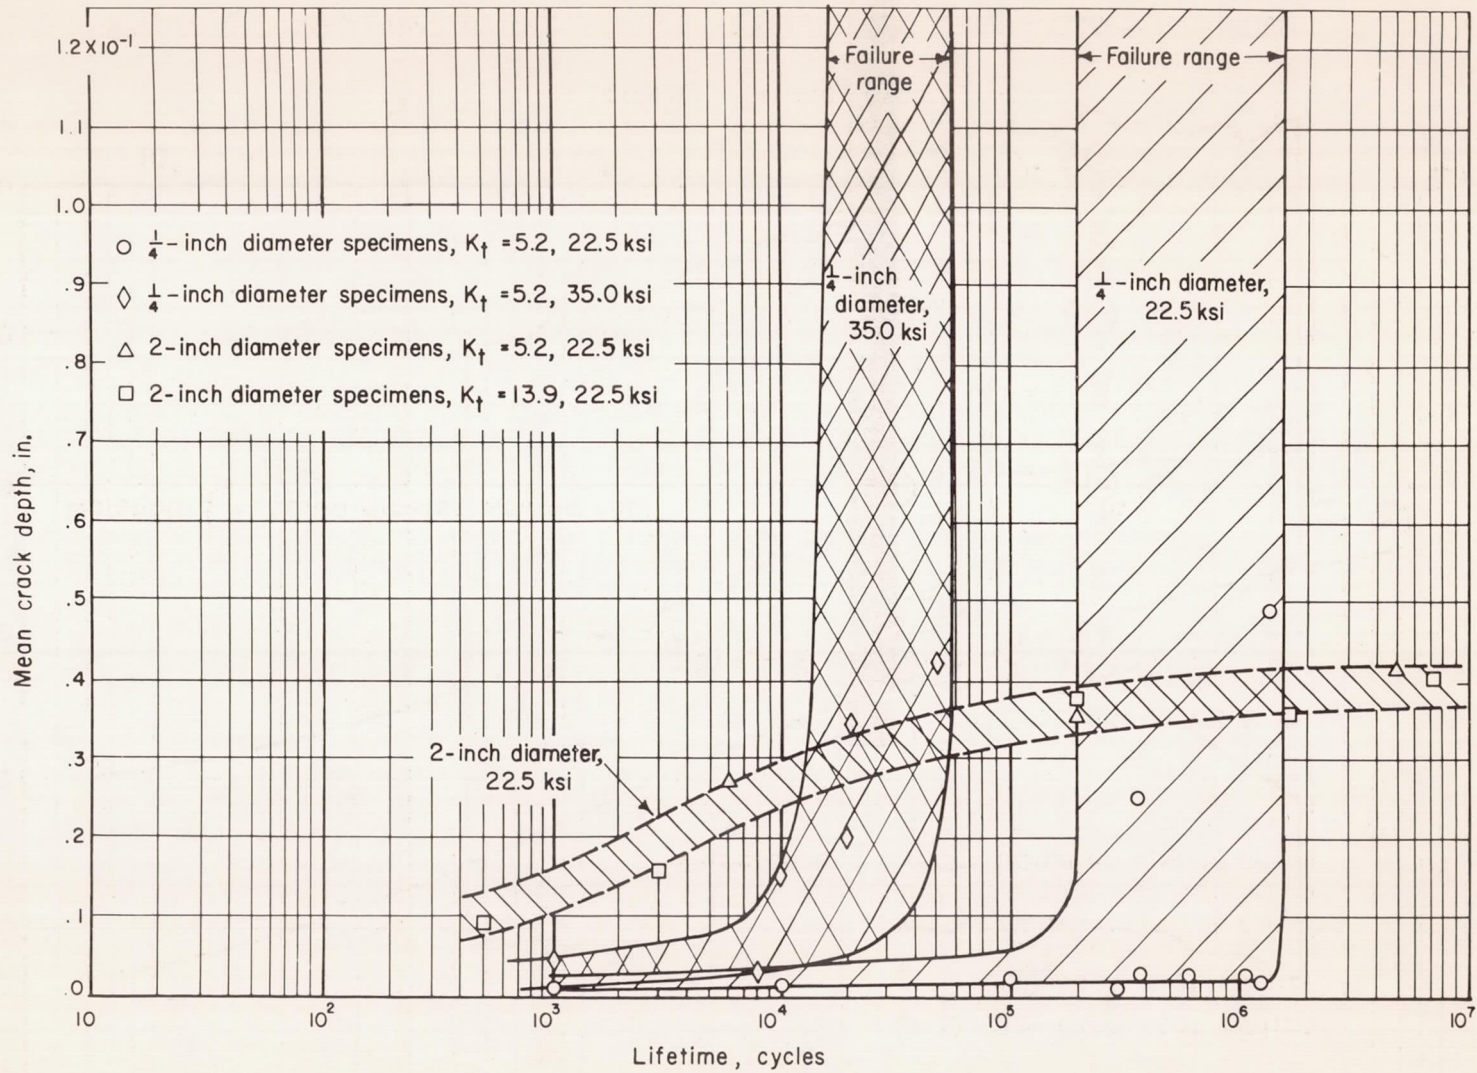
Figure 7.- Mean crack depth versus lifetime for severely notched specimens.

Data on specimens tested at 22.5 ksi and at 35.0 ksi are plotted in figure 7. The points represent the average crack depth obtained generally from four measurements on each specimen. At the top of the graph, roughly corresponding to the radius of the specimen, are indicated the estimated failure ranges of specimens tested at each stress level. Also indicated in the figure are bands to represent the scatter in crack-depth—lifetime observations.

Information obtained from these tests is plotted on crack-depth—lifetime coordinates in figure 7. The triangles represent average crack depth for notched specimens ($K_t = 5.2$); the squares represent average crack depth for the more severely notched specimens.

Early development of cracks also was observed in the large bars. In figure 7, bands are drawn of crack depth versus cycles showing differences in crack development for small- and large-diameter specimens. These differences in behavior noted in the figure, first in early stages and then at longer lifetimes, might result from a number of factors including (1) differences in residual stress at the notch root resulting from machining, (2) differences in the gross residual-stress picture resulting from heat treatment, (3) differences in stress gradient and other factors related to specimen size, and (4) others.

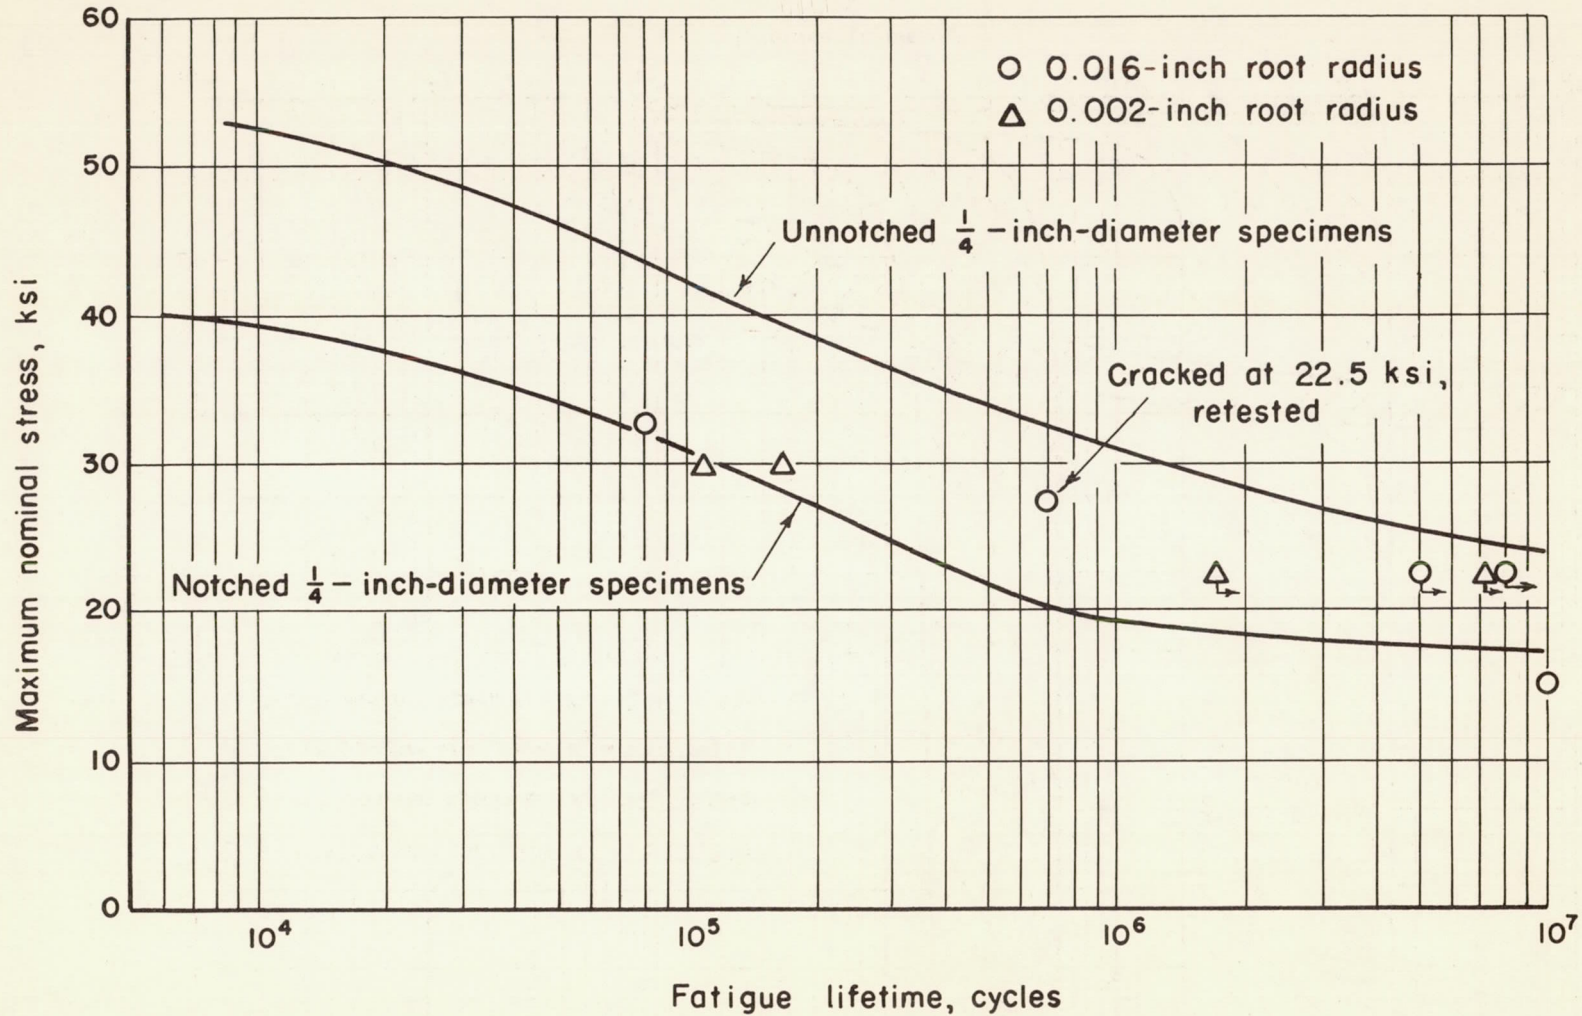
Figure 8.- Comparison of failure data obtained with large-diameter notched specimens with data from 1/4-inch-diameter specimens.

Crack propagation studies of the larger size notched specimens were carried out at 22.5 ksi. A few additional fatigue tests were carried out at higher stresses to compare failure data with those of smaller diameter notched specimens. Results are plotted in figure 8. The limited data suggest that specimens with notches of both severities were behaving similarly.

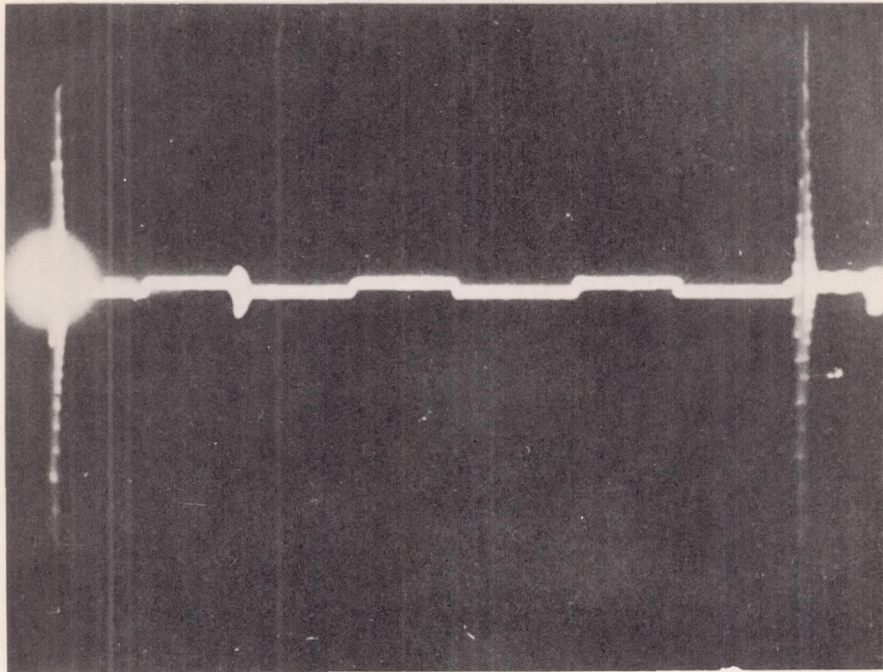
Figure 9.- Reflectoscope pattern of bar C7.

Back-reflection decay patterns were recorded by photographing the cathode-ray tube screen. A set of five reflection patterns was taken on each bar at 5 megacycles. One of these was at the center of the bar; the other four were at 90° increments on a circle 1 inch from the axis of the bar.

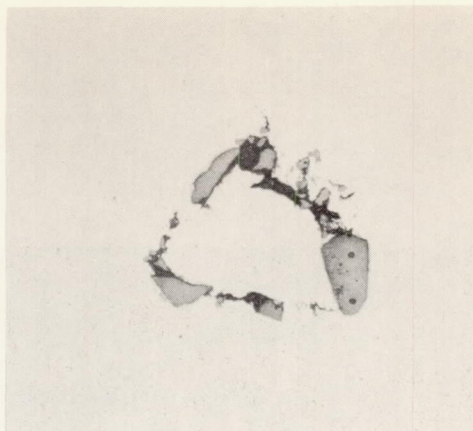
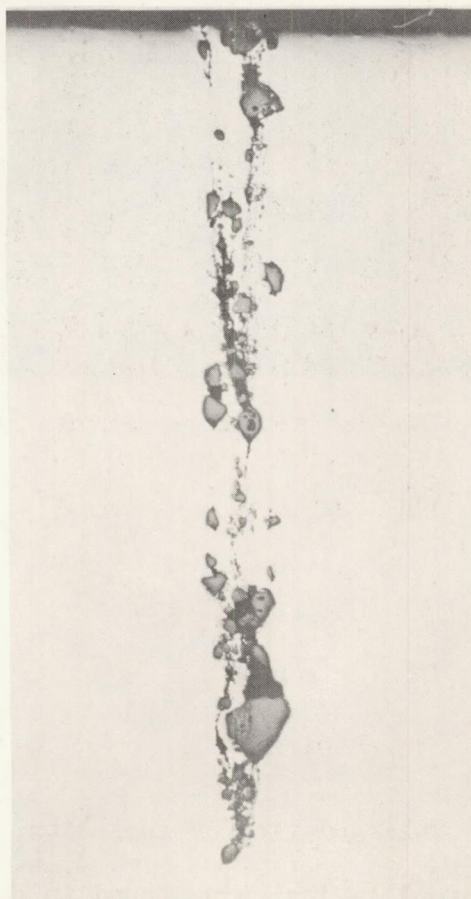
(a) End view of inclusion; 100X.

(b) Side view of inclusion; 45X.

Figure 10.- Inclusion found in bar C7.

was found. The end view of the inclusion is shown magnified 100 times in figure 10(a). The specimen was remounted and polished from the side to determine the length of the inclusion. It was found to be about $3/32$ inch in length. Figure 10(b) shows the side view of the inclusion at 45X.

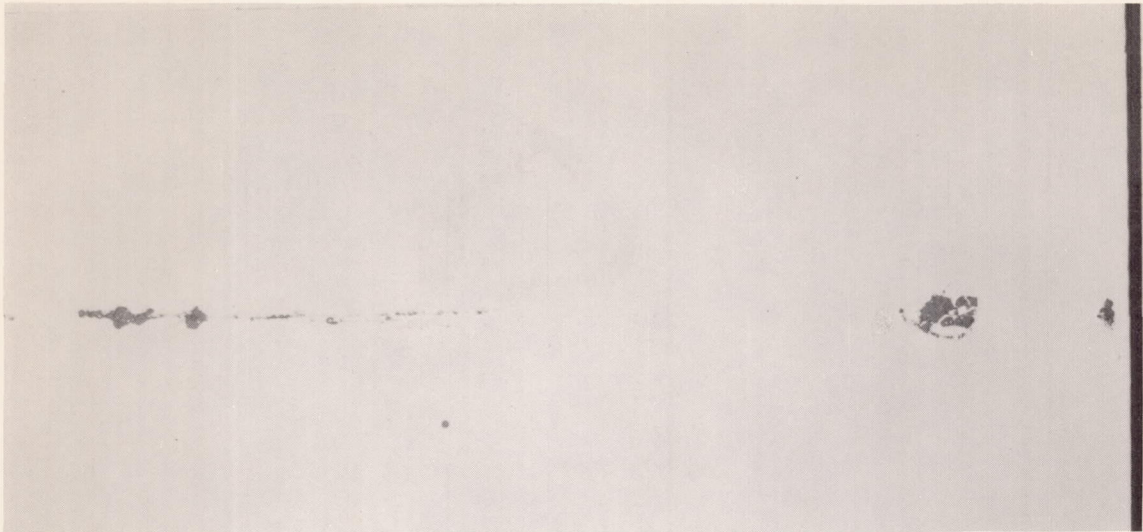
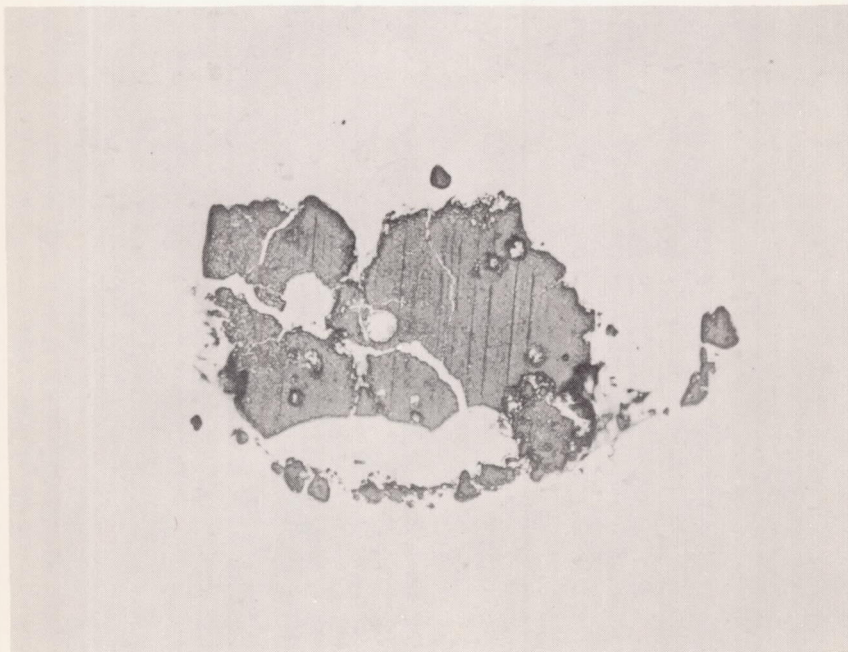
(a) Side view of inclusion; 15X.

(b) Enlarged view of inclusion; 100X.

Figure 11.- Inclusion found in bar C5.

Similar results were obtained on specimen C5. The inclusion found is observed in figure 11.
