TECHNICAL NOTE 3108

RELATION OF MICROSTRUCTURE TO HIGH-TEMPERATURE
PROPERTIES OF A WROUGHT COBALT-BASE ALLOY

STELLITE 21 (AMS 5385)

By F. J. Clauss and J. W. Weeton

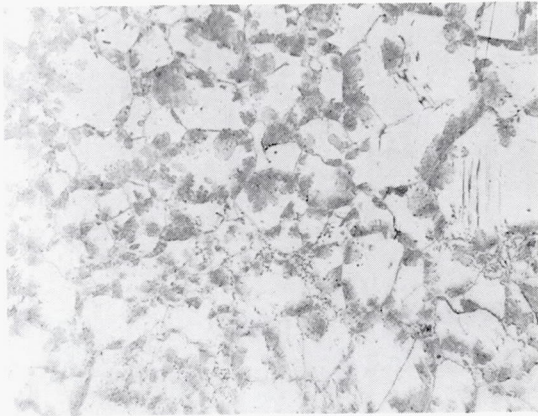
X100

Figure 7. - Continued. Microstructure of specimens after heat treatment.

The structures formed after isothermal transformation for 2 hours (groups 2 to 6) and 72 hours (groups 7 to 12) at various temperatures are shown in figures 7(a) and (b). For both transformation times and at all temperatures investigated, the structure is characterized by a pearlitic precipitation of the carbides. In general, the amount and the interlamellar spacing of the pearlite increase with increasing temperature, which is typical of most lamellar formations. At the shorter transformation time, the pearlite appears to be nucleated primarily at the grain boundaries; while, at the longer time, some precipitation within the grains is also evident, particularly at the higher temperatures. Also noted is a pronounced spheroidization of precipitates in 72 hours at 1950° F.

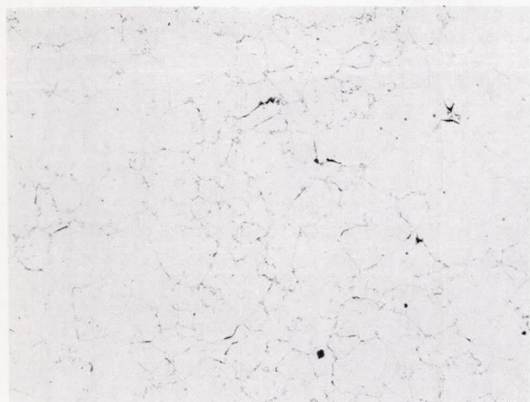
X100

Figure 7. - Continued. Microstructure of specimens after heat treatment.

Microstructures after aging (fig. 7(c), groups 13 to 17, and fig. 7(d), groups 18 to 26) are generally similar to those after isothermal transformation, in that pearlite is formed at all temperatures. The amounts of pearlite, however, are less than for isothermal transformation; and, in addition, much more scattered precipitation within the grains is developed by aging. Increasing the time of aging from 2 to 72 hours results in an increase in the amount of this scattered precipitate within the grains rather than the growth of pearlite from the grain boundaries.

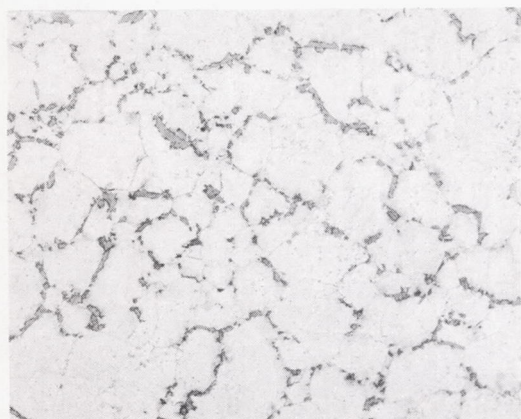
1200° F

(d) Groups 18 to 26 (solution-treated and aged 72 hr at indicated temperatures).

Figure 7. - Continued. Microstructure of specimens after heat treatment.

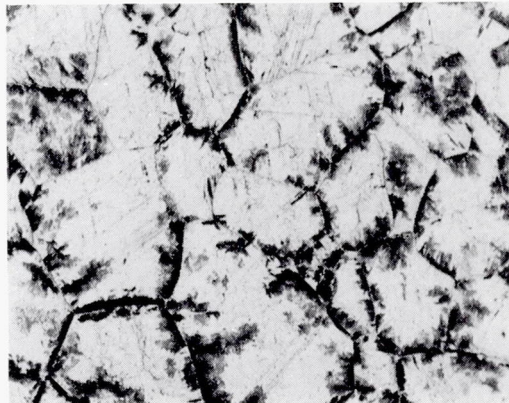
1550° F

Figure 7. - Concluded. Microstructure of specimens after heat treatment.

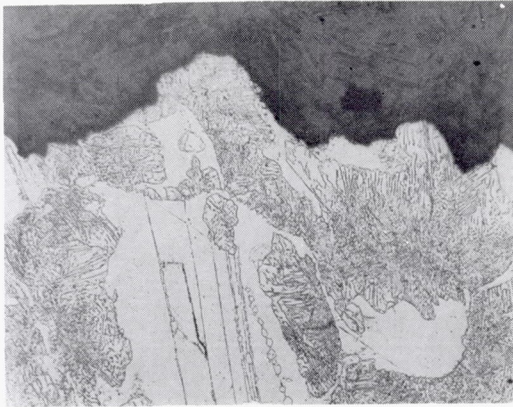
X250

Figure 8. - Continued. Microstructure of solution-treated wrought Stellite 21 after fracture in stress-rupture at 1500° F.

Photomicrographs of specimens fractured in stress-rupture at 1500° F are shown in figure 8. Comparison of the photomicrographs of the fractured specimens with those of the same specimens as heat treated

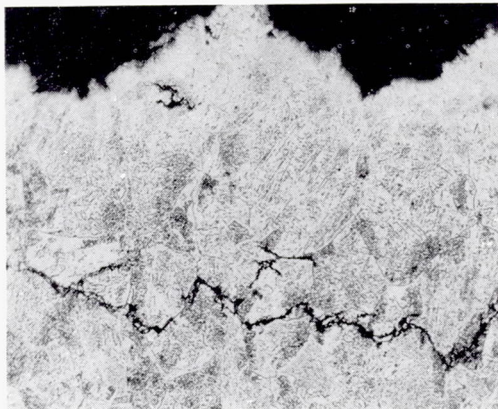
Fractured after 30.1 hr at 25,000 psi

(h) Aged 72 hours at 1950° F.

Figure 8. - Concluded. Microstructure of solution-treated wrought Stellite 21 after fracture in stress-rupture at 1500° F.

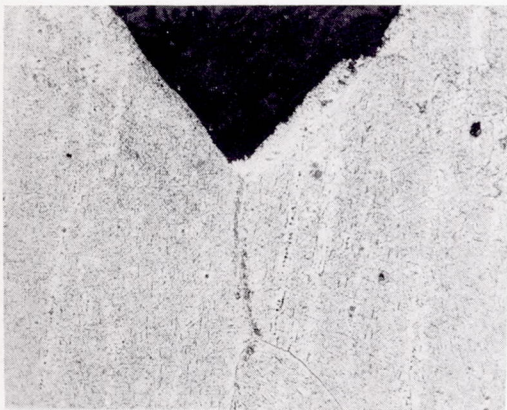
X250

Solution-treated and "double-aged" 72 hr at 1200° F plus 24 hr at 1500° F

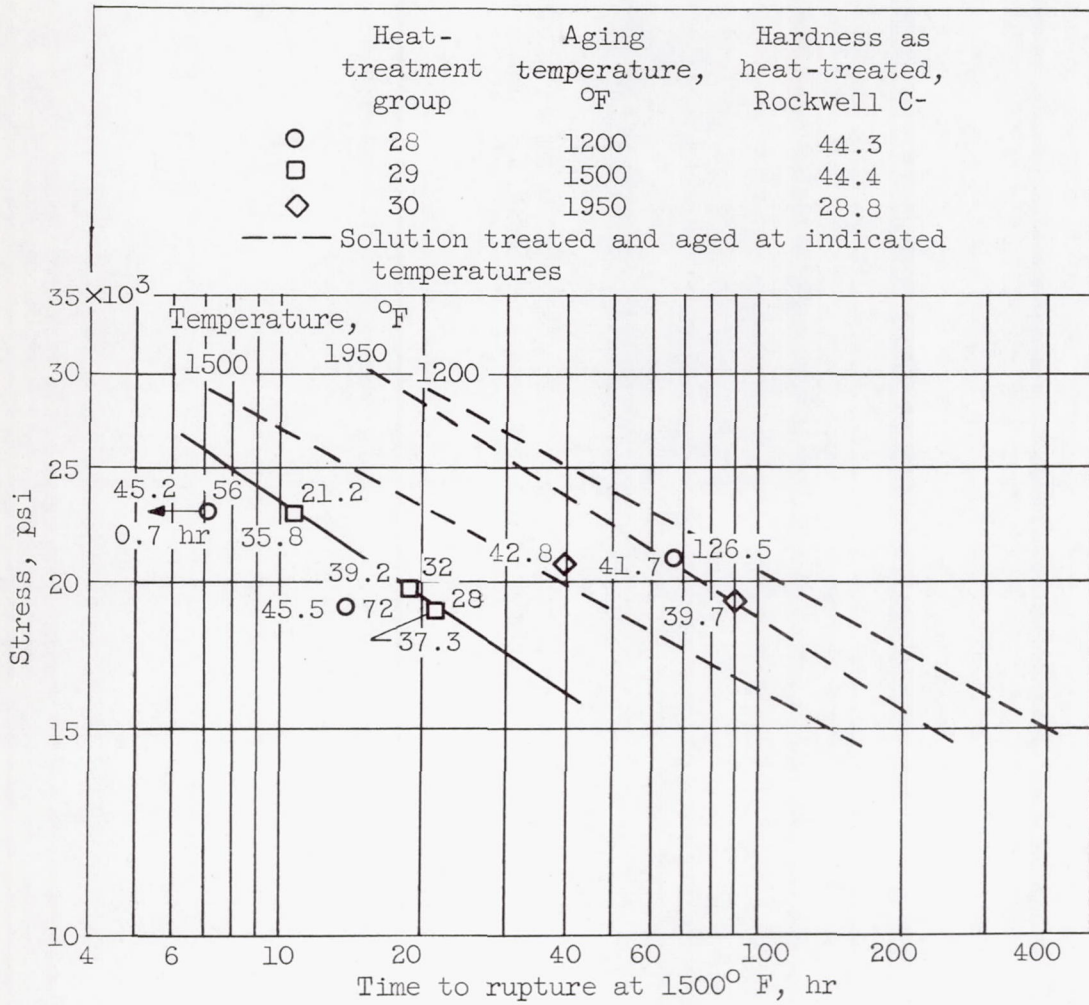
Figure 13. - Comparison of stress-rupture lives of specimens aged 72 hours with and without prior solution treatment. (Data points are plotted only for aging without solution treatment; Rockwell hardness values are to left, and total elongation at fracture (percent) to right of points.)

Aging the as-wrought alloy for 72 hours at 1200° F (fig. 10) produced no perceptible change in the microstructure of the material. The stress-rupture behavior remained the same as without heat treatment - that is, poor lives (e.g., 0.7 hr at 23,000 psi and 1500° F), erratic behavior, and very high elongation at fracture (e.g., 127 percent for the specimen tested at 21,000 psi). In all cases, the specimens failed in shorter times than when aging at 1200° F was preceded by solution treatment.

Aging the wrought alloy for 72 hours at 1500° and 1950° F gave some improvement in the stress-rupture life over that of the as-wrought condition, but again the lives were poorer than when the aging was preceded by solution treatment. It may be added that some solution treatment was effected by "aging" at 1950° F. Precipitates in the grain boundaries were removed and carbides within the grains were spheroidized by aging at this temperature. Whether temperatures as high as 1950° F are to be considered aging or solution-treating temperatures is a matter of definition and the condition of the alloy. With a solution-treated material, "aging" is the more properly descriptive term for holding at 1950° F; while, if the alloy is in the as-wrought condition, the term "solution treatment" is probably more applicable.
