NATIONAL ADVISORY COMMITTEE  
FOR AERONAUTICS

TECHNICAL NOTE 2709

FATIGUE AND STATIC TESTS OF FLUSH-RIVETED JOINTS

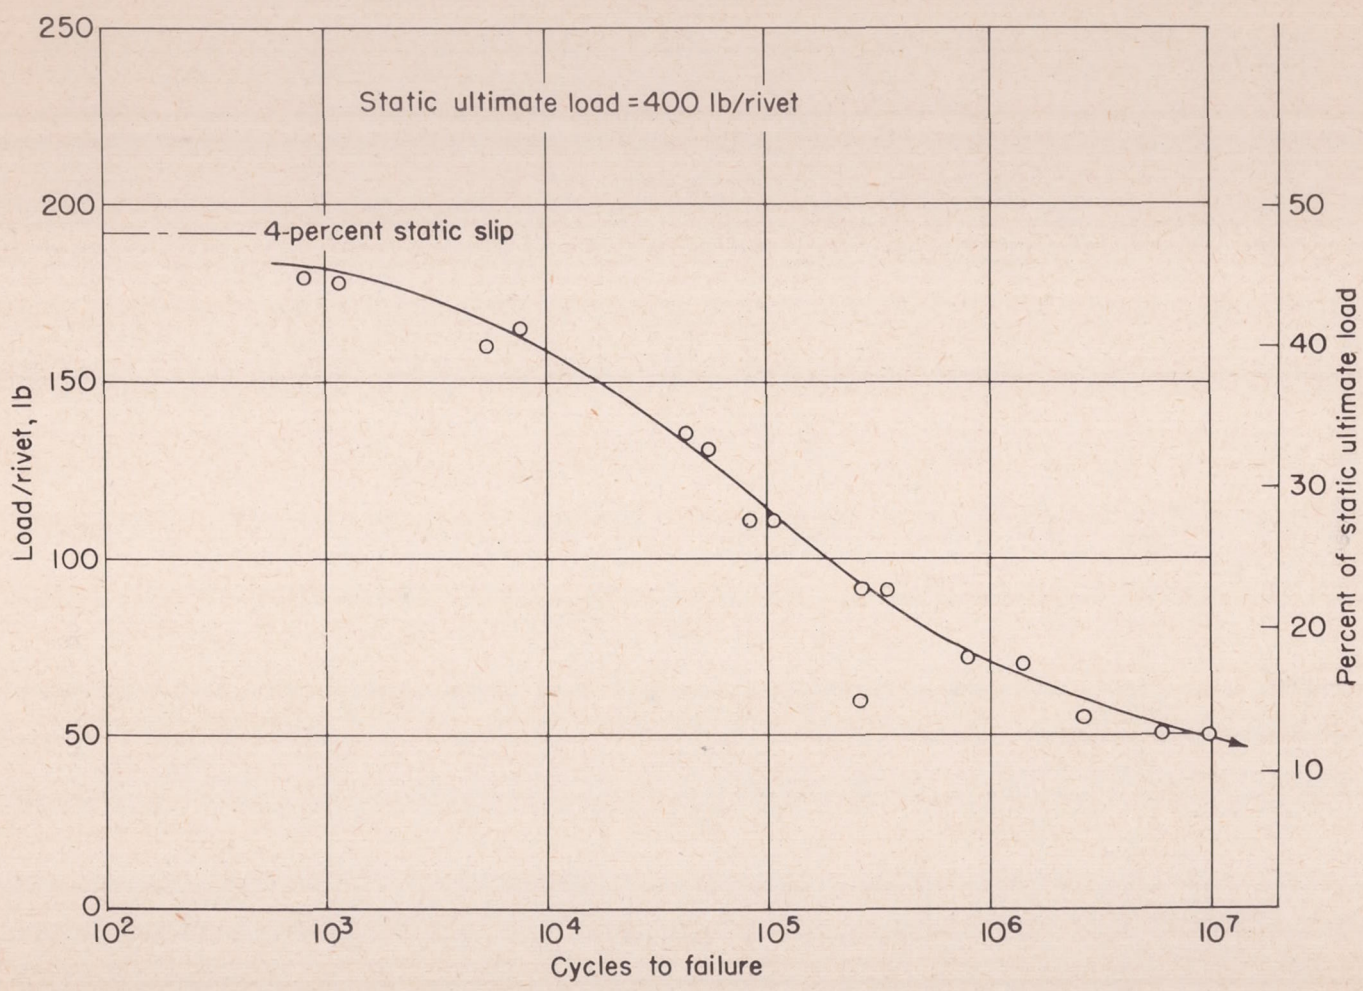
(e) 0.032-inch bare 24S-T3.

(d) 0.032-inch bare 75S-T6.

(c) 0.032-inch alclad 24S-T3.

(b) 0.064-inch alclad 75S-T6.

(a) 0.032-inch alclad 75S-T6.

Figure 9.- Curves of load per rivet against cycles to failure for machine-countersunk lap joints.

Fatigue tests at zero mean load were made on 190 multiple-rivet joints. The types of joints for which the fatigue tests were made and the number of tests of each type are listed in table 3. The curves of load per rivet against cycles to failure are given in figures 8, 9, and 10. The average load for a slip of 4 percent of the rivet hole diameter and the maximum static load, as given in table 2, are shown in each figure. A scale obtained by dividing the fatigue load amplitude by the average maximum static load per rivet as given in table 2 is also shown on the right side of each figure. The results show that joints of alclad sheets using machine-countersunk holes had greater fatigue strength than similar joints of bare sheets. Also, comparison of the lap and butt joints using machine-countersunk holes shows that the lap joints were superior under fatigue loads.

The curves faired through the data of figures 9 and 10 (lap joints) are repeated in figure 11 for comparison with each other. It is evident

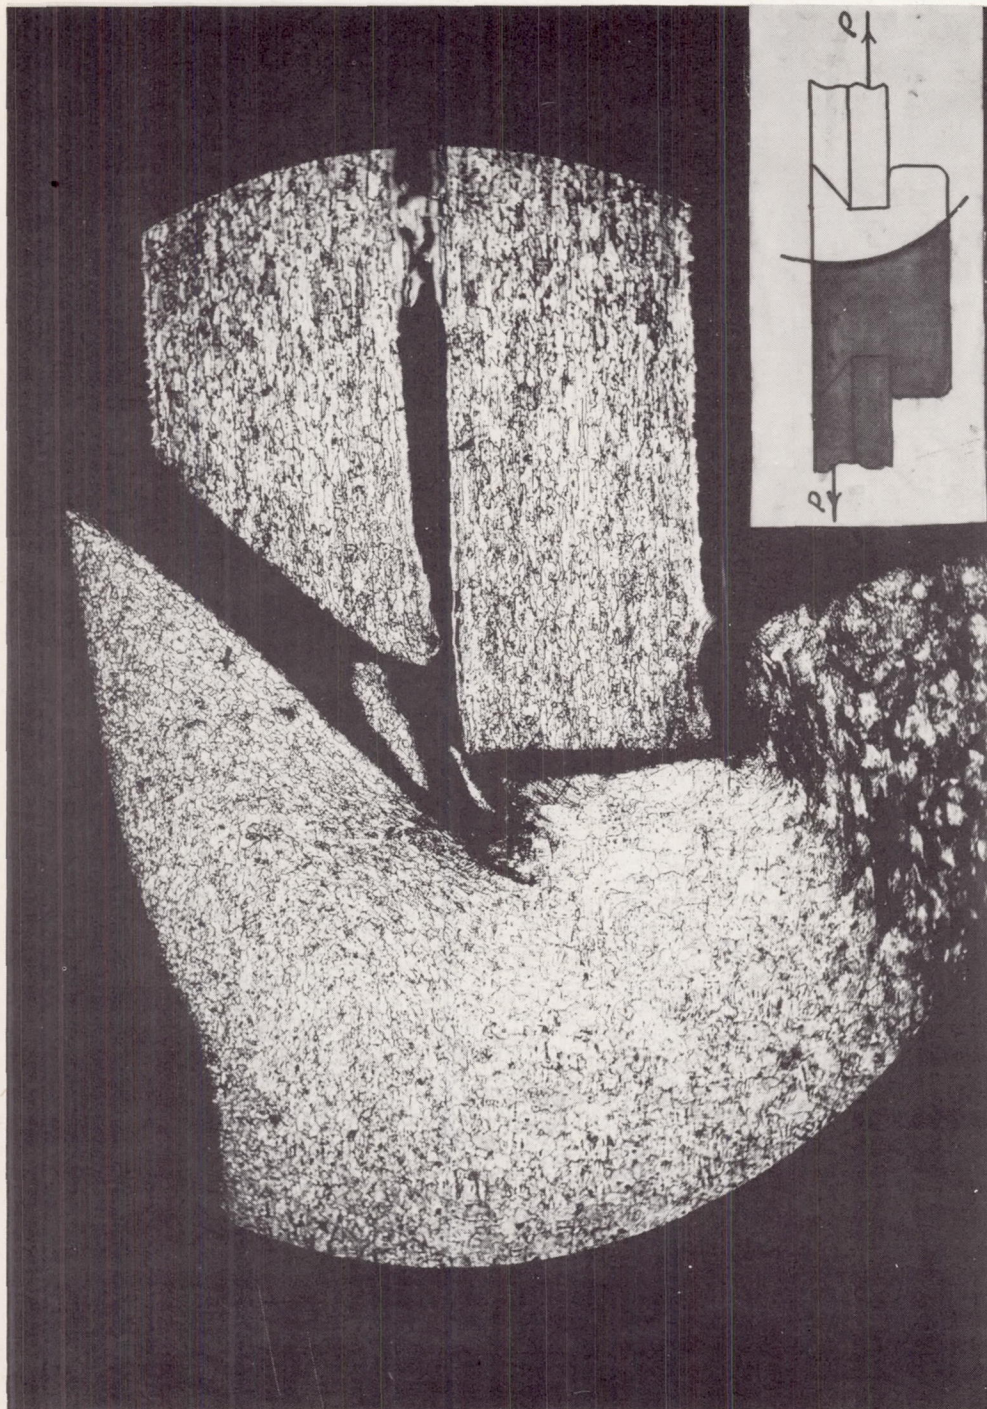
(a) Left side.

Figure 14.- Rivet after test. Lap joint in alclad 24S-T3 with machine-countersunk holes.

(b) Right side.

Figures 13(a) and 13(b) are photomicrographs of the left and right sides of a rivet in an 0.032-inch-thick alclad 24S-T3 aluminum-alloy lap joint with machine-countersunk holes. Photomicrographs of a similar joint after it had been subjected to 200 cycles of completely reversed load slightly above the 4-percent static-slip value are shown in figures 14(a) and 14(b). The fatigue loading caused gouging of the rivet, tipping of the rivet head, and deformation of the sharp edge of the upper plate.
