NACA TN 2039

INVESTIGATION OF FRETTING CORROSION

BY MICROSCOPIC OBSERVATION

By Douglas Godfrey

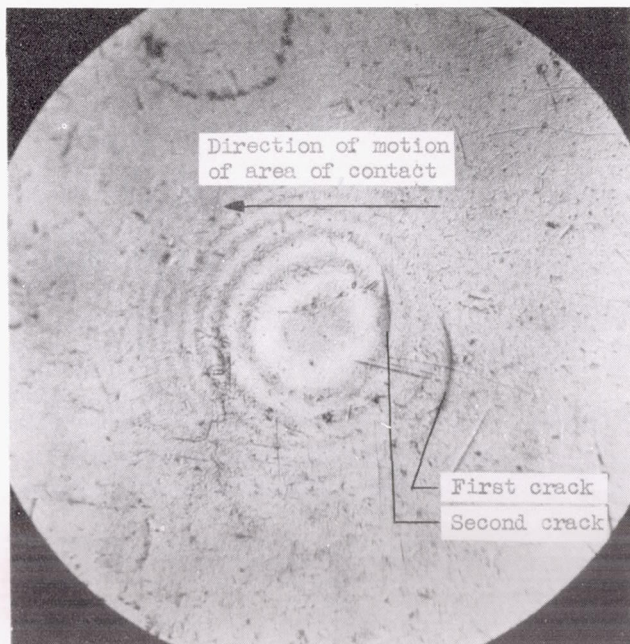
(a) View of glass slide showing amount of debris transferred from roughened steel.

(b) View of ball through glass showing second crack being formed in glass on trailing edge of area of contact.

(c) View of glass slide showing resultant row of cracks.

Figure 7. - Photomicrographs showing effects of one-half cycle vibration between glass and steel surface. X140.

Under the conditions of the 1/2-cycle experiment two types of action were observed. If the surface of the ball was previously roughened with 2/0 emery paper, the glass would polish the contact area on the ball and become smeared with the semi-fluid oxide, which would again tenaciously adhere to the glass. The amount of debris accumulated in three 1/2 cycles of vibration is shown in figure 7(a).

An increase in frictional force was apparent when the oxide was present between the surfaces. This greater motivating force was required to continue relative sliding because a nonlubricating material was present between the surfaces and tenaciously adhered to each. The oxide itself was sheared and the two new faces thus formed became the sliding surfaces. If a ball with its original polished surface was used, much less oxide would be smeared, but the movement would cause the glass to grip the ball and as the relative sliding continued the glass would visibly and audibly crack. The cracking occurred at the trailing edge of the contact area. A photomicrograph of the glass through which the picture was taken in the process of forming a second crack is shown in figure 7(b). The row of cracks produced in the glass during continued sliding is shown in figure 7(c). The smearing of the metallic oxide onto the glass and the cracking of the glass are apparently due to a great amount of adhesion permitted by the extreme cleanliness of the specimens. The surface finish on the ball determines which phenomenon will occur. A rough surface supports the load on a number of peaks, the average particle of which is relatively exposed. Sliding of the smooth glass over these peaks results in disintegration of the peaks and subsequent

oxidation of the removed metal. A smooth polished surface on the ball supports the load on a few broad undulations, the material of which is secure. Sliding of the smooth glass over these contact areas results in failure of the glass rather than the metal. This concept is in agreement with reference 7, which presents data to show that the amount of material transferred from base to rider increased with increase in surface roughness if the rider was harder than the base. Considering the steel ball as the rider and the steel harder than the glass, some incongruity may exist in this comparison in that the glass picked up material from the steel.

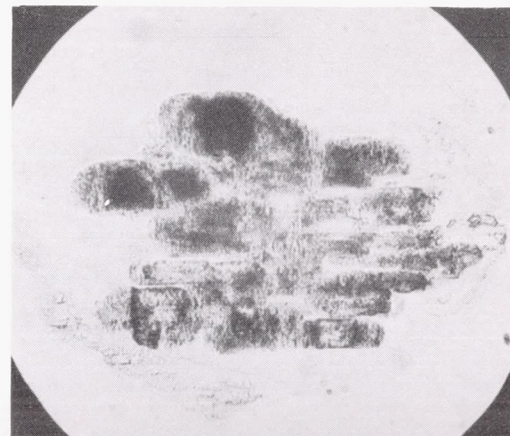
(a) Early stage.

(b) Advanced stage.

(c) Advanced stage after
removal of debris.

Figure 8. - Photomicrographs showing results of fretting corrosion between ruby and glass. X140.

The independence of fretting corrosion from chemical action was indicated in a group of experiments involving the nonmetallic, nonoxidizing materials glass against quartz, ruby, or mica. By vibrating a ruby with a convex surface against a glass slide and observing the action under a microscope, surface disintegration could be seen to occur. The glass, after 2 to 3 seconds of rubbing, suddenly collapsed locally and distributed debris about the contact area, leaving a pit. This action shifted the bearing area to the edge of the pit and the disintegration was continued (fig. 8). An early stage of disintegration with two pits formed is shown in figure 8(a) whereas the advanced stage of 20 or more pits is shown in figure 8(b). The ruby was simply further polished, that is, the microscopic scratches were erased. The vibration was not continued long enough to pit the ruby. Quartz against glass acted the same as ruby against glass. Mica against a glass ball and Lucite against a glass ball also behaved similarly. In all cases, the debris was produced, extruded, and accumulated in the same manner observed with metal debris, except that no change in color took place. Fretting corrosion occurred to mica in the least number of cycles, the number required being progressively greater for Lucite, glass, quartz, and ruby, which is also the order of increasing hardness of the
