TECHNICAL NOTE

No. 1186

REVIEW OF AN INVESTIGATION OF CERAMIC COATINGS FOR
METALLIC TURBINE PARTS AND OTHER
HIGH-TEMPERATURE APPLICATIONS

By W. N. Harrison, D. G. Moore, and J. C. Richmond

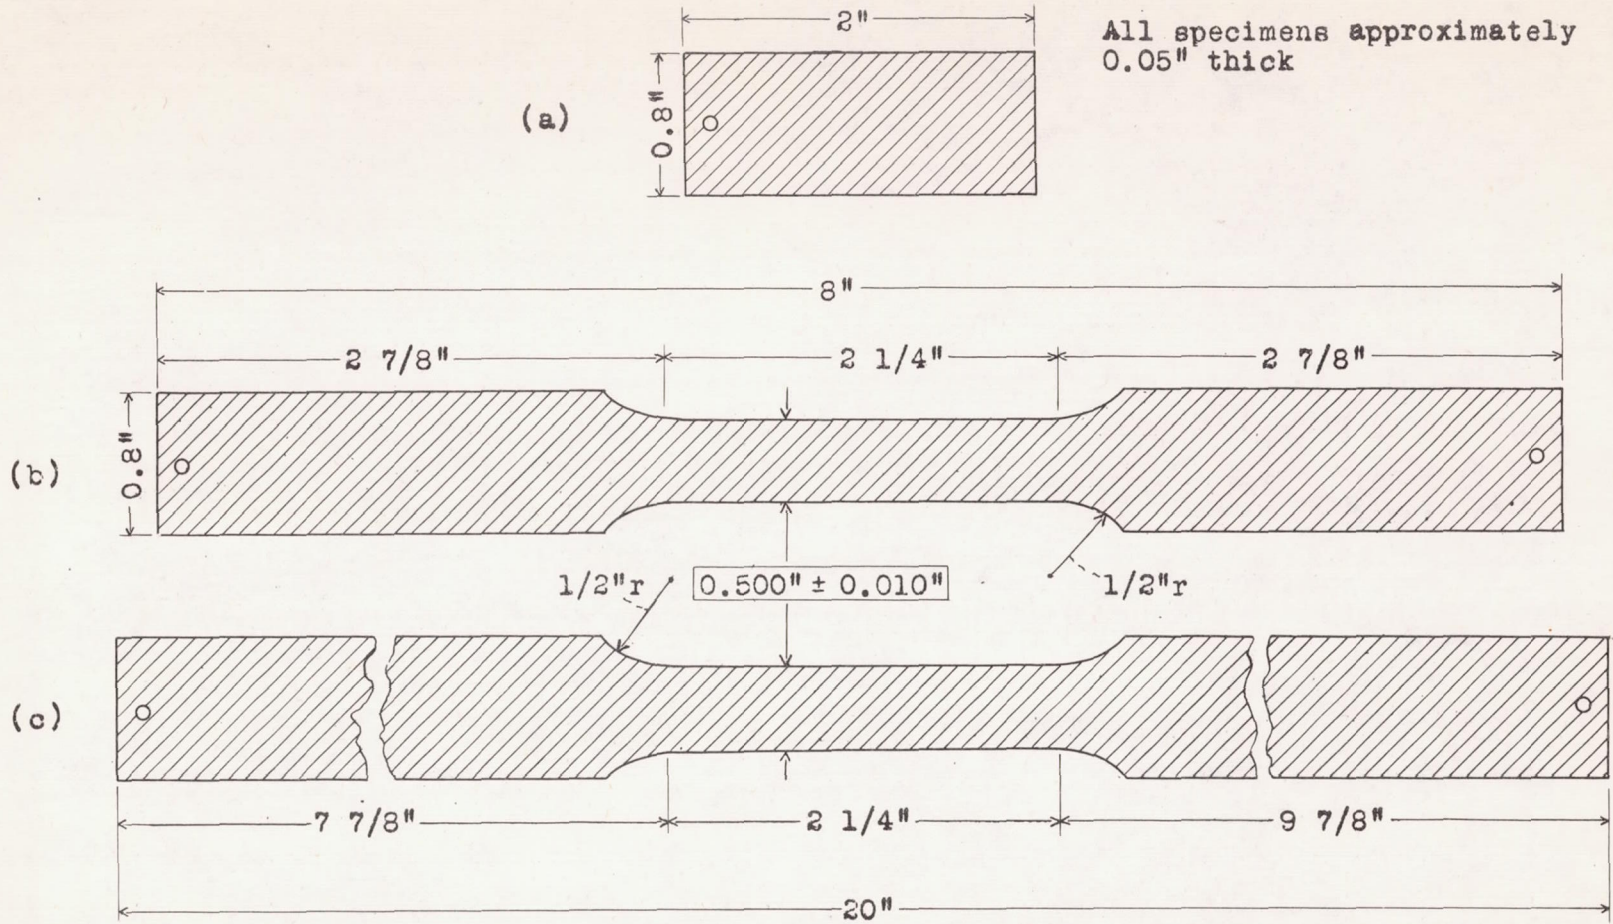
Figure 1.- Sketch of specimens used in the investigation of ceramic coatings.
 (a) Specimens used for heating without load.
 (b) Specimens for heating without load followed by tensile tests at room temperature.
 (c) Specimens for heating while under load. The 20-inch length provides for gripping outside the furnace.

Equipment for heating specimens in air without load.- The furnace used for long-time heating in air without load was electrically heated. A recorder-controller was used for obtaining constant temperatures within the range 1000° to 2200° F. The dimensions of the specimens subjected to this treatment were approximately 0.05 by 0.8 by 2 inches, as shown in figure 1(a).

Equipment for controlled-atmosphere tests.— Two resistance-type vitreous-silica-tube furnaces were used for controlled-atmosphere heating tests. The inside diameter of the fused silica tube was 2 inches and a platinum hanger was so arranged that eight tensile specimens 0.05 by 0.8 by 9.0 inches (see fig. 1(b)) could be suspended in parallel for test.

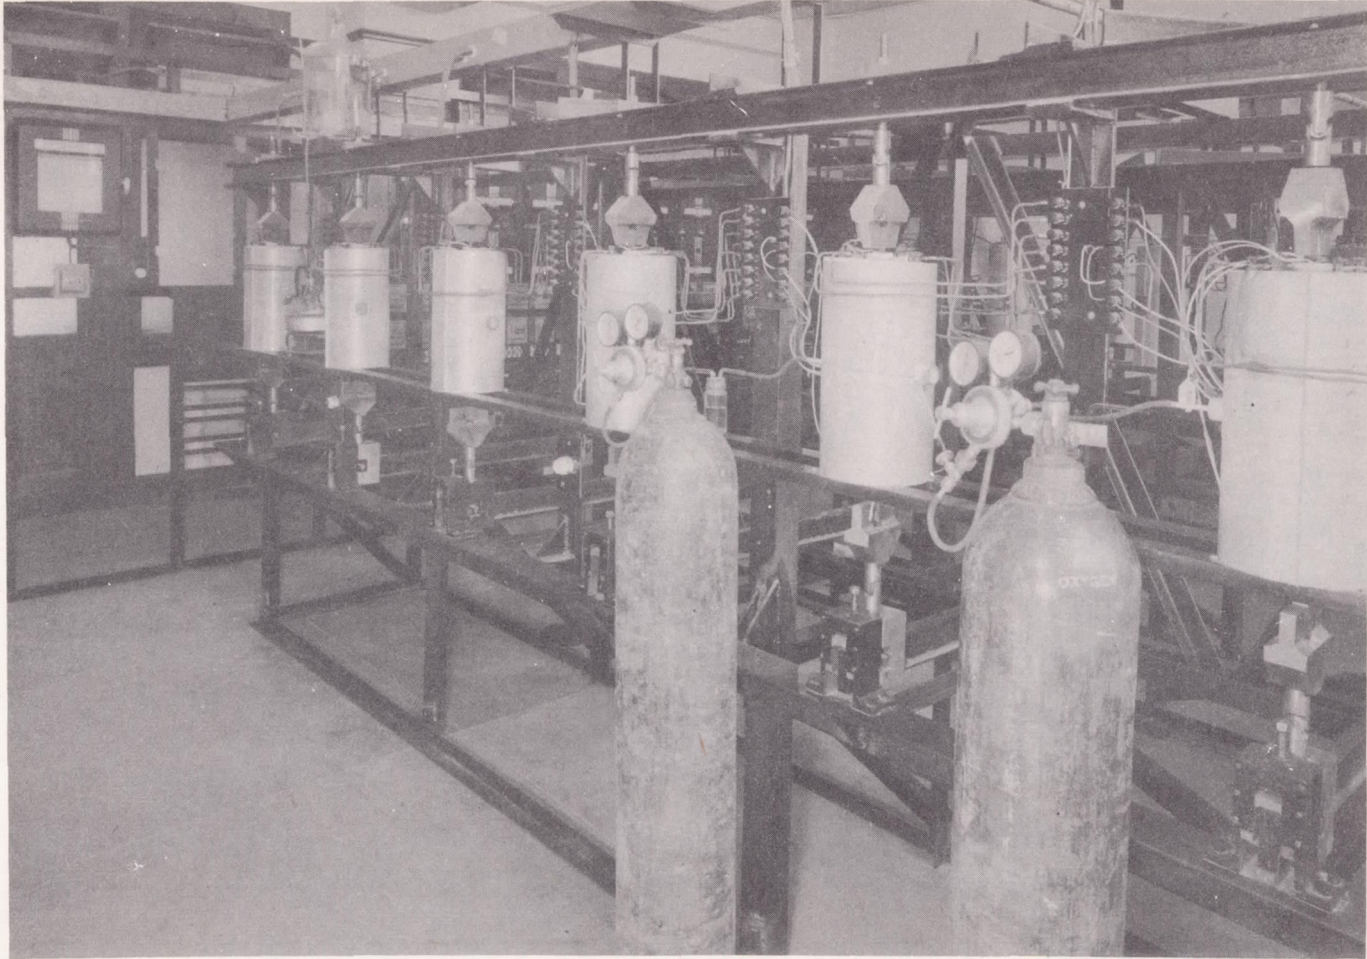
Figure 2.- Furnaces and lever systems for applying loads to 20-inch specimens. The pair at the left are operating with a steam atmosphere supplied by water dripping into a flask containing a filler of broken ceramic material and heated with an electric hot plate. The pair in the middle have an air atmosphere, and the pair at the right are operating with an oxygen atmosphere supplied from separate tanks provided with regulators.

Equipment for treating specimens at high-temperature under load.- Six resistance-type tube furnaces with individual temperature controllers were used. Temperature distribution over the gage length of the specimen was regulated by three variable transformers connected with separate sections of the furnace winding. Temperature measurements of the specimen were made by means of two thermocouples, one at the shoulder above the neck and one at the shoulder below. The two wires of each thermocouple were spot welded to opposite sides of the specimen. The temperature of each specimen as indicated by these thermocouples was held constant during the test to within $\pm 5^\circ$ F. The specimens were 20 inches long to permit gripping outside the furnaces (see fig. 1(c)). Figure 2 shows the furnaces and parts of the lever system for applying controlled loads to the specimens while heated.

Tensile tests at high temperatures were made with a Southwark-Tate-Emery testing machine, used in connection with a furnace wound and controlled similarly to those shown in figure 2.

It was thought that stress-rupture tests might bring out the effect of the coatings but, since the equipment shown in figure 2 was not suitable for such tests with most alloys, it was necessary to use an alloy which would fail with little elongation, and the 2520 alloy was selected. By reference to table III and figure 9 it can be seen that, in air, the

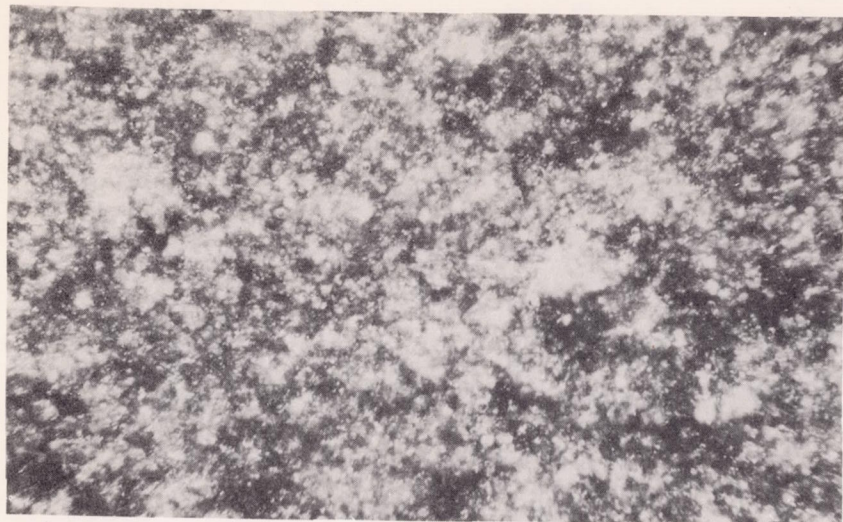
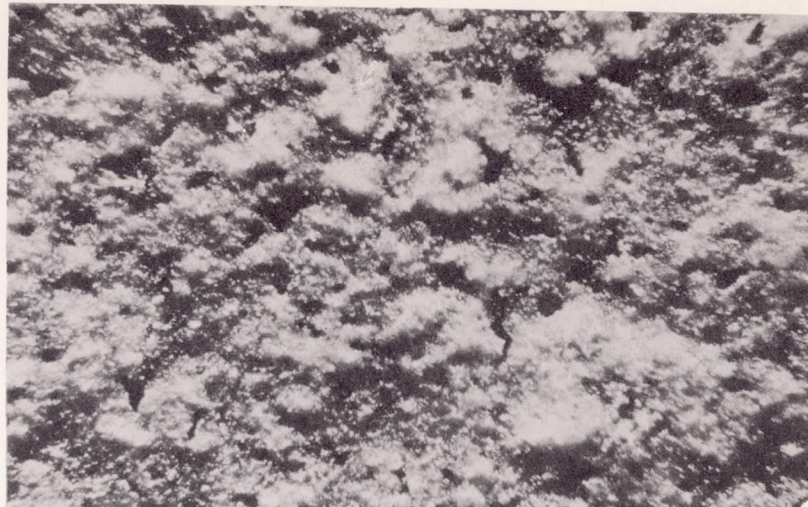
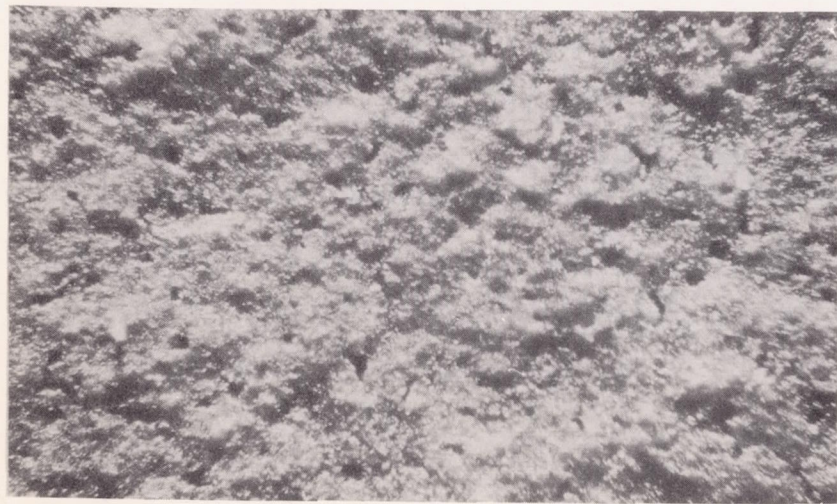
(a) Before heat treatment.

(b) After 200 hours at 1500°F in air.

(c) After 500 hours.

Figure 3.- Photomicrographs at 120X of coating L-6A on alloy S-590. Note the development of discontinuities that did not initially exist. This coating underwent considerable deterioration during the first 200 hours with very little change in the next 300 hours.

During the 500 hours of heating there were considerable changes in microstructure of some of the coatings, whereas others showed little or no change. Photomicrographs of the same field on selected specimens were taken at 120 magnification before treatment and after 200 and 500 hours, respectively. Figure 3 shows three such views of coating L-6A on alloy S-590, which is an example of a type of coating that showed considerable deterioration during heating in air at 1500° F. Figure 4 is a series of photomicrographs of coating A-309 applied on alloy S-816, which is an example of a coating type that showed no appreciable change in the microstructure during the 500-hour heating treatment in air. The only visible change that occurred with this specimen was a small decrease in glossiness from a slightly glossy original condition. Figure 5 represents coating L-5AC as applied on alloy S-816, and illustrates the unusual property of self-sealing of discontinuities that were initially present.

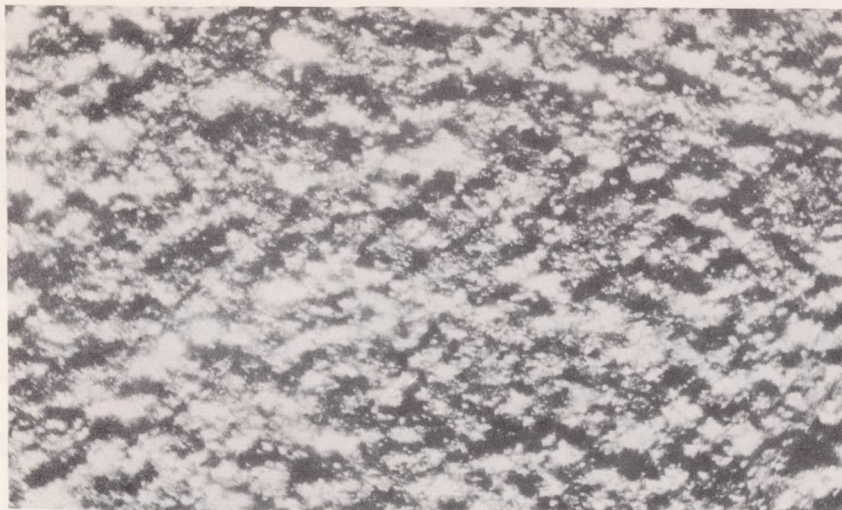
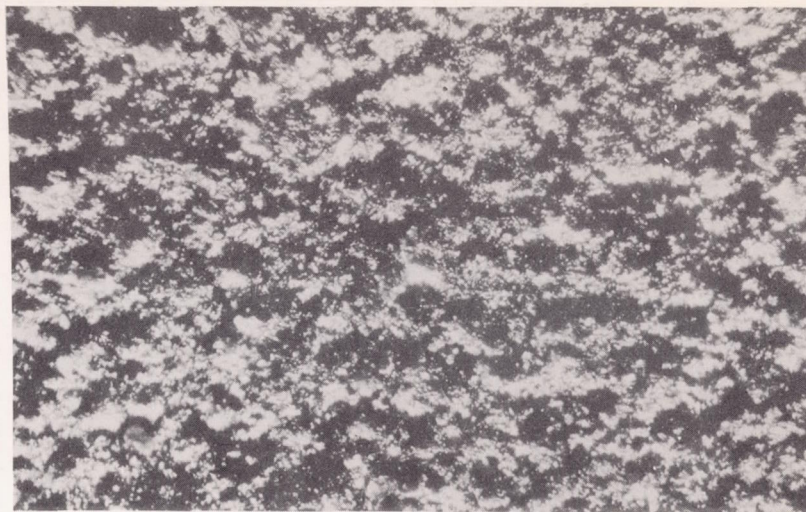
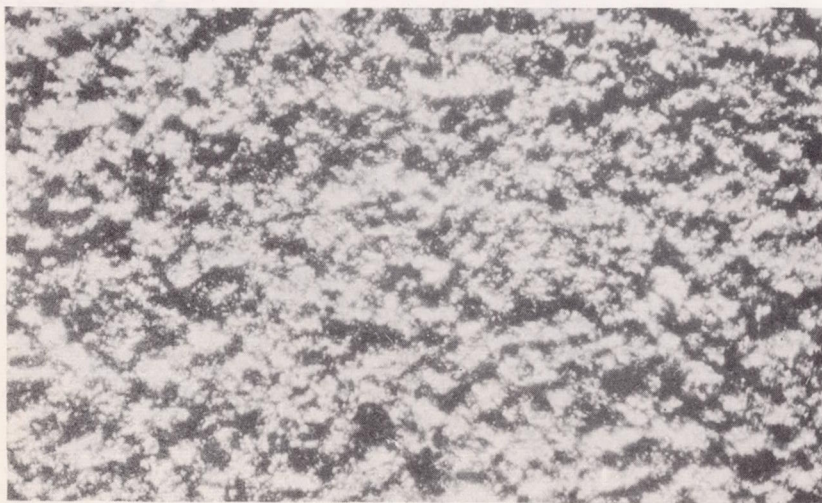
(a) Before starting treatment.

(b) After 200 hours.

(c) After 500 hours.

Figure 4.- Photomicrographs at 120X of coating A-309 on alloy S-816, showing little or no change during 500 hours of heating in air at 1500°F.

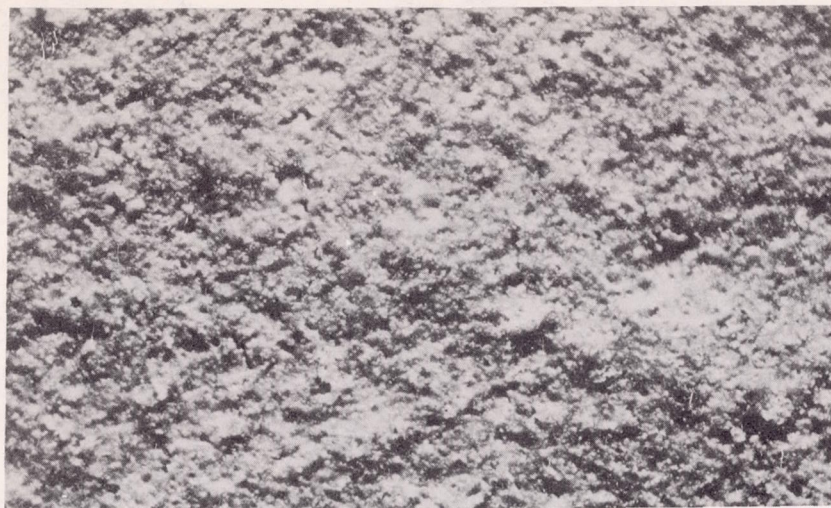
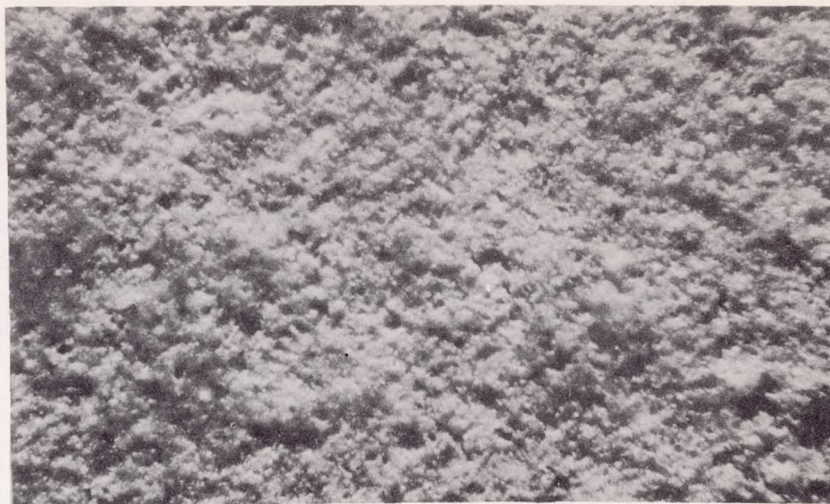
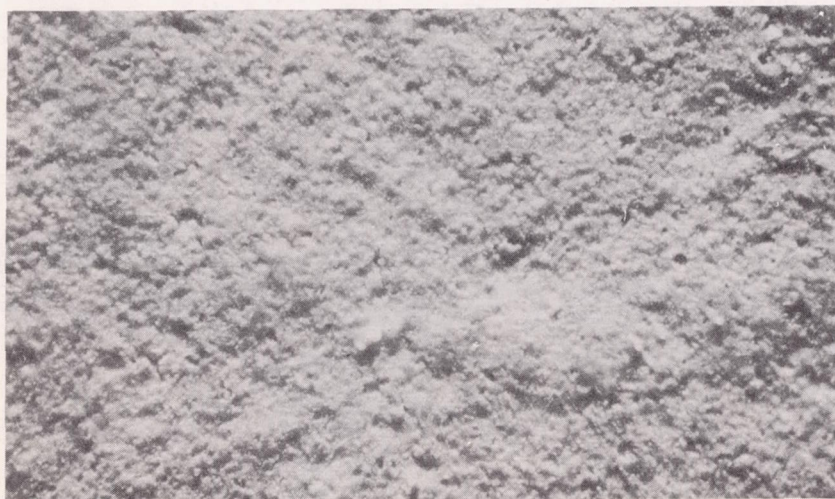
(a) Before heating.

(b) After 200 hours.

(c) After 500 hours.

Figure 5.- Photomicrographs at 120X of coating L-5AC on alloy S-816, showing a gradual healing of discontinuities initially present as the specimen was heated in air at 1500°F.

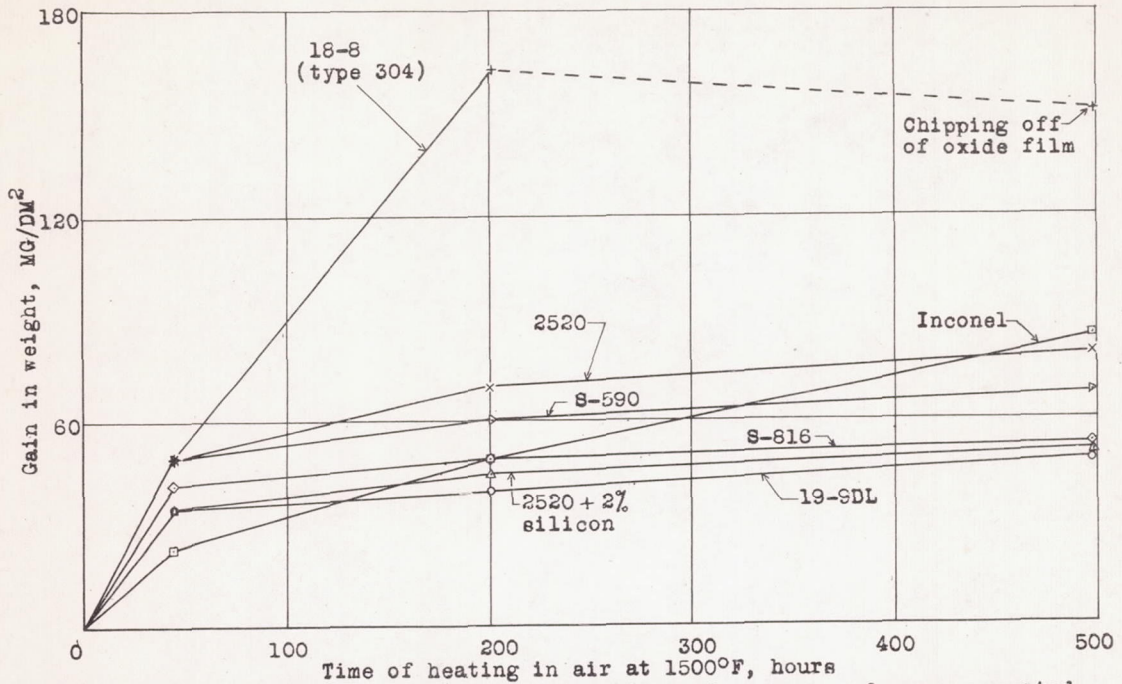
Figure 6.- Graph showing gain in weight, per unit surface area, of seven uncoated alloys due to oxidation during heating in air at 1500°F for 500 hours. The gain in weight of 18-8 alloy beyond 200 hours is not apparent because the oxide film flaked off in sufficient quantity to mask it.

For the specimens that did not undergo appreciable chipping and consequent vitiation of the significance of the results, a comparison of the gains in weight of uncoated specimens and the data obtained by weighing the coated specimens before and periodically during the heating tests indicated the degree of protection afforded the alloys against oxidation. Figure 6 shows change-in-weight curves of the seven uncoated alloys included in the latest test. Figure 7 shows similar curves of two specimens having coating L-4A fired to different stages of vitrification and an uncoated specimen of alloy S-590. The average thickness of the L-4A coatings was approximately 1 mil while that of the scale or oxide film on the bare alloy was about 0.3 mil. The advantage of the more vitrified (less porous) coating is demonstrated in this figure.

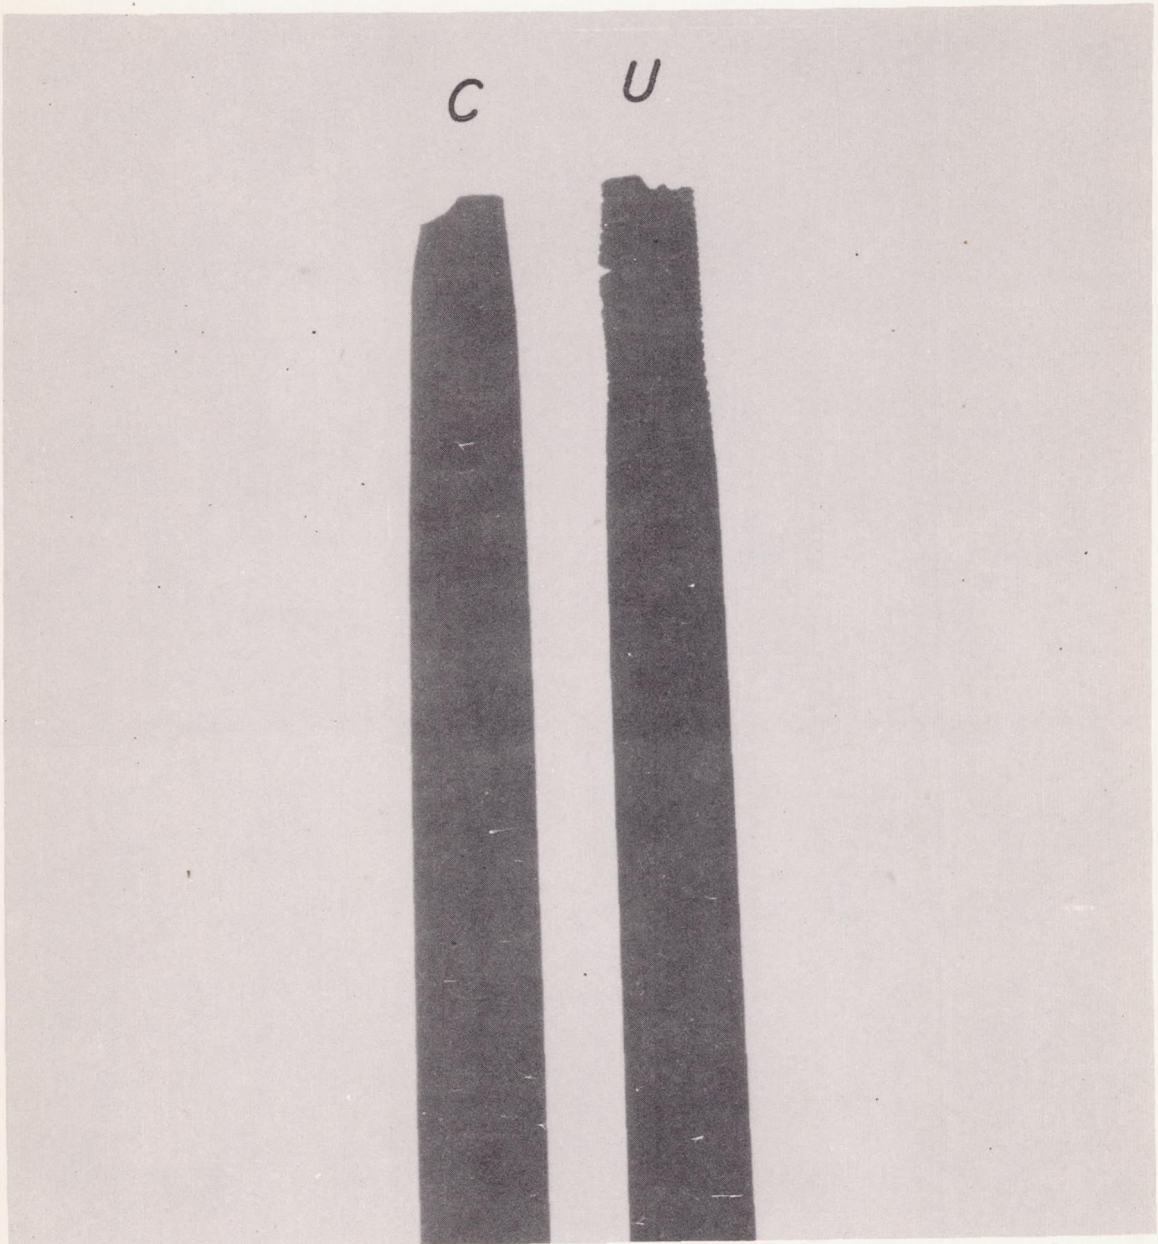
Figure 8.- Coated (C) and uncoated (U) specimens of 19-9 DL alloy held under tensile stress of 5,000 pounds per square inch at 1350°F for 172 hours and subsequently broken in a short-time tension test at 1350°F (table I, test 5). Note irregular silhouette (saw-tooth effect) of uncoated specimen resulting from widening of cracks produced in tension.

⁴ Arbitrary rating in which A indicates virtual absence of saw-tooth effect and D indicates severe saw-tooth effect (fig. 8).

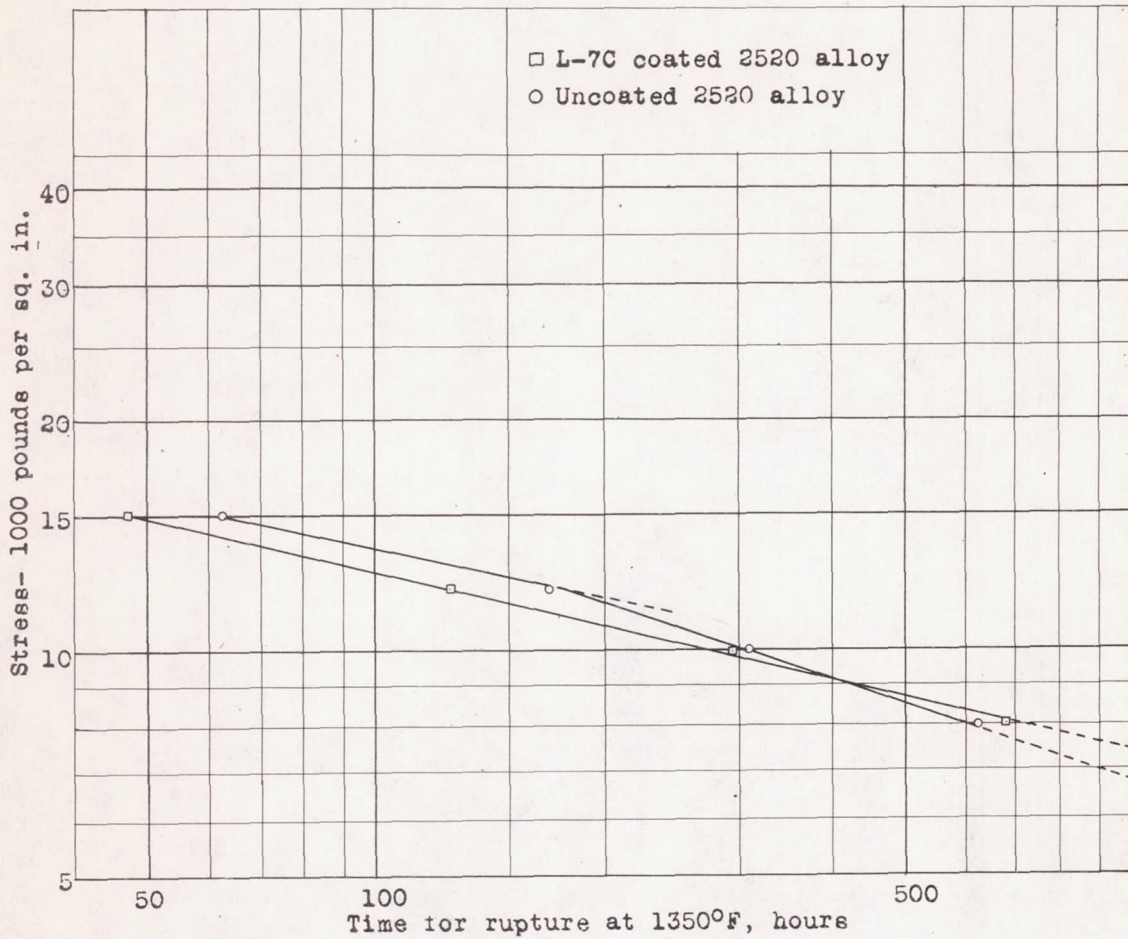
Figure 9.- Stress-rupture curves for uncoated and L-7C coated specimens of alloy 2520. Tests were made at 1350°F in air. Note that a "knee" occurs at 168 hours for the uncoated metal, but had not occurred for the coated specimens up to 672 hours.

coated specimens broke somewhat sooner at the high loads, but for the stress range within which the alloy might be used, this relation was reversed. A "knee" in the stress-rupture curve for the uncoated metal occurred at 168 hours, while for the coated specimens none had occurred up to 672 hours. The values for the L-6A coatings and the uncoated companion specimens are not comparable with those having coating L-7C as the firing temperatures for applying the coatings were different.

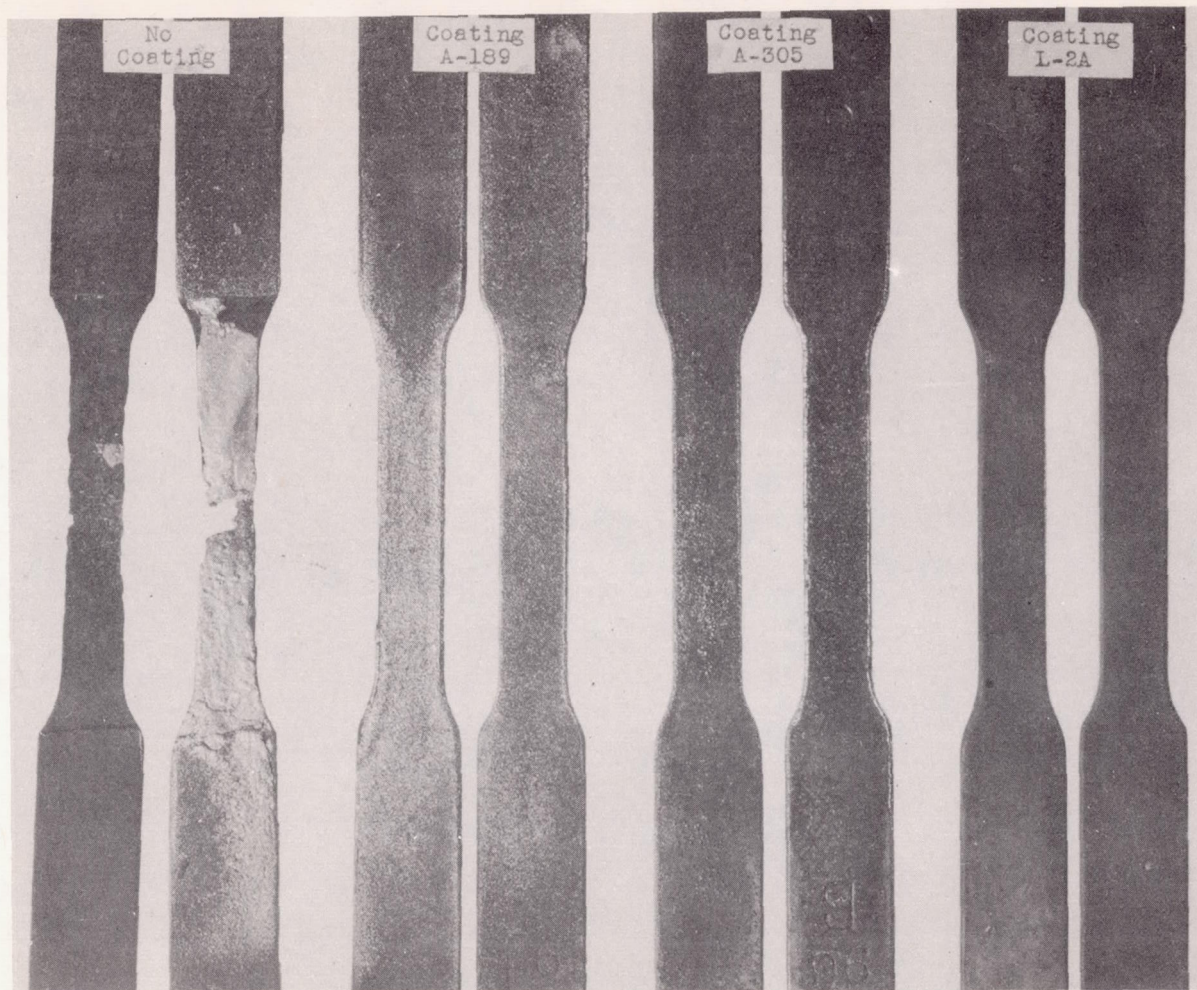
Figure 10.- Specimens of alloy S-590, coated and uncoated, which have been treated in an atmosphere of H_2S for 189 hours at $1350^{\circ}F$. The uncoated specimens at the left were almost completely corroded. The other three pairs of specimens have three different coatings as indicated, single coat at the left and double coat at the right in each pair. Attack through the coatings took the form of tubercules, which are apparent as light specks in the photograph. Note the decreasing number of such tubercules, indicating improved protective action of the coatings, from left to right.

Figure 10 shows the specimens of alloy S-590, coated and uncoated, that were treated in an atmosphere of H_2S for 189 hours at $1350^\circ F$. At the left are the uncoated specimens which were almost corroded through; one of them broke of its own weight during the treatment. The coated specimens show increasing degrees of protection from left to right.

The attack through coatings A-189 and A-305 took the form of tubercles, consisting probably of sulfides of the alloying elements, and these are apparent in figure 10 as white specks. Very few of them, if any, are visible on coating L-2A. The specimens with coating A-305 shown in figure 11 offer a favorable opportunity for a study of the mechanism of the attack. The locations of the tubercles on these specimens correspond to the locations of discontinuities in the coating, which were visible under the microscope before the H_2S treatment and which appeared to result from gas evolution during firing of the coating. Figure 11(a) shows the appearance of coating A-305 at a magnification of 30X before the tubercles had begun to form; 11(b) shows the early stages of tubercle formation and 11(c) a more advanced stage. With continued treatment, growth of the nodules continues. The selective attack on the metal is illustrated in figures 12(a) and 12(b), which are photographs taken at 30X after the coating was removed by sandblasting. Figure 12(a) corresponds to 11(a), and 12(b) to 11(c). Figure 12(b) shows cavities resulting from selective attack where discontinuities occurred in the coating. Figure 12(c), which is a photomicrograph of coating L-2A as shown in figure 10, illustrates the appearance of a coating that gave successful protection of the alloy against the attack by H_2S at $1350^\circ F$. Figure 12(c) should be contrasted with figure 11(c).

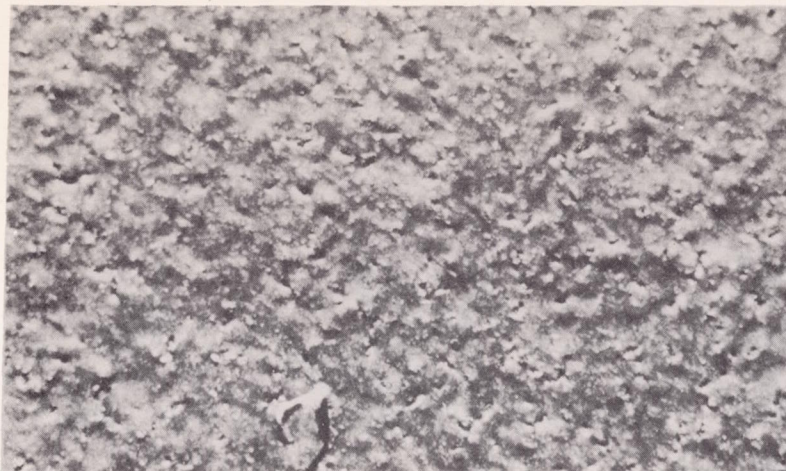
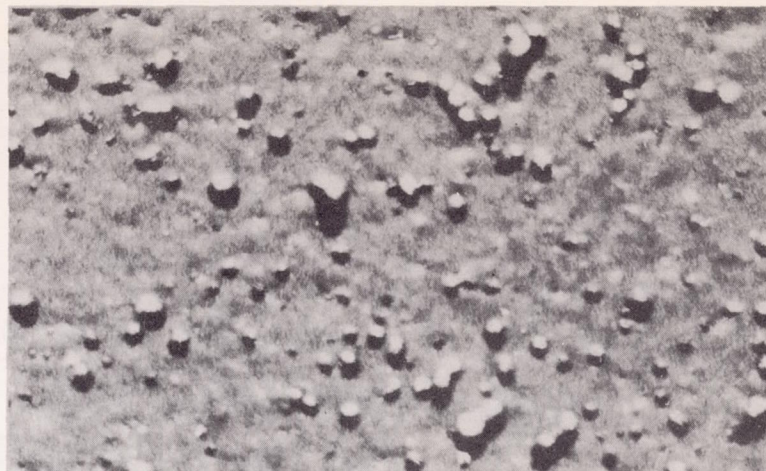
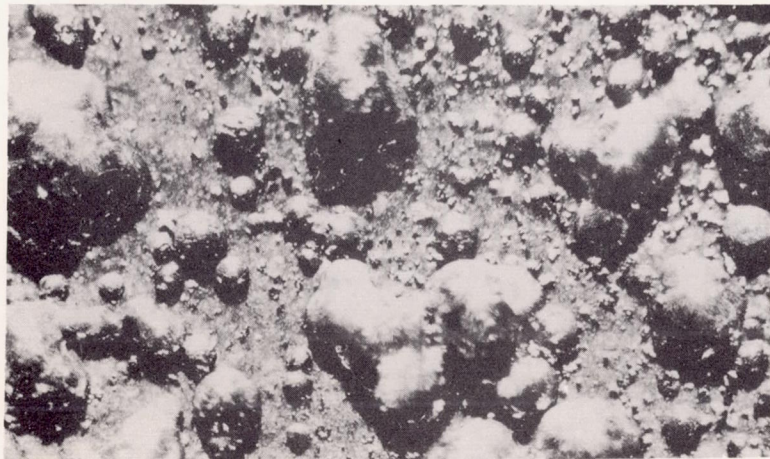
(a) Condition of coating before tubercules had begun to form. Note discontinuities in the coating (probably caused largely by gas evolution from the metal during the firing process).

(b) Early stage of tubercule formation.

(c) Advanced stage of tubercule formation.

Figure 11.- Photomicrographs at 30X, showing development of tubercules. Areas shown are from specimen with coating A-305 (see fig. 10), which was treated at 1350°F in H₂S for 189 hours. Locations of the tubercules are controlled by the locations of the original discontinuities.

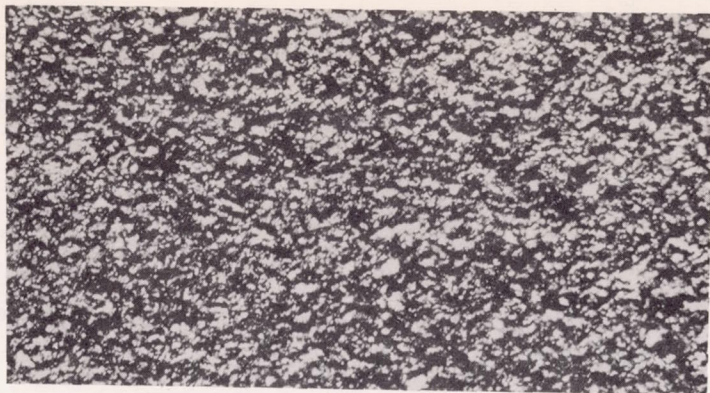
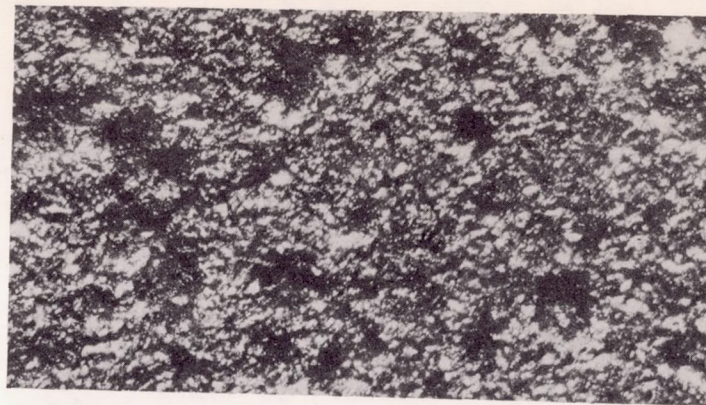
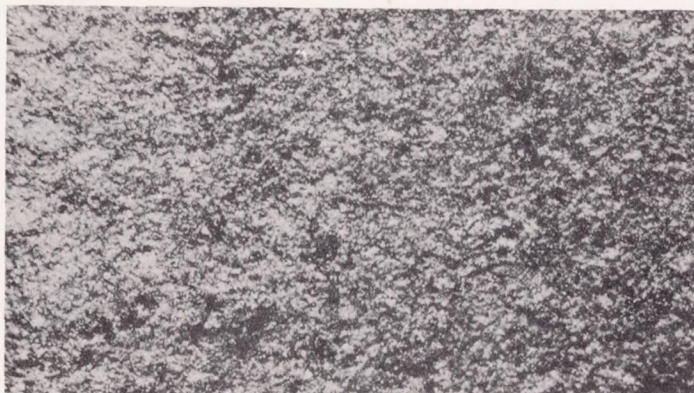
(a) No tubercles yet formed; corresponds to figure 11a.

(b) Cavities in the alloy beneath the tubercles caused by attack of the H_2S atmosphere at $1350^{\circ}F$; corresponds to figure 11c.

(c) 30X magnified view of coating L-2A (see fig. 10) which withstood treatment with little or no formation of tubercles. This photomicrograph should be contrasted with figure 11c, which is a magnified view of coating A-305 (see fig. 10) after formation of tubercles.

Figure 12.- Photomicrographs at 30X, showing appearance of specimens shown in figure 11 after removal of coating by sand-blasting.
