NATIONAL ADVISORY COMMITTEE FOR AERONAUTICS

TECHNICAL NOTE

No. 1132

AN ELECTRON-MICROSCOPE STUDY OF USED
NITRIDED-STEEL PISTON RINGS

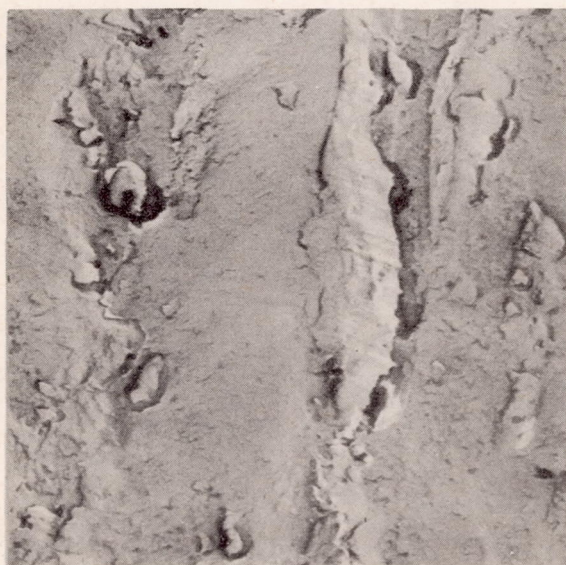
Figure 14. - Electron micrograph of cross section of used nitrided-steel piston ring showing nitrided case below worked-crystal area. Etched in nital. X10,000.

An actual coating area, which gave a visible cross section such as can be seen in a photomicrograph, often extended beyond the limits of the field available in the electron microscope. Figure 16 shows the edge of such a coating area. The smooth coating occupies the lower half of the figure and the area of strained crystal edges slopes down from the coating plateau to a surface visible at the top of the picture, which resembles the unworked case crystals in figure 14.

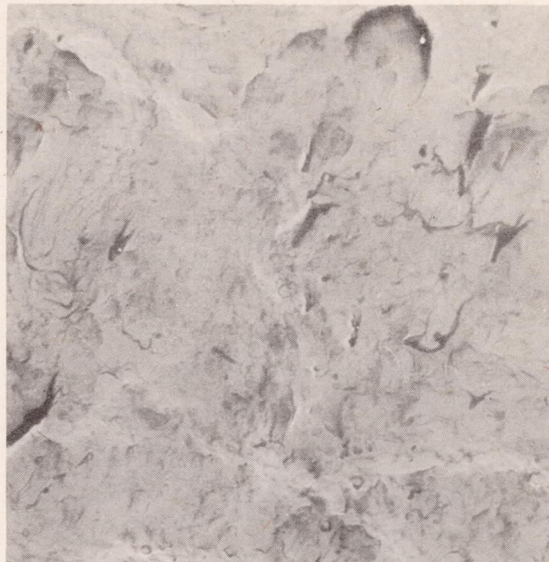
Figure 19. - Electron micrograph of running face of new nitrided-ring showing unworked surface area. Etched in potassium hydroxide. X10,000

after using nital. This difference can be seen by comparing figures 15 and 18. Unworked surface areas, on the other hand, were severely attacked but no preferential etching was apparent. The uniform pebble-grained etch characteristic of this type of area is shown in figure 19.
