TECHNICAL NOTES
NATIONAL ADVISORY COMMITTEE FOR AERONAUTICS

No. 736

TIDEWATER AND WEATHER-EXPOSURE TESTS ON METALS
USED IN AIRCRAFT

By Willard Mutchler and W. G. Galvin
National Bureau of Standards

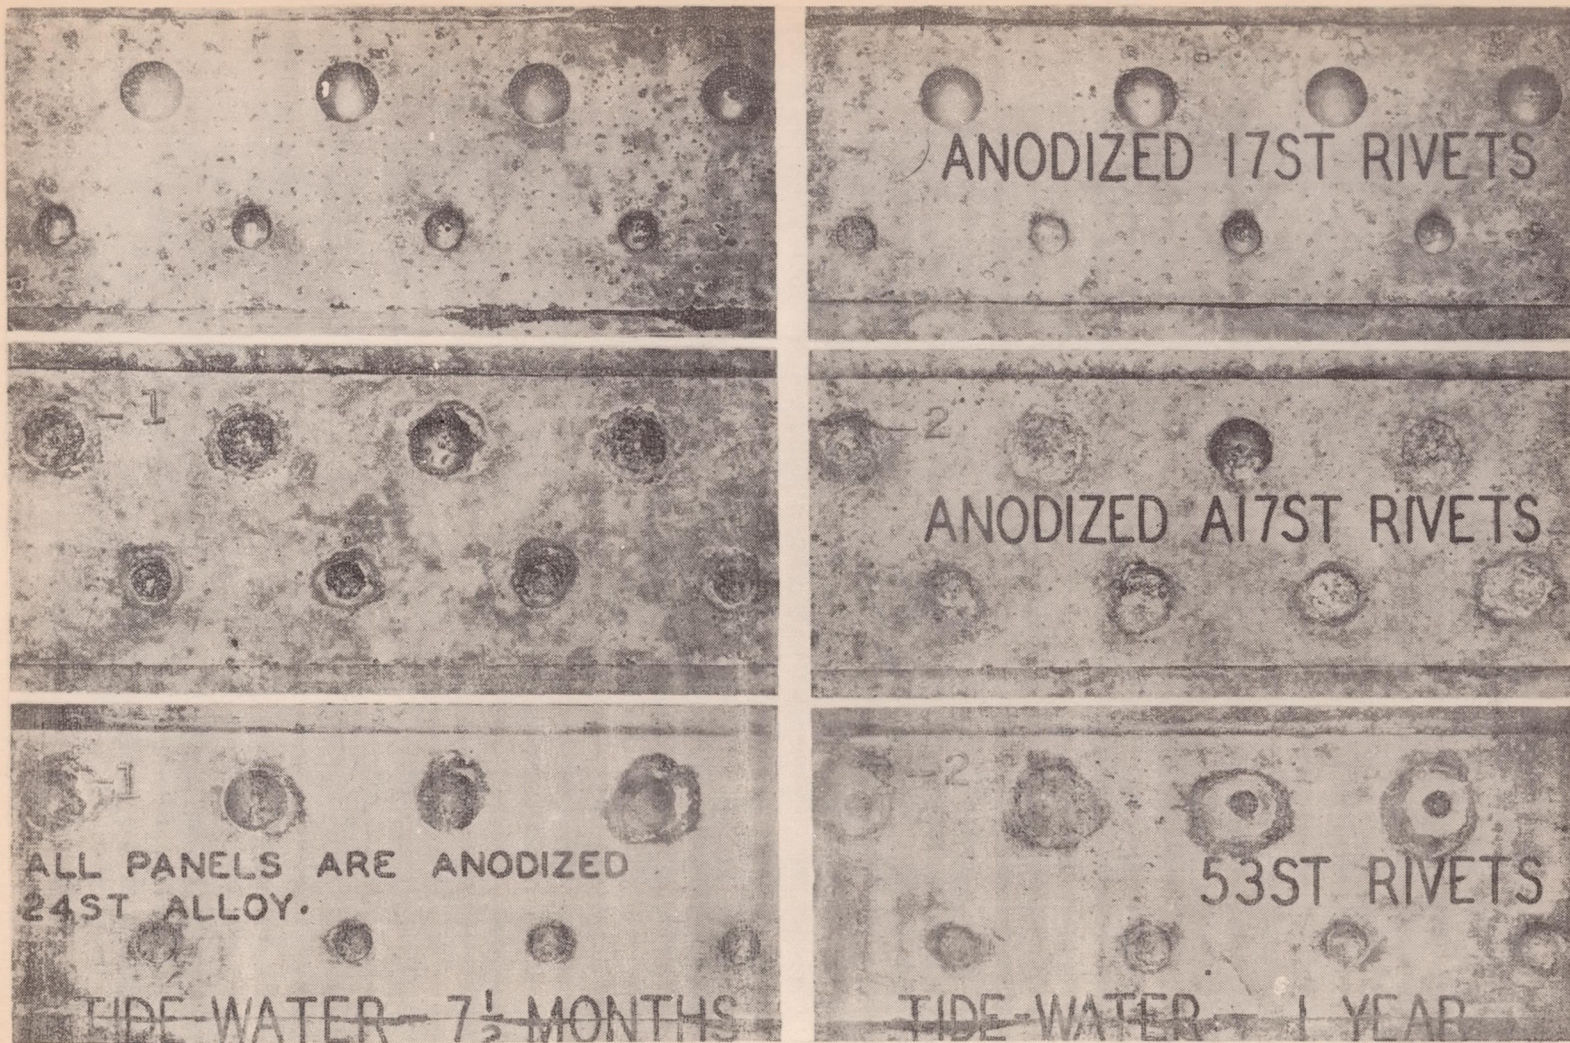
Figure 4.- Rivets used on anodized 24ST alloy panels exposed to tidewater. Note the severe corrosion on anodized A17ST and 53ST rivets, and the relatively slight attack on anodized 17ST rivets. In this, and all of photographs which follow, the large letters at the right apply to the entire horizontal rows, while those at the tops or bottoms apply to the entire vertical rows. $\times 1$

Withdrawals of the riveted aluminum-alloy panels were made after 7-1/2 and 12 months in the tidewater tests and after an exposure of 12 months to the weather. The tidewater tests disclosed that both the anodized A-17ST and the 53ST rivets were anodic with respect to 24ST alloy. Corrosive attack was very severe, especially on the 53ST rivets, from which at the end of a year several heads had corroded completely off (fig. 4). On the other hand, corrosion of the anodized 17ST rivets used with 24ST alloy was only in its initial stage after 1 year's exposure. No attack whatever was observed after a year in tidewater on any of the rivets tested when they were used to join alloys 52S-1/2 H, 53ST, or Alclad 24ST (fig. 5). Hence, the differences in potentials involved for these combinations, in salt water, are either very small or the alloy of which the main panel

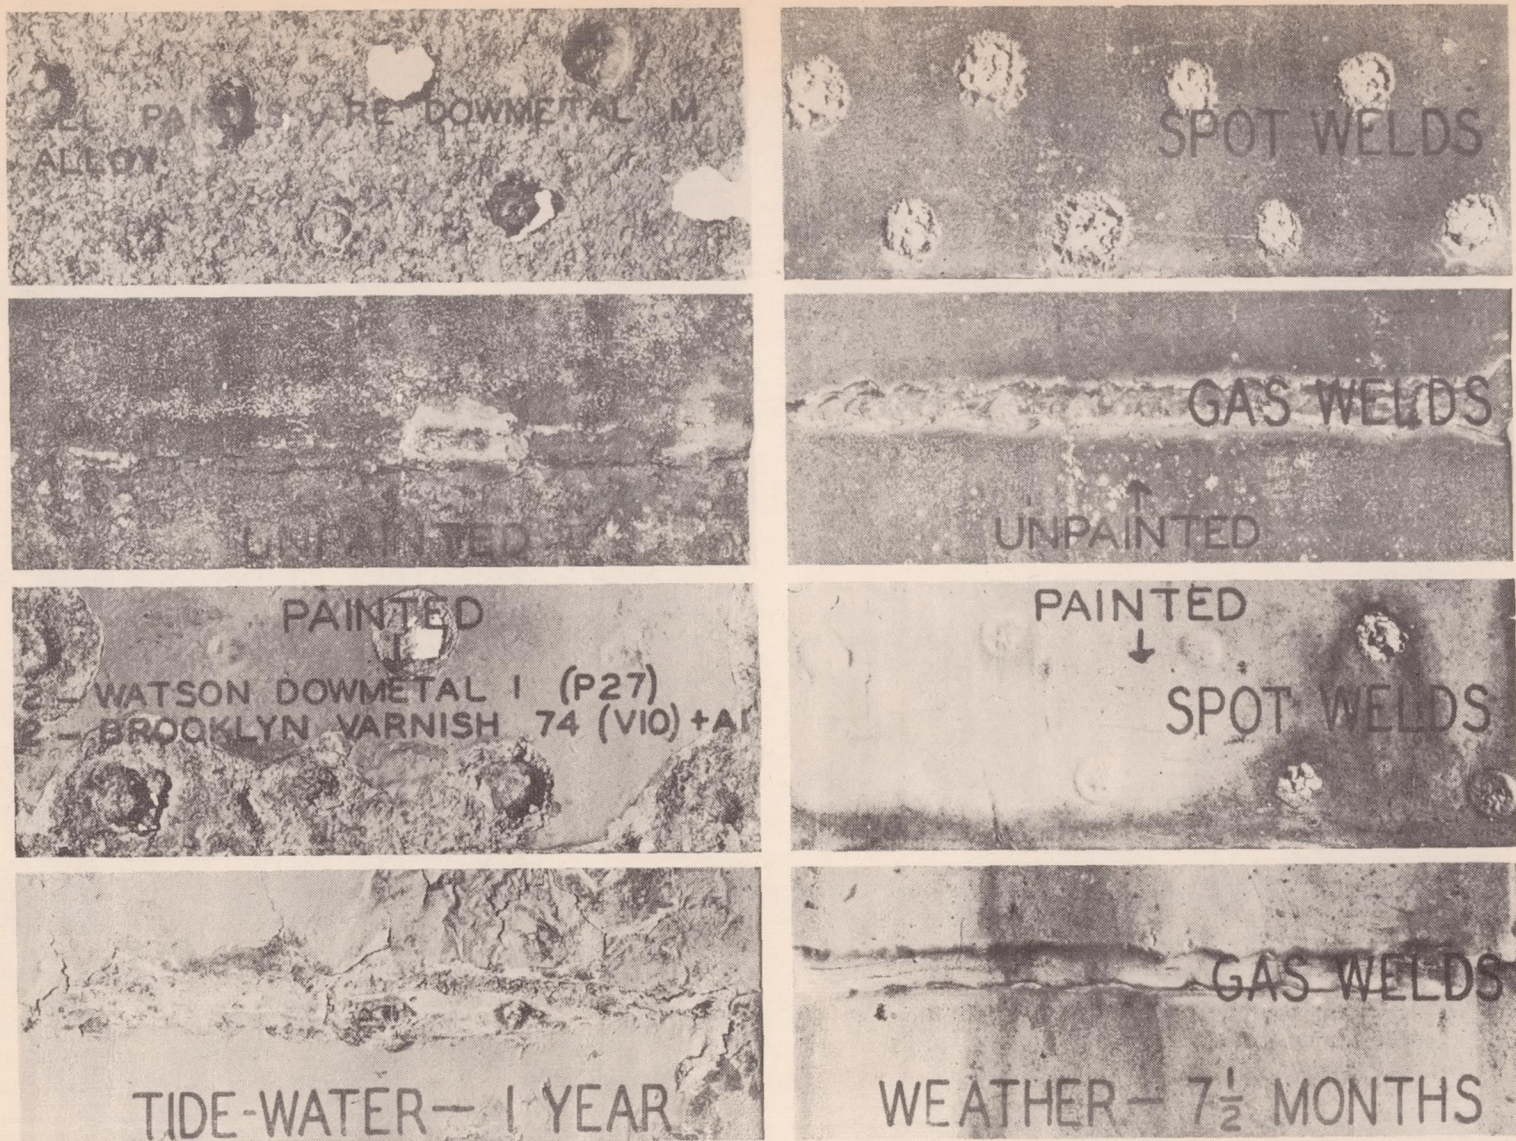
Figure 12.- Welded Dowmetal M alloy panels exposed to tidewater or to the weather. The spot welds were very susceptible to attack, but the gas welds were quite resistant. $\times 1$

Welded magnesium-alloy panels.— The behavior of Dowmetal M alloy, anodized after welding, is illustrated in figure 12. It will be noted that, at the end of a year in the tidewater tests, the spot welds were severely attacked, both on painted and unpainted panels. Corrosion began within 2 days after installation on the unpainted spot welds and within a month on the painted spot welds. Corrosion at the unpainted gas welds was no worse than on the rest of the panel but, on the painted panel, failure occurred at the weld. The superiority of gas-welded over electric-resistance spot-welded Dowmetal M was also apparent from the weather-exposure test (fig. 12), but the attack was less severe.

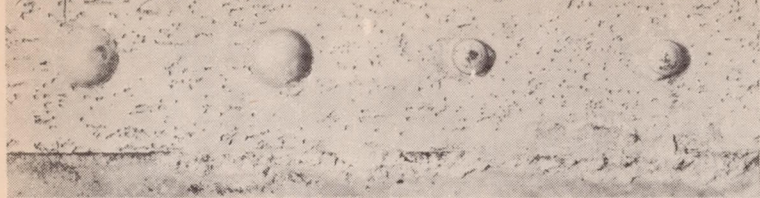
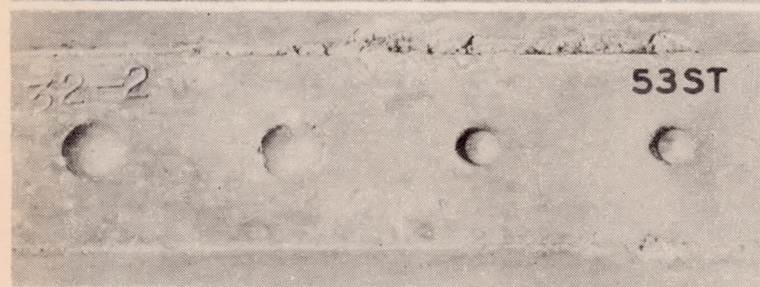
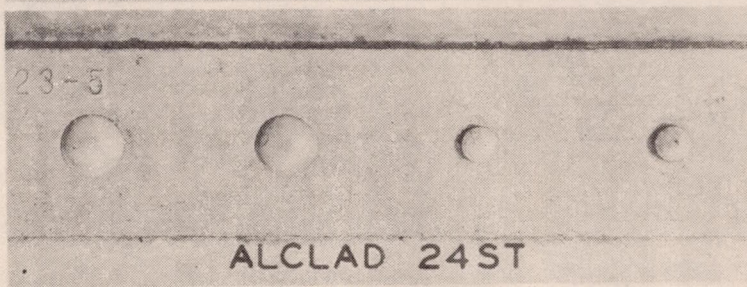
Note: - All rivets are ANODIZED 17ST.
EXTRUDED

Figure 14.- Panels exposed to tidewater and having 24ST material in contact with other aluminum alloys, which were anodic to it. Note the very severe pitting on the 52S-1/2H strip and the differences in behavior depending on which alloy had the greater area. $\times 1$
